Client Name: **Treble Cone Ski Area**

Report: **May 2018 Annual Bridge Inspection Report & Review of Bluffs above**

Site Address: **Treble Cone Ski Area Access Road, Wanaka**

Date Issued: 10 July 2018

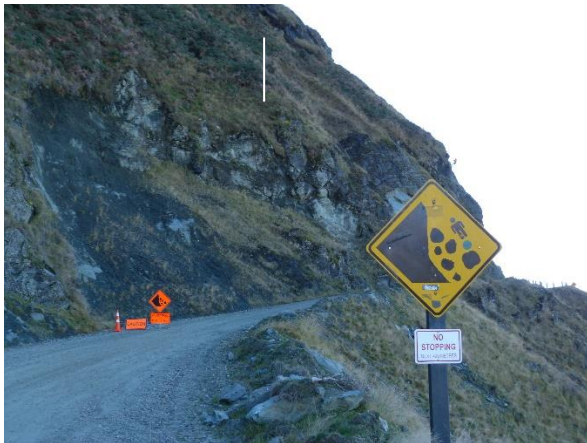
Photo 1 – new no stopping sign (uphill approach)

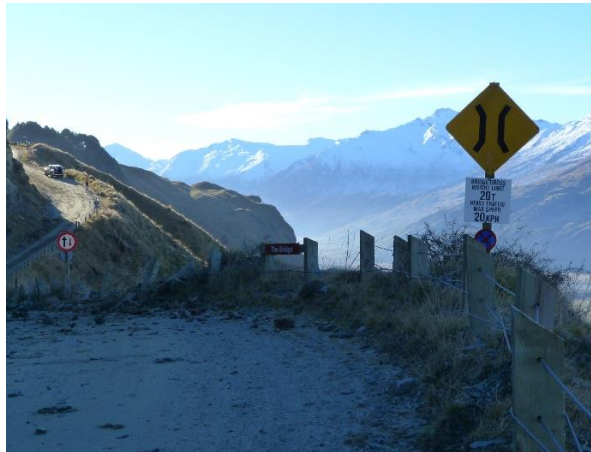
Photo 2 – Speed/weight limit (uphill approach)

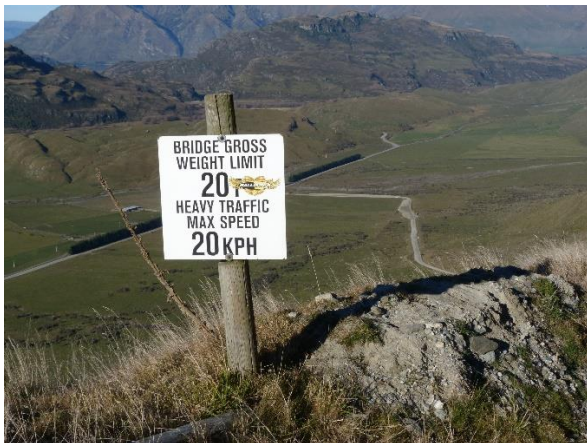
Photo 3 – Speed/weight limit (downhill approach)

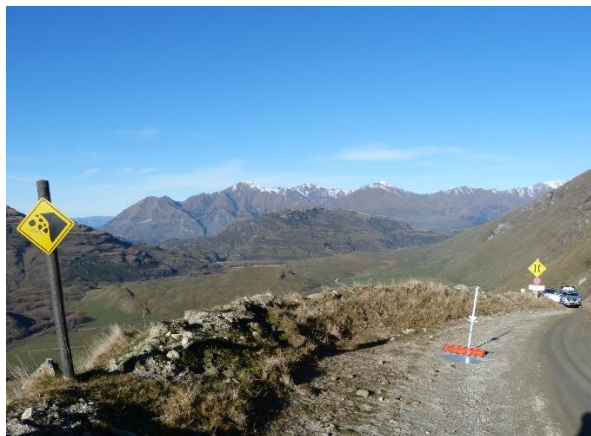
Photo 4 - signage (downhill approach)

- j. Signage in place including new 'No Stopping' sign installed in 2017 (see Photos 1. – 4. above). Noted that the uphill approach rock fall sign is wrong handed (upside down) and 'No Stopping' plaque missing.

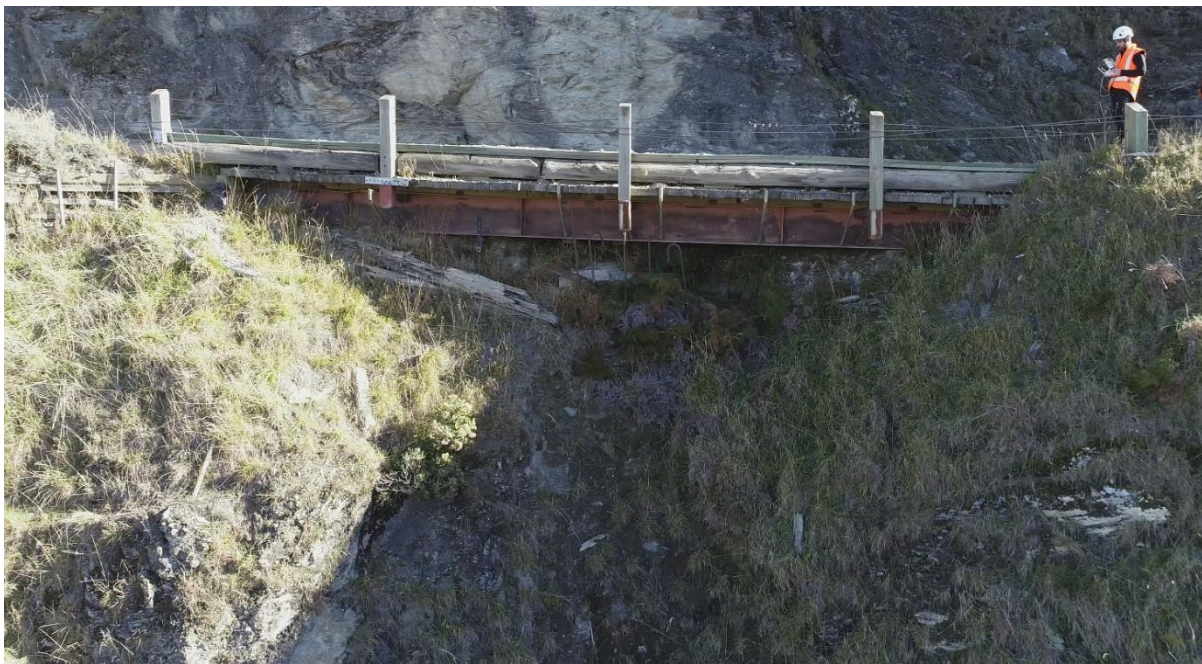
- c. Area adjacent abutments and beam support areas under the bridge relatively dry with no evidence of any issues / undue movement / degradation / water flow or silt build up and no apparent regression of the surface slip. This area has considerable grass growth indicating the area is not being constantly flushed with water (see Photos 5., 10. & 11. below).

Photo 5 – No indication of movement / slips around abutment or old sluff area

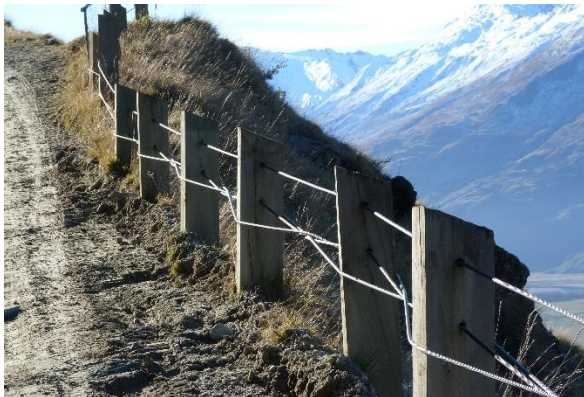
Photo 6 – Guard cables relatively tight

5. Visual check of all cable clamps to the wire ropes on the outer edge along its length including at anchor block locations.
6. There has previously been a weekly inspection regime established for the bridge and Bluffs area (to be inspected throughout the season by no more than 3 specific individuals). The three particular areas are shown in Photo 16 (Grid references provided – see Appendix for plan showing Grid elevation). PLEASE NOTE: This inspection is to occur directly following significant rain events or as scheduled. Please provide photo evidence of a completed inspection sheet and names of the 'inspectors' for the initiation of the season.
Contacts for any queries related to inspections / observations are Leon Gerrard (Geosolve – 0204 076 4510) or Graham McDougall (BMC – 027 440 1926)

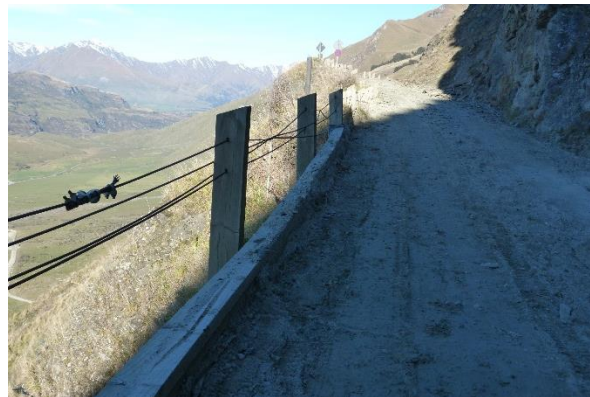
- d. The road gravel depth over the bridge boards is greater than 150mm on the outer edge and it is possible for a wheel to climb the side guard logs / board (see Photo 8. Same issue as last year

Photo 7 – Hardfill to deep next to guard log

1. The overall depth of the hardfill on the deck is too high on the outer edge such that the log & top edge board will not be effective in deflecting a wheel into the road (rather than climbing over it). There still needs to be a small cross fall to the inside and the overall minimum depth of hardfill is best known to the roading contractor.
2. The concrete dish between the last bridge board and the vertical bluff face needs to be exposed such that water will flow down it (toward the west) and into the entry area for the drainage pipe that goes under the road.

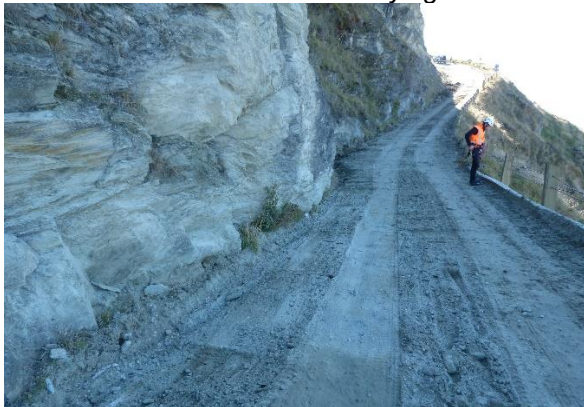
- e. The concrete dish channel that has been installed to exit beyond west/uphill end of bridge pipe has been completely covered with hardfill (see Photo 8. below). Similar issue as last year.

Photos 8 – Concrete Dish channel blocked

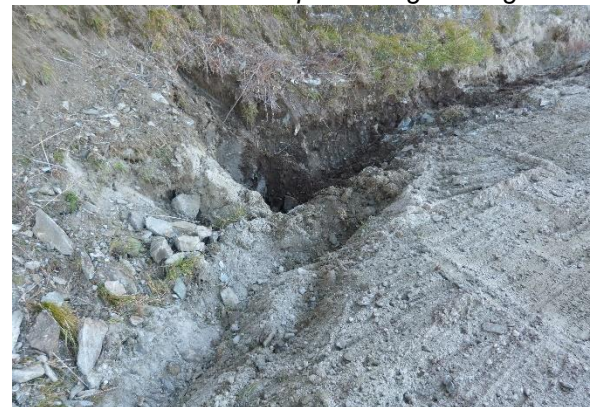
- f. The sump area for the exit pipe from the concrete dish channel ((located at uphill end of bridge) was completely filled in and needs to be cleaned out (see Photo 9. below). Similar issue to last year.

Photos 9 – Dish channel sump area filled in

3. This drainage pipe that allows runoff to flow under the road at the west end of the bridge (from the inside edge of the road against the bluffs) has been filled in and needs to be dug out, shaped and lined with some stone to prevent erosion, the pipe end exposed and the pipe cleaned out of debris / silt.

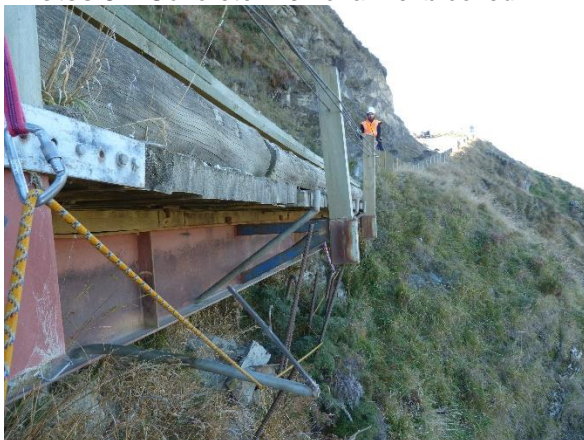
Photos 10 & 11 – No apparent further regression of 'sluff' under washing of silt under uphill end

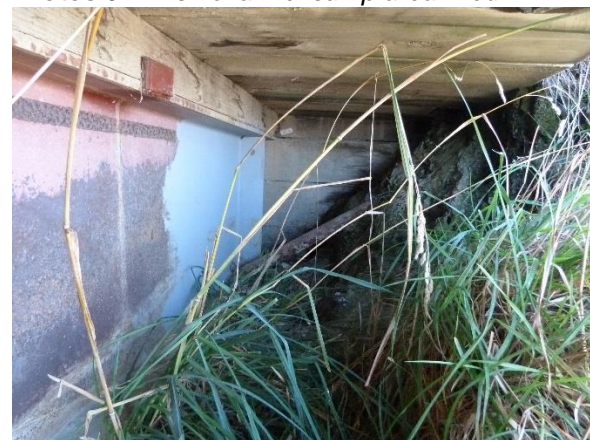
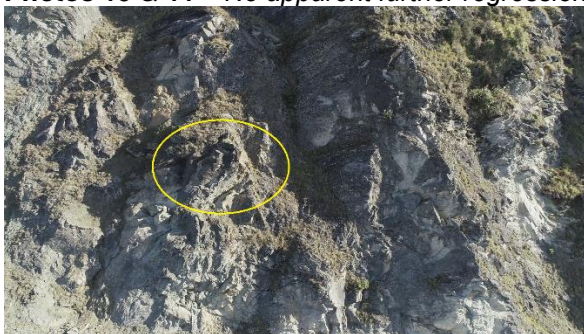
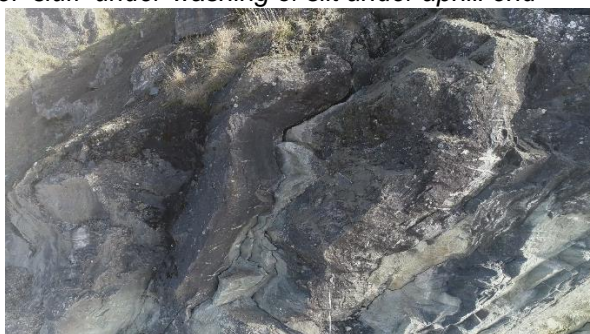
- h. Scaling works were in progress in apparent active areas of Bluff face.
- i. Drone was operated close to rock face and generally over the face. Images viewed on site have subsequently been reviewed by Leon Garrard (Geosolve) from link provided by BMC to Leon on 08/06/2018. The same area of potential instability identified in 2016 & 17 appears to have some soil erosion at the head with potential loosening of boulders there (see Photos 12.- 16. below). These areas to be closely watched.

Photo 12 & 13 – Bluff area Grid reference C1 (see BMC Bluff Elevation drawing G01 Rev C attached as Appendix), to be monitored in 2018 (in particular)

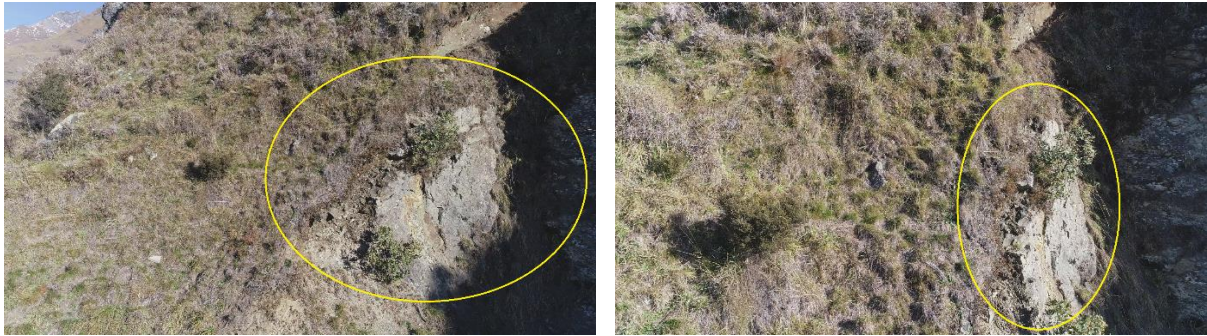
Photos 14 & 15 - Bluff area Grid reference B3 (see BMC Bluff Elevation drawing G01 Rev C attached as Appendix), to be monitored in 2018 (in particular)

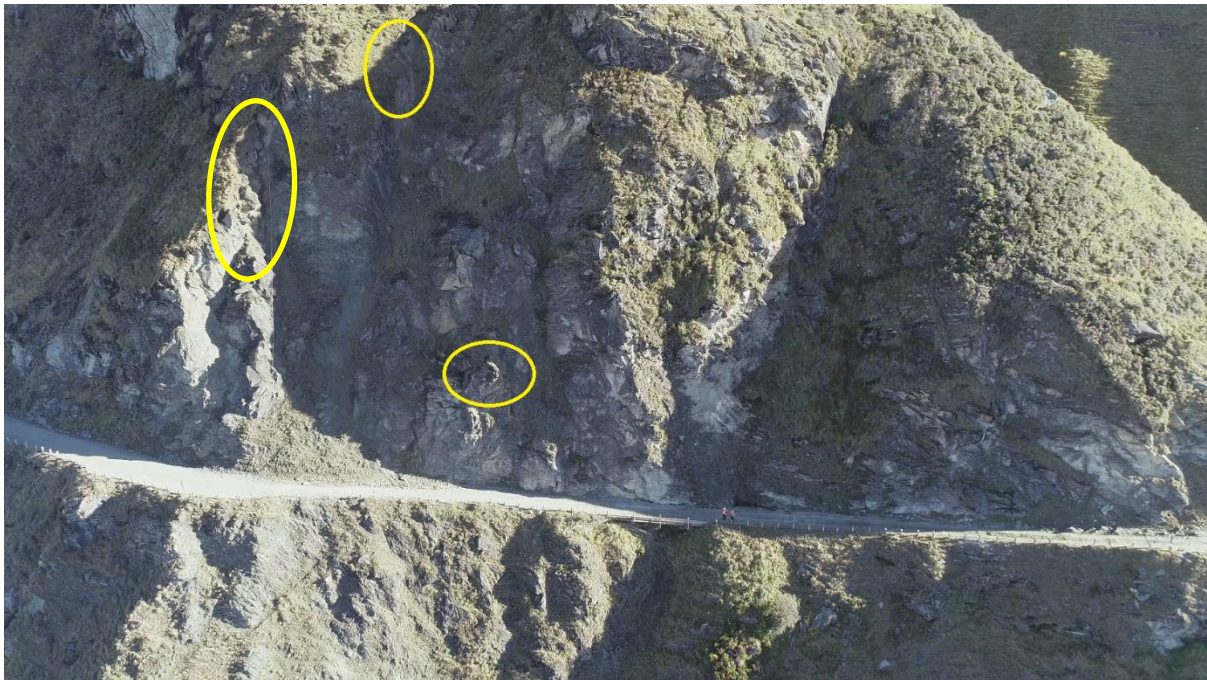
Photo 16 – Three particular areas to be monitored in 2018, also includes Grid reference A2 adjacent the measurement waratahs (far left circle on photo above)
