Geotechnical Risk- Restoration & Rebuild
of Reefton's Historic Power Project

5/30/2013

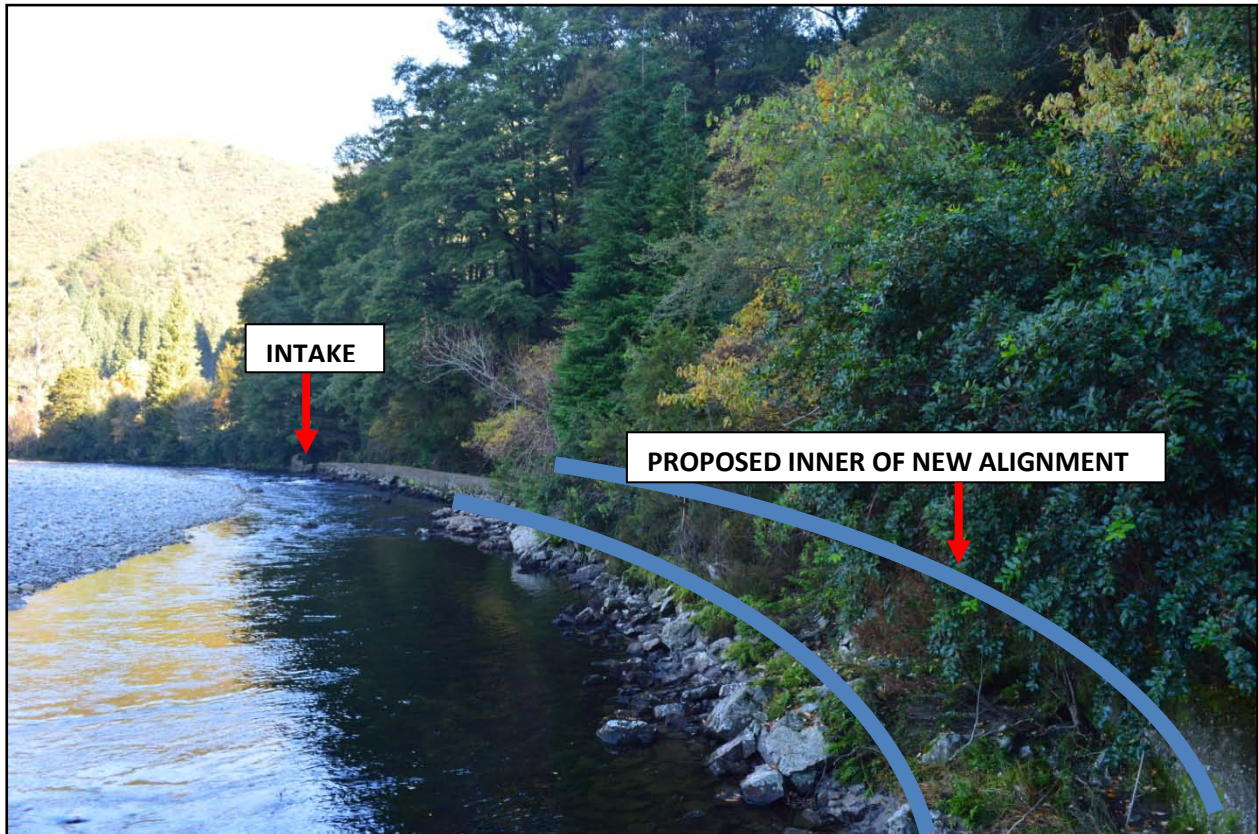
- A colluvium slip (containing angular material from a close to source location), has come down from the bank above and deposited inside of the concrete canal. Vegetation is established on top of the slip and has stabilised the surface material for the time being.

- It is clear from bulging seen on the bank side of the concrete canal, at the downstream end of the slip that the canal has acted as a bunding to stabilise the toe of the slip at some stage. Bulging at the toe indicates pushing from behind, and may be a sign of that it was not simply an overtopping of material from above, but also of lateral spreading, which could indicate a larger unstable mass than what is evident at the surface. The nature of the concrete used looks to be low quality and unreinforced, this could have contributed to what is seen at the surface (essentially due to lack of structural strength).

- It is not known from the first pass review how far back into the bank until bedrock is intercepted, however there is competent bedrock outcropping in the stream.

Figure 2. Photograph of site 2, the intake can be seen in the background of the photograph, with the slip over concrete canal in the frontage of the photo. Note, new alignment is not drawn to scale.

- Based on the current proposal for the reinstatement of this section of canal, Geotech Ltd suggest that when works begin, a timeframe when low river flows are expected should be used, a ramp is constructed using river material on the outer (river) side of the canal to gain access to the site should be constructed (after excavation natural scour should remove this material). Excavation should be carried out by a 20 T hydraulic excavator. Assessing of the concrete walls should be carried out during excavation of the in filled section of the canal, under careful supervision of an engineer with suitable experience, along with some basic survey to monitor any movement that may occur on the slope. It is suggested that a structurally reinforced section of concrete replaces the bank side concrete wall to minimize any future bulging which may occur as a result of future bank failures in this section. Rip-rap should be placed on the bank above the concrete canal in an effort to put weight on the toe of the slip. With this option Geotech Ltd stresses that excavation of the historic canal at site 1, may induce unforeseen geotechnical failure which will be difficult to budget for, and cannot back that the removal of this material will not adversely affect the current landscape above.

- Geotech Ltd suggest that the a new straightened alignment around this slip is installed, which will have minimal impact on the existing canal structure; with the exception of a diversion upstream and downstream of the slip, and therefore the historic integrity of the scheme will remain intact, and there will be minimal risk of inducing failure of the slip above. Design of the proposed new alignment seen in Figure 2 should include the placing of rip rap above the new bank side of the canal to reduce the possibility of further natural failure of the slip. Costing for such a project will be simplified, as there will be less financial risk associated with the unknown ground conditions which may be encountered with the above proposal. Concerns have been raised with regards to the impact on the river that this might

cause for neighboring properties, but two points should be brought up here, since the scheme was abandoned the riverbed has lowered more than a meter according to Watson (2013), and that water will be essentially still travelling in the current location, but will be segregated (i.e. within the canal and in the natural river course). *It is recommended that this is peer reviewed by a hydrologist to provide support on rationality.*

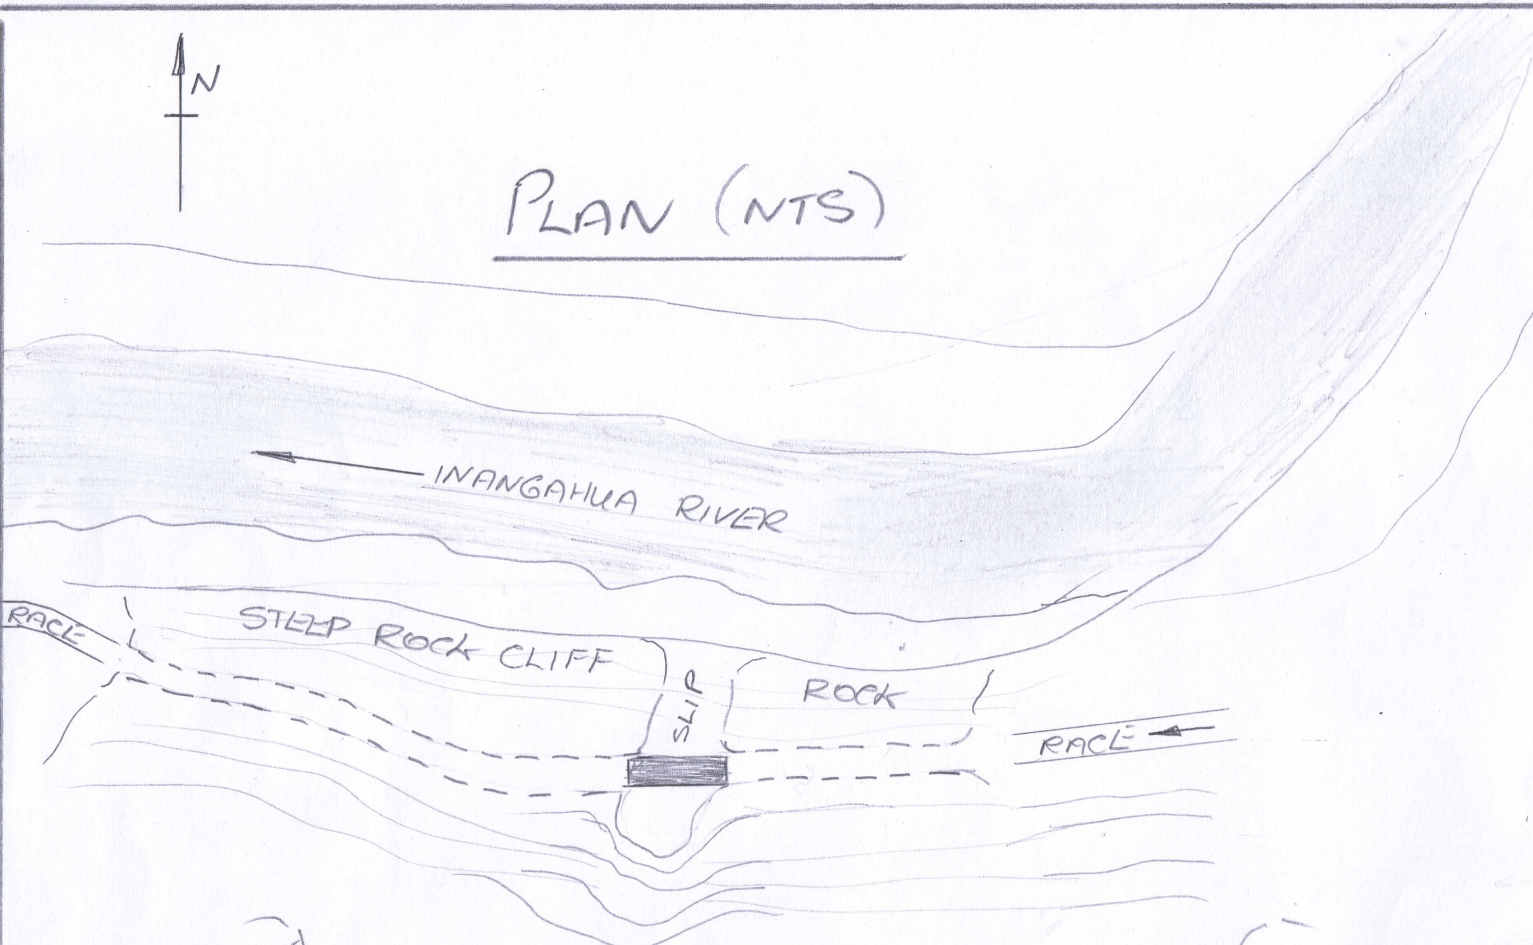
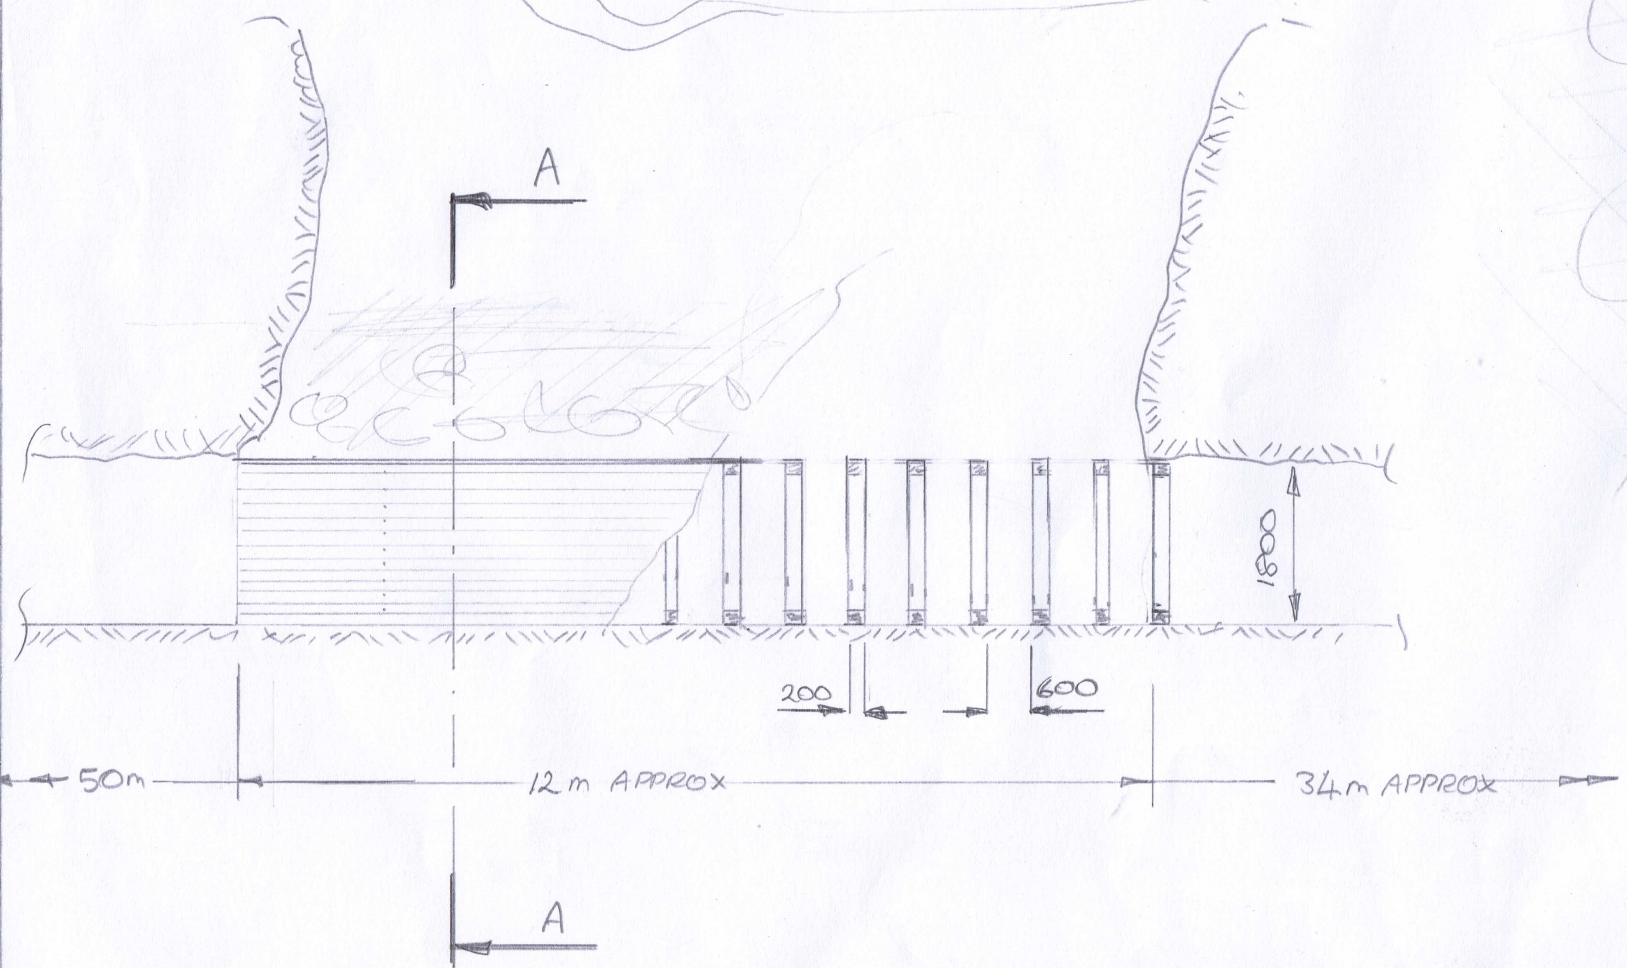
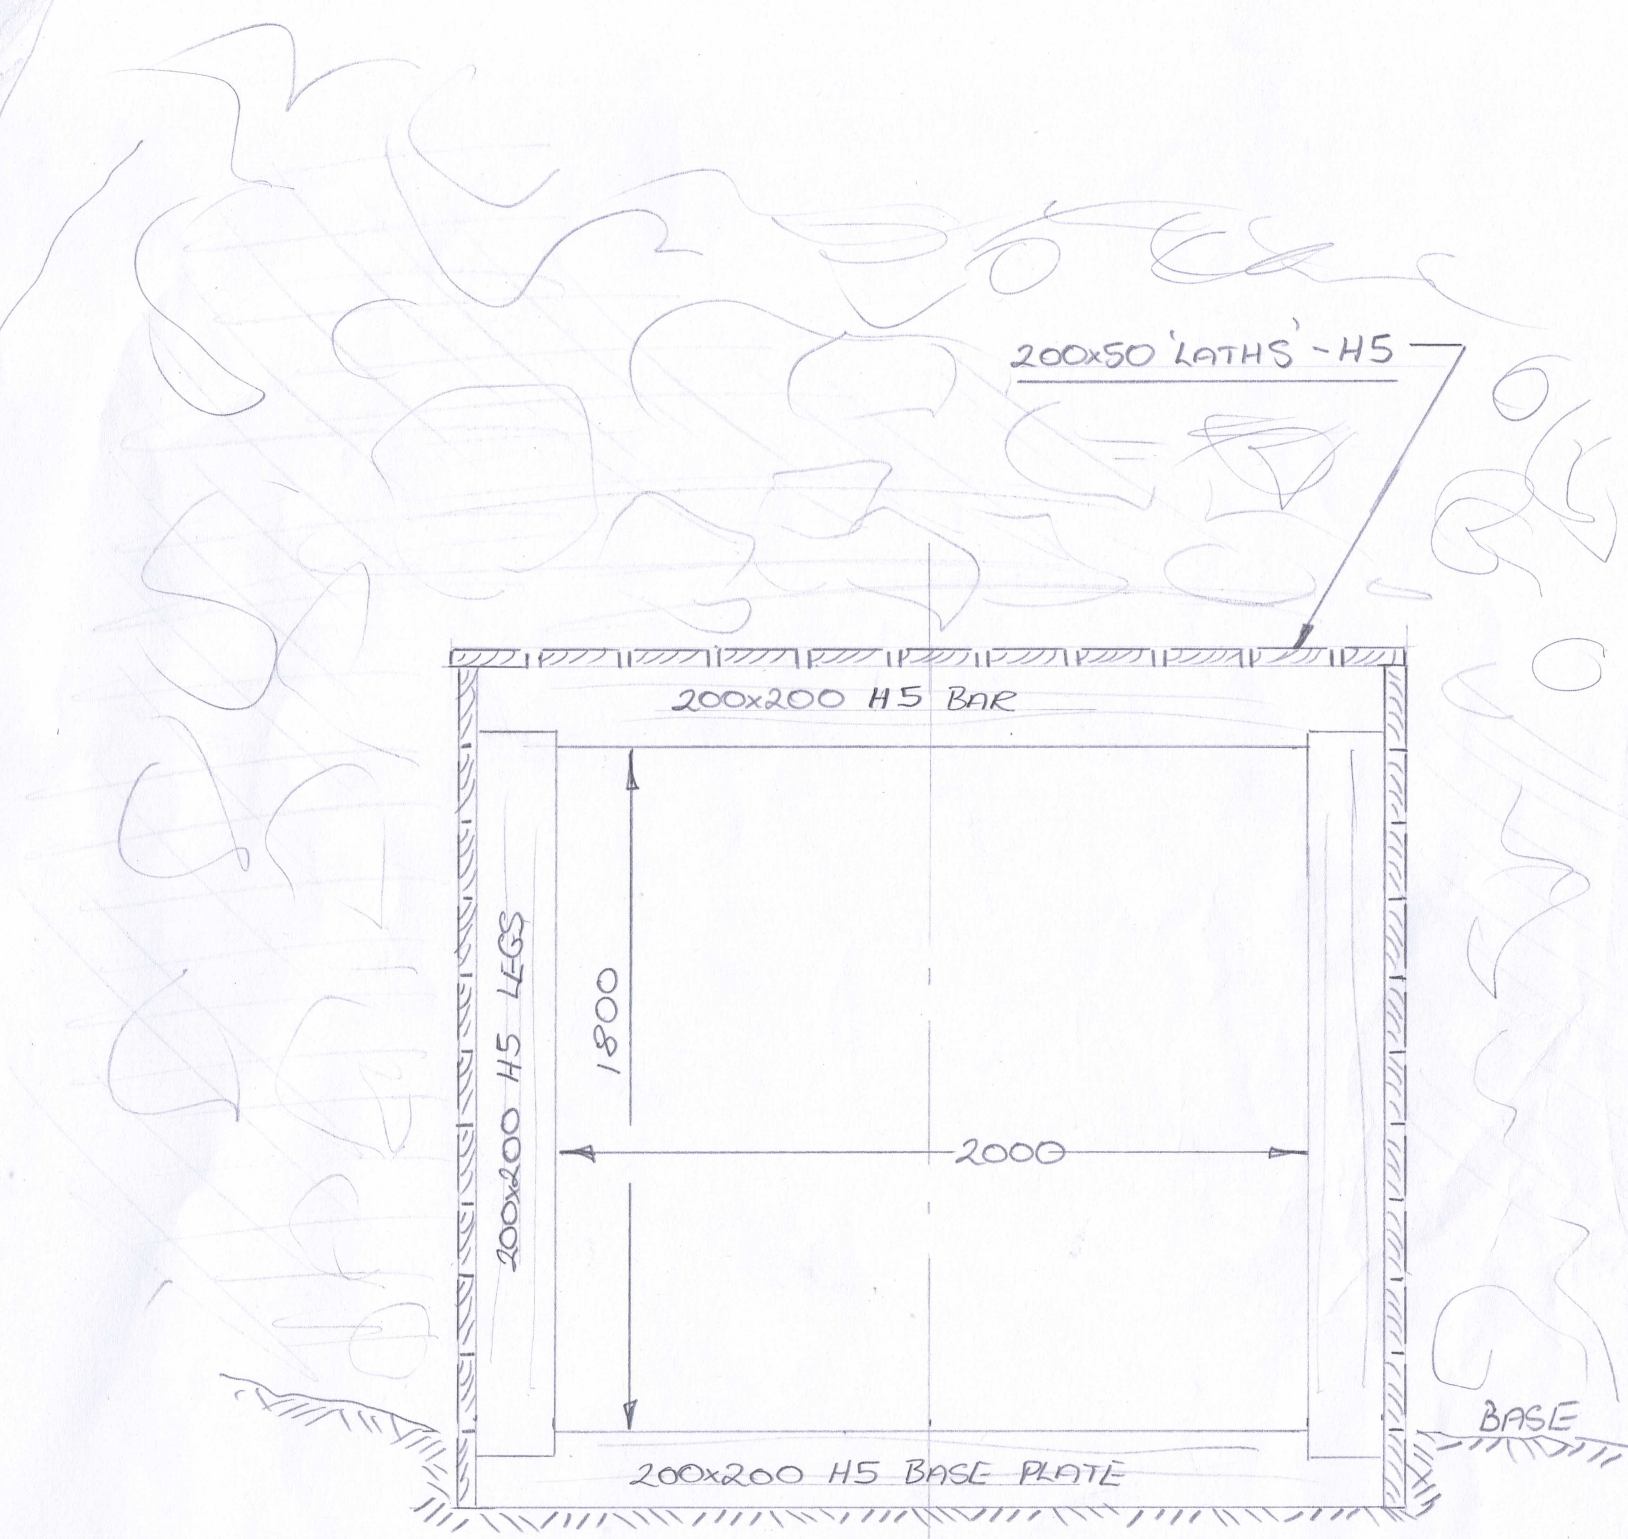
Figure 3. Rock tunnel slip remediation design (Archer 2013).

The rock tunnel slip is located approximately a third of the way down the scheme's waterway, and can be seen in Figure 1. The affected section of approximately 12m chainage has left 2 portals daylighting at both sides, and a localised slip through the centre. Figure 3 shows an outline of the proposed remediation of this section from Allan Archer. A brief summary of what was seen on the site visit, along with several points for discussion are listed below.

- It is recommended that the structure that bridges the two portals is designed for a dead load of at least 16 T per lineal meter to allow for the weight of 3 to 4 vertical meters of material to sit on top of the structure.

- It is recommended for a quick installation that the bridging is pre-cast or already built prior to installation, so that it can be lifted and lowered directly into the excavation, minimizing the need for workers to be placed in any hazardous positions, attached is the NZ regulations for working in excavations.

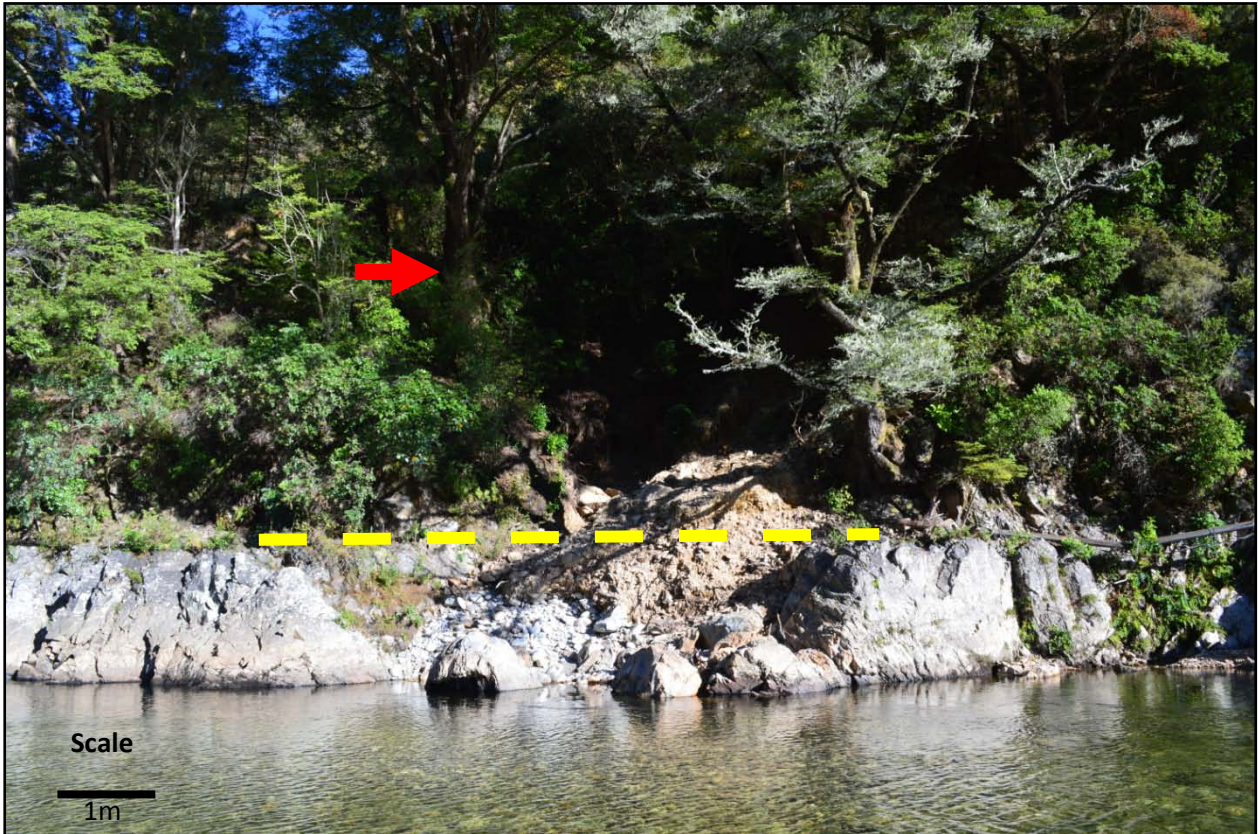
- The tunnels daylight in blocky but competent greywacke (with the downstream side portal just covered from view due to a recent slip).
- There appears to be insitu bedrock approximately 1-2 meters horizontally back towards the scarp of the slip at the level of the tunnels, however this should be confirmed for the downstream portal from records.
- The slip material is angular and ranges in size from pebble to boulder size, there is little vegetation growing on the slip material, indicating that the surface is active.

- Under natural conditions unaffected by any anthropogenic influence, it is expected that the slip will continue to fail during heavy periods of rain saturating the colluvium above, and river flooding due to the undercutting of the toe which will induce localised land sliding at the site. It is therefore expected that the proposed activity will not adversely affect the current stability of the site more than what is already happening naturally. It is expected under careful management of the proposed works that the site will become more stable in the long term.

Figure 4. Photograph of the rock tunnel slip, taken from across the river, photo taken May 14th, 2013. Yellow dashed line indicates the level where rip rap should be placed up to (atleast), based on the scour level on the slip toe from high flow. The red arrow points to a tree that is recommended to be removed.

- Large rip-rap should be placed at the toe of the slip to effectively buttress the slip in the final design, the rip-rap should be placed up to at least the level indicated in Figure 4, large rip-rap placed at the toe of the slip will reduce natural scour from flooding. Slip material should be landscaped above this level; the angle of the final landform should be approximately 38 degrees/ the angle of repose (or lower) for longevity of the slope.

- It is recommended that the large tree located just above the upstream portal seen in Figure 4, is removed due to the effects the roots will have on the tunnel entrance.
