FOX GLACIER — ROAD ACCESS

ENGINEERING REVIEW

*Report prepared for Department of Conservation
by Matthew Gardner and Gary Williams*

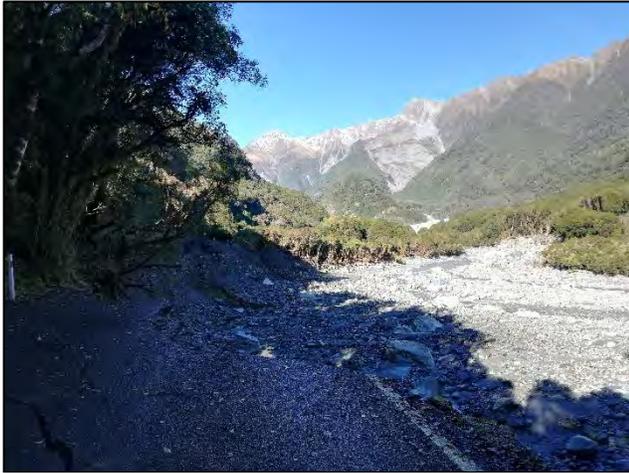
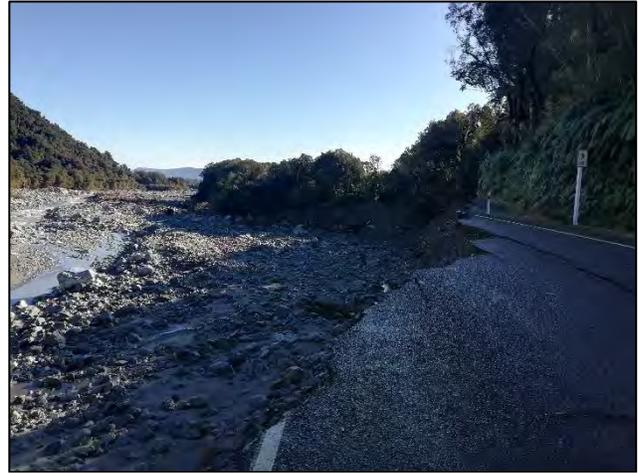
North Washout 1 – This washout consists of a large erosion embayment into the road. Approximately 190 m of this section of the road has been washed away, leaving a high steep bank of loose materials, with a pronounced hook curvature along the embayment. This bank is now highly vulnerable to further erosion.

Figure 1-4 – Photos of the North Washout 1 – looking upstream & downstream

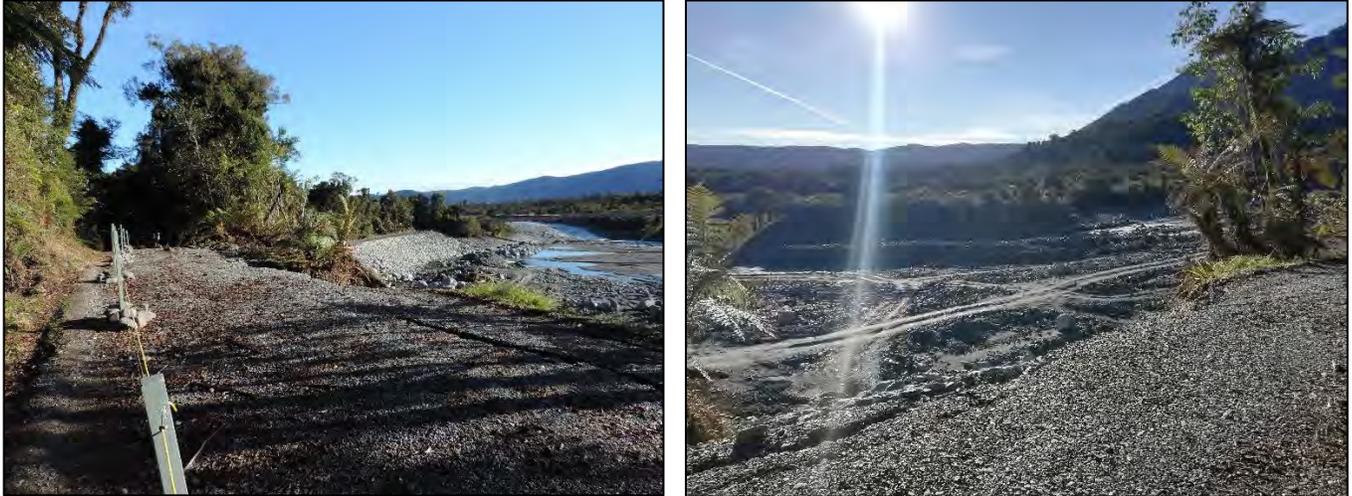
South Washout 1 – A large embayment that formed upstream of the S H Bridge eroded up to the road, leaving a very high steep bank up to the road formation. Rock lining works of NZTA are now protecting the toe of this bank.

Figure 1-8 – Photos of the South Washout 1 location – looking downstream & across

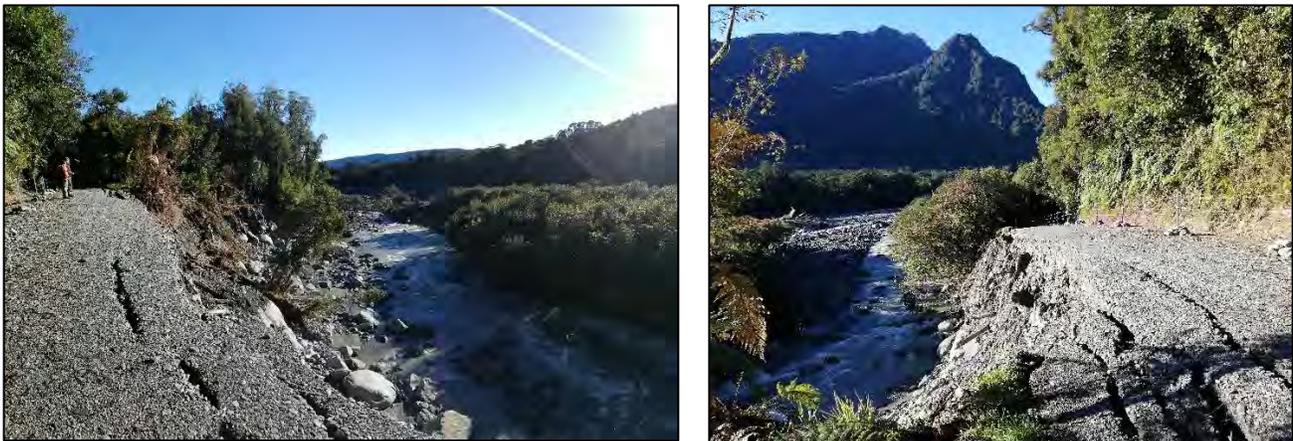
South Washout 2 – The river now has a split channel here, with erosion up to the road leaving a very high steep bank of loose materials. This bank is highly vulnerable to further erosion.

Figure 1-9 – Photos of the South Washout 2 location – looking downstream & upstream

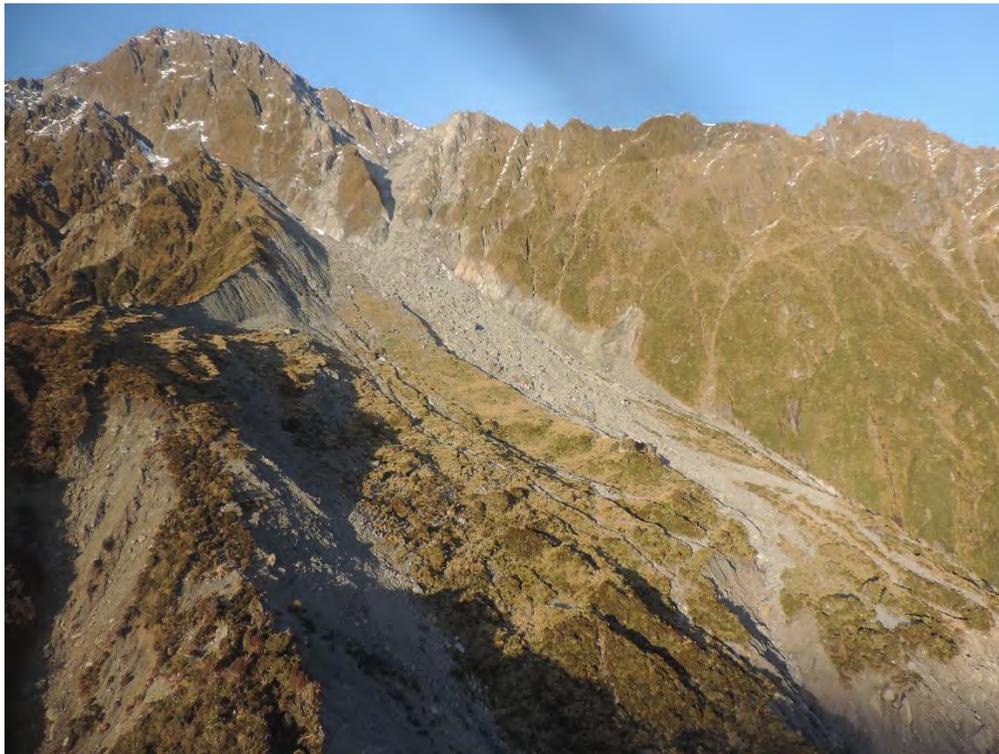
Figure 2-9 - The Alpine Garden debris accumulation below Craig Peak. Note the slip faces, cracking and active working of the material.

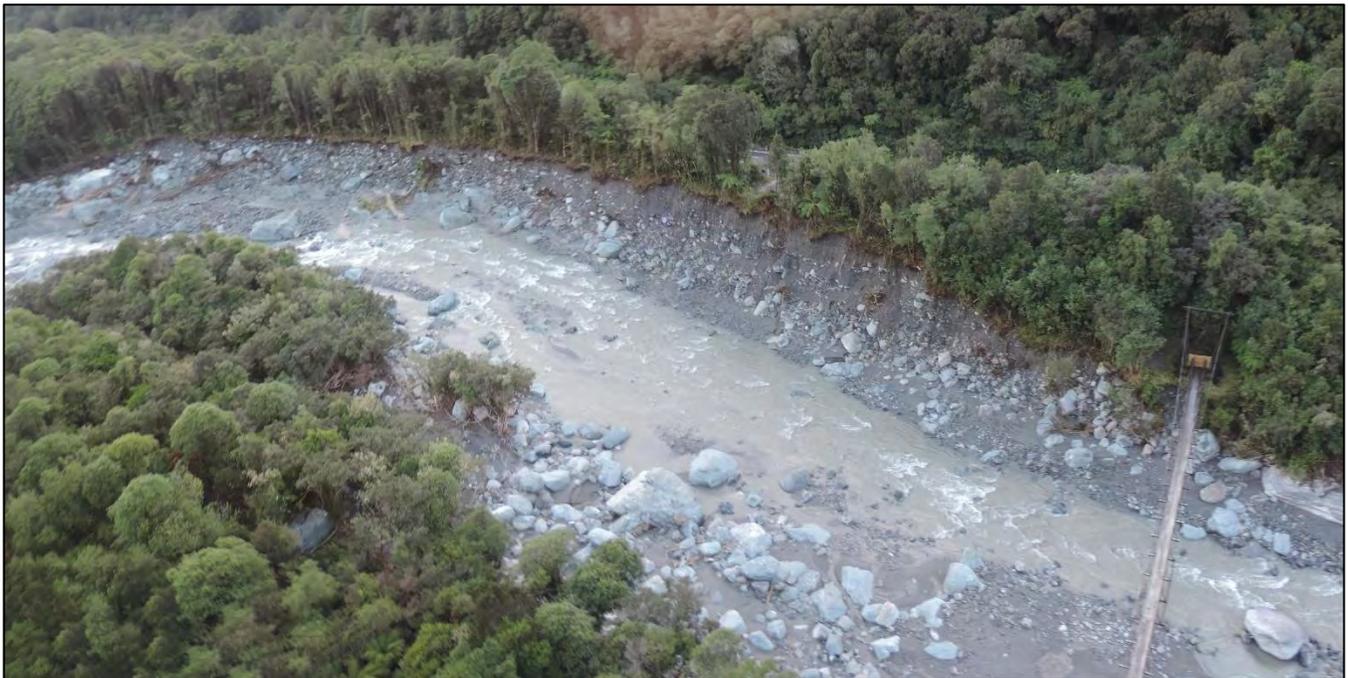
The river has widened with a very rough boulder channel at the bridge. The mass of boulders on the left side would provide some deflection and hence protection to the left side bridge tower. The confining of river flows to the right side does, however, increase the erosion hazard on this side, and the present bank is right at the outer side of the tower footings.

The tower footings are simple concrete blocks, with no apparent under-piles. The right side tower is, thus, likely to fail from underscoring by the river. The height of the bank, its closeness to the bridge towers, the loose bank material and the boulders in the river bed, all add up to a very difficult site for any protection works.

Figure 3-1 – Erosion embayment at and downstream of bridge

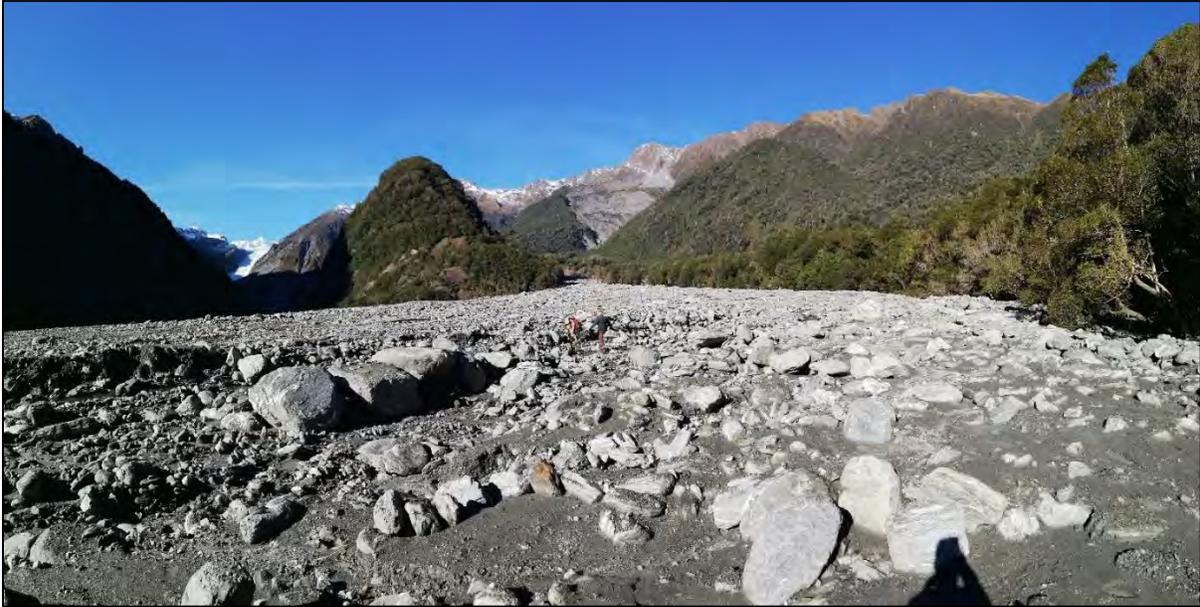
In this case an access by the south side and then across the Mills Creek fan may have looked possible. However, the main problem is the nature of the fan. In essence, it is too large, too active and too full of large boulders (see Figure 3-3). Given the damage to the south side road as well, there is no practical route for an in-river 4-wheel drive access way.

Figure 3-3 - Photo showing the wide extent of the Mills Creek fan and highlighting the size and type of rock material. Fox Glacier to the left of Cone Rock, Alpine Garden and Craig Peak to the right

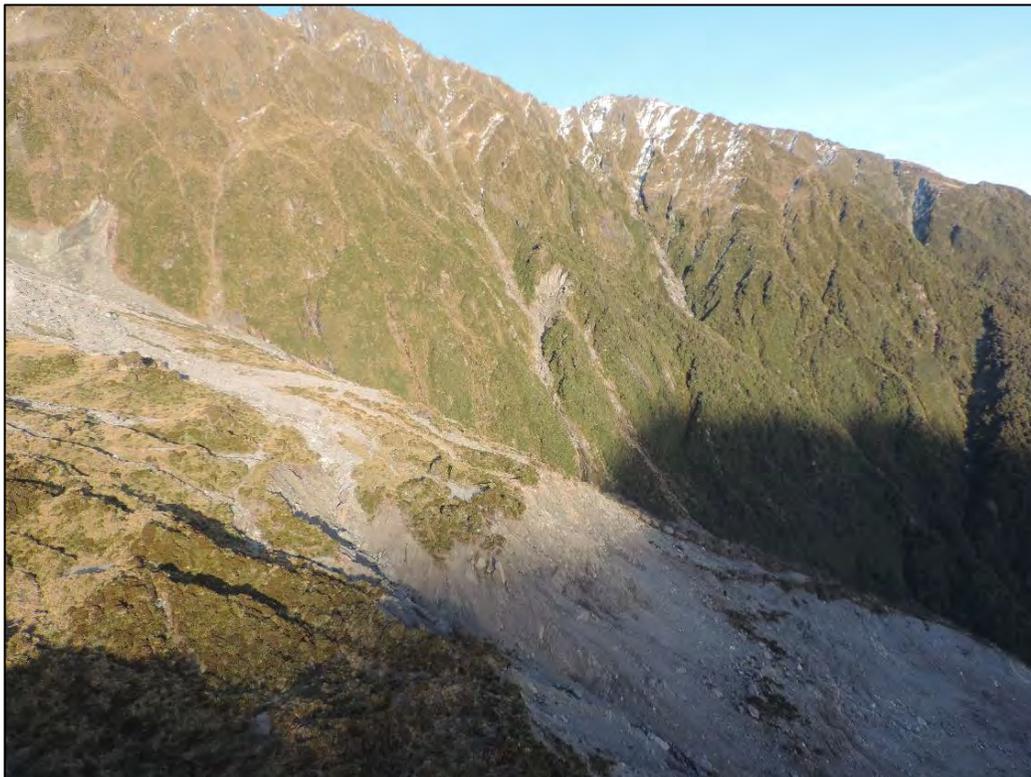
Photo 10 - Shows the main deposits of the Alpine Garden, and it's very actively eroding front face on the downhill side.

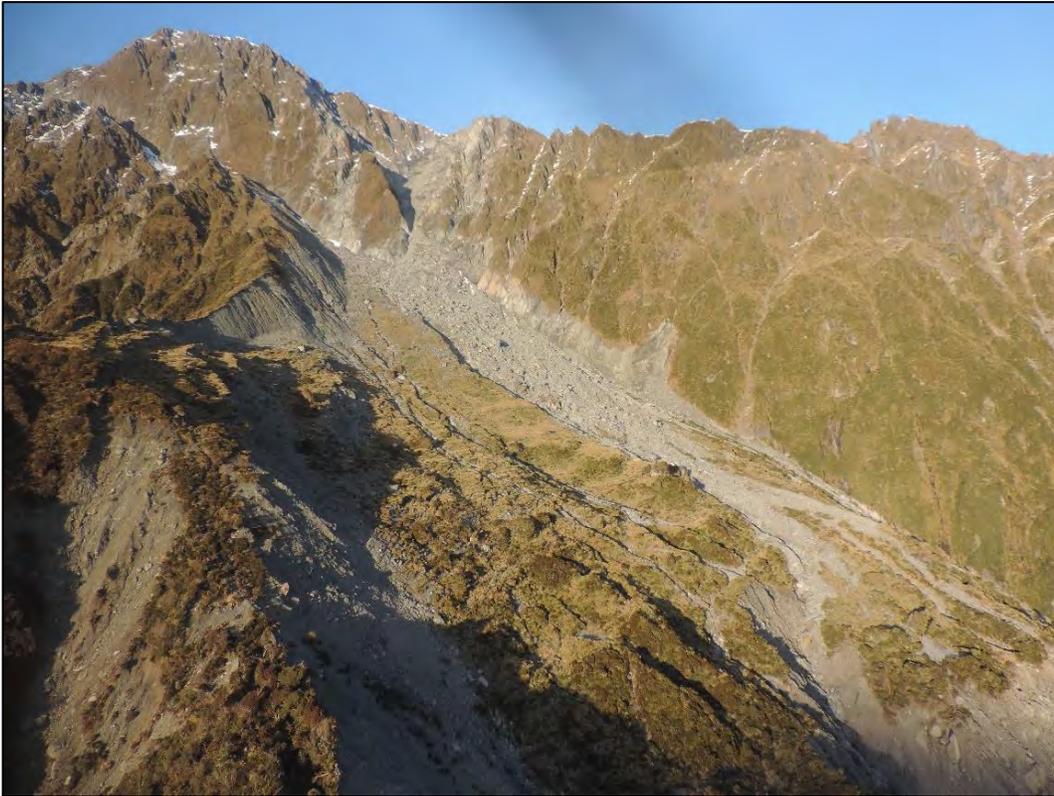
Photo 11 - The upper part of the Alpine Garden, showing the slip faces, cracking and active working of the material.

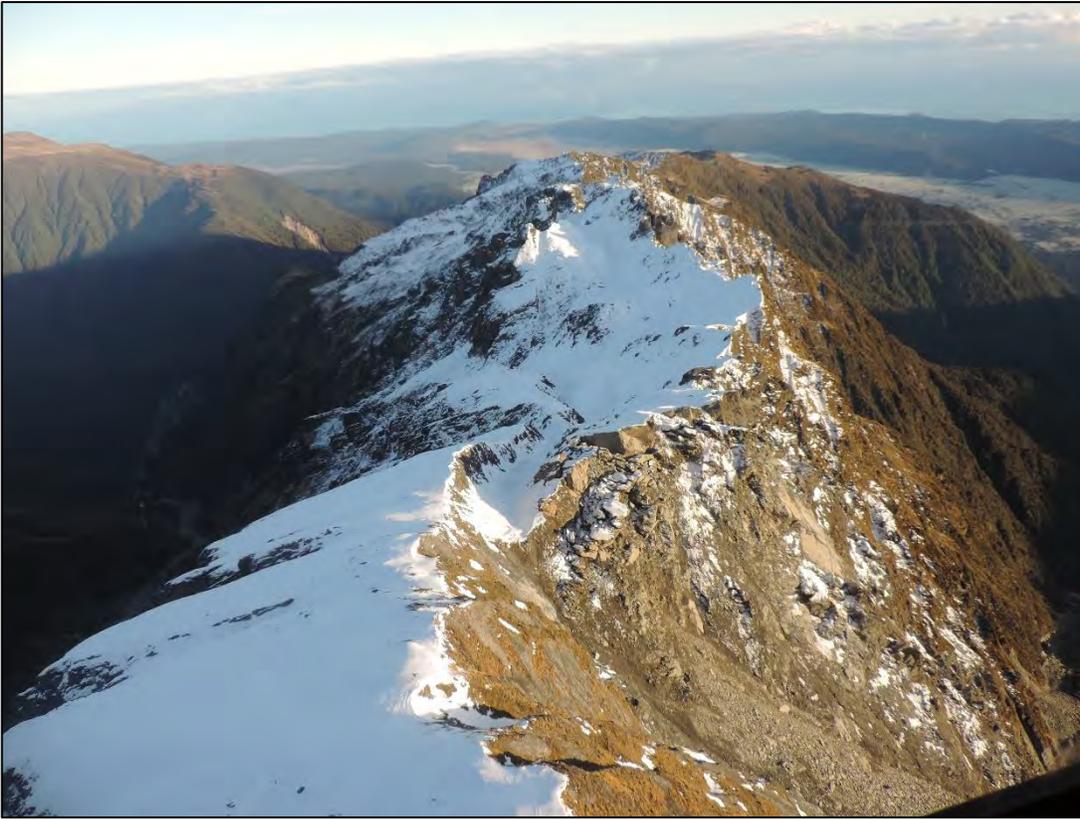
Photo 13 -The mountain crest above the Alpine Garden, showing the potential failure plane at the crest (the hollow under the snow), with the slip plane on the north-east side down to the Mills Creek system.

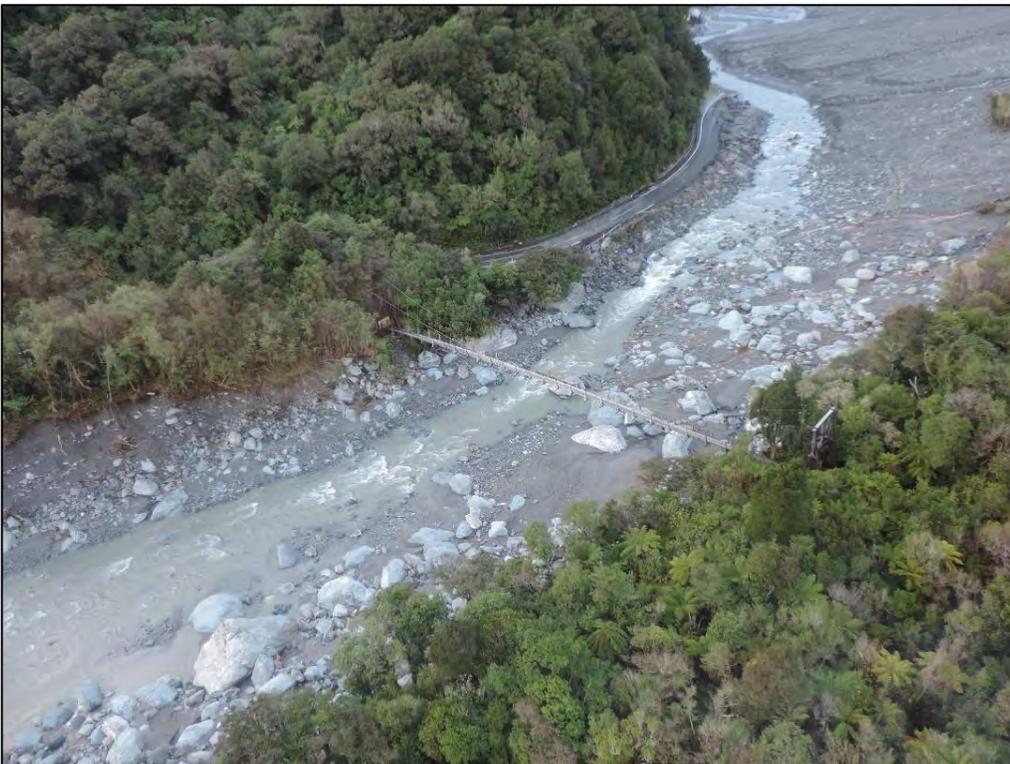
Photo 14 - Looking upstream over the footbridge, showing the bottom edge of the Mills Creek fan just above it. North Washout 2 is also just above the footbridge, with the Fox River now squeezed between the fan and the roadway.

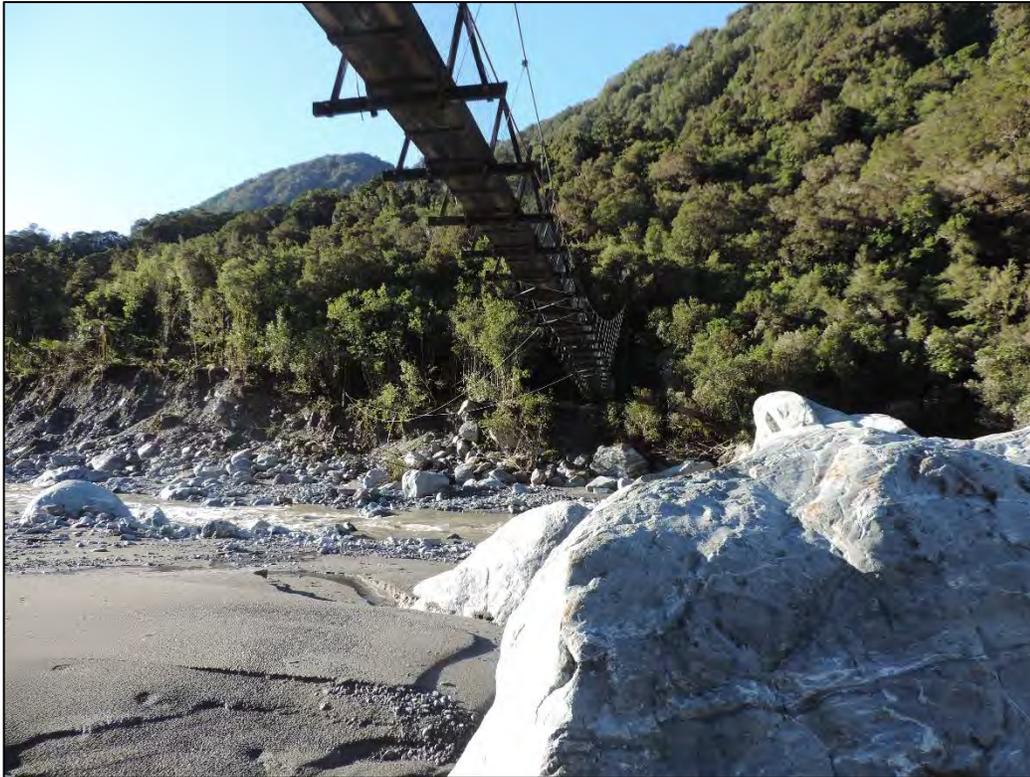
Photo 15 - The right (north) side of the abutment, showing the eroding bank, with a large boulder in the foreground.

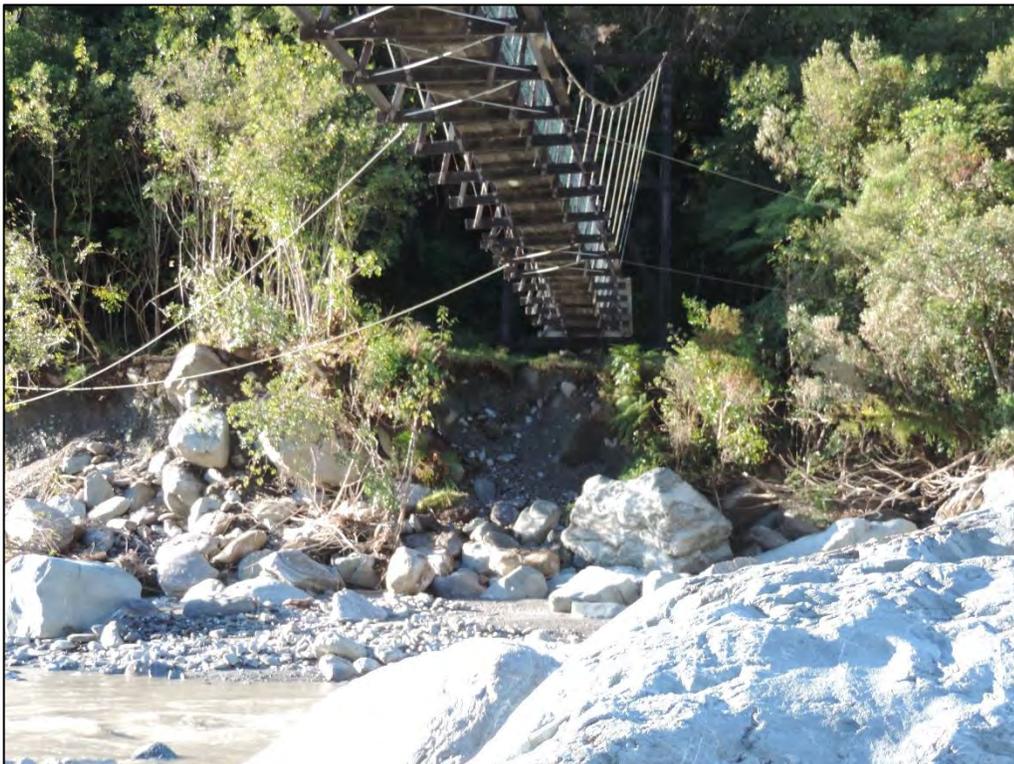
Photo 16 - A closer view of the right side, with the bridge tower on a concrete footing just above the raw bank that can be seen underneath the bridge.

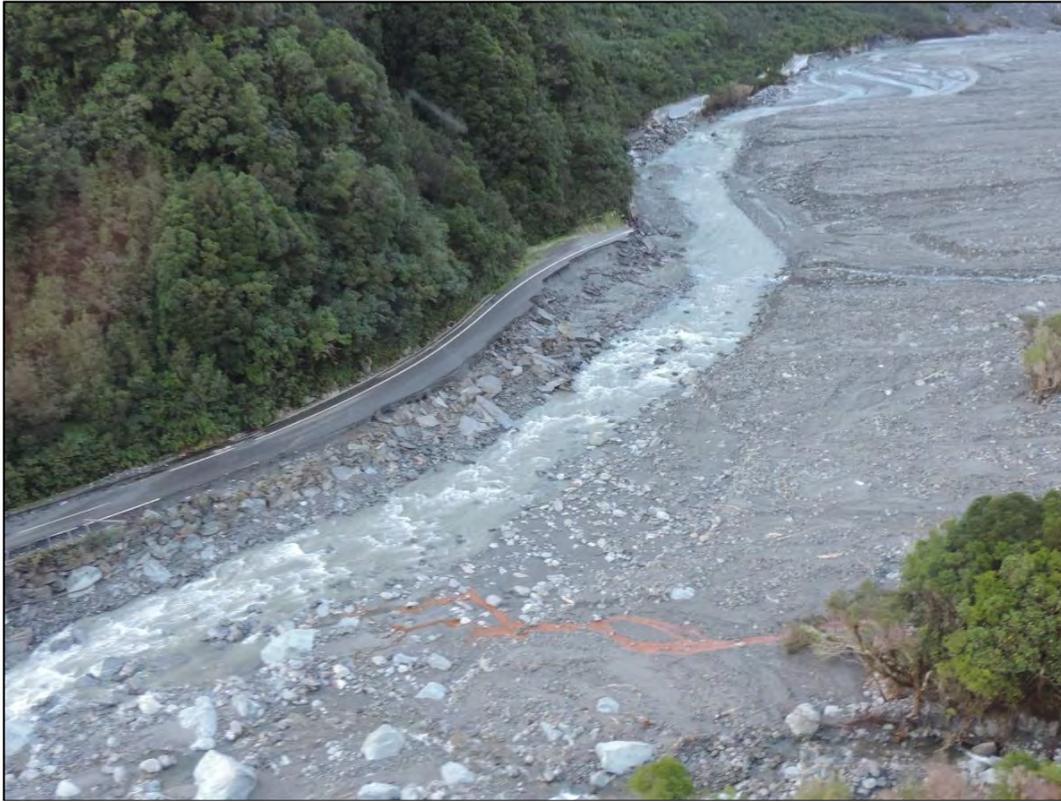
Photo 21 - North Washout 2, looking upstream.

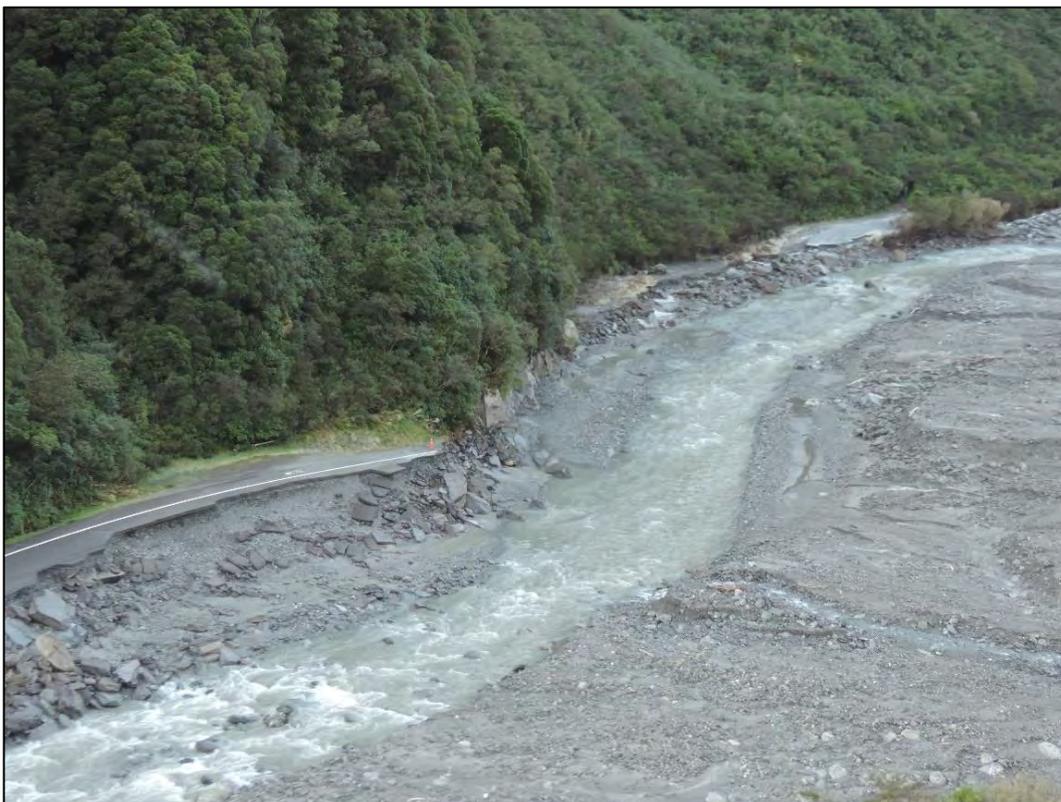
Photo 22 - North Washout 3 looking upstream. The bluff at the outer edge of the high mountains is the point between the two washouts, where the remaining seal ends.

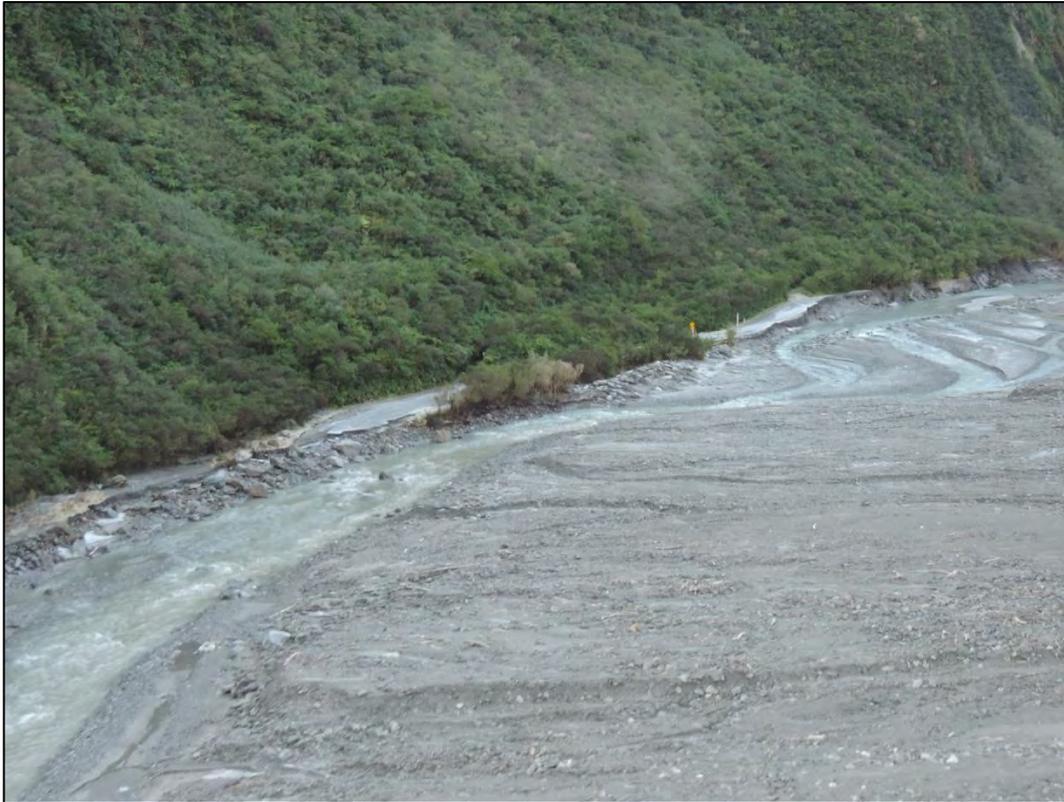
Photo 23 - North Washout 3 and upstream, showing the Fox River between the toe of the Mills Creek fan and the roadway along the edge of the very steep mountainsides.

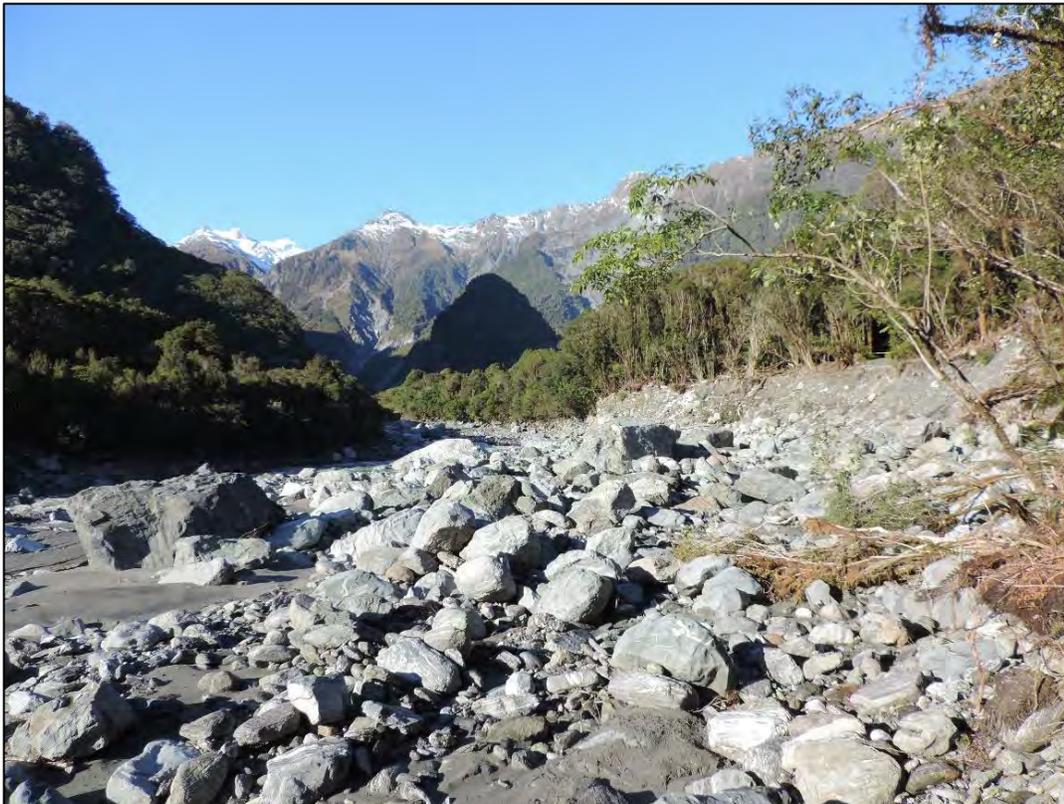
Photo 24 - South Washout 3 looking upstream. The road is at the small square shadow area under the overhanging branch. Note the large boulders and very rough river bed, with much finer loose material in the river bank.

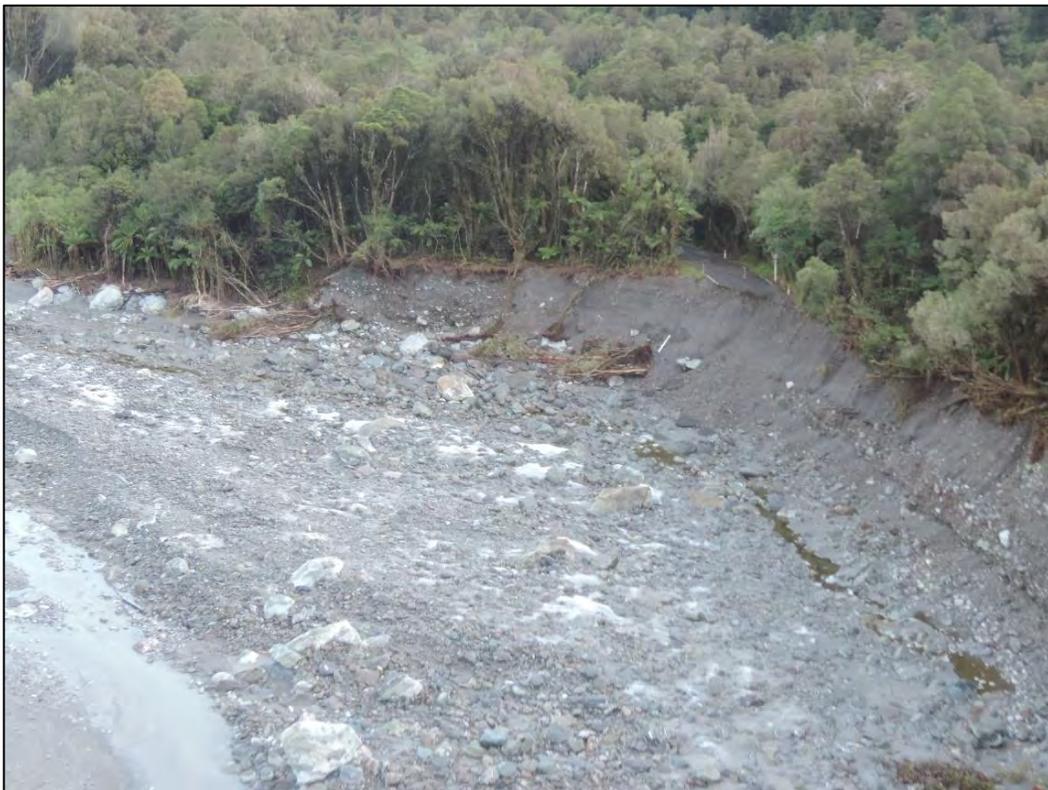
Photo 26 - The erosion embayment that gave rise to the North Washout 1. Note the road on the bank crest, where there is a square shadow. Note also the fineness of the river bank material compared to the river bed.

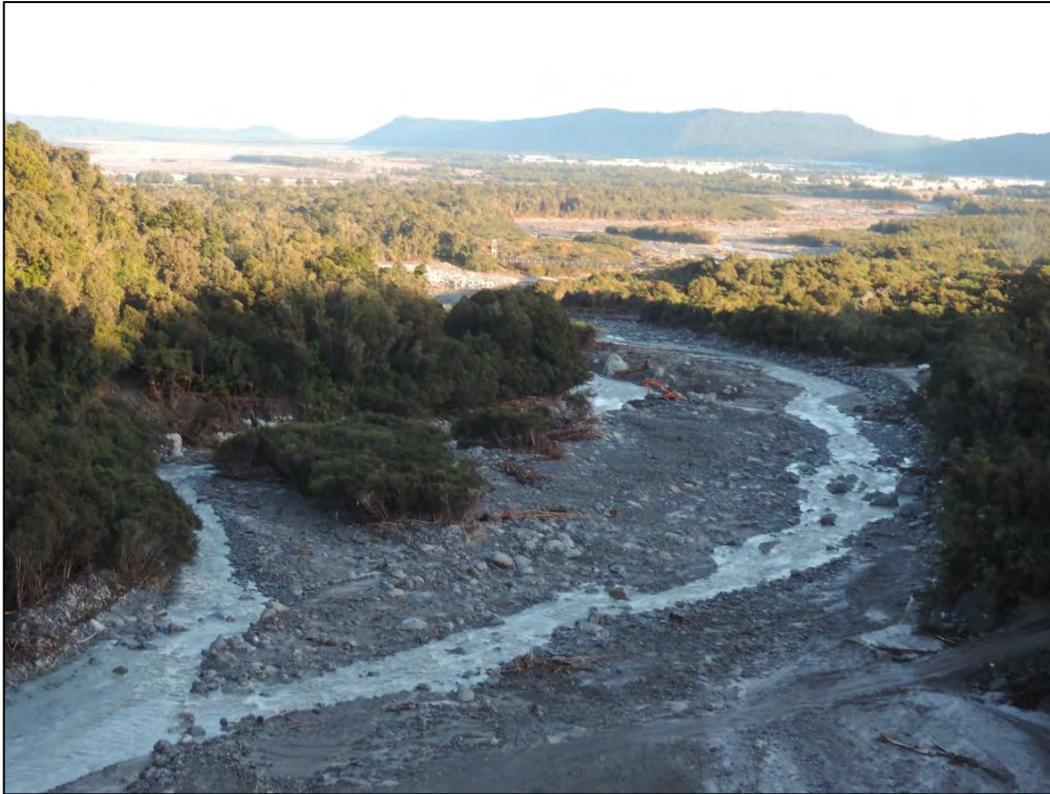
Photo 27 - The channel splitting that has developed along the river reach. The South Washout 2 is on the left side at the point of the island where there is remaining vegetation. The old dump is on the right side, opposite where the excavator is working.
