**Cathedral Cove Basic Level  
Landslide Risk Assessment**

**Prepared for**  
Department of Conservation  
**Prepared by**  
Tonkin & Taylor Ltd  
**Date**  
July 2023  
**Job Number**  
1007838.3000 v3

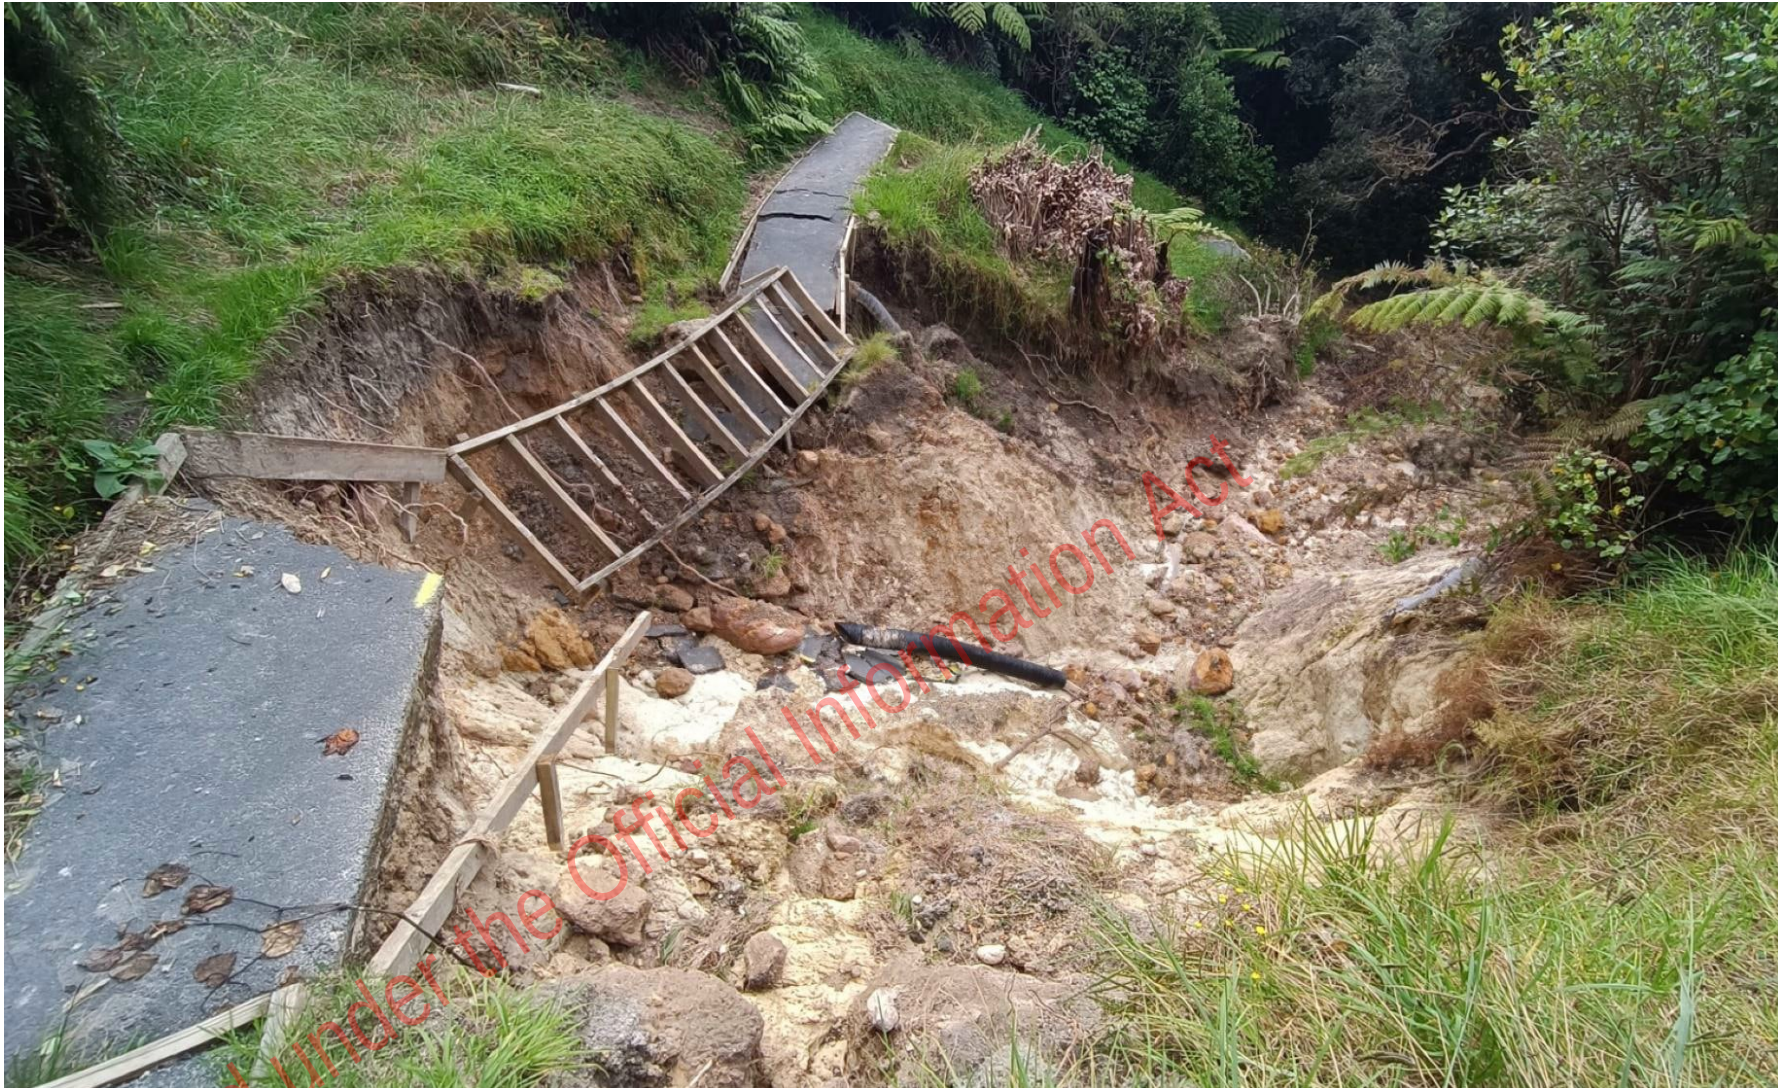
| Site Location | Site details/damage | Mitigation option description | Additional considerations |
|---|---|---|---|
| <b>Cathedral Cove lower track access (Track Section 12, 13 &amp; 14)</b><br>(Refer Figure 10.1 and Figure 10.2) | <p>Landslides have damaged a 10 m section of stairs and track. This section is in the steep coastal hill landform. Site observations identified an upper soil profile of colluvium overlying residual soil.</p> <p>The existing landslides have potential to regress and very steep ground adjacent to the track nearby may fail in a similar type of landslide.</p> <p>Furthermore, the current public toilet site on the southern portion of Mare's Leg Beach has been damaged by storm surge in recent weather events. Relocation of the toilet is being considered by DoC.</p> | <b>Option 1 – Alternative track route</b><br><p>A potential route option was traversed by T+T and DoC during recent site visits and is shown in Figure 10.2.</p> <p>The proposed route would detour north-west of the current track and re-join the track just above the current beach access structure.</p> <p>The re-route would also present an opportunity to locate a new toilet site in an area of ground over a minor spur at the start of the new route as shown in Figure 10.2.</p> | <p>The coastal cliffs on the northern side of Cathedral Cove are nearby to the potential re-aligned track. A potential fall hazard is possible if public detour off the track northward. While this hazard has always been present, bringing the track closer may mean public access this area. The track could be positioned below a slight rise southward of the cliff crest to help avoid this area. Other mitigation options such as barriers and signage could be considered.</p> <p>Ongoing landslide risk would remain from new or regression of existing landslides, however the re-route would largely avoid the current areas of instability.</p> <p>The option is a relatively a low cost and practical option.</p> |

Figure 10.1 Cathedral Cove lower track landslide damage.

| Site Location | Site details/damage | Mitigation option description | Additional considerations |
|---|---|---|---|
| | | <b>Option 2 – Reinstate the damaged track.</b><br><p>Reinstate the track in its current alignment.</p> <p>This would likely entail a resilient engineered solution, particularly as it would require traversing unstable ground. An engineered solution would likely include slope stabilisation, earthworks, and structures such as stairs and/or bridges.</p> | <p>The option is likely to be costly and subject to further geotechnical considerations including slope stabilisation.</p> <p>If engineered appropriately, the option would provide resilient access for this section of the track. Noting that this may be a higher level of resilience than other track sections.</p> <p>Given the current and potential land instability, a non-engineered track/stairs are not appropriate for this location.</p> <p>The proposed new toilet site could still be utilised with this option.</p> |

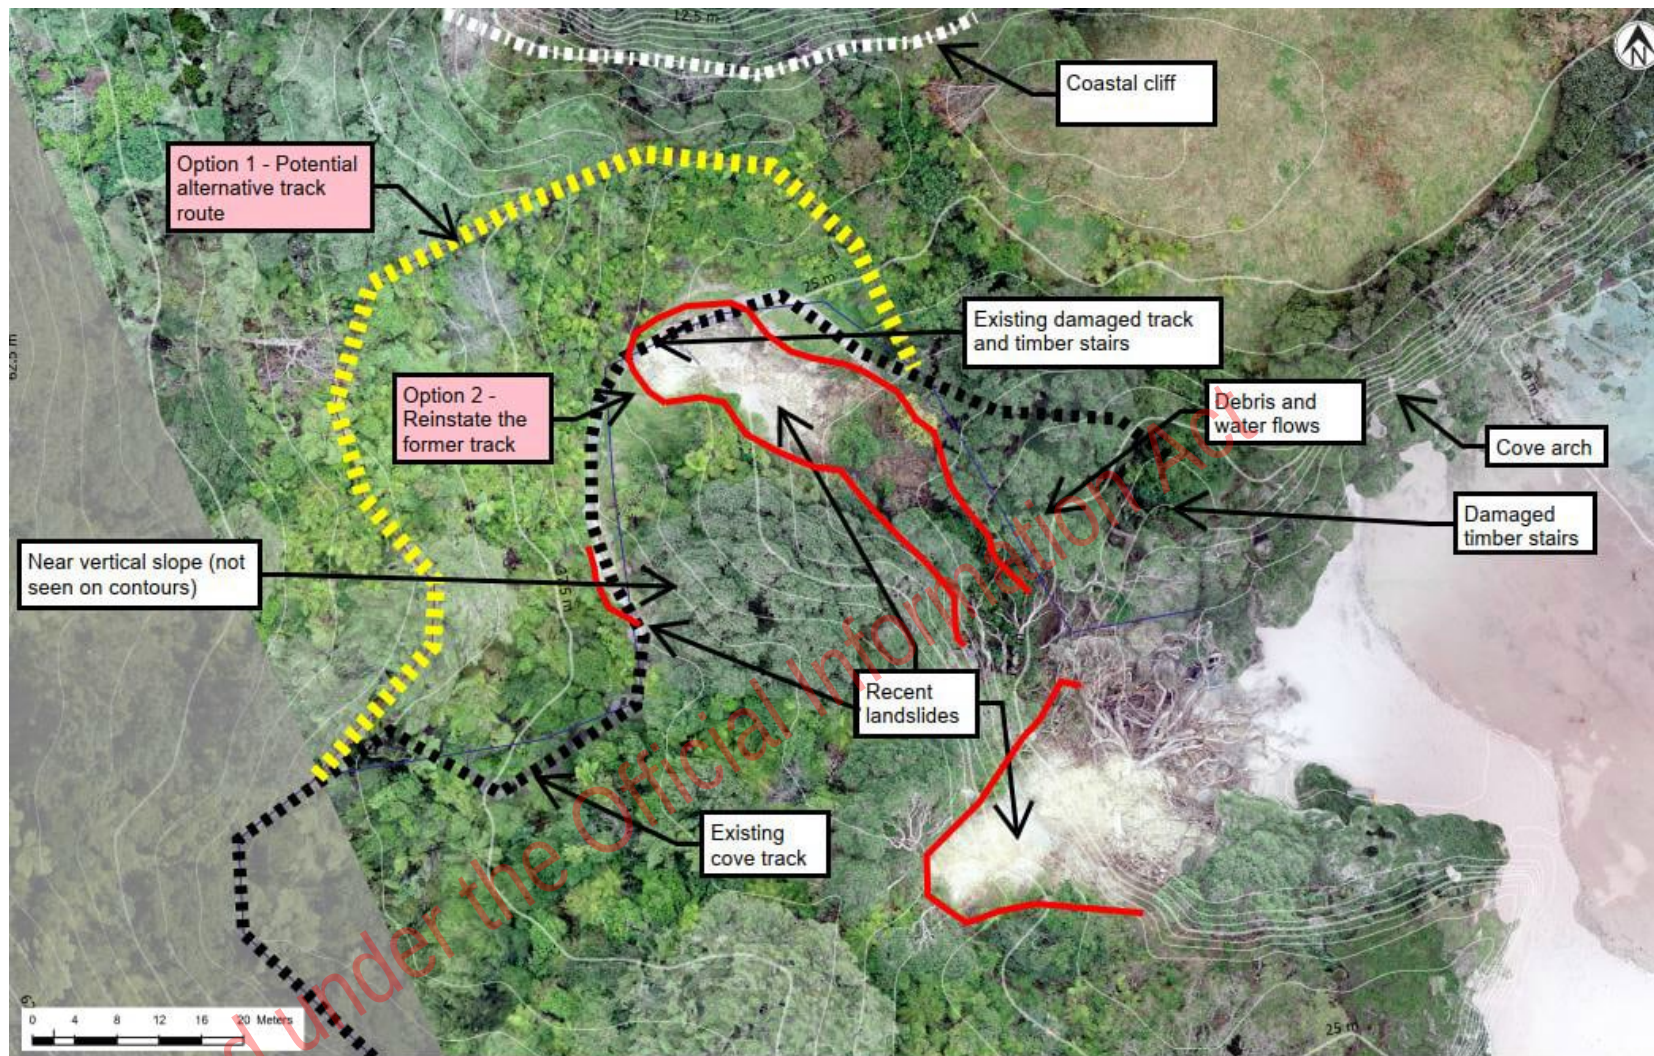
Figure 10.2 Cathedral Cove Lower Track Damage and Mitigation Options (T+T UAV photograph).

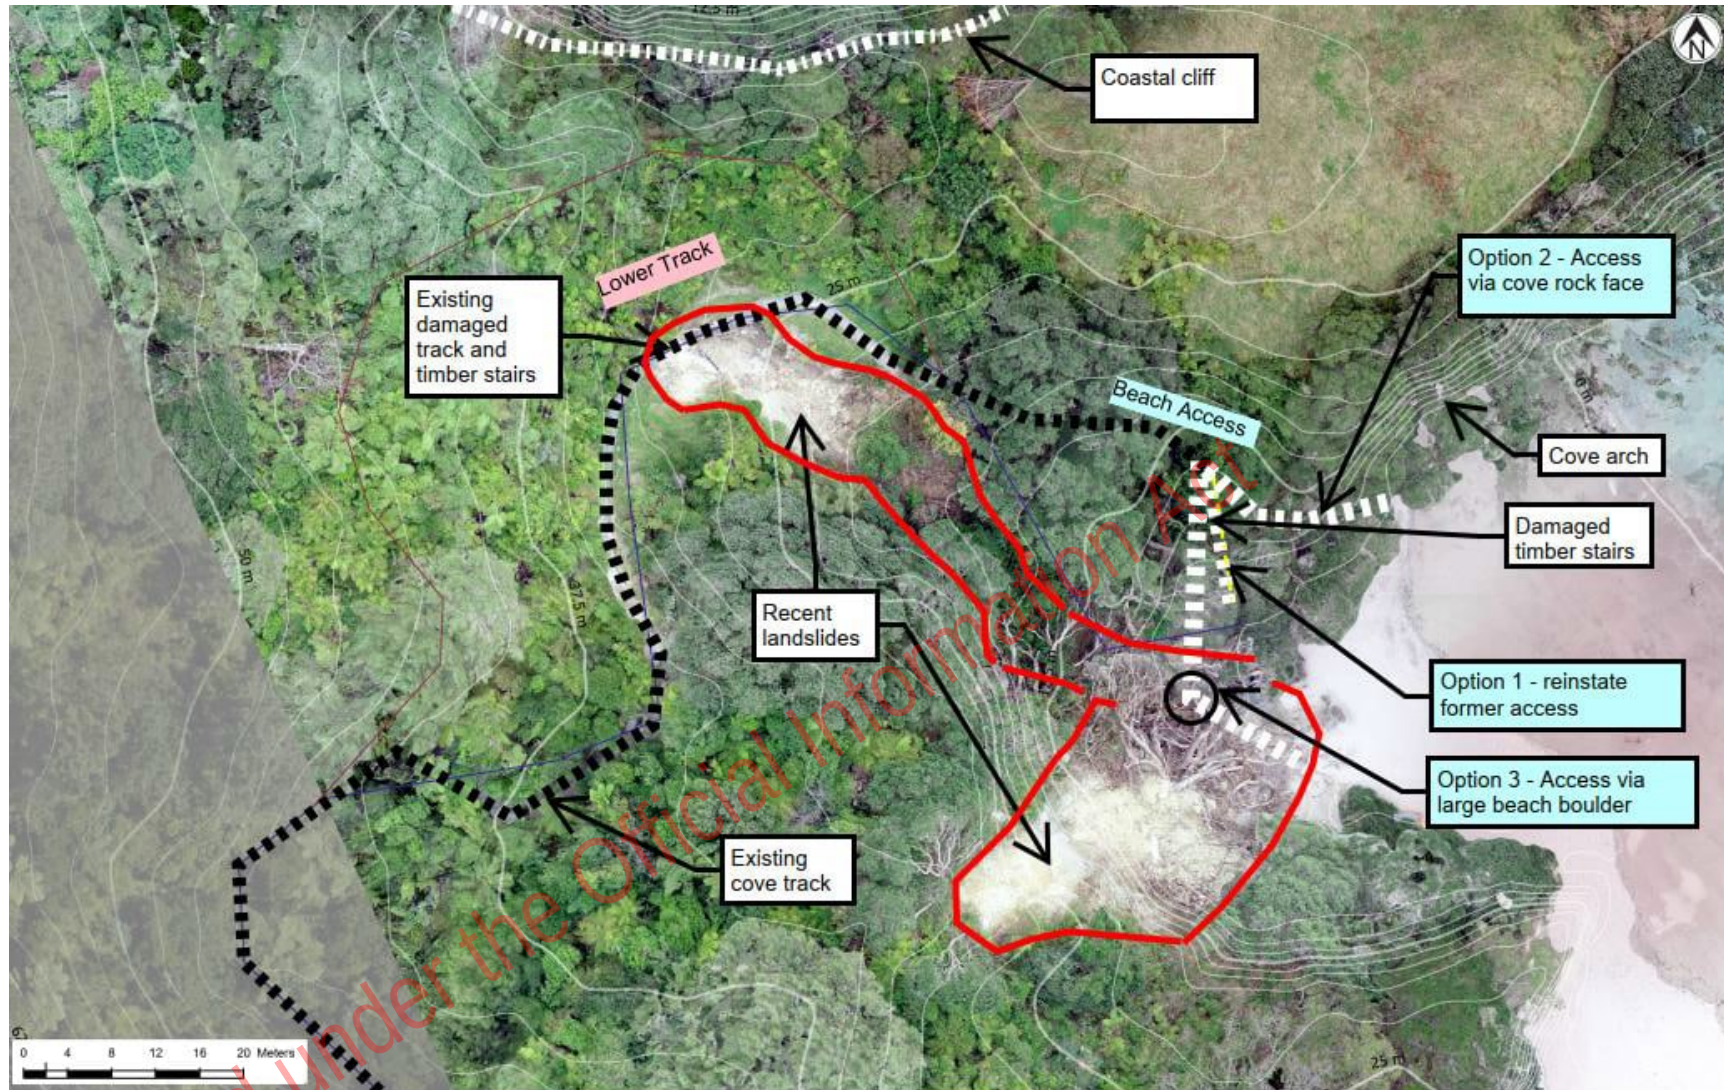
Figure 10.3 Cathedral Cove Beach Access Damage and Mitigation Options (T+T UAV photograph).

| Site Location | Site details/damage | Management and mitigation options | Comments / risks |
|---|---|---|---|
| | | <p><b>Option 2 – New access via the cliff rock face</b></p> <p>This option would involve securing a new stair structure to the rock face.</p> <p>Rock anchors would need to be fixed to the cliff face.</p> | <p>This option would likely provide potential resilience to storm surge, washout and landslide debris interactions.</p> <p>This option may encroach into the arch 'view'.</p> <p>Geotechnical and structural considerations would be required.</p> <p>The option would be directly below the cliff face and could be subject to rockfall/landslide hazard.</p> |
| | | <p><b>Option 3 – New access via a large boulder</b></p> <p>This option was proposed by DoC and would involve aligning a new timber access way to land further south than the former stairs, secured into a large boulder located on the beach.</p> <p>DoC considered establishing a viewing area/platform along this option so that a view to the Cove Arch could be provided during high tides/storm surge.</p> | <p>This option would be more challenging to provide a resilient structure due to the location being closer to the location of recent beach cliff landslide run-out.</p> <p>Relatively large structures would require structural and geotechnical engineering, and it may be difficult to establish suitable founding materials.</p> |

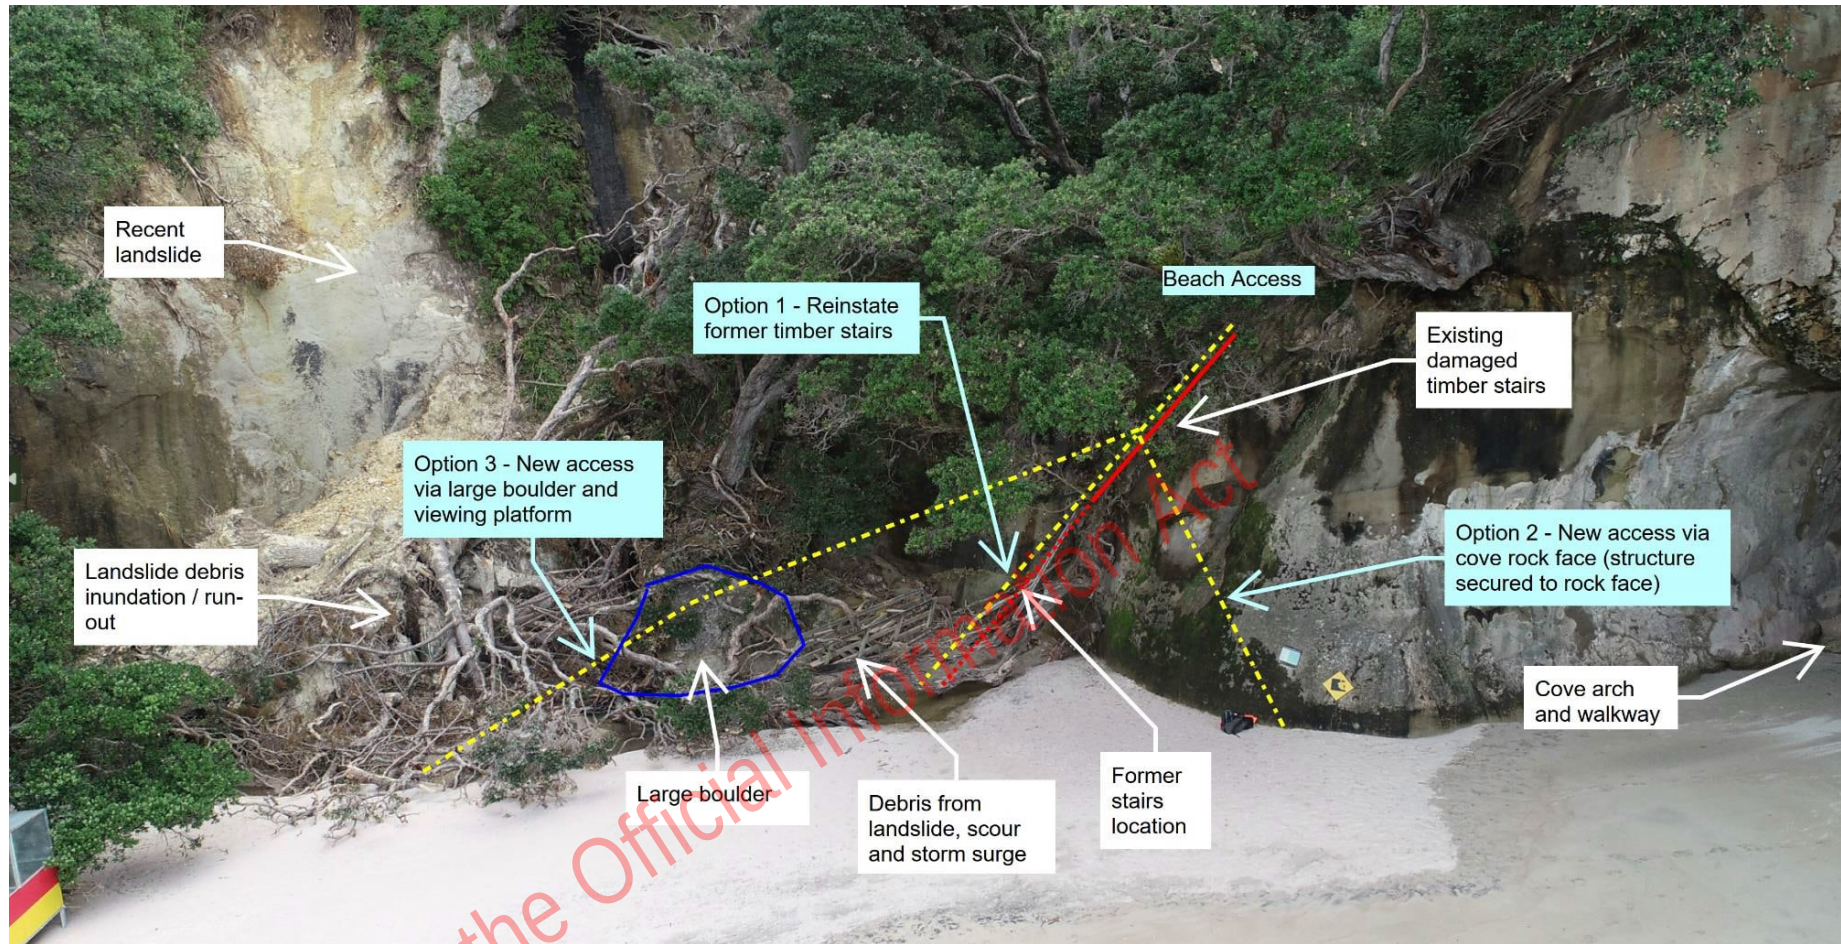
Figure 10.4 Cathedral Cove Beach Access Damage and Mitigation Options (T+T UAV photograph).

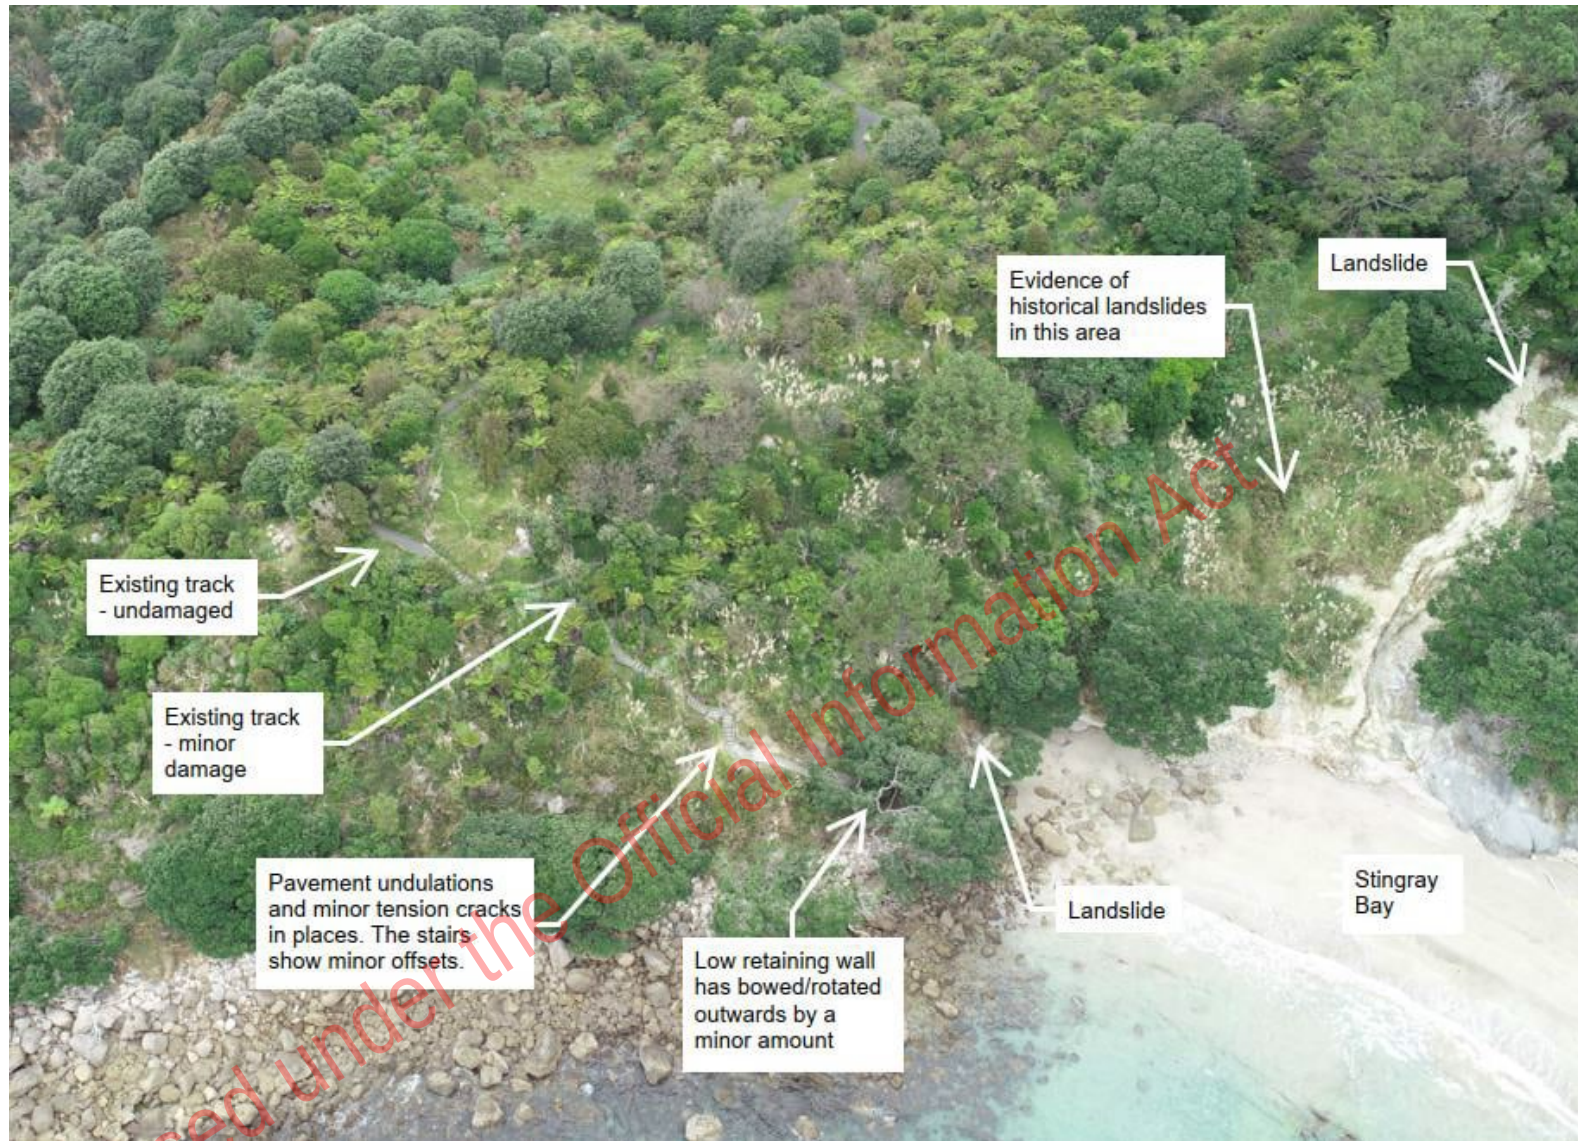
Figure 10.5 Stingray Bay Beach Access Damage (T+T UAV photograph).

| Site Location | Site details/damage | Management and mitigation options | Comments/risks |
|---|---|---|---|
| | | <b>Option 2 – Stabilisation options</b><br>Construction of slope stabilisation such as retaining walls or soil nails could help to reduce future instability. | This option will be a relatively high cost.<br>Geotechnical design will be required.<br>The option will provide a high level of resilience for the track. |
| | | <b>Option 3 – Realign track.</b><br>Realign the track to an area more stable and less likely to be subject to soil creep and slope instability. | Initial mapping of the area did not identify a suitable track realignment.<br>Given the steep coastal hills and cliffs in Stingray Bay there is limited opportunity for realign to significantly improve the track resilience. |

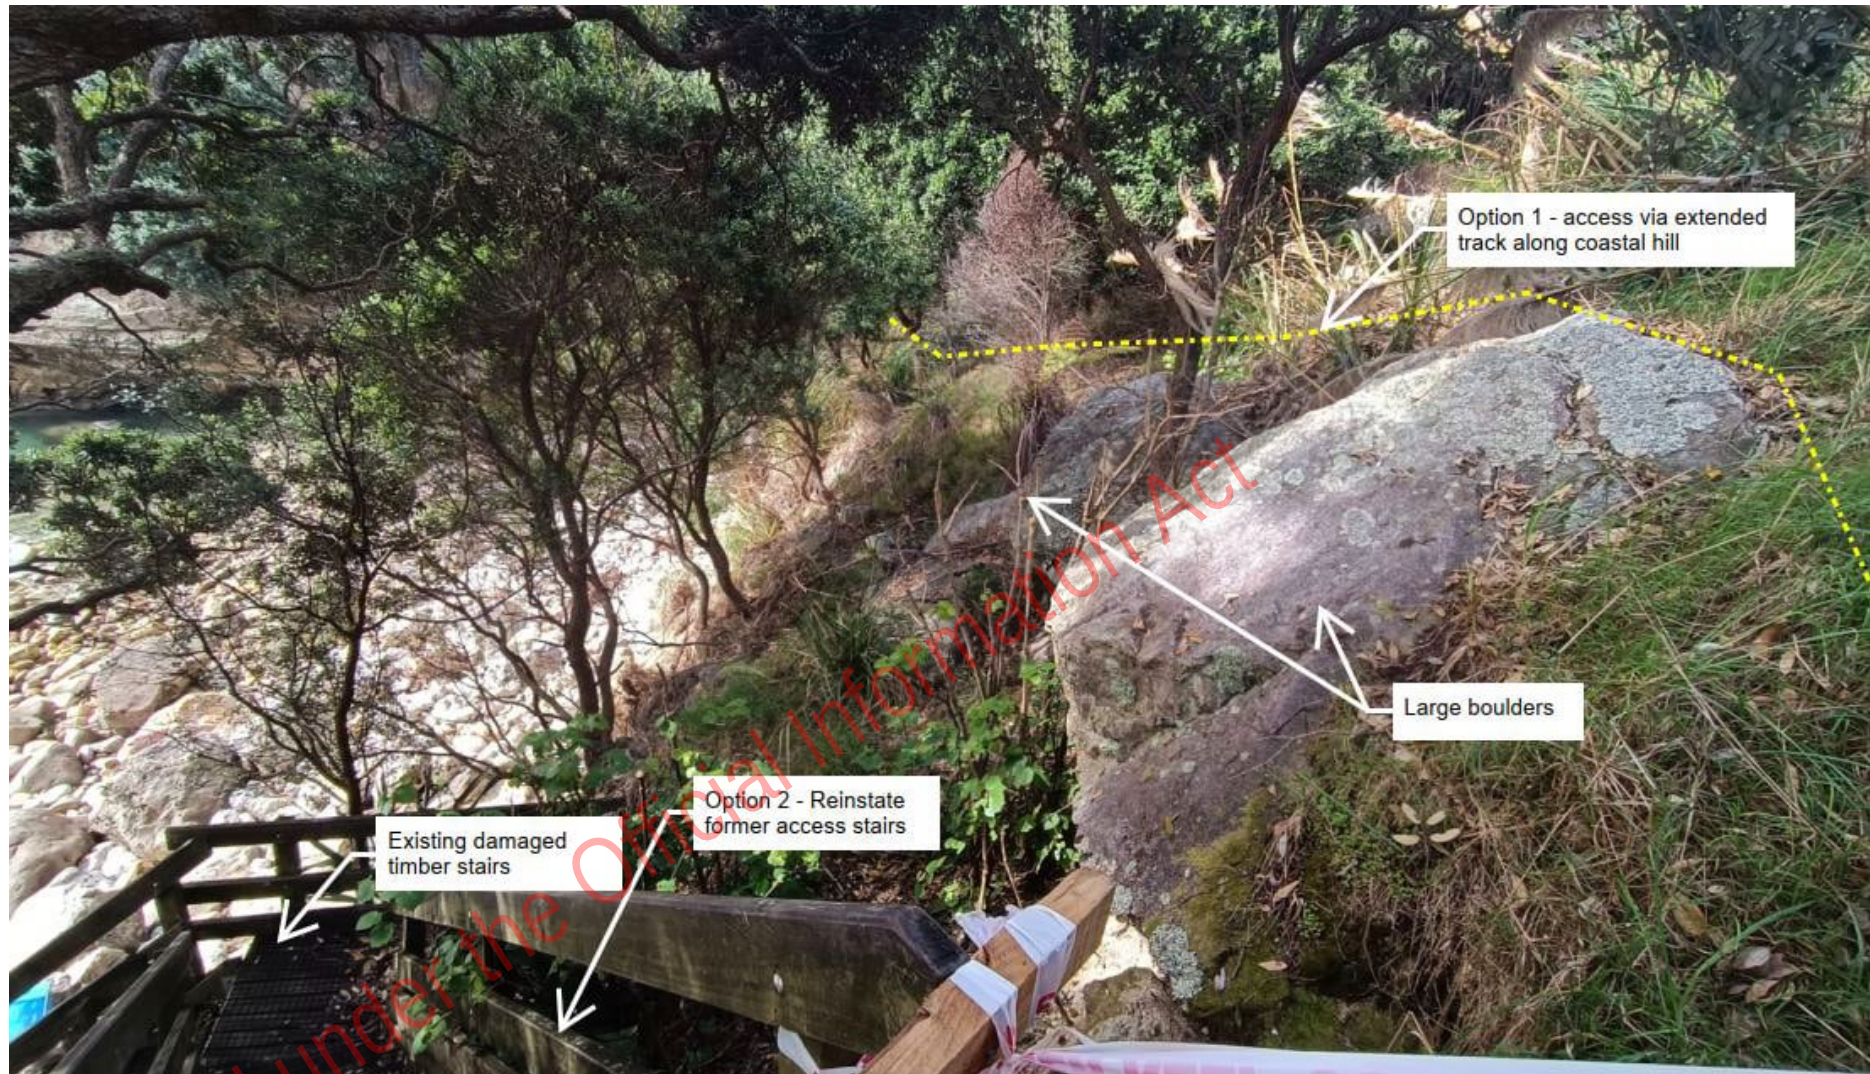
| Site Location | Site details/damage | Management and mitigation options | Comments/risks |
|---|---|---|---|
| Gemstone Bay Beach Access (refer Figure 10.6 and Figure 10.7) | <p>The existing timber stairs which lead to the beach have been severely damaged during the February weather events and cannot be used. The cause of the damage is likely from a combination of scour, debris, loose founding materials and storm surge.</p> <p>Options for beach access are required.</p> <p>The track above the stairs shows some tension cracks similar to the Stingray Bay access track.</p> <p>The hill directly above Gemstone Bay appears to comprise colluvium, a mixture of boulders, gravel and fine soils, likely emplaced from very large landslides.</p> | <p><b>Option 1 – access via alternative route</b></p> <p>This option involves creating a new route which avoids the current stairs (including the tension cracks) by extending the current track to the south. The track would extend approximately 20 m down the steep coastal hill to the beach.</p> <p>This would entail some minor earthworks to form a suitable track width.</p> | <p>The route would need to work around large existing boulders present on the slope which would make earthworks difficult.</p> <p>This option would not provide resilience to storm surge and beach erosion could create a small cliff prohibiting access.</p> <p>This option would be relatively low cost, provided earthworks can be kept to a minimum.</p> <p>On going track maintenance would be required.</p> <p>There is evidence of past landslides on the hill slope and the realigned track would potentially be affected by future slope instability.</p> <p>Consideration was given to realigning track to the north away from the colluvium/bouldery hill slope, however low coastal cliffs are present, and a large stair structure would be required making the route relatively costly and impractical.</p> |

Figure 10.6 Gemstone Bay Beach Access Damage and Mitigation Options (view from top of access stairs).

| Site Location | Site details/damage | Management and mitigation options | Comments/risks |
|---|---|---|---|
| | | <p><b>Option 2 – reinstate former beach access stairs.</b></p> <p>A new set of stairs could be constructed broadly in the same aligned as the previous stairs.</p> <p>Stabilisation of the slope below the stairs would be required to reduce instability and protect from scour.</p> <p>The previous stairs landed on boulders and an ad hoc concrete structure. This may need to be replaced by an engineered structure.</p> | <p>This option would provide a direct route to the beach and the stair structure if appropriately engineered would be relatively resilient.</p> <p>This option could be relatively high cost.</p> <p>An alternative is to construct a stair access with minimal stabilisation and scour protection, broadly similar to the previous stairs. This option would have reduced resilience to storm events and slope instability. It would likely be damaged after large events and require replacement.</p> |

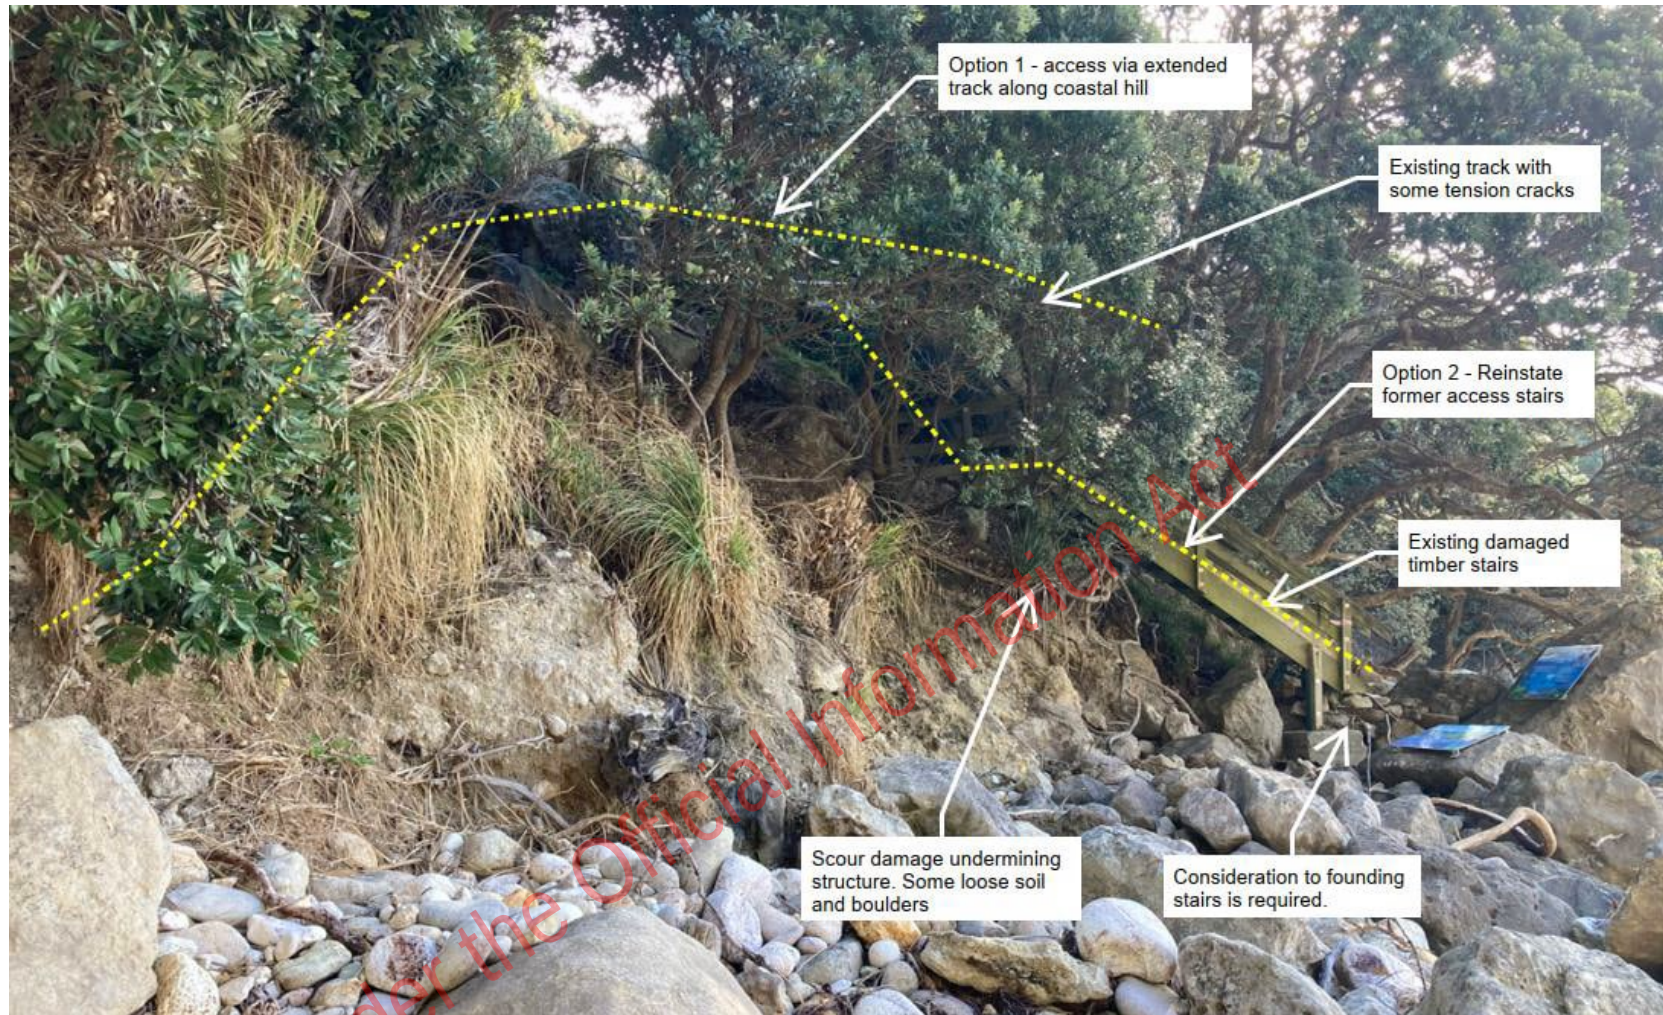
Figure 10.7 Gemstone Bay Beach Access Damage and Mitigation Options (view from beach).

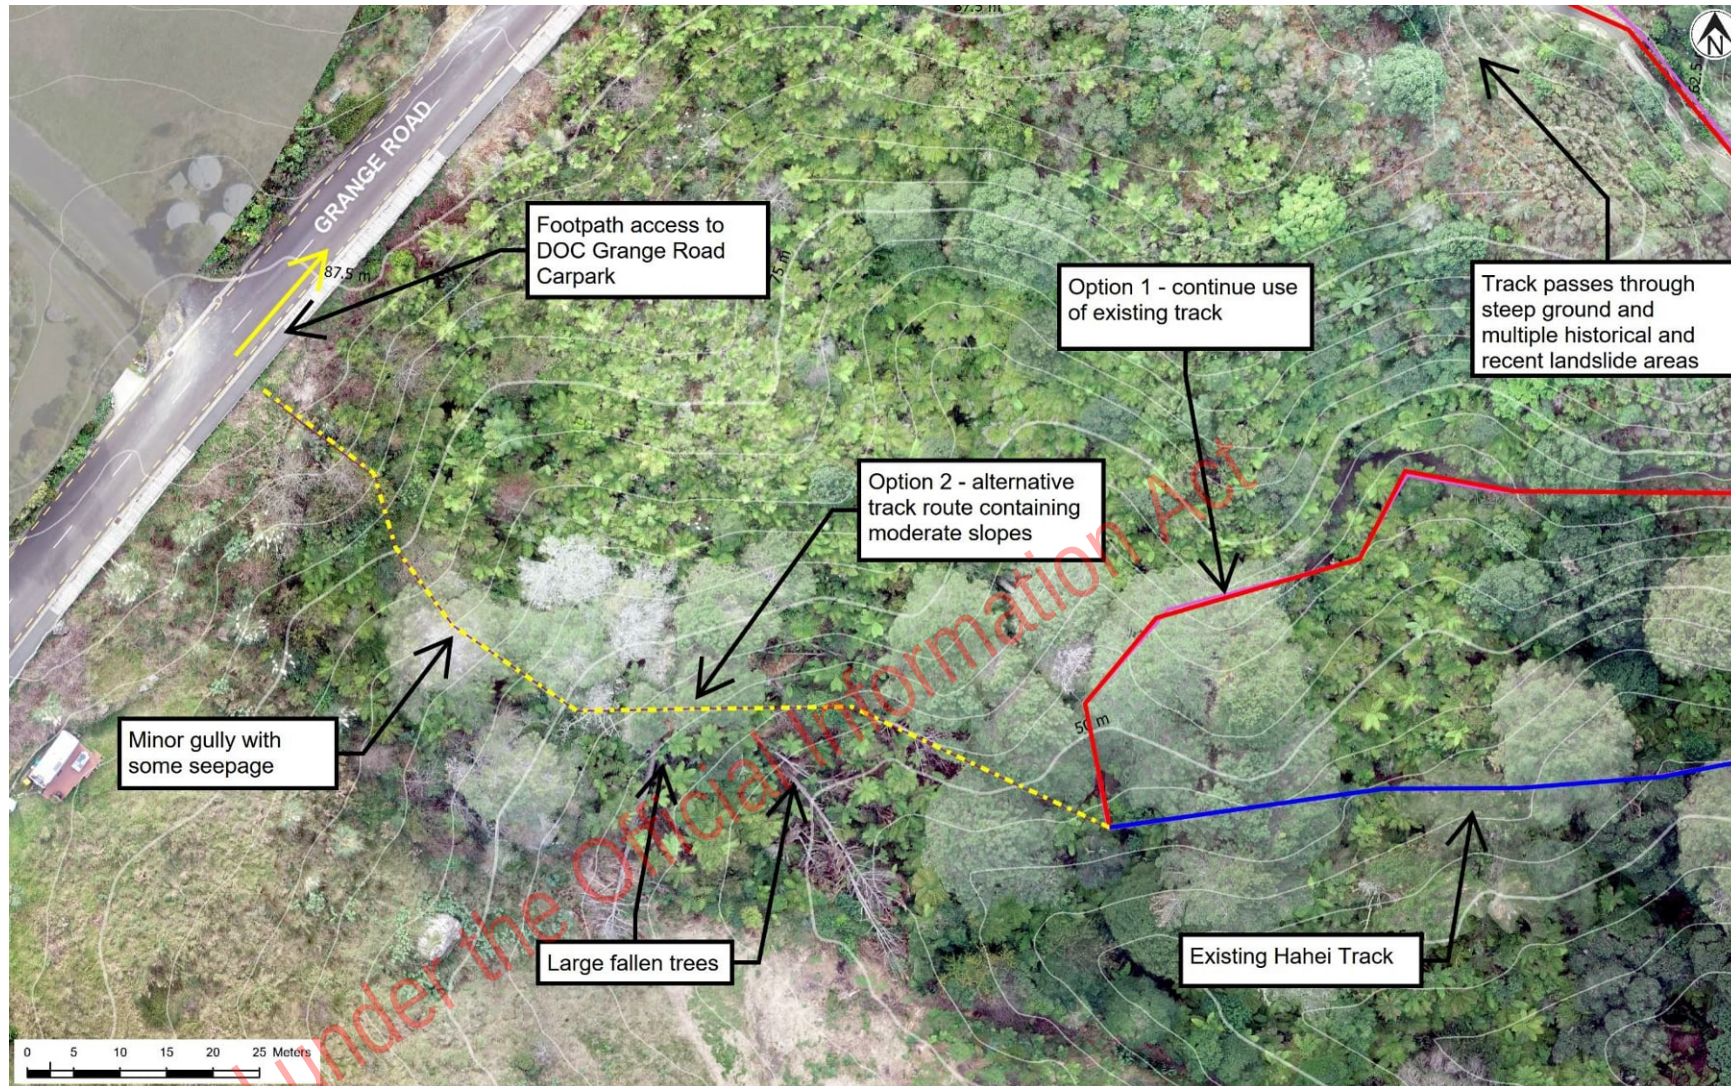
Figure 10.9 Hahei Track Mitigation Options (T+T UAV photography).

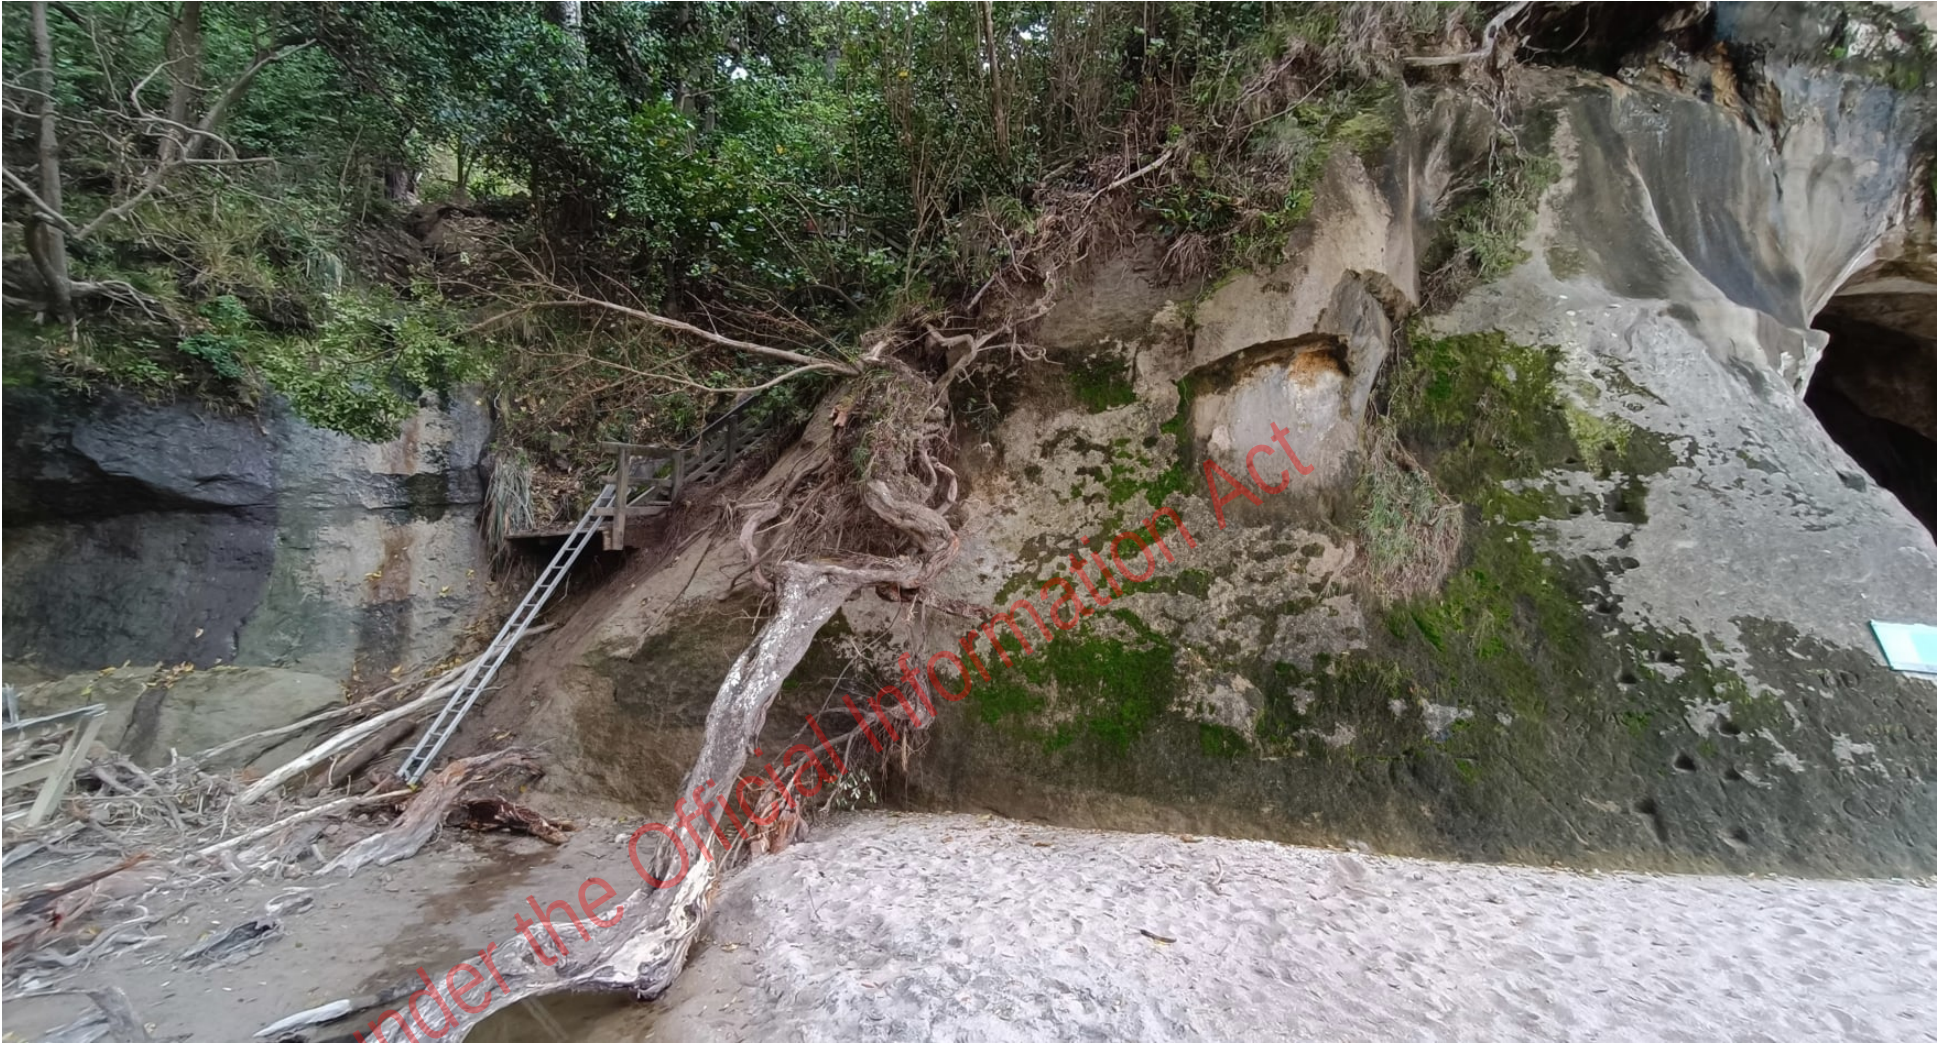
Figure C1 Damage to Cathedral Cove Access

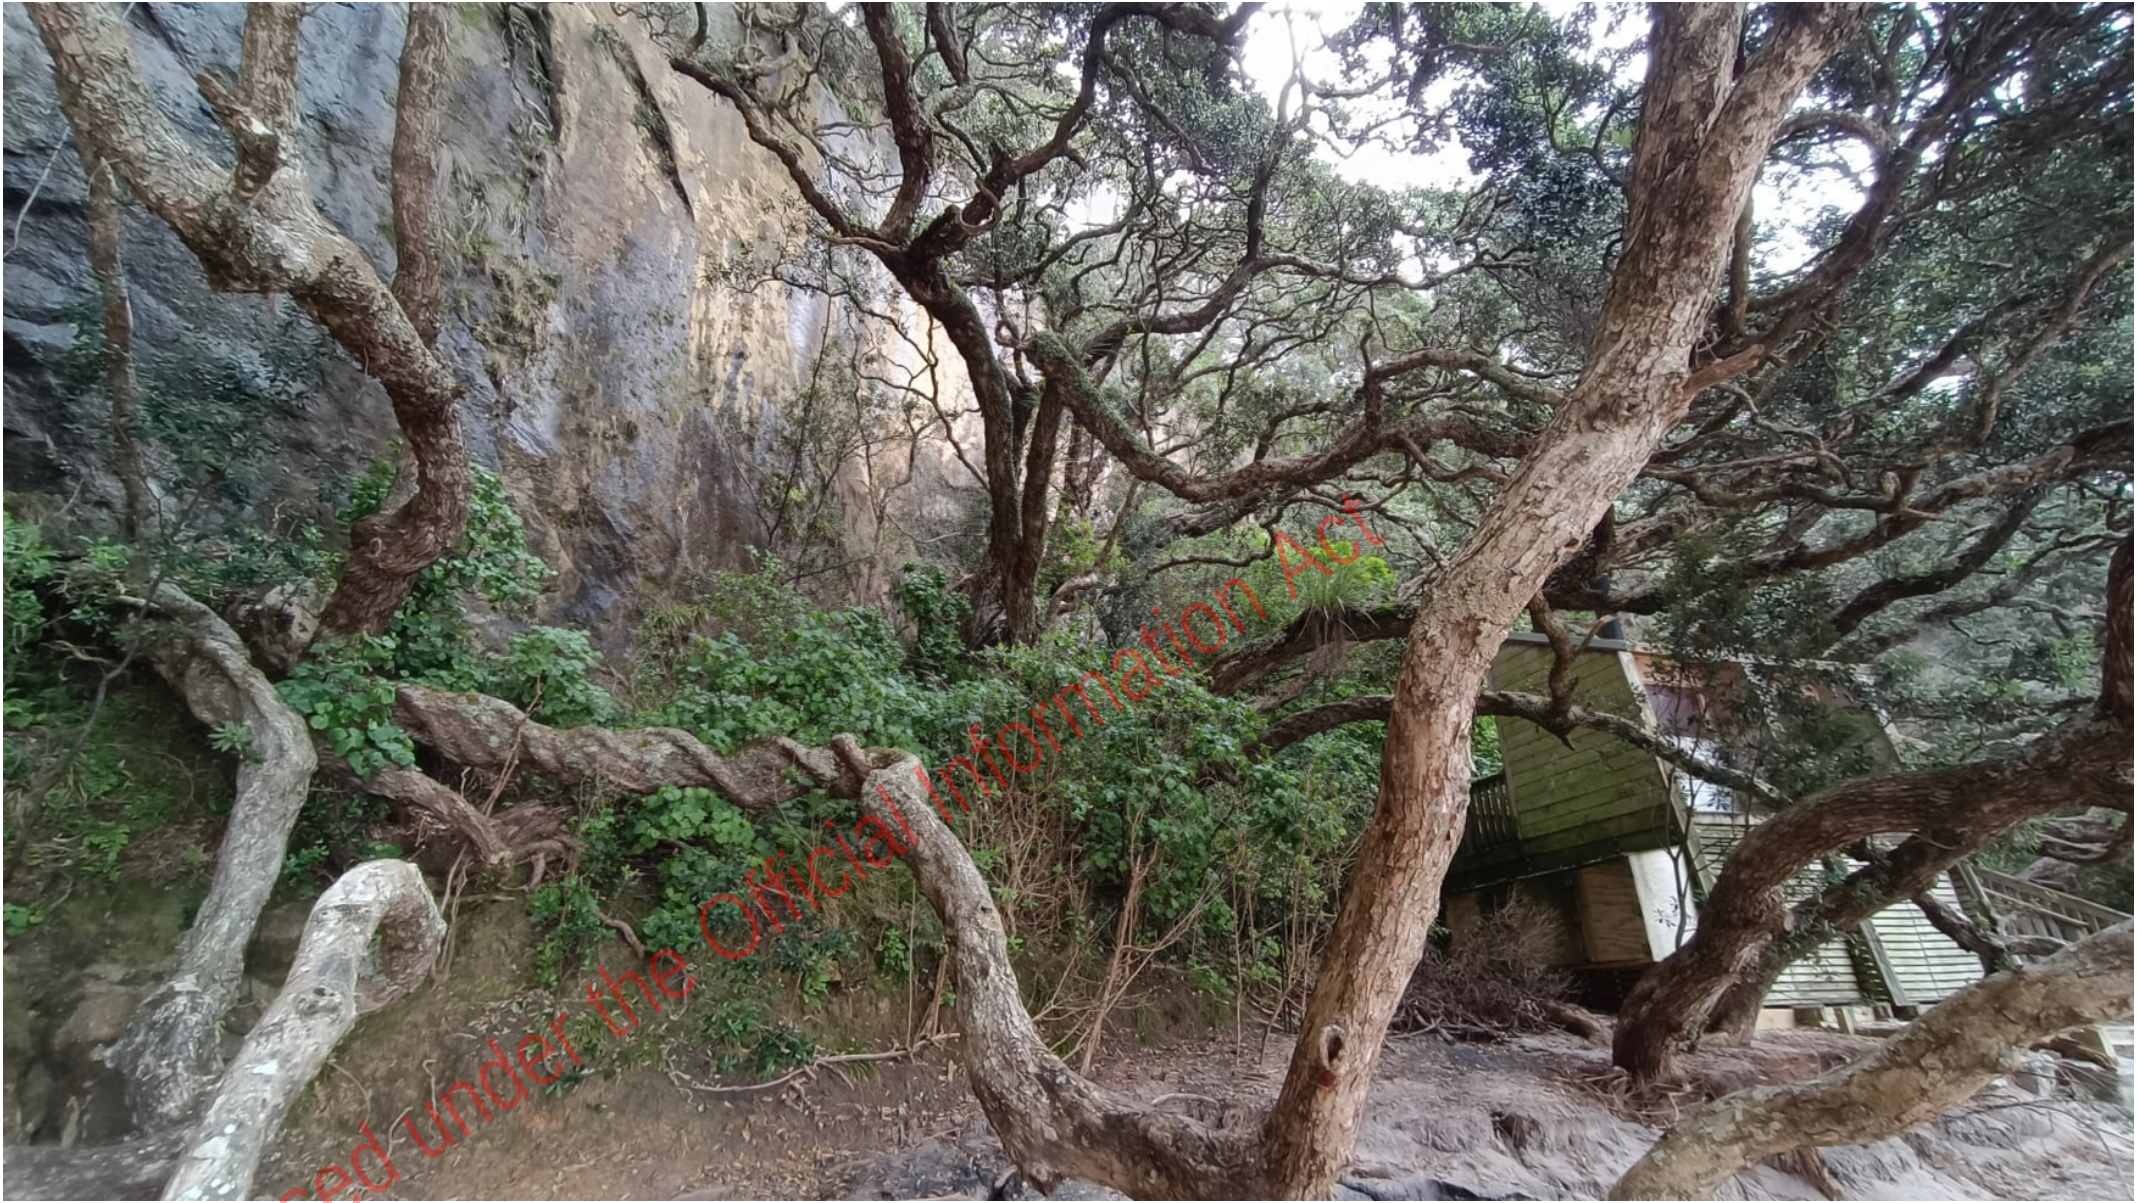
Figure C2 Historical debris / talus at the toe of the coastal cliff behind the existing toilet at Cathedral Cove Beach
