**Cathedral Cove Basic Level  
Landslide Risk Assessment**

**Prepared for**  
Department of Conservation  
**Prepared by**  
Tonkin & Taylor Ltd  
**Date**  
July 2023  
**Job Number**  
1007838.3000 v3

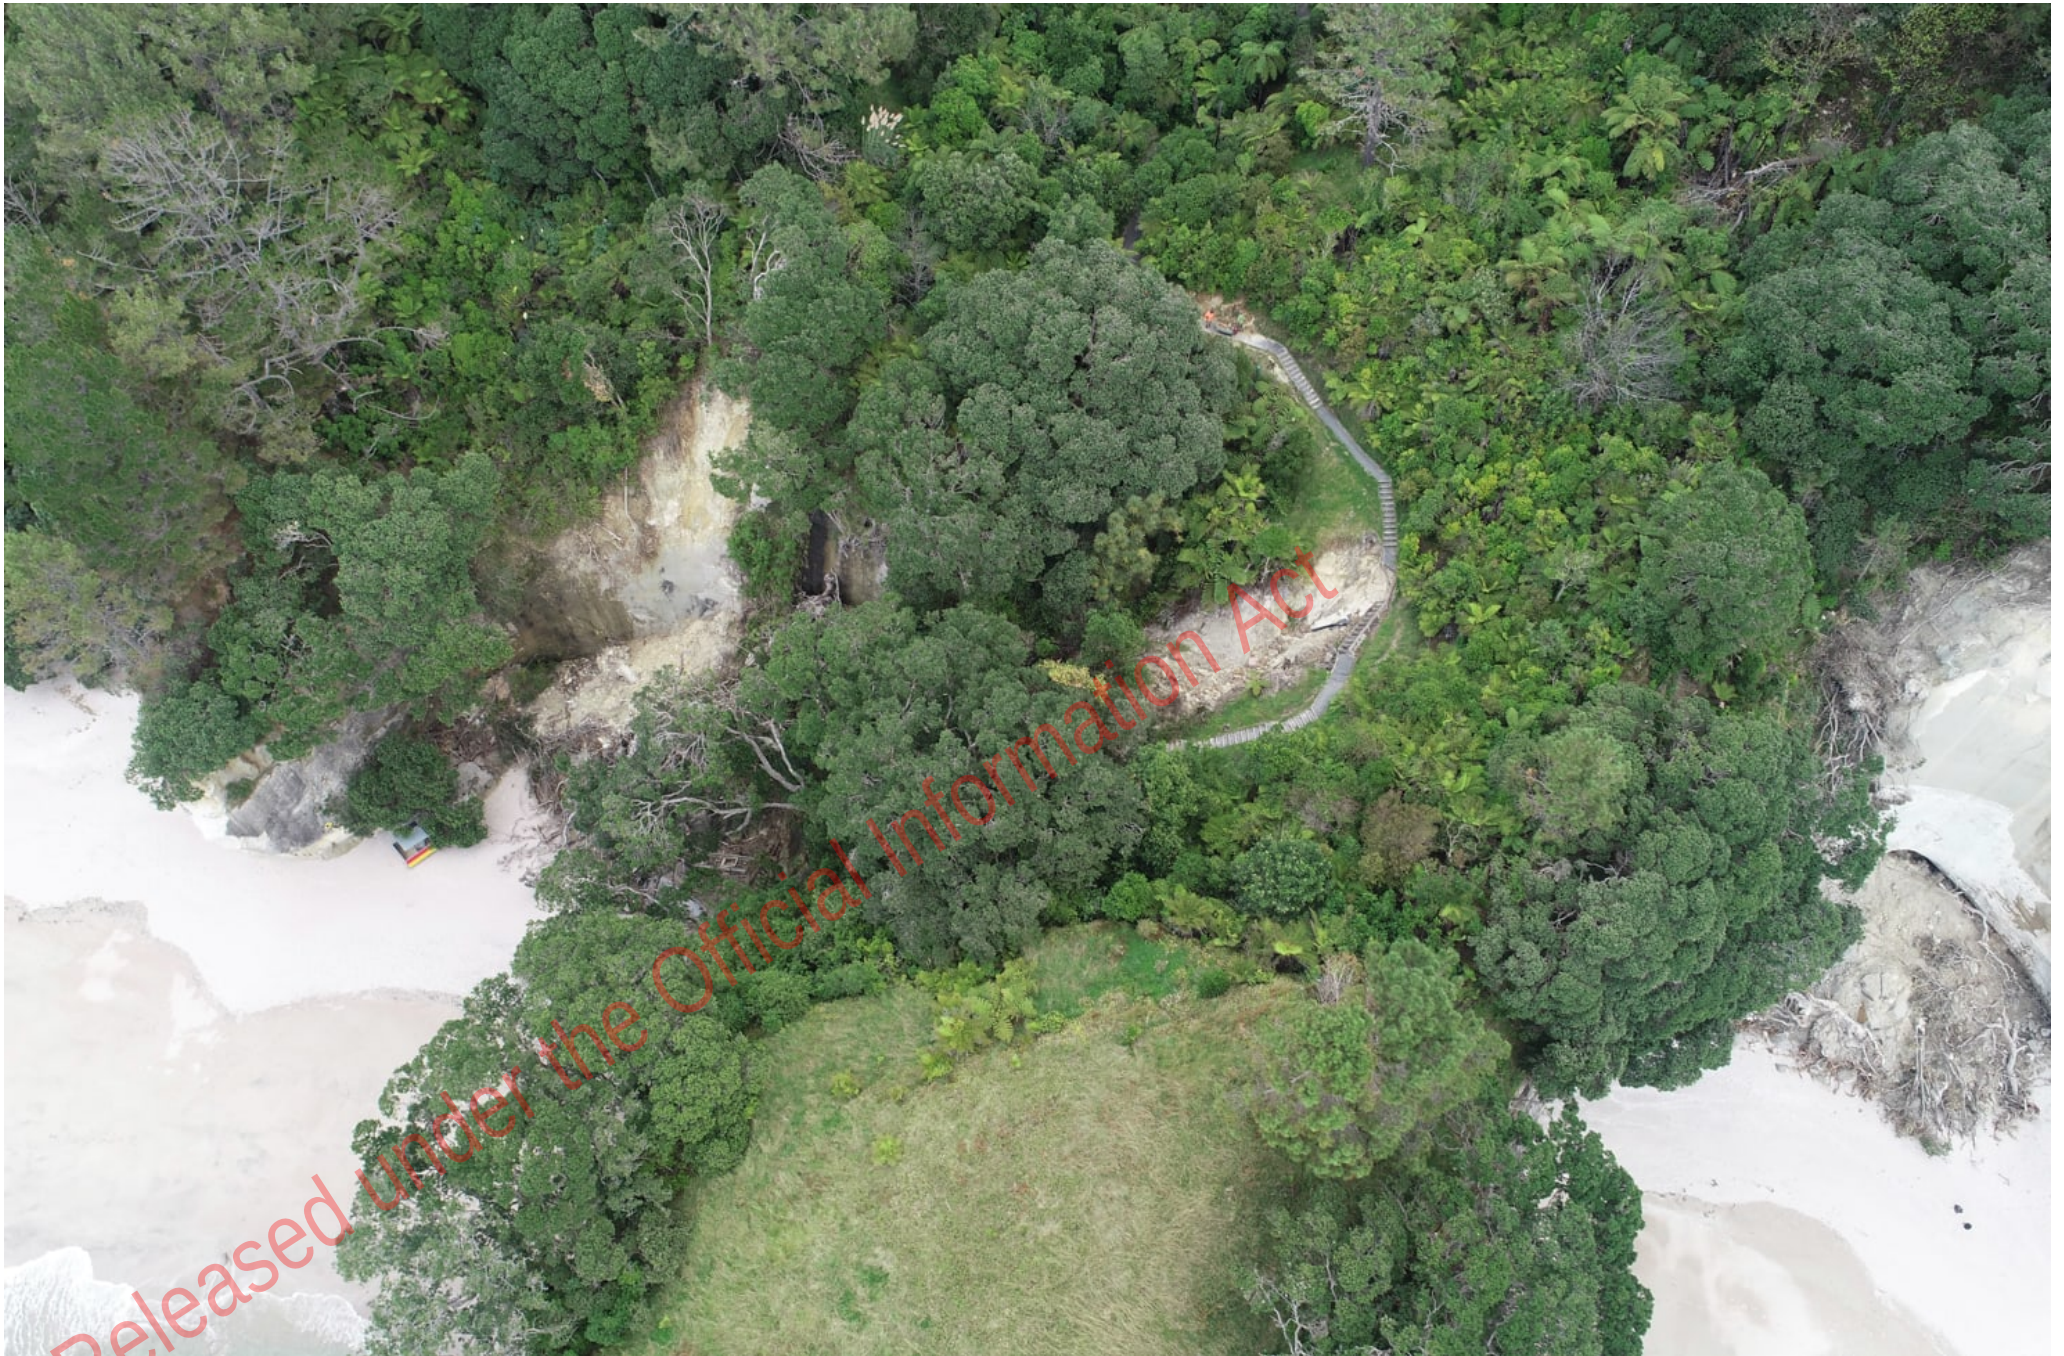
Figure C4 Aerial view of the damage to Cathedral Cove Track

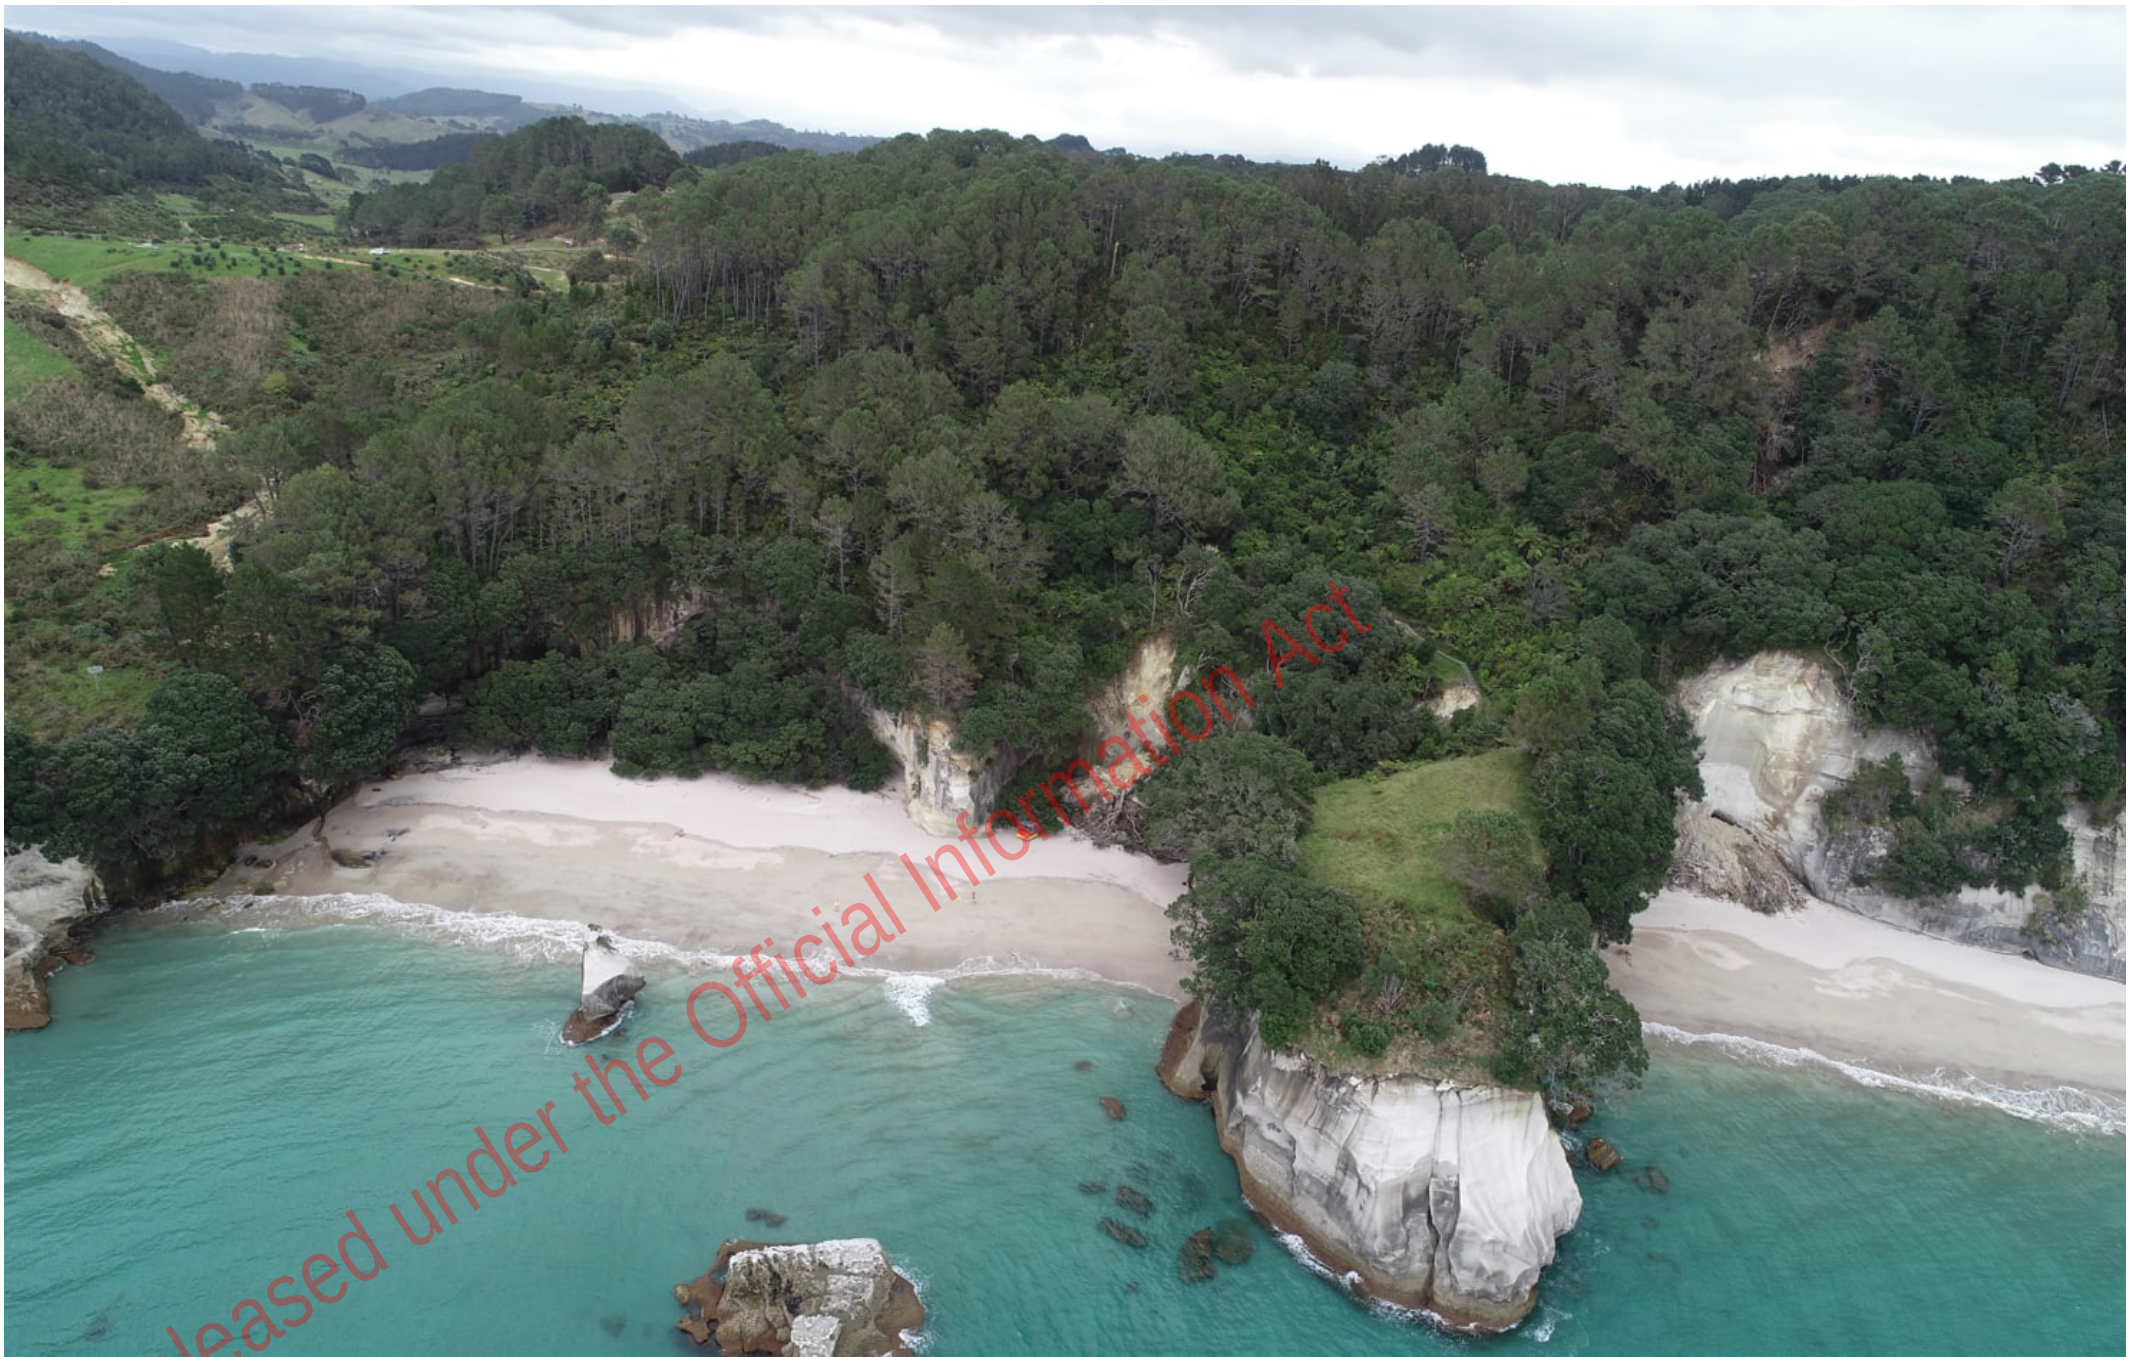
Figure C5 Aerial view of multiple landslides and rockfall at Cathedral Cove Track

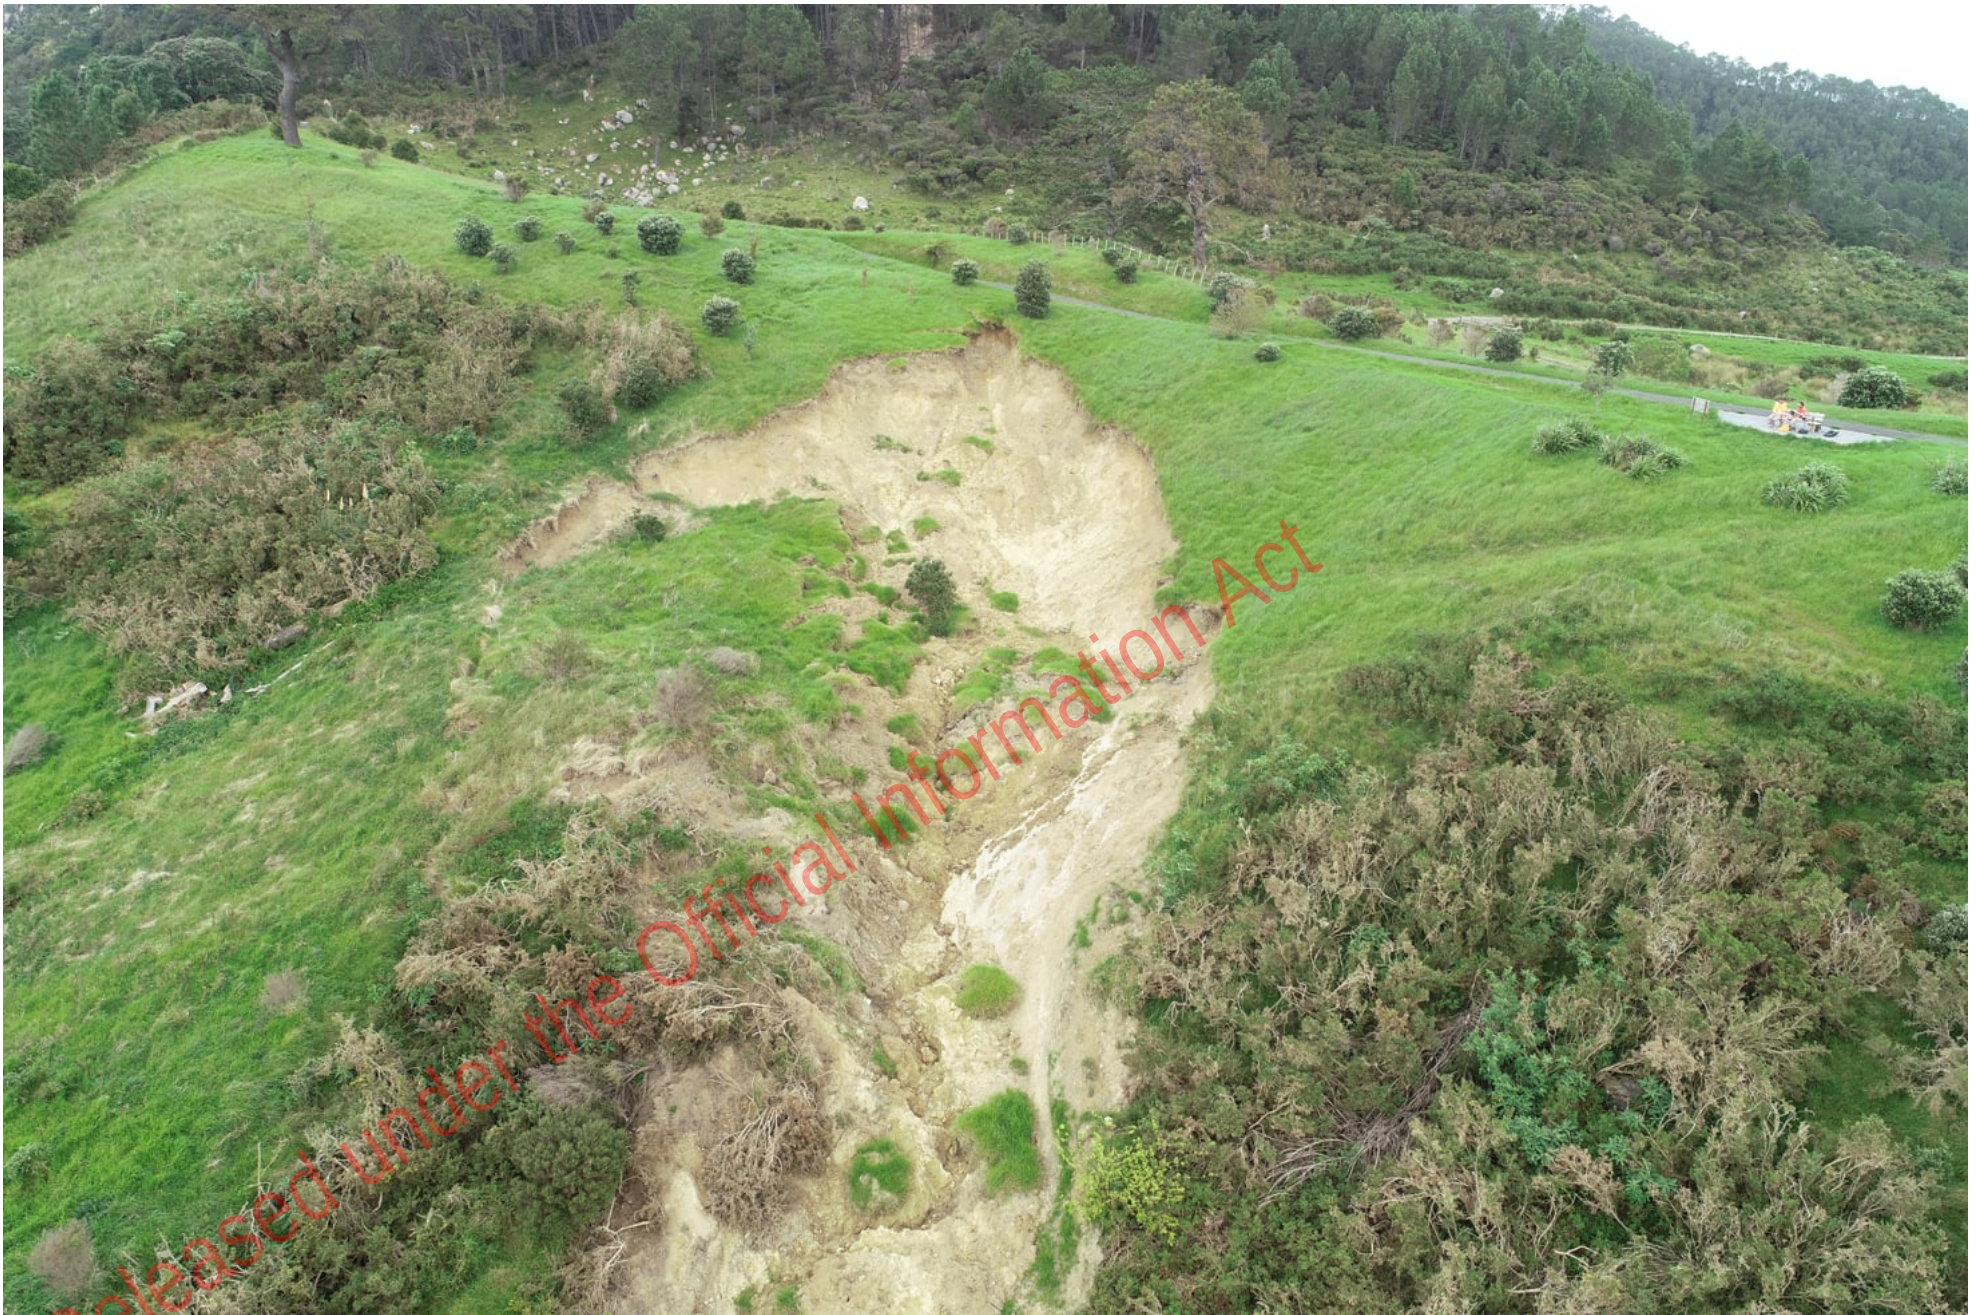
Figure C6 Aerial view of debris flow headscarp.  
Tension cracks are visible in grass above headscarp  
(directly below track).

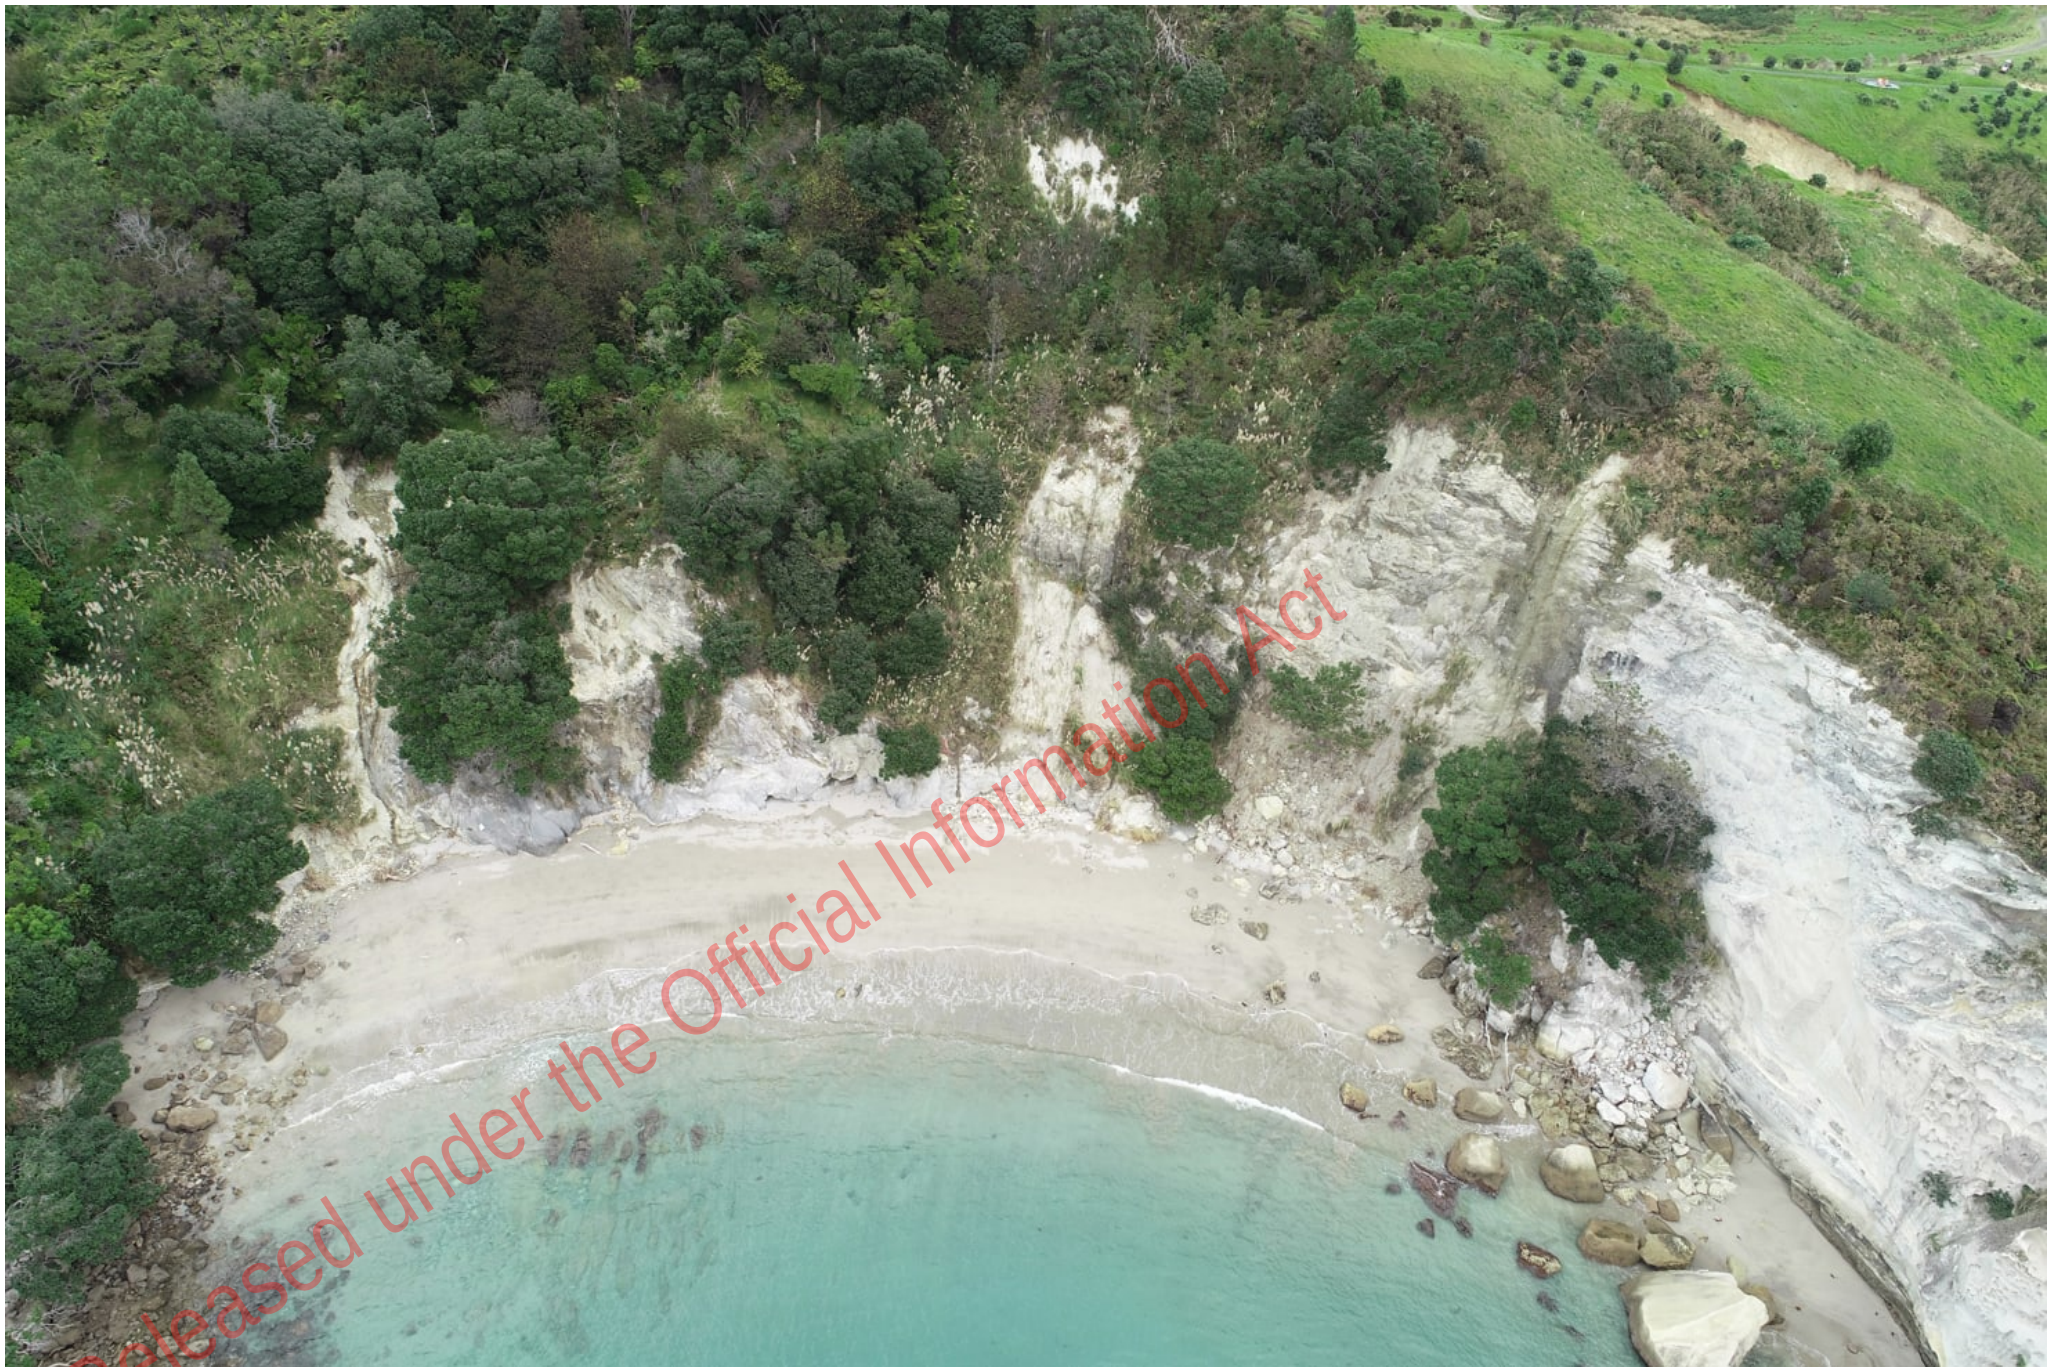
Figure C7 Aerial view of landslides at Stingray Bay

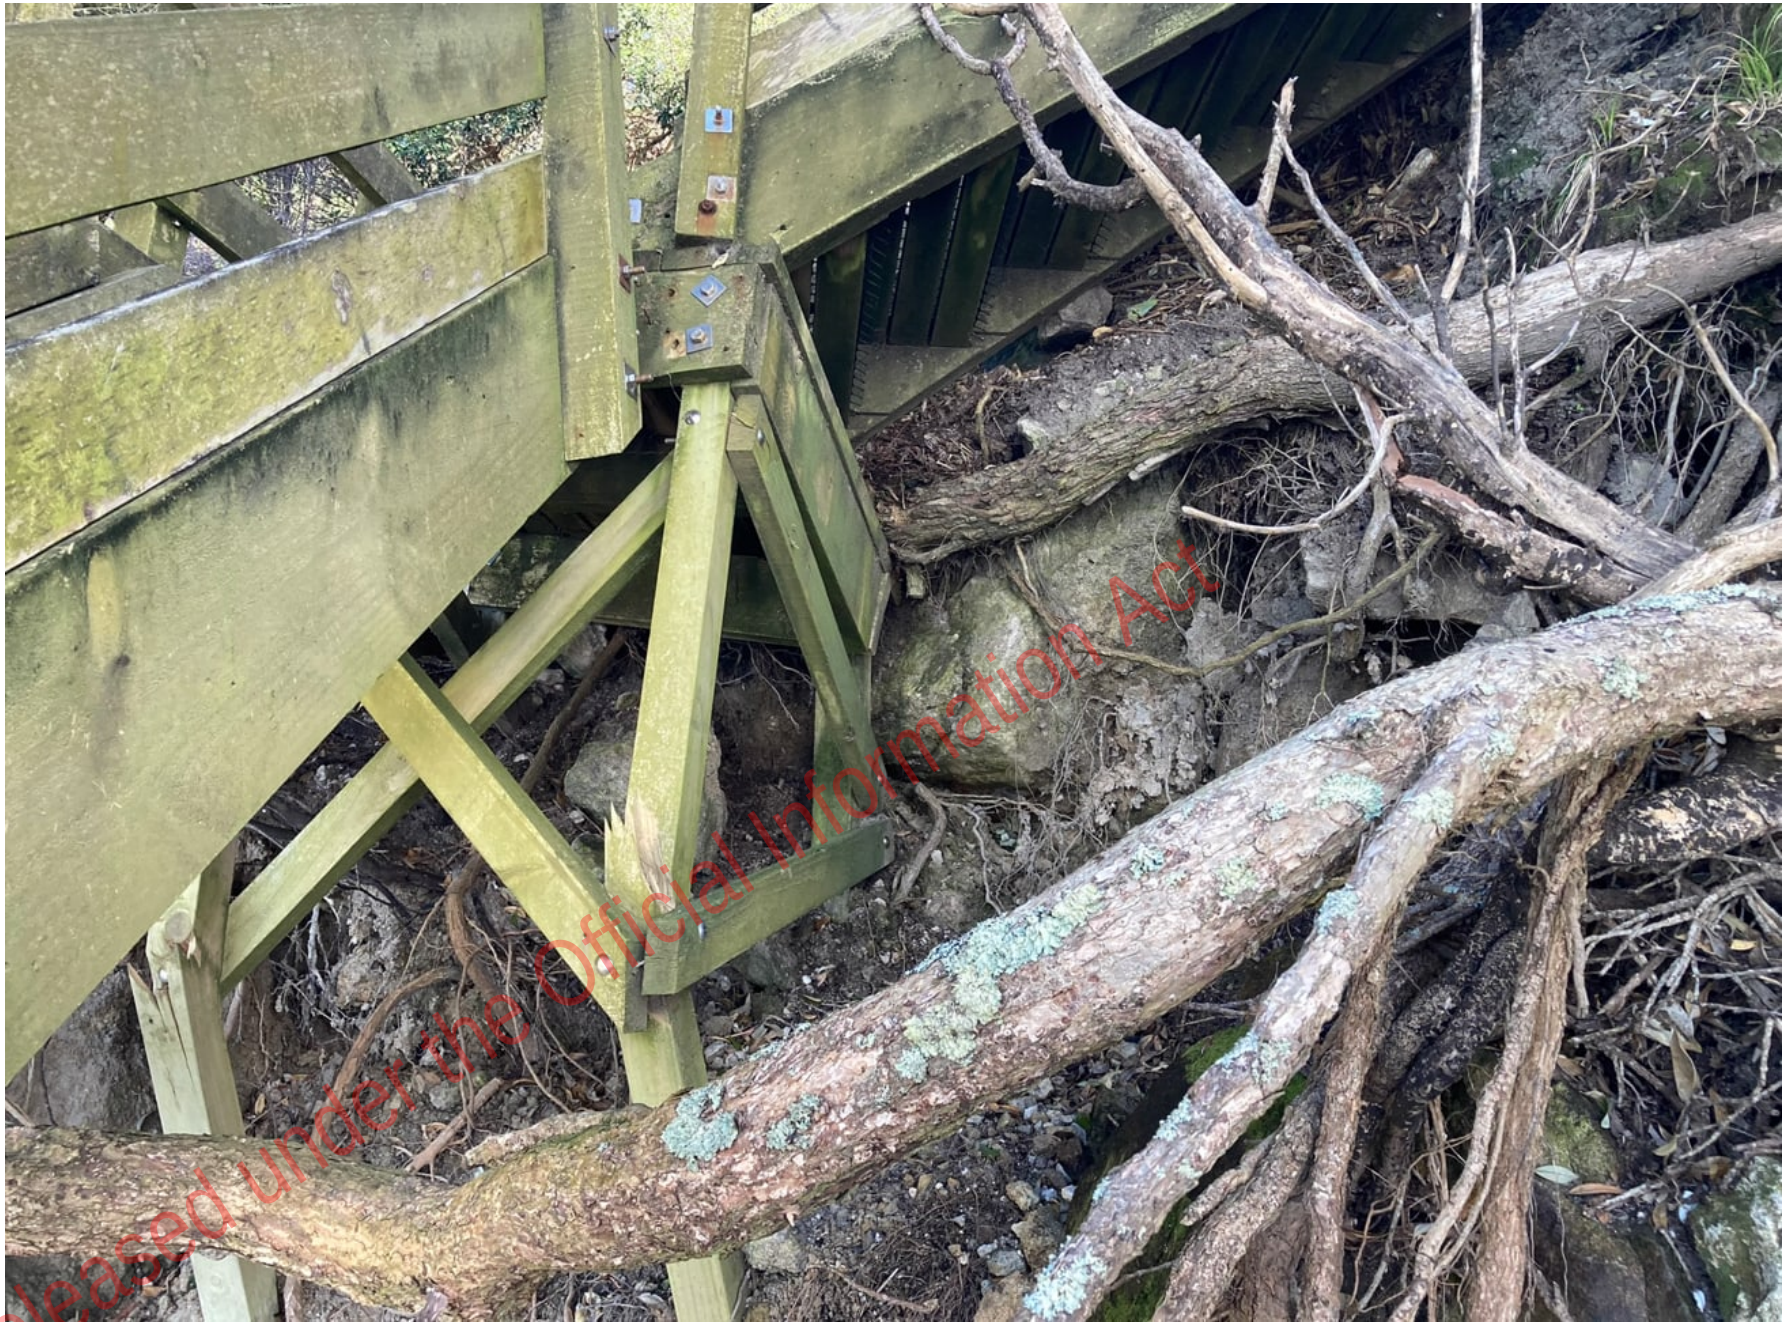
Figure C12 Gemstone Bay stair access damage and scour of loose boulders in slope.

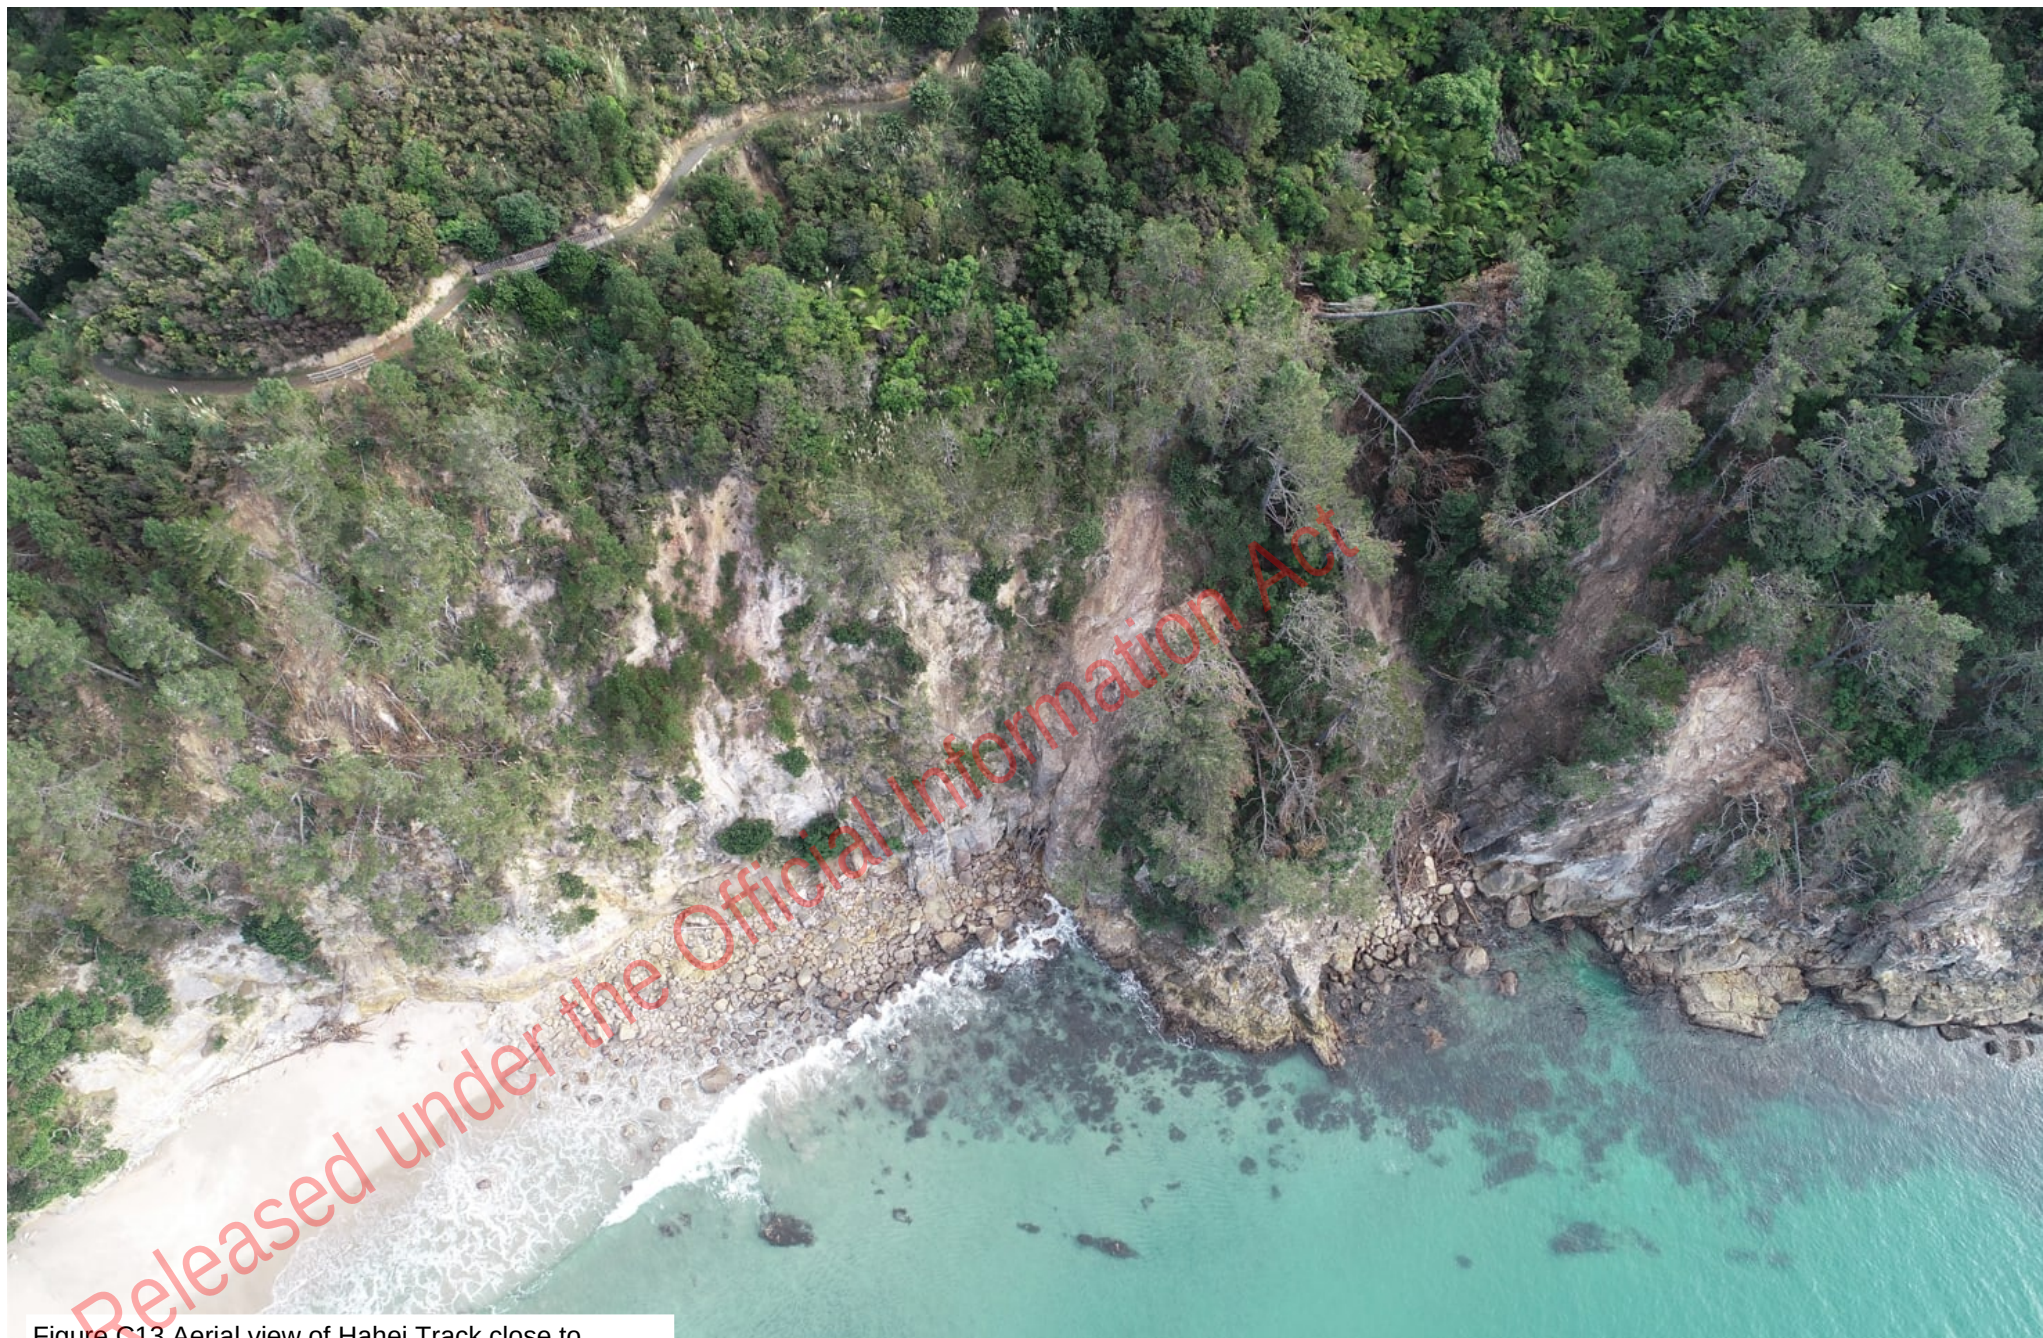
Figure C13 Aerial view of Hahei Track close to coastal cliff and recent landslides.

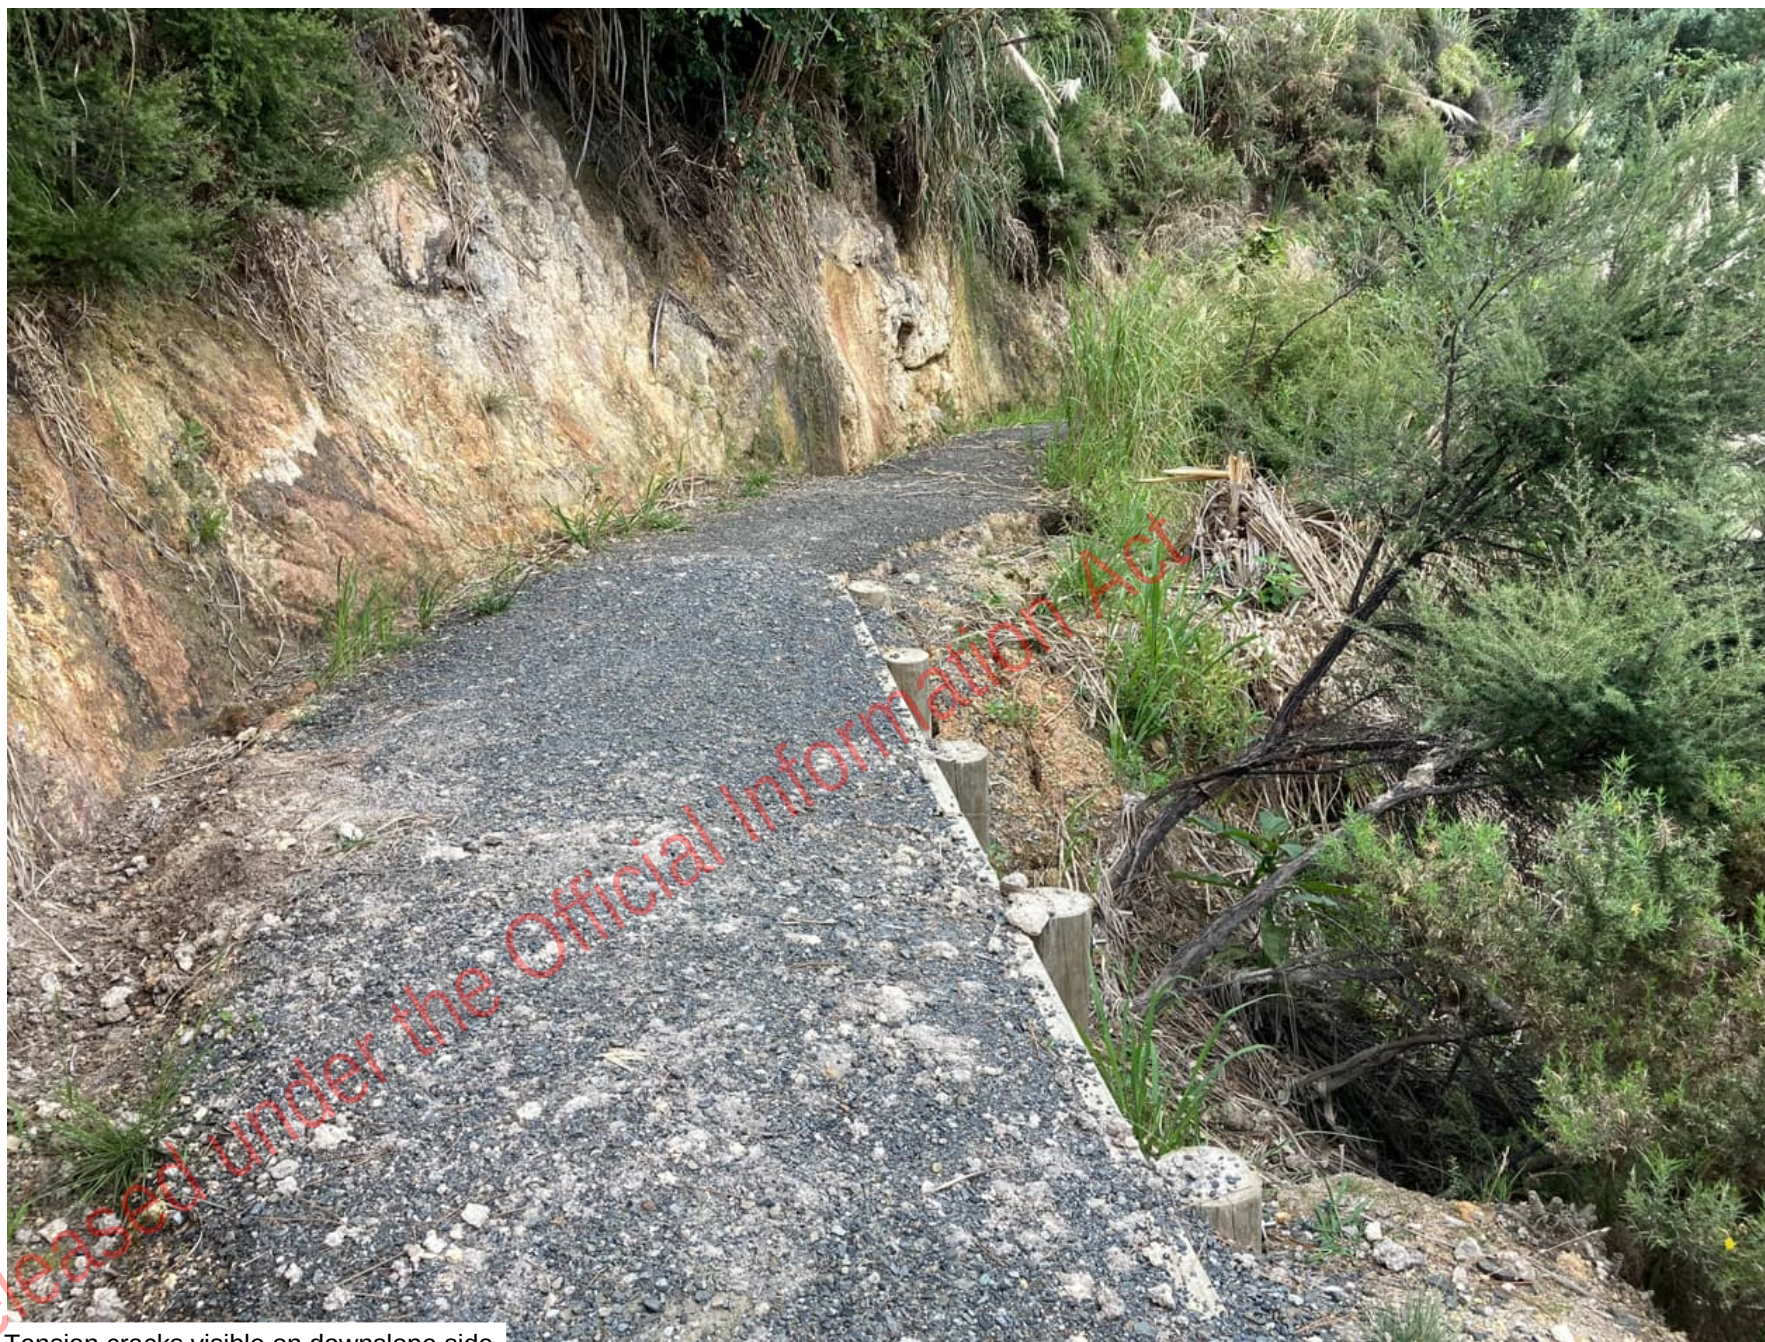
Figure C14 Tension cracks visible on downslope side of Hahei Track

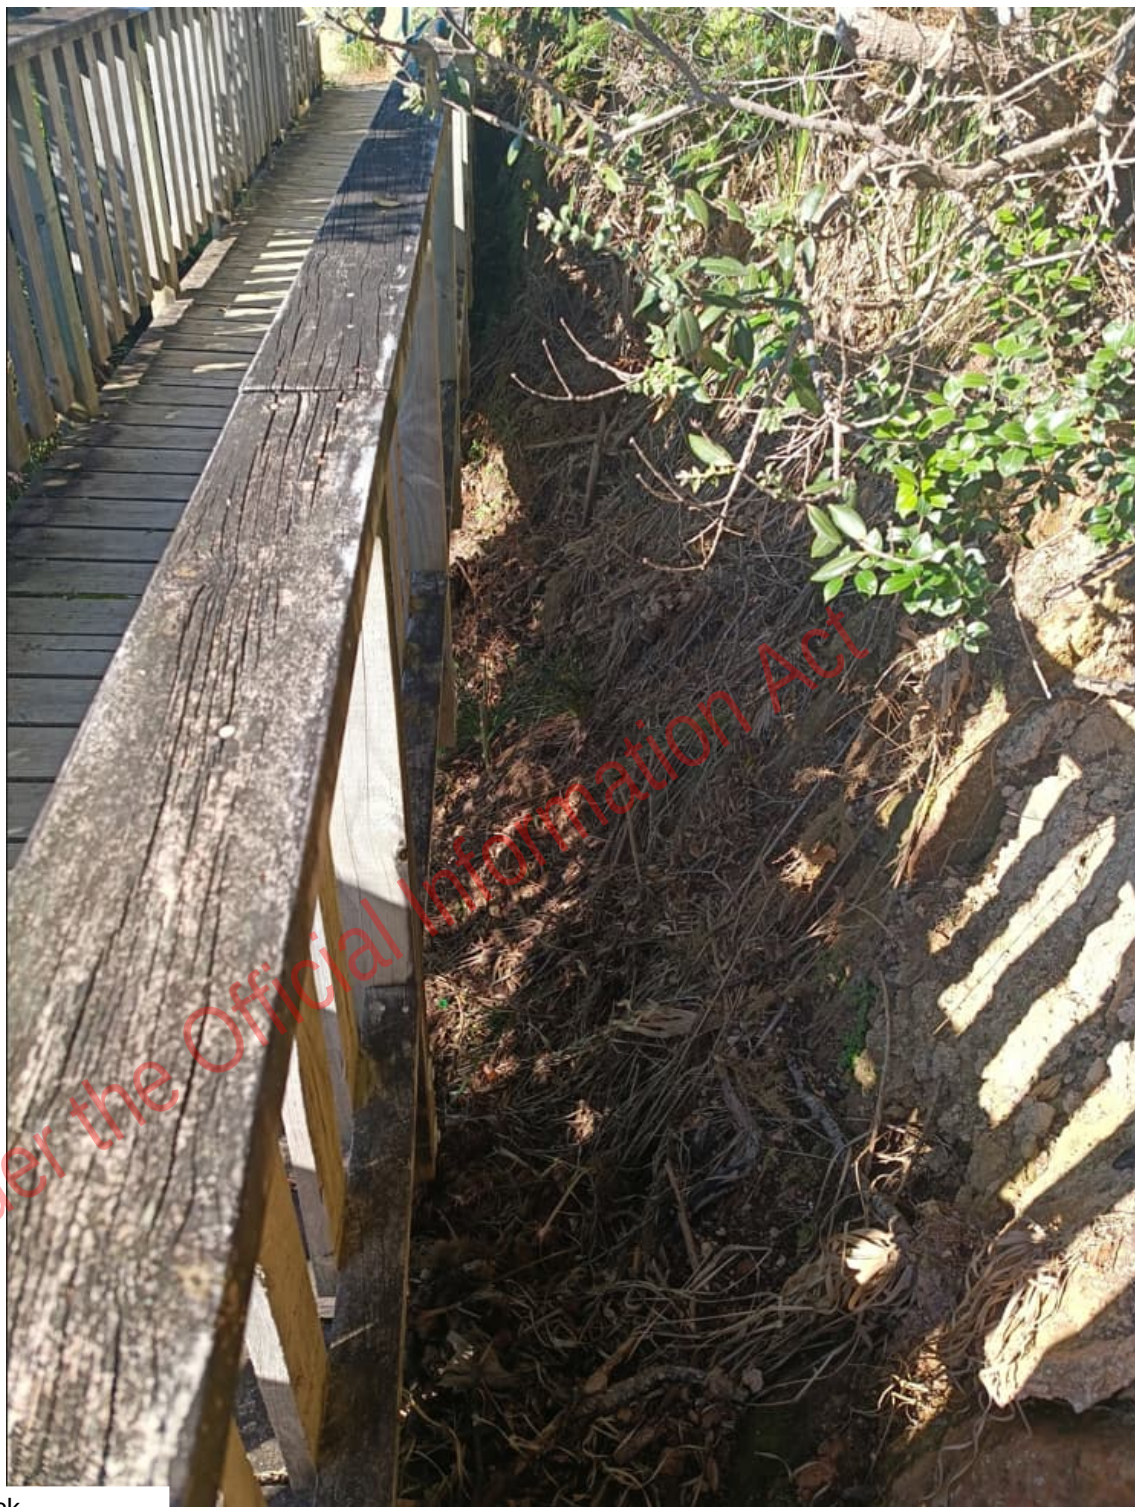
Figure C15 Landslide behind Hahei Track

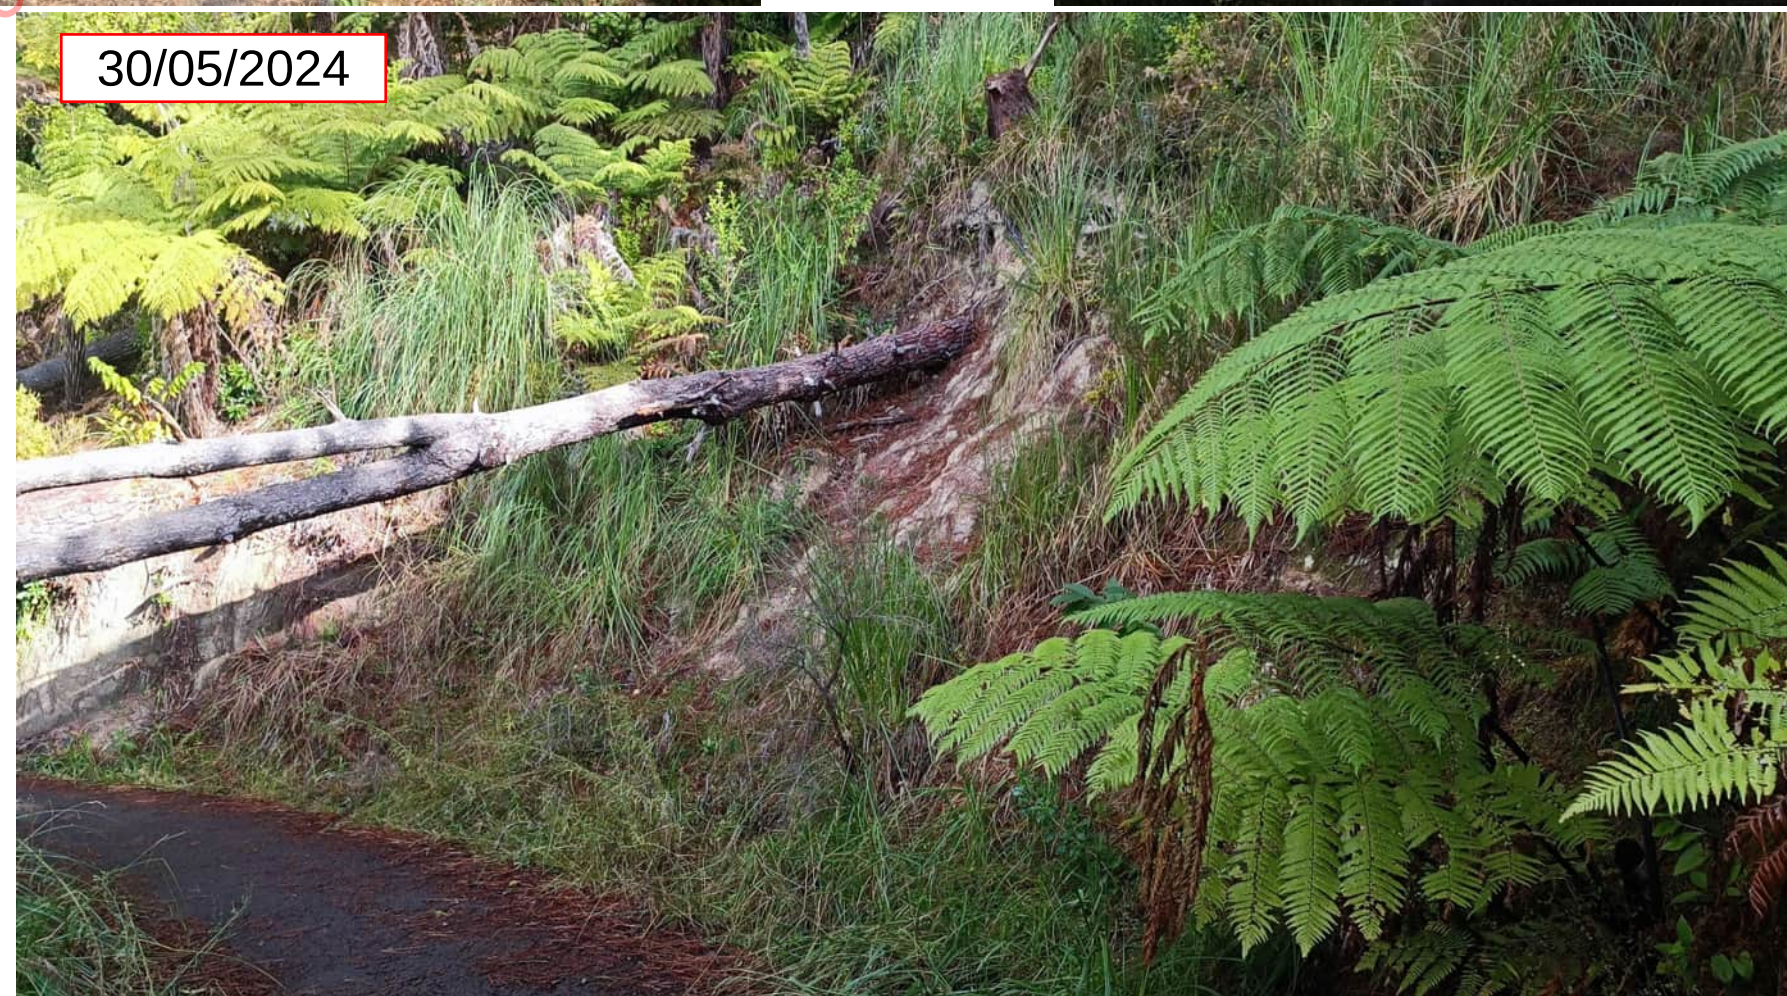
Feature 6 - Translational landslide. No new movement.
