**Cathedral Cove Basic Level  
Landslide Risk Assessment**

**Prepared for**  
Department of Conservation  
**Prepared by**  
Tonkin & Taylor Ltd  
**Date**  
July 2023  
**Job Number**  
1007838.3000 v3

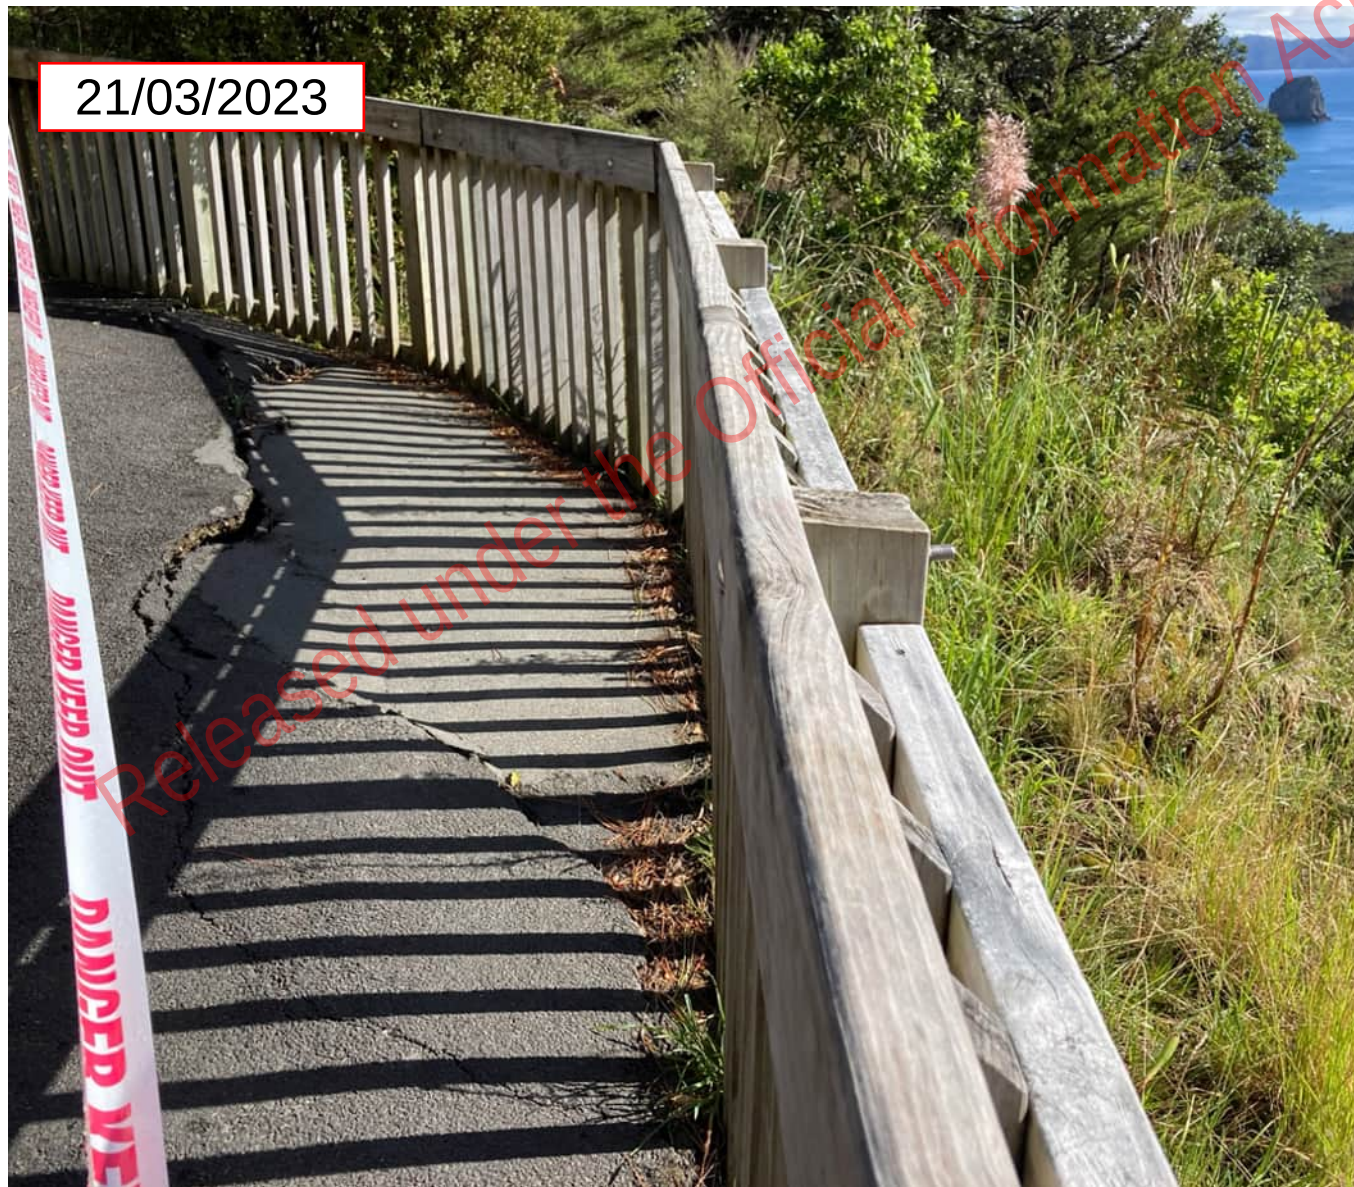
Feature 7 - Translational landslide  
Small amounts of additional deflection  
in the scarp observed during Feb 2024  
visit.

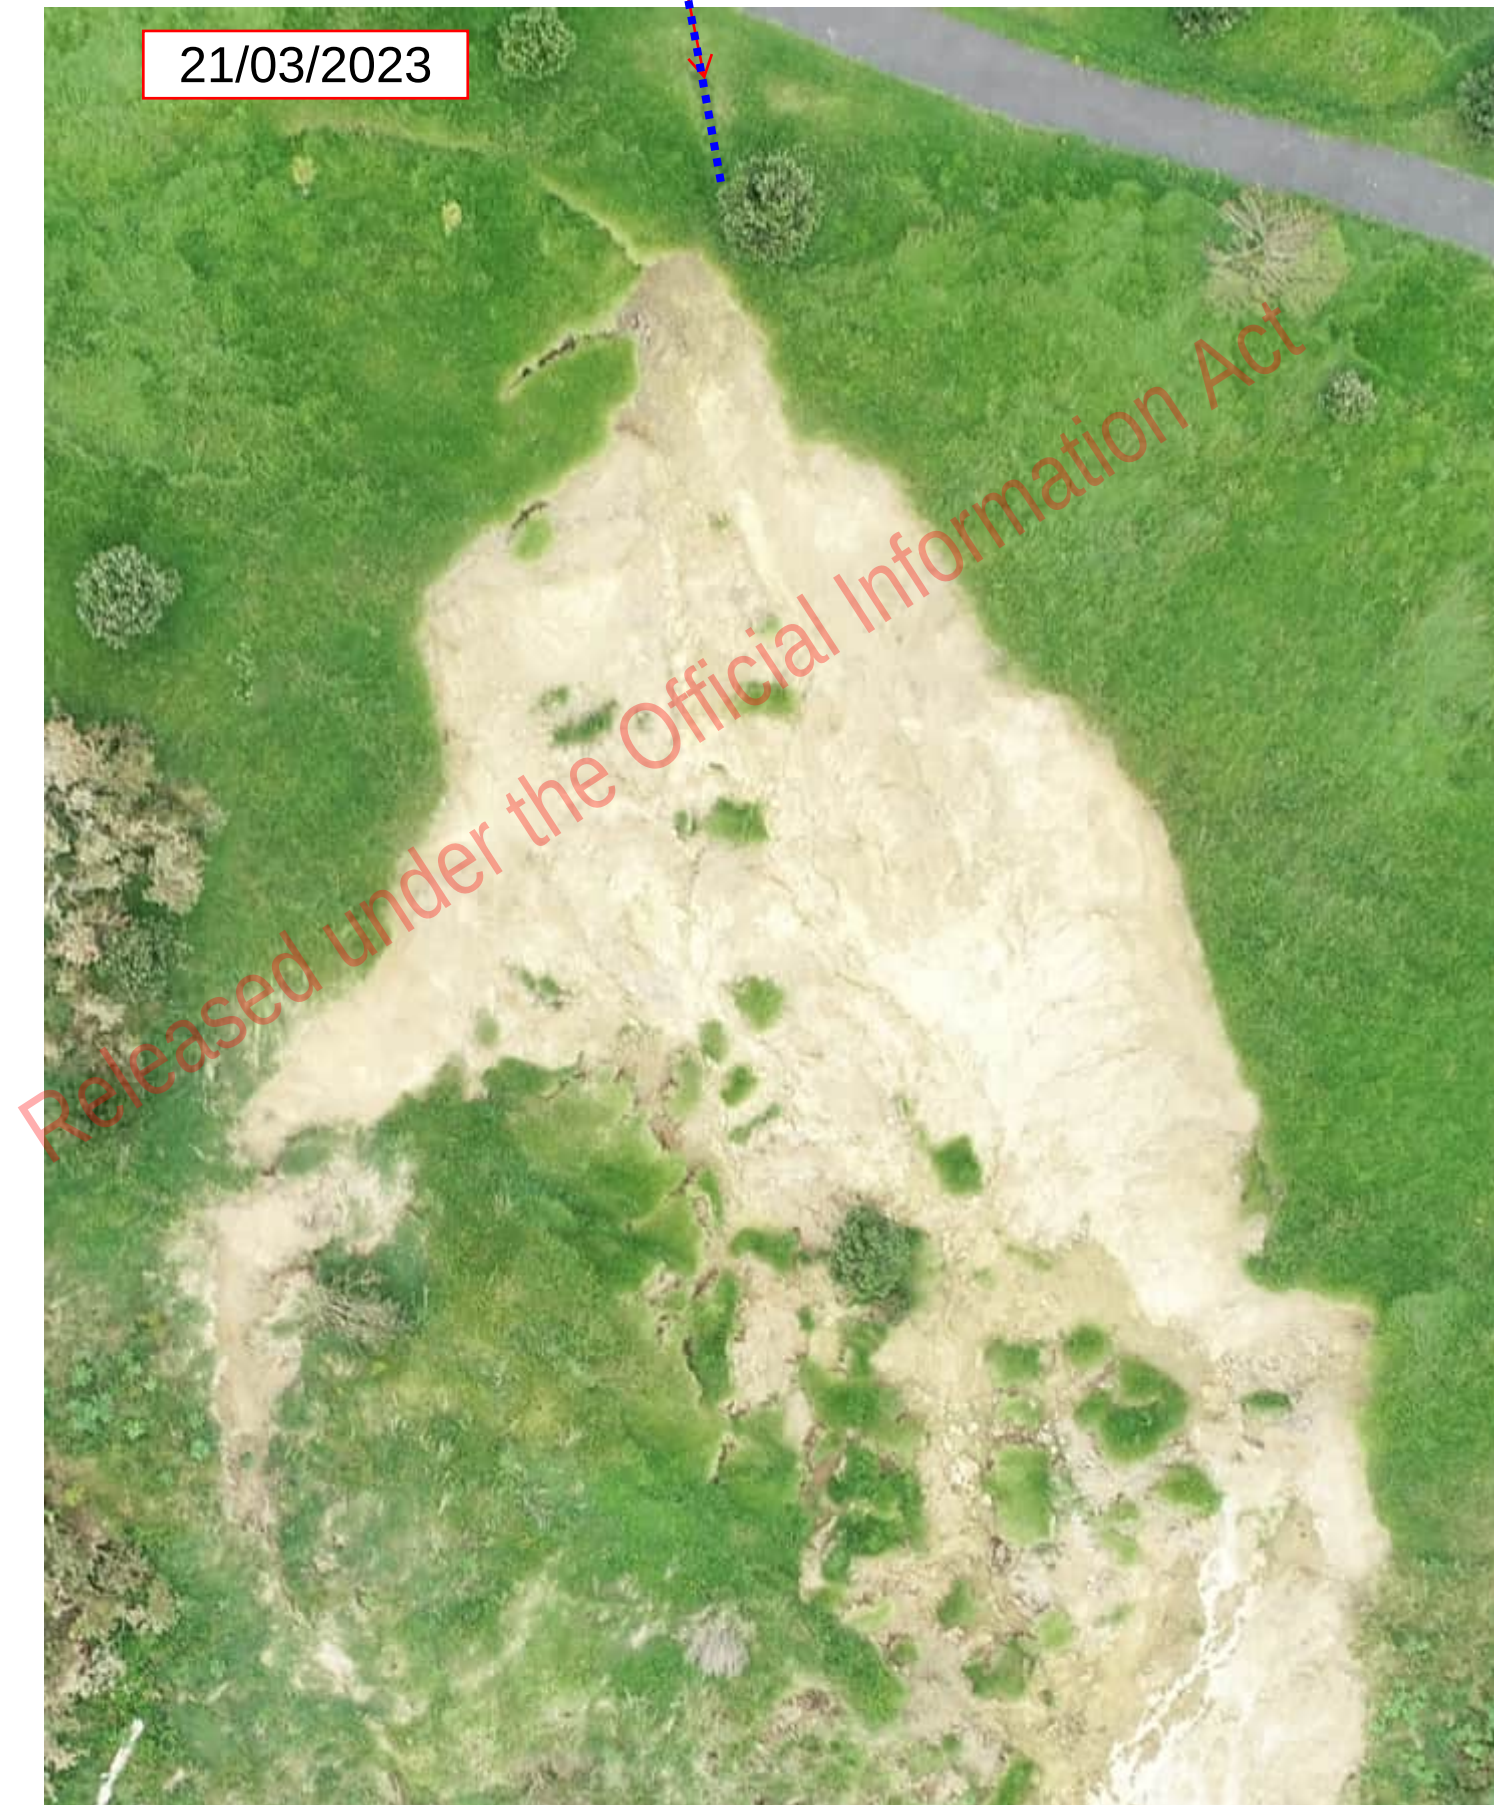
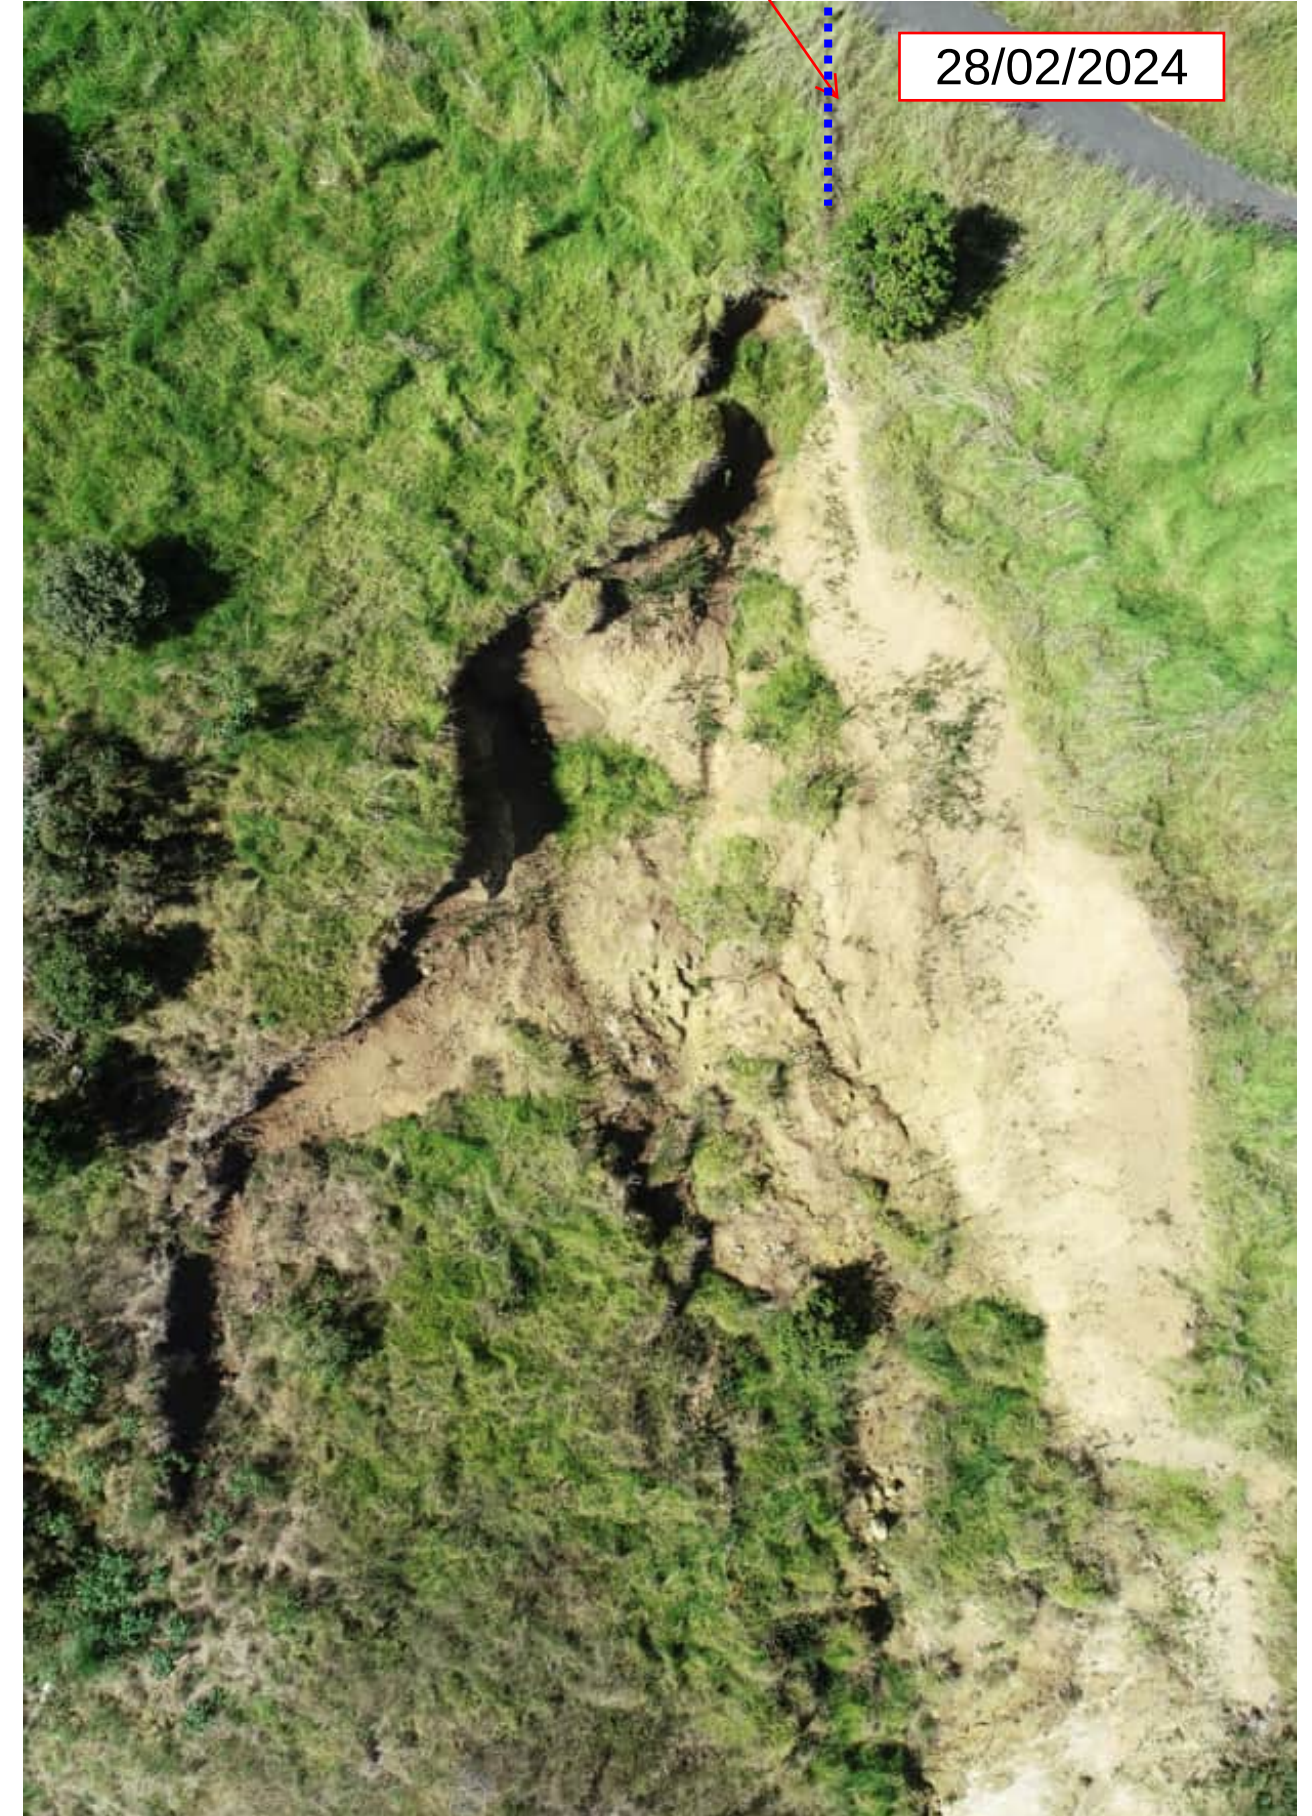
Feature 9 and 10 - Landslide earth flow and tension crack. No new significant damage observed during Feb 2024 visit. Erosion (< 0.25 m) of headscarp.

A culvert discharges to the vicinity of the headscarp

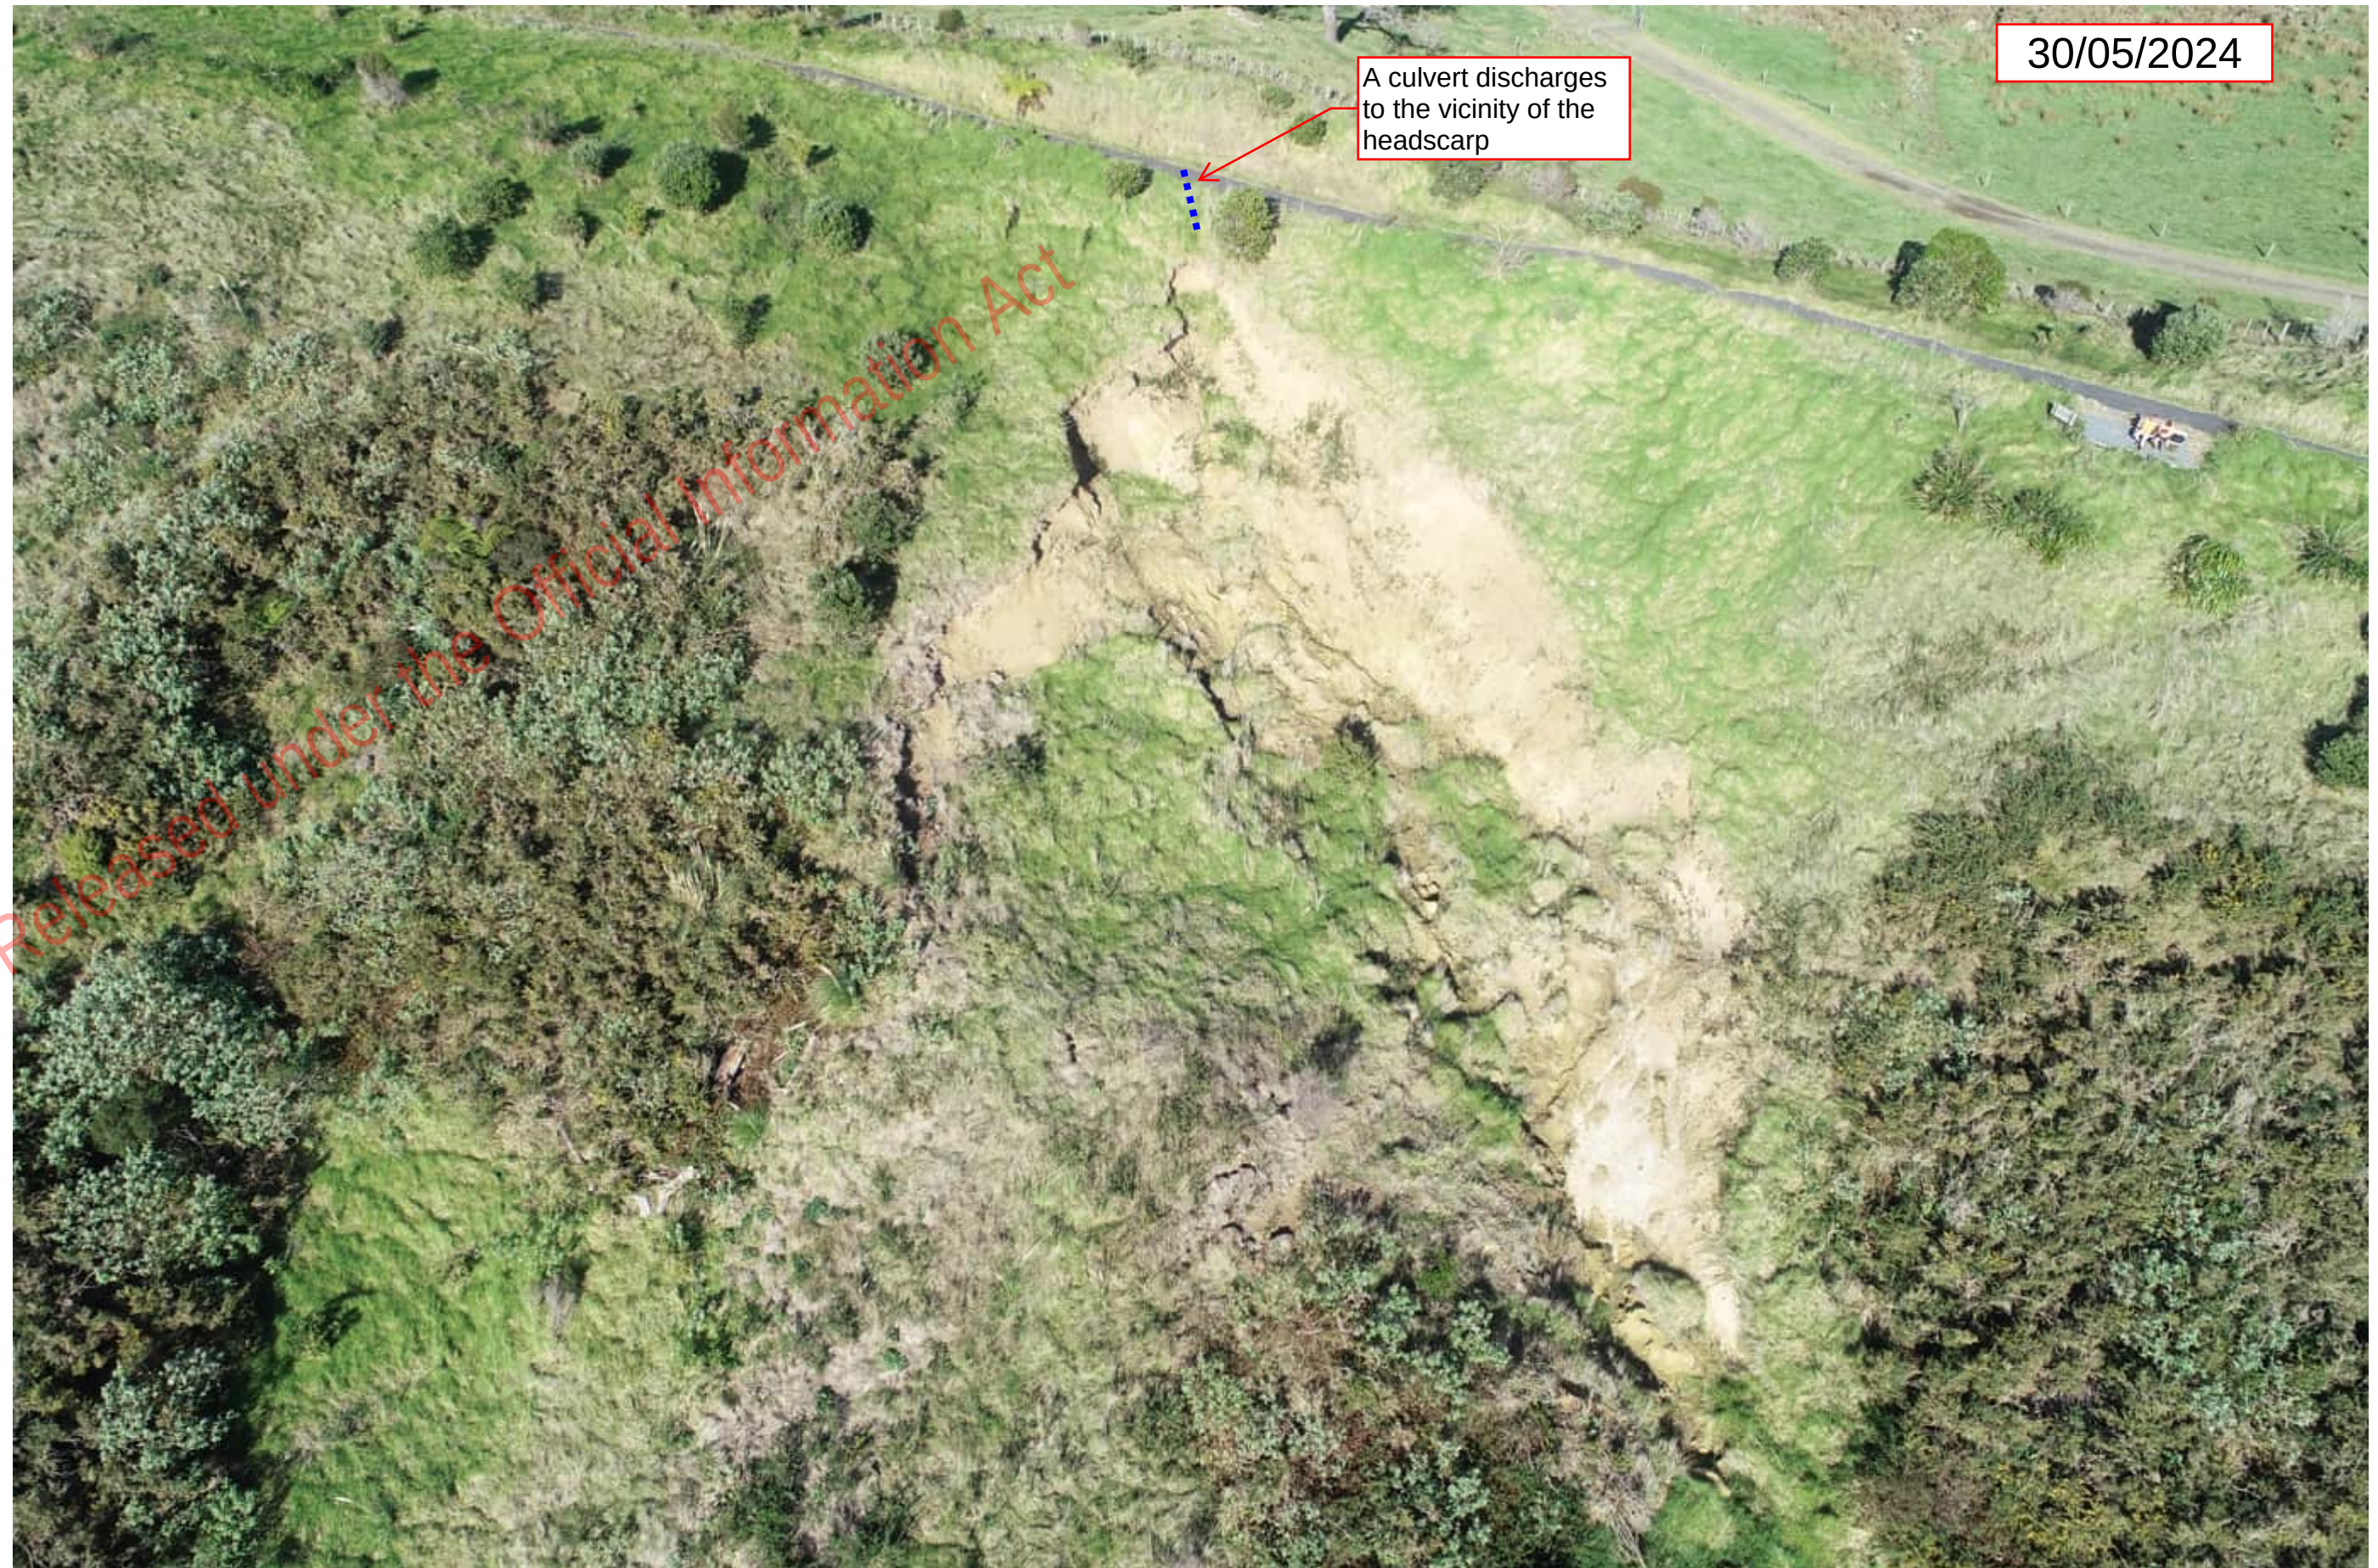
Feature 9 and 10 - Landslide earth flow  
and tension crack.  
No new movement since Feb 2024.

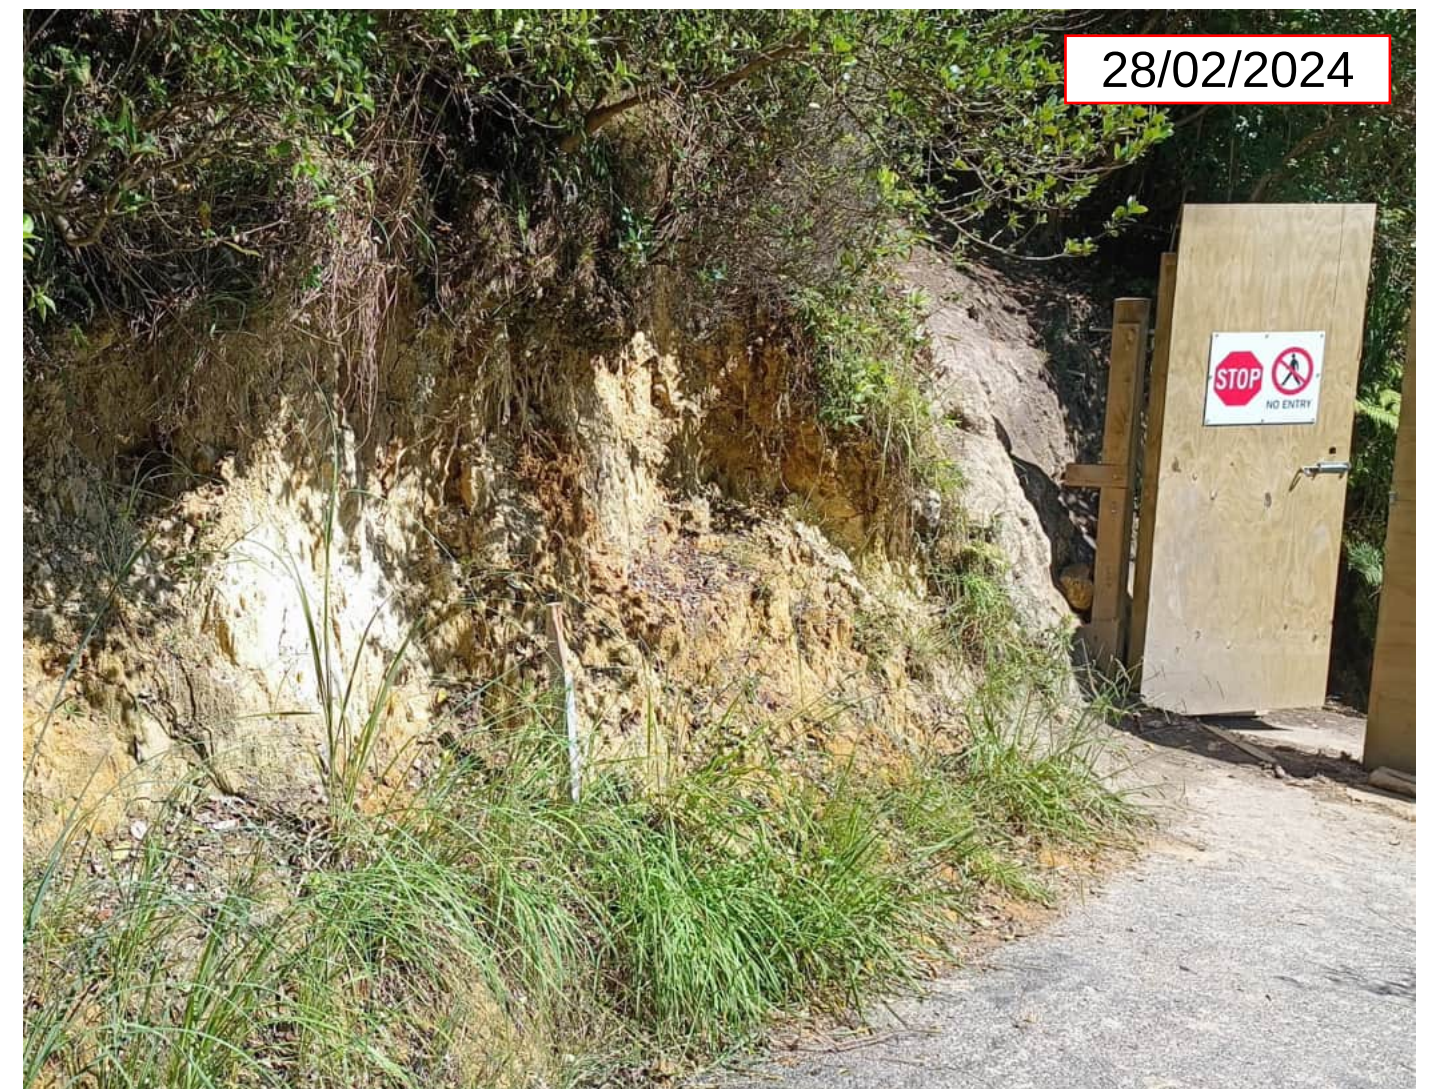
Feature 13 - Translational landslide  
No new landslide movement. Some erosion  
( $<100$  mm) of the head scarp.  
An older associated scarp was observed  
encroaching into the ground adjacent to the  
proposed new toilet block location.

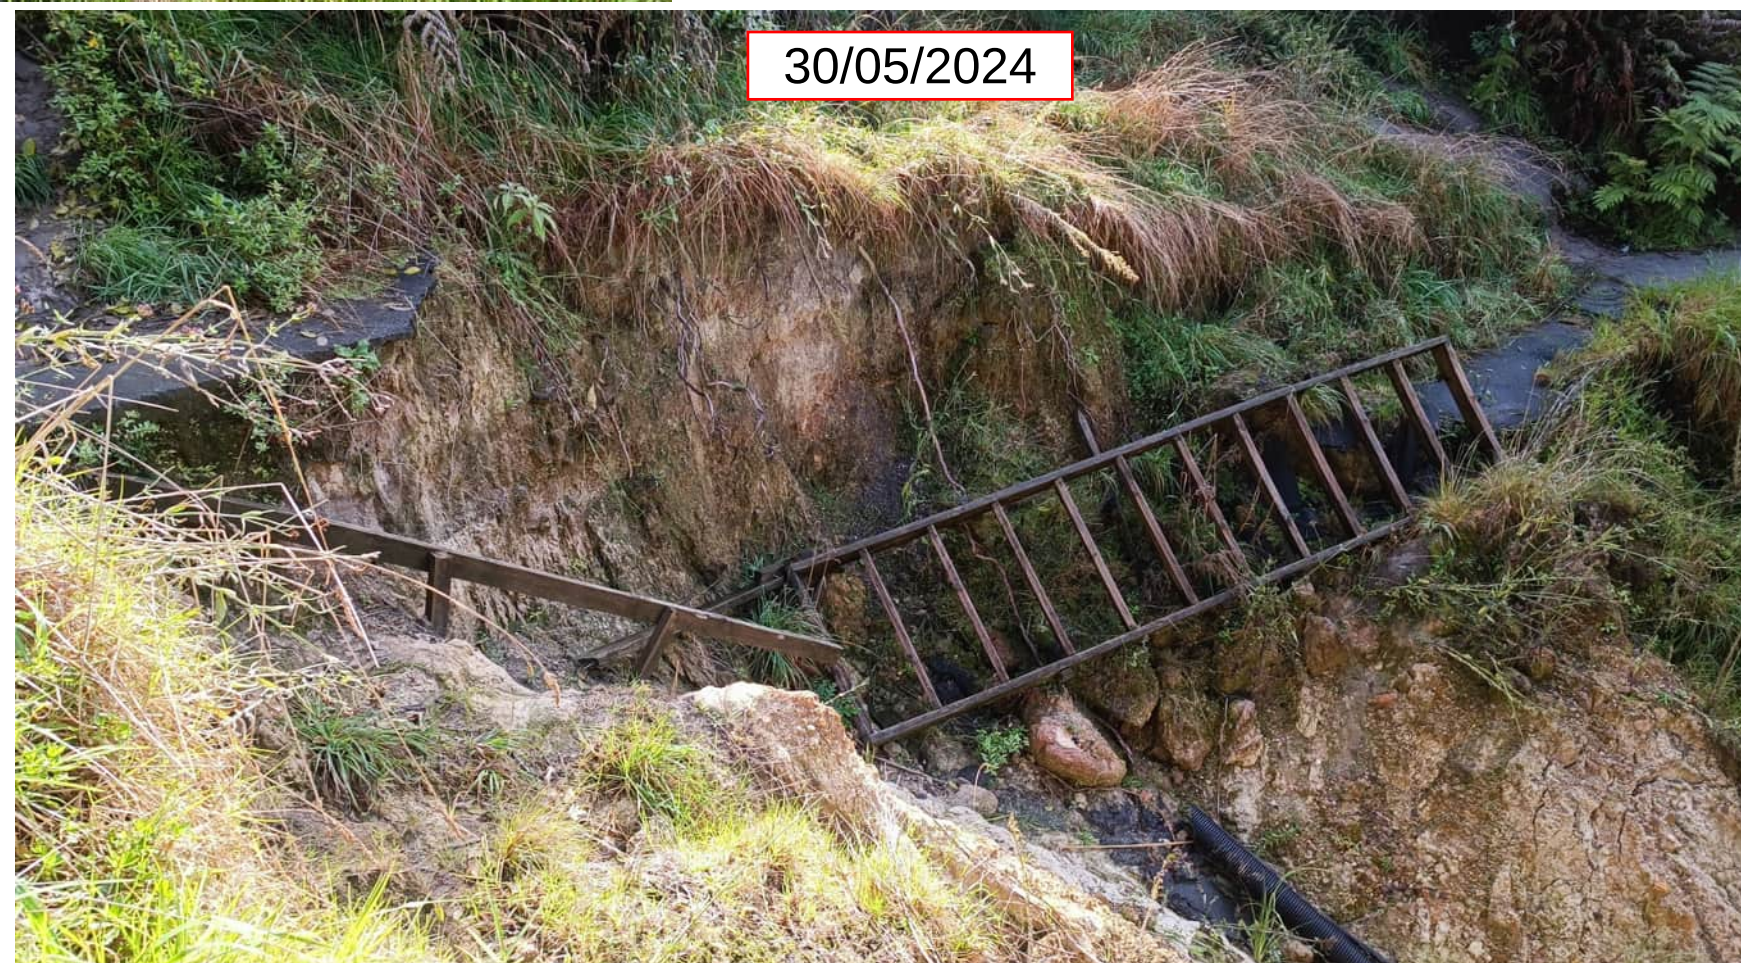
Feature 14 - Debris flow landslide  
No new significant damage. Some regression of the head scarp  
has occurred (approximately  $< 200\text{mm}$ ) due to erosion  
(observed during Feb 2024 visit).

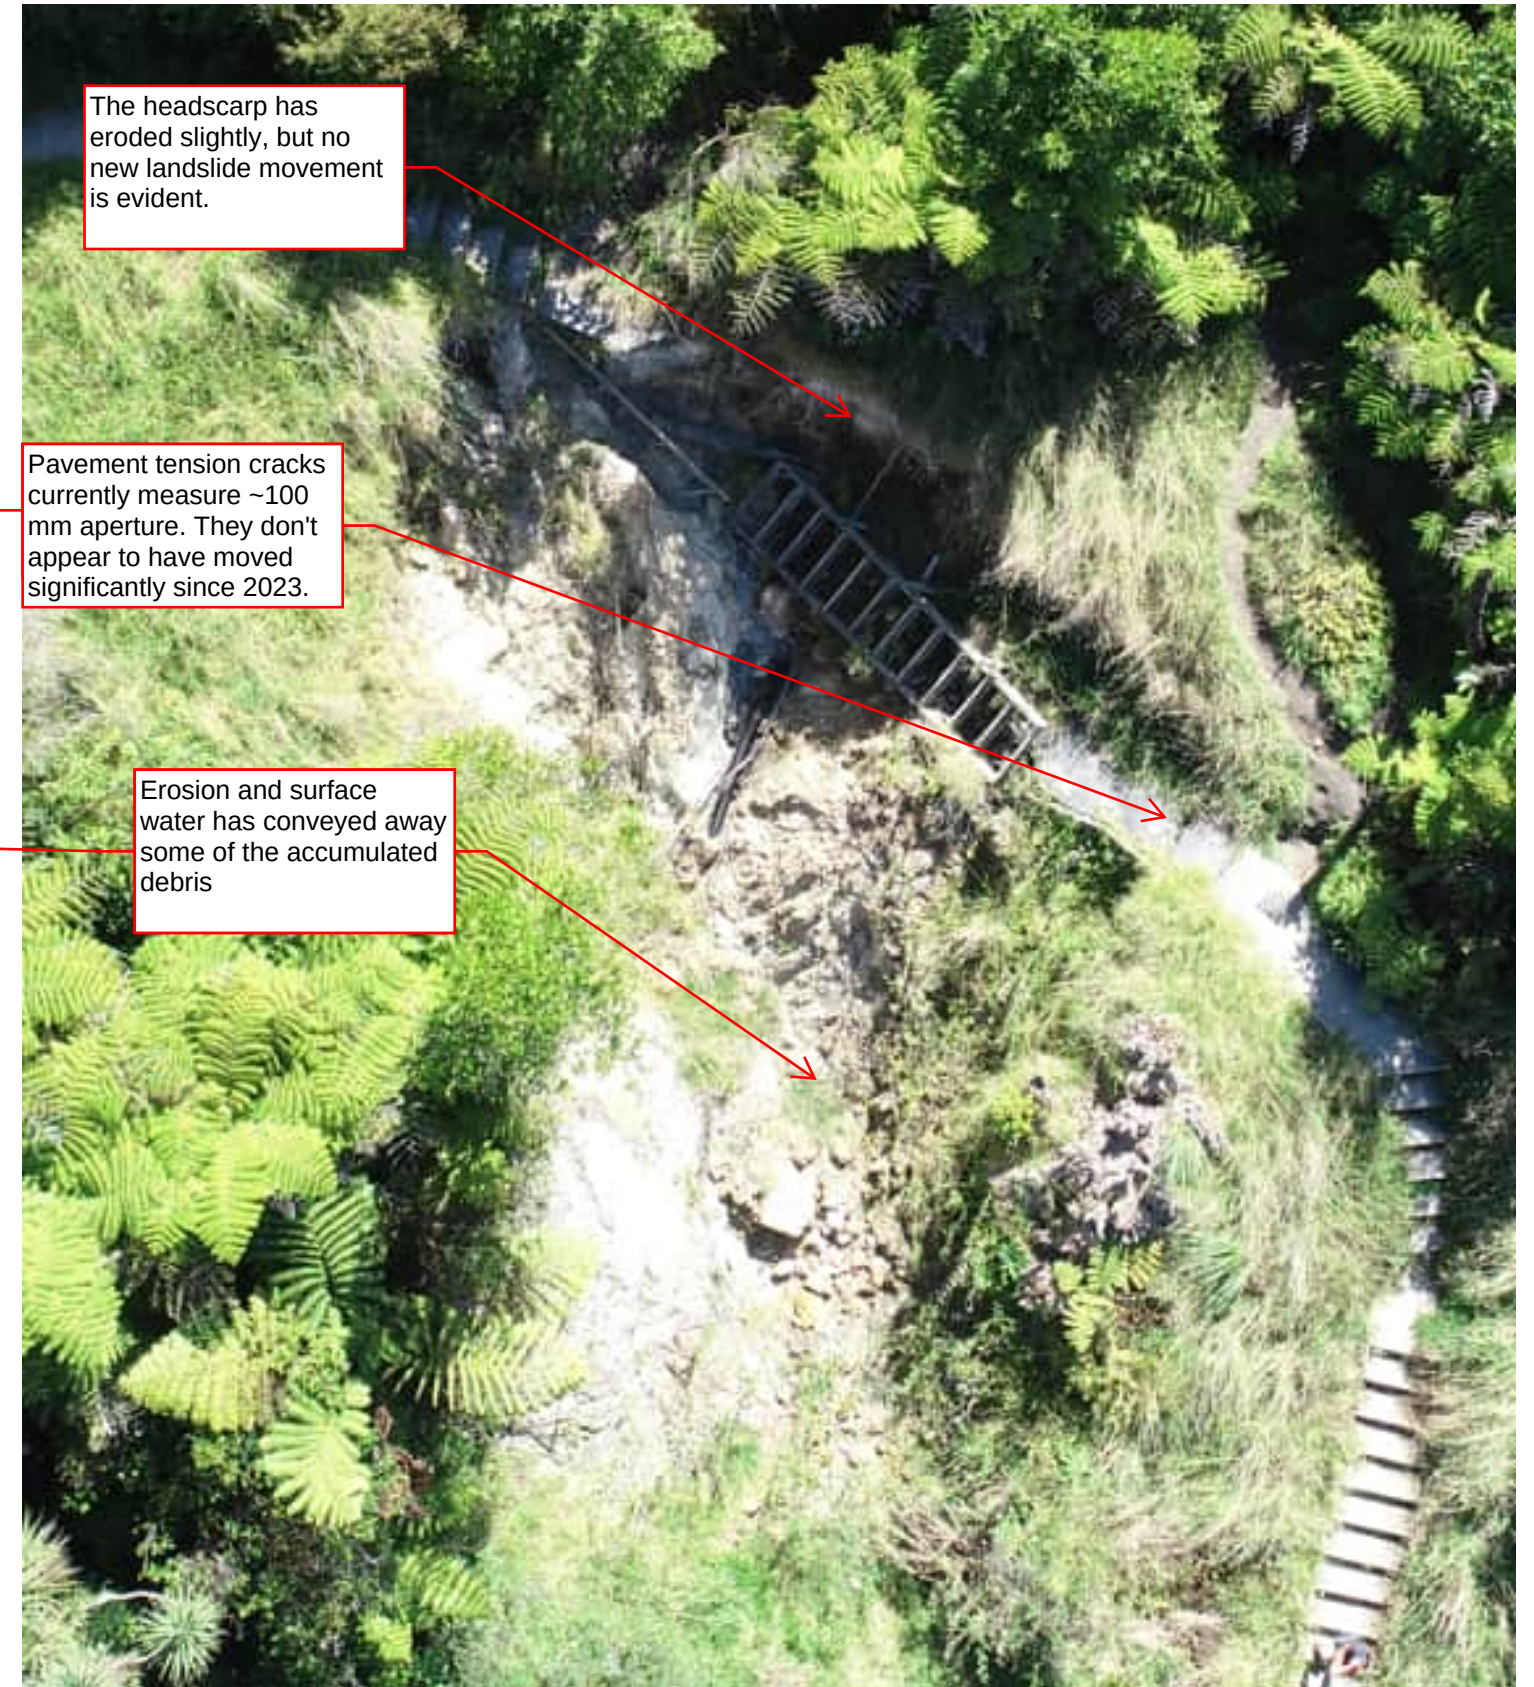
Feature 14 continued.  
No new movement  
observed during May  
2024 visit.

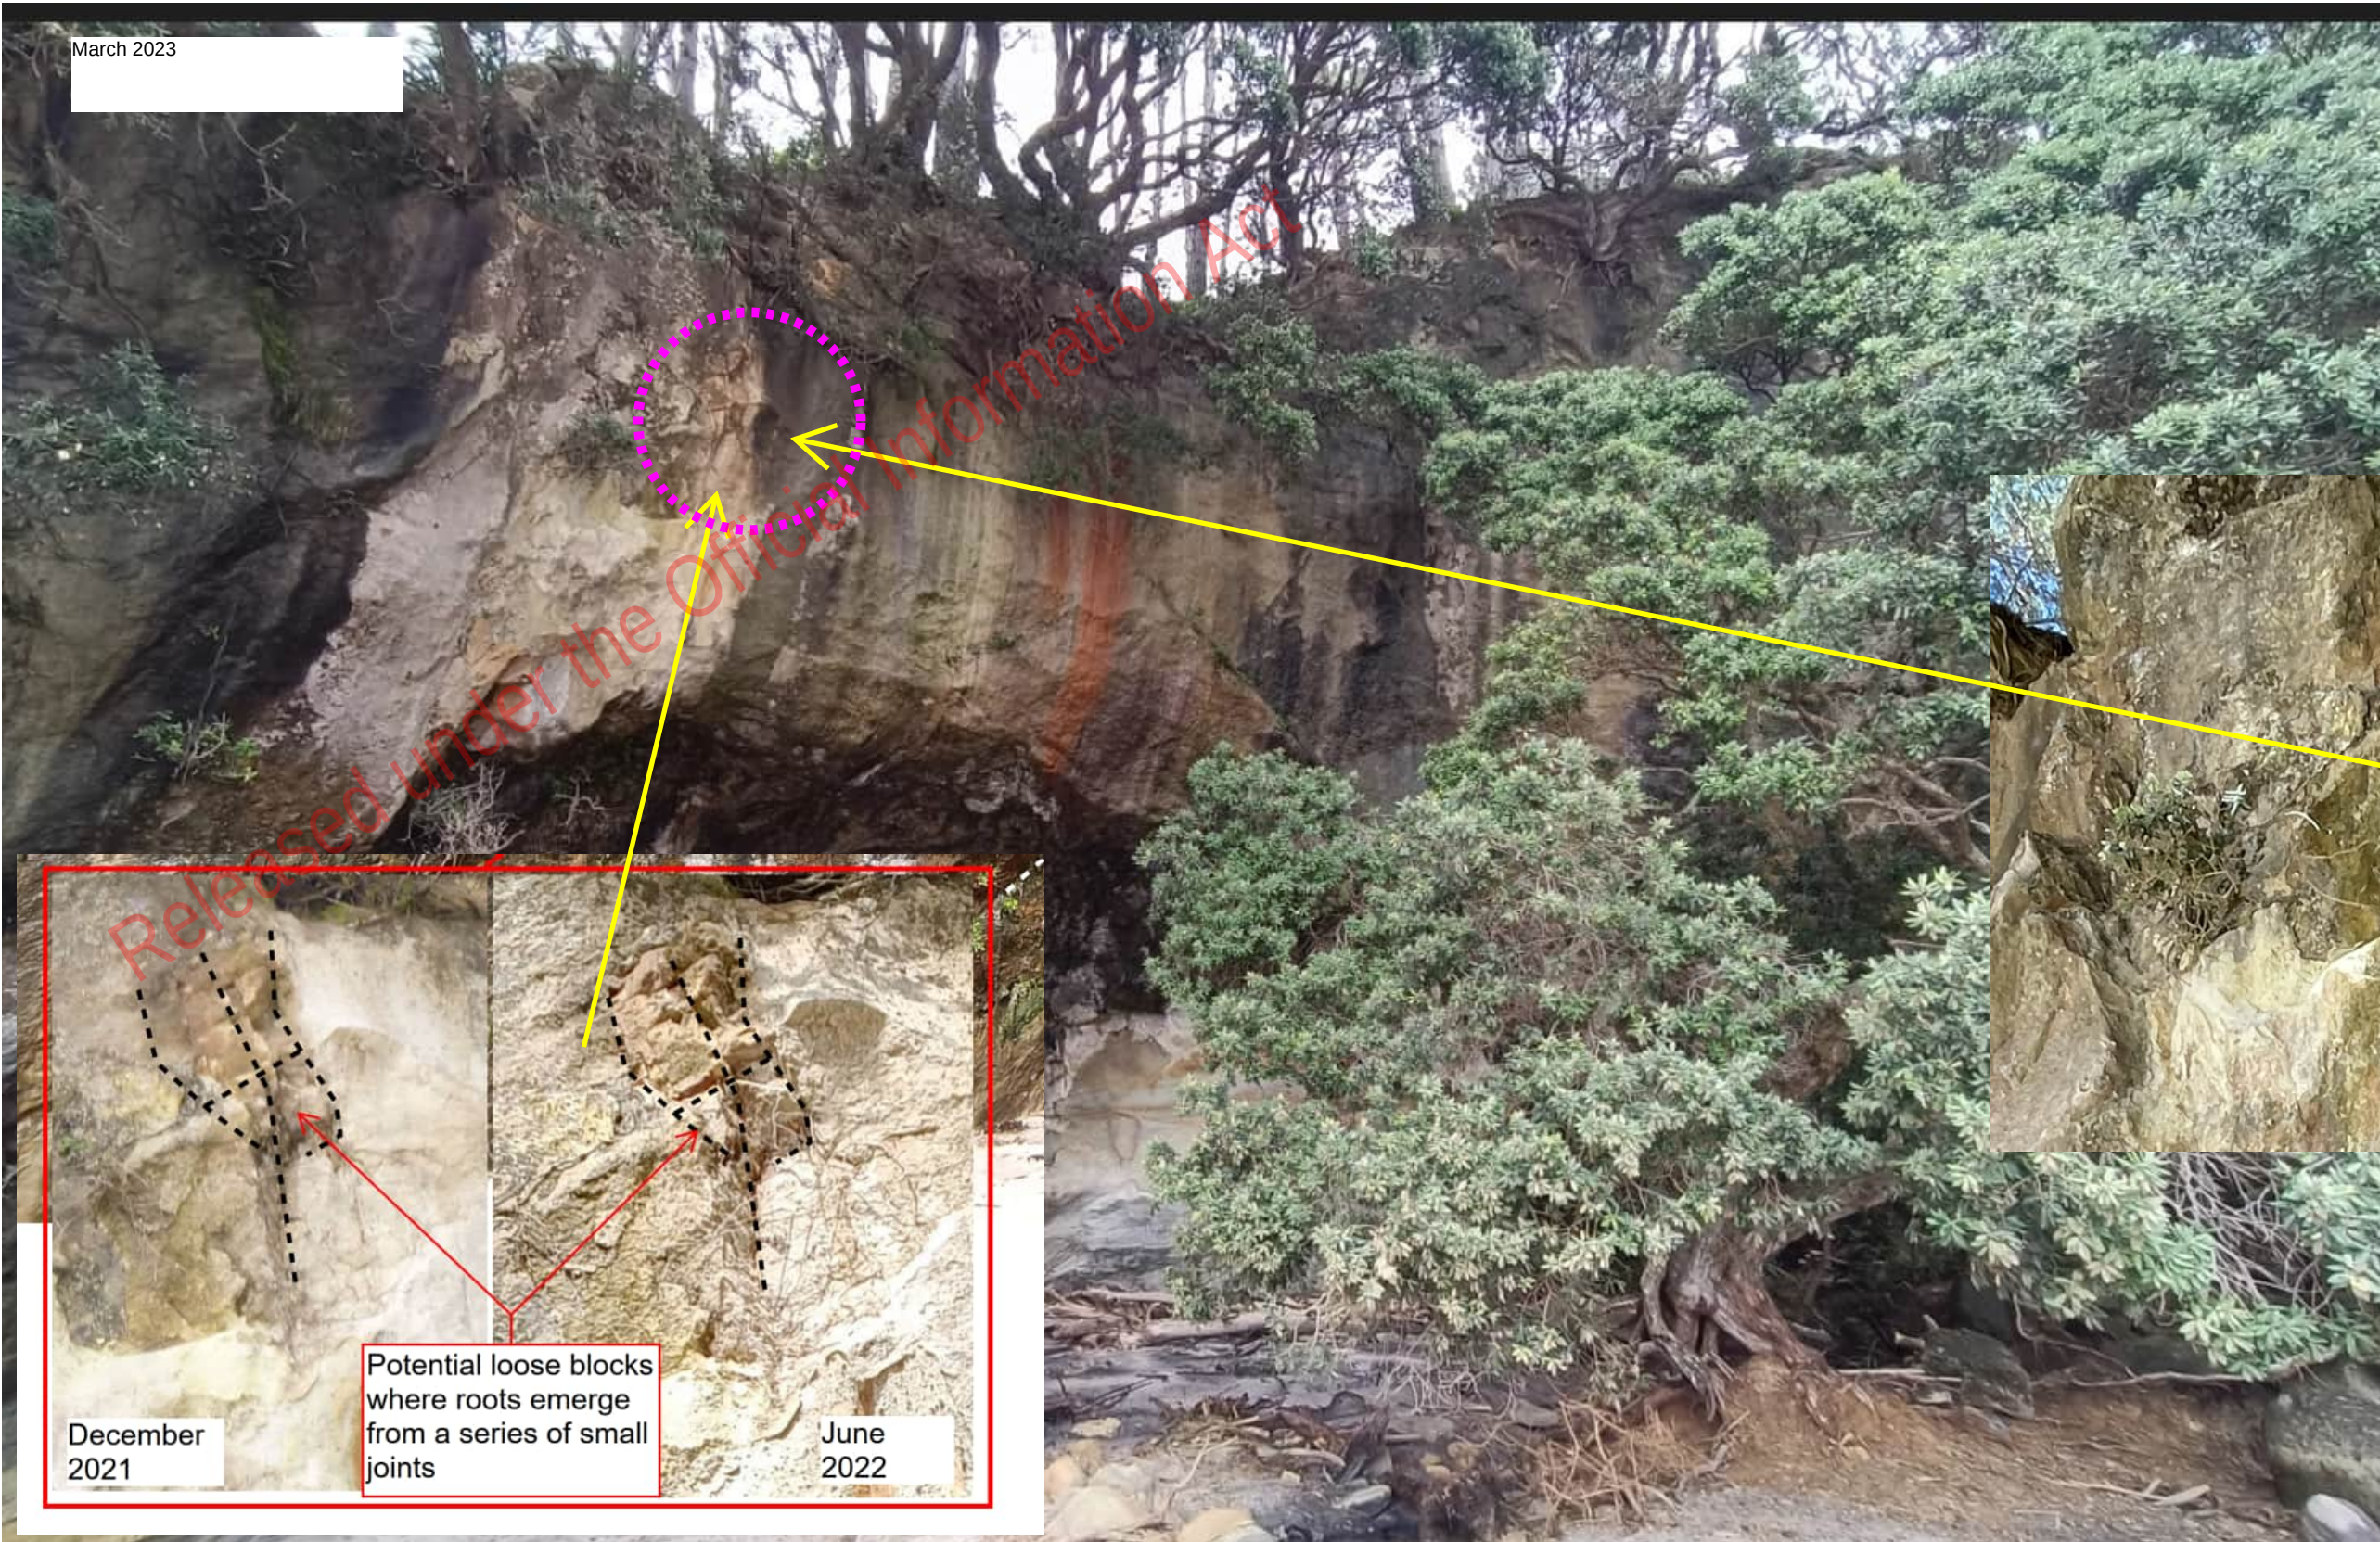
189 South Cliff Section  
Additional rockfall (<0.1 m3)  
observed in Feb 2024

Feb 2024, small rockfall from area with roots.
