**Cathedral Cove Basic Level  
Landslide Risk Assessment**

**Prepared for**  
Department of Conservation  
**Prepared by**  
Tonkin & Taylor Ltd  
**Date**  
July 2023  
**Job Number**  
1007838.3000 v3

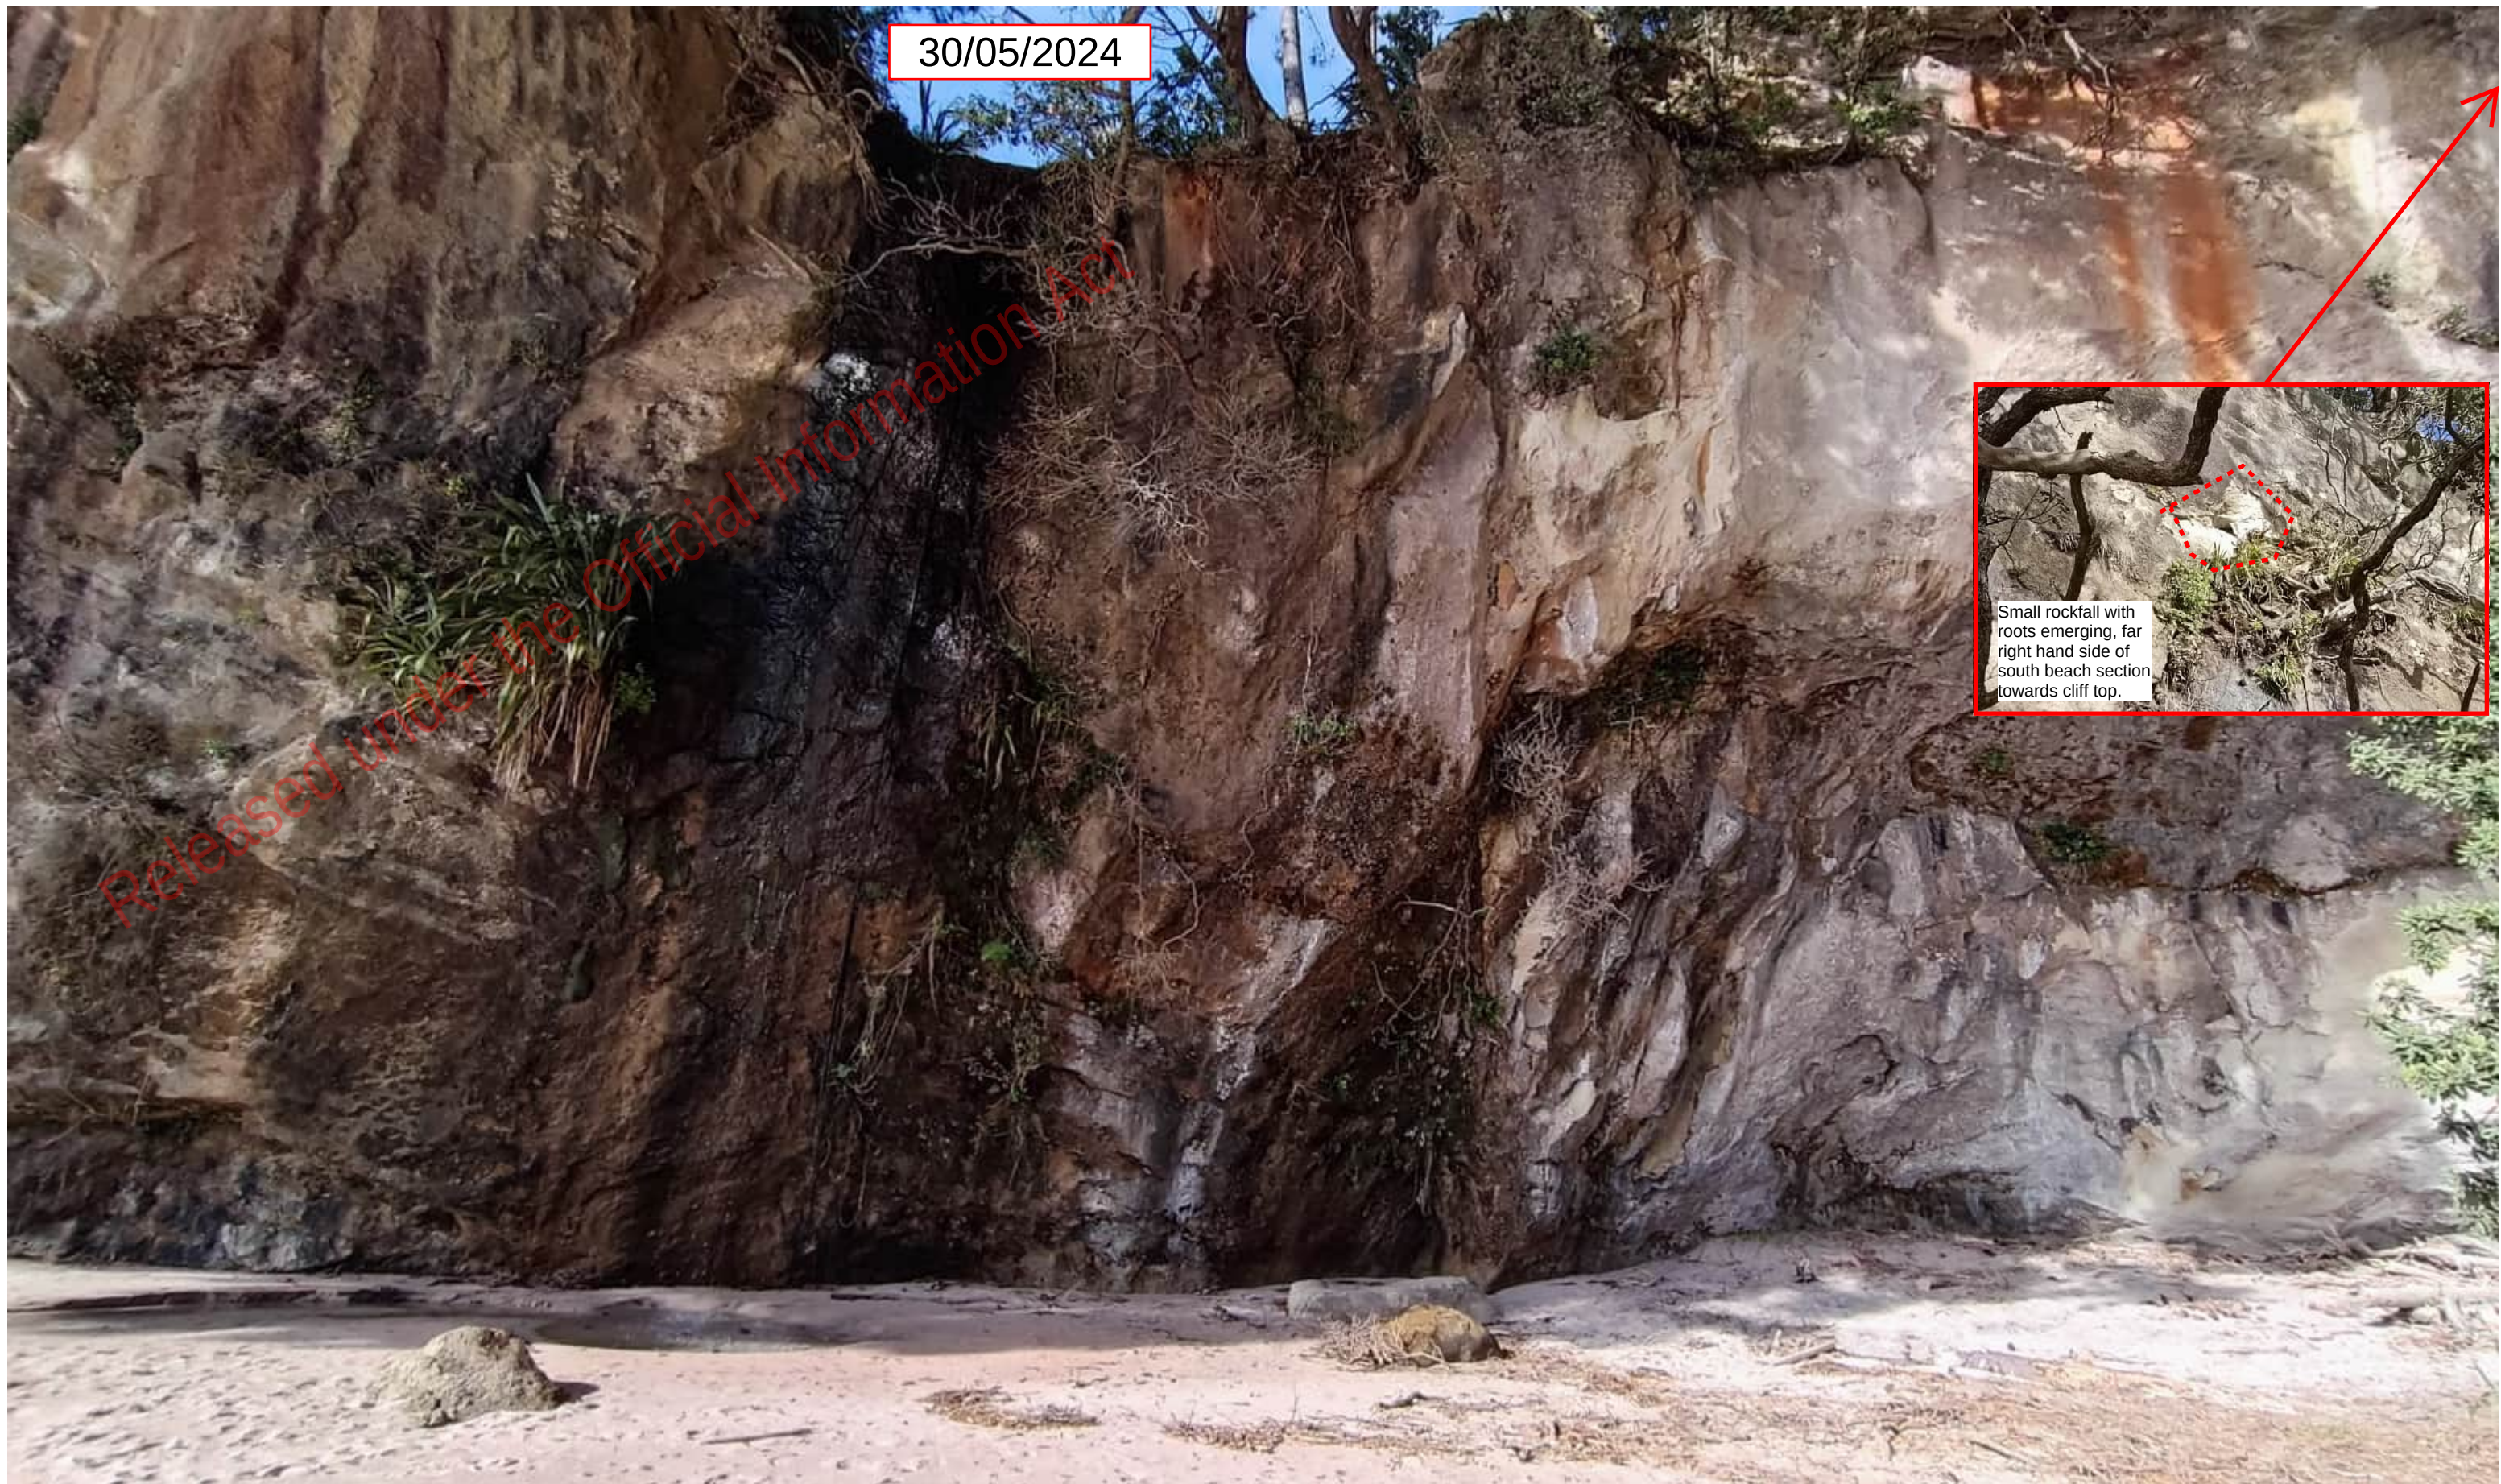
189 South Cliff Section  
Continued. 1 x small rockfall  
observed (<1m<sup>3</sup>) during May  
2024 visit.

Small rockfall with  
roots emerging, far  
right hand side of  
south beach section  
towards cliff top.

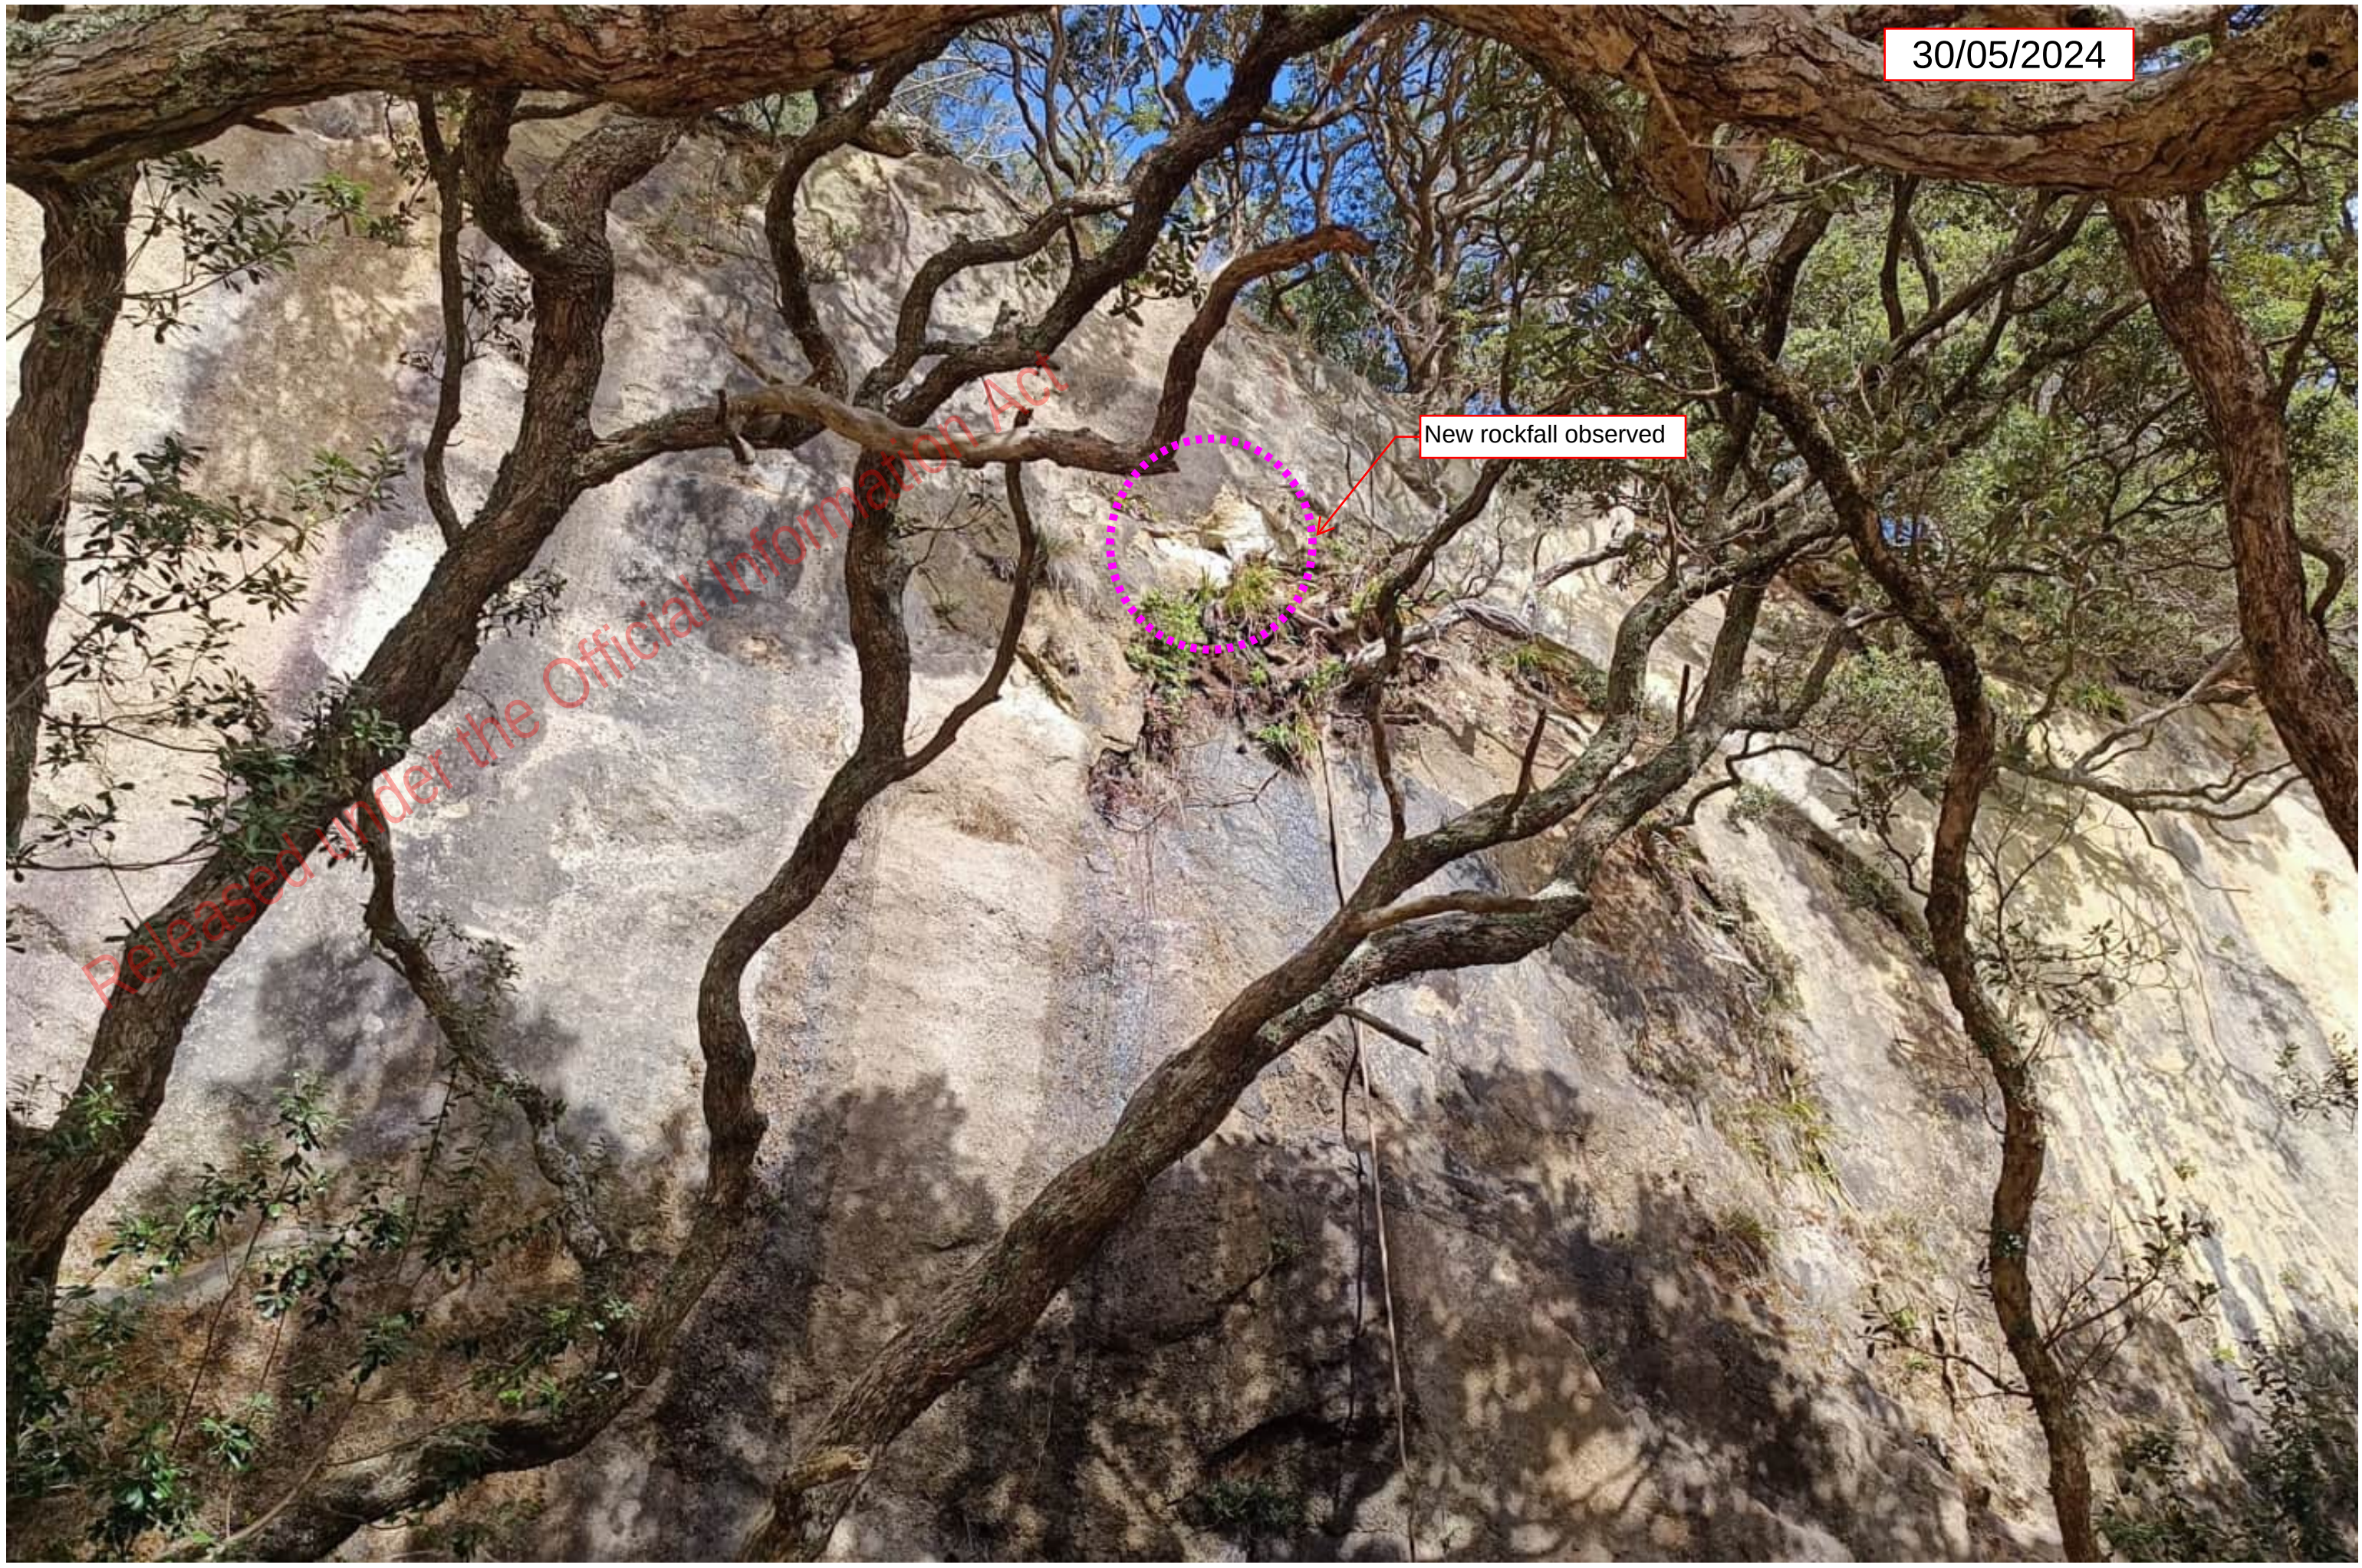
South cliff area - New feature (197)

New rockfall observed

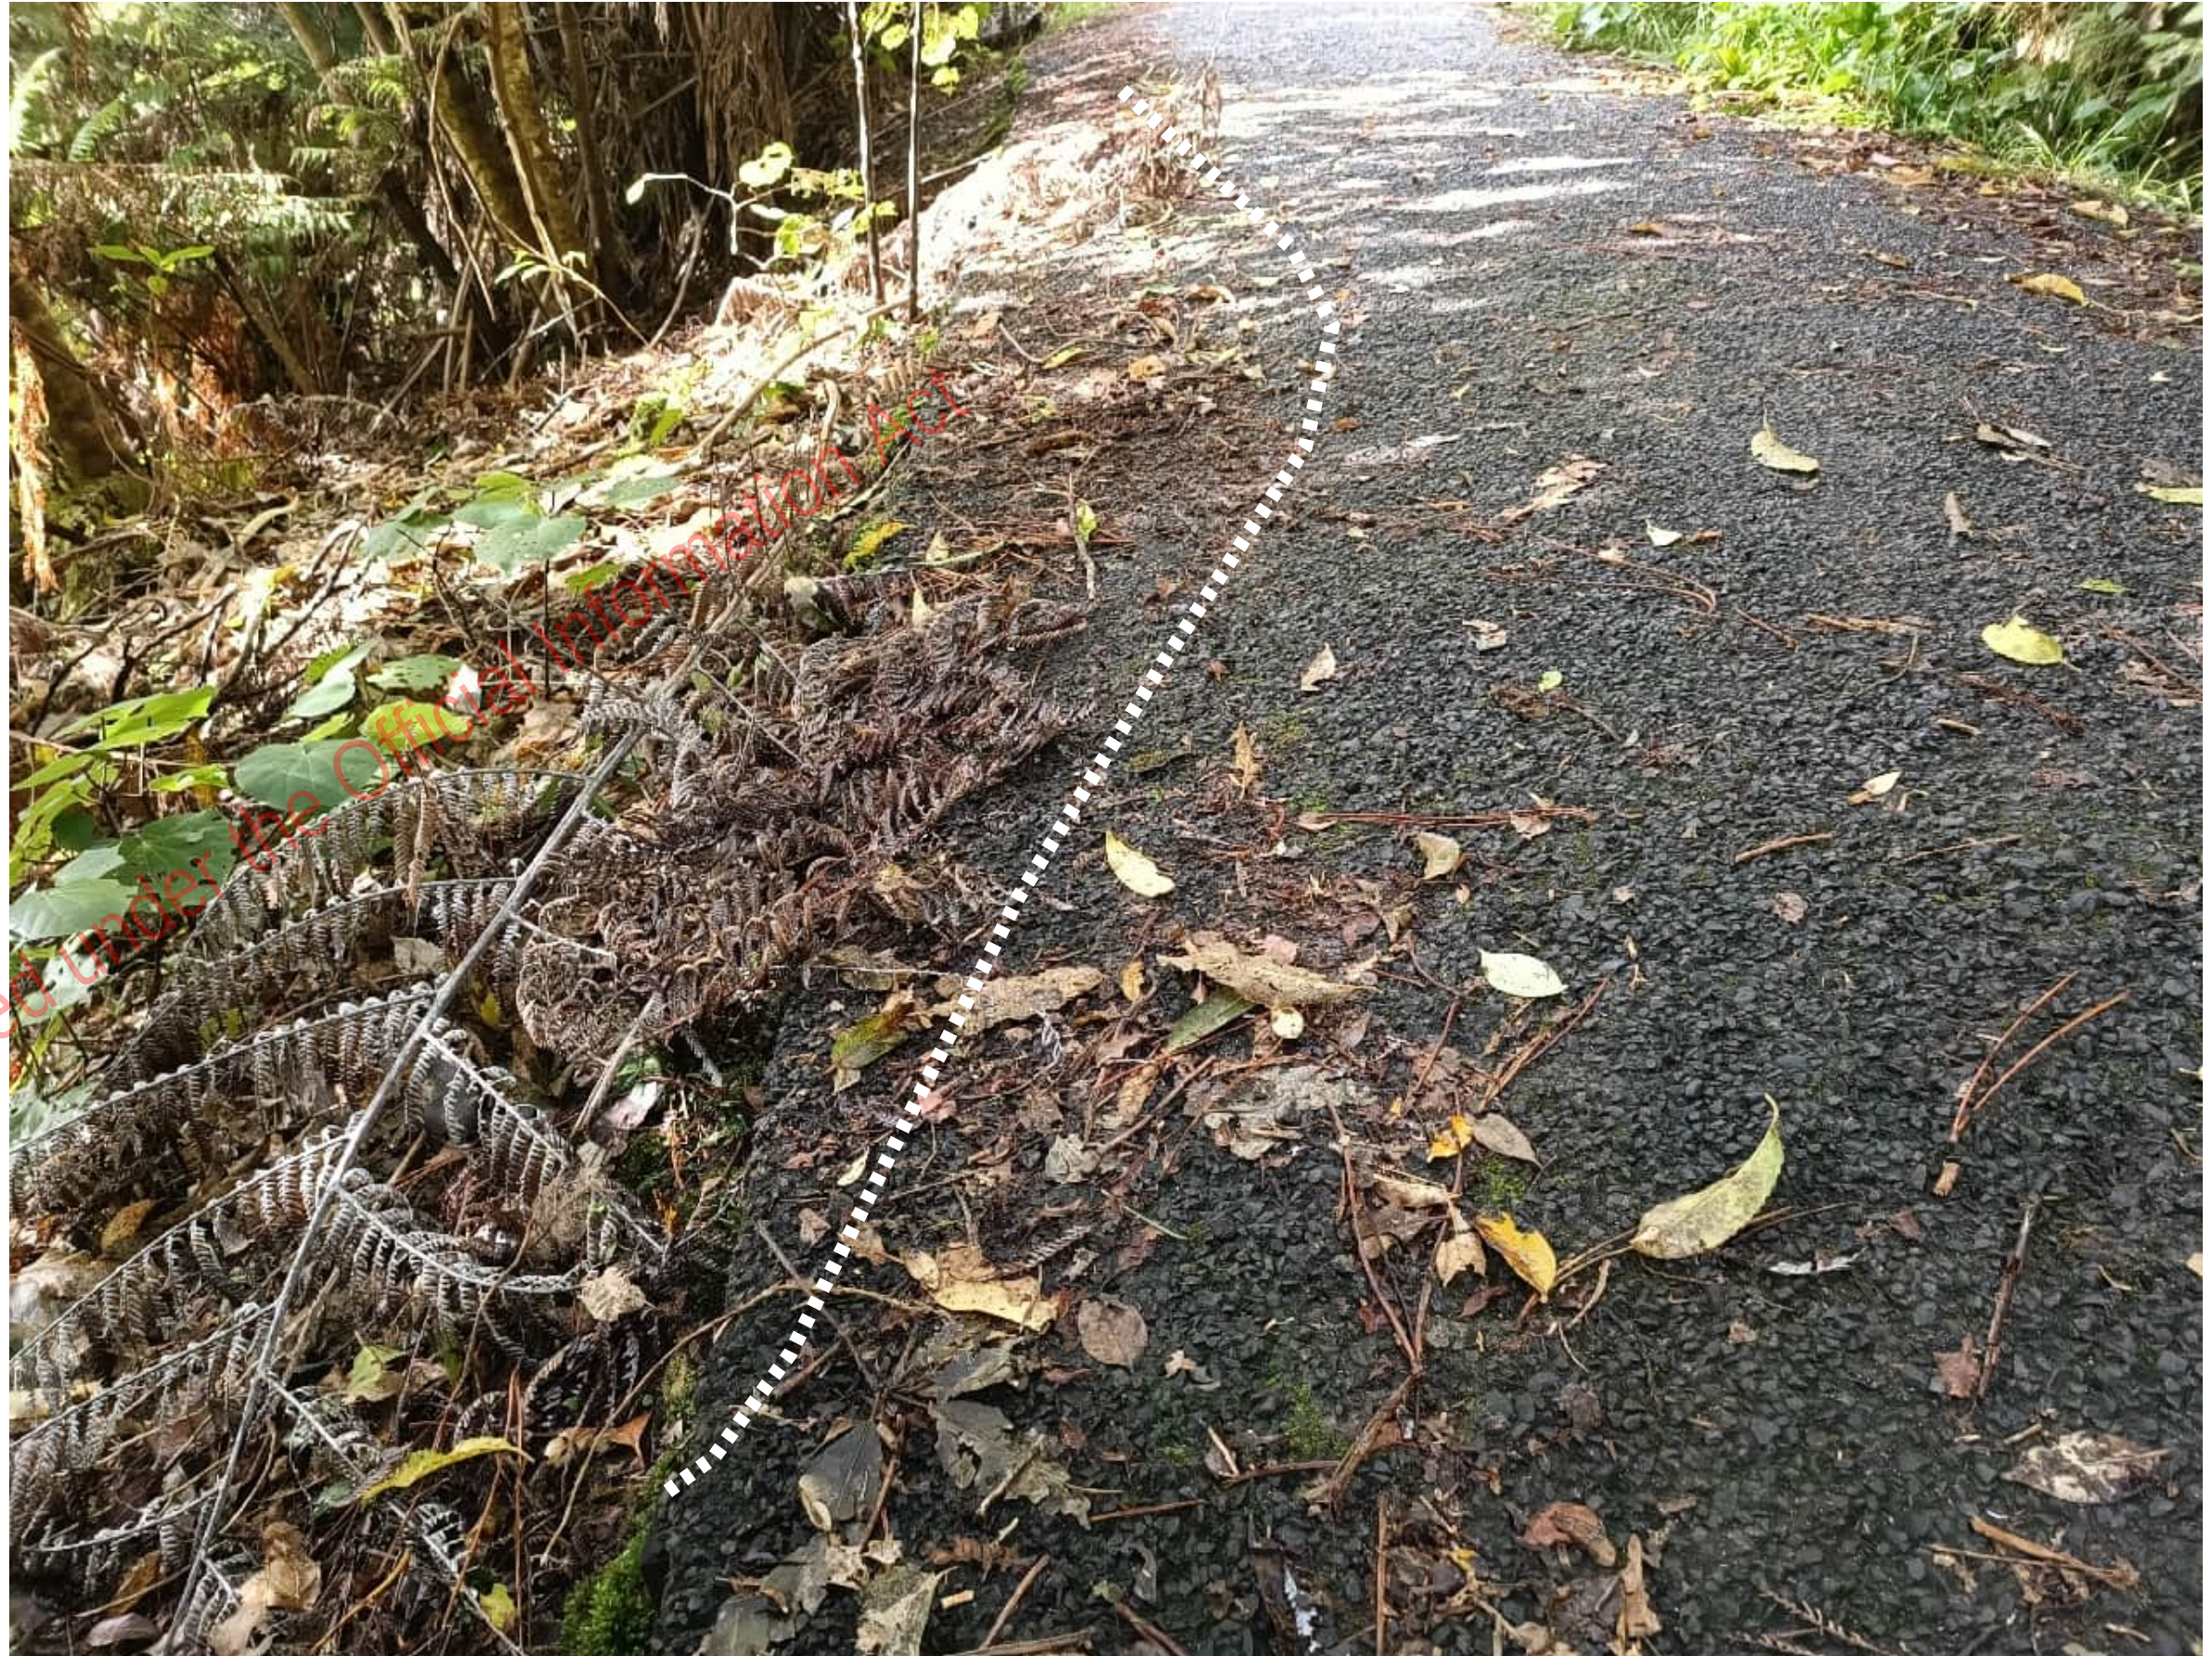
Feature 194 - Tension crack. Newly observed in May 2024 visit.  
This event is difficult to see and likely to be historical.

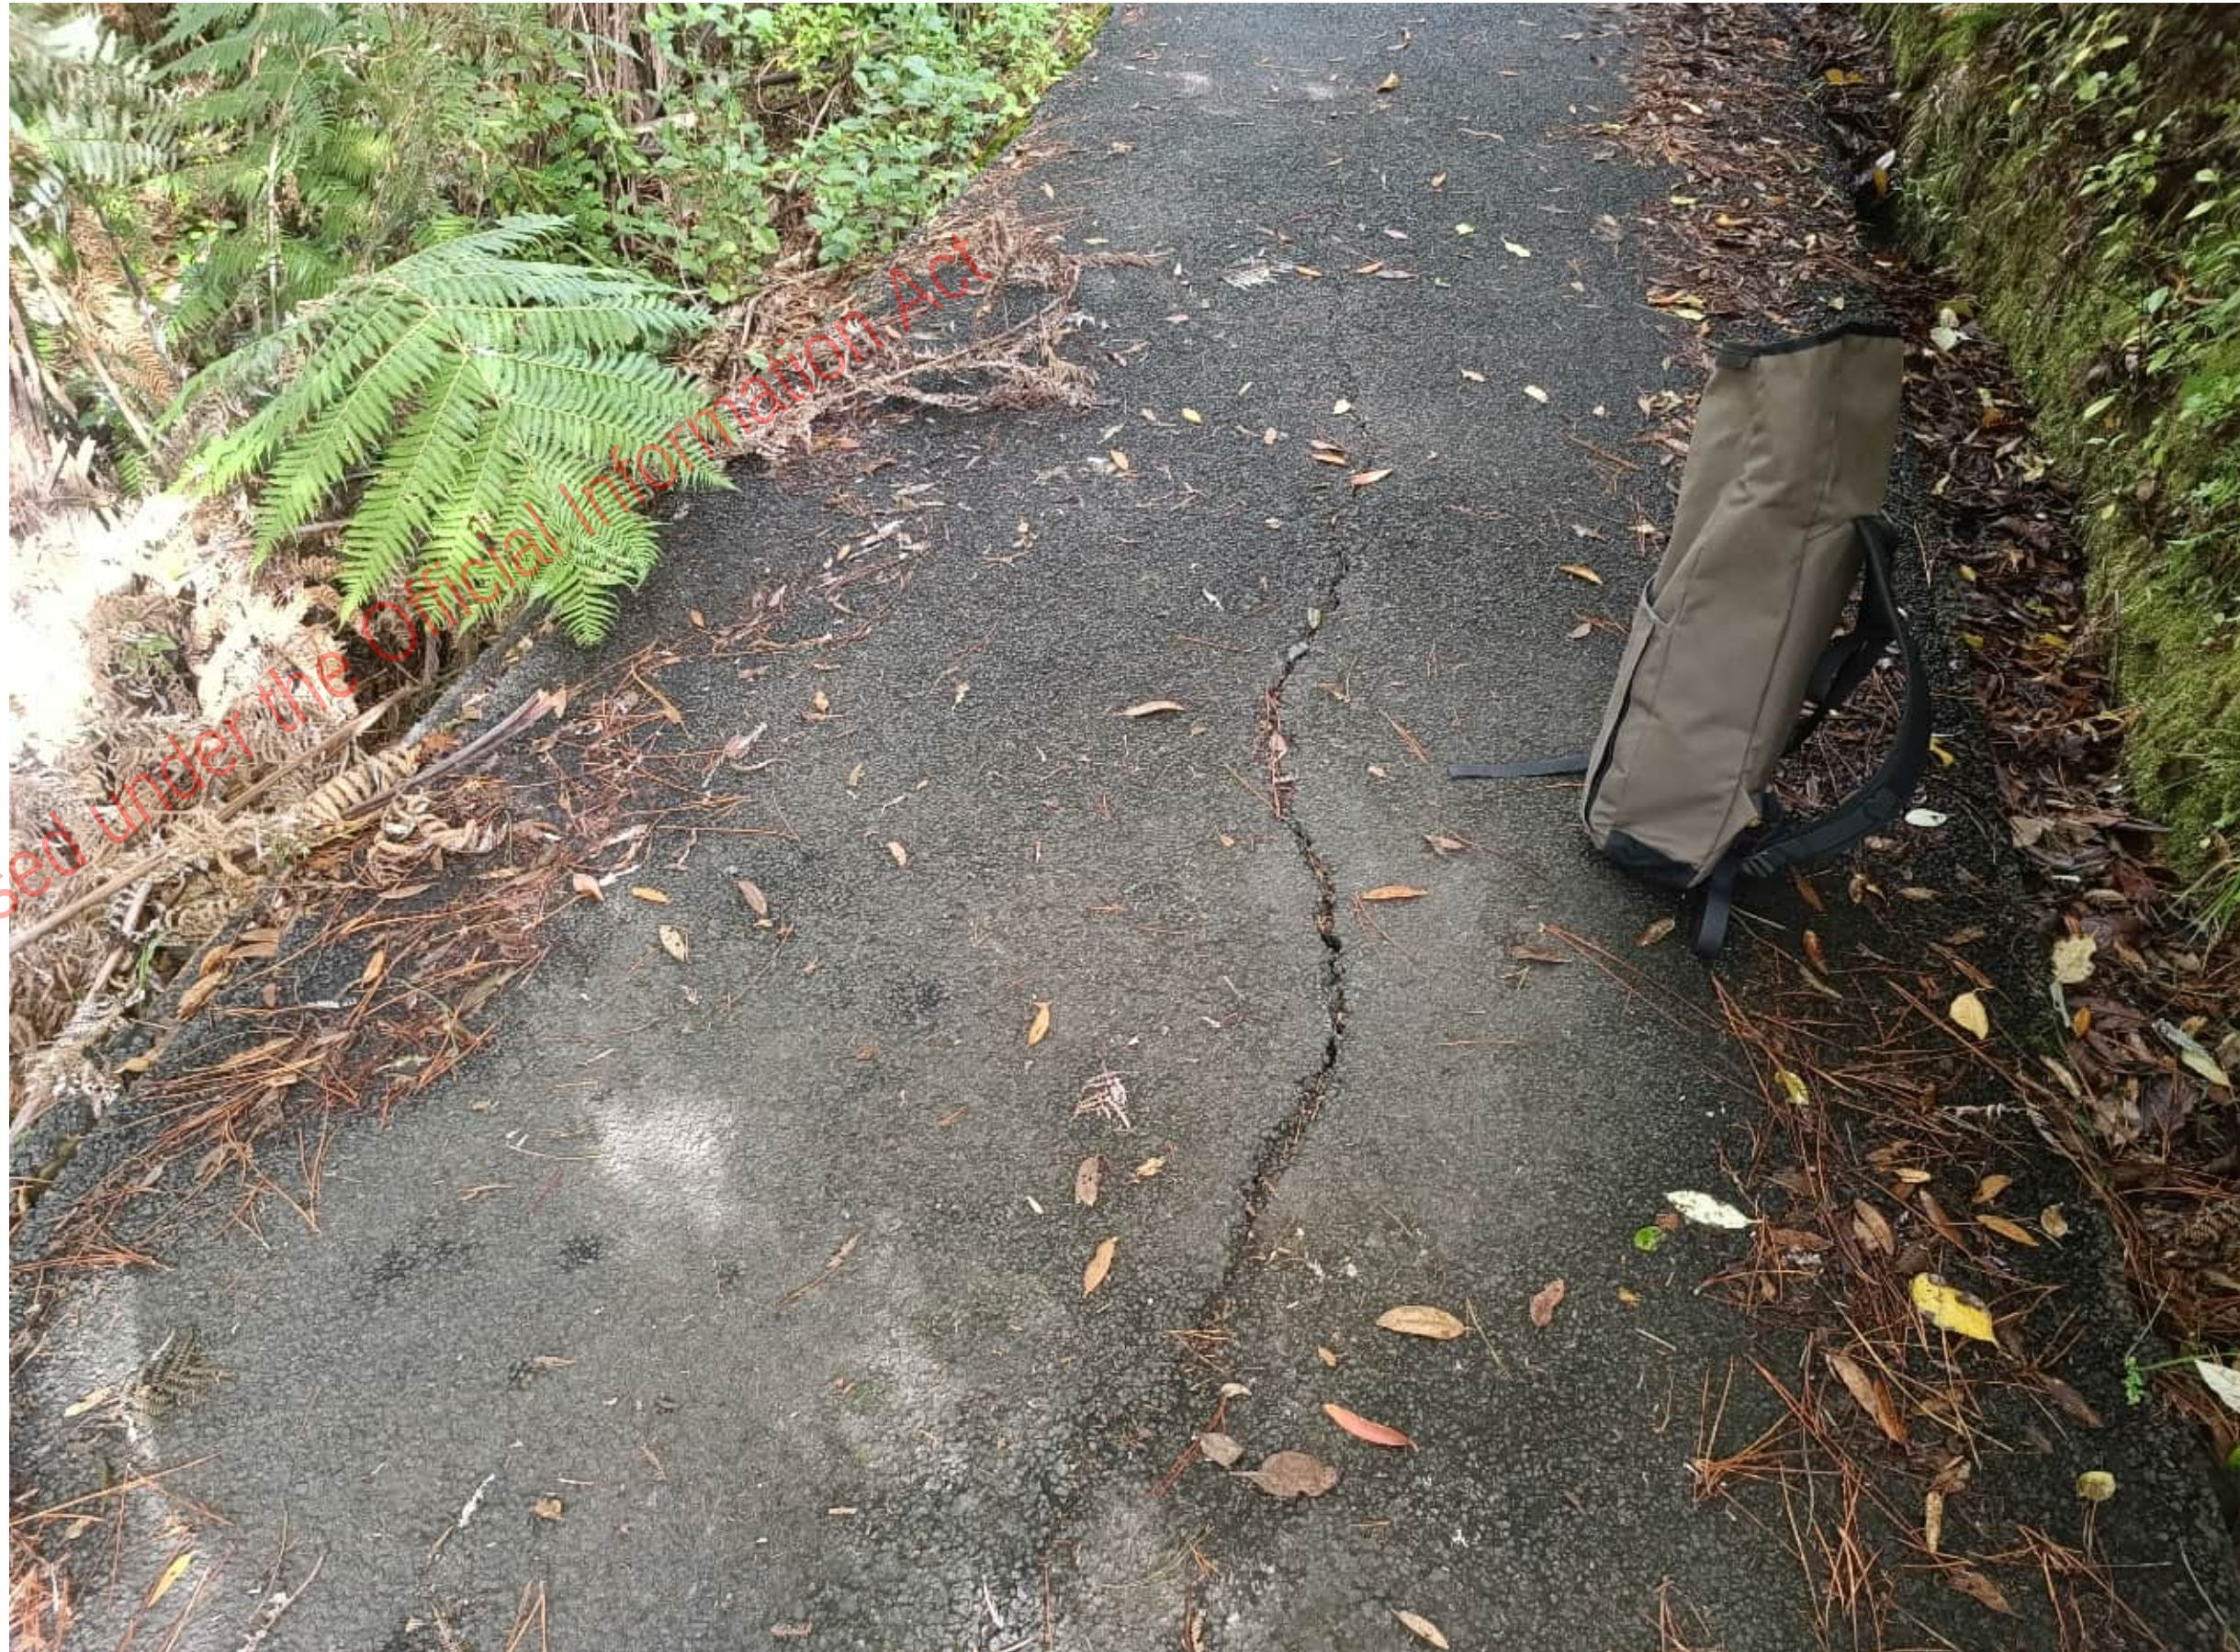
Feature 195 - Tension crack. Newly observed in May 2024 visit.  
The event may be historical.

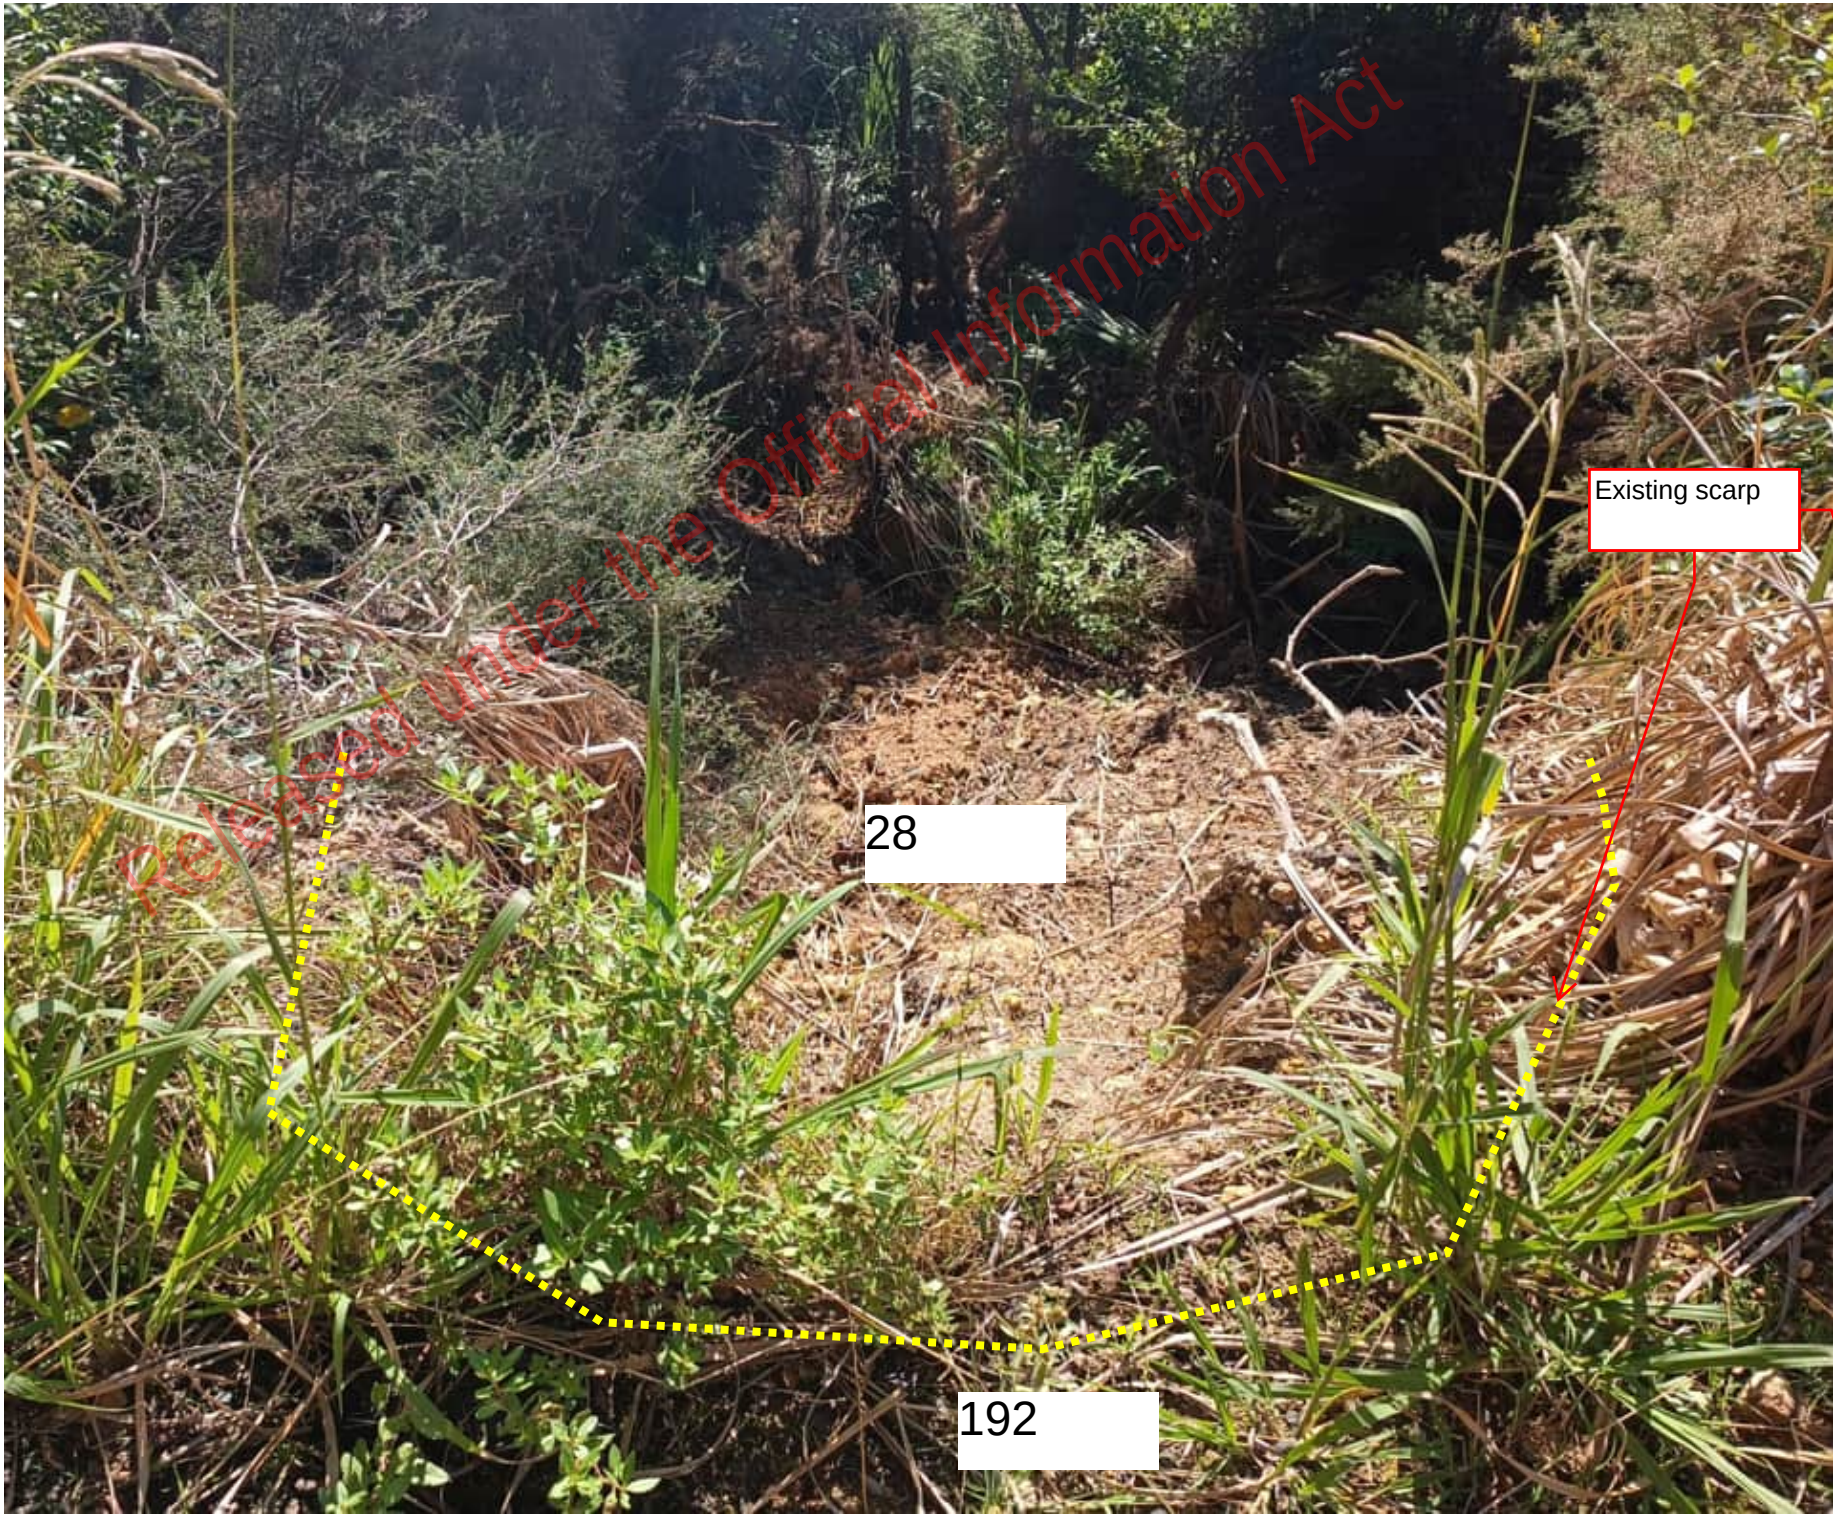
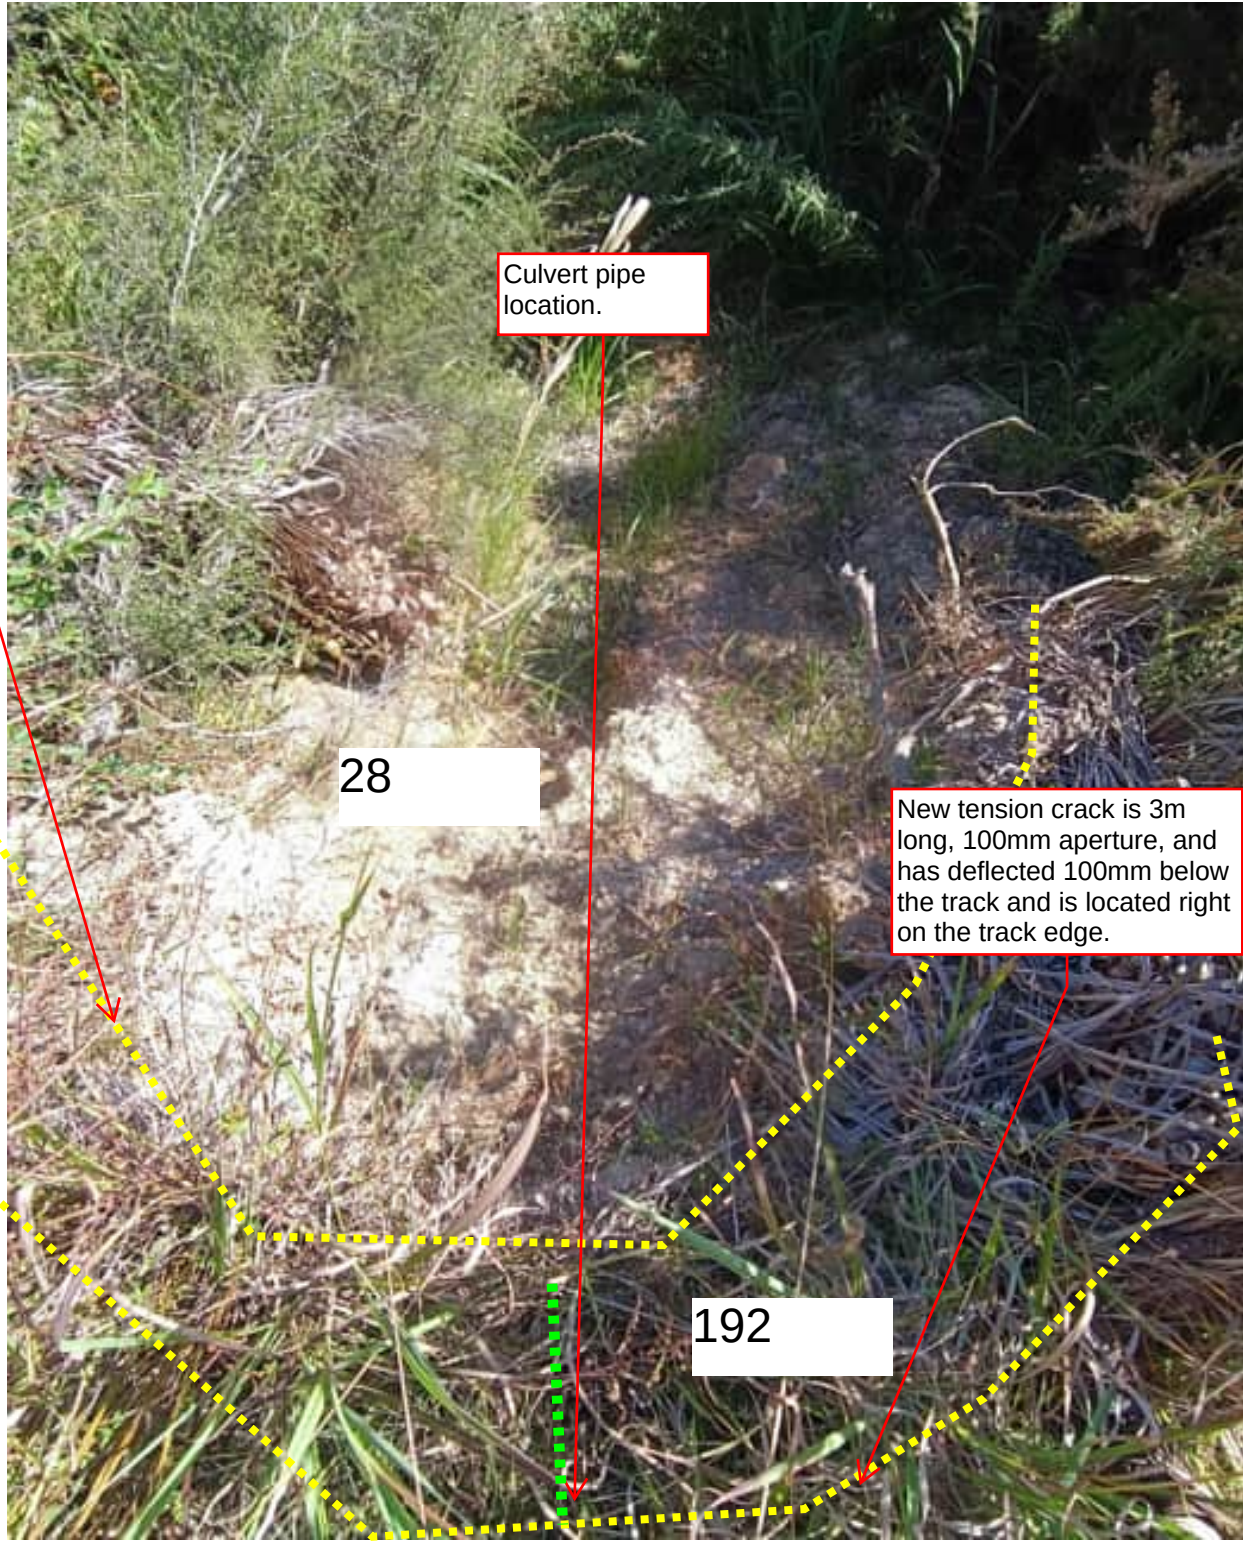
Feature 28 - Translational landslide.  
A new tension crack developed (observed Feb 2024) approximately  
300mm behind the headscarp (192)
