**Cathedral Cove Basic Level  
Landslide Risk Assessment**

**Prepared for**  
Department of Conservation  
**Prepared by**  
Tonkin & Taylor Ltd  
**Date**  
July 2023  
**Job Number**  
1007838.3000 v3

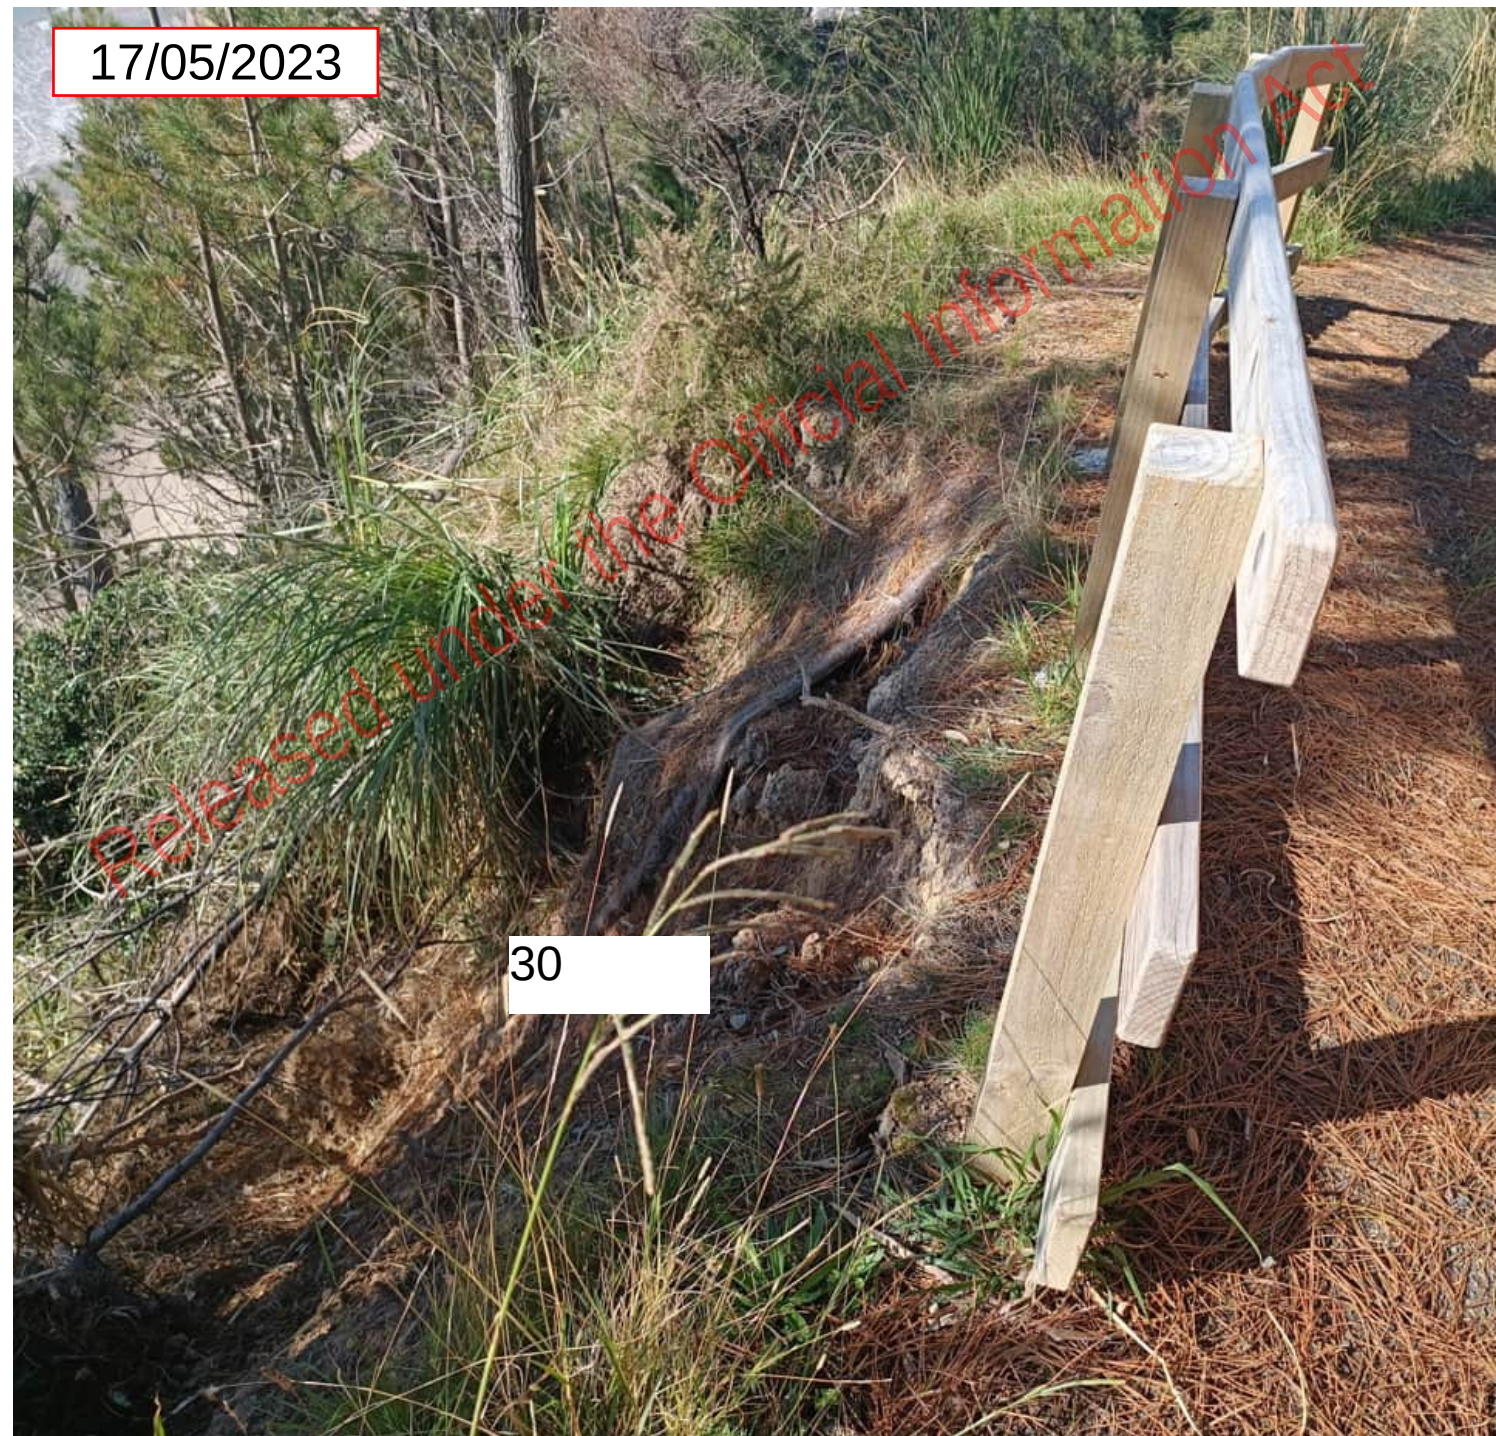
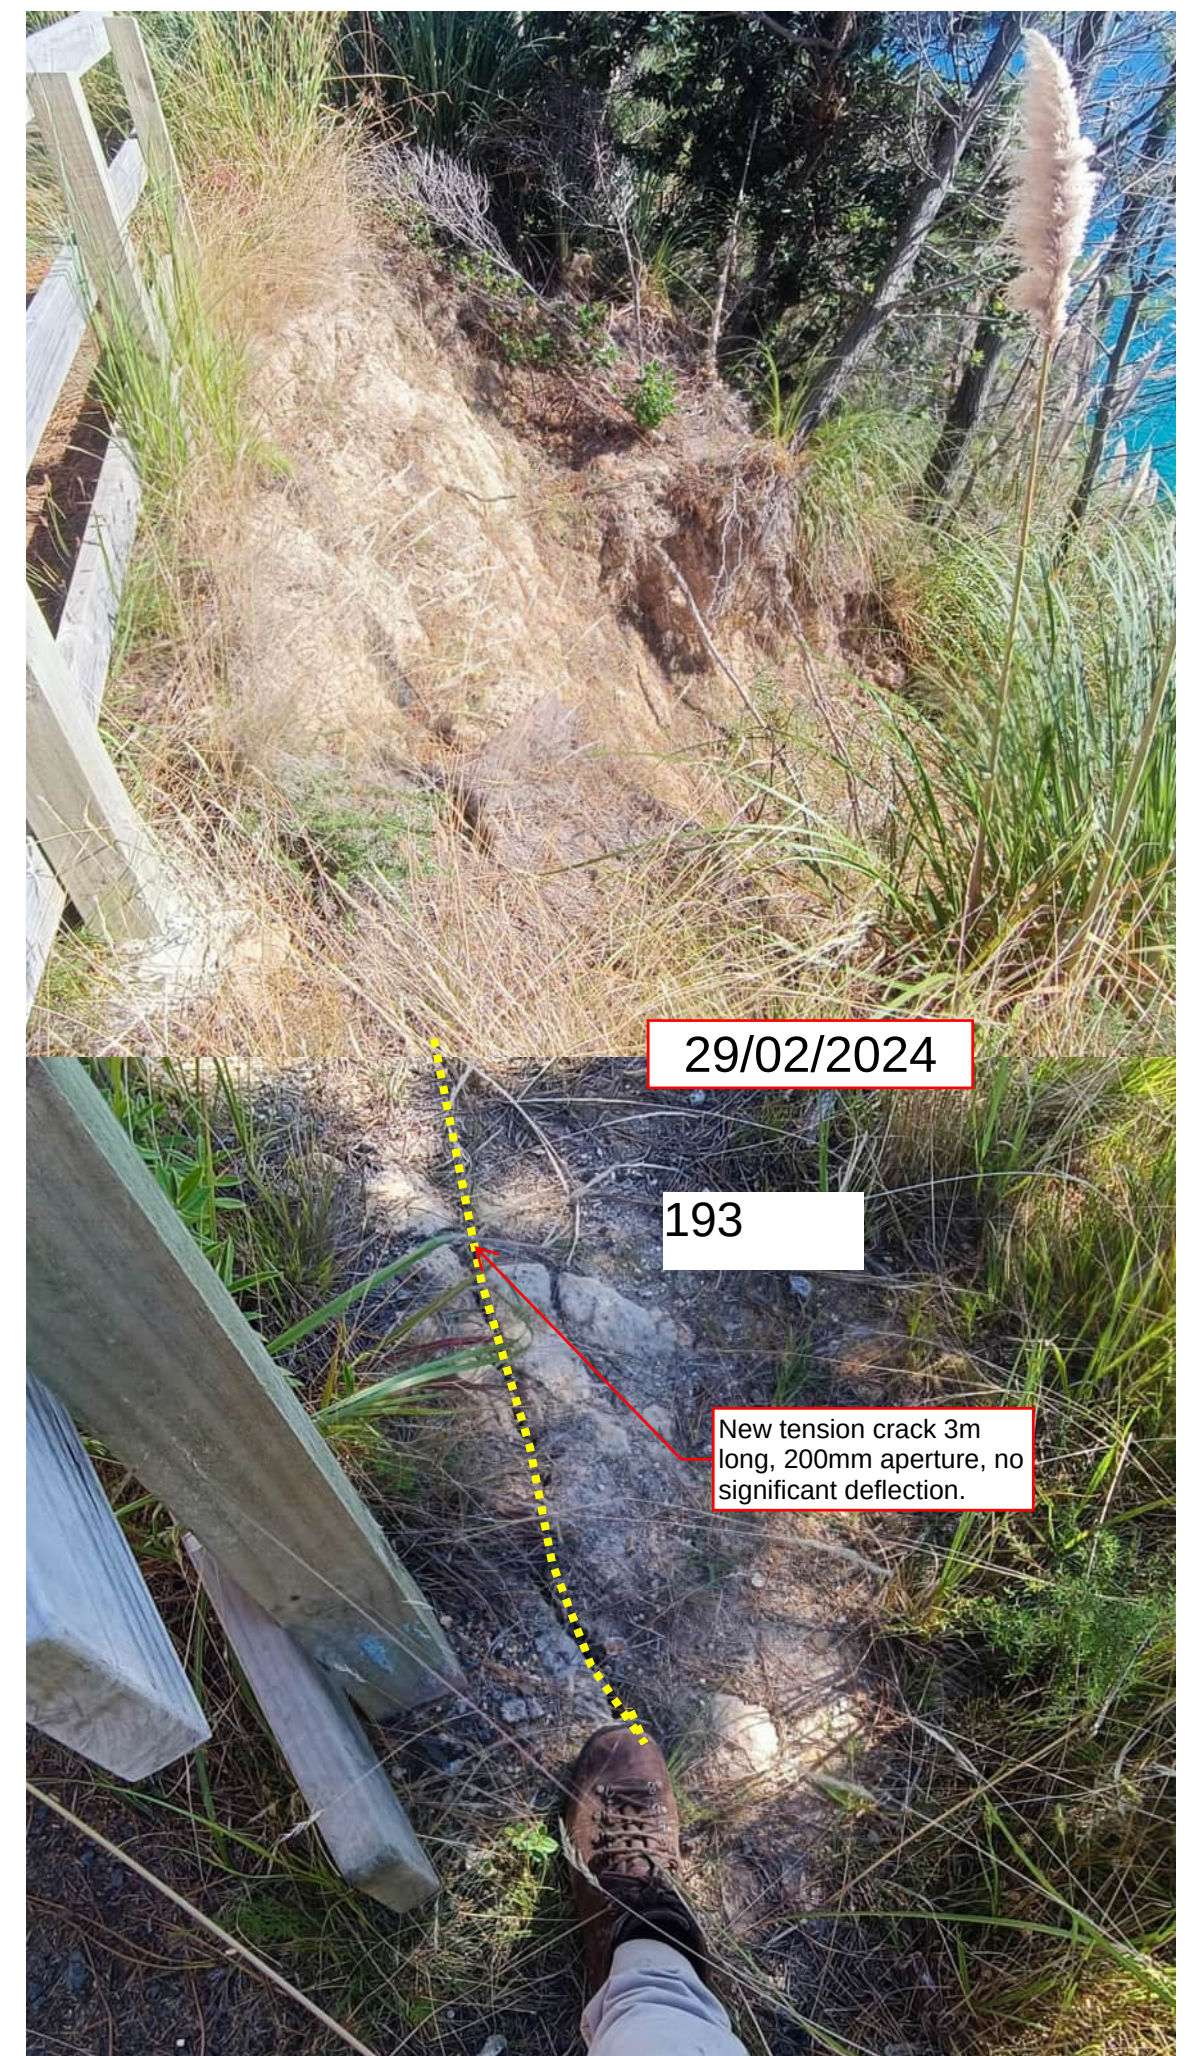
Feature 30 - Translational landslide  
Headscarp is now 150mm away from the  
fence. A new tension crack has formed  
near the Southern end of the fence (193).  
(Observed during Feb 2024 visit).

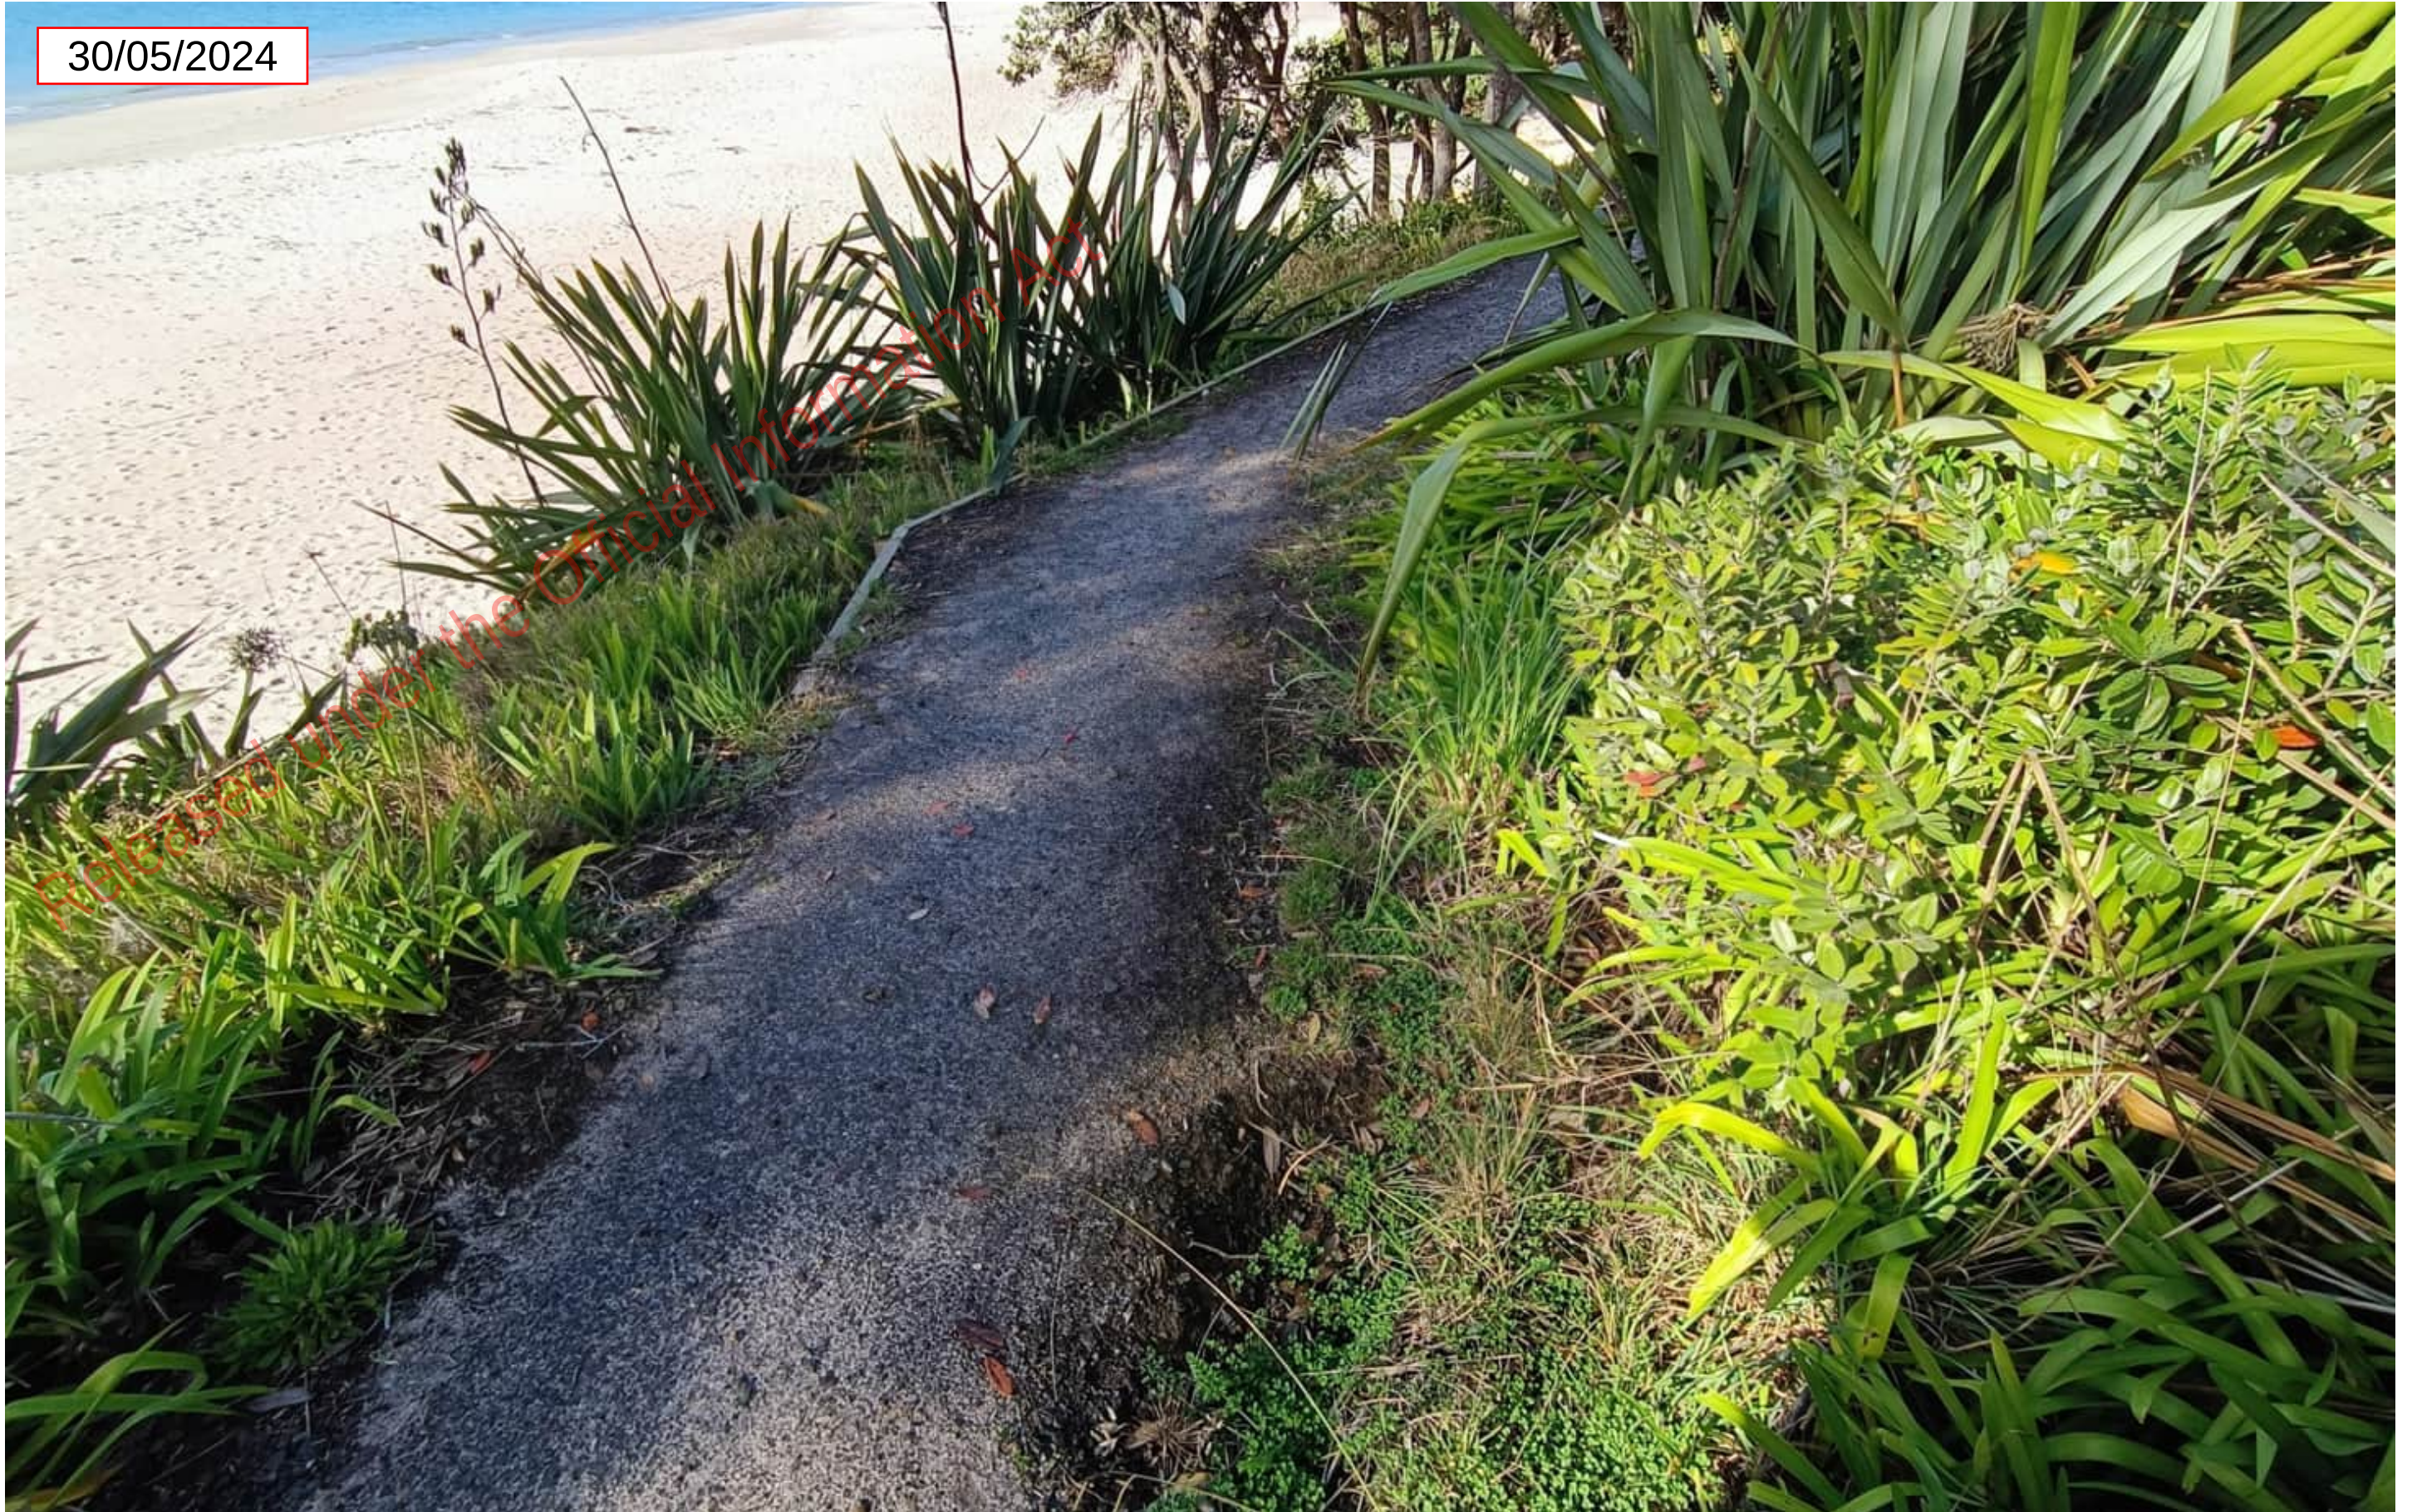
Feature 53 - Tension crack/creep.  
No new movement of the tension crack  
observed. Current aperture  
approximately 50mm, no deflection.  
(Observed during Feb 2024 visit).

Feature 53 Continued - No new damage  
observed during May 2024 visit.
