Lessons Learnt 007

February 2020 V 2

Retrofitting weirs to create fish ramps in Gibbons Creek, Hamilton

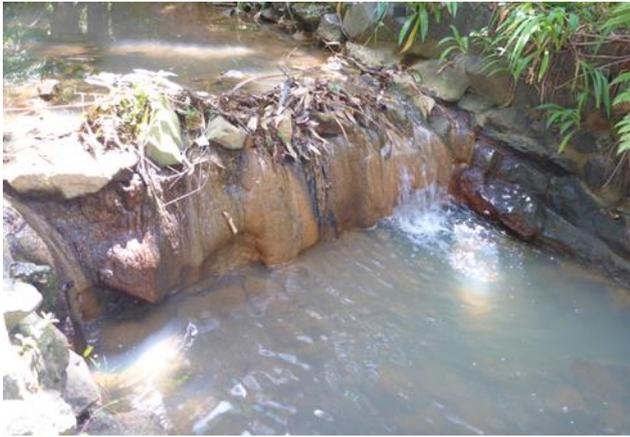
Gibbons Creek is a catchment in central Hamilton that joins the Waikato River through Memorial and Parana Parks. Three rock weirs and one timber weir have reduced upstream fish passage (Figure 1) for the two weak swimming species, inanga (*Galaxias maculatus*) and common smelt (*Retropinna retropinna*).

Figure 1: One of four weirs on Gibbons Creek that impeded passage for weak swimming fish, December 2015. Photo: NIWA

In 2016, we built concrete rock ramps on the true left side at the downstream face of three weirs (Figure 2) and physically removed the fourth (timber) weir. Ramps were built by laying rocks on geotextile and securing smaller rocks in place using rapid-set concrete to create a continuous wetted path for fish.

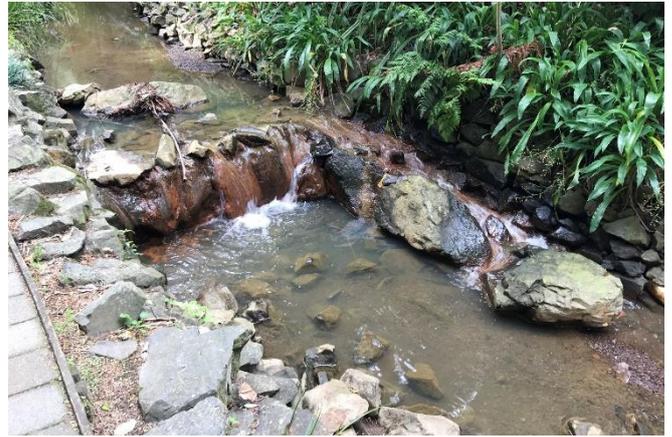
Figure 2: After installation of a concrete rock ramp to provide passage for swimming fish species, March 2016. Photo: NIWA

Yes, smelt and inanga successfully migrated upstream over the first two fish ramps within a year of installation. These species had not been found above the third fish ramp in monitoring completed up to February 2018, which suggests this ramp may still be a partial barrier to these weaker swimming fish.

1. Without monitoring we would not know which ramps were successful at improving fish passage.
2. Further modifications to weir three may be required to enable weak swimming fish species to pass upstream. This site has a naturally steeper gradient and at low flows the channel we created around the weir isn't always flowing. In these conditions, fish are still required to surmount the top section of the weir. Reducing the level of the channel entrance should remedy this issue.
3. Inexpensive concrete rock-ramps can mitigate low head / small migration barriers.
4. This project demonstrates small weir remediation is valuable. As this is in a public park this site raises awareness and educates the community about fish passage restoration work for native fish.

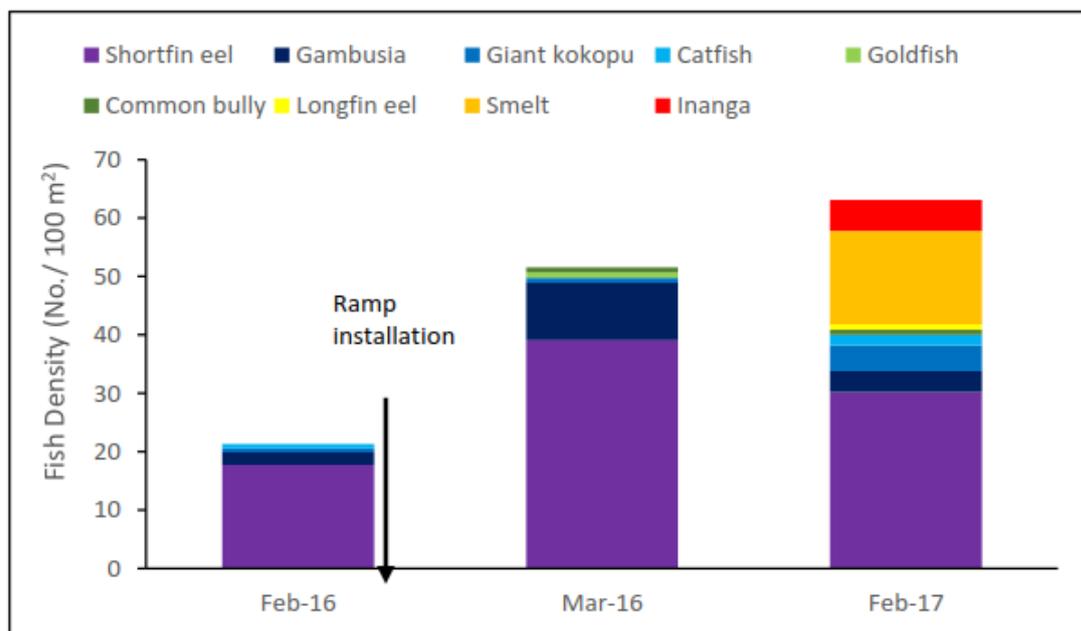
Monitoring showed that installation of the fish ramps at the first three weirs and removal of the fourth weir allowed more fish species to access Gibbons Creek, including inanga and smelt for the first time (Figure 3). However, inanga and smelt were not recorded above the third retrofitted weir in March 2016 or February 2017.

Although higher numbers of exotic fish were also found above the weirs, including gambusia, catfish & goldfish, these species were already present further upstream and likely to have recruited from the headwater lakes. Despite this, the density and diversity of native fish has improved indicating that the ramps are beneficial overall to native fish passage.

Figure 3: Standardised single pass electrofishing results of fish communities before and after installation of the fish ramps in Gibbons Creek. The survey reach is located upstream of the second retrofitted weir.
