Lessons Learnt 011

Floating fish ramp provides passage for inanga in Irongate Stream

May 2021 V 1

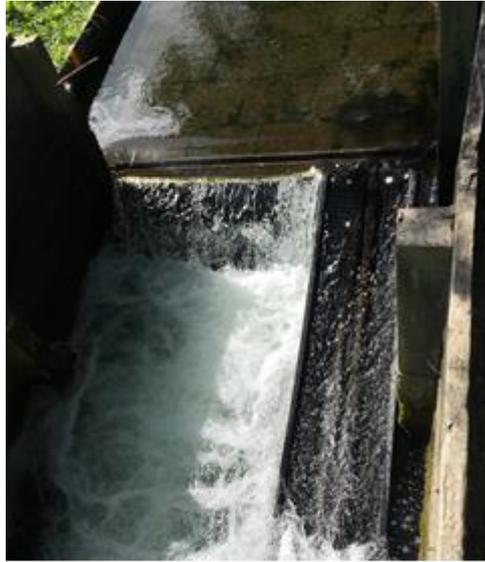
Figure 1: The floating fish ramp (with spat rope) on the Irongate Stream weir

The post-remediation survey in November 2016 (post-remediation 1) found 504 inanga downstream, but none upstream. Upon inspection of the ramp, it was revealed that the ramp had sunk and was not providing passage for inanga. Water ingress had caused the ramp to partially sink, resulting in a much shorter, steeper ramp. It was hypothesised that the screw holes from the baffled sheets had leaked.

A new ramp was deployed in January 2019, with the baffled sheets plastic welded to the ramp, resulting in a fully sealed unit. This replacement ramp floated as intended. After installing the fully sealed ramp unit, another survey in April of 2019 (post-remediation 2) found 1354 inanga downstream and 704 upstream of the ramp.

3. By plastic welding the baffled sheets onto the ramp, and keeping it fully sealed, the ramp remained buoyant and facilitated better passage of inanga. The sealed ramp has now been in place for 2 years and is still buoyant.
