Changes in stream morphology at two mining sites near Reefton

SCIENCE FOR CONSERVATION: 53

Graham Macky

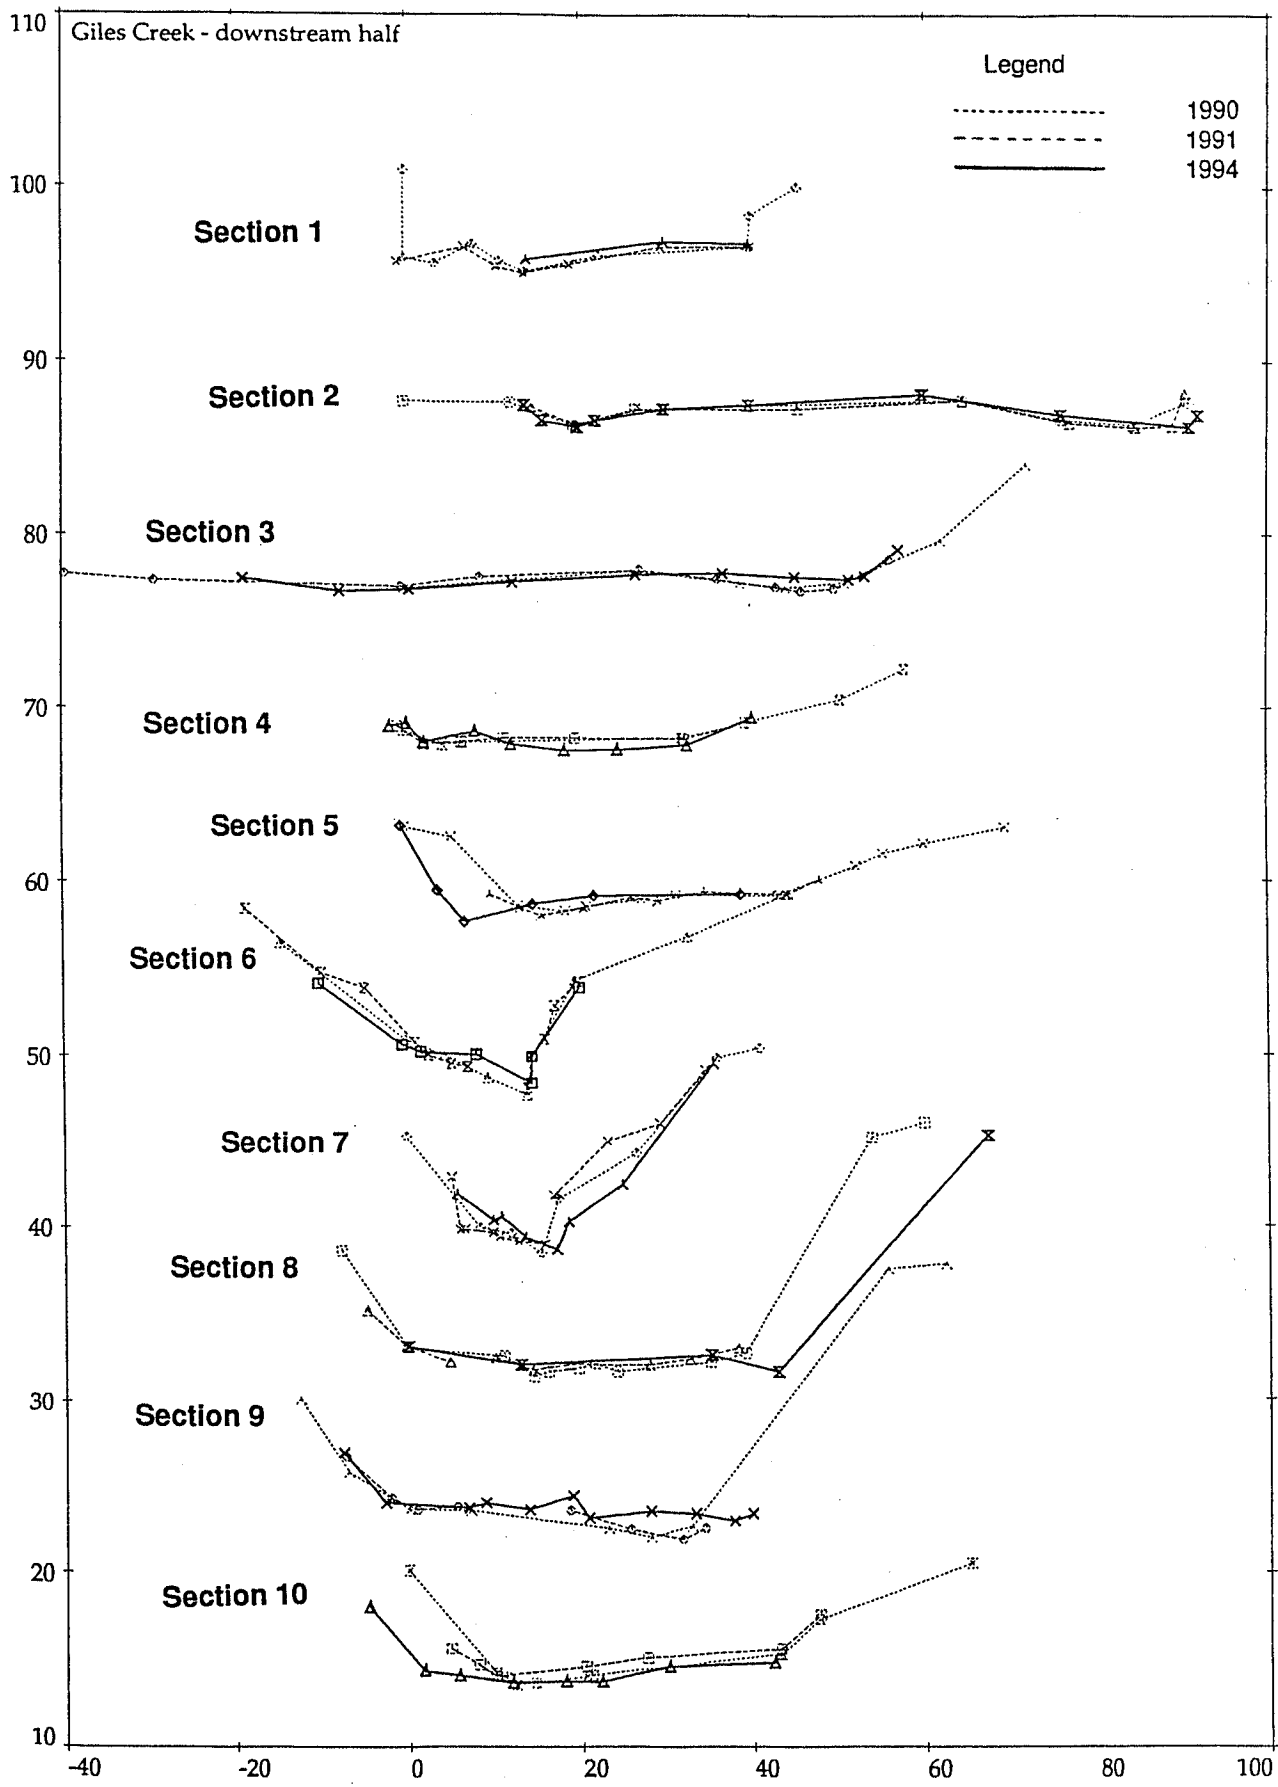
FIGURE 4. SURVEYED CROSS-SECTIONS DOWNSTREAM OF MINE SITE, GILES CREEK.

Further downstream the channel returns to a wide, stable condition. At cross-section 1 the stream is back in its natural channel, where a hole too deep to survey has formed on the true left side since 1991.

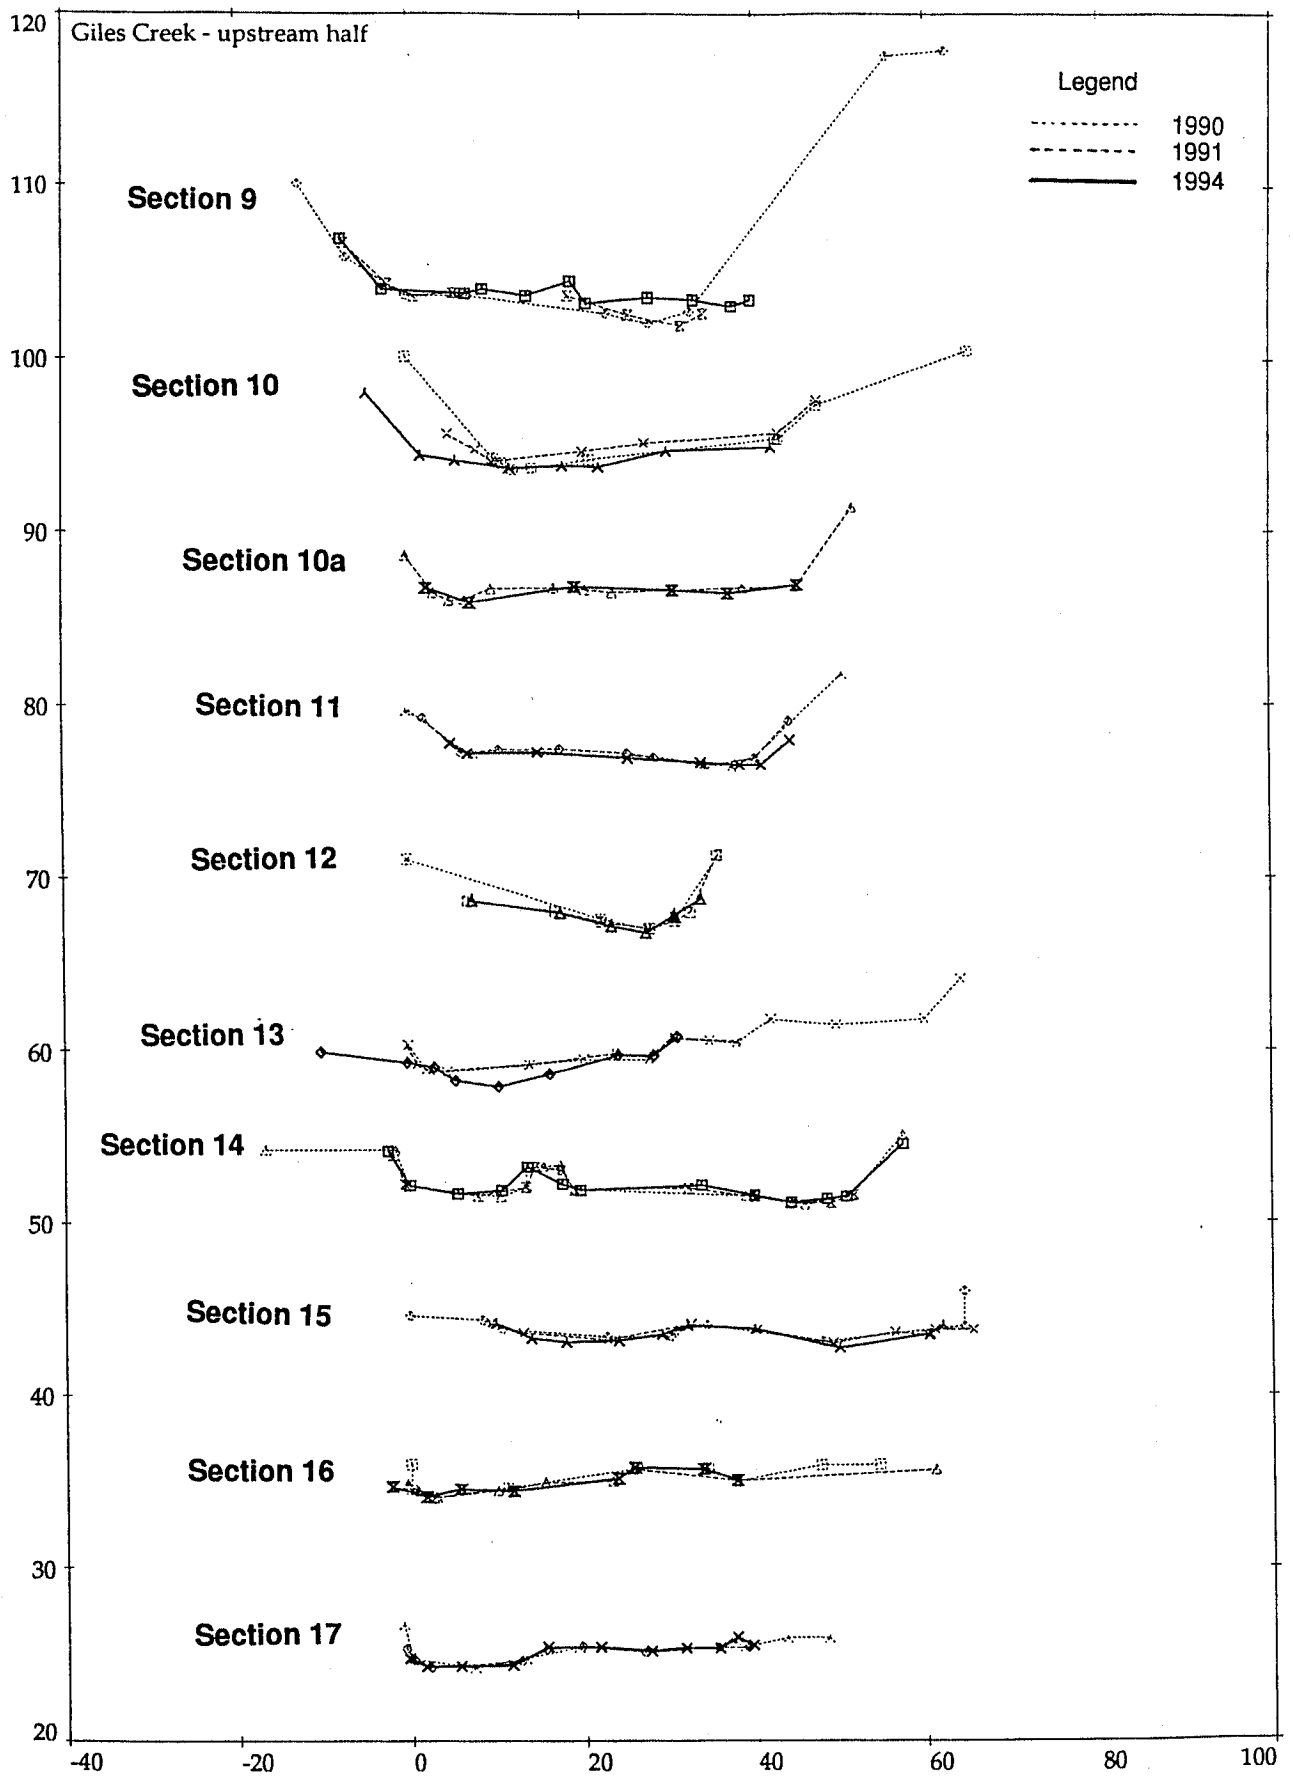
FIGURE 5. SURVEYED CROSS-SECTIONS UPSTREAM OF MINE SITE, GILES CREEK.

No change was measured at cross-sections 10a-17 between 1990 and 1994, and the January 1995 floods appear to have caused only minor bed changes and some bank erosion at Sections 10a-11 (Fig. 5). Sections 15-17 are in an undisturbed part of the natural channel, which appears from inspection to be fairly stable, with only gradual erosion on the outside of bends (see Appendix Figs 1-3). The artificial channel diversion starts at section 14, but the true right bank has been protected with rip rap rock and the channel is a similar width to the natural channel.
