# Applicant Information Form 1a Notified or Non-notified Process

**Coronet Peak Lease  
Application  
Ecological Assessment**

Coronet Peak  
Mountain Bike  
Tracks  
Ecological Impact  
Assessment

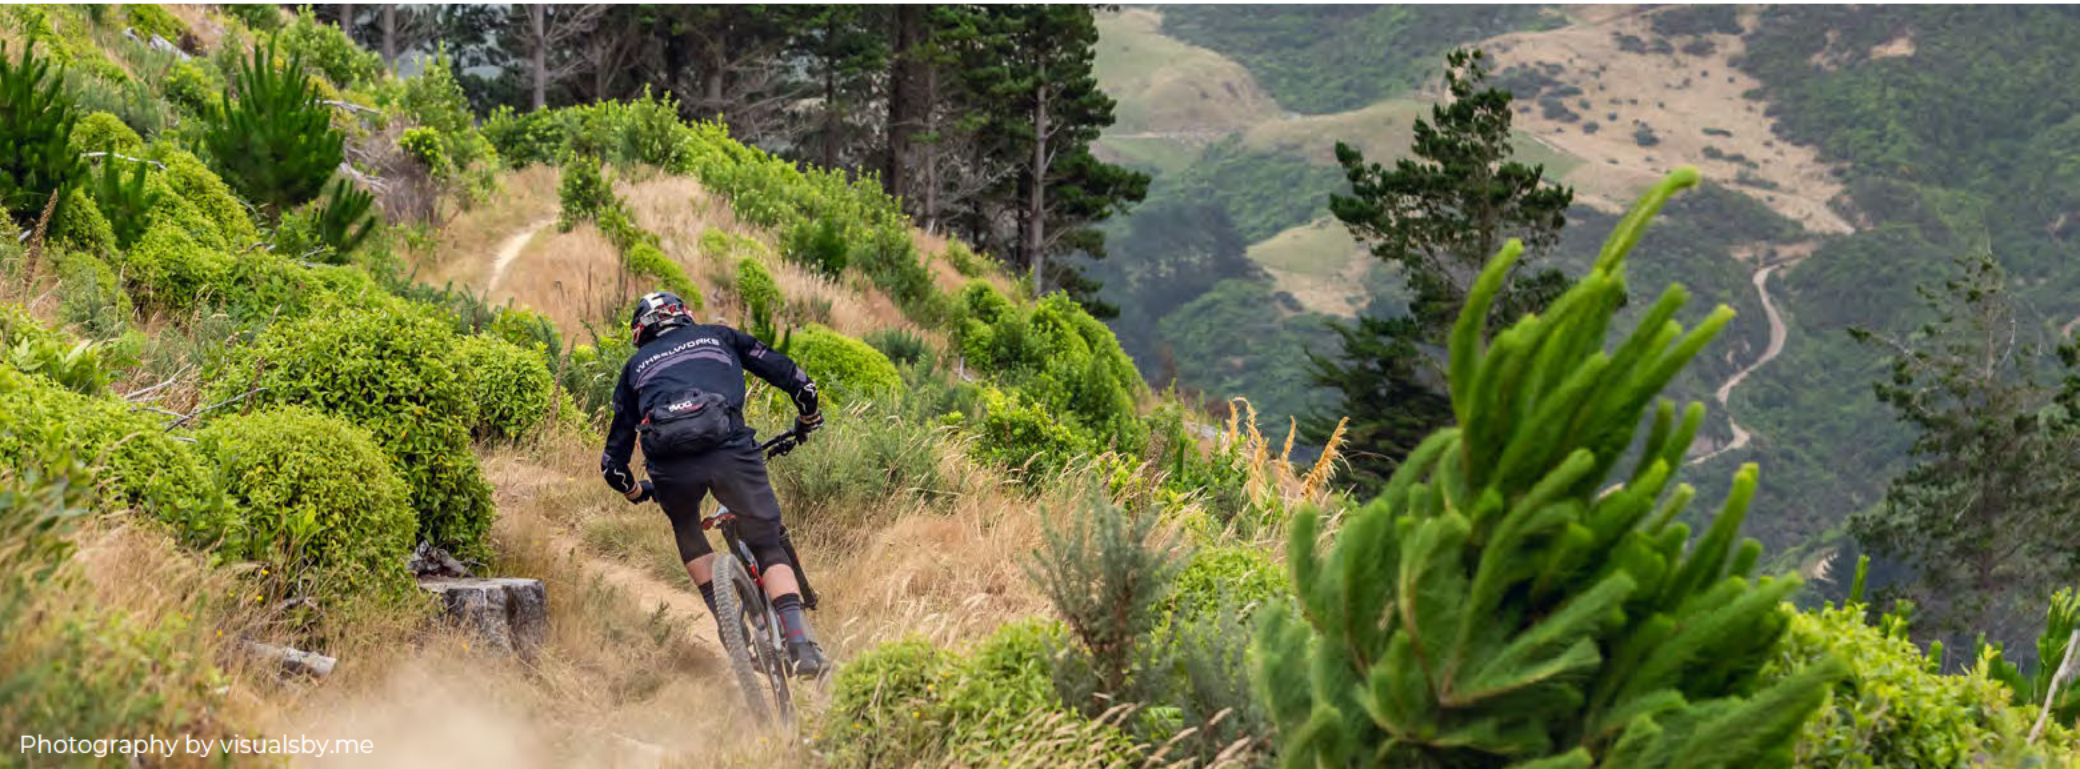
## Guideline for the Provision of Barriers beside Tracks and Structures (based on SNZ HB 8630:2004)

Measure Fall Height Hf 1.5m out from edge of track, or structure that is <1.5m high, for structures that are between 1.5 and 2m high measure Fall Height at the same distance out from the structure as it is high, For Structures >2m high, measure Fall Height 2m out from the structure edge.	Grade 1 Easiest	Grade 2 Easy	Grade 3 Intermediate	Grade 4 Advanced	Grade 5 & 6 Expert & Extreme
Fall onto a benign surface presenting features that will tend to reduce the effect of impact (a) Deep moss (b) Soft vegetation (c) Shallow still water deep enough to cushion a fall (d) Swamp	Hf > 2.0m Provide Type A Barrier Hf = 1.0-2.0m Provide Type B barrier Hf < 1.0m no barrier	Hf > 3.5m Provide Type A Barrier Hf = 2.0-3.5m Provide Type B barrier Hf < 2.0m no barrier	Hf > 2.0m Provide Type B Barrier Hf < 2.0m no barrier	Hf > 2.5m Provide Type C Barrier Hf < 2.5m no barrier	Hf > 3.5m Provide Type C Barrier Hf < 3.5m no barrier

Hazardous surface presenting features that will result in serious harm, regardless of the effect of fall to the initial impact point (a) Swiftly flowing water without means of exit (b) Boiling mud or water (c) Extended falls arising from rolling or sliding, following initial impact, on terrain whose slope exceeds 35deg. Mitigating factors such as vegetation likely to arrest rolling shall be taken into account when assessing extended falls	Provide Type A Barrier	Provide Type A Barrier	Provide Type B Barrier	Provide Type C Barrier	Provide Type C Barrier

**Note 2:** For tracks and structures with tread width <1.2m it's recommended that barriers be angled outwards at approx. 5 deg from vertical to allow clearance for handlebars

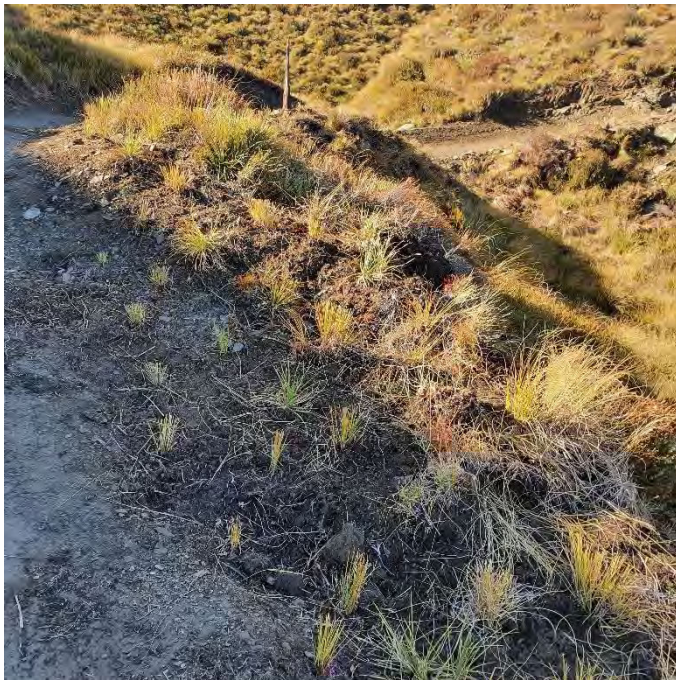
### Re vegetation

It is important to remember at higher altitudes successful restoration of the environment takes years. However within the reserve there is now the Upper Rude Rock trail built in the last year by small digger and revegetated by hand to give an understanding of the immediate effect. And the XC trail which has had to be refreshed this year but original works were in 2005. Grade 4 Upper Rude Rock Link Trail following hand revege and additional replanting alongside the trail.

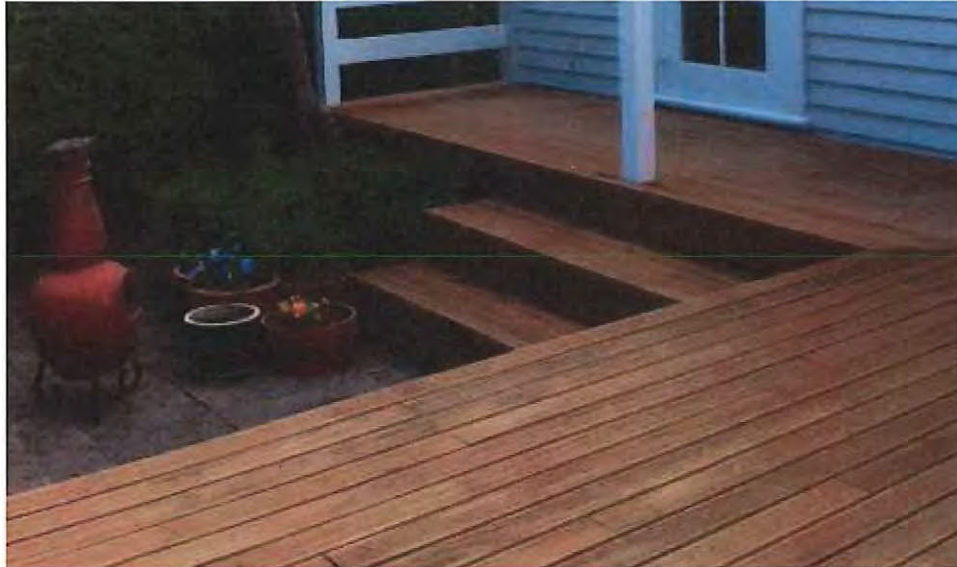
### 7.1. Decks, platforms, bridges, boardwalks, etc

A building consent is not required for work on decks, platforms, bridges, boardwalks and like structures where it is not possible to fall more than 1.5 metres.

Note that a safety barrier is still required under Building Code clause F4 – Safety from falling where there is a fall of 1 metre or more.

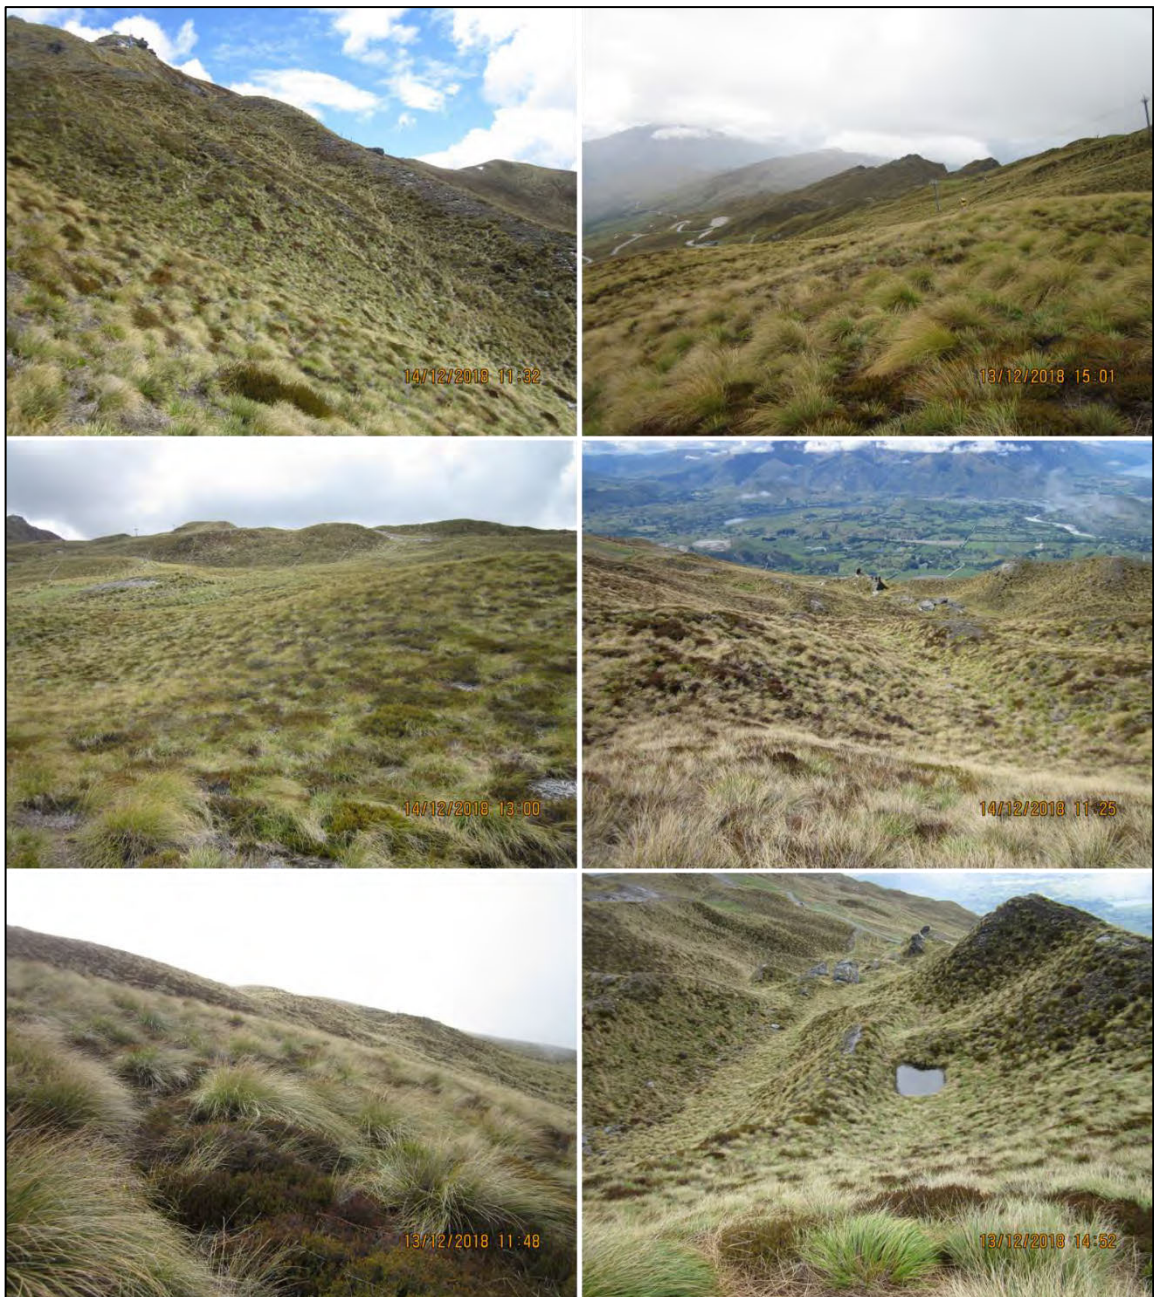
Plate 1: *Dracophyllum* tussock shrubland across the Reserve.

*Dracophyllum* tussock shrubland is the dominant vegetation present throughout the Reserve (see Figure 3 and Plate 1), however, this vegetation community varies in the composition of the dominant species. For example, above approximately 1500 m asl, *Chionochloa macra* is present rather than *Chionochloa rigida*, which is present over the rest of the Reserve. The elevation at which *C. rigida* replaces *C. macra* is approximately 1500 m, however there is a transition zone where *C. macra* can extend to lower elevations and vice versa.

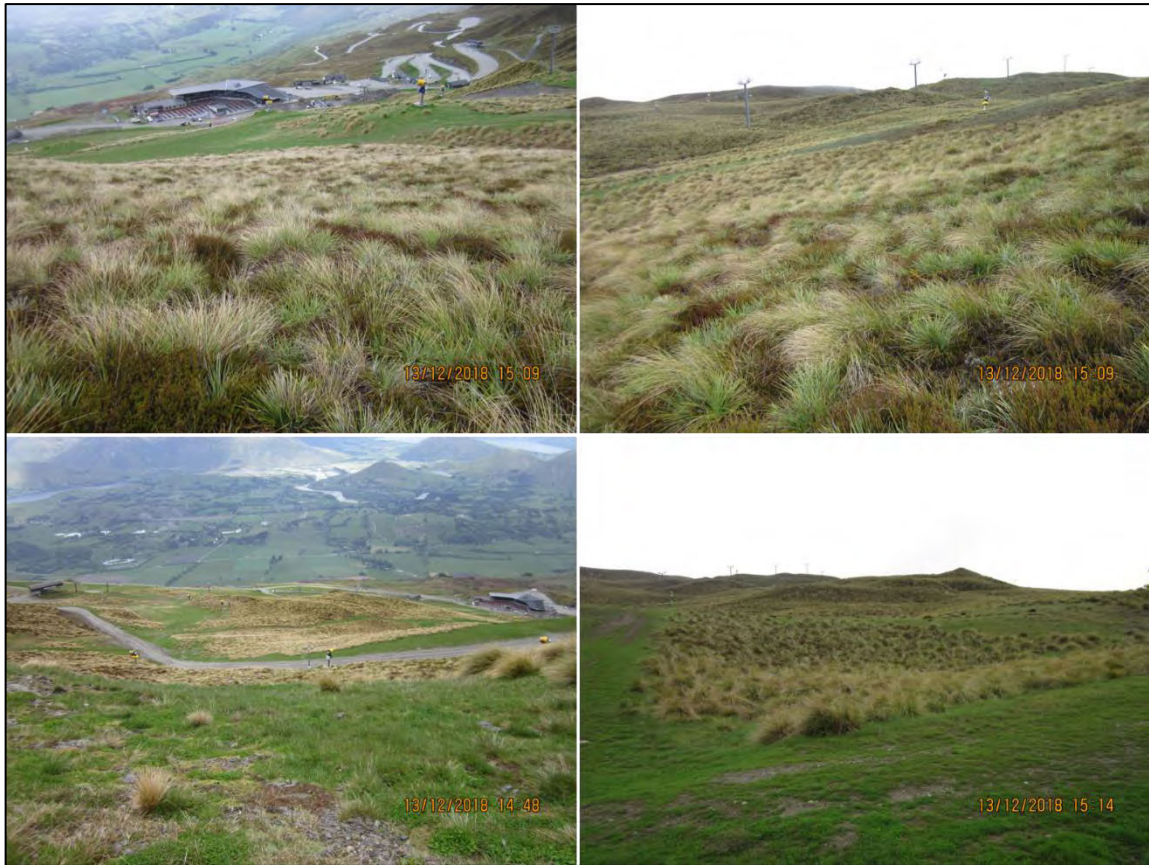
The area of *Dracophyllum* shrubland that is located above the base building and between the main ski trails (see Figure 3 and Plate 2) has a higher proportion of *Celmisia lyallii*. This area is also scattered with blue tussock, snow tussock and *Veronica hectorii*. The increased presence of *Celmisia lyallii* in this area is noticeable, and most likely attributable to the higher level of historic and current disturbance that has occurred.

Plate 2: Co-dominant *Dracophyllum spp.* and *Celmisia lyallii* located near the base building and between the main ski trails.

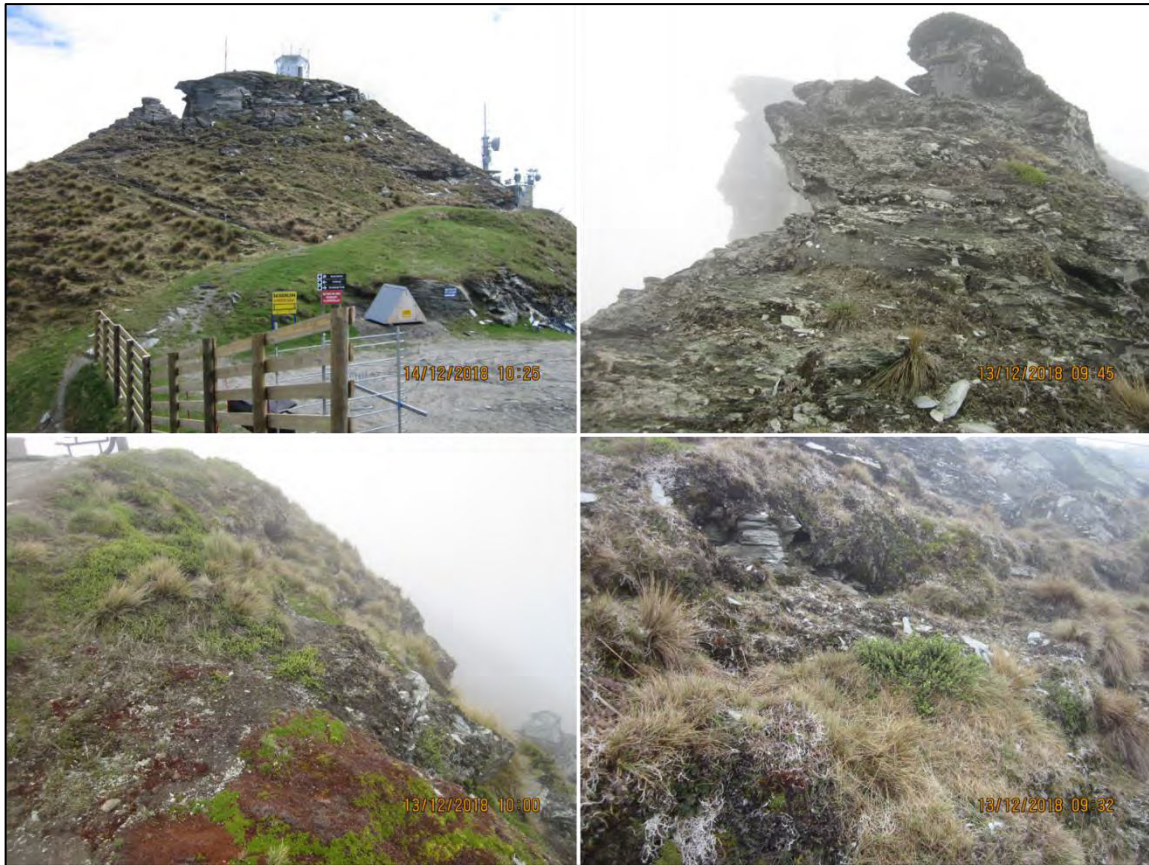
Rocky outcrop plant communities are present in small pockets over the Reserve, however the main area is around the summit of Coronet Peak (see Plate 3). This area has a wide range of species, which is a result of soil depth and exposure. Species found on the rocky summit include *Veronica buechananii*, *Poa colensoi*, *Brachyglottis bellidioides*, *Brachyscome montana*, *Dracophyllum pronum*, *Raoulia hectorii*, *Raoulia subsericea*, *Ourisia glandulosa*, *Ourisia caespitosa*, *Gaultheria depressa* var. *novae-zealandiae*, *Celmisia angustifolia*, *Dracophyllum muscoides*, *Epilobium purpuratum*, *Thamnolia vermicularis*, *Anisotome flexuosa*, *Acaena saccaticupula*, *Lycopodium fastigiatum* and *Luzula pumila*. The rocky summit vegetation incorporates species that are found in the cushion fields (see below) but did have species that were also not widely spread such as *Epilobium purpuratum* which is Naturally Uncommon and the rush, *Marisoppospermum gracile*, which was only present in patches.

Plate 3: Coronet Peak rocky outcrop habitat.

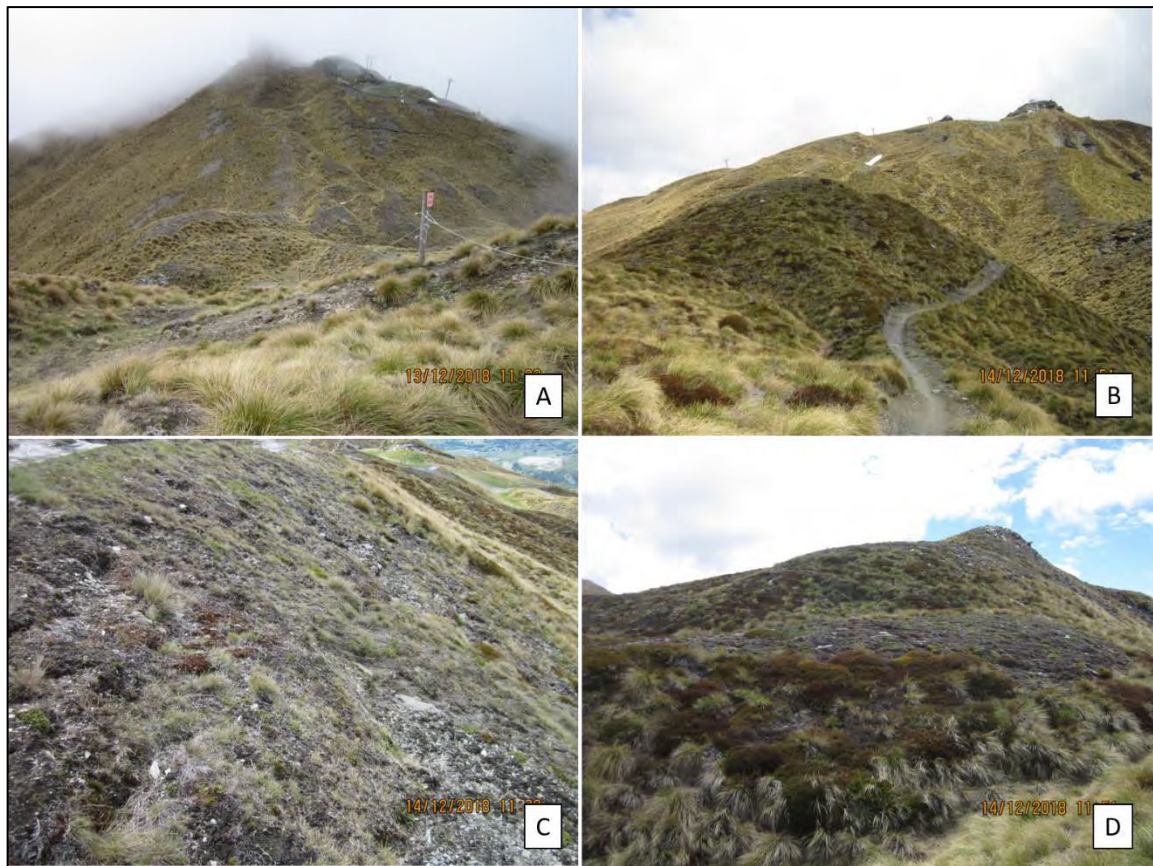
The cushion fields within the Reserve are typically found in small, narrow strips on exposed ridges and spurs in the upper elevations of the Reserve (see Figure 3 and Plate 4). These communities have been developed in response to high wind and sun exposure on and relatively shallow soil depths. Species within these communities include *Dracophyllum muscoides*, *Raoulia hectorii*, *Raoulia grandiflora*, *Hectorella caespitosa*, *Poa colensoi*, *Luzula pumila*, *Rytidosperma pumilum*, *Abrotanella inconspicua*, *Ourisia glandulosa*, *Ourisia caespitosa*, *Veronica densifolia* and *Celmisia laricifolia*. Larger species such as *Veronica buchananii*, *Anisotome flexuosa*, *Gaultheria depressa* var. *novae-zealandiae* and *Acaena saccaticupula* are also present.

Plate 4: Cushion field habitat. A and B – Photos showing the location of cushion field habitat along the tops of the exposed ridges and spurs.

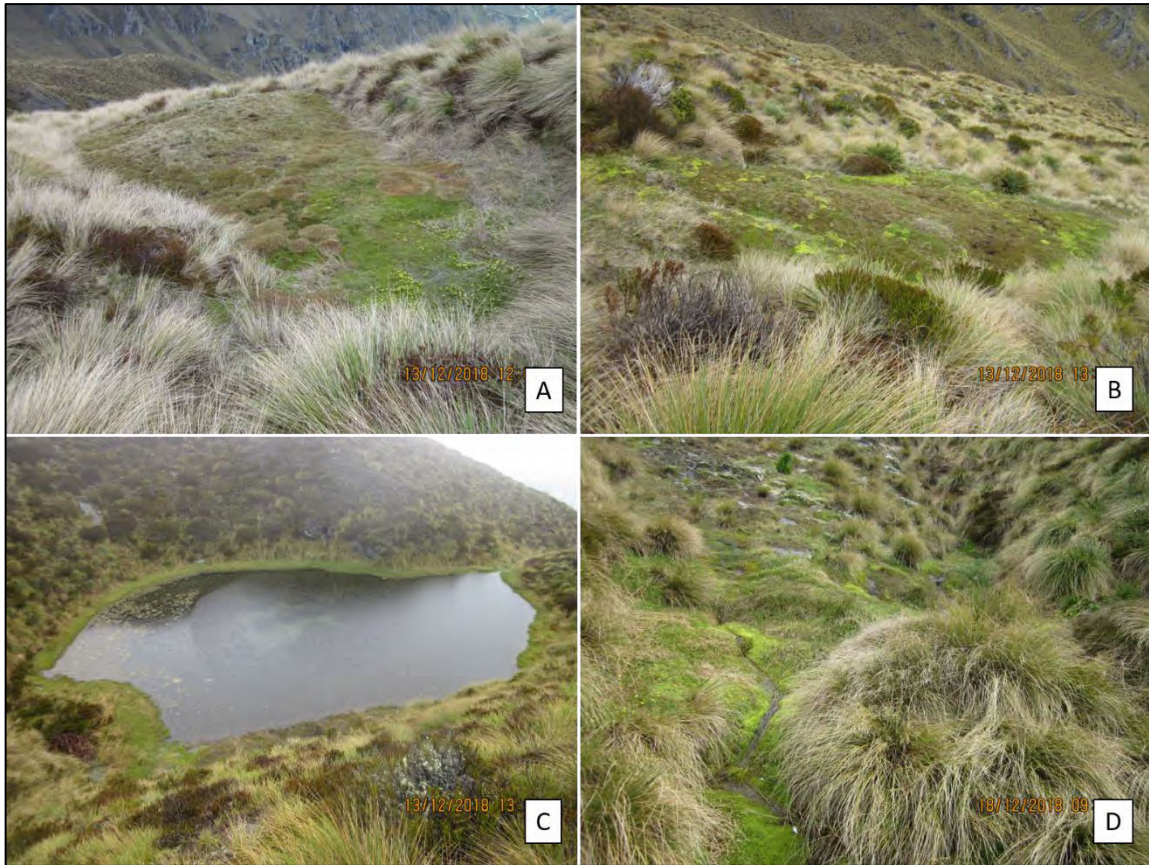
A number of wetlands are present across the ski area including three tarns, multiple streams and seepage areas (see Figure 3 and Plate 5). The wetlands and seepages vary from cushion wetlands dominated by comb sedge (*Oreobolus pectinatus*) with a range of small herbs and wetland plants to *Schoenus pauciflorus* dominated sedge lands. The wetlands are small in area and predominantly found on the western side of the Reserve. Species present included *Abrotanella caespitosa*, *Ranunculus gracillipes*, *Nertera balfouriana*, *Carex gaudicaudiana*, *Caltha obtusa*, *Coprosma perpusilla*, *Plantago unibracteata*, *Cardamine corymbosa*, *Anisotome aromatica*, *Ourisia caespitosa*, mosses and lichens. *Dolichoglottis lyallii* was found along the stream and seepage margins, and *Coprosma rugosa* at lower elevations along the steep creek banks.

Plate 5: A and B – Small wetlands near the western boundary of the ski field. C – Large tarn. D – Seepage area.

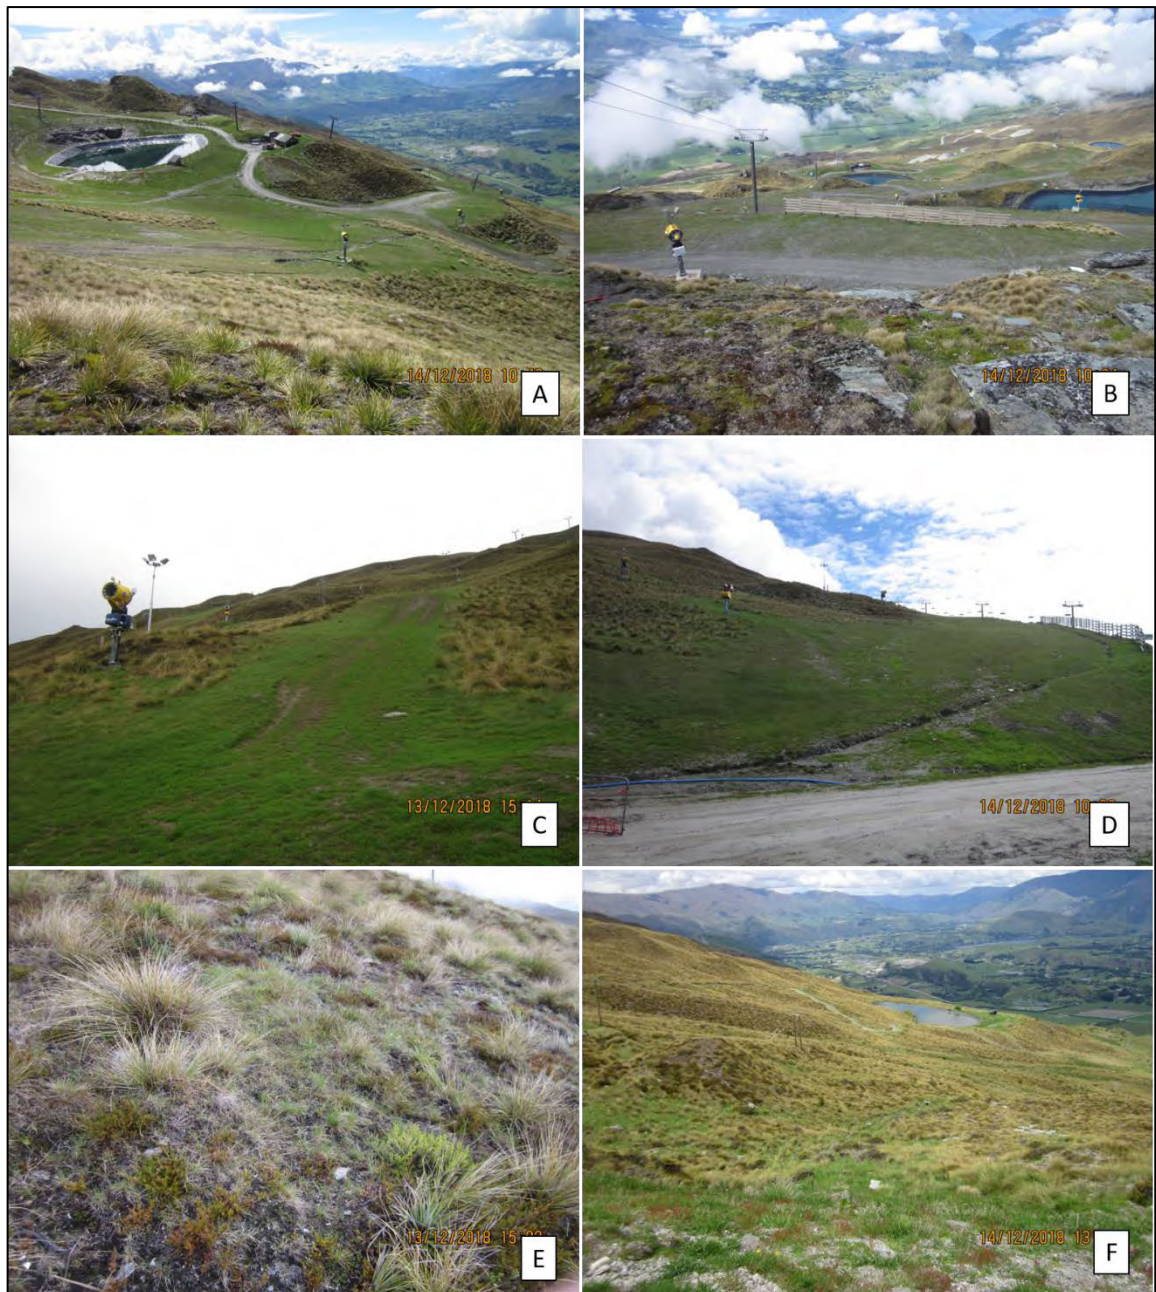
Exotic species are widely spread over the Coronet Peak Recreation Reserve. Exotic species are the dominant vegetation on the ski trails as well as any disturbed ground (see Plate 6). Common weed species present included brown top (*Agrostis capillaris*), white clover (*Trifolium repens*), yarrow (*Achillea millefolium*), sweet vernal (*Anthoxanthum odoratum*), tussock hawkweed (*Hieracium lepidulum*), mouse-ear hawkweed (*Hieracium pilosella*), creeping thistle (*Cirsium arvense*), broad leaved dock (*Rumex obtusifolius*) and sheeps sorrel (*Rumex acetosella*). Brown top and white clover are present within most of the of the vegetation communities but are at low levels in the *Dracophyllum* shrublands to the west of the ski area. Grey willow and wilding conifer seedlings were present, however control of these two species across the Reserve was evident.

Plate 6: A – D Photographs showing the exotic grass habitat associated with the ski trails within the Reserve. E and F – Examples of exotic grasses moving into native habitat.

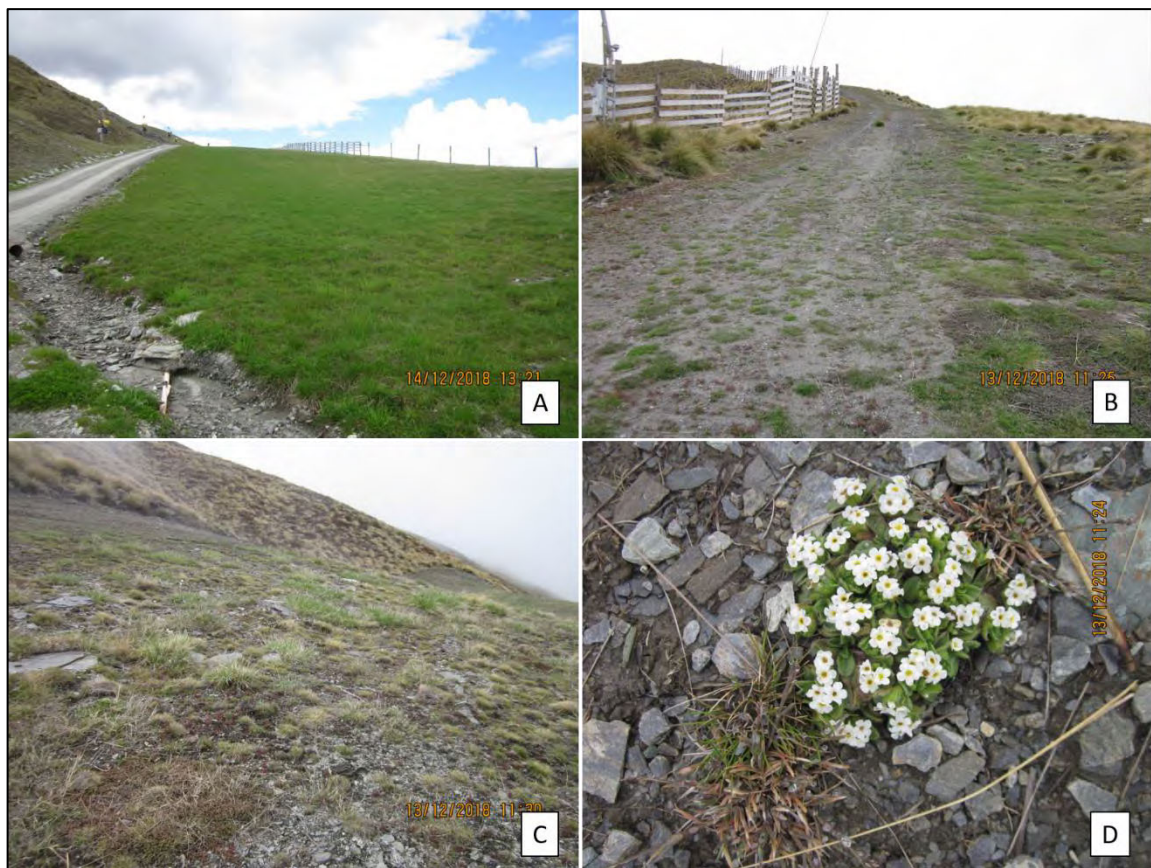
The regeneration of native species on the disturbed areas such as the ski trails was more evident at higher elevations, where the exotic grass mix was less successful in striking (see Plate 7). The presence of bare soil has enabled native species to colonise disturbed sites. Native species which are spreading over these bare areas include *Raoulia tenuicaulis*, *Acaena saccaticupula*, *Poa colensoi*, *Rytidopserma pumilum*, *Epilobium* spp. In one location the Nationally Vulnerable, small rosette *Myosotis elderi* was present (see Plate 7). In the lower elevations, such

as on the Big Easy trail, where the exotic species have formed a thick cover, regeneration of native species is much lower (see Plate 7).

Plate 7: A – Exotic grass mix forming thick cover at lower elevation. B – Exotic grass mix seeding showing bare patches at higher elevation. C – Example of native regeneration coming through exotic grass mix at higher elevation where exotic seeding has not been successful. D – *Myosotis elderi* on exposed ground where exotics have not yet established.

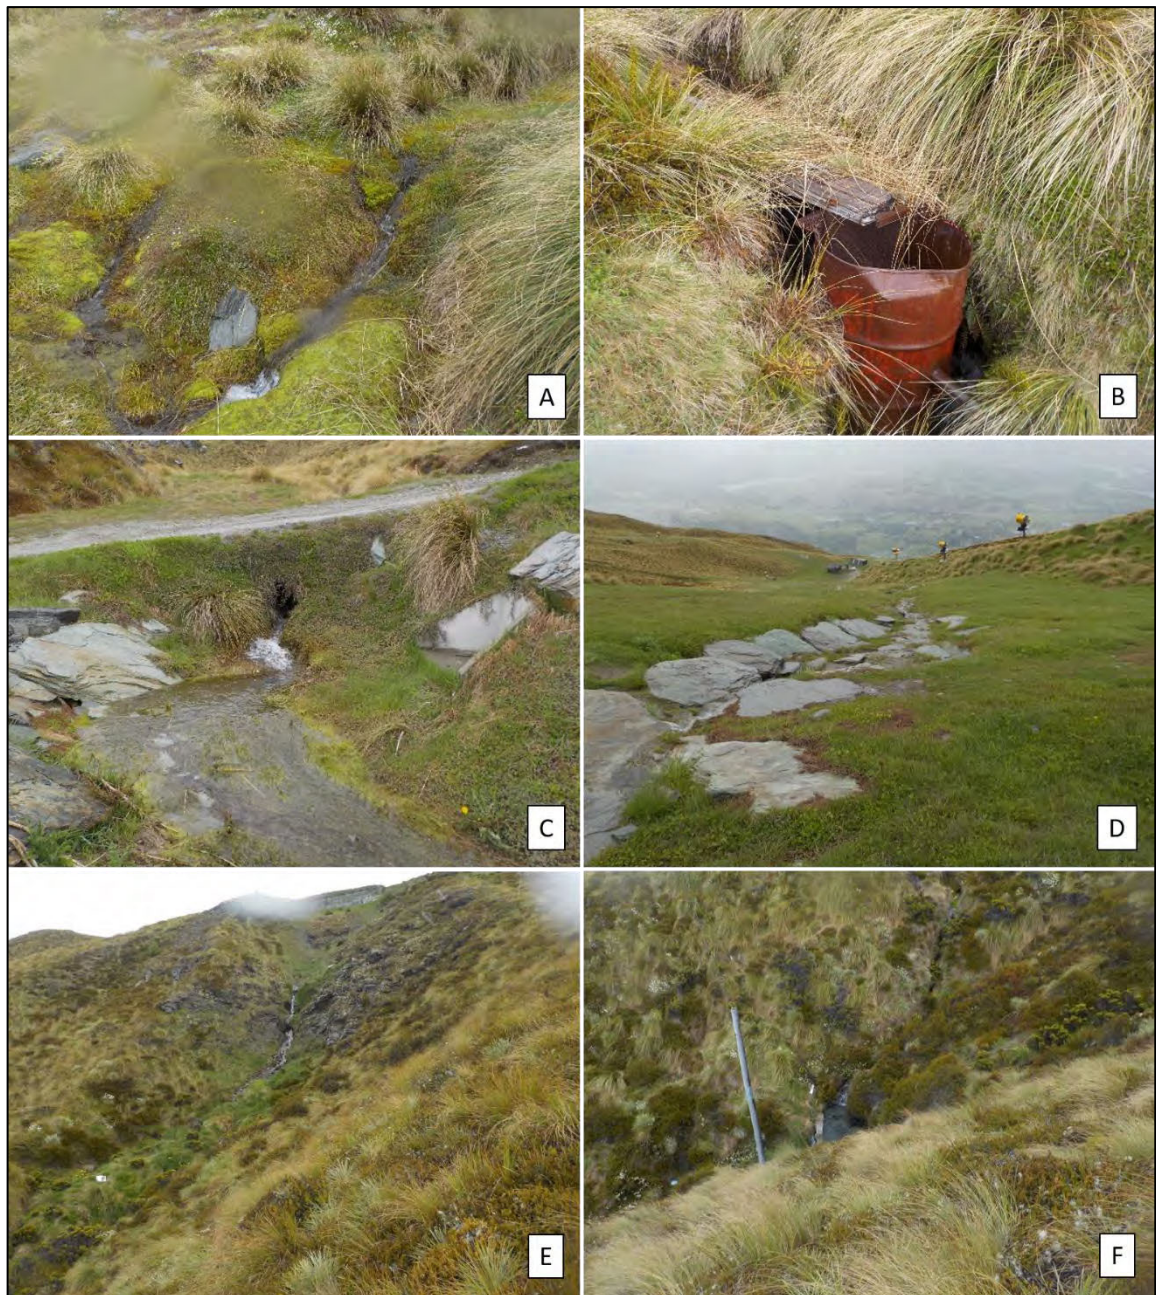
Plate 8: Stream 1. A – Springs at the stream source. B – Disused instream infrastructure. C – Track and culvert. D – Highly modified reach of Stream 1. E – Tributaries and waterfalls downstream of the access road. F – Water intake weir.

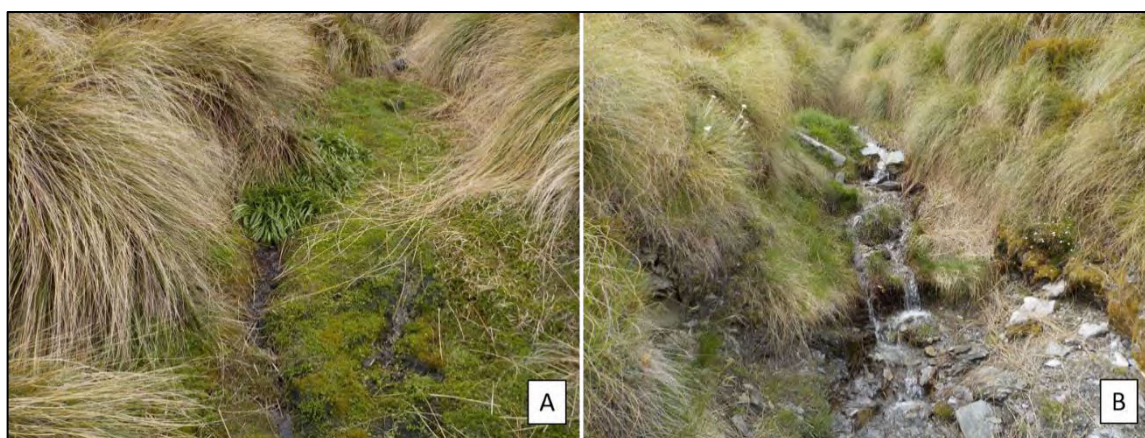
Stream 3 is a small seepage at the head of a tributary of Dirty Four Creek, which flows into the Shotover River. Dirty Four Creek is the only stream that flows into the Shotover River catchment from the Coronet Peak Ski Field. The seepage area is a mossy wetland with a small 0.1 – 0.2 m wide stream channel with a maximum depth of 0.05 m (Plate 10A). The stream bed included a mix of well compacted soil, sand and gravel, with the riparian vegetation being mainly moss. Invertebrates sampled included *Zealandobius* stoneflies and *Maoridiamesa* midge larvae that were both common. Less frequently found were flatworms, amphipods.

Plate 10: A – Stream 3, a small seepage area at the headwater of Dirty Four Creek. B – Stream 4, upstream of the main car park area.

Stream 4 is a short spring fed stream that flows approximately 70 m from its spring source to a culvert pipe that diverts the stream under the carparking area and into a water storage pond for snow making. This stream has an average width of 0.6 m and maximum depth of 0.2 m. The stream bed consists of loose schist fragments, which provides riffle and run habitat (Plate 10B). Spot searches for invertebrates in this stream found *Deleatidium*, which was common and flatworms. No other taxa were observed.

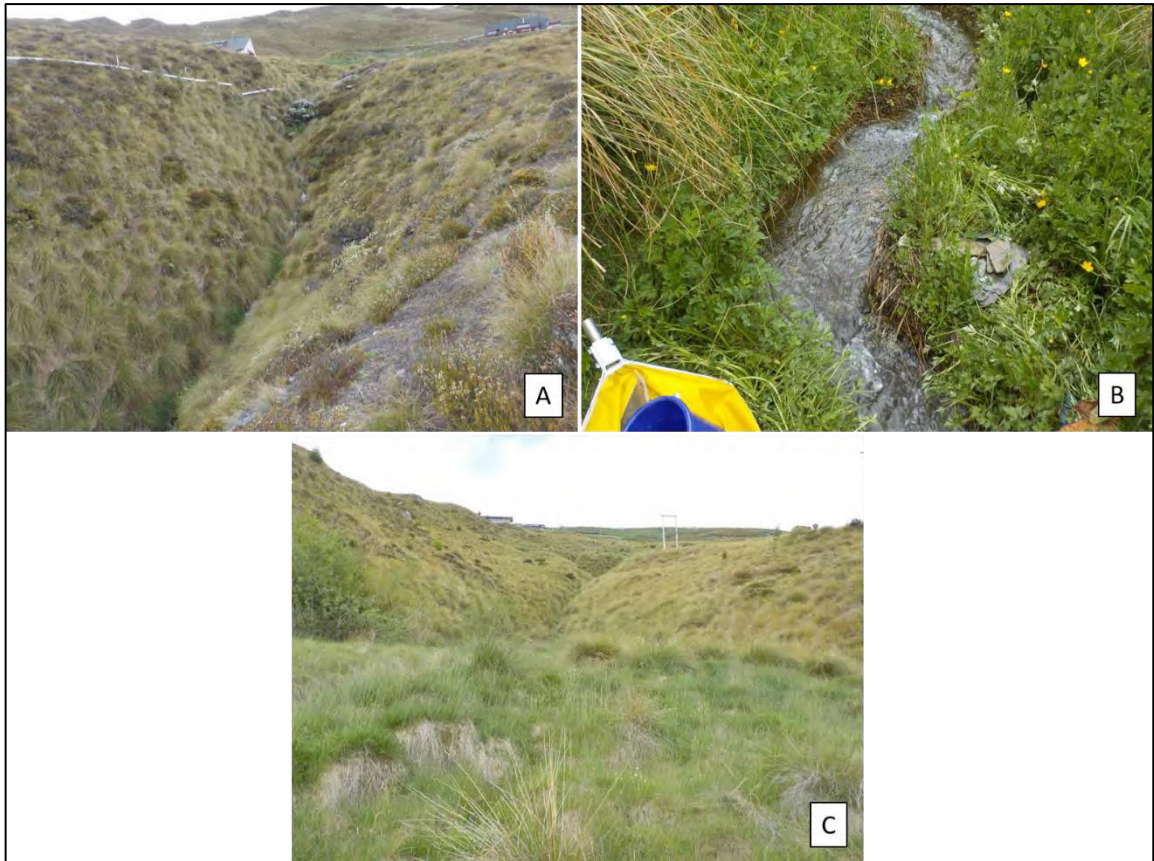
Stream 5 originates down slope from the base building and carpark areas. This stream is steep with riffle and cascade habitat and a narrow channel less than 0.5 m wide and up to 0.2 m deep. The main riparian vegetation is native tussocks. The steep, narrow nature of the stream creates a high-water velocity habitat and the roots of riparian grass and buttercup provide no undercut banks (Plate 11A and Bbelow). Invertebrates were not encountered within the loose mobile schist bed or root wads within the stream.

Stream 6 also starts down slope from the base building and carparks, however the catchment area for this stream includes the waste water soakage field. This stream is small, and less than 0.2 m wide and less than 0.1 m deep. It is initially steep, but the gradient becomes gentler and then flows through a relatively broad valley floor (Plate 11C). The riparian margin of this stream is well vegetated with tussock, introduced grasses and the occasional hebe and willow. The small size of the stream, despite the wet weather indicates the stream may be ephemeral. Invertebrates were not encountered during the survey, although searching was limited due to habitat availability.

Plate 11: A – A steep cascade section of Stream 5. B – Stream 5, note schist fragments that were inspected for invertebrates on the riparian grasses. C – Stream 6 in the gentle sloping reach.

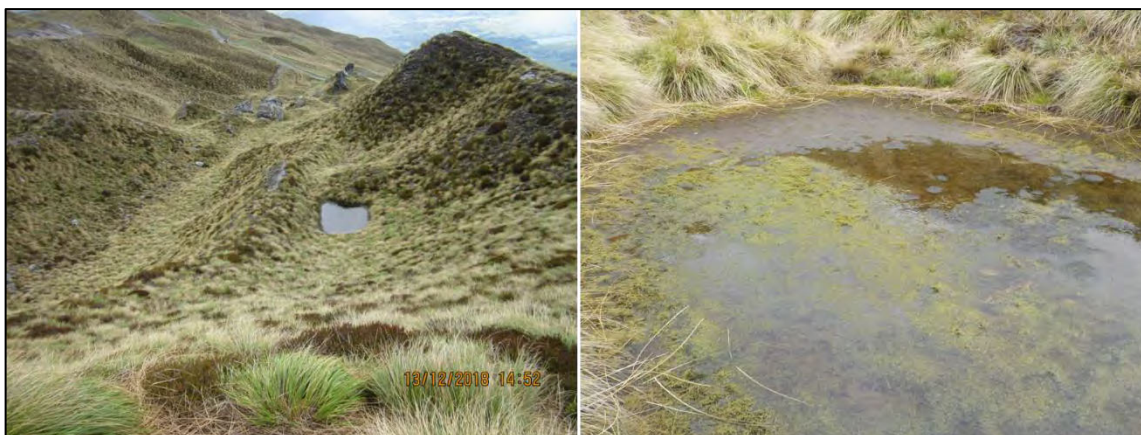
Tarn 1 (Plate 12) is a small circular ephemeral tarn with no inflowing stream. On the day of the site visit, this tarn had a maximum depth of 0.1 m and it was estimated that it would reach 0.3 m deep before flowing out the outflow channel. The dominant floral components included a green algae and a turf community, however, areas of the tarn bed were bare ground. A single species of small beetle was observed swimming in the tarn. This was identified as the Dytisadae beetle species, *Antiporus* sp.

Plate 12: Tarn 1 and close up of the turf community.

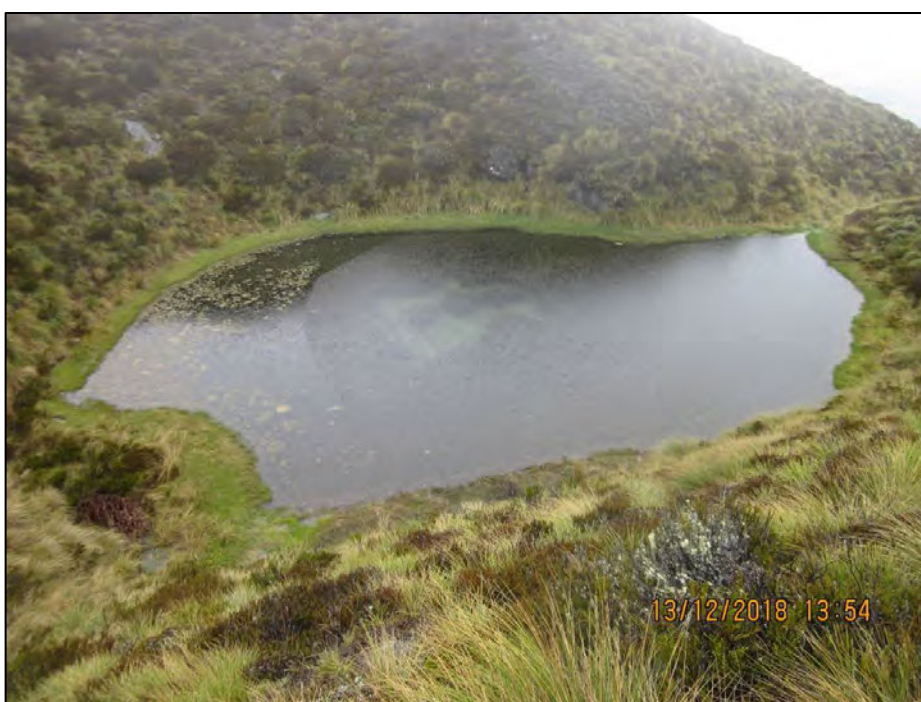
Tarn 2 (Plate 13) was a large circular tarn approximately 20 – 25 m in diameter. It sits in a depression in a small water course and has both an inflow and outflowing stream, although the outflow will not flow when the tarn has a low water level. The margin of the tarn was steep sided and water depth exceeded 0.25 m throughout the tarn. This tarn had dense *Myriophyllum* beds with a gelatinous green alga abundant in the water column, as well as on the macrophyte beds. Two mollusc taxa were collected, the bivalve Sphaeriidae and the introduced great pond snail (*Lymnaea stagnalis*). No native snails were located in the tarn. *Xanthocnemis* damselflies, nymphs and *Rhantus* beetles were common and orthoclad midges larval were also present in the tarn.

Plate 13: View of tarn 2 and the outflow.

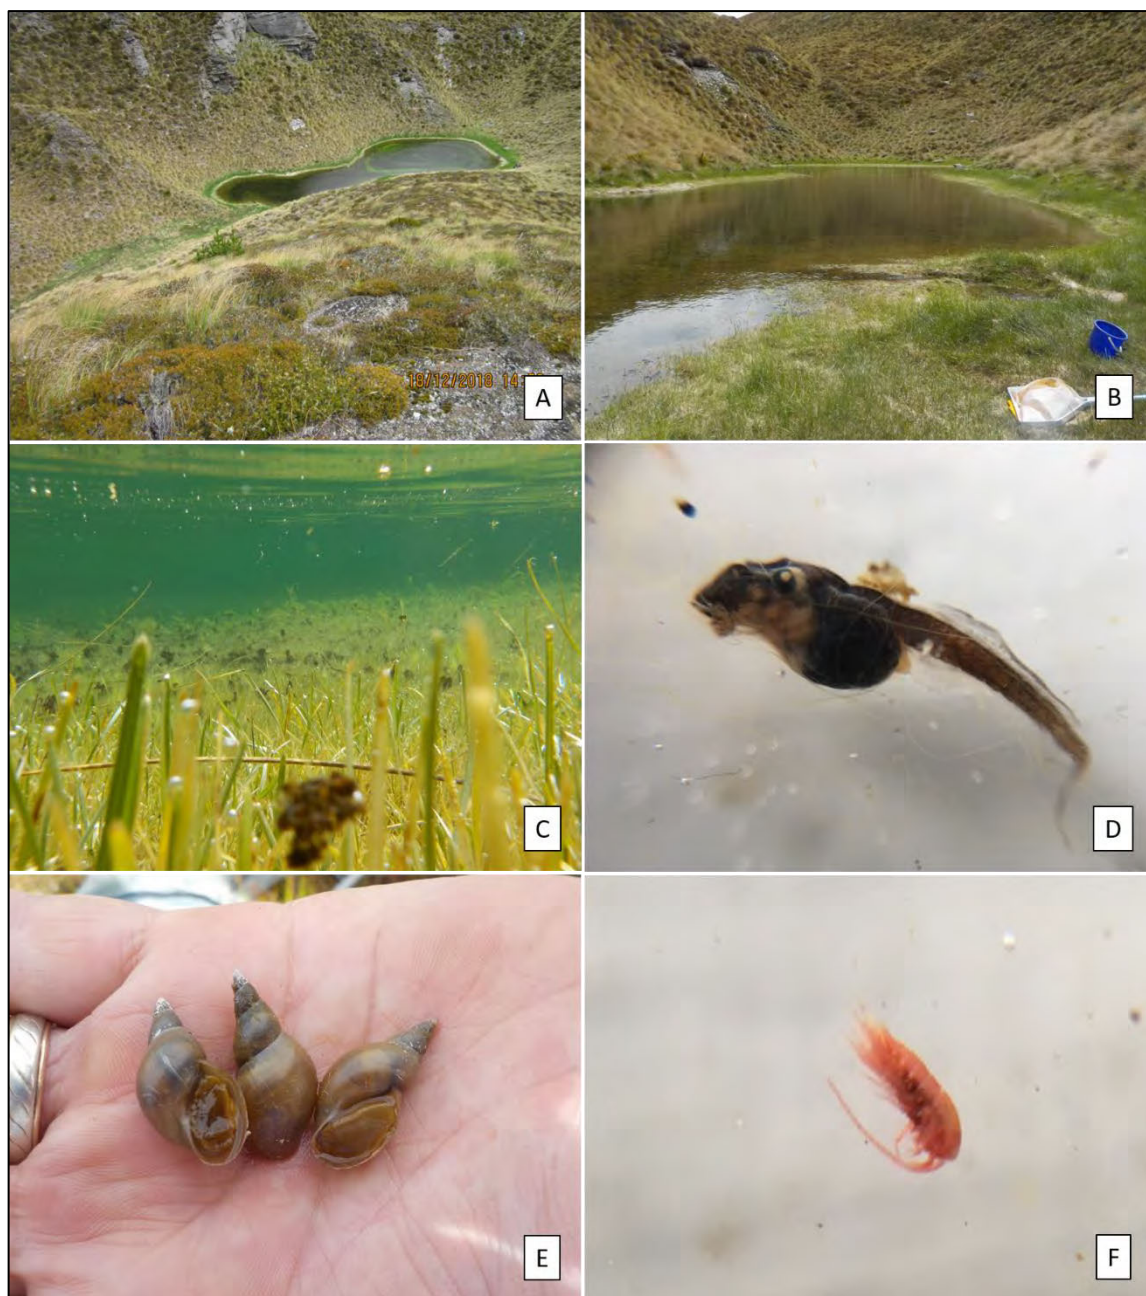
Tarn 3 is the largest tarn within the Reserve and has a figure of eight shape with two pool areas connected by a narrow section of water. This tarn is located in a small basin that has an in-inflow stream, but no outflow. The inflow stream is approximately 100 m long and originates as a spring. Additional surface inflows are likely during high rainfall events and aerial photography indicates that the tarn varies in size. The margins of the tarn are gently sloping and a turf community (Plate 14) was present around the margins to a depth of 0.5 m. In the centre of the western end of the tarn a *Myriophyllum* bed was present. This probably reflects the area of permanent or near permanent water in the tarn.

A large number of great pond snails (*Lymnaea stagnalis*) (Plate 14) (estimated density 50-100/m<sup>2</sup>), were collected during the survey, however no native snails or bivalves were located. *Rhantus* beetles were also common amongst the turf. Large numbers of copepods were collected, and a single tadpole was collected with a second seen swimming in the tarn. The tadpoles were identified as the brown tree frog (*Litoria ewingii*) (NZFrog, 2019). No damselfly nymphs were collected, but adults were present around the tarn and it is expected that the nymphs were residing in the macrophyte beds that were not sampled. The inflow stream was also sampled for invertebrates, however only oligochaetes were collected.

Plate 14: Tarn 3. A – Overview of tarn 3. B – Tarn 3 at the inflow stream. C – The shallow water turf community. D – Tadpole (preserved). E – *Lymnaea stagnalis*. F – Red copepod.

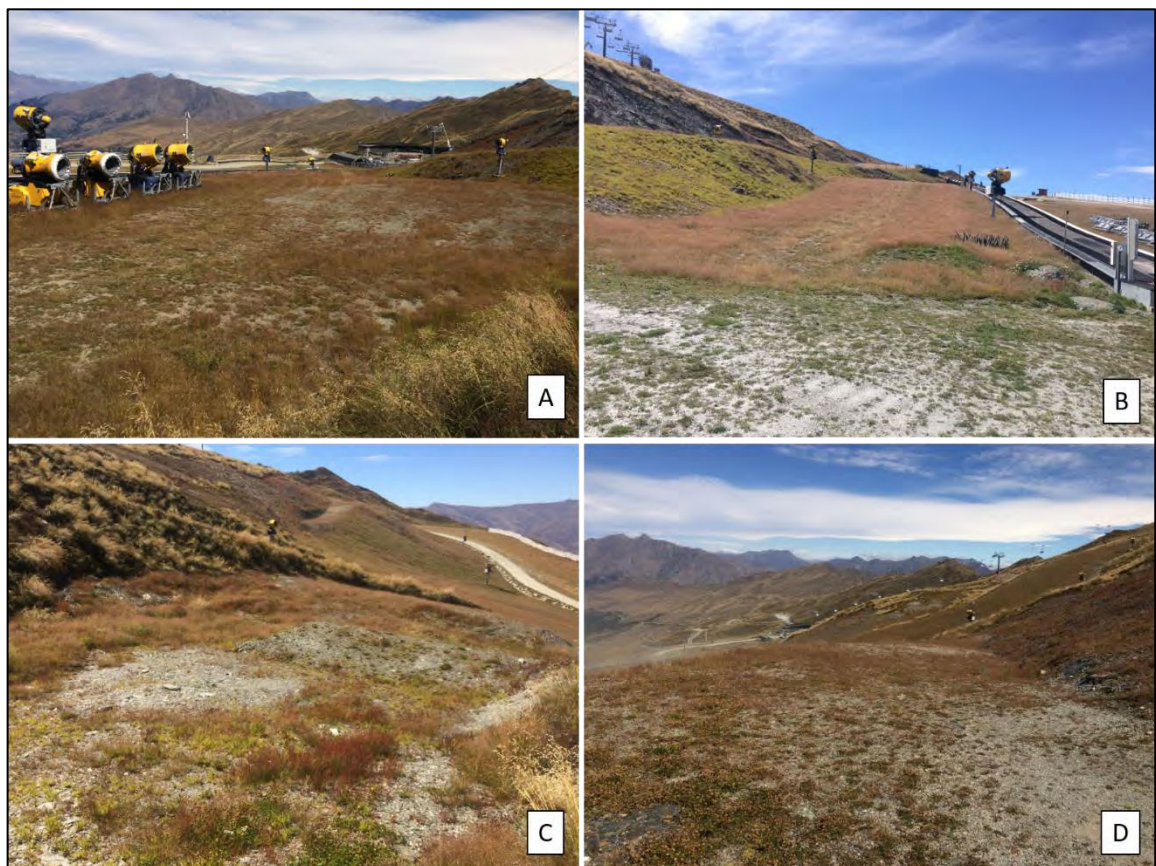
The vegetation present within the services route and the preferred and alternate summer snow locations is exotic grasses, weed species (see Plate 16), with a few scattered regenerating native species. The dominant species present include brown top, white clover and fine fescue. A range of other exotic species are present including yarrow, red clover, stinking mayweed, sheeps sorrel, chickweed, mouse ear hawkweed, cocksfoot, sweet vernal and timothy-grass. Native species include *Wahlenbergia albomarginata*, *Raoulia subsericea*, *Geranium brevicaula*, *Anaphalioides bellidioides*, *Epilobium pernitens* and *Gaultheria depressa* var. *novae-zealandiae* as well as small seedlings of *Ozothamnus vauvilliersii* and *Dracophyllum rosmarinifolium*.

Plate 16: Photographs showing the vegetation present in the preferred summer snow location (A and B) and the services route (C and D).

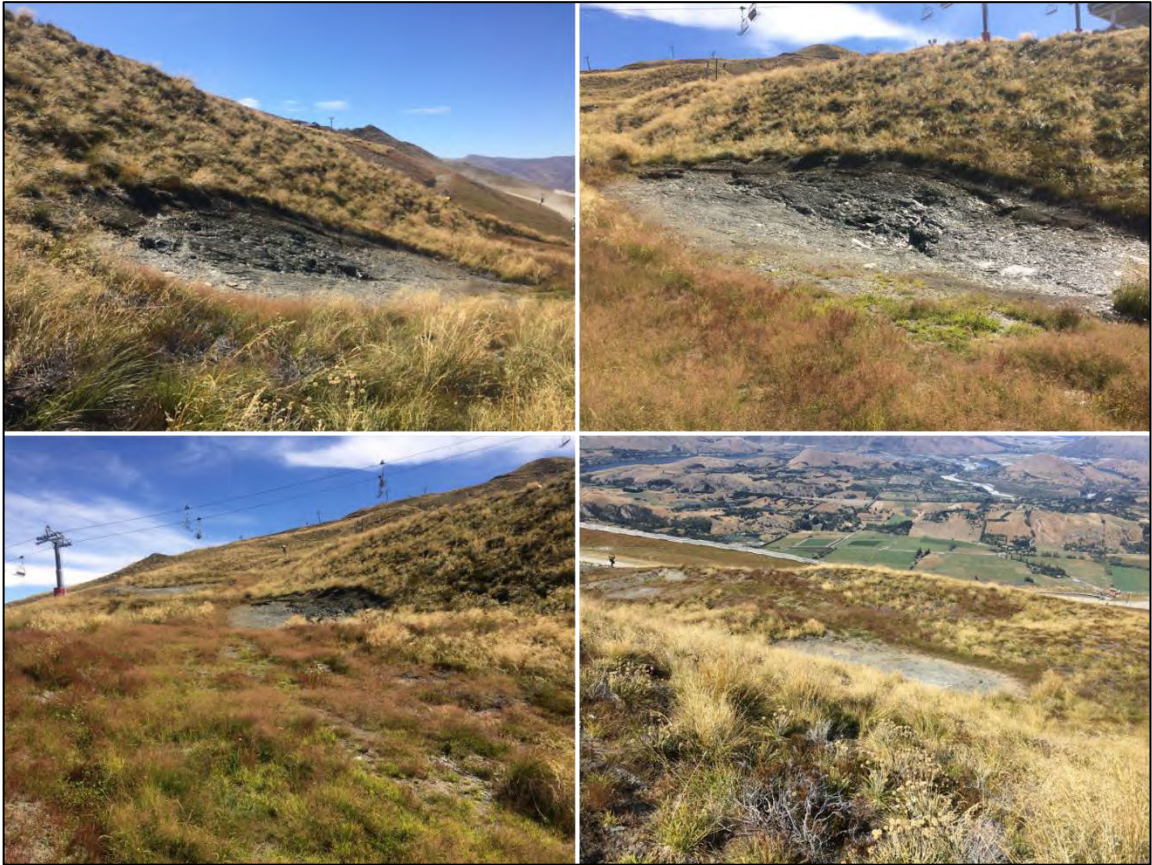
Plate 17: Photographs showing the proposed location of the SnowFactory and surrounding vegetation.

The location of the proposed SnowFactory containers is predominantly on existing disturbed ground and exotic grasses and weeds (see Plate 17). However, upslope of the proposed location, *Dracophyllum* tussock shrubland vegetation is present (see Section 4.1 for a description of this vegetation). The area of native vegetation that would be relocated for the SnowFactory has already been disturbed.
