# Applicant Information Form 1a Notified or Non-notified Process

**Coronet Peak Lease  
Application  
Ecological Assessment**

Coronet Peak  
Mountain Bike  
Tracks  
Ecological Impact  
Assessment

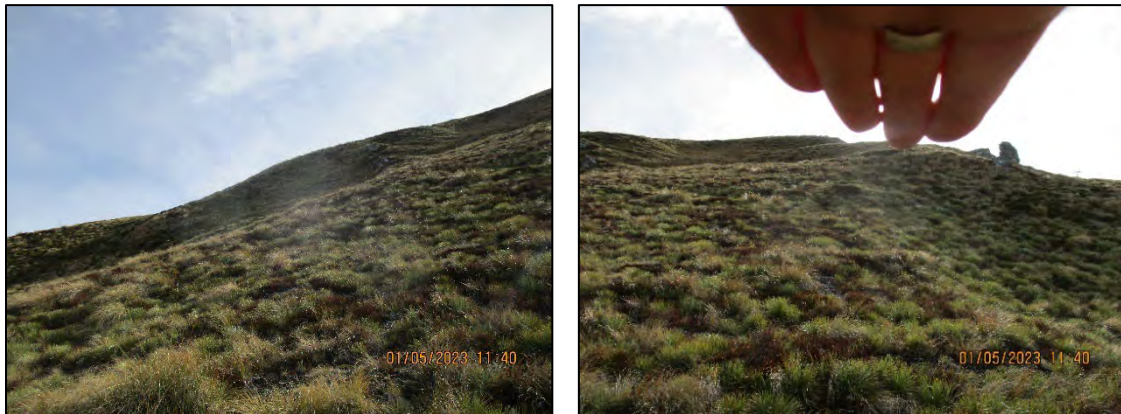
Plate 2: Co-dominant *Dracophyllum* spp. and *Celmisia lyallii* located near the base building and between the main ski trails.

The area of *dracophyllum* shrubland that is located above the base building and between the main ski trails (see Figure 3 and Plate 2) has a higher proportion of *Celmisia lyallii*. This area is also scattered with blue tussock, snow tussock and *Veronica hectorii*. The increased presence of *Celmisia lyallii* in this area is noticeable, and most likely attributable to the higher level of historic and current disturbance that has occurred.

The area of *Dracophyllum* shrubland that is located above the base building and between the main ski trails (see Figure 3 and Plate 2) has a higher proportion of *Celmisia lyallii*. This area is also scattered with blue tussock, snow tussock and *Veronica hectorii*. The increased presence of *Celmisia lyallii* in this area is noticeable, and most likely attributable to the higher level of historic and current disturbance that has occurred.

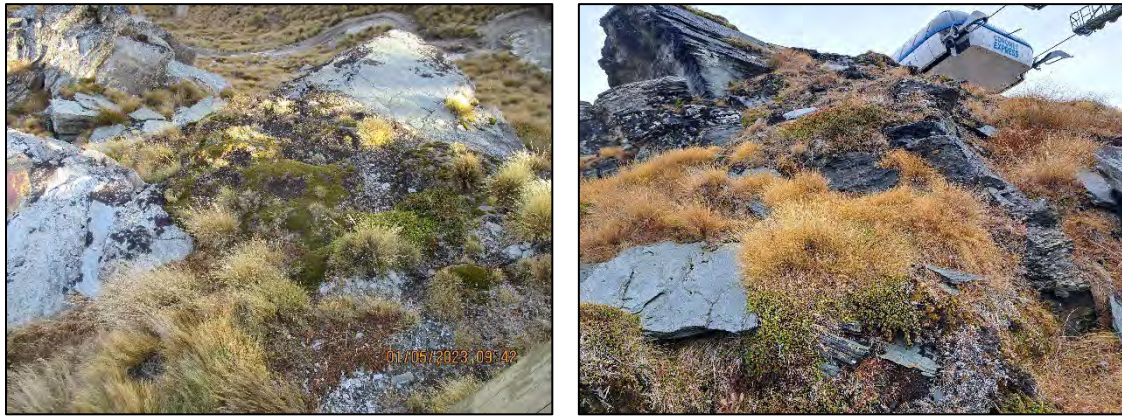
Plate 3: Coronet Peak rocky outcrop habitat.

Rocky outcrop plant communities are present in small pockets over the Reserve, however the main area is around the summit of Coronet Peak (see Plate 3). This area has a wide range of species, which is a result of soil depth and exposure. Species found on the rocky summit include *Veronica buechananii*, *Poa colensoi*, *Brachyglottis bellidioides*, *Brachyscome montana*, *Dracophyllum pronum*, *Raoulia hectorii*, *Raoulia subsericea*, *Ourisia glandulosa*, *Ourisia caespitosa*, *Gaultheria depressa* var. *novae-zealandiae*, *Celmisia angustifolia*, *Dracophyllum muscoides*, *Epilobium purpuratum*, *Thamnotia vermicularis* var. *vermicularis*, *Anisotome flexuosa*, *Acaena saccaticupula*, *Austrolycopodium fastigiatum*, *Luzula rufa* var. *rufa*, *Luzula pumila*, *Wahlenbergia albomarginata*, *Styphelia nesophila*, *Veronica densifolia*, *Festuca novae-zealandiae*, *Melicytis alpinus*, *Rytidosperma pumilum*, *Raoulia grandiflora*, *Austroblechnum penna marina* subsp. *alpina*, *Raoulia glabra*, *Leptinella pectinata*, *Kelleria dieffenbachia*, *Myosotis pulvinaris*, and *Colobanthus Buchananii*. The rocky outcrop vegetation incorporates species that are found in the cushion fields (see below) but also contains species that are not widespread such as *Epilobium purpuratum* which is Naturally Uncommon and the rush, *Marsippospermum gracile*, which is only present in patches.

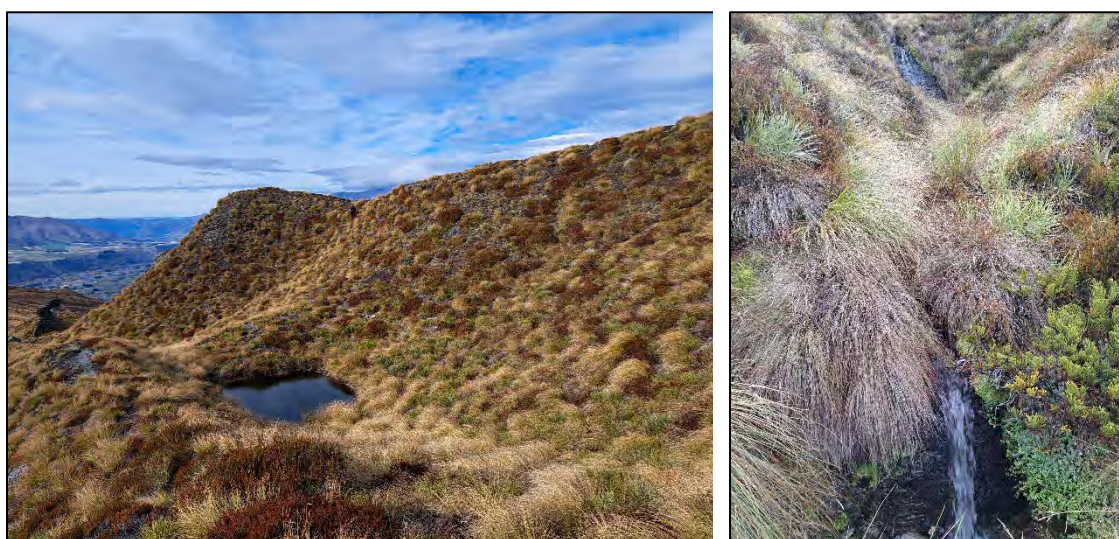
Plate 5: Left – Alpine tarn near lower Whakatipu view proposed trail. Right – Riparian wetland near ka kite ano proposed trail.

A number of wetlands are present across the study area including tarns, multiple streams and seepage areas (see Figure 3 and Plate 5). The wetlands and seepages vary from cushion wetlands dominated by comb sedge (*Oreobolus pectinatus*) with a range of small herbs and wetland plants to *Schoenus pauciflorus* dominated sedge lands. The wetlands are small in area and predominantly found on the western side of the Reserve. Species present include *Marsippospermum gracile*, *Abrotanella caespitosa*, *Ranunculus gracillipes*, *Nertera balfouriana*, *Carex gaudicaudiana*, *Juncus edgariae*, *Caltha obtusa*, *Coprosma perpusilla*, *Plantago unibracteata*, *Cardamine corymbosa*, *Anisotome aromatica*, *Ourisia caespitosa*, mosses and lichens. *Dolichoglottis lyallii*, *Anaphalioides bellidioides*, and *Viola cunnghamii* were found along the stream and seepage margins, and *Coprosma rugosa* at lower elevations along the steep creek banks.

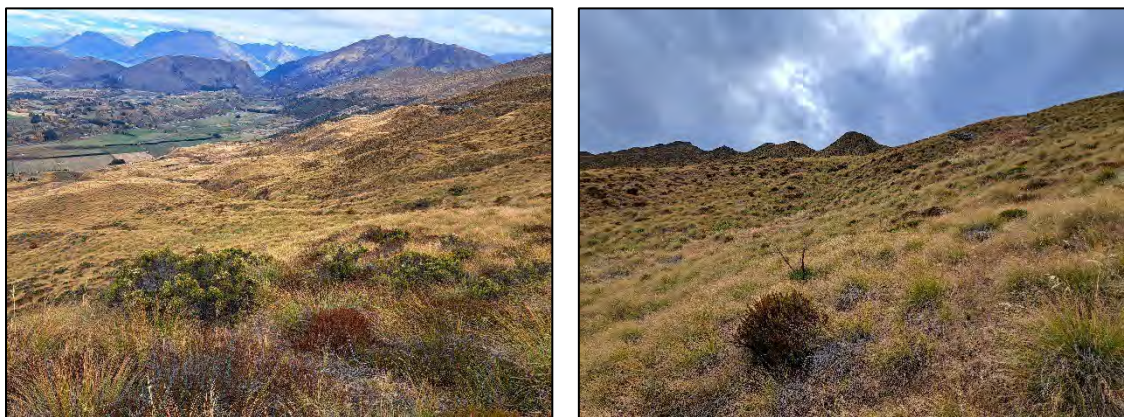
Plate 6: Photos showing transitional vegetation zone.

Exotic species intermixed within the community included, *Rumex acetosella*, tussock hawkweed (*Hieracium lepidulum*), *Plantago lanceolata*, *Hypochaeris radicata*, mouse-ear hawkweed (*Pilosella officinarum*), scotch thistle (*Onopordum acanthium*), briar (*Rosa rubiginosa*), brown top (*Agrostis capillaris*), white clover (*Trifolium repens*), yarrow (*Achillea millefolium*), sweet vernal (*Anthoxanthum odoratum*). *Pinus* sp. seeding becomes more abundant at lower elevations and are scattered across the lower faces.

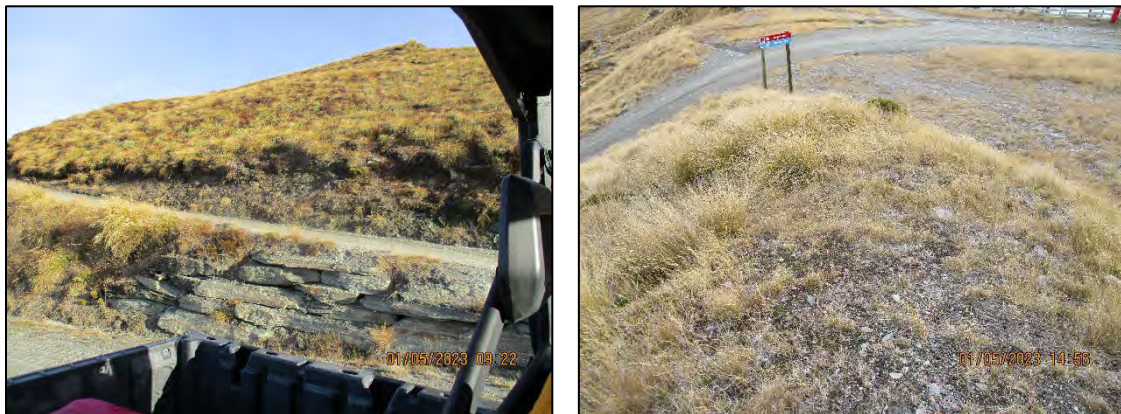
Plate 7: Regenerating native and exotic dominant vegetation communities, characteristic of disturbed areas within the CPRR.

The regeneration of native species on the disturbed areas such as the ski trails is more evident at higher elevations, where the exotic grass mix was less successful in striking (see Plate 7). The presence of bare soil has enabled native species to colonise disturbed sites. Native species which are spreading over these bare areas include *Raoulia tenuicaulis*, *Raoulia youngii*, *Acaena saccaticupula*, *Poa colensoi*, *Rytidopserma pumilum*, *Epilobium* spp. In one location the Nationally Vulnerable, small rosette *Myosotis elderi* is present. In the lower elevations, such as on the Big Easy trail, where the exotic species have formed a thick cover, regeneration of native species is much lower.

The regeneration of native species on the disturbed areas such as the ski trails was more evident at higher elevations, where the exotic grass mix was less successful in striking (see Plate 7). The presence of bare soil has enabled native species to colonise disturbed sites. Native species which are spreading over these bare areas include *Raoulia tenuicaulis*, *Acaena saccaticupula*, *Poa colensoi*, *Rytidopserma pumilum*, *Epilobium* spp. In one location the Nationally Vulnerable, small rosette *Myosotis elderi* was present (see Plate 7). In the lower elevations, such

as on the Big Easy trail, where the exotic species have formed a thick cover, regeneration of native species is much lower (see Plate 7).

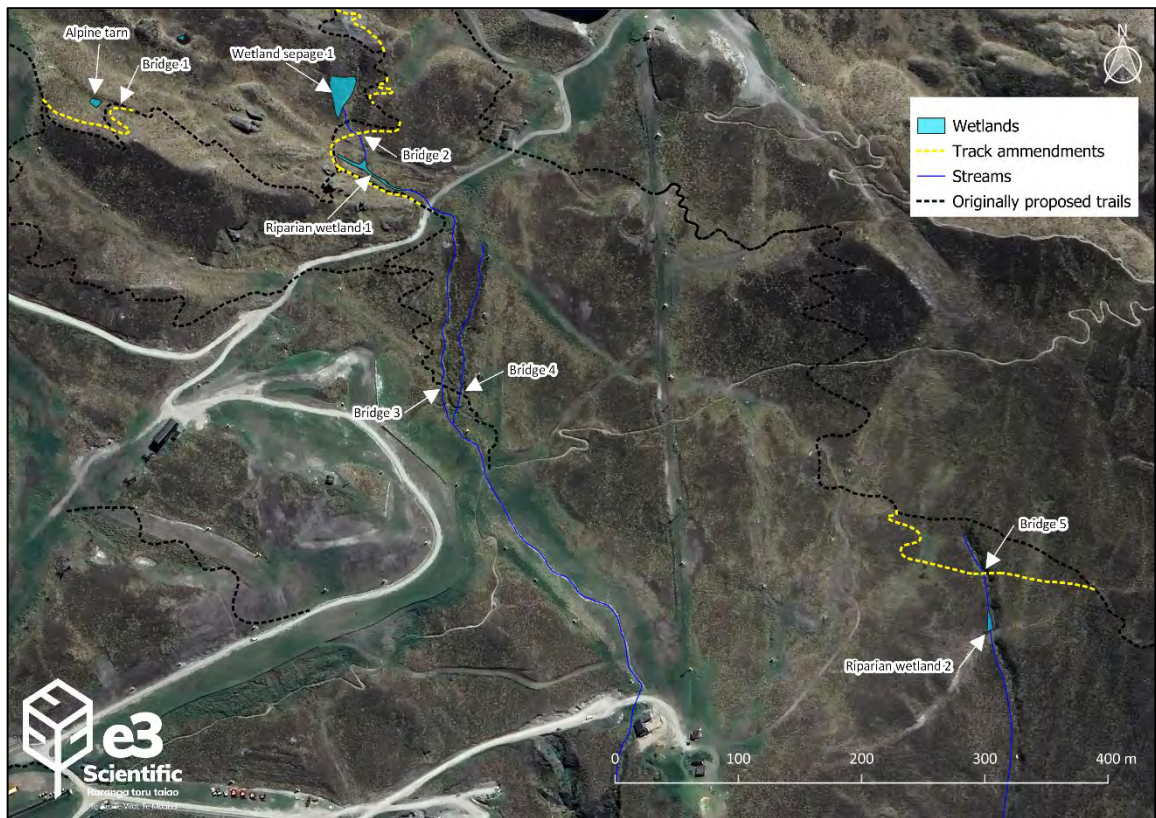
Figure 4: Location of freshwater values – eastern locations.

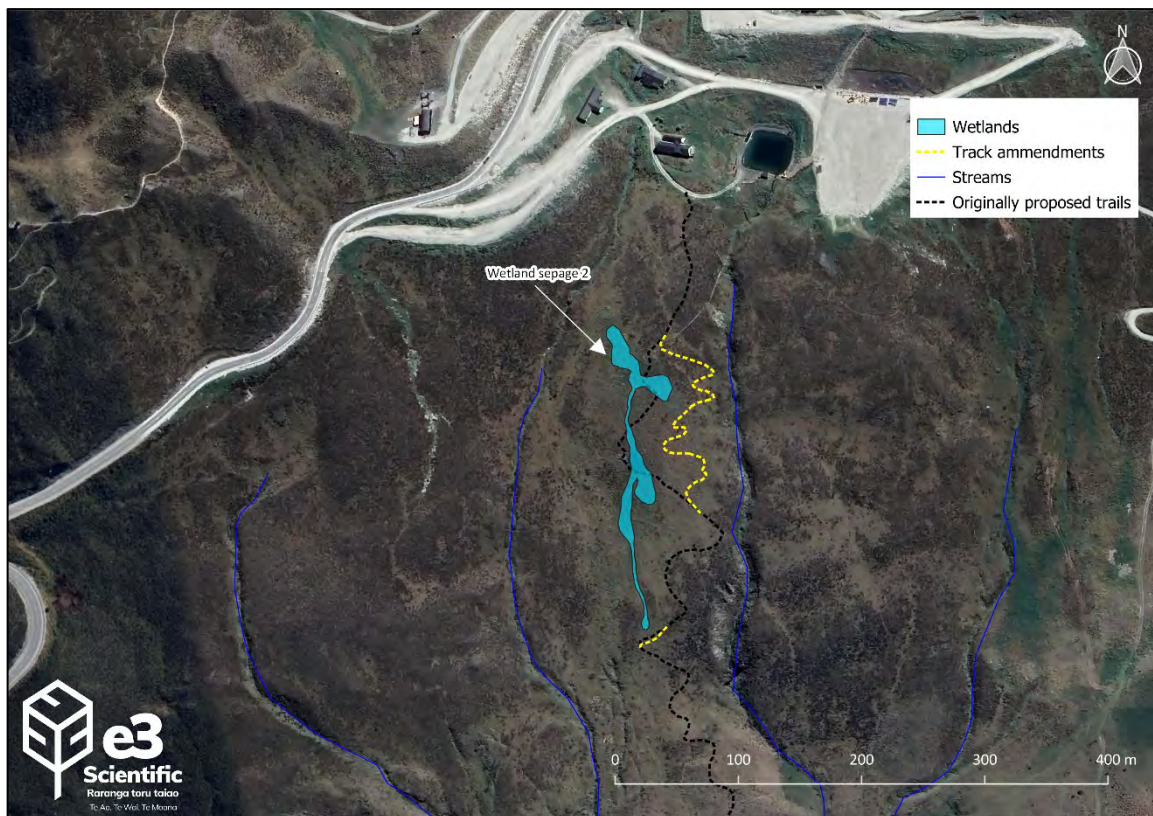
Figure 5: Location of freshwater values – western locations.

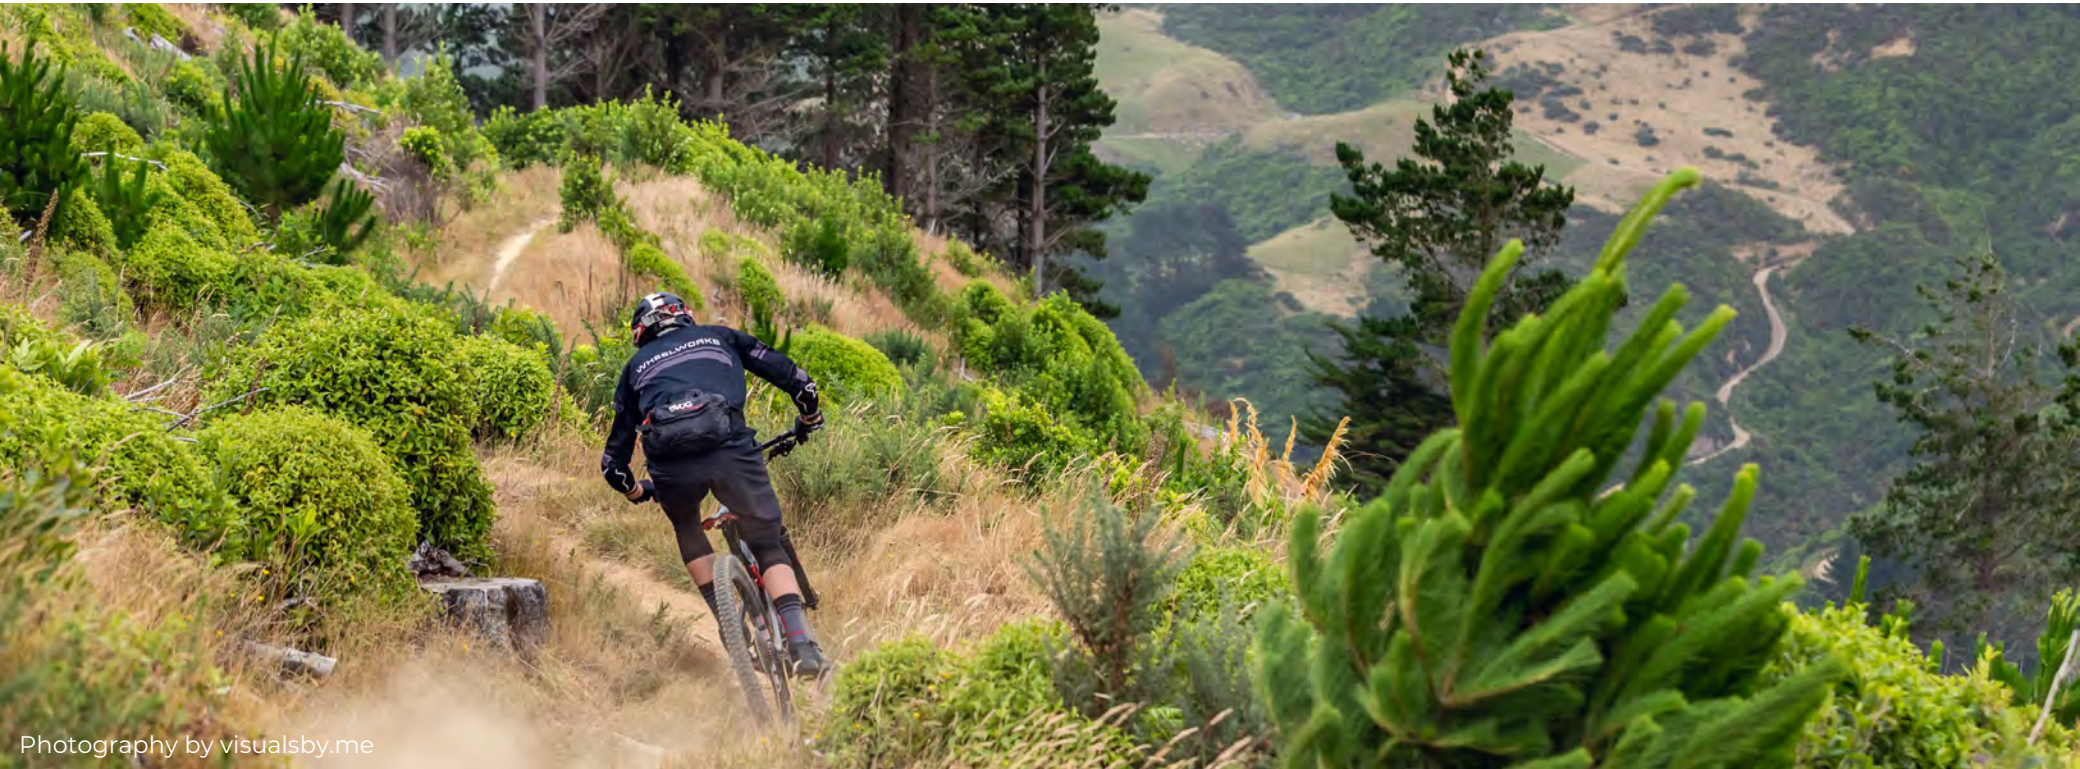
## Guideline for the Provision of Barriers beside Tracks and Structures (based on SNZ HB 8630:2004)

Measure Fall Height Hf 1.5m out from edge of track, or structure that is <1.5m high, for structures that are between 1.5 and 2m high measure Fall Height at the same distance out from the structure as it is high, For Structures >2m high, measure Fall Height 2m out from the structure edge.	Grade 1 Easiest	Grade 2 Easy	Grade 3 Intermediate	Grade 4 Advanced	Grade 5 & 6 Expert & Extreme
Fall onto a benign surface presenting features that will tend to reduce the effect of impact (a) Deep moss (b) Soft vegetation (c) Shallow still water deep enough to cushion a fall (d) Swamp	Hf > 2.0m Provide Type A Barrier Hf = 1.0-2.0m Provide Type B barrier Hf < 1.0m no barrier	Hf > 3.5m Provide Type A Barrier Hf = 2.0-3.5m Provide Type B barrier Hf < 2.0m no barrier	Hf > 2.0m Provide Type B Barrier Hf < 2.0m no barrier	Hf > 2.5m Provide Type C Barrier Hf < 2.5m no barrier	Hf > 3.5m Provide Type C Barrier Hf < 3.5m no barrier
