Atutahi spawning habitat in Whanganui River

Randomised assessment of atutahi (*Galaxias maculatus*) spawning habitat in the Whanganui Awa Hannah Rainforth, Rosemary Miller, Jane Taylor, Oliver Gansell. Kāhu Environmental for Department of Conservation, 2022. This is a summary of the full report. Images are by Hannah Rainforth unless specified.

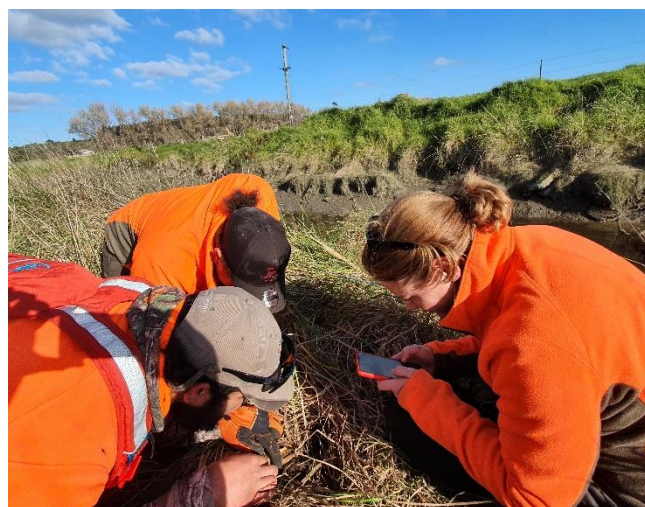
Hunting for atutahi eggs in grass beside the river. Image: DOC

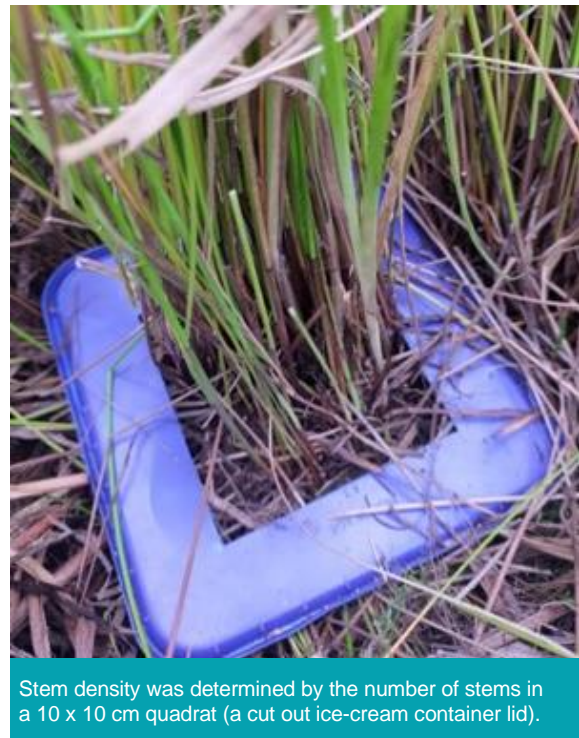
Stem density was determined by the number of stems in a 10 x 10 cm quadrat (a cut out ice-cream container lid).

Result: Stem density ranged from 0–0.24 stems per cm², average 0.08 stems per cm².

Only 6% of sites had a high enough stem density (0.2 stems per cm²) to be considered moderate or high-quality habitat. Most of the area (62%) was dominated by pasture grass, which although suitable for spawning, needs to be thicker and cover more of the area.

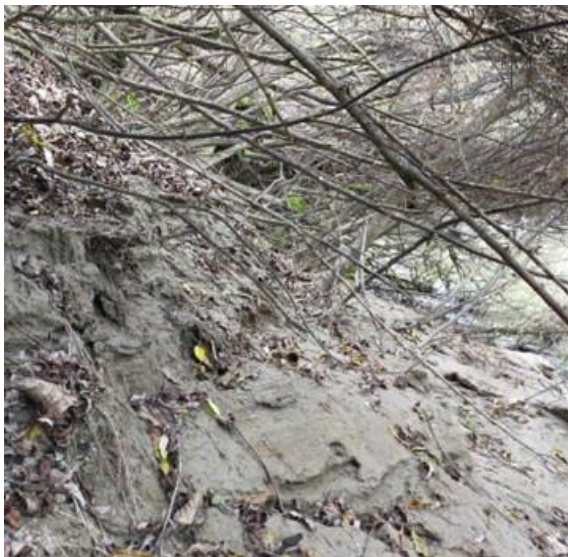
Shading from willow trees prevents any vegetation growth on the riverbank.

Remove willow trees

Nearly 40% of the spawning area is shaded, mostly by willow trees. They prevent the growth of native and introduced spawning vegetation and cause the banks to become steeper. Intensive willow removal from above Dublin Street Bridge to Hipango Park is recommended.

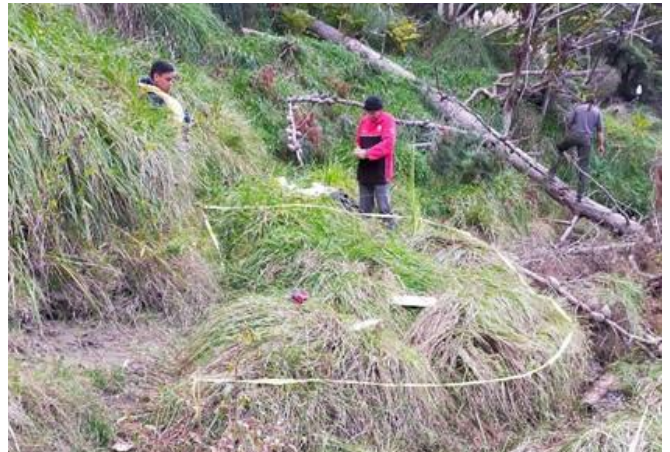
A slumped area of riverbank that provided atutahi spawning habitat.

The banks of the Whanganui River are generally too steep for atutahi spawning and the fish are relying on small, slumped areas. Any angle over 35° is considered poor, so the average of 50° clearly shows that bank slope needs to be reduced to improve spawning habitat.

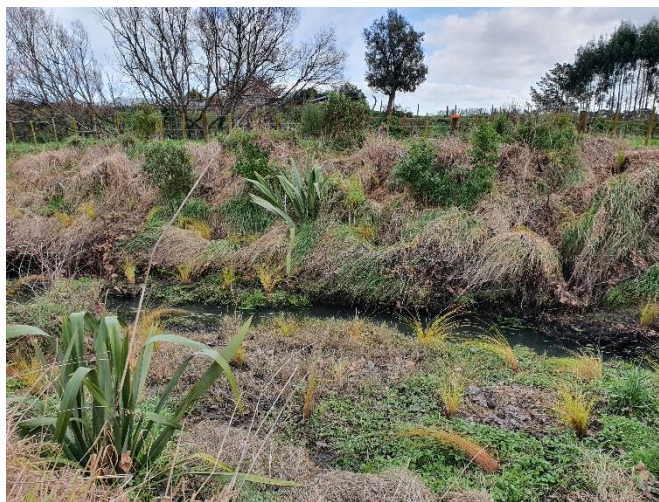
Restoration planting beside a tributary. Image: DOC
