# WHANGANUI RIVER

# **ATUTAHI SPAWNING HABITAT**

# **ENGINEERING REPORT**

# AN ASSESSMENT OF HABITAT IMPROVEMENT

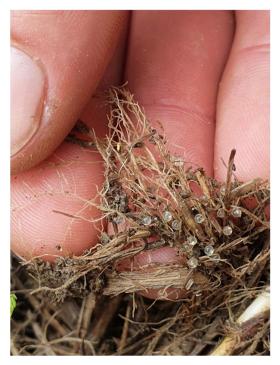
Photo 1. Atutahi eggs found in the roots of riparian vegetation.

The Department of Conservation (DOC) has undertaken a survey of potential atutahi (īnanga) spawning habitat in the lower Whanganui River (Rainforth et al., 2022). Atutahi deposit their eggs in the riparian vegetation at the high spring tide level where the saltwater mixes with freshwater (Photo 1). The eggs must survive for up to a month out of water, and unfortunately the habitat needed for egg survival is often not available. One of the key conclusions of the Rainforth et al. report is that whilst there is potential for spawning along about 30 km of the lower reach and tributaries, there is actually very little suitable habitat. The presence of willows, lack of suitable dense grasses and very steep banks are the main limiting factors.

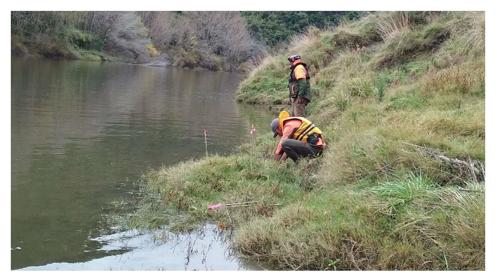
Photo 2. Exotic grasses growing on an area of bank slumping where atutahi eggs have been found.

The high suspended sediment load gives rise to accumulations of fine materials on the steep banks of the lower river, with high rates of deposition within the riverbank margin vegetation. There is a cycle of deposition, accumulation and over-steepening of the banks, and then undermining and bank slumping during flood events, carrying vegetation into the river channel, and leaving a slumped and broken bank. The deposition cycle then starts again on the lowered area of the bank (Photo 2)

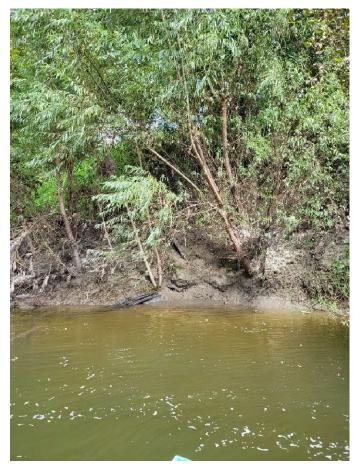
Photo 3. Willows on steep banks.

A naturally forested bank, of native vegetation, with a forest edge margin at the river channel, will give rise to a diffuse flow boundary along the channel edge during flood flows, and the rate and amount of fine sediment deposition along this margin will be relatively restricted by the diversity and density of the edge vegetation. A band of willows and poplars with a light-sensitive undergrowth will give rise to a more pronounced influx of sediment laden floodwaters (Photo 3). This gives rise to a steeper bank of silt deposits among the larger trees, which becomes progressively more unstable (Photo 4).

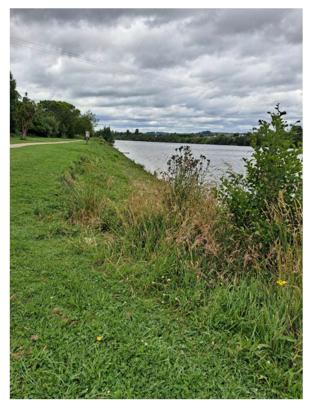
Photo 5. Aramoho Rowing Club launching area.

The Rowing Clubs are sites along a straight reach of the river, but the strong outer bank flows are along the opposite left side of the river channel. There is a small floodable berm area, which is used by the clubs for arranging and launching, as well as for spectators (see Figure A-2 and Photo 5).

There are defined launching ramps and the area between the flat berm and the tidal river edge could be managed for atutahi spawning, through the use of appropriate plants and an awareness of their usefulness for spawning. A bank section along the bank is shown on Figure 2, with the section position shown on Figure A-2.

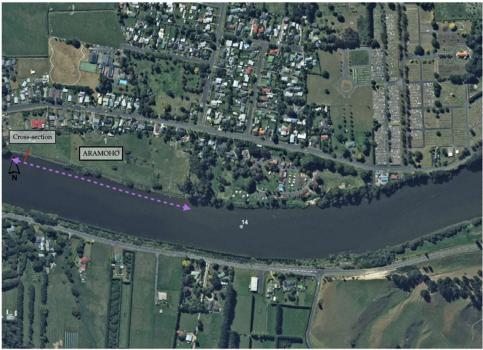
# ATUTAHI SPAWNING – WHANGANUI RIVER FIGURE A4 SITE – ARAMOHO AERIAL 2021

There is a small floodplain area on the right side in Aramoho, between the Te Ao Hou Marae and the Whanganui River TOP 10 Holiday Park. Here again, there is a relatively low bank on the inner side of the channel, with few larger trees along the potential length. The bank does, though, have flushing flows on flood recessions given the slight meander form.

Some trial planting has been undertaken along this bank, near the Marae, on the existing bank profile. A more diverse edge vegetation with suitable plants for atutahi spawning could be easily established along this bank with some reforming of the bank (Figure A-4). Here too, the excavation material can be spread on the adjacent floodplain area. A bank cross section at the lower end of this site, where there is the trial planting, is shown on Figure 2 and potential bank reforming on Figure 4.

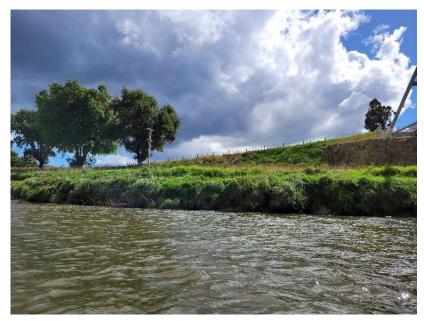
Photo 6. River bank along alongside Papaiti Road.

There are lengths of bank along the right side of the river alongside Papaiti Road, between the road and the channel edge, where bank planting, with or without bank re-forming, could be undertaken (Photo 6).

The banks are higher and steeper than the lower river sites, and disposal of cut material would be more difficult. Access would be off Papaiti Road, and spoil could be carted off site.

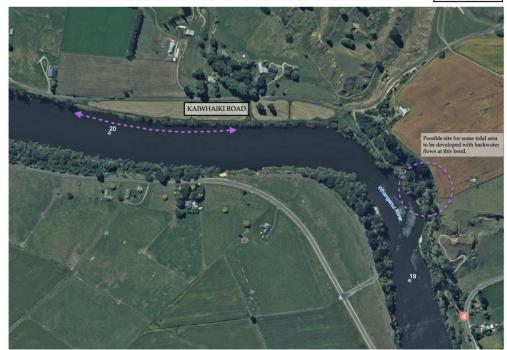
## ATUTAHI SPAWNING – WHANGANUI RIVER FIGURE A-6 SITE – KAIWHAIKI ROAD 1 AERIAL 2021

There are two potential sites along Kaiwhaiki Road where there would be flushing recession flows but relatively low erosion pressures, and the bank height is not too great with not too many larger trees (Figures A-6 & A-7).

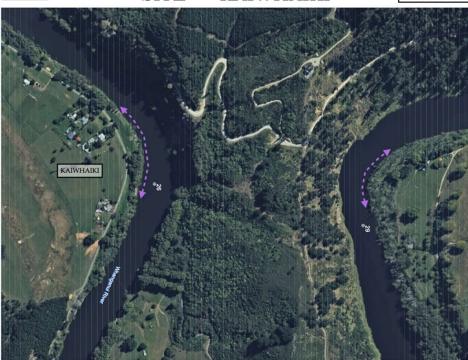
ATUTAHI SPAWNING – WHANGANUI RIVER FIGURE A-8 SITE – KAIWHAIKI AERIAL 2021

The sharpness of the bend means that the inner side beach is a defined deposition area, with a relatively stable bar, that has a high central area. Some re-shaping of the downstream end of the beach may allow a small area of tidal level planting (Figure A-8).

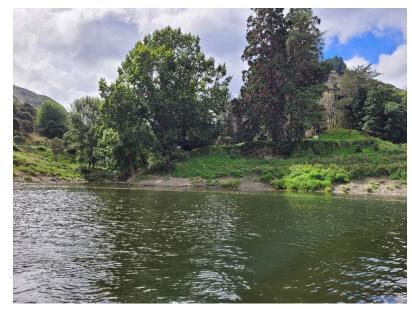
Photo 7. Site of Kemps Pole at the confluence of the Kauarapaoa Stream and the Whanganui River

The Whanganui River is sharply deflected by hill country at the confluence of the Kauarapaoa Stream (Photo 7). The flood flows at this confluence are especially dynamic, and depend on the timing of flows in the tributary and main river. This gives rise to shifting point bars on the inner side of the main channel and around

the confluence, including scouring and erosion of the river banks as well as deposition.

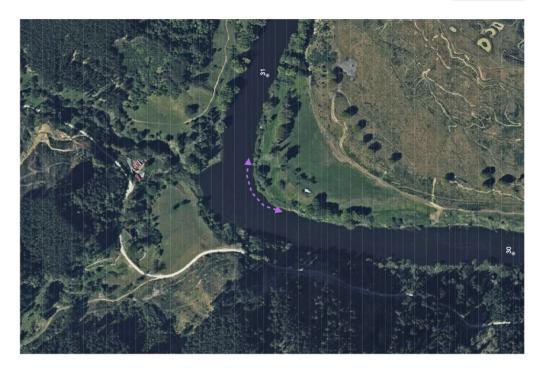
## ATUTAHI SPAWNING – WHANGANUI RIVER FIGURE A-10 SITE – KEMP'S POLE AERIAL 2021

There is a small terrace above the inner side at the bend, but access to the site would be difficult (Figure A-10). The shifting nature of the confluence at a sharp bend in the river means that any low-level planting on the beaches is unlikely to last.
