REEFTON POWER SCHEME: AN ARCHAEOLOGICAL ASSESSMENT

LES WRIGHT, KATHARINE WATSON AND KIRSA WEBB (UNDERGROUND OVERGROUND ARCHAEOLOGY LTD)

SEPTEMBER 2017

UNPUBLISHED REPORT FOR THE REEFTON POWERHOUSE CHARITABLE TRUST INC.

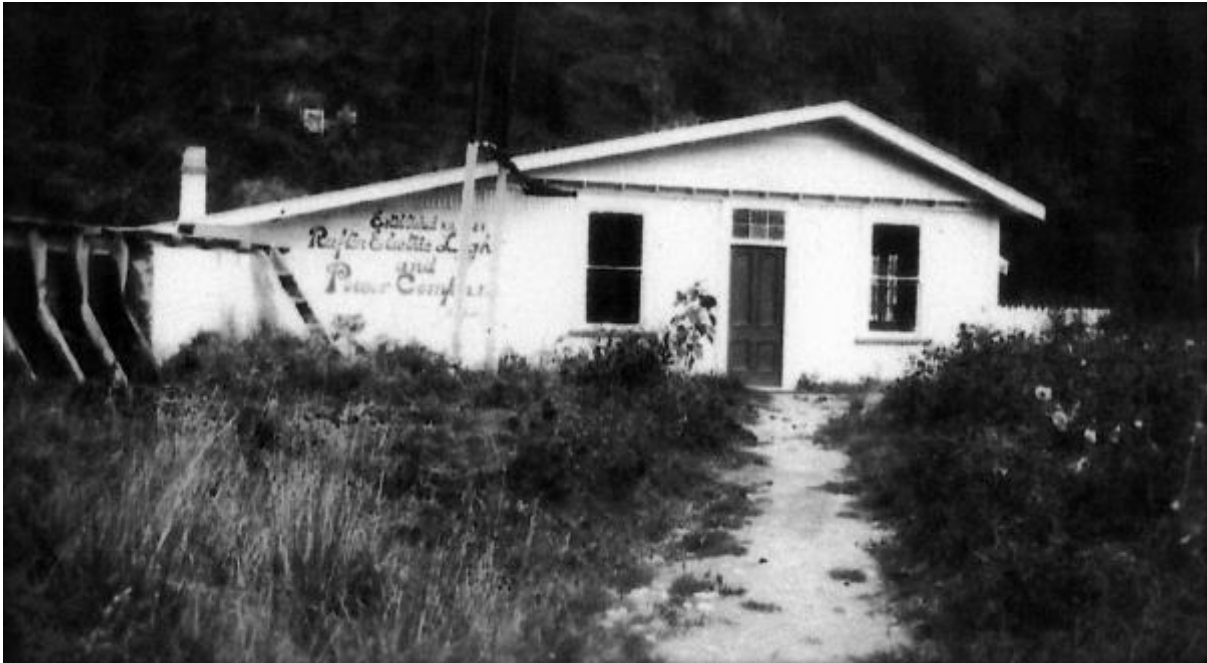
By 1906 demand had exceeded generating capacity to the point where an entirely new generating plant was required (Figure 7).³ A concrete-lined pit was constructed behind the existing power house and water was diverted from the race via a new concrete penstock to a new British Boving 110hp horizontal turbine with an oil pressure governor (Rosanowski 1984) down in the pit. Tail water escaped via a tunnel driven through to the existing tail race below the original race terminal and turbine (Figure 6). Apparently that was all accomplished without major interruptions to the power supply.

Figure 7. The 1906 power house, looking north.

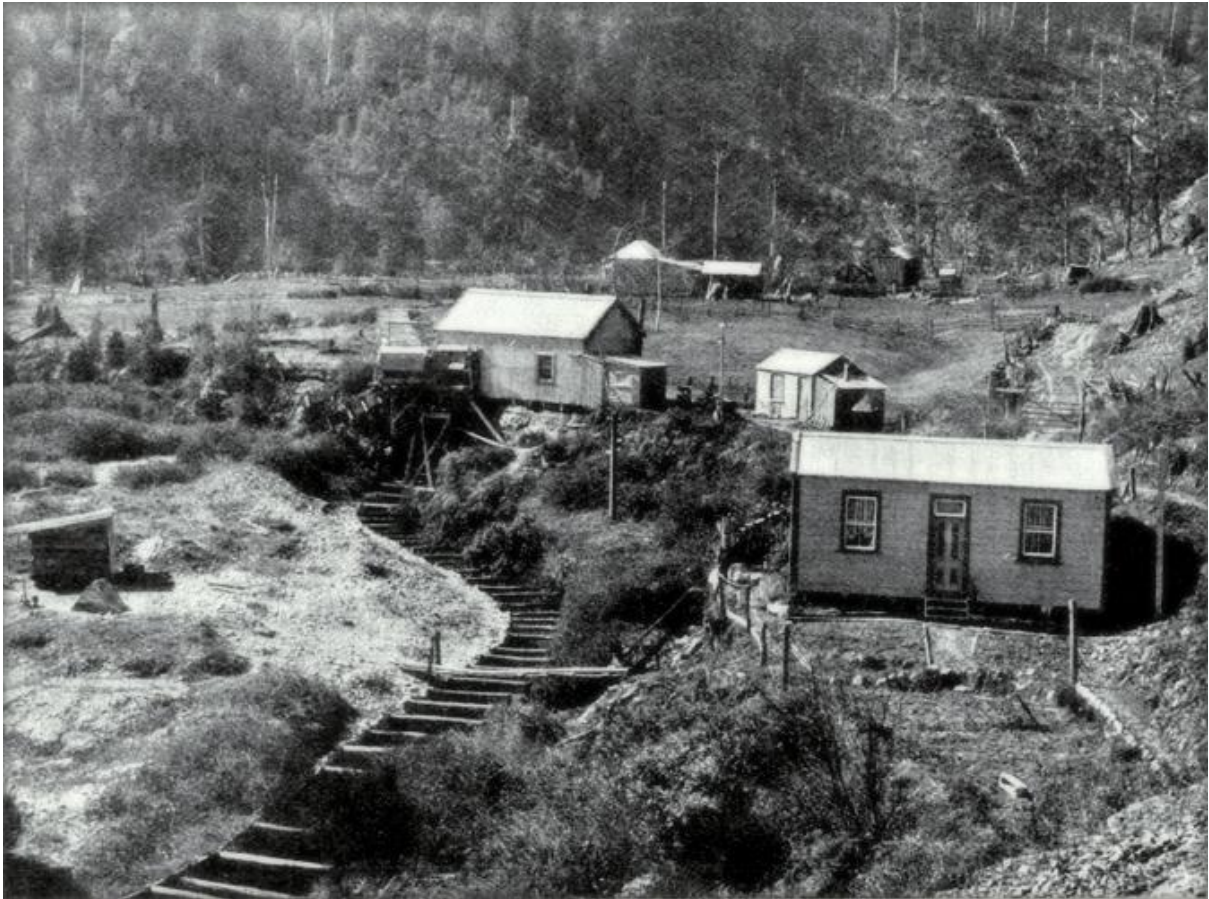
Figure 9. The tail race (foreground), power house (centre) and manager's house (right), 1888. Image supplied by R. Inwood.

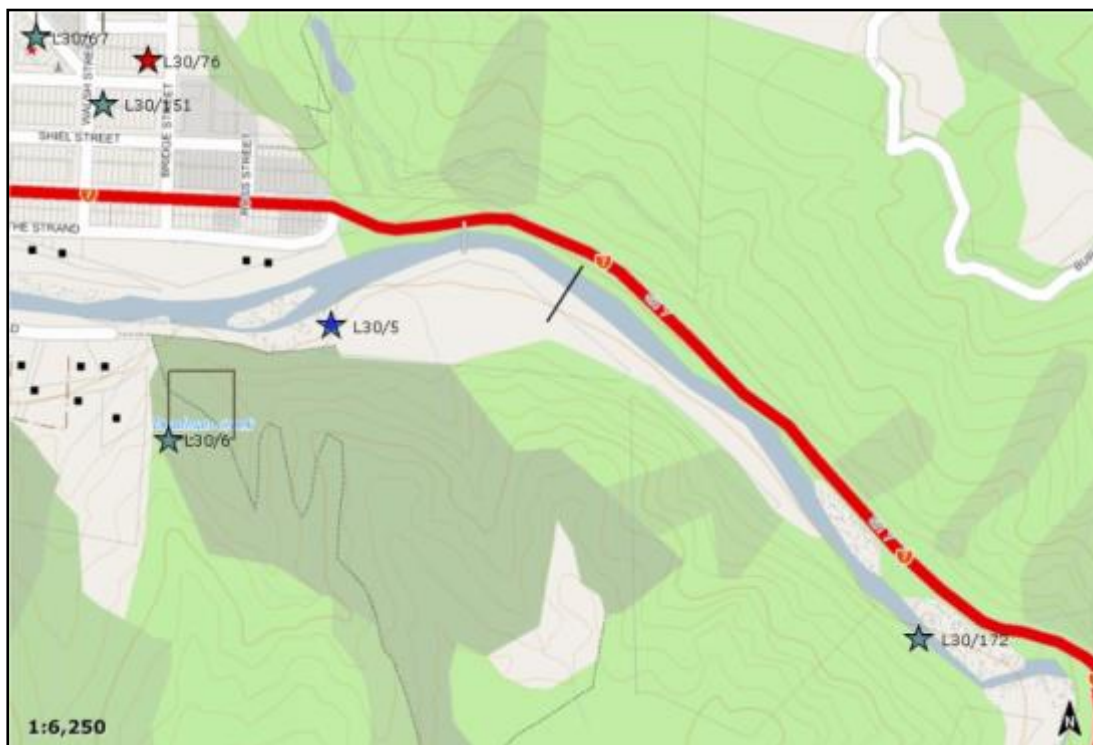
Figure 10. Recorded archaeological sites in the vicinity of the power house (L30/5). Image: ArchSite.

The power house remains were recorded as archaeological site L30/5, Reefton Electric Light Co, in the New Zealand Archaeological Association (NZAA) recording scheme decades ago and updated in 2012 in conjunction with a report on the water race rock tunnel for the walkway committee. The adjacent Reefton water supply pipeline was also recorded as site L30/172. There are a number of recorded archaeological sites near the power house, but the only recorded sites within the footprint of the project are the power house and the water supply pipeline (Figure 10).

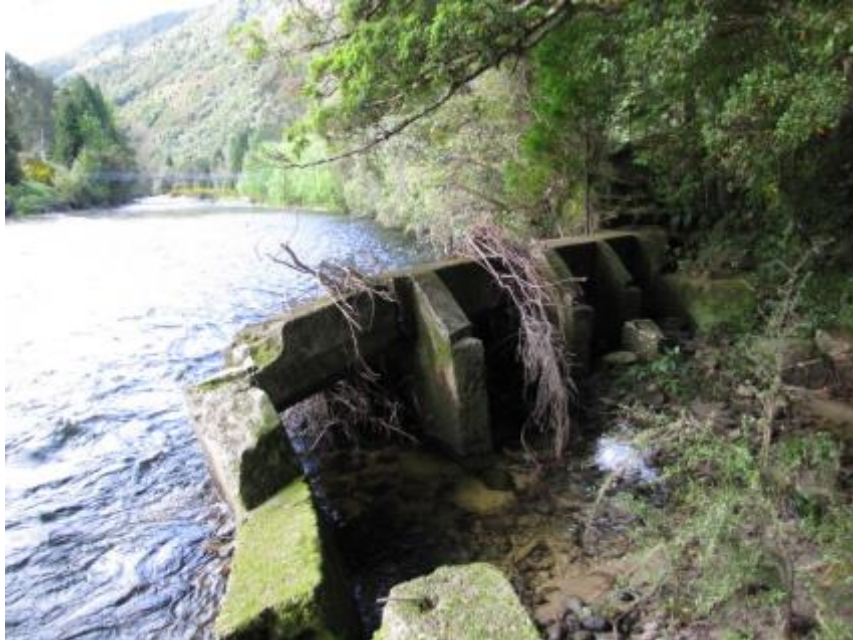
At the top end of the system is a concrete wall built into the river bank and out into the true left side of the Inangahua River (Figure 11). It incorporates apertures that allow water into the race and steps providing access from the river bank. Two of the apertures have broken away, the steel 'trash racks' that kept debris out of the race are in poor condition and the gates that controlled inflow have gone entirely, but the rest is fine. Water now enters only during floods because the riverbed has lowered by more than a metre since the scheme was abandoned.

Figure 11. The intake. Image: R. Inwood.

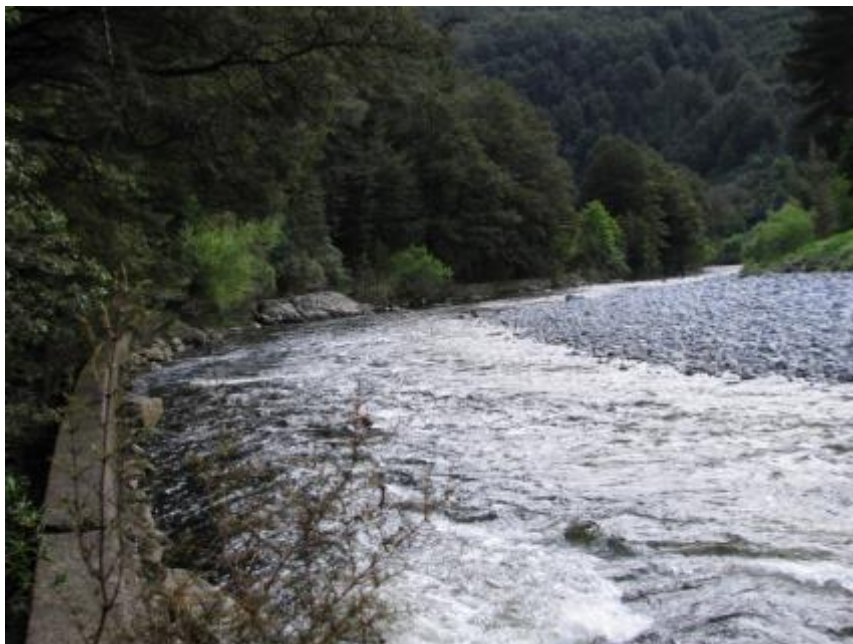
Downstream from the intake a concrete wall and the rock of the river bank form a channel about 230m long (Figure 12). Its condition is difficult to assess, as it is almost completely full in places with shingle from the river and rock from a large hillside slip. However, it is evident that the lowered river has scoured out gravel from underneath the wall in places, effectively suspending it and no doubt adding stress. Otherwise it appears generally in fair condition at present with some cracks and slumps but few portions missing entirely.

Figure 12. The concrete channel. Image: R. Inwood.

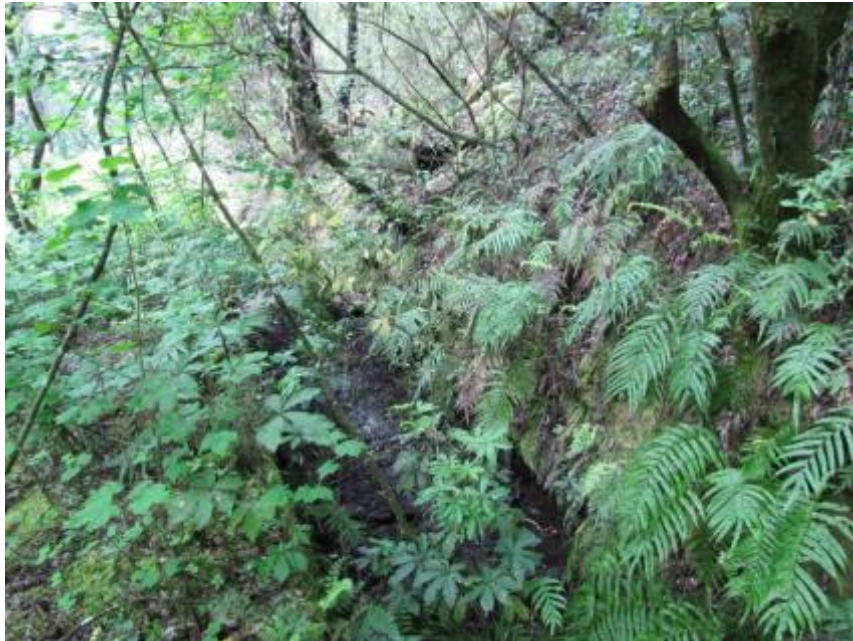
Past the sluice is 230m of open earth ditch, in good condition where visible between dense blackberry and other growth (Figure 13 and Figure 14). There is some timber lining, 1.5m wide and 1.2m deep, rotten but otherwise intact. While not likely to date from the 19th century it was probably built to the same dimensions and design as the structure it replaced during the race's working life.

Figure 13. The upper ditch. Image: R. Inwood.

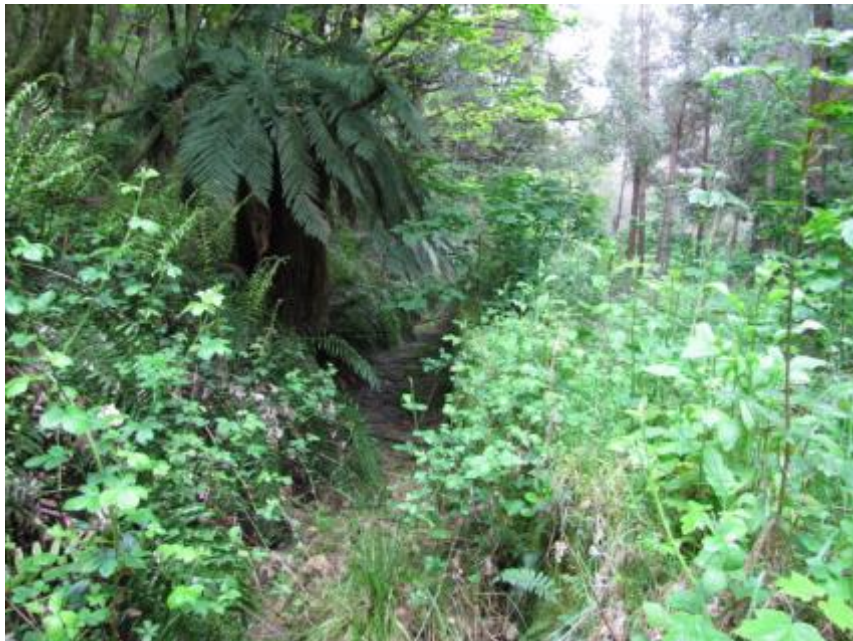
Figure 14. The lower ditch. Image: R. Inwood.

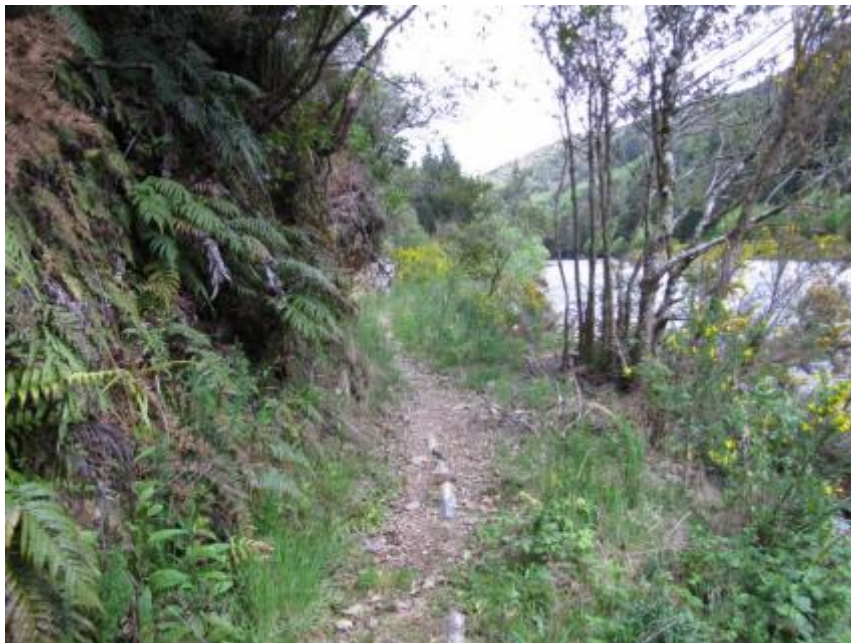
Beyond the tunnel is 120 m of side cutting that carried a timber flume with a walkway on top for the inspector (Figure 15). While the cutting is in good condition the sole remnant of the flume is a heavy timber with housings cut in at intervals, probably a sill supporting cross members.

Figure 15. The side cutting. Image: R. Inwood.

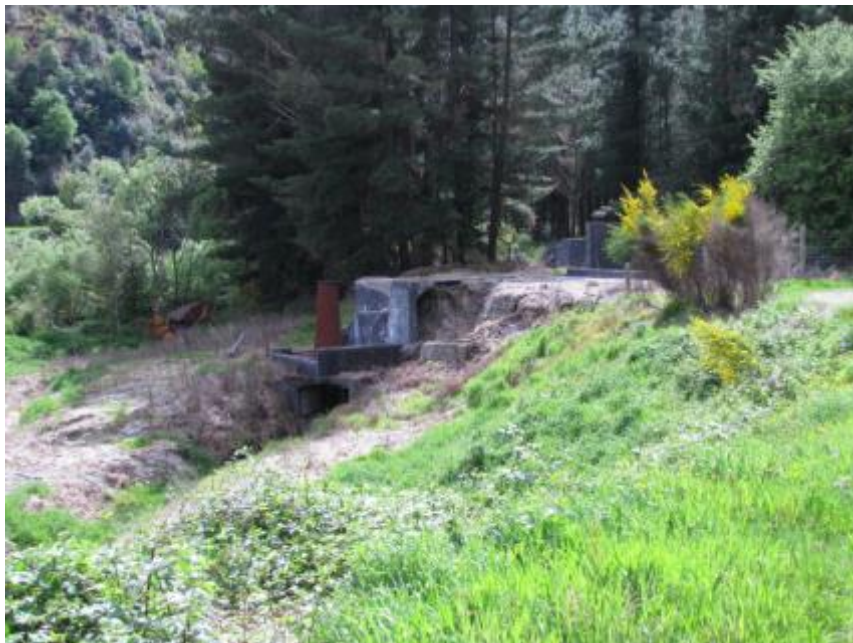
The largest and most complex feature, this comprises the concrete-lined turbine pit plus a series of other concrete floors south of the three dynamo foundations (Figure 16). Until recently the pit still contained the Boving turbine, the flywheel and a generator armature, but they have been removed for conservation work. A drainage ditch that ran into the pit, causing erosion of the ground below, has recently been diverted around the south side of the site. The tail race tunnel has largely collapsed under the workshop floor and has gone entirely to the west.

Figure 16. The power house. Image: R. Inwood.

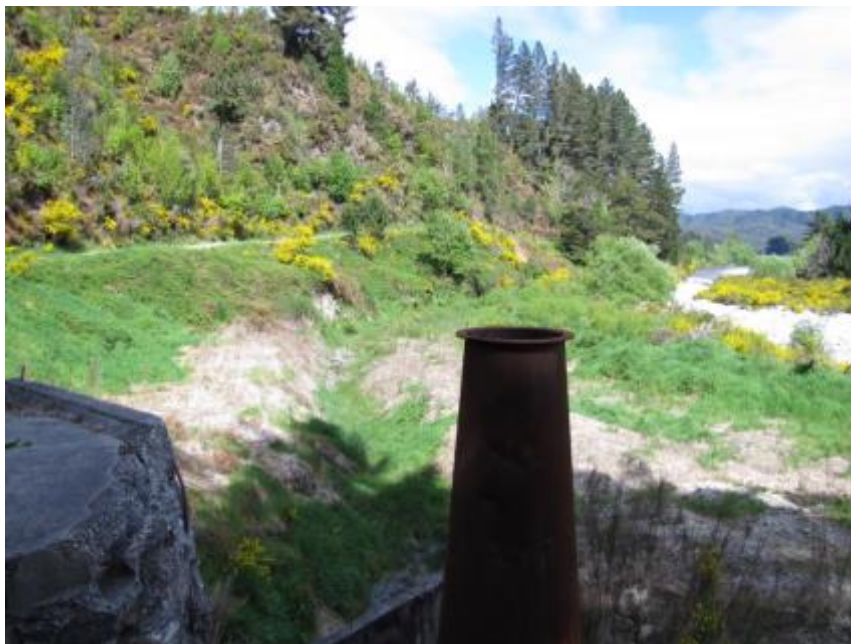
A 150 m long channel, approximately 3 m wide and 1 m deep, leads from the 1935 power house foundations along the foot of the terrace into the Inangahua River (Figure 17). The channel appears to be in much the same place as the original but is poorly defined and there is no sign of the timber lining evident in old photographs. There is a shallow channel below the penstock headwall which we believe formed the original by-pass for the scheme.

Figure 17. Looking down the tail race from the power house. Image: R. Inwood.
