PROJECT	
WAKA KOTAHI (NZ TRANSPORT AGENCY) HOMER TUNNEL - SH94 RP 240 / 0.00 RESILIENCE IMPROVEMENTS - PHASE 1	
TITLE	
PROPOSED PLANT ROOM AND ACCESSWAY PLAN	
WSP PROJECT NO. (SUB-PROJECT)	SHEET NO.
6-DC734.00 (003)	C01
REVISION	A

**Homer Tunnel Improvements Works 2021/22 | New Plant and Equipment Facilities**  
Landscape and Visual Assessment  
APPENDICES

**Appendix F**  
**Heritage Assessment**

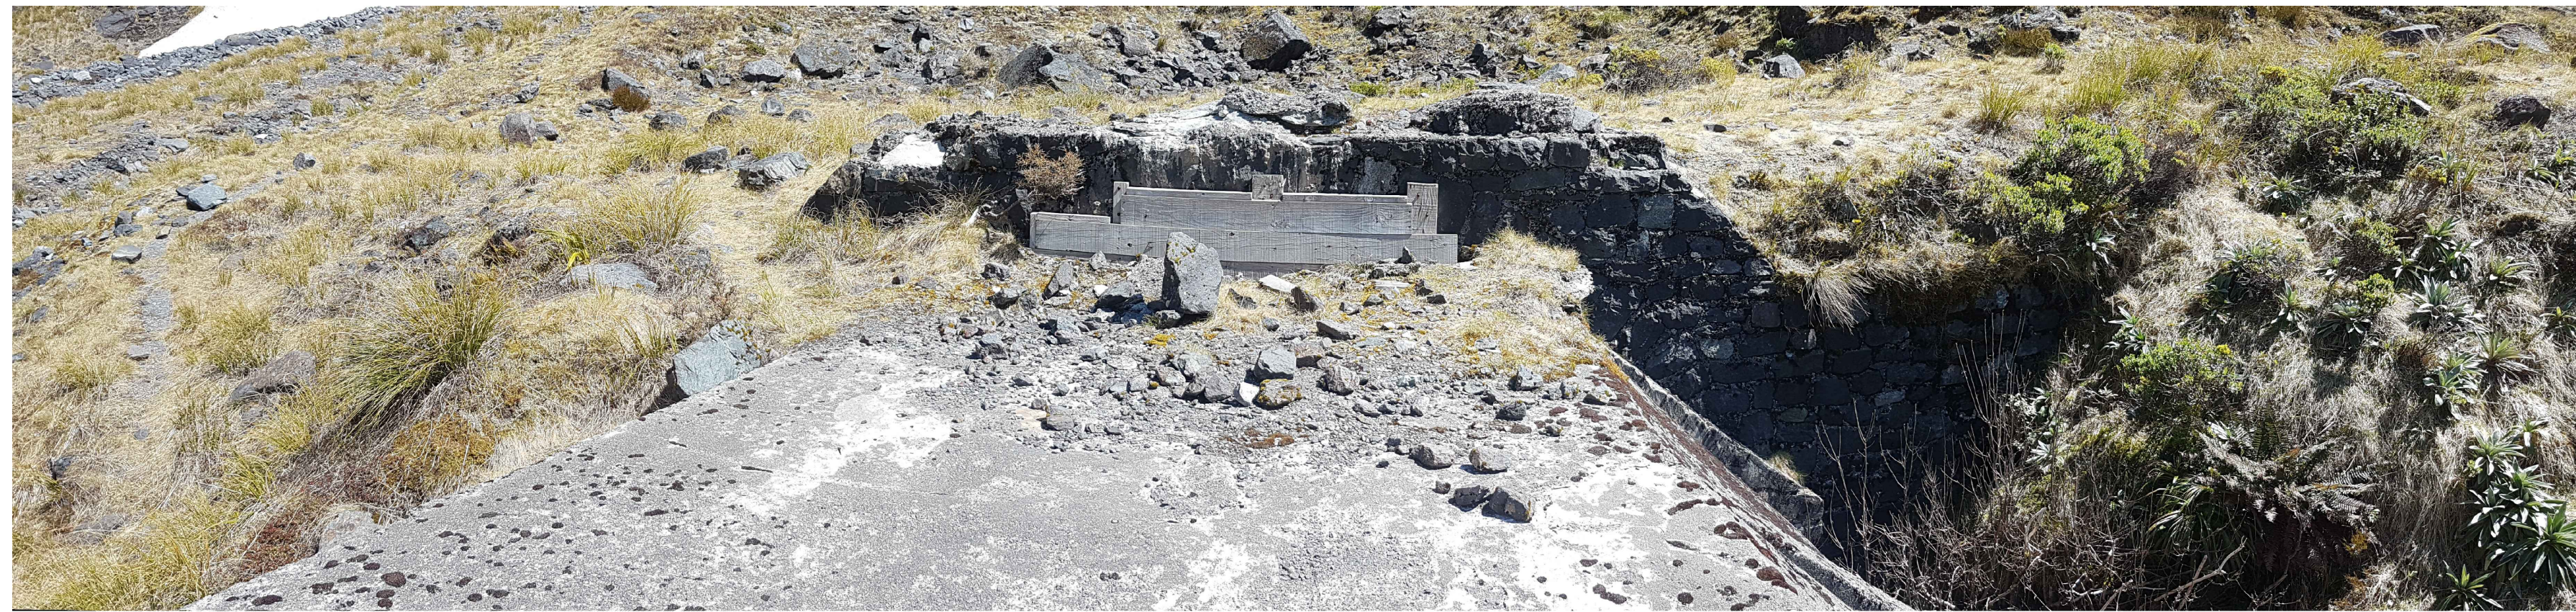
PROJECT	
WAKA KOTAHI (NZ TRANSPORT AGENCY) HOMER TUNNEL - SH94 RP 240 / 0.00 RESILIENCE IMPROVEMENTS - PHASE 1	
TITLE	
PROPOSED PLANT ROOM AND ACCESSWAY SECTIONS	
WSP PROJECT NO. (SUB-PROJECT)	SHEET NO.
6-DC734.00 (003)	C02
	REVISION
	A

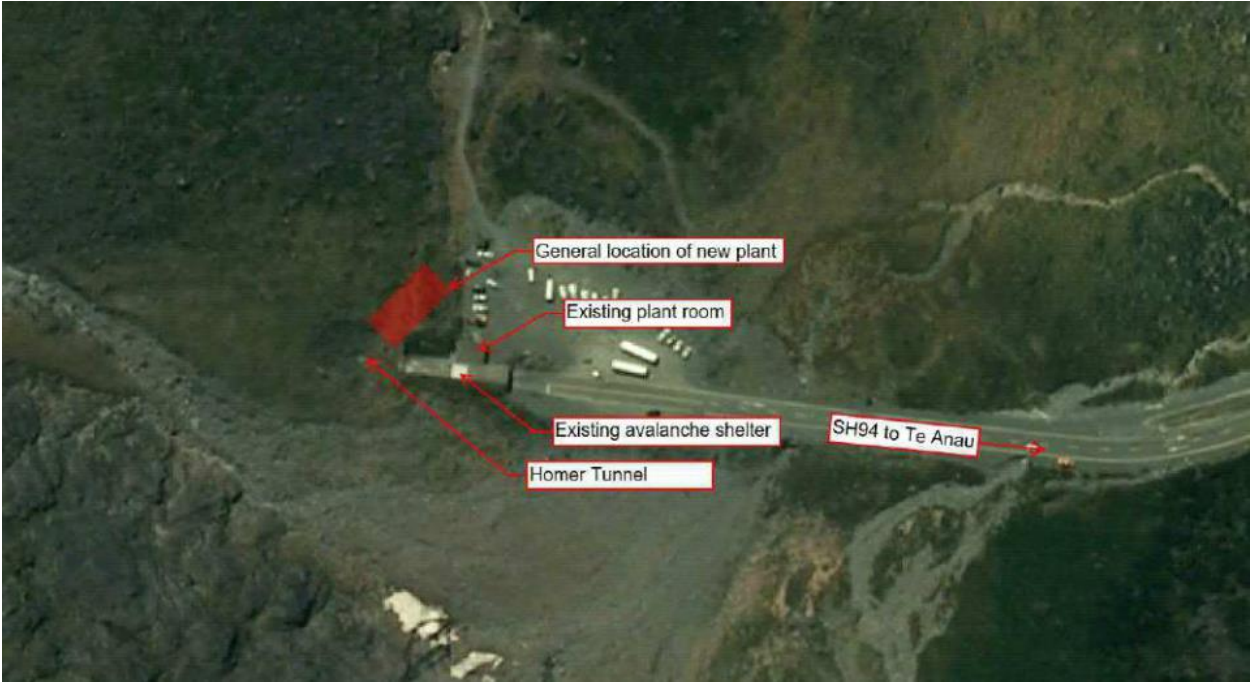
Figure 1 Location plan

This Landscape Advice Note outlines the likely landscape and visual effects associated with this project and recommends landscape mitigation treatment. Figures 1 and 2 show the location and general context of the existing plant room.

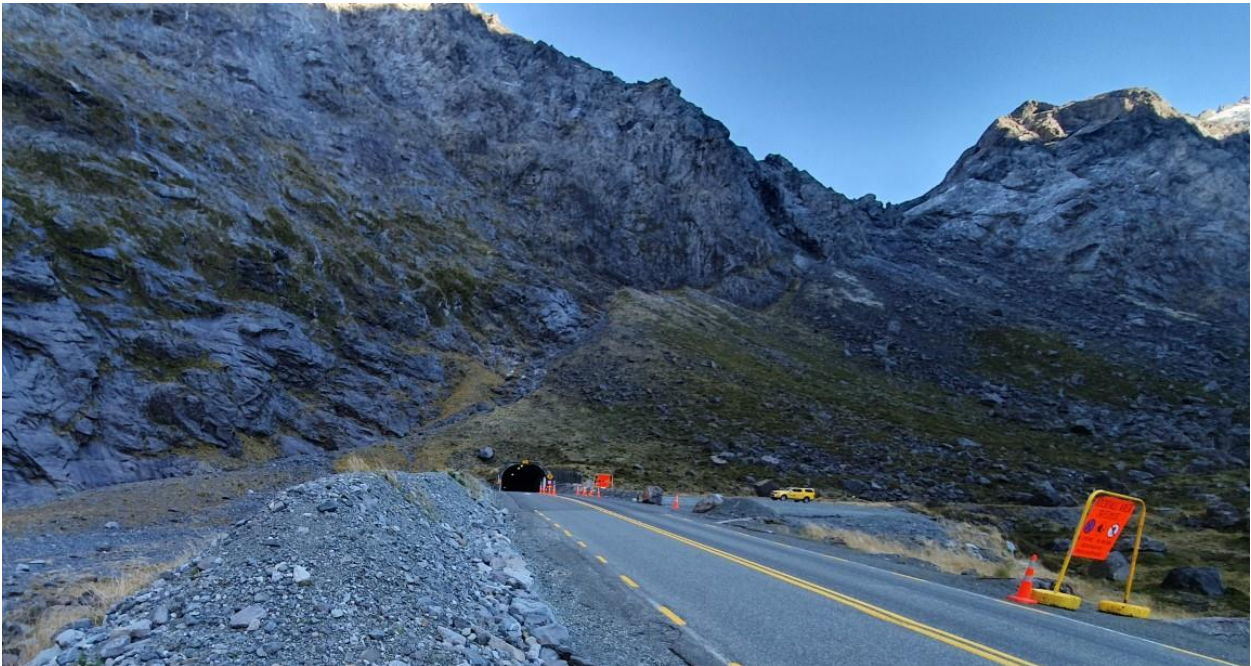
Figure 2: Approaching the eastern portal and avalanche shelter, with the concrete plant room just visible to the right of the tunnel entrance. There are earth bunds either side of the carriageway; that on the left side provides rockfall protection and the one on the right side prevents access to the now-closed car park

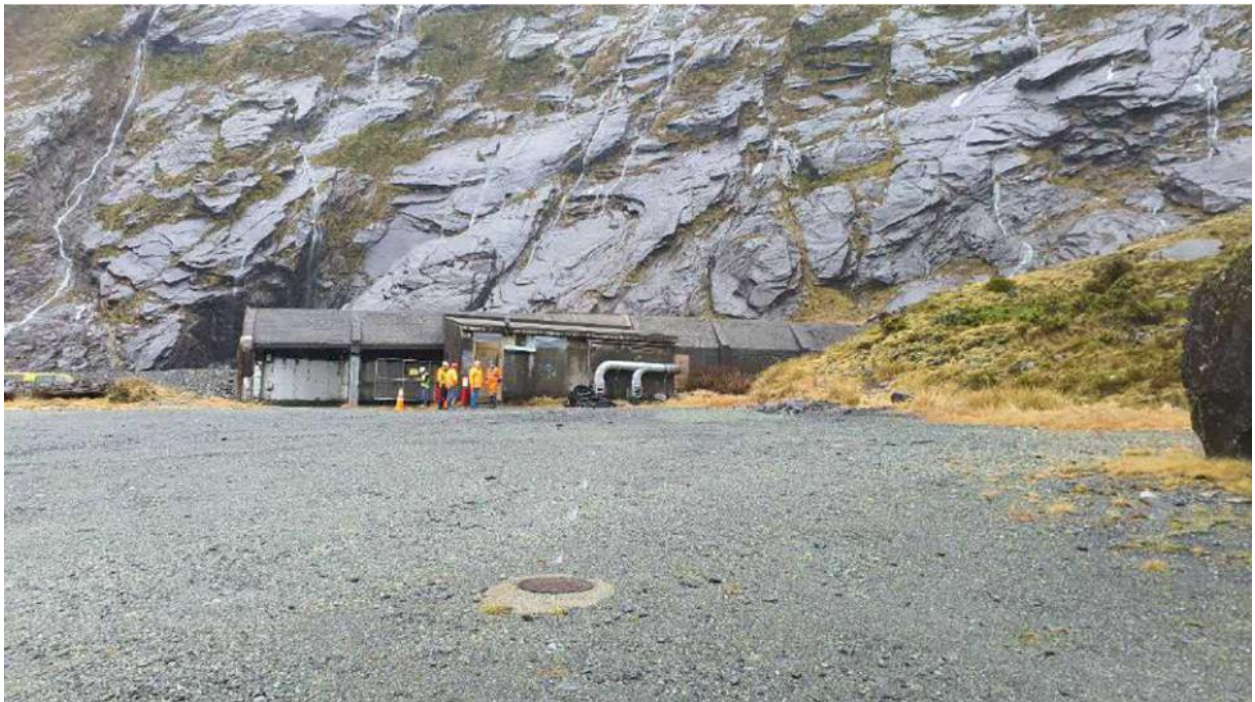
*Figure 3: Existing plant room, avalanche shelter and talus slope viewed from car park*

*There is a small concrete building attached to the northern side of the eastern portal. This was originally built as a shed for drill sharpening and replaced an earlier timber building destroyed in an avalanche in 1945. It is now used as a plant room. This building is located within an area of high rockfall and known avalanche paths and is the building that is proposed to be replaced.*

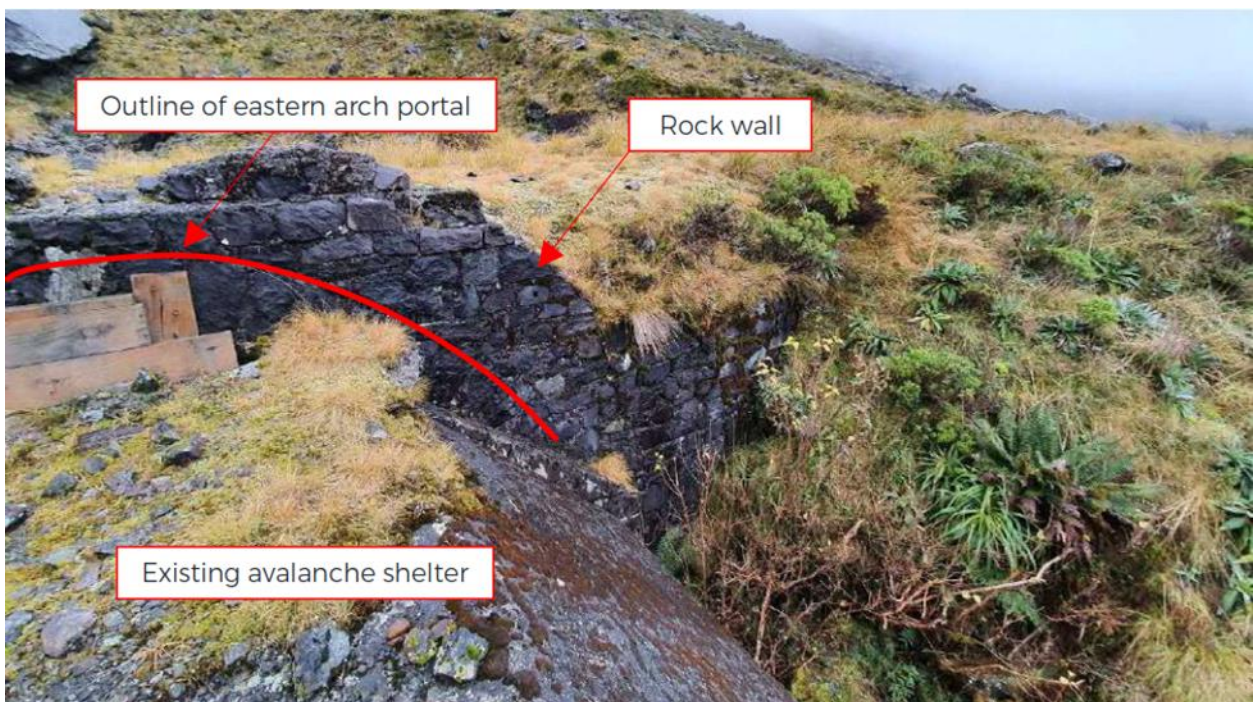
Figure 5: Rock wall at tunnel portal

There is a stone masonry (*bonded course stone façade*) wall at the existing tunnel portal which is identified as having significant heritage value. The plant room location needs to consider the implications of disturbing or damaging the stone masonry wall including additional consenting requirements which may impact on programme. A photo of the rock wall is shown in Figure 3.

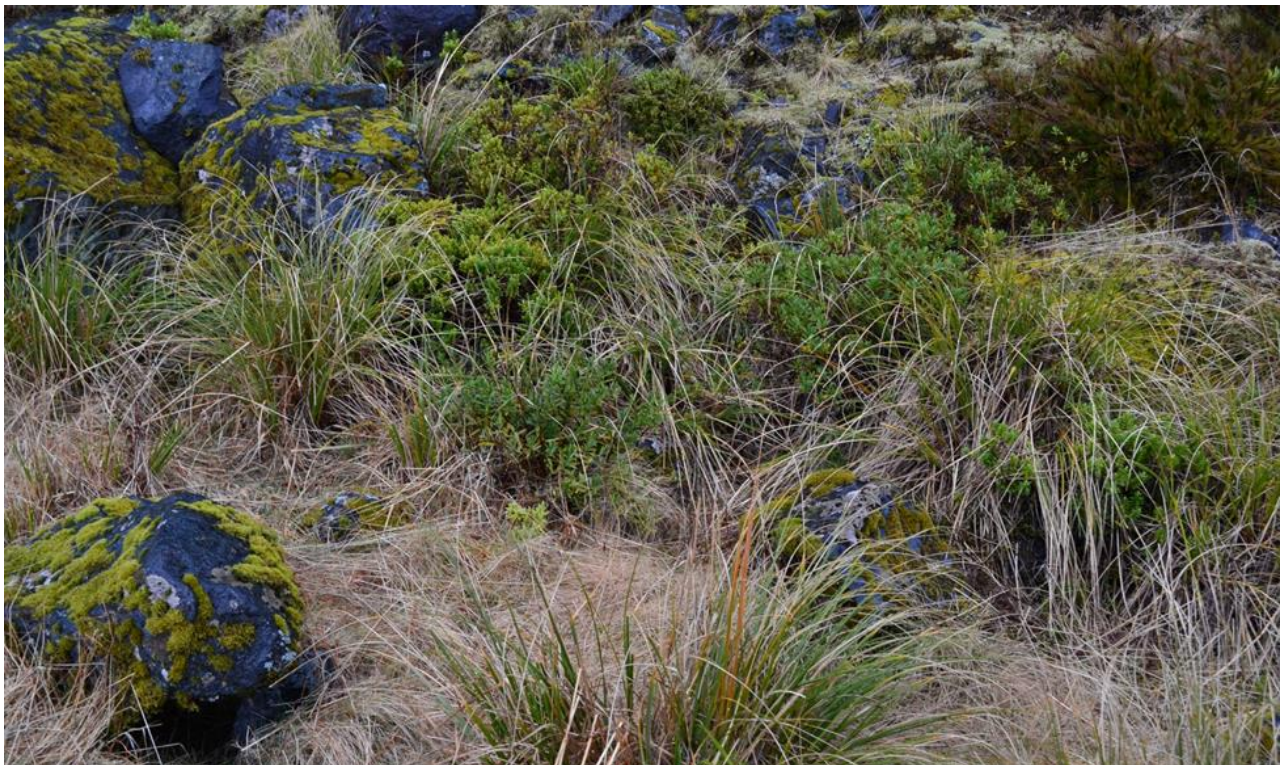
Figure 7: Existing vegetation and lichen-covered rocks on talus slope

In excavating the talus slope to place the plant room, it is intended to disturb as little as possible of the slope and its vegetation cover, larger rocks on the surface of the slope will be uplifted and placed aside with their lichen-cover kept exposed, areas or clumps of vegetation will also be uplifted intact and placed aside. Figure 7 provides a typical view of the vegetation and rock cover on the existing talus slope.

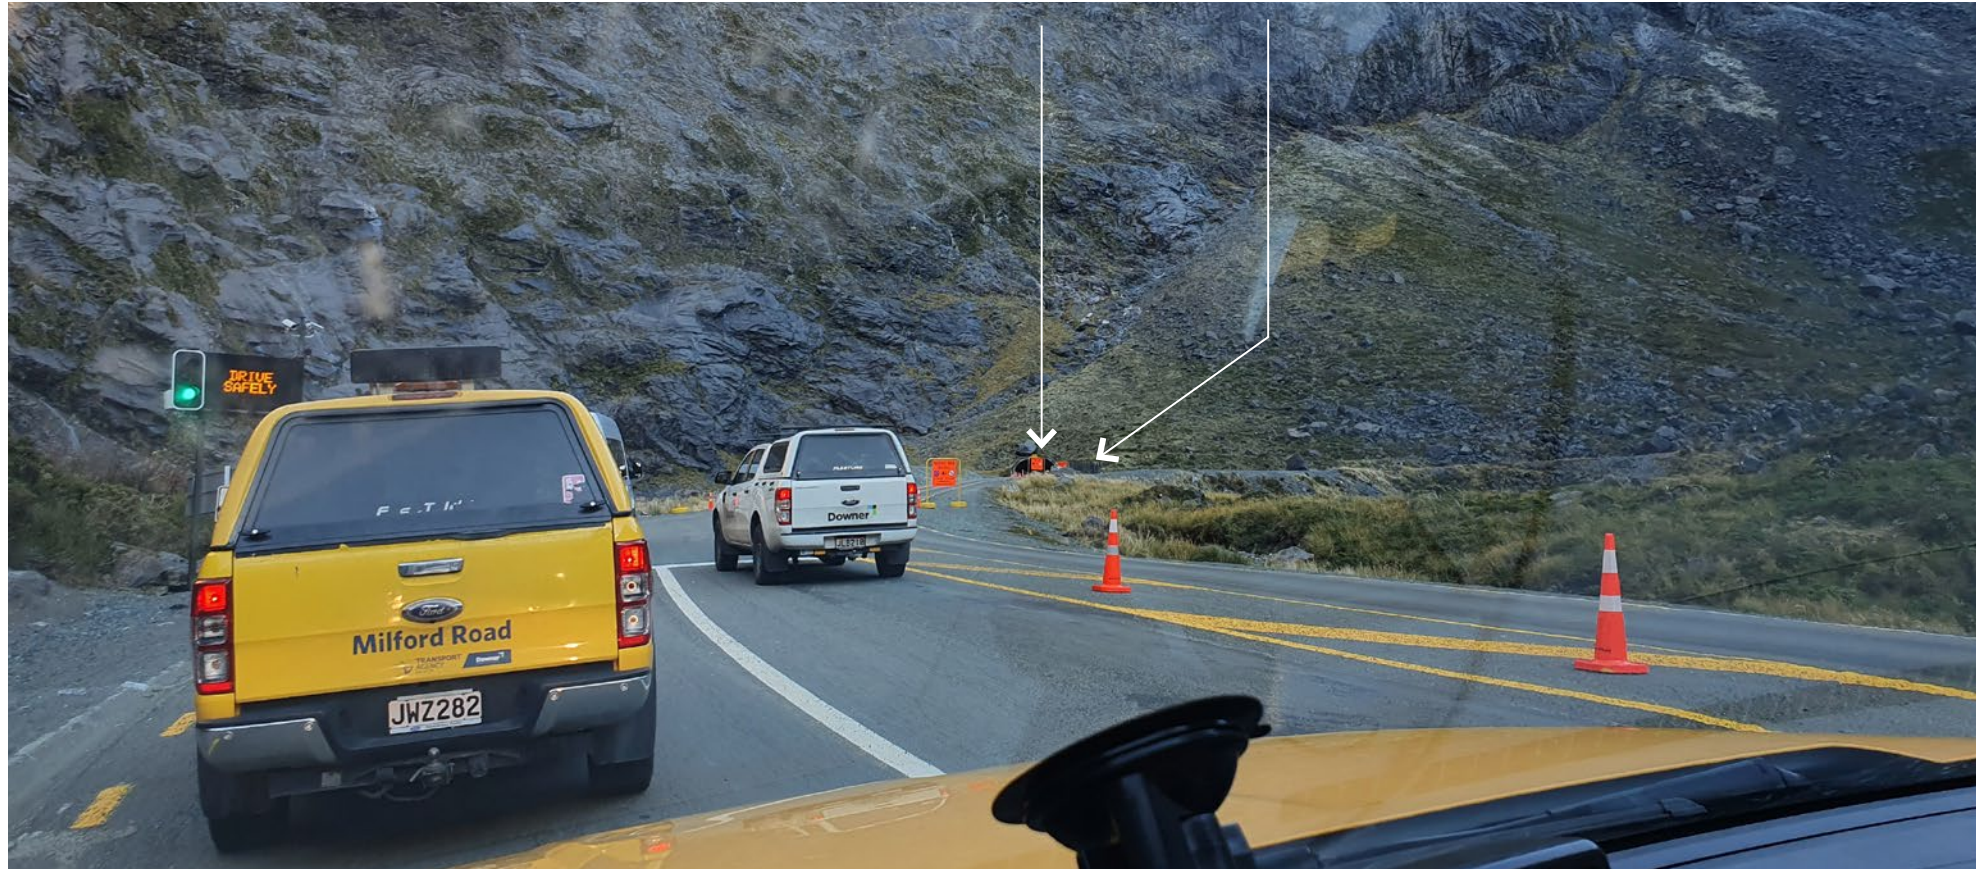
BEFORE: PHOTO 1

Tunnel Existing plant room

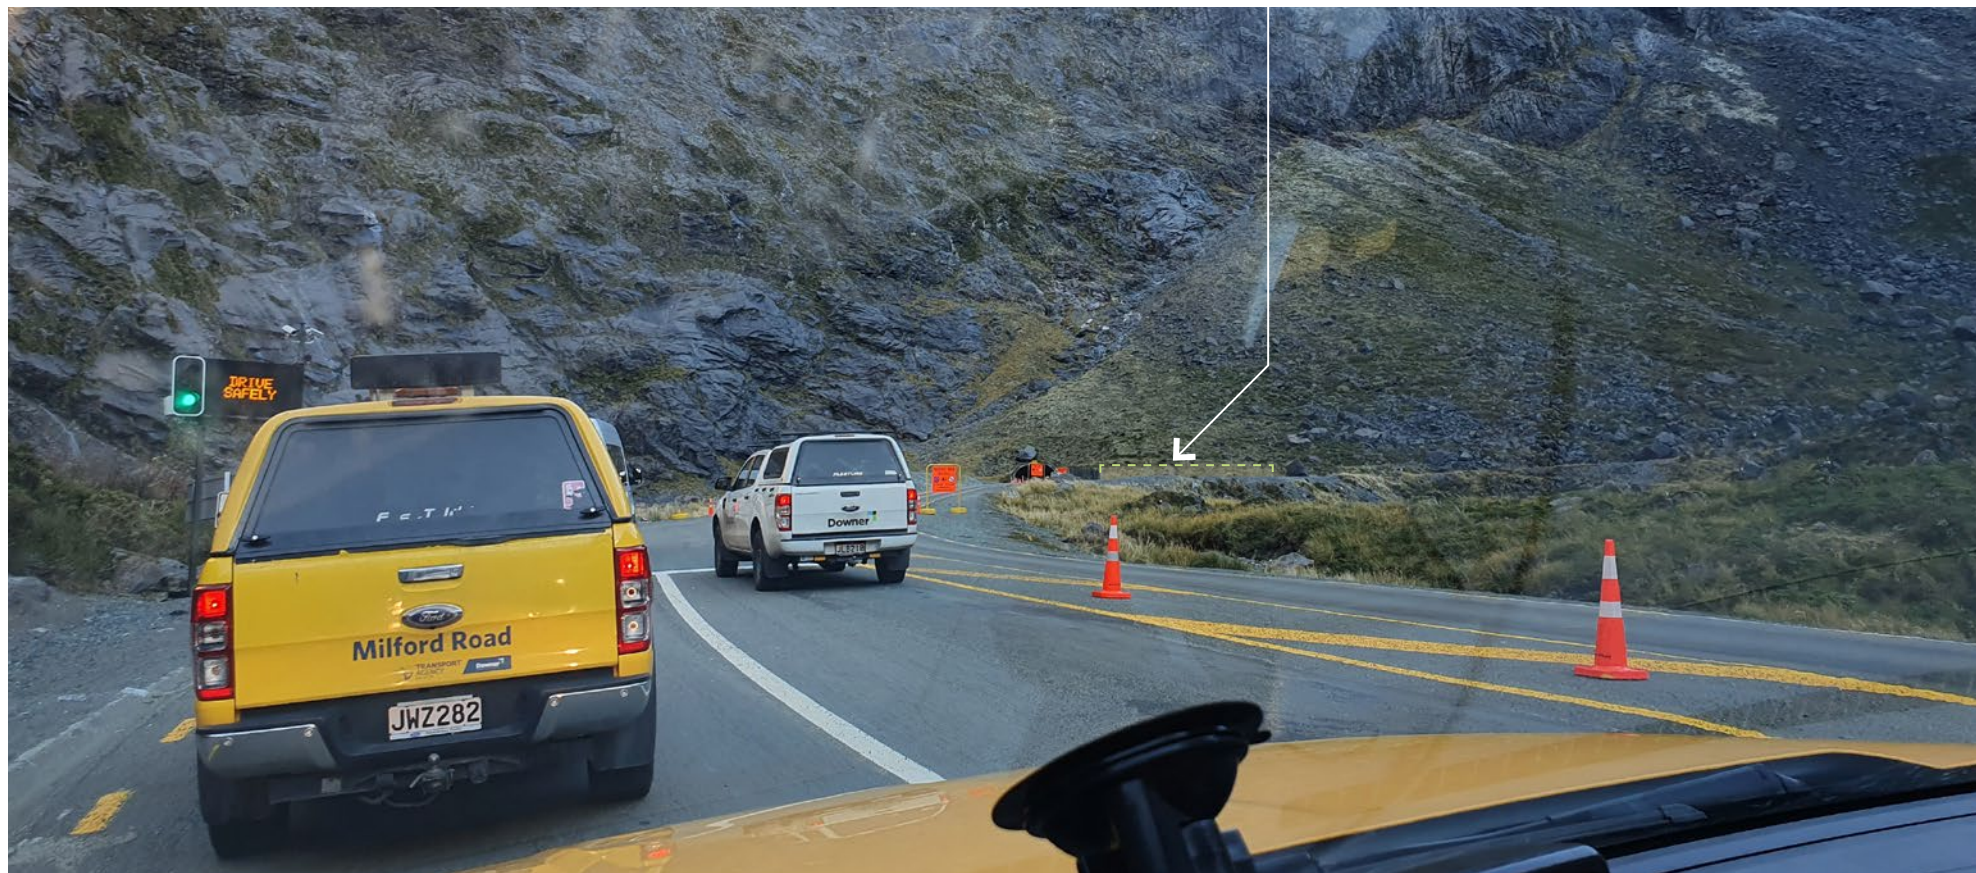
AFTER: VISUALISATION 1

Proposed Structure & mounding

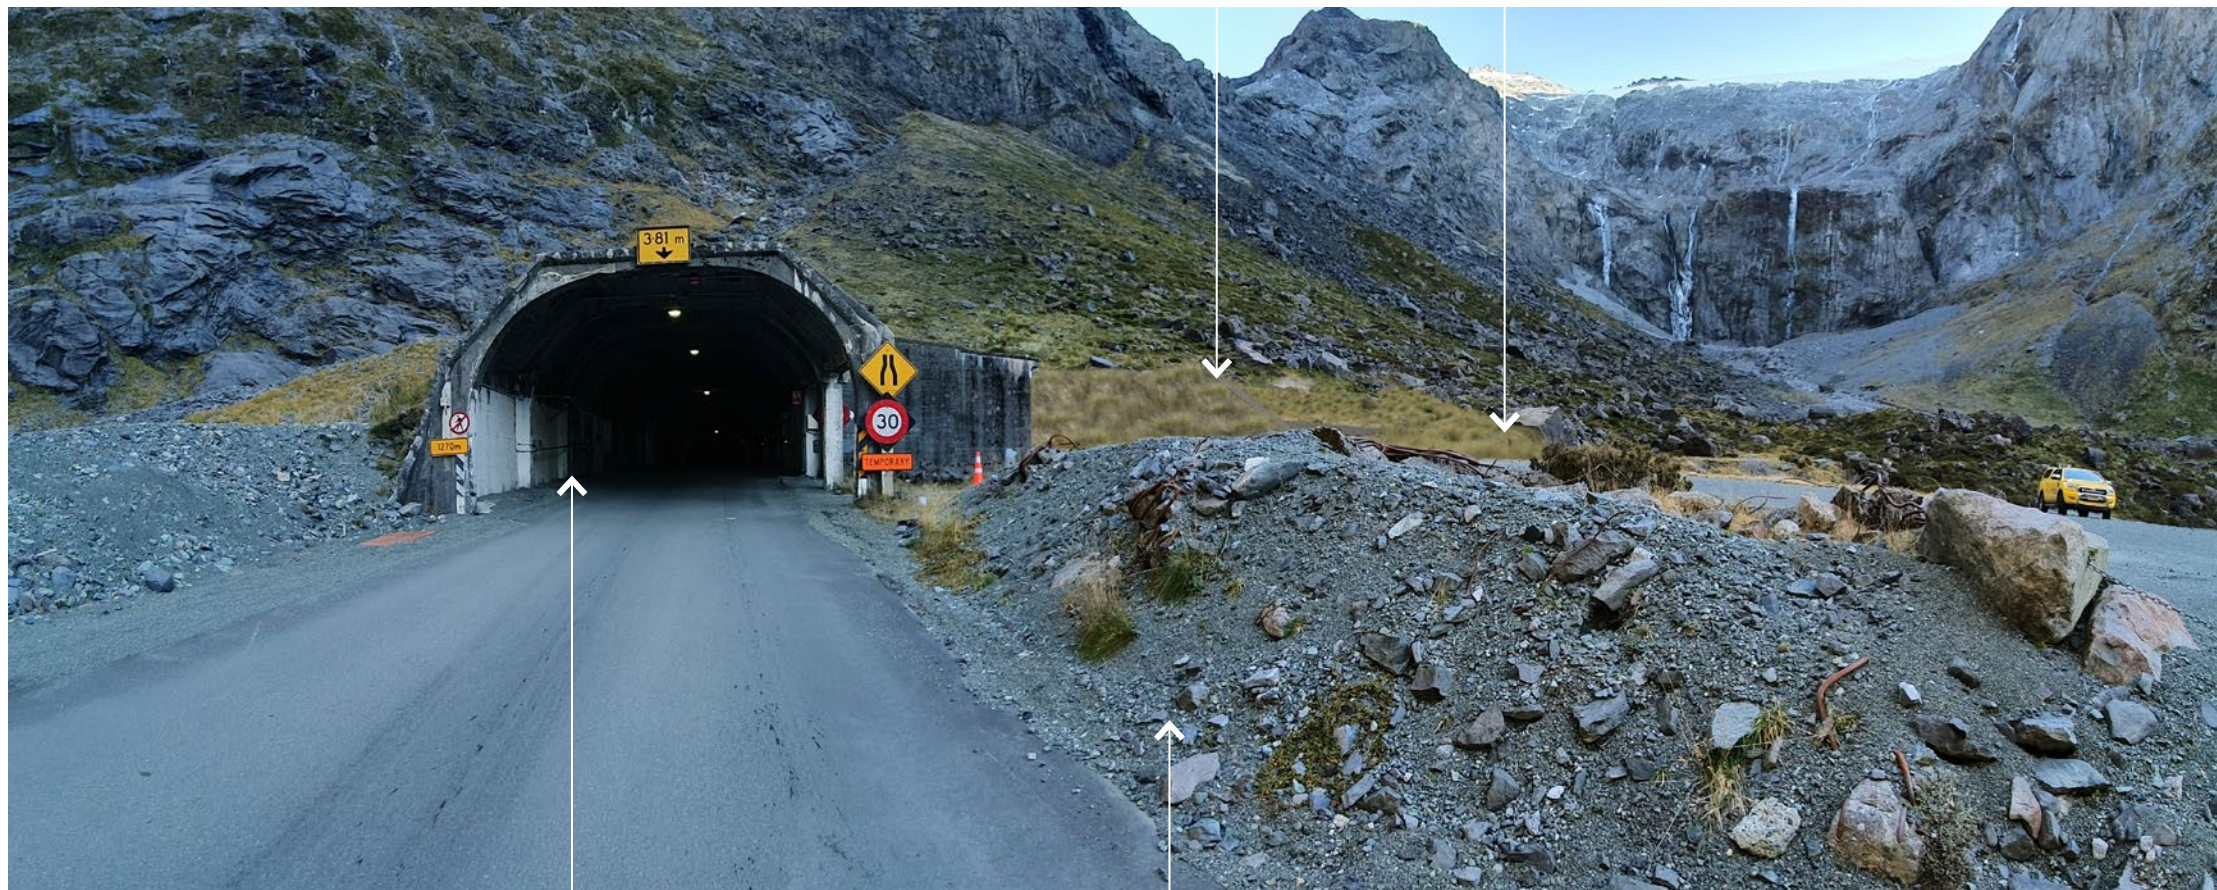
AFTER: VISUALISATION 2

Proposed Structure

Proposed mounding

As SH94 ascends towards the tunnel, it may be possible to see the top edge or outline of the plant room 'wing walls', but the carpark 'exclusion bund' on the north edge of the road will obscure this view, especially when closing in on the tunnel. Refer to Photo 2 and its associated visual simulation at Appendix 1: Attachment 2.

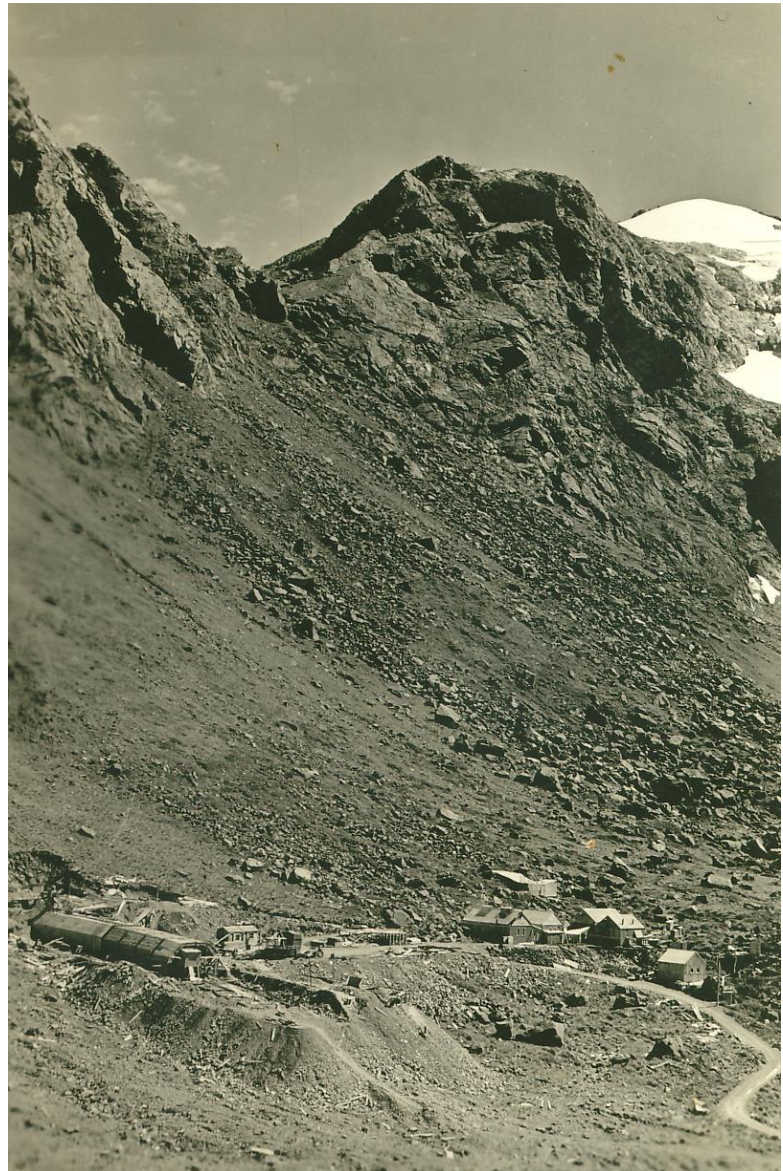
Figure 3-1: Homer Tunnel Construction Work Site, 1937.  
Source: Downer.

A photo taken in 1937 of the eastern entrance (Figure 3-1) shows the extent of the earthworks and infrastructure related works that had occurred during the early stages of construction.

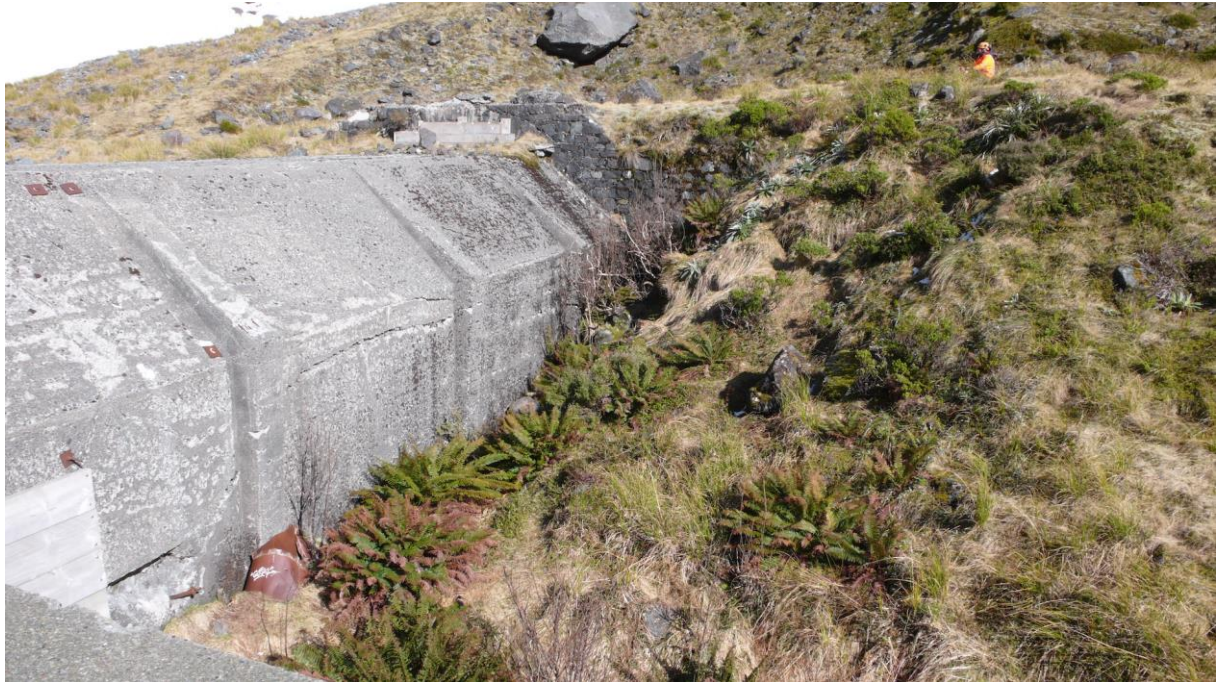
Photo 1: View of an area where the proposed plant room will be sited adjacent to the avalanche shelter and where much of the earthworks and vegetation clearance will occur.

Evidence of previous earthworks is clearly evident today in and around the site of the proposed plant room (Appendix 2, Photo 1).

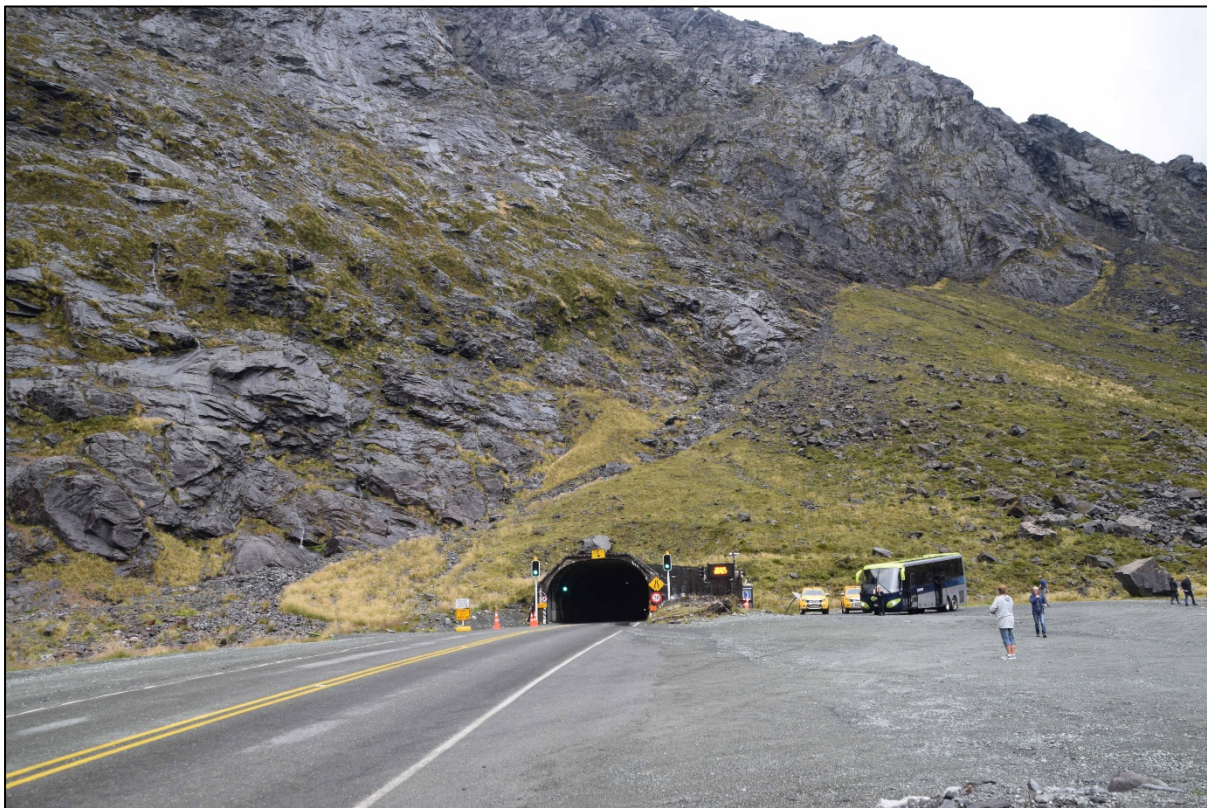
Figure 1. Eastern portal and avalanche shelter, with the concrete plant room visible to the right of the tunnel entrance.

The eastern portal tunnel entrance is composed of a semi-circular concrete arch, with a construction date of 1936/1937. It has a bonded course stone façade with a parapet to the external face. The eastern portal (on the Te Anau side) avalanche shelter is constructed in reinforced concrete and is semi-octagonal in section. It was constructed from 1938 to 1941 and truncated following avalanches in 1945 and 1997. There is a small concrete building attached to the northern side of the eastern portal. This was originally built as a shed for drill sharpening and replaced an earlier timber building destroyed in an avalanche in 1945. It is now used as a plant room for the Homer Tunnel. This building is located within an area of high rockfall and known avalanche paths.

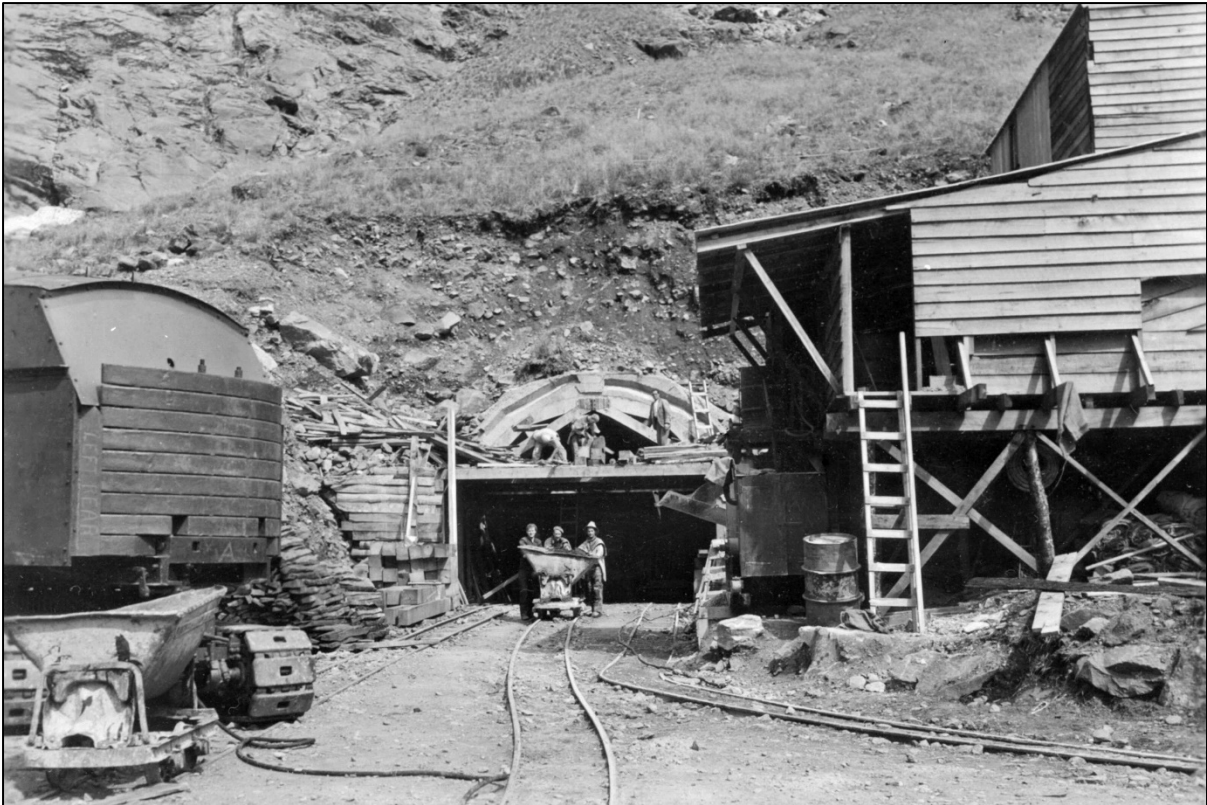
Figure 2. Constructing the eastern tunnel portal in 1936.<sup>27</sup> The original timber drill shed is on the right.

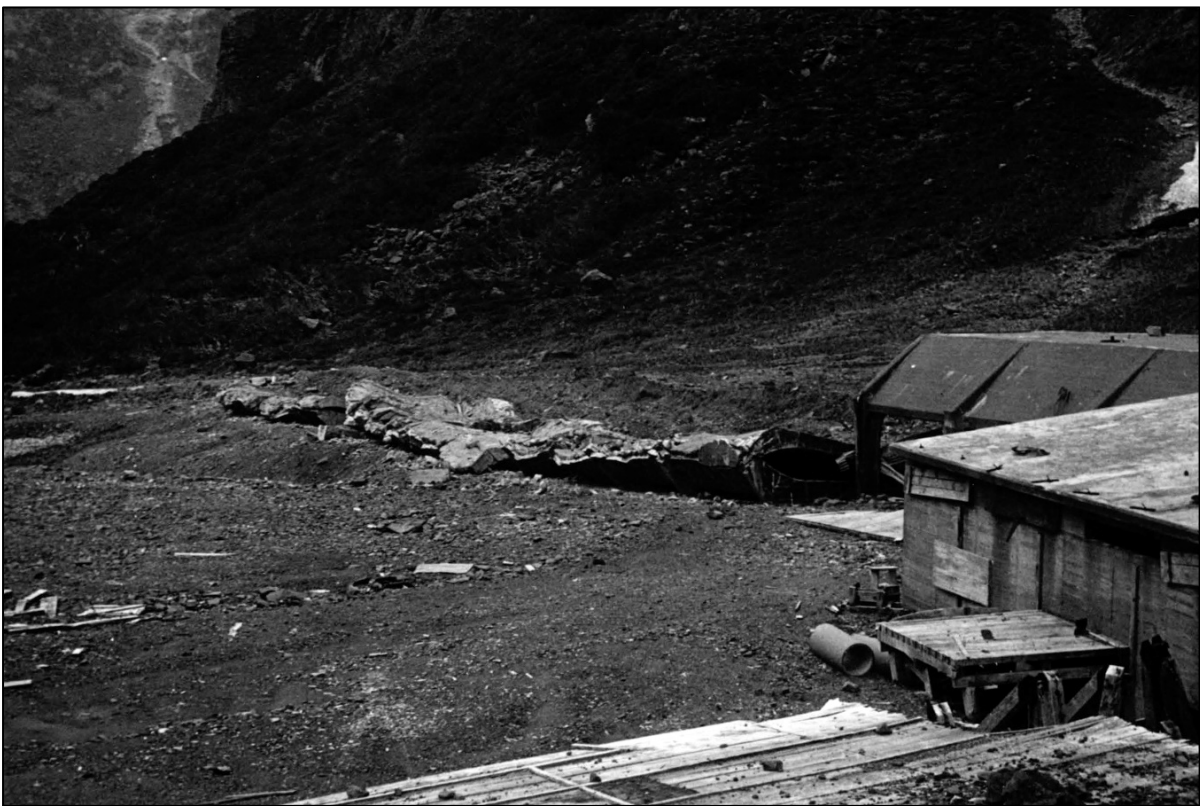
Figure 3. View of collapsed eastern portal avalanche protection, 14 January 1946.<sup>28</sup>
