Cathedral Cove Basic Level Landslide Risk Assessment

Prepared for
Department of Conservation

Prepared by
Tonkin & Taylor Ltd

Date
July 2023

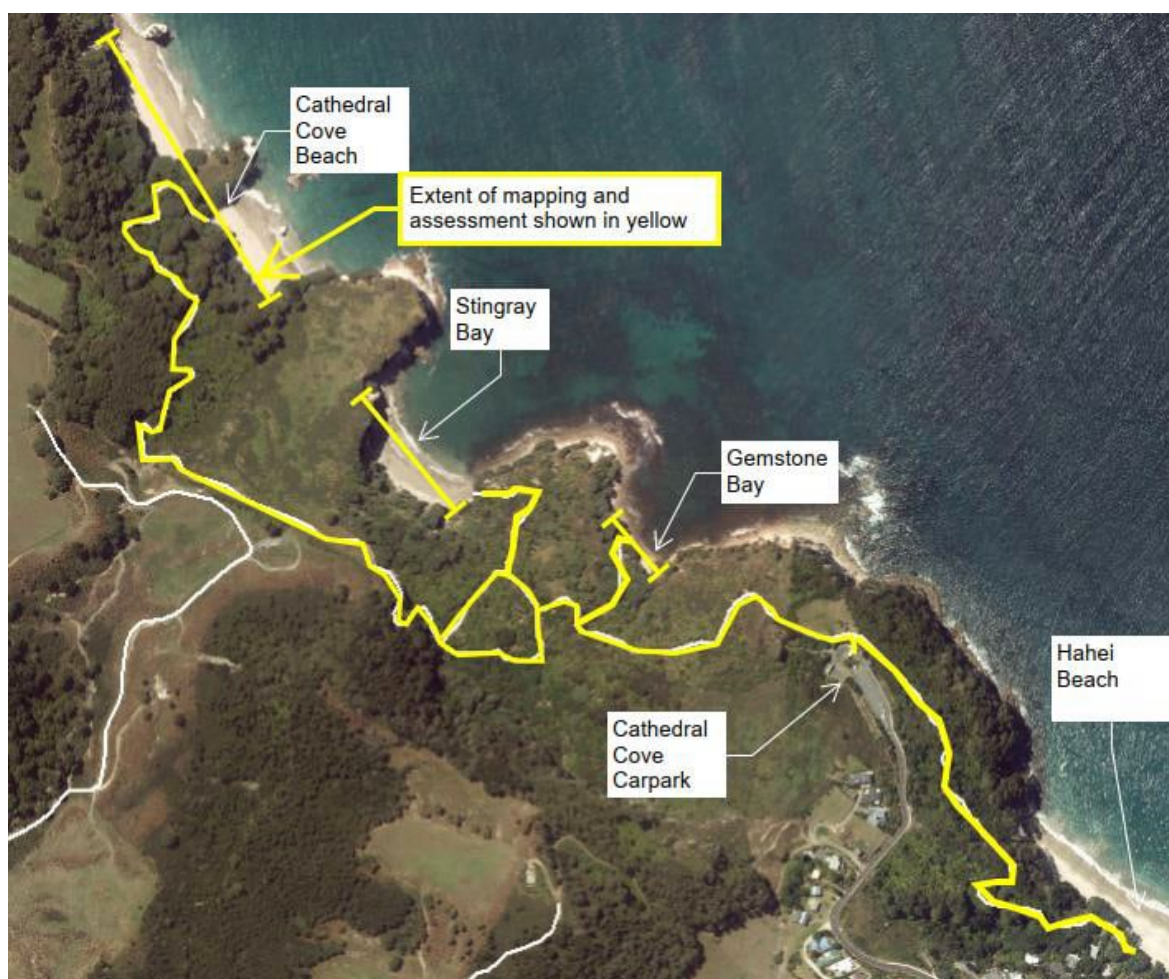
Figure 1.1: Site plan showing extent of the risk assessment area.

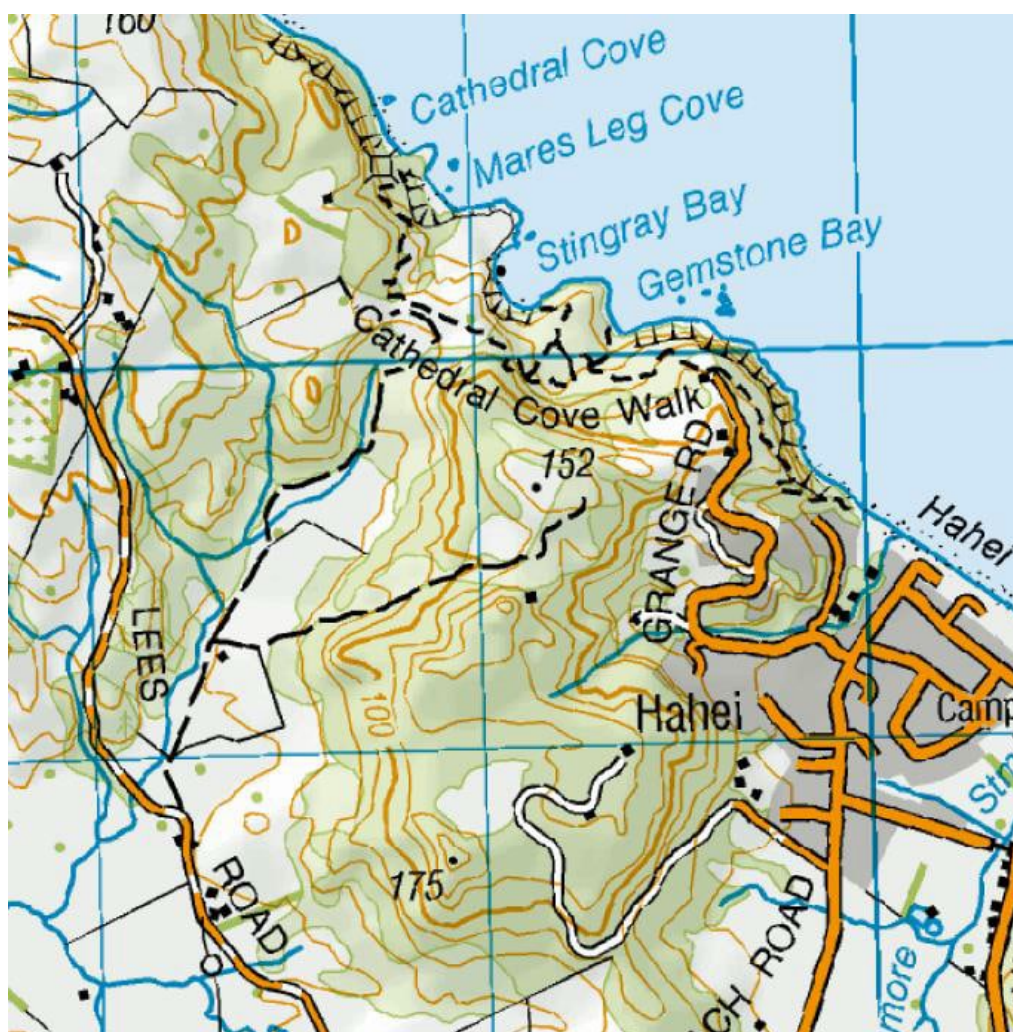
Figure 4.1: 1:50:000 Topo map (Source Topomap.co.nz / LINZ). Blue grid lines are spaced 1 km and vertical blue lines are oriented to grid north.

The site area is situated on the east coast of the Coromandel. It is a very popular tourist location and is accessed by walking tracks from Hahei beach, Lees Road, or a carpark at the end of Grange Road, see Figure 4.1. The Lees Road track is excluded from our assessment.

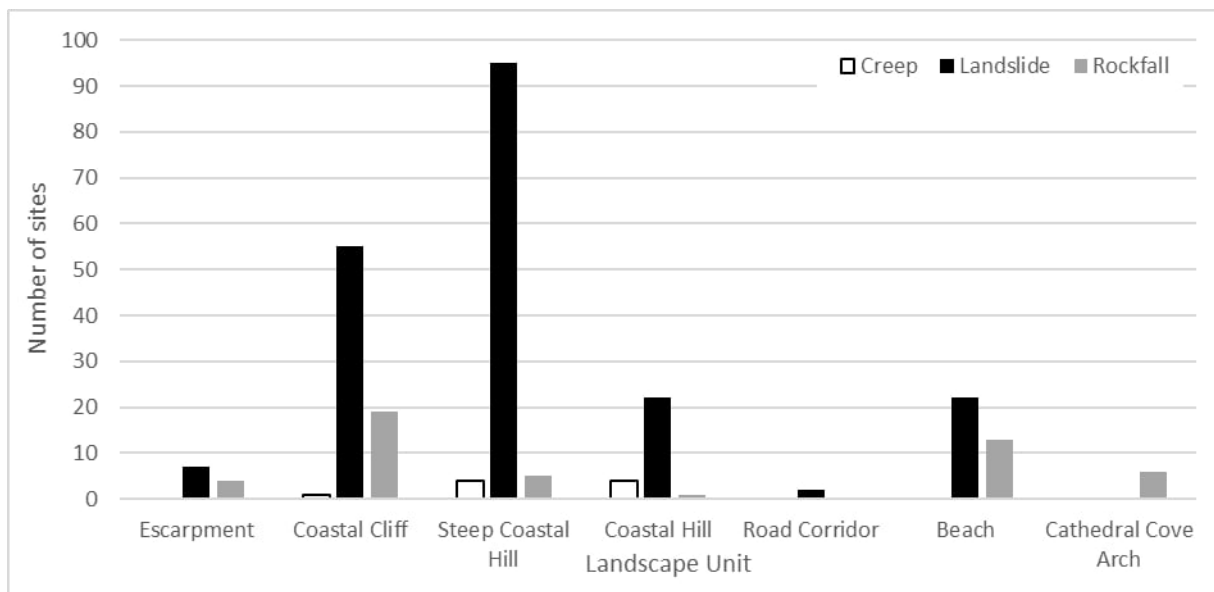
Figure 7.1: Number site landslide/rockfall/creep sites within landscape units. Note that sites can be counted twice if debris travel through multiple areas.

Landslide, rockfall and creep failure types summarised for each landscape unit in Figure 7.1.

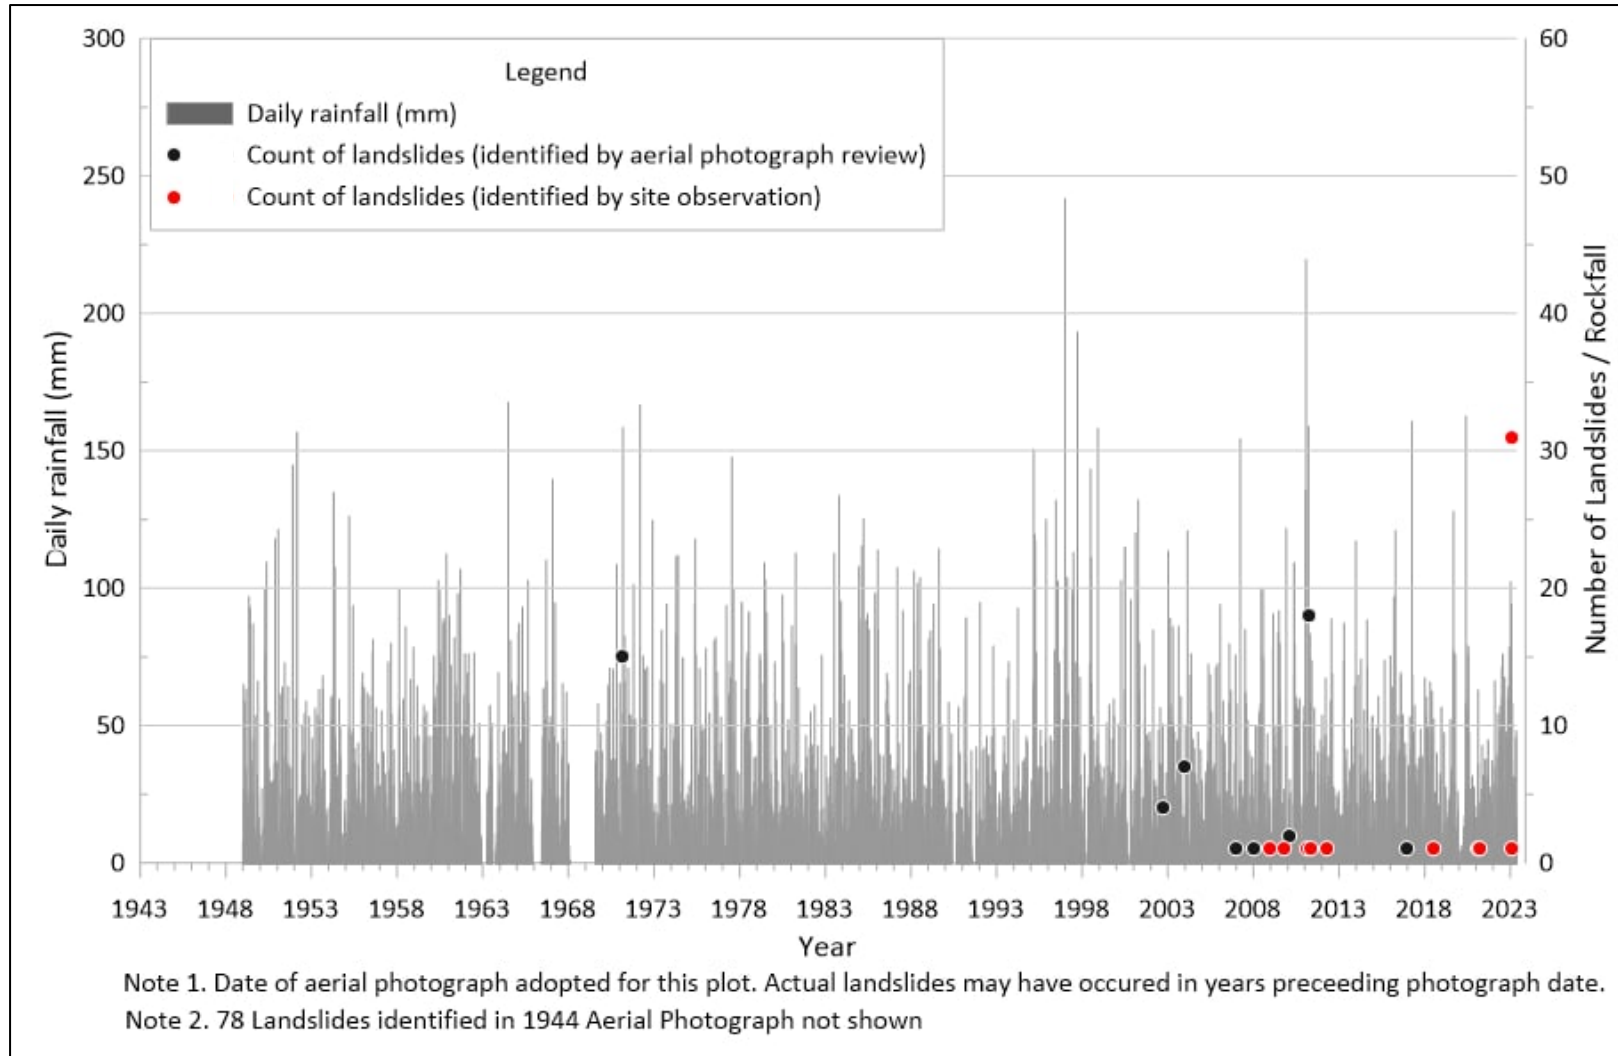
Figure 8.2: Daily rainfall (mm) and count of mapped landslides / rockfall.

Triggering of landslides/rockfall across the site is assumed to be primarily due to elevated groundwater conditions as a result of prolonged and/or intense rainfall. No known landslides/rockfall within the inventory are known to have occurred as a result of earthquakes.

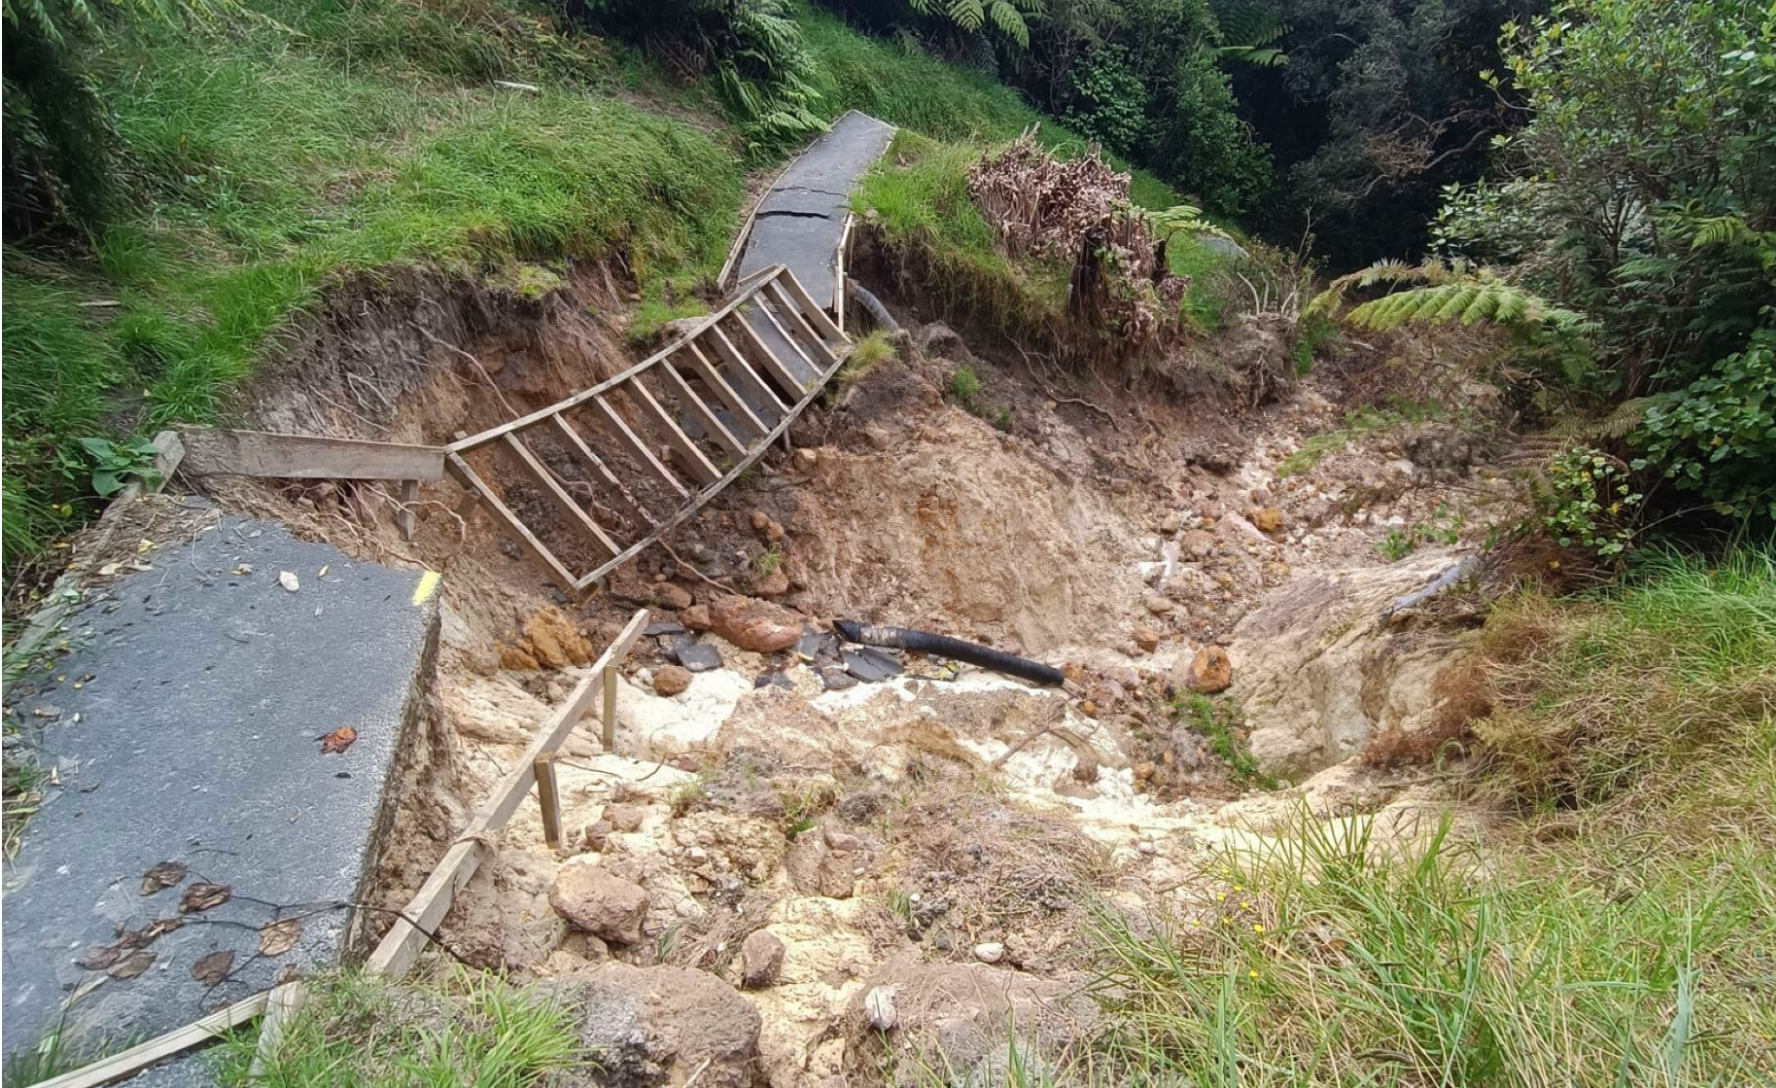
Site Location	Site details/damage	Mitigation option description	Additional considerations
Cathedral Cove lower track access (Track Section 12, 13 & 14) (Refer Figure 10.1 and Figure 10.2)	<p>Landslides have damaged a 10 m section of stairs and track. This section is in the steep coastal hill landform. Site observations identified an upper soil profile of colluvium overlying residual soil.</p> <p>The existing landslides have potential to regress and very steep ground adjacent to the track nearby may fail in a similar type of landslide.</p> <p>Furthermore, the current public toilet site on the southern portion of Mare's Leg Beach has been damaged by storm surge in recent weather events. Relocation of the toilet is being considered by DoC.</p>	<p>Option 1 – Alternative track route</p> <p>A potential route option was traversed by T+T and DoC during recent site visits and is shown in Figure 10.2.</p> <p>The proposed route would detour north-west of the current track and re-join the track just above the current beach access structure.</p> <p>The re-route would also present an opportunity to locate a new toilet site in an area of ground over a minor spur at the start of the new route as shown in Figure 10.2.</p>	<p>The coastal cliffs on the northern side of Cathedral Cove are nearby to the potential re-aligned track. A potential fall hazard is possible if public detour off the track northward. While this hazard has always been present, bringing the track closer may mean public access this area. The track could be positioned below a slight rise southward of the cliff crest to help avoid this area. Other mitigation options such as barriers and signage could be considered.</p> <p>Ongoing landslide risk would remain from new or regression of existing landslides, however the re-route would largely avoid the current areas of instability.</p> <p>The option is a relatively a low cost and practical option.</p>

Figure 10.1 Cathedral Cove lower track landslide damage.

<p>Option 2 – Reinstate the damaged track.</p> <p>Reinstate the track in its current alignment.</p> <p>This would likely entail a resilient engineered solution, particularly as it would require traversing unstable ground. An engineered solution would likely include slope stabilisation, earthworks, and structures such as stairs and/or bridges.</p>	<p>The option is likely to be costly and subject to further geotechnical considerations including slope stabilisation.</p> <p>If engineered appropriately, the option would provide resilient access for this section of the track. Noting that this may be a higher level of resilience than other track sections.</p> <p>Given the current and potential land instability, a non-engineered track/stairs are not appropriate for this location.</p> <p>The proposed new toilet site could still be utilised with this option.</p>

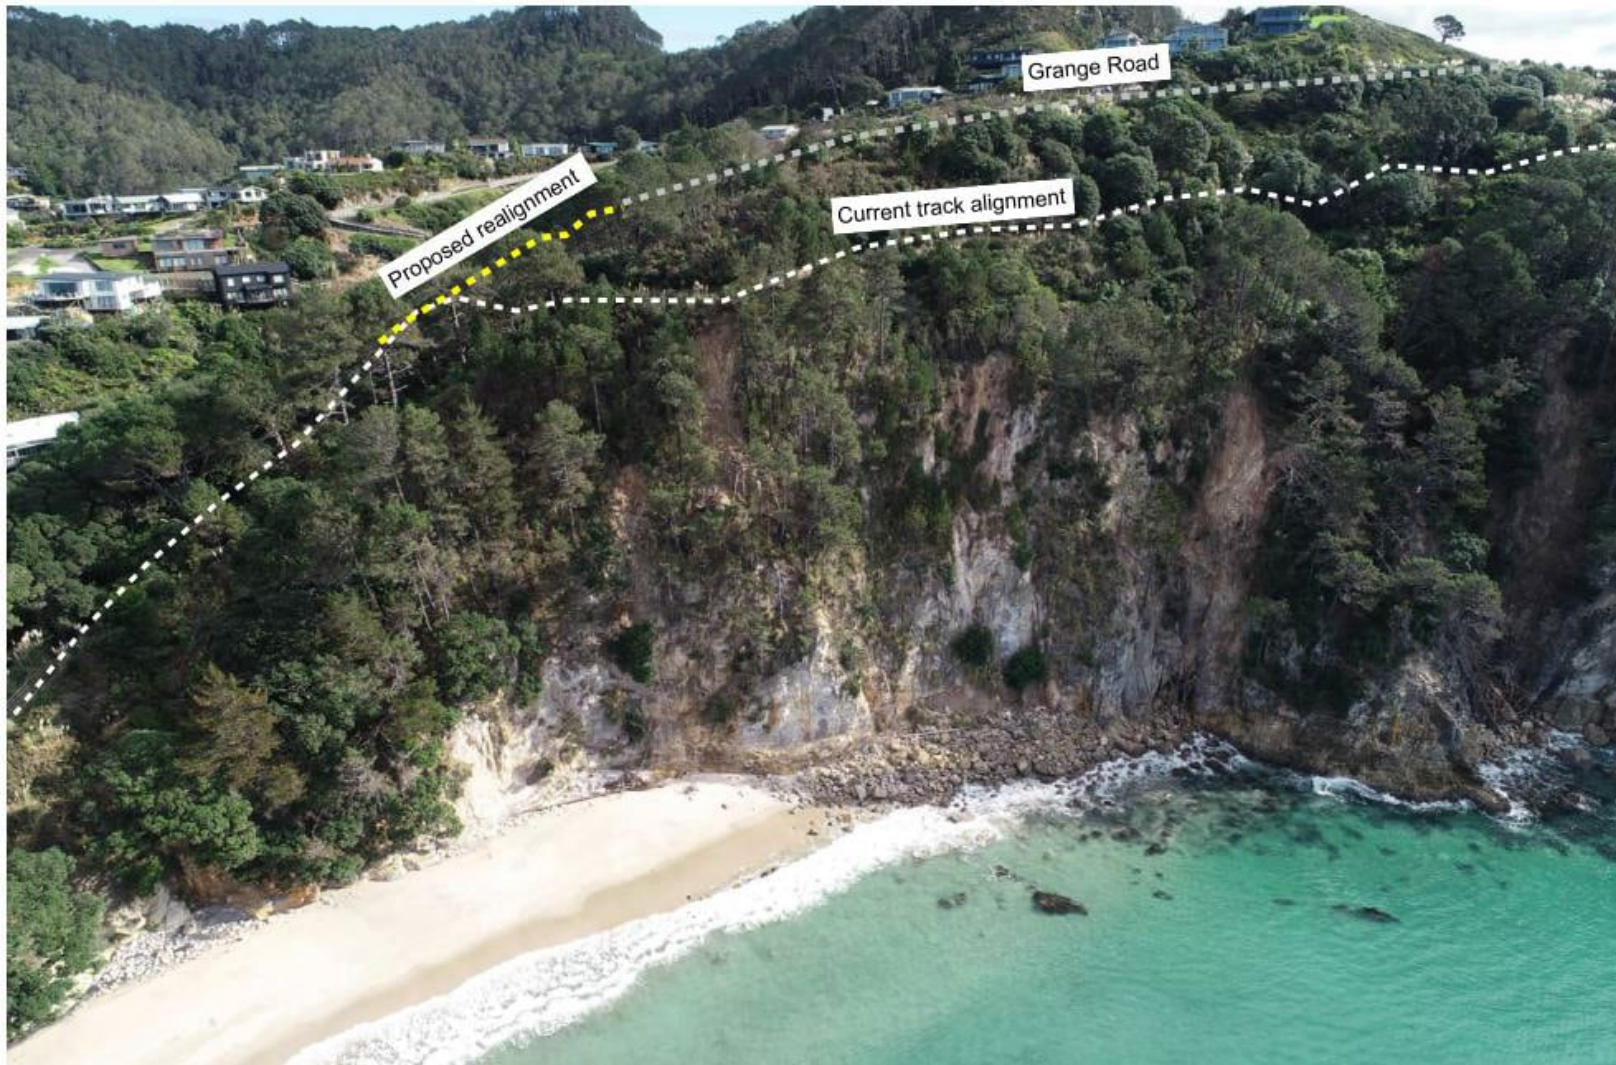
Figure 10.8: Hahei track realignment option.

<p>Option 2 – alternative access via Grange Road and DoC carpark.</p> <p>A potential alternative route option was traversed by T+T and DoC during site visits and is shown in Figure 10.9).</p> <p>The alternative track would connect the existing Hahei Track to Grange Road, a short walk from the existing DoC carpark.</p> <p>The track would pass through a gully with moderate ground slopes and wilding pines.</p>	<p>The track would bypass the steep landslide prone hillslope reducing risk to users.</p> <p>The realigned track does not provide the same views to users.</p> <p>Fallen trees were present within the route of the new track and existing large trees may require removal.</p> <p>Areas of groundwater seepage should be avoided.</p> <p>Consideration is required for traffic safety related issues and confirm whether the current footpath is suitable for the expected visitor numbers.</p>

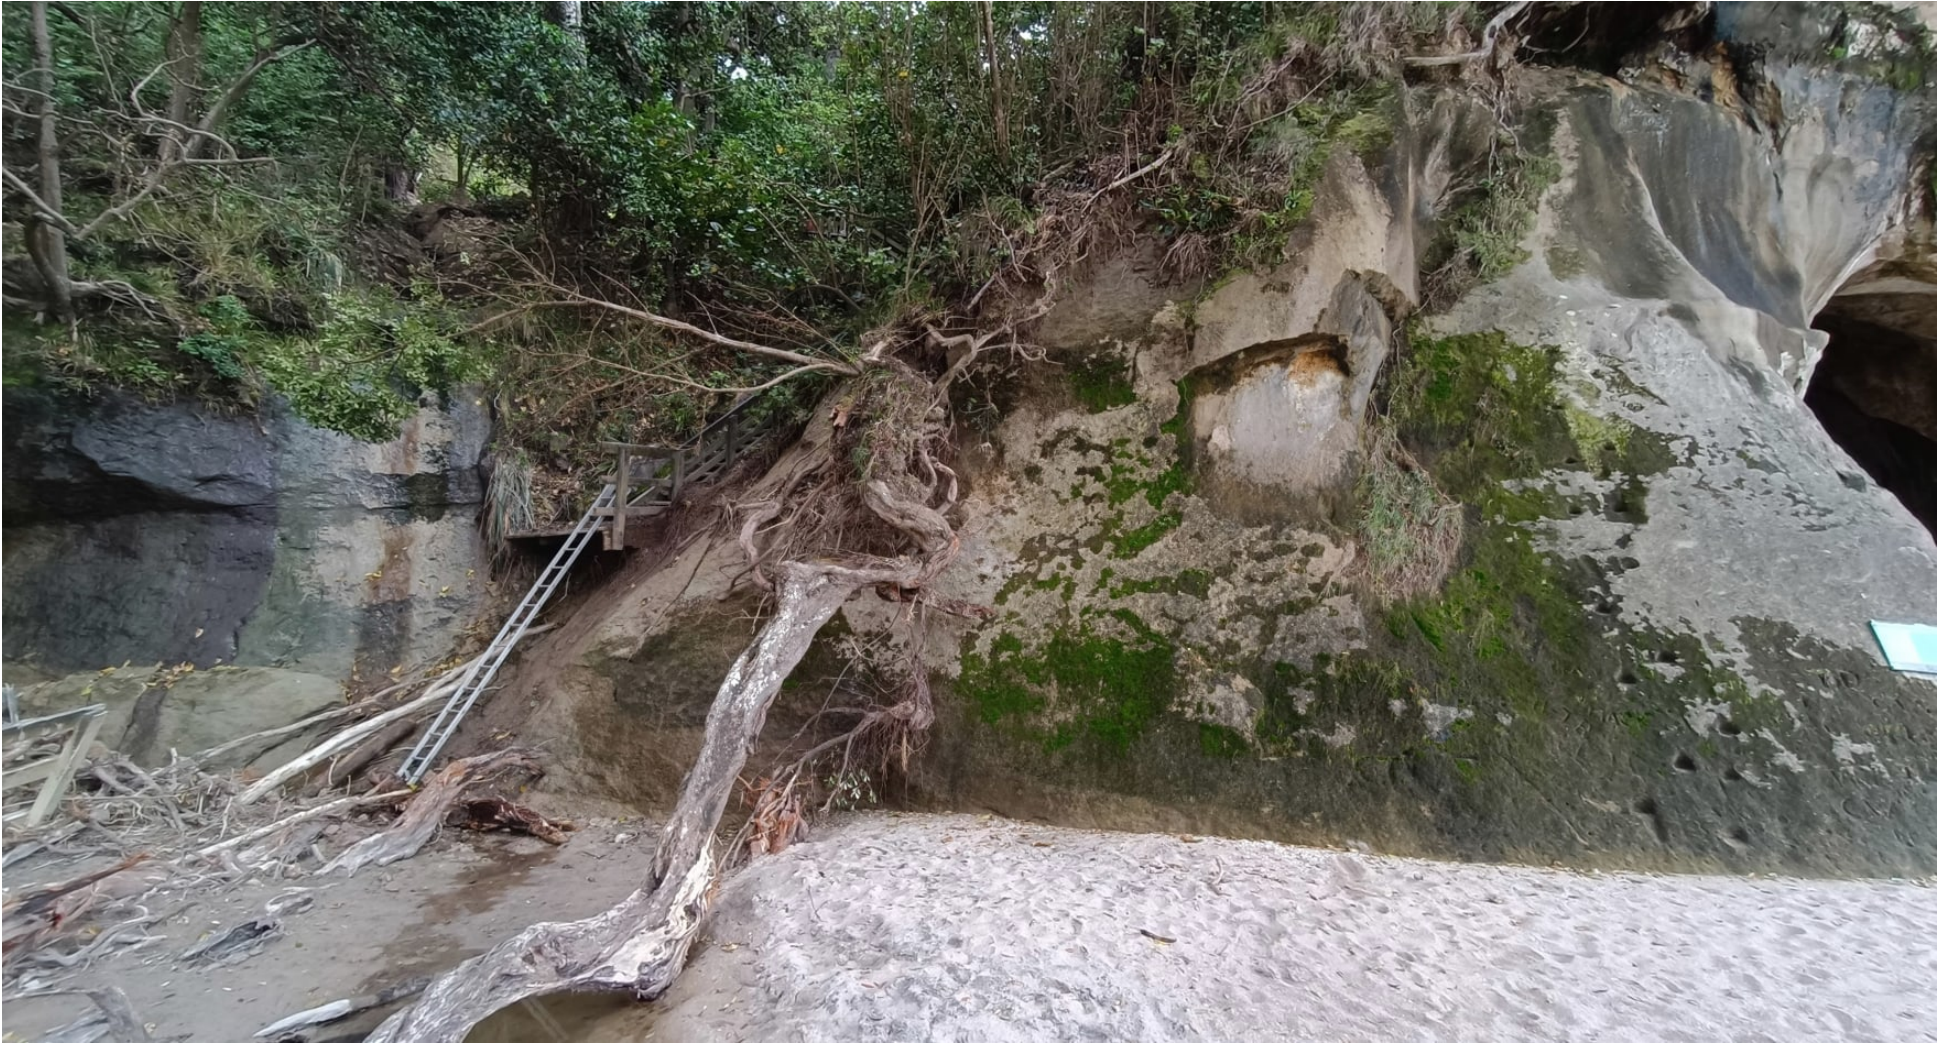
Figure C1 Damage to Cathedral Cove Access

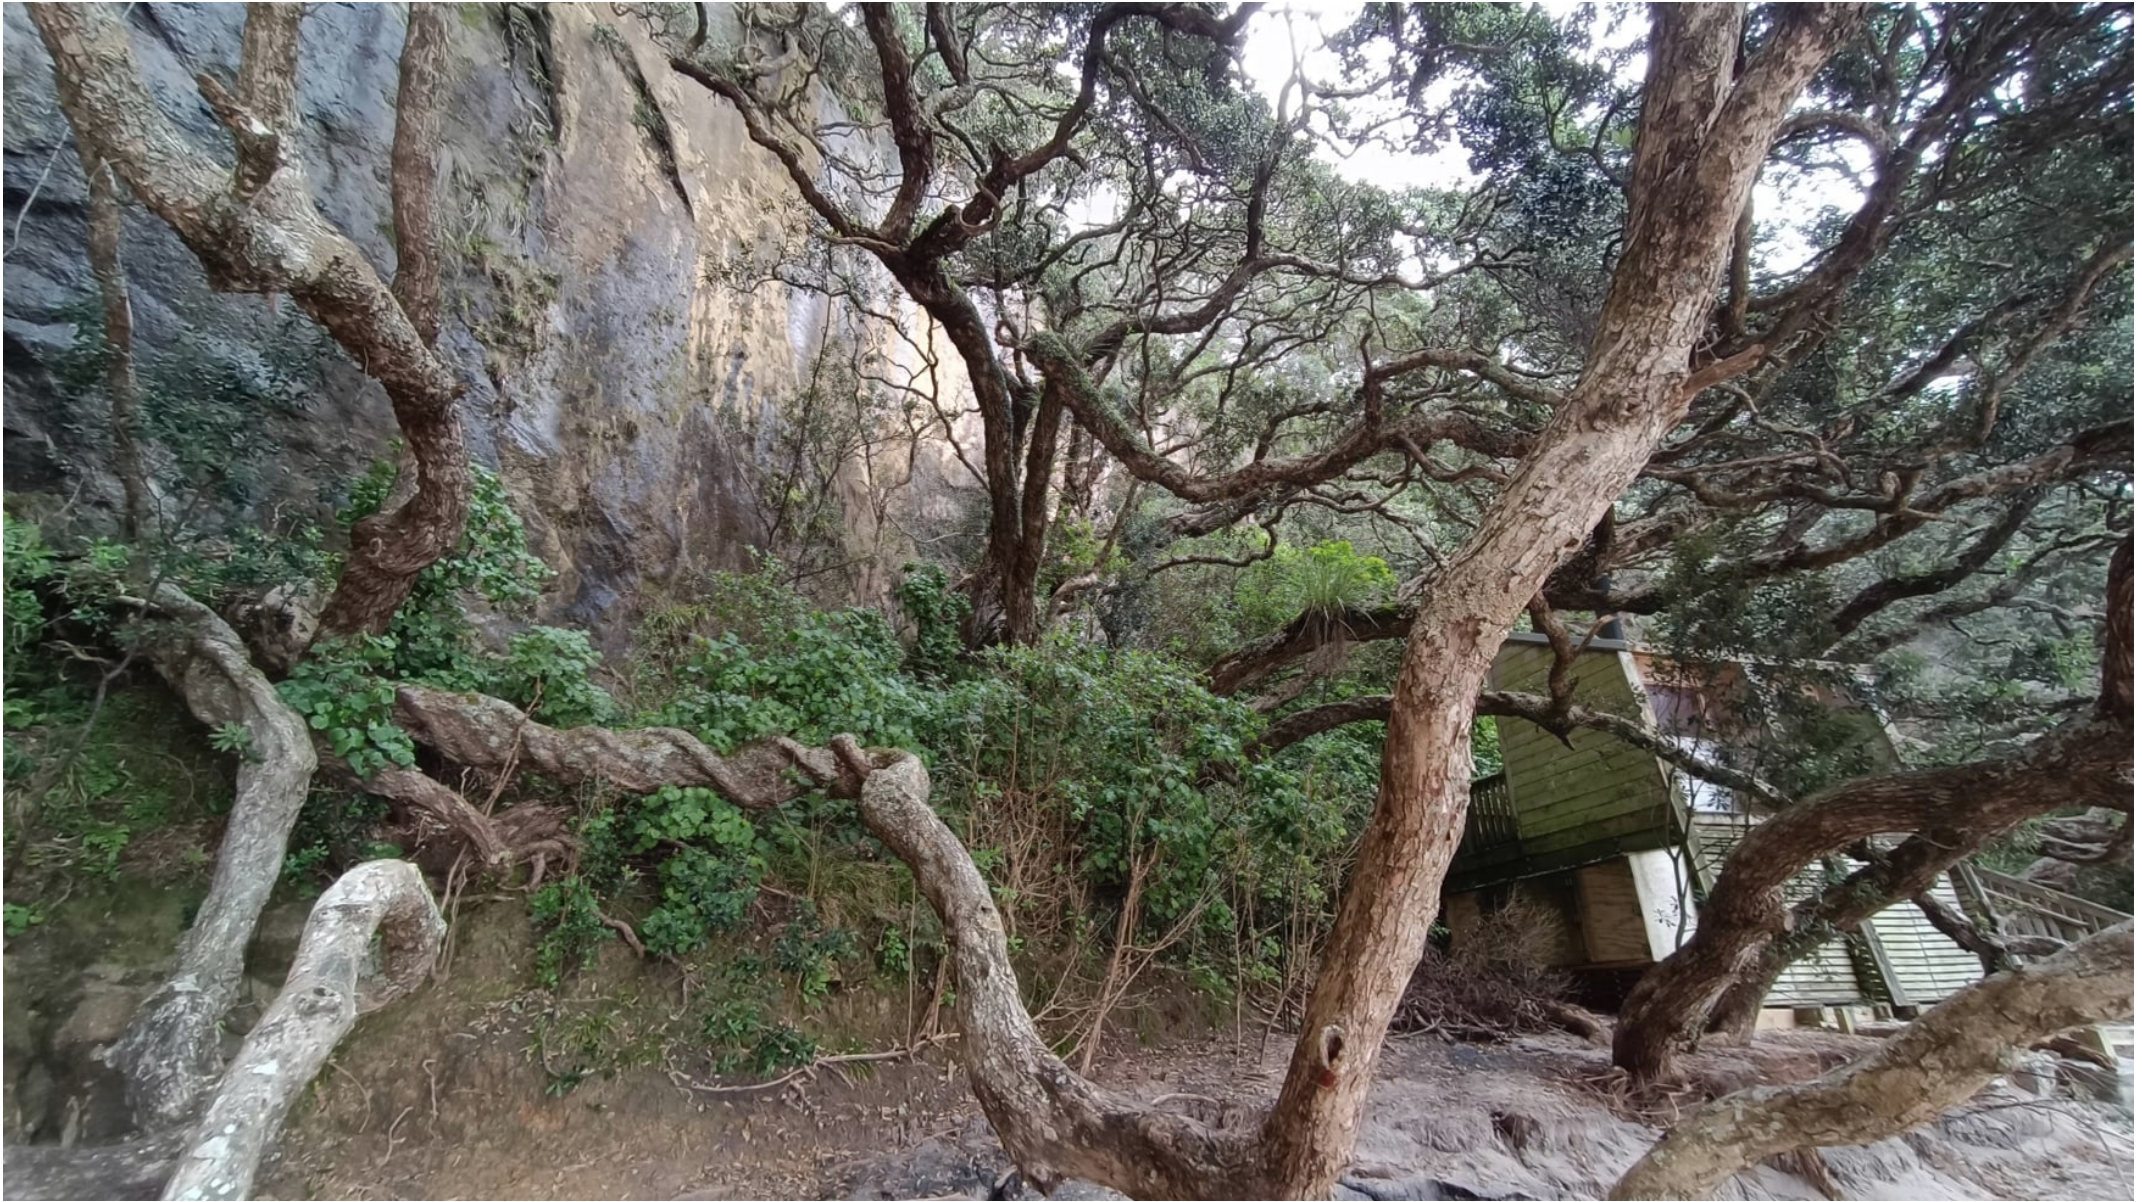
Figure C2 Historical debris / talus at the toe of the coastal cliff behind the existing toilet at Cathedral Cove Beach

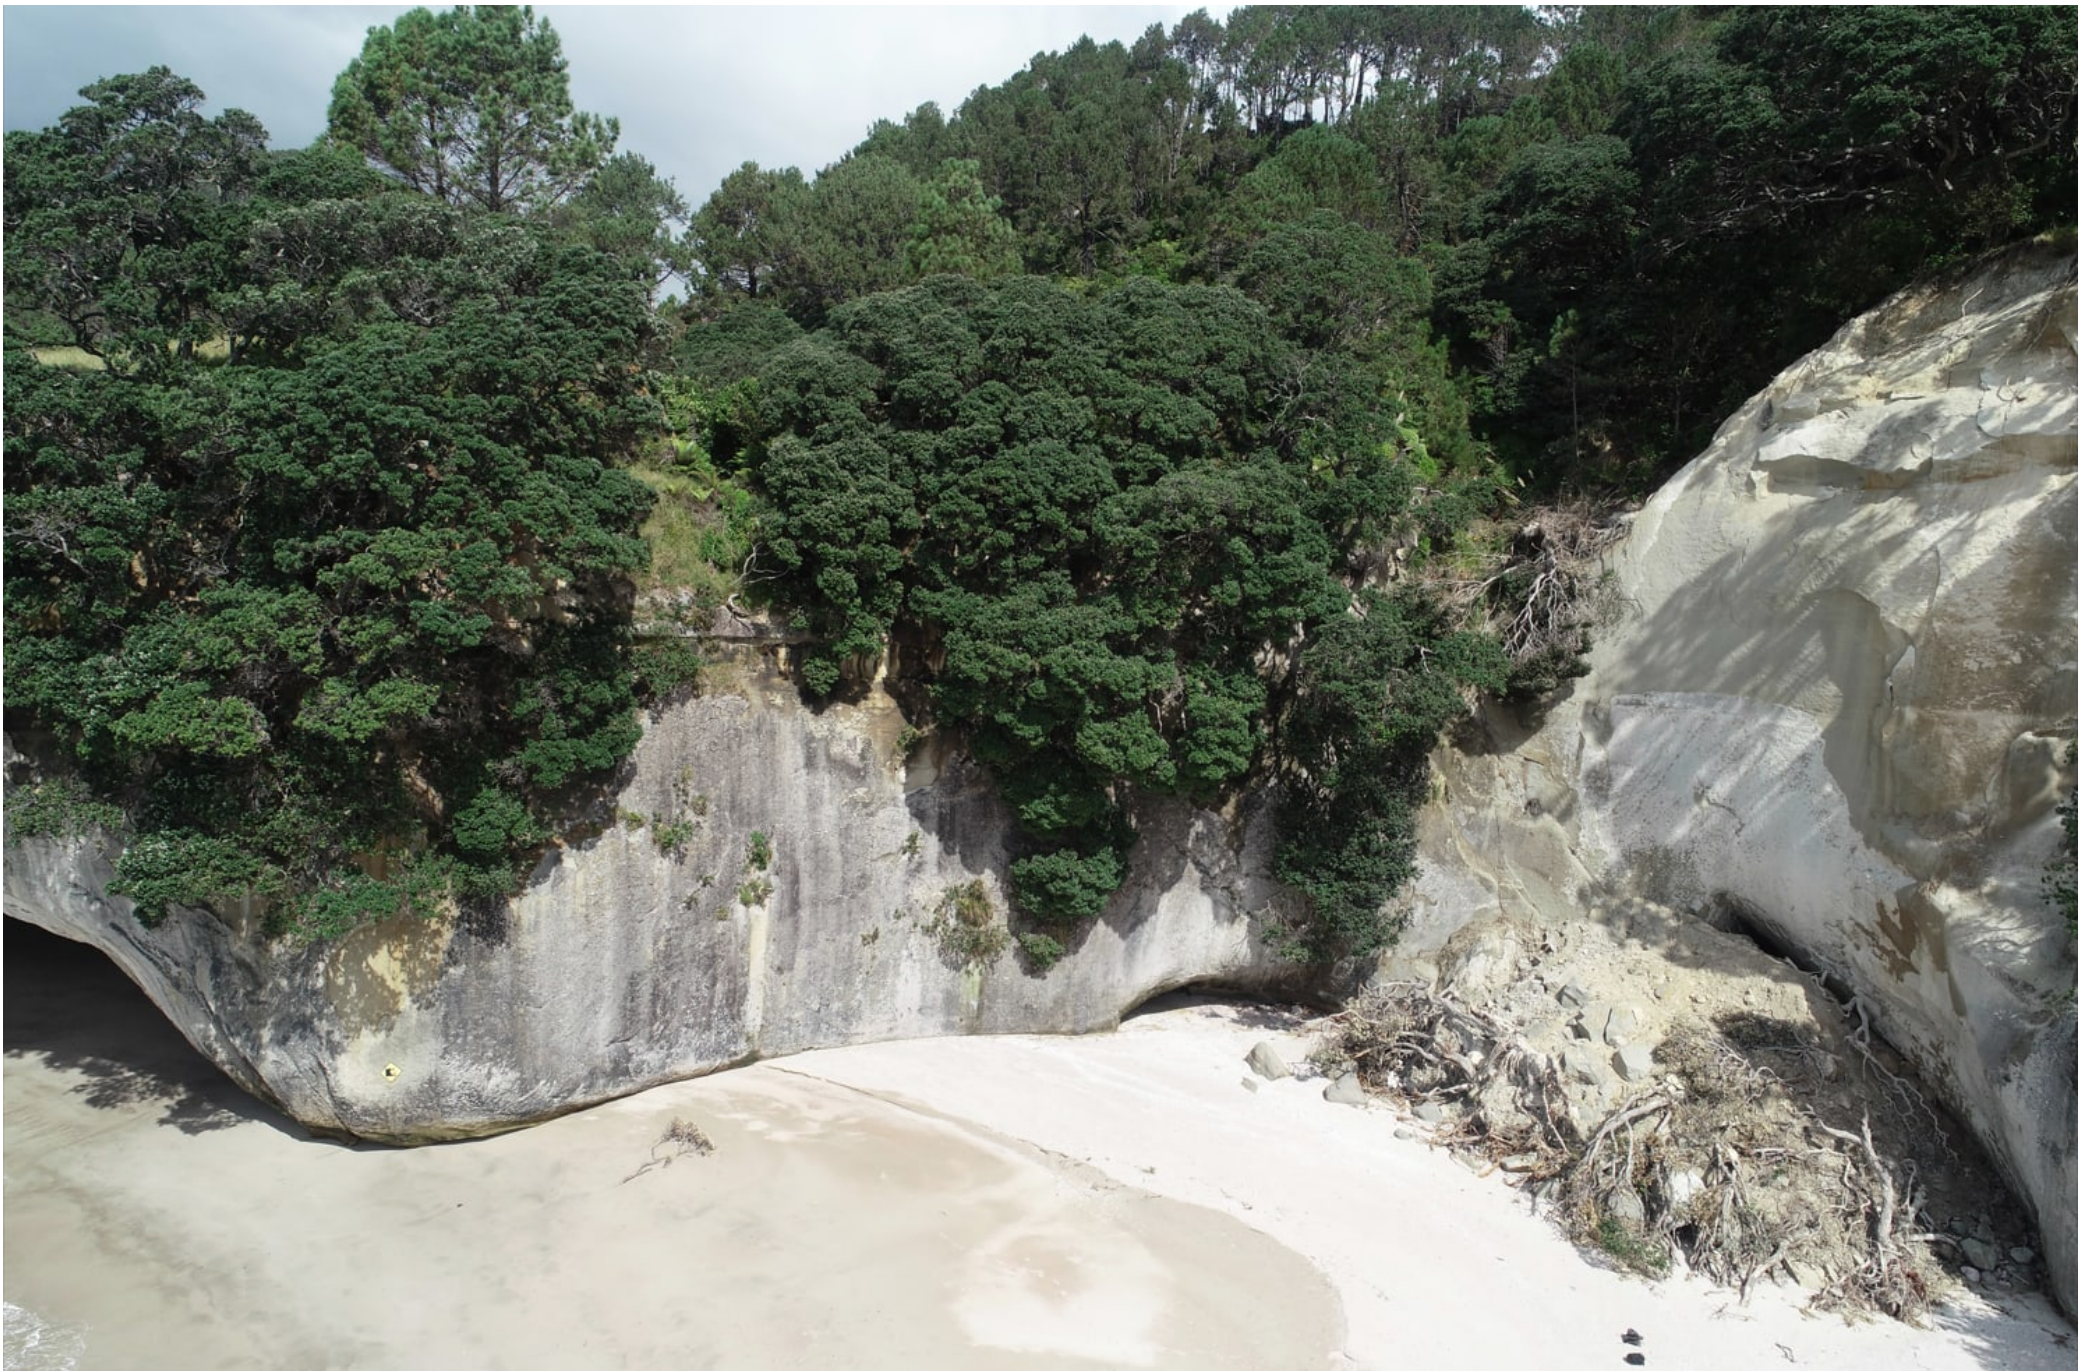
Figure C3 Recent and historical debris / talus at the toe of the coastal cliff on Cathedral Cove Beach

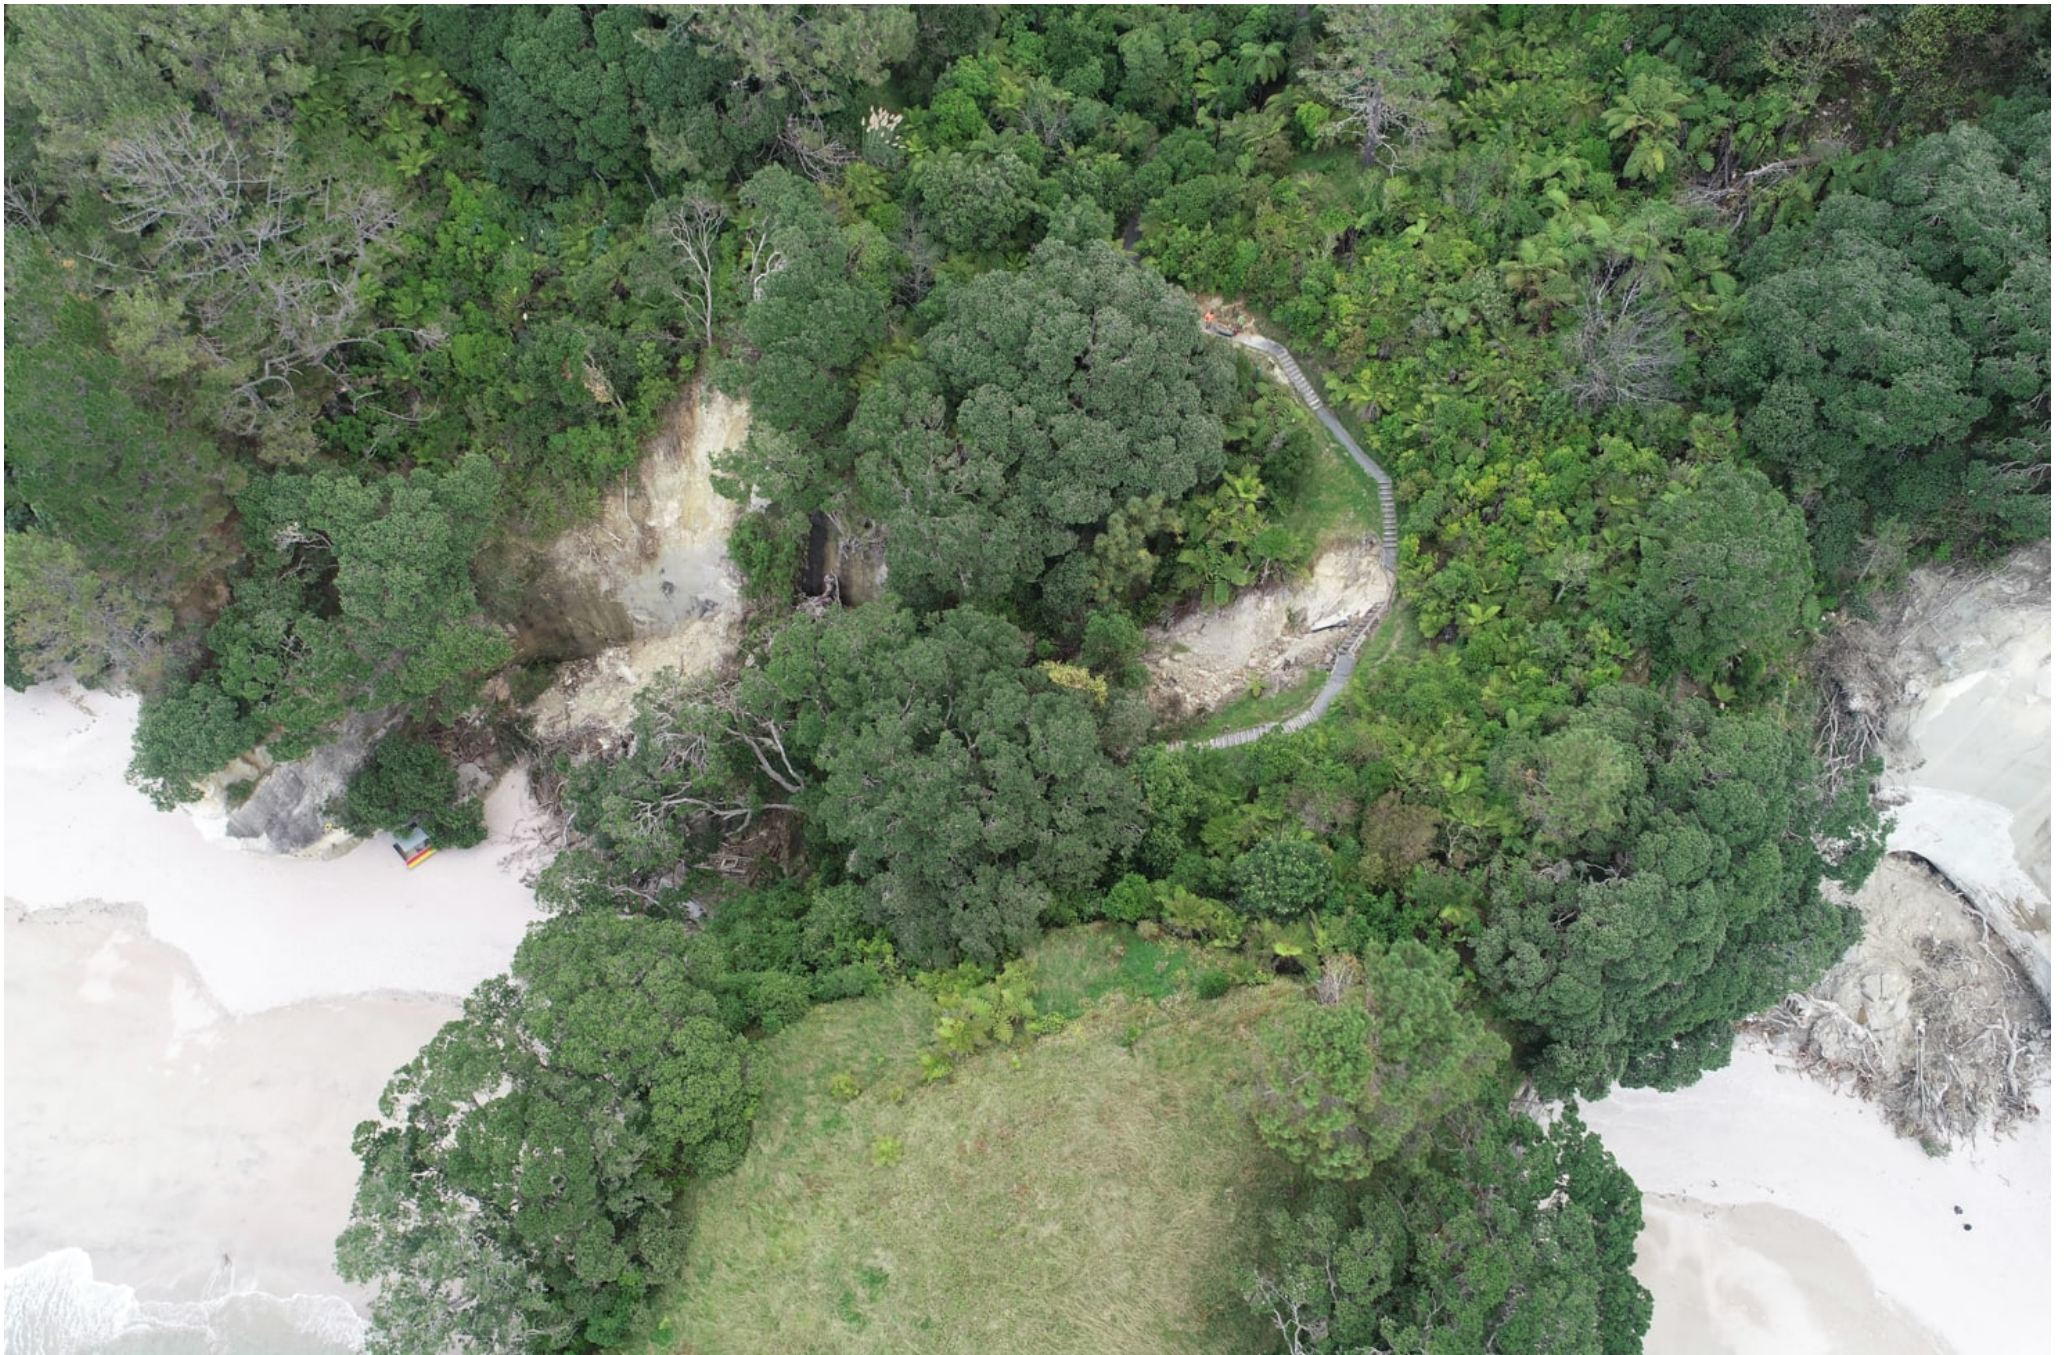
Figure C4 Aerial view of the damage to Cathedral Cove Track

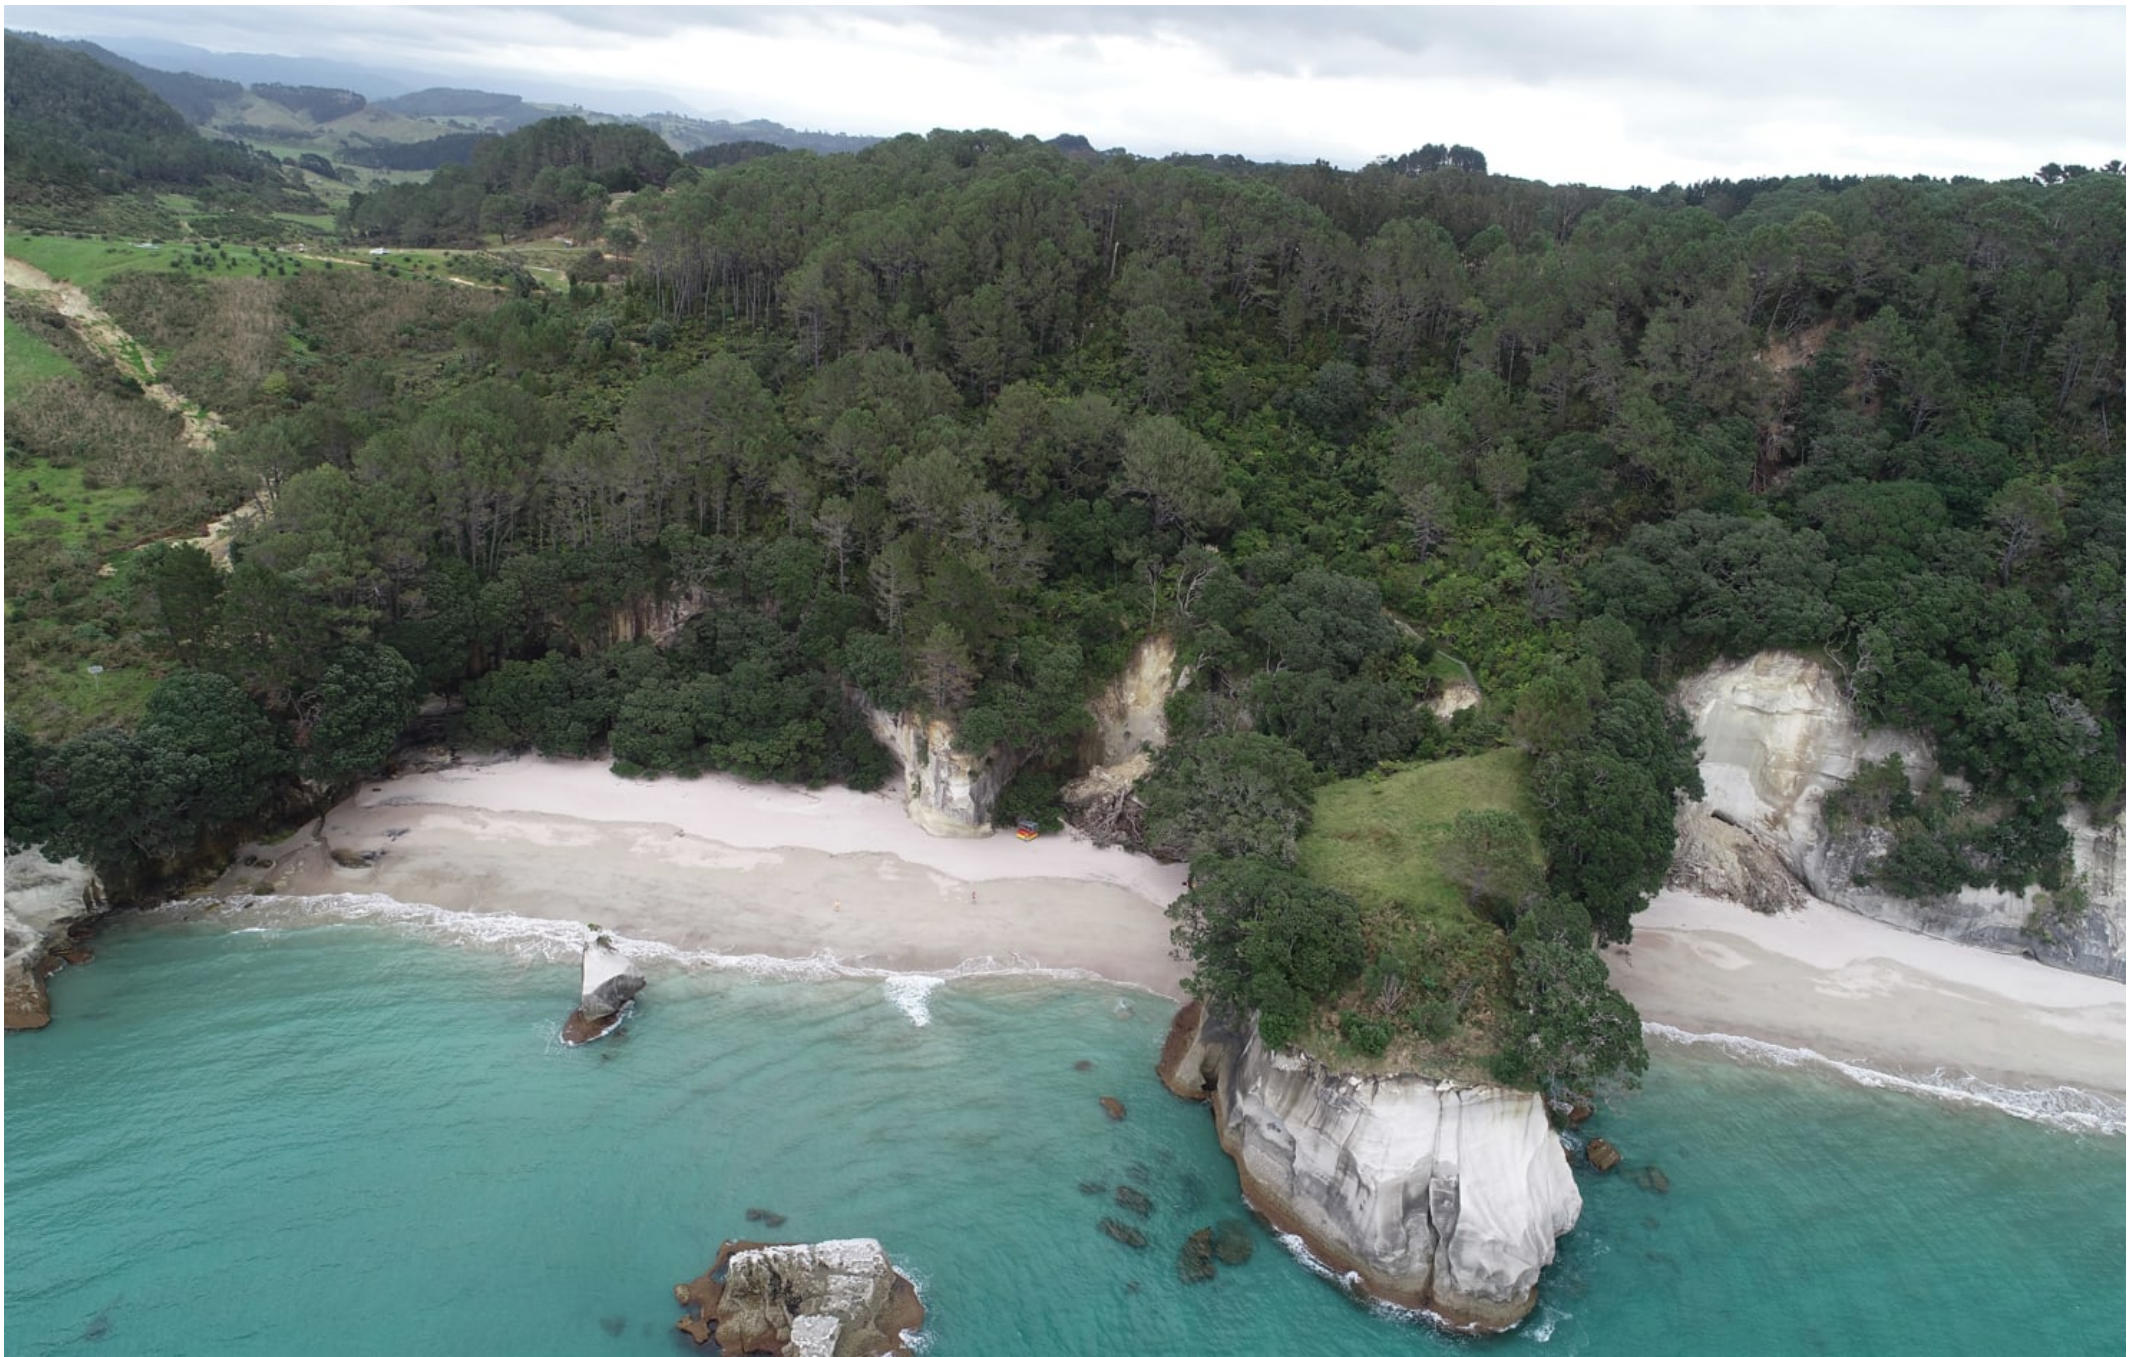
Figure C5 Aerial view of multiple landslides and rockfall at Cathedral Cove Track
