Cathedral Cove Basic Level Landslide Risk Assessment

Prepared for
Department of Conservation

Prepared by
Tonkin & Taylor Ltd

Date
July 2023

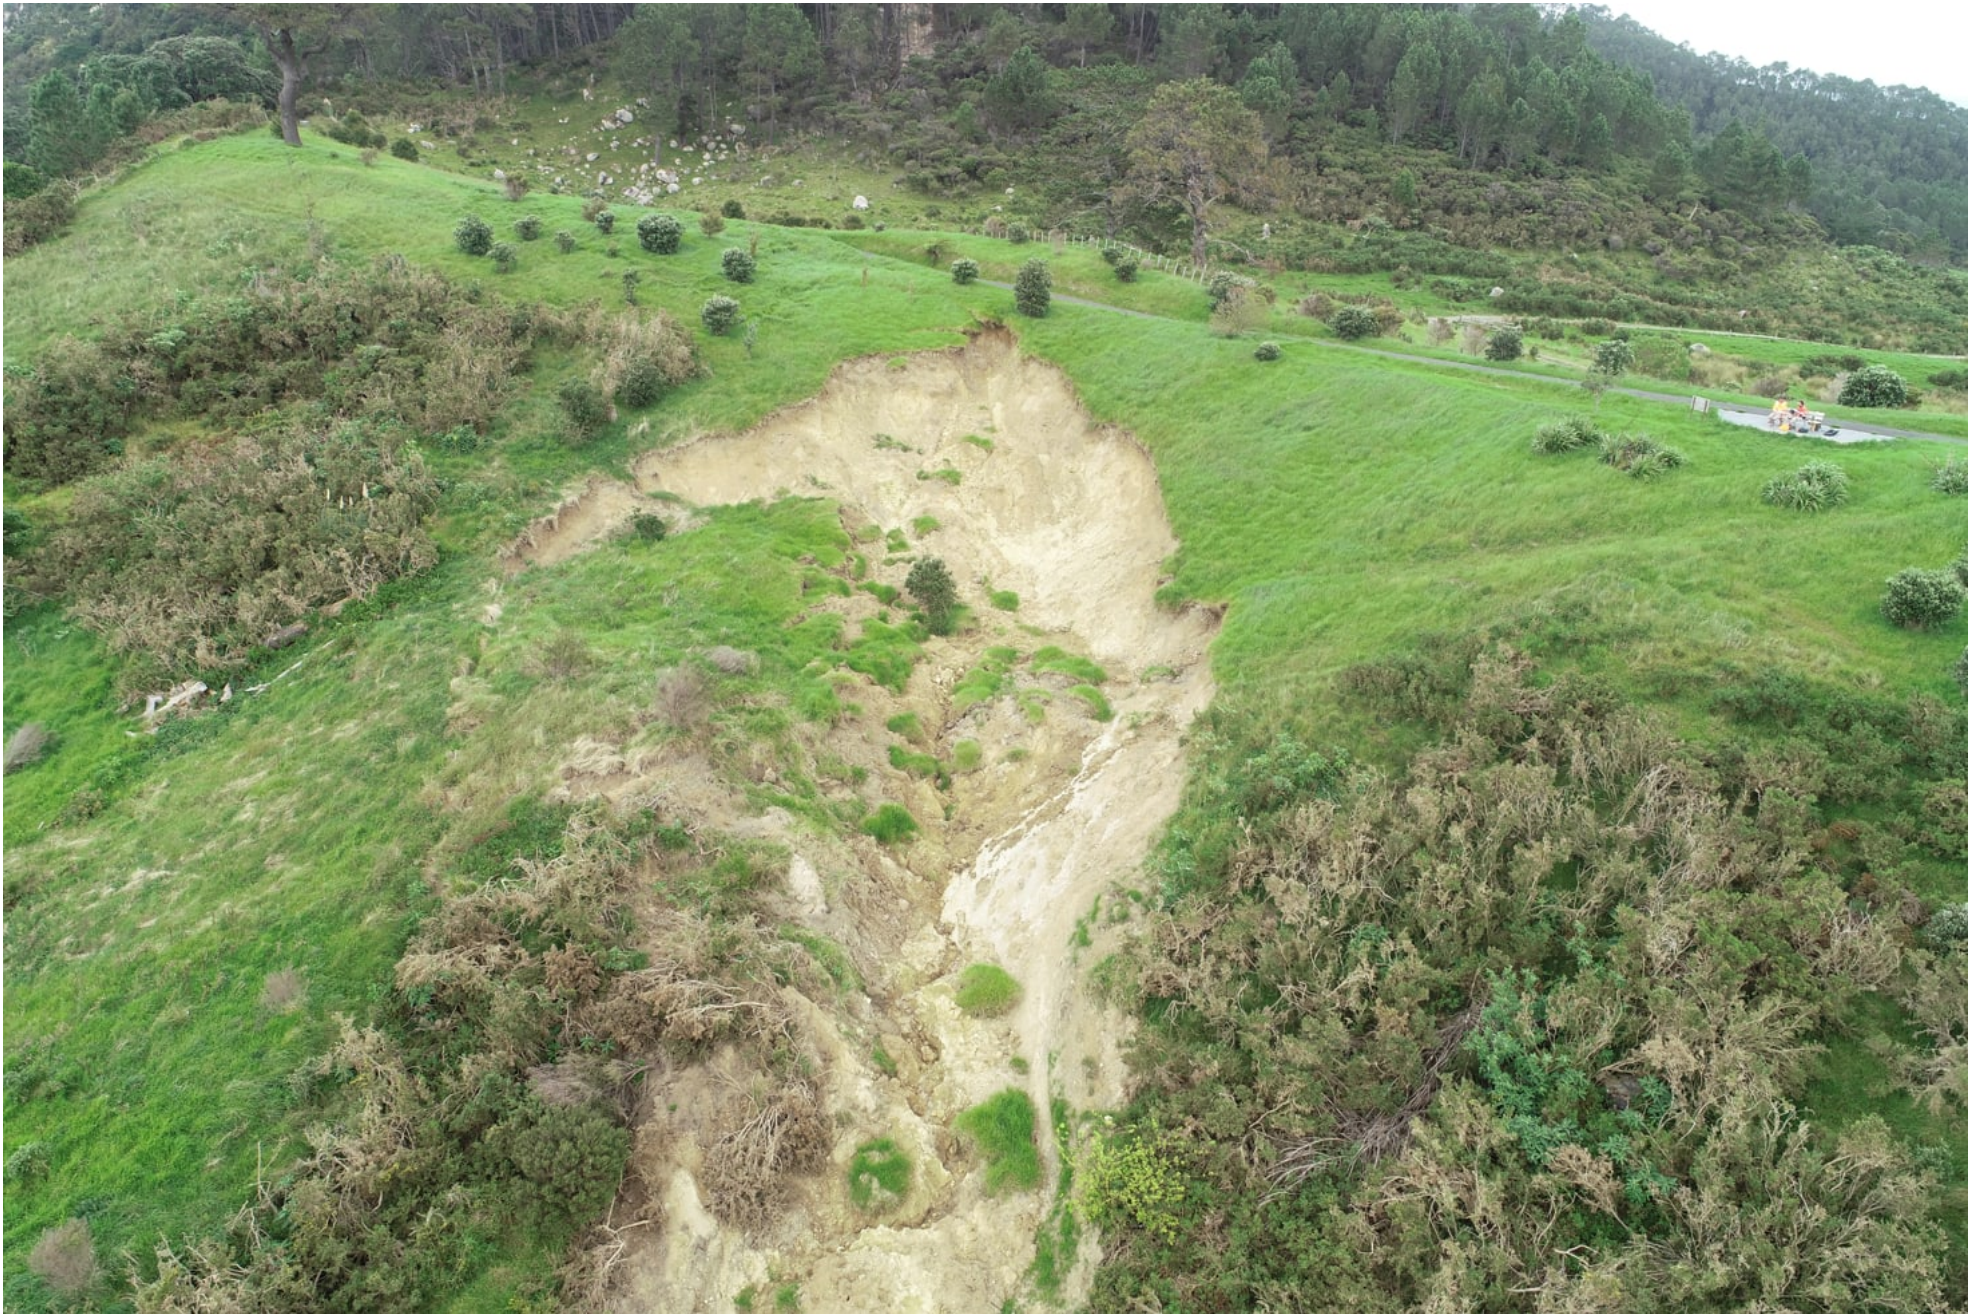
Figure C6 Aerial view of debris flow headscarp.
Tension cracks are visible in grass above headscarp
(directly below track).

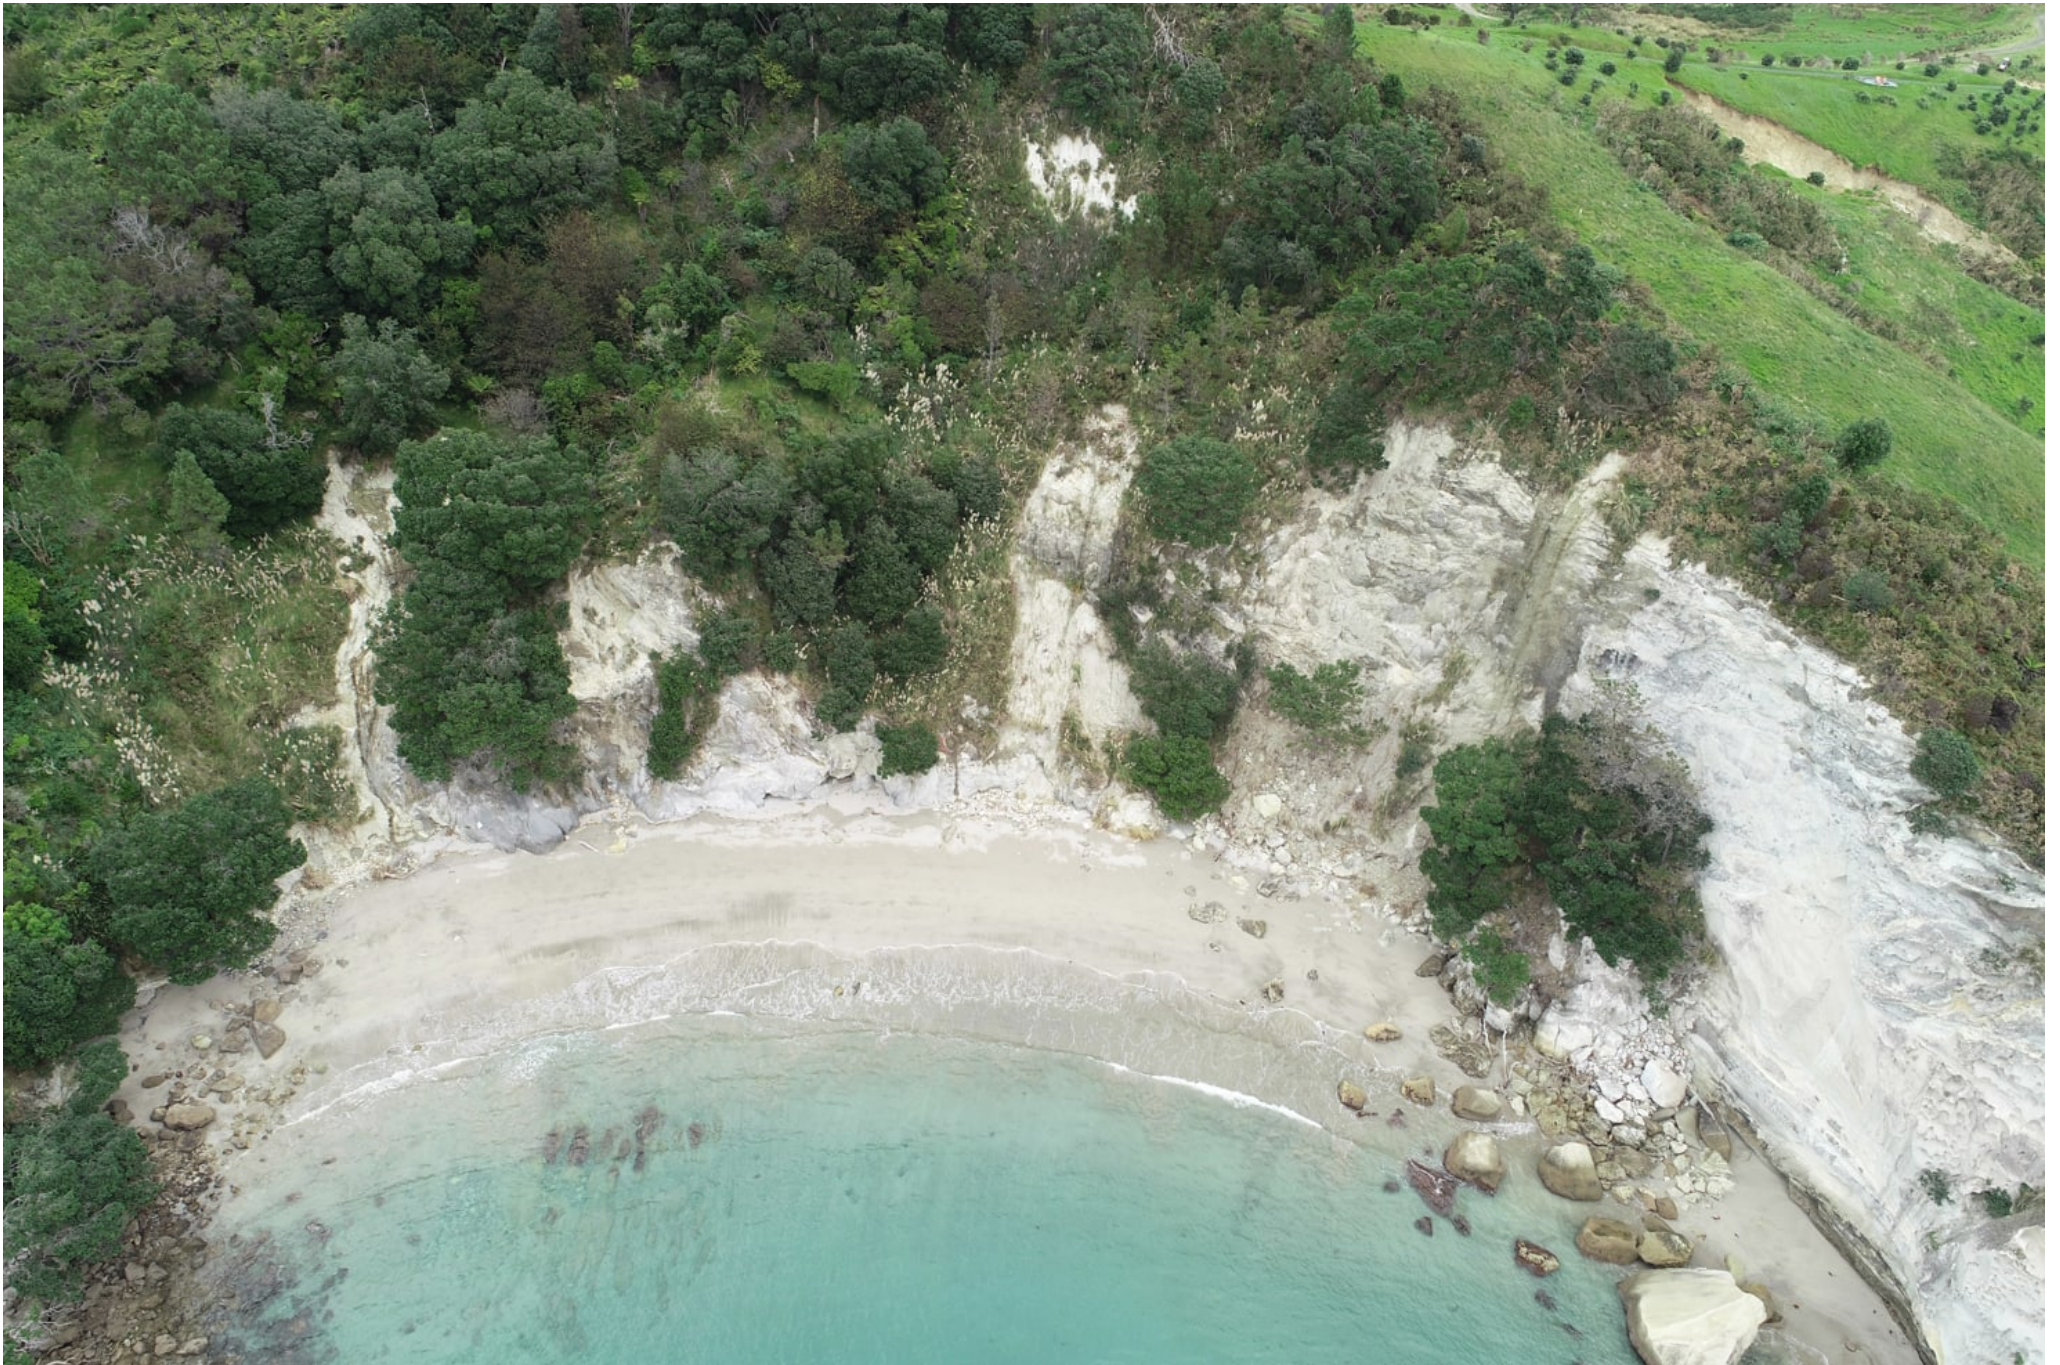
Figure C7 Aerial view of landslides at Stingray Bay

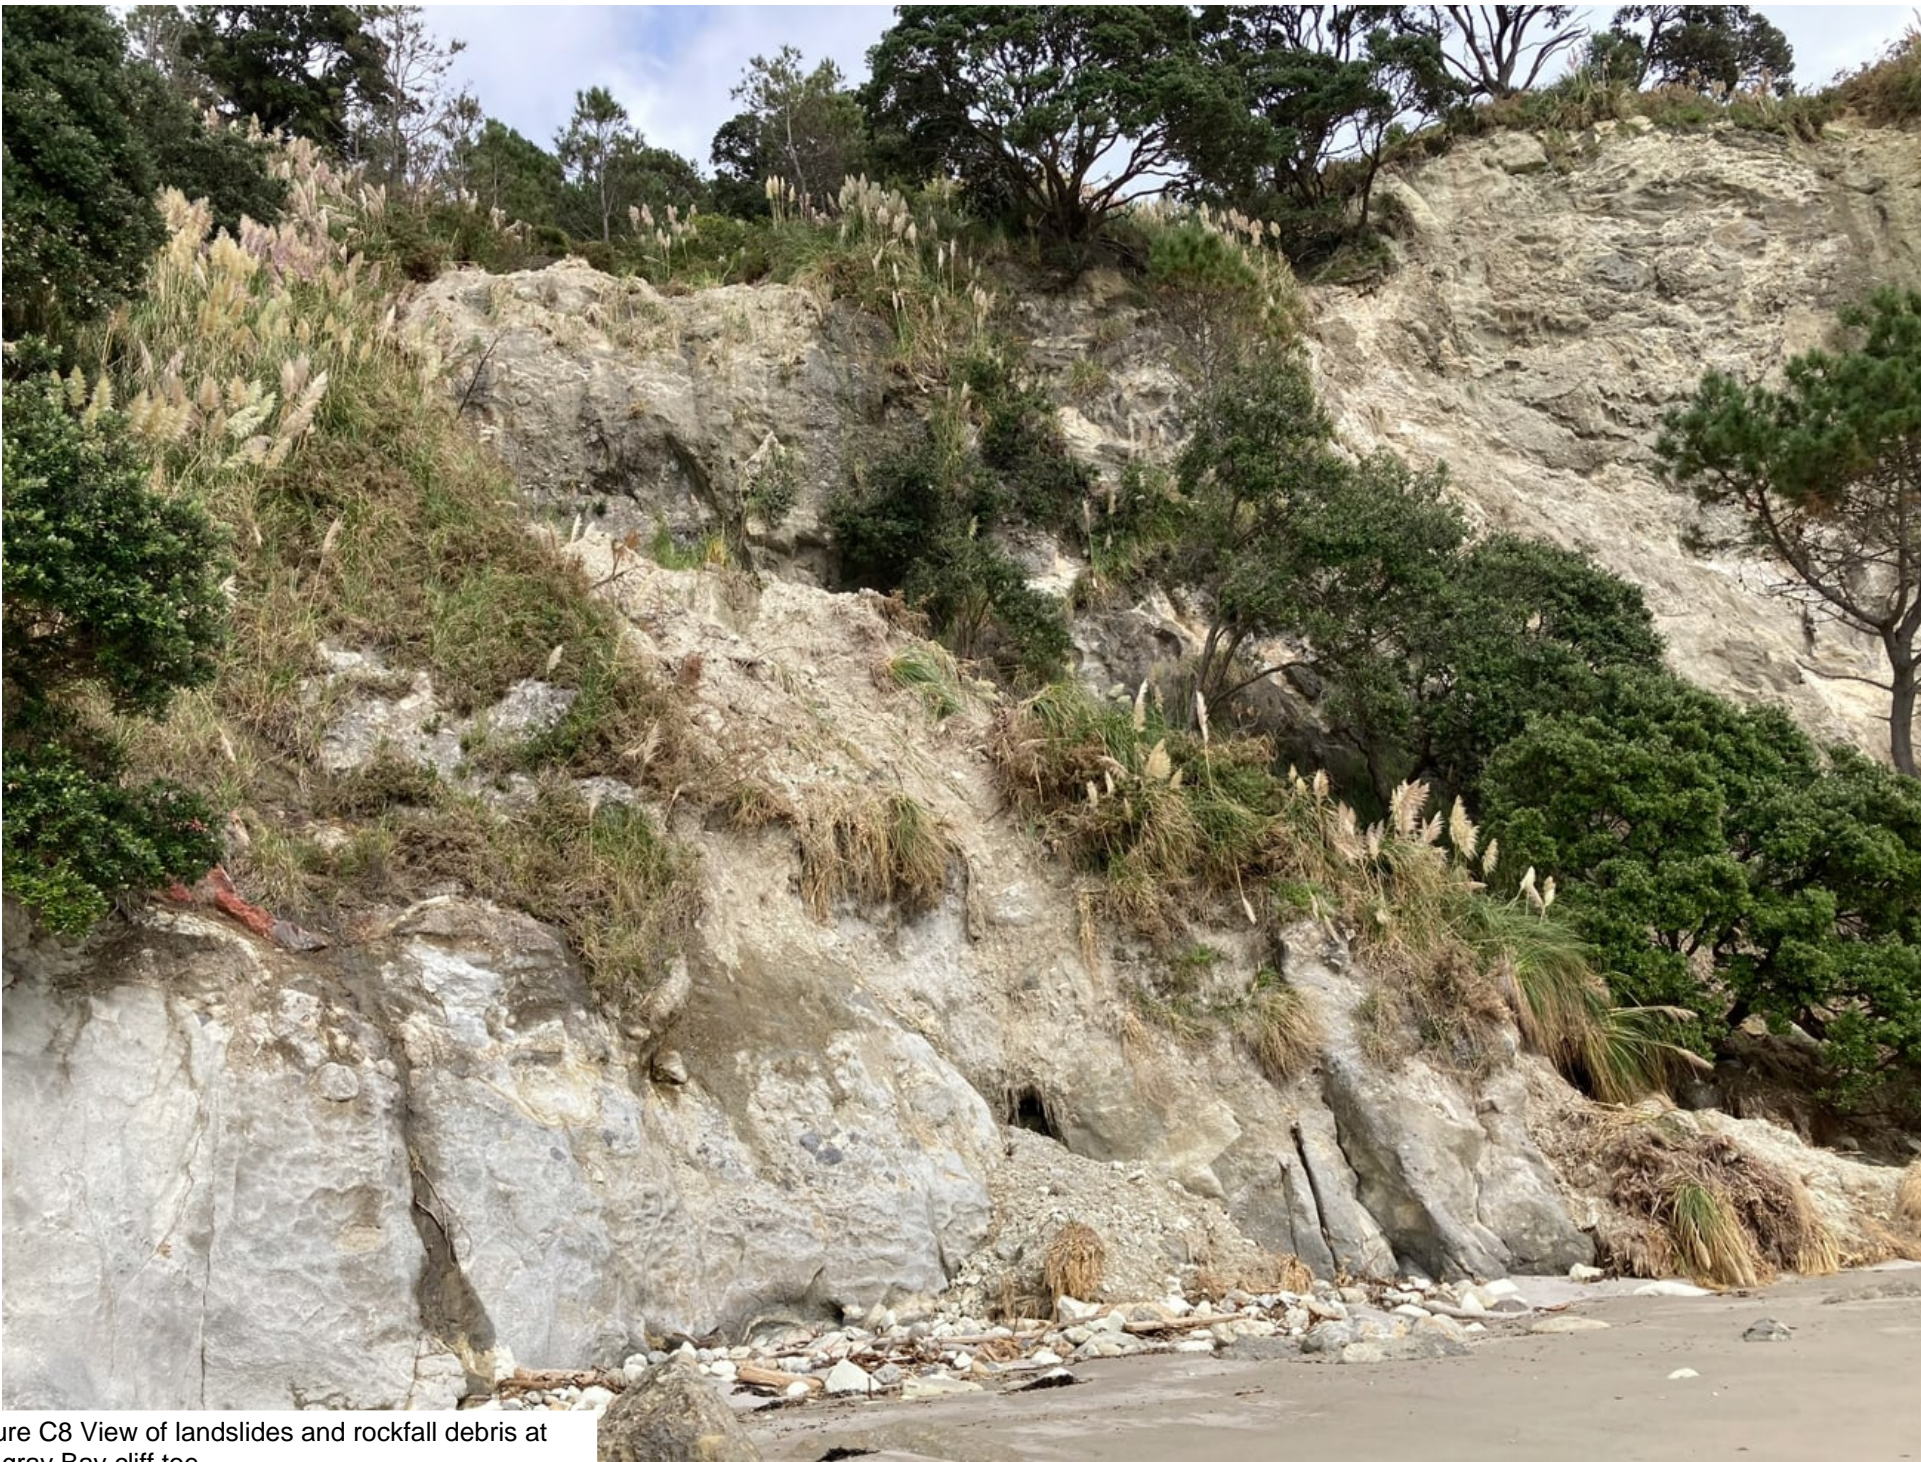
Figure C8 View of landslides and rockfall debris at Stingray Bay cliff toe

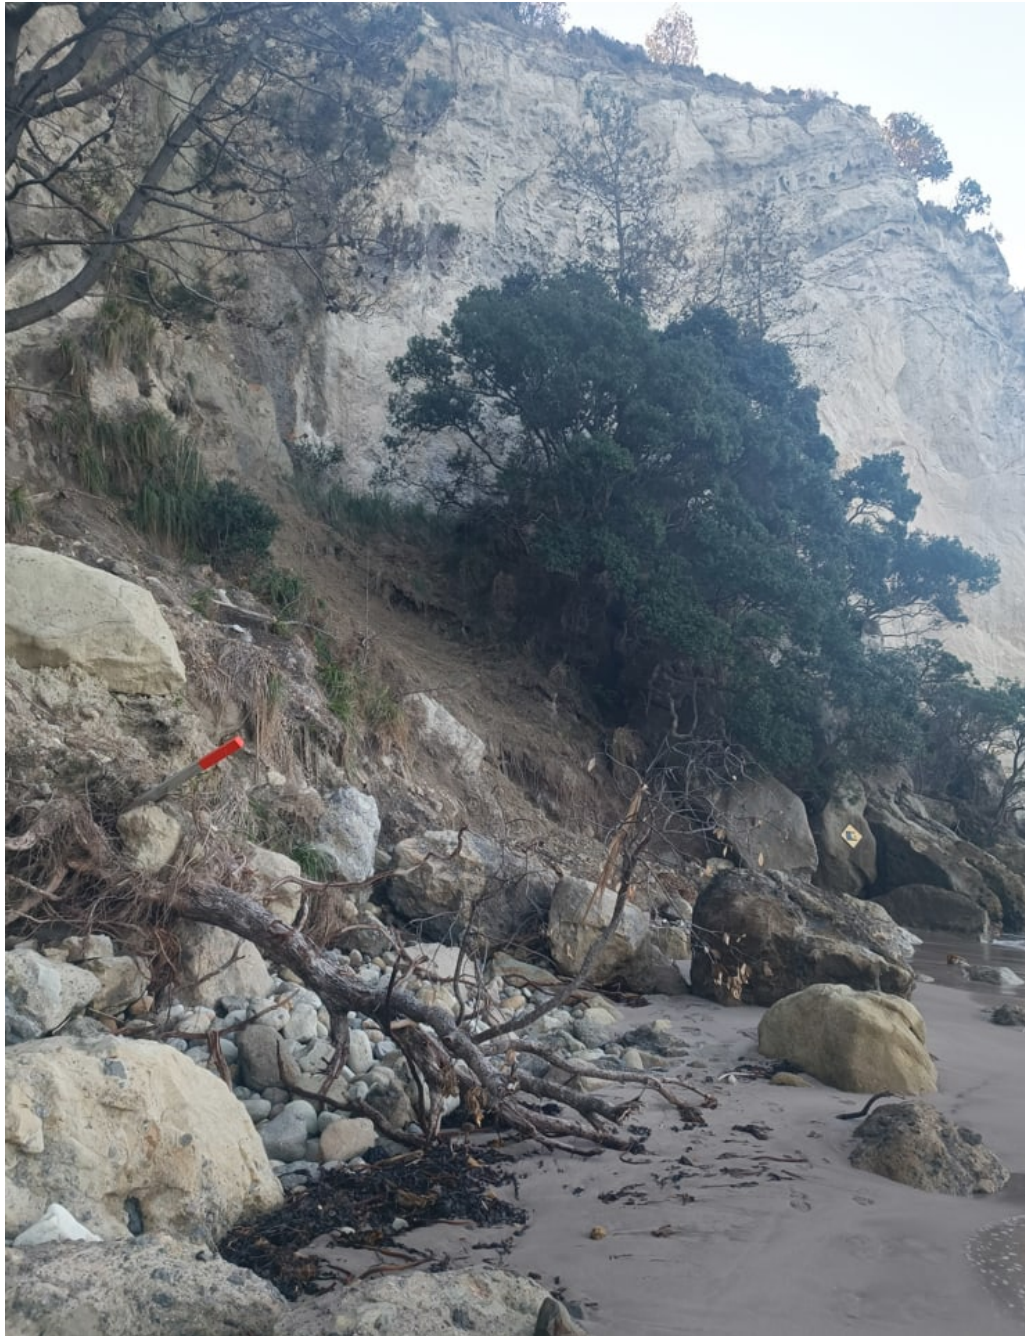
Figure C9 View of landslides and rockfall debris at Stingray Bay cliff toe

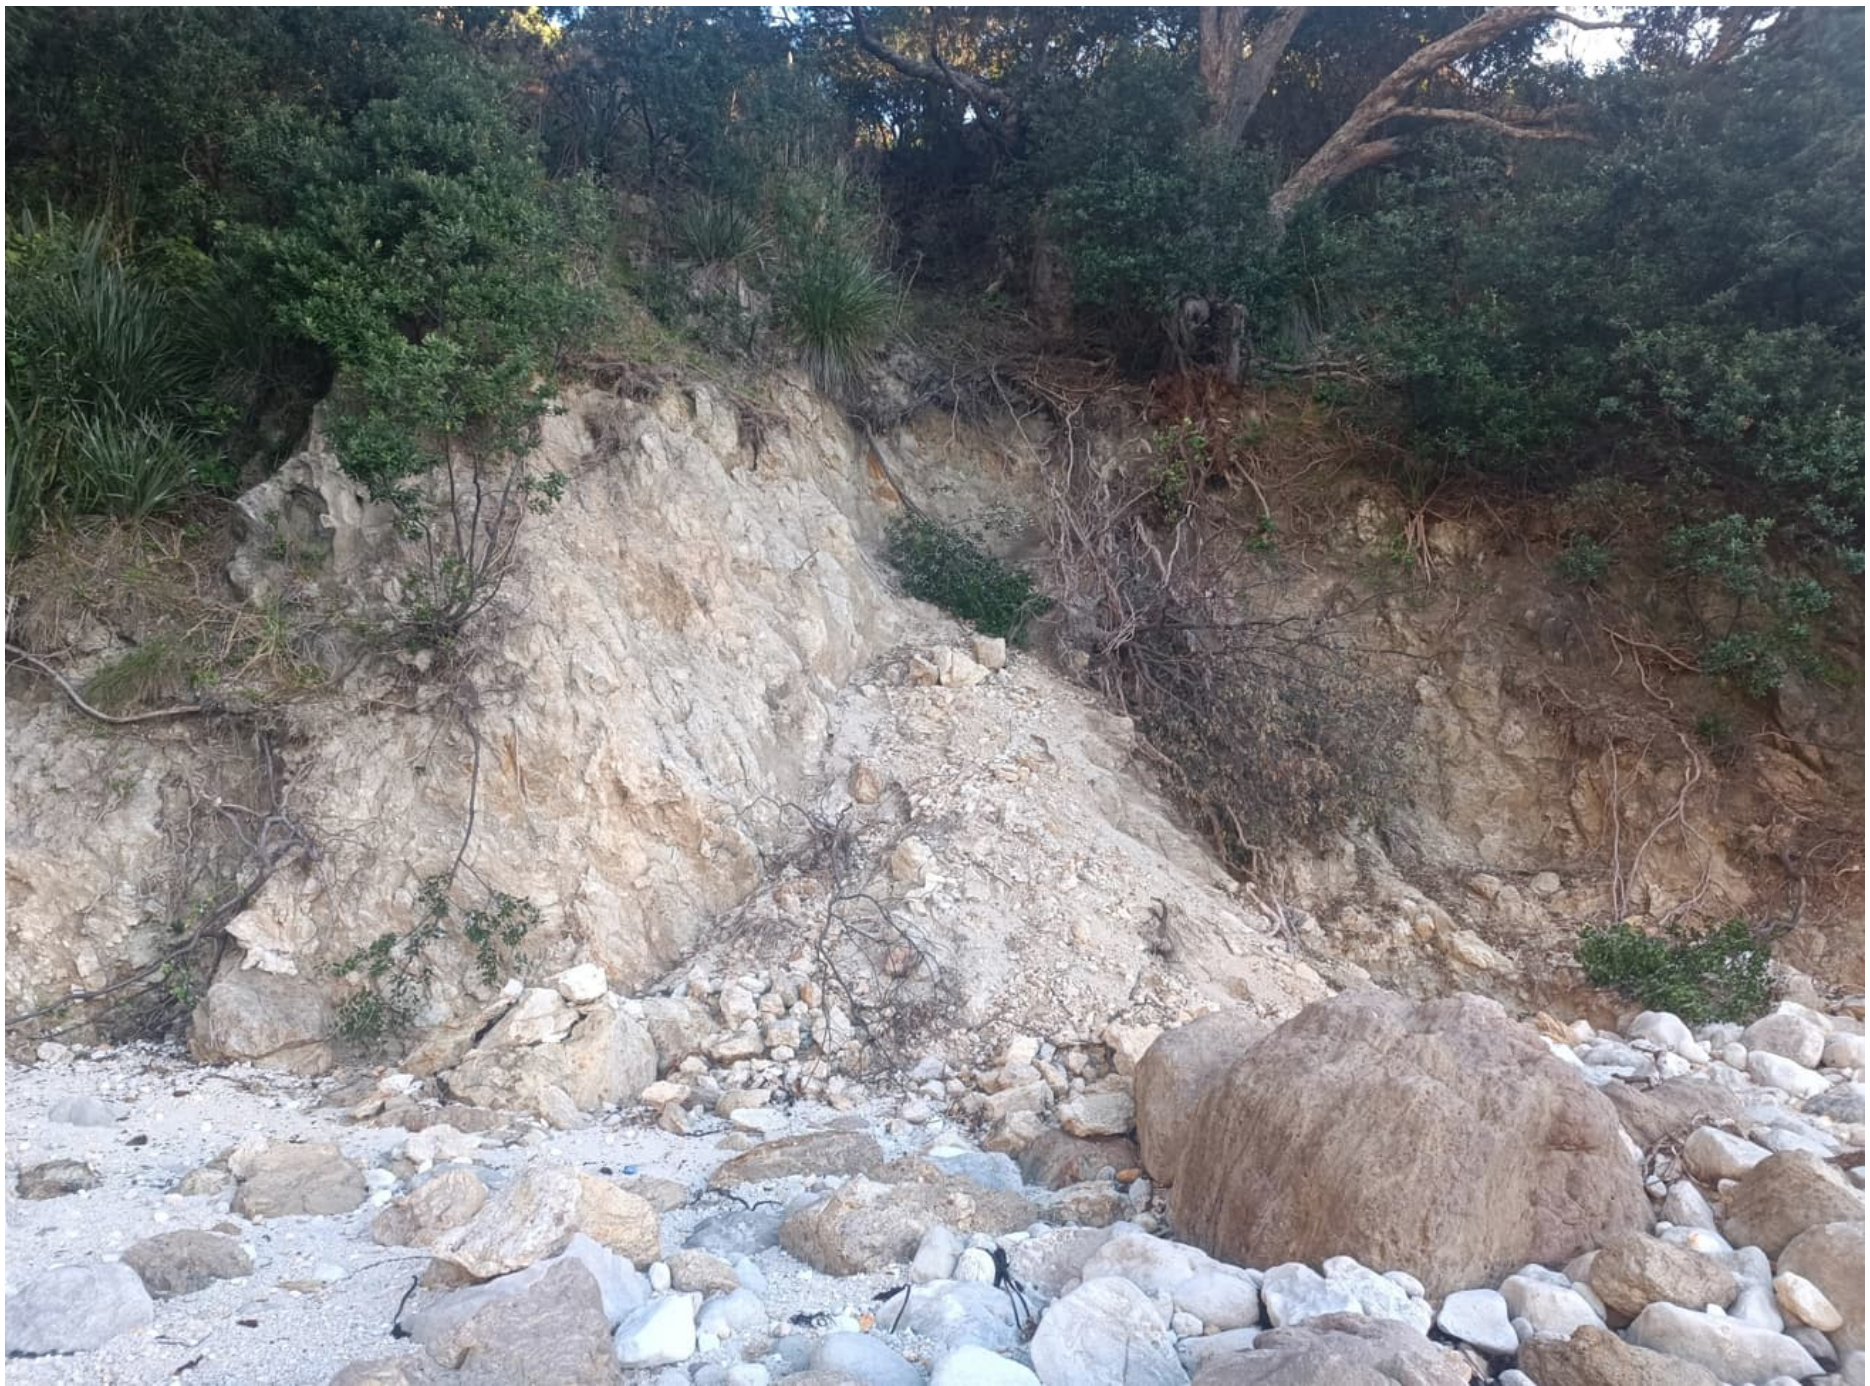
Figure C10 Rock and landslide debris at north end of Gemstone Bay

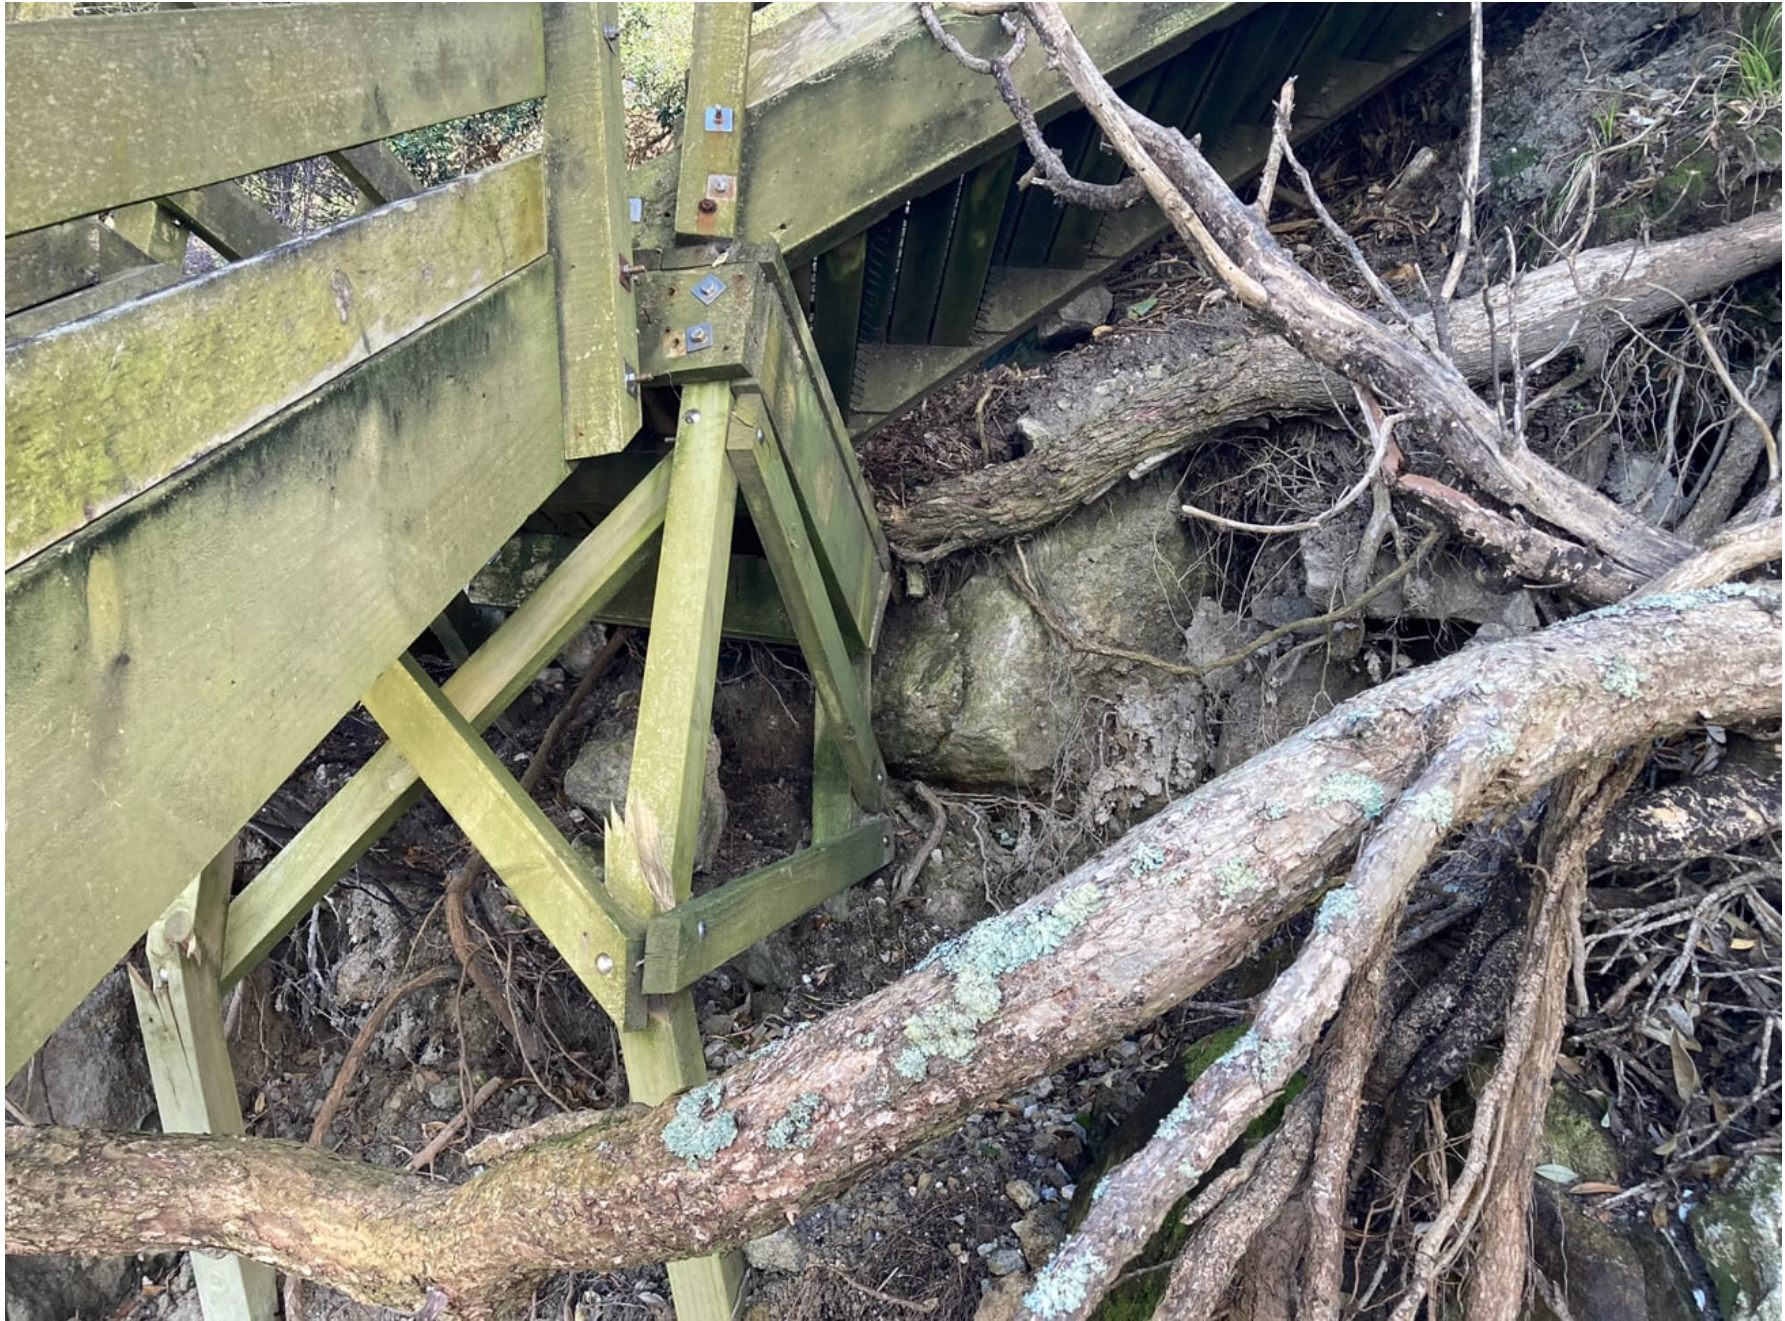
Figure C12 Gemstone Bay stair access damage and scour of loose boulders in slope.

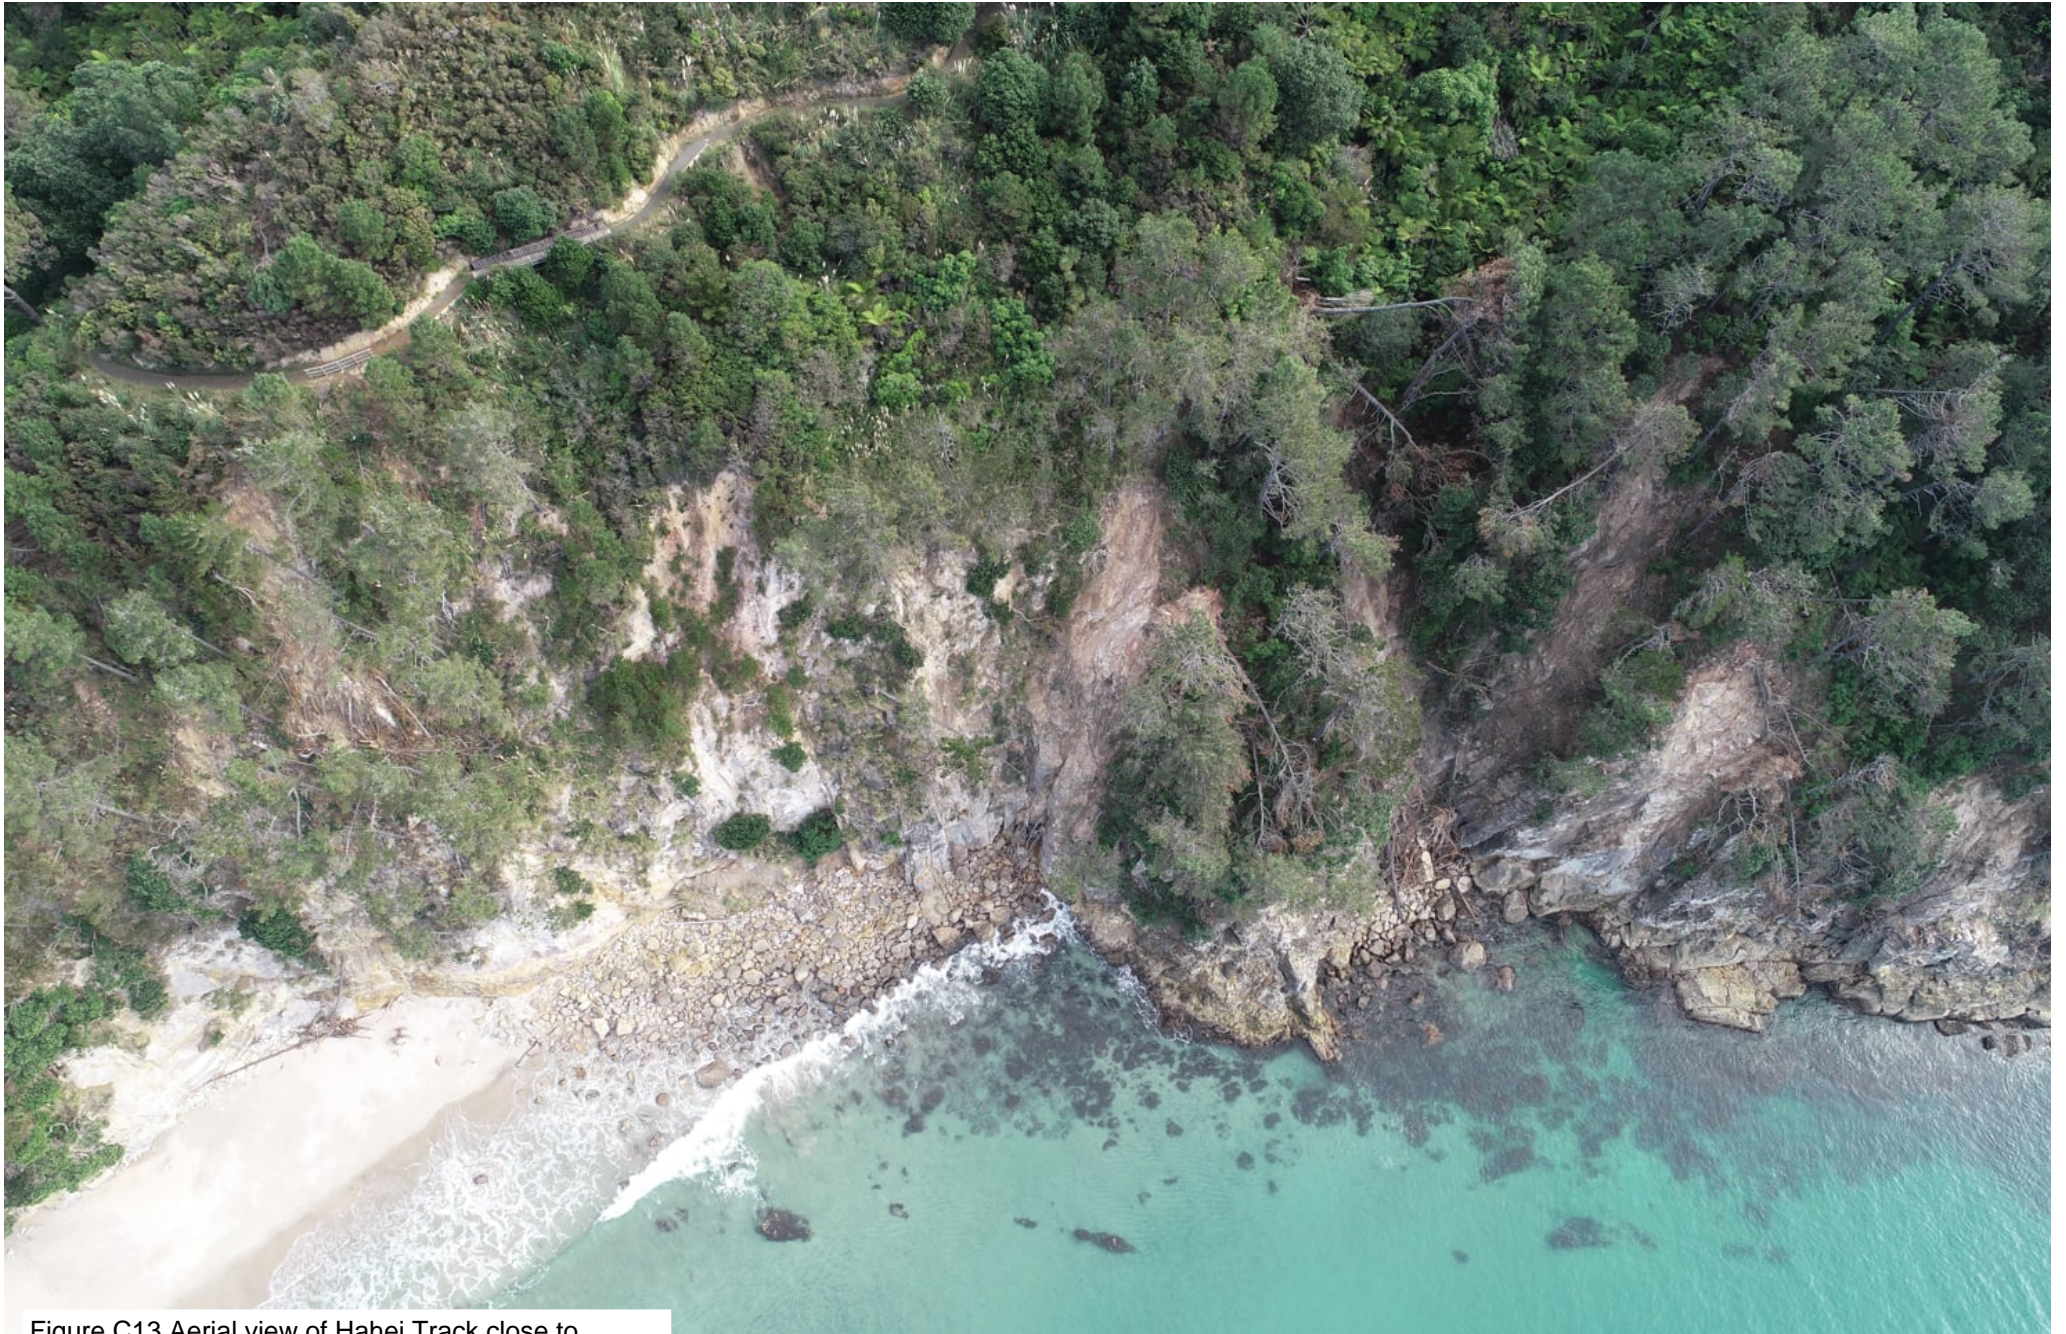
Figure C13 Aerial view of Hahei Track close to coastal cliff and recent landslides.

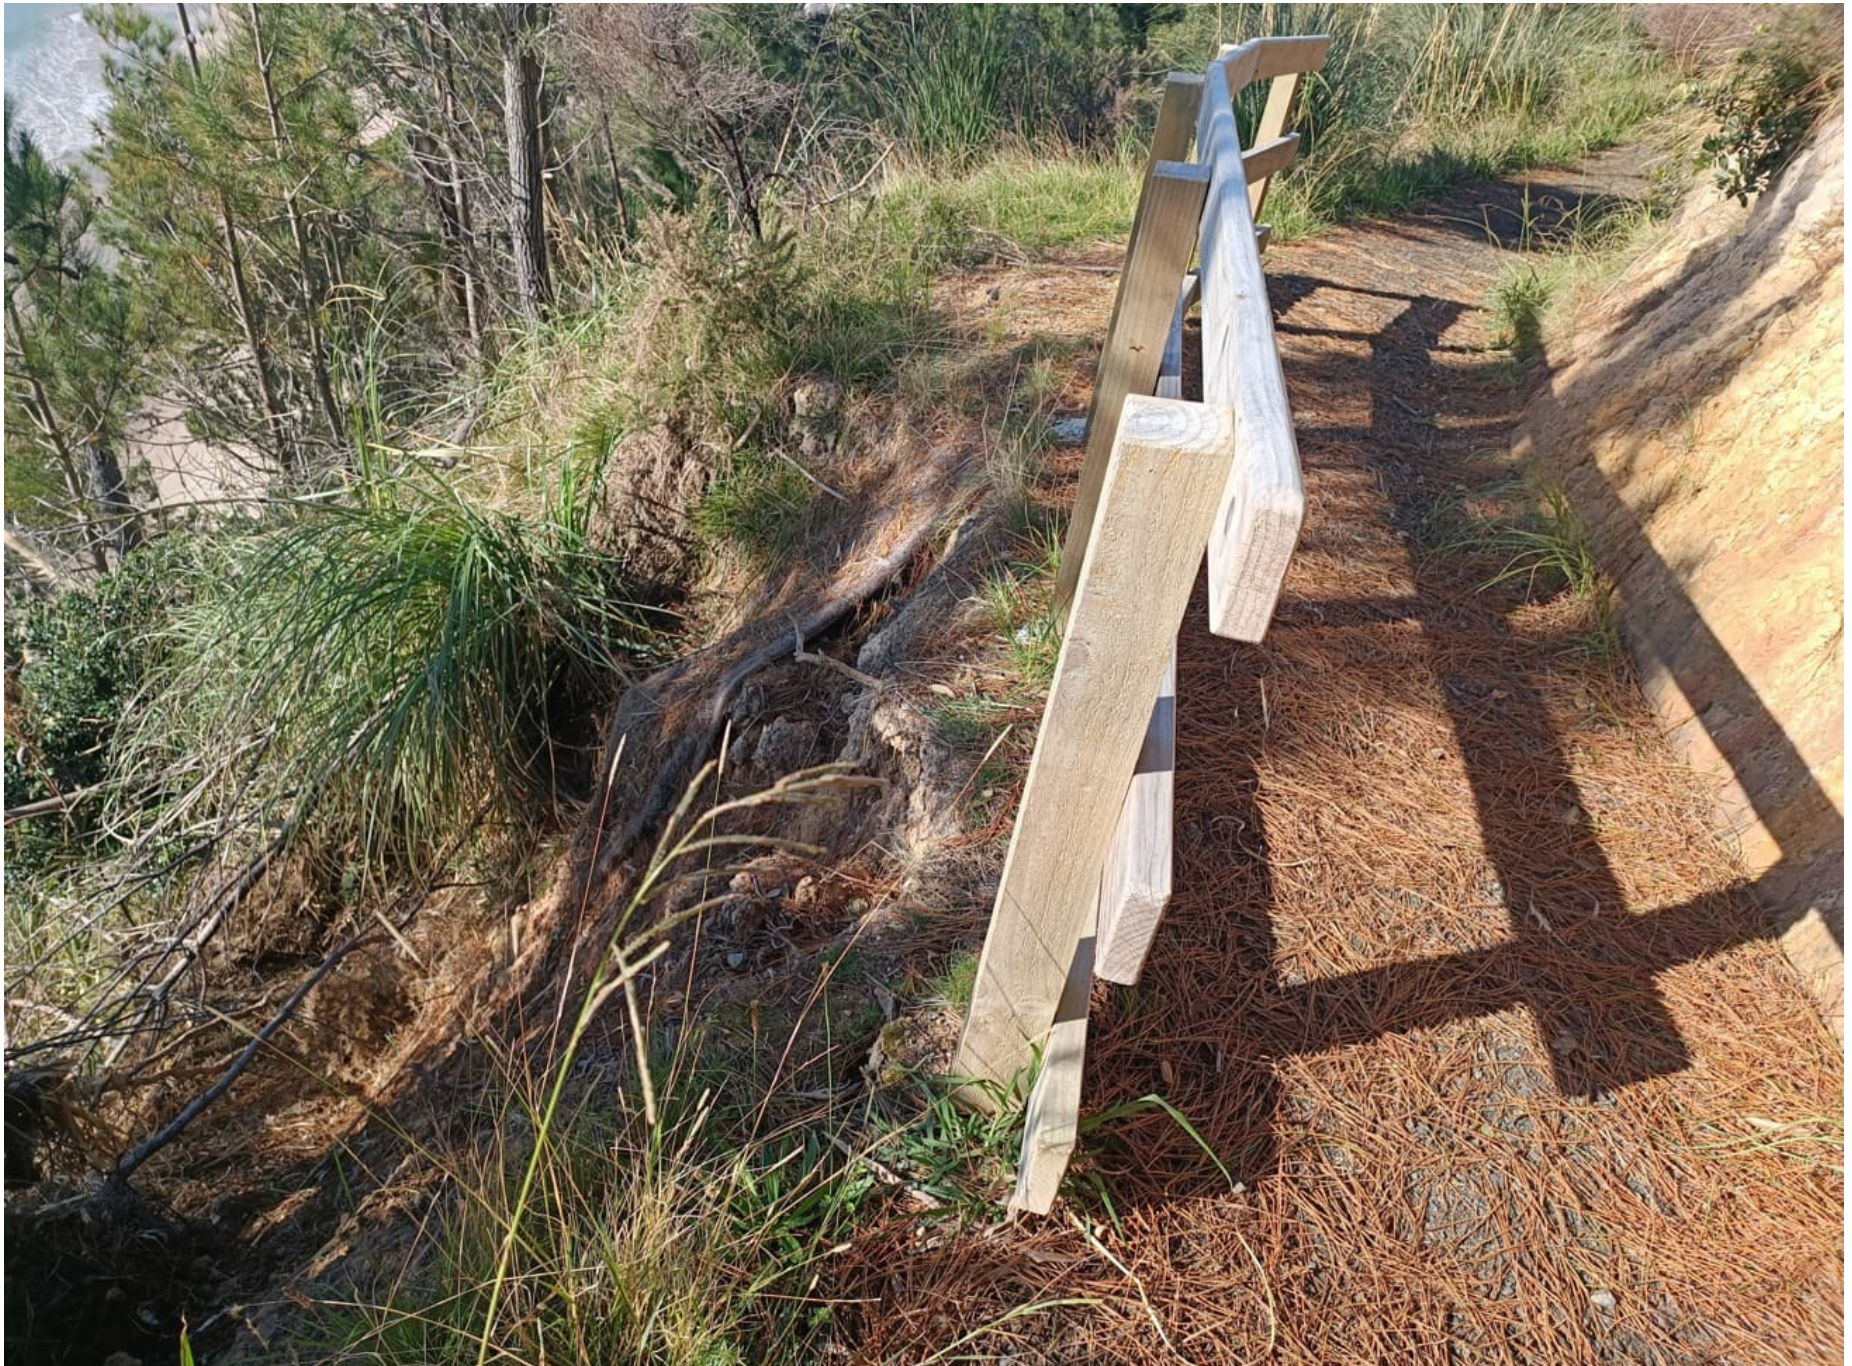
Figure C14 Landslide scarp close to Hahei Track

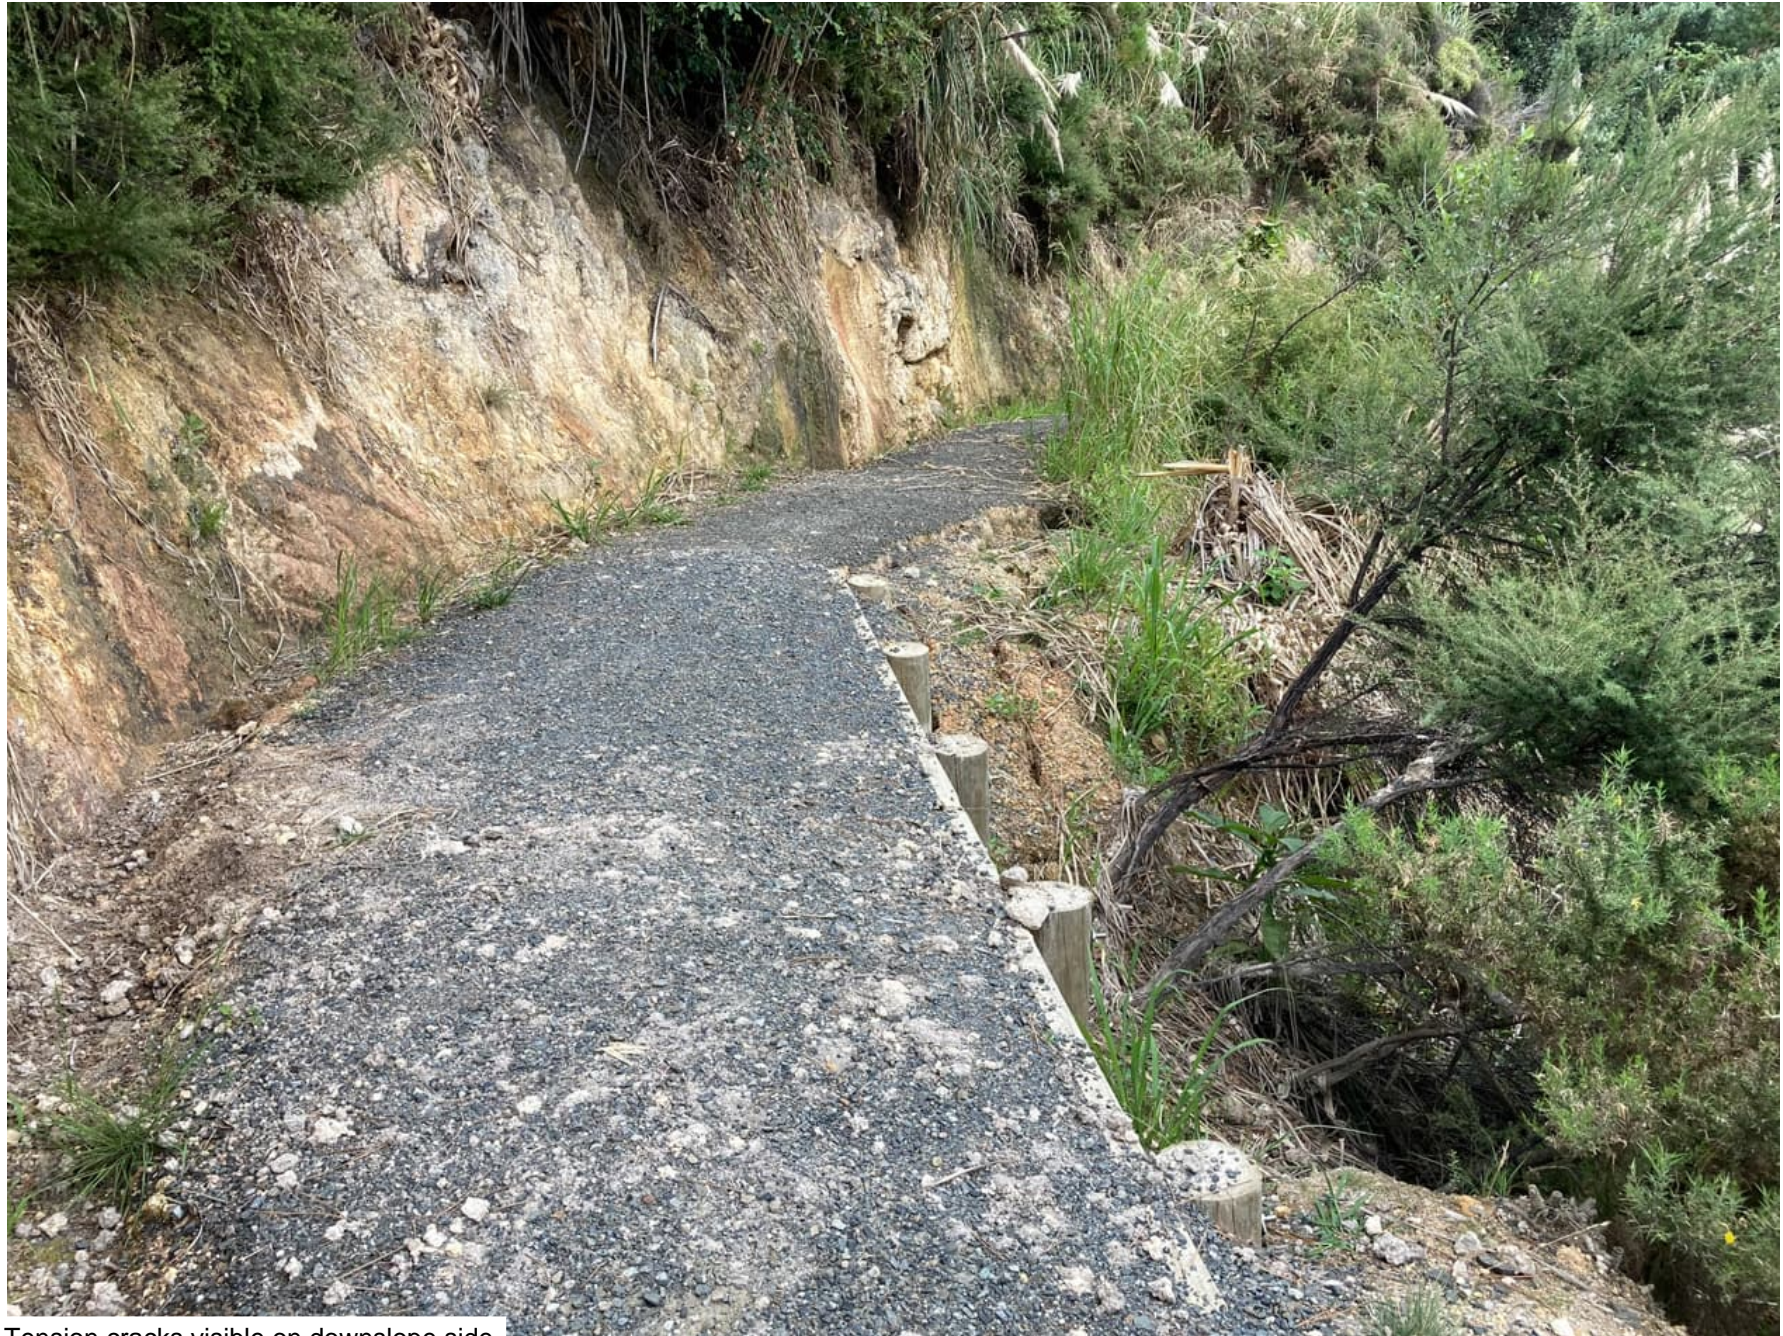
Figure C14 Tension cracks visible on downslope side of Hahei Track
