Cathedral Cove Basic Level Landslide Risk Assessment

Prepared for
Department of Conservation

Prepared by
Tonkin & Taylor Ltd

Date
July 2023

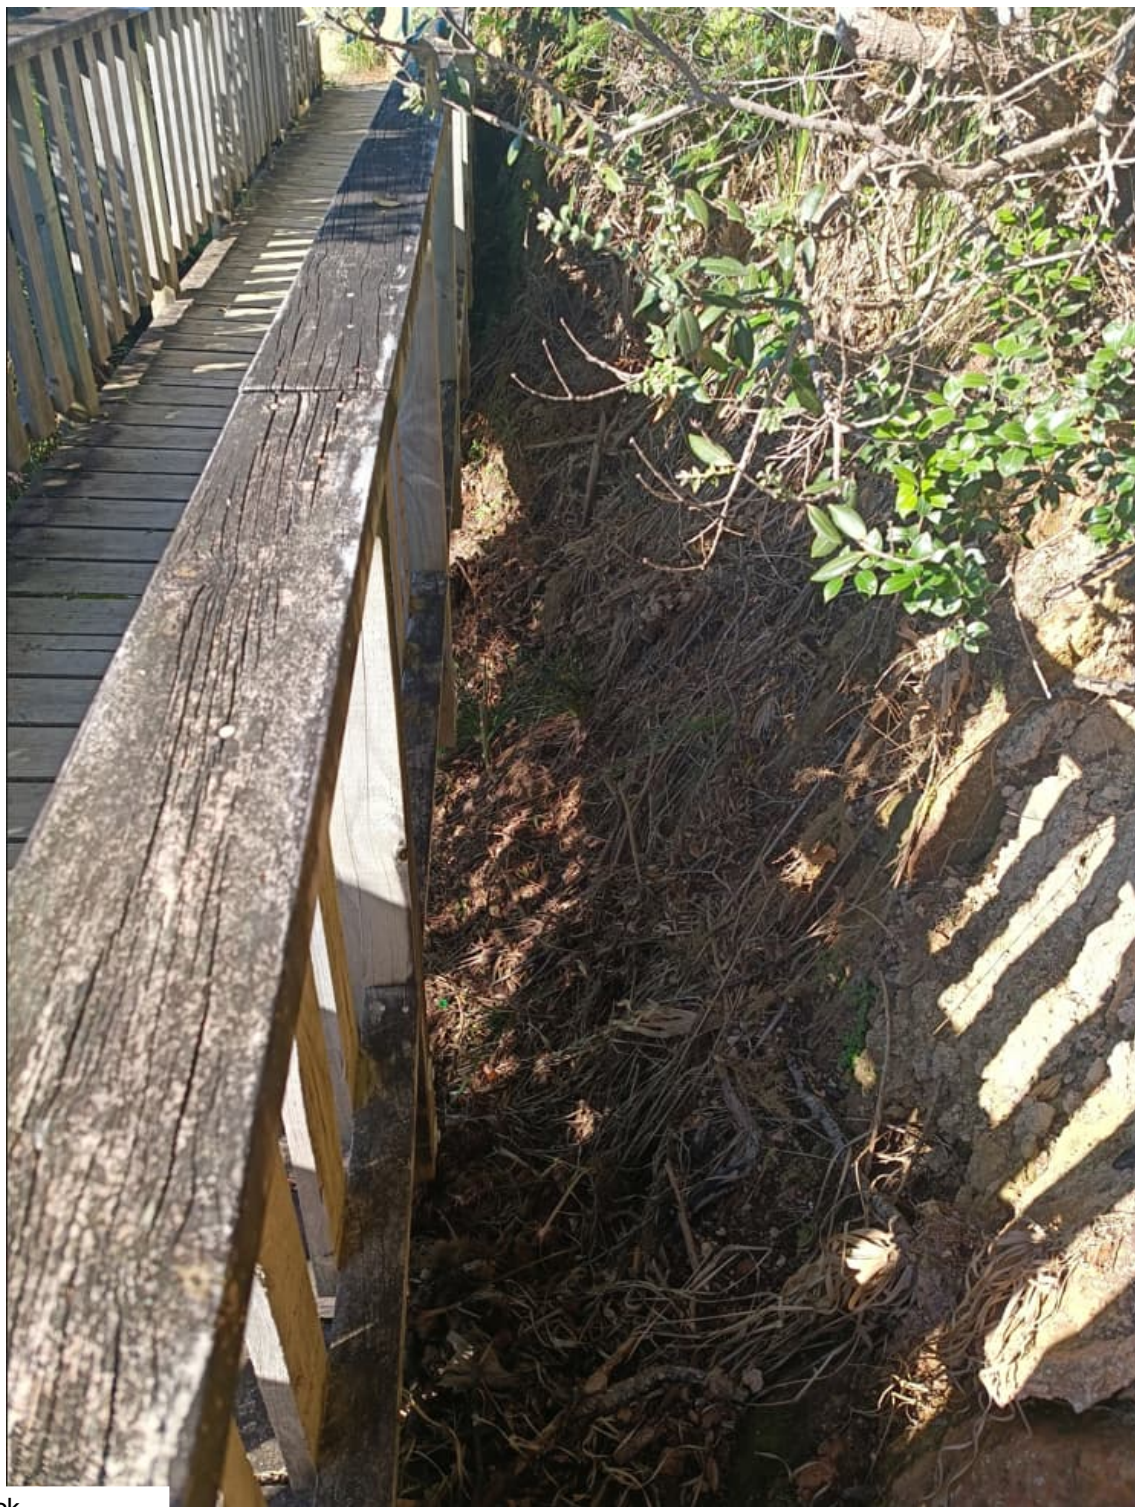
Figure C15 Landslide behind Hahei Track
