# Macrophyte monitoring in Waituna Lagoon - summer 2017

*Prepared for Department of Conservation, Murihiku Area Office,  
Southland*

*November 2017*

NIWA CLIENT REPORT No: 2017381HN  
Report date: November 2017  
NIWA Project: DOC16206

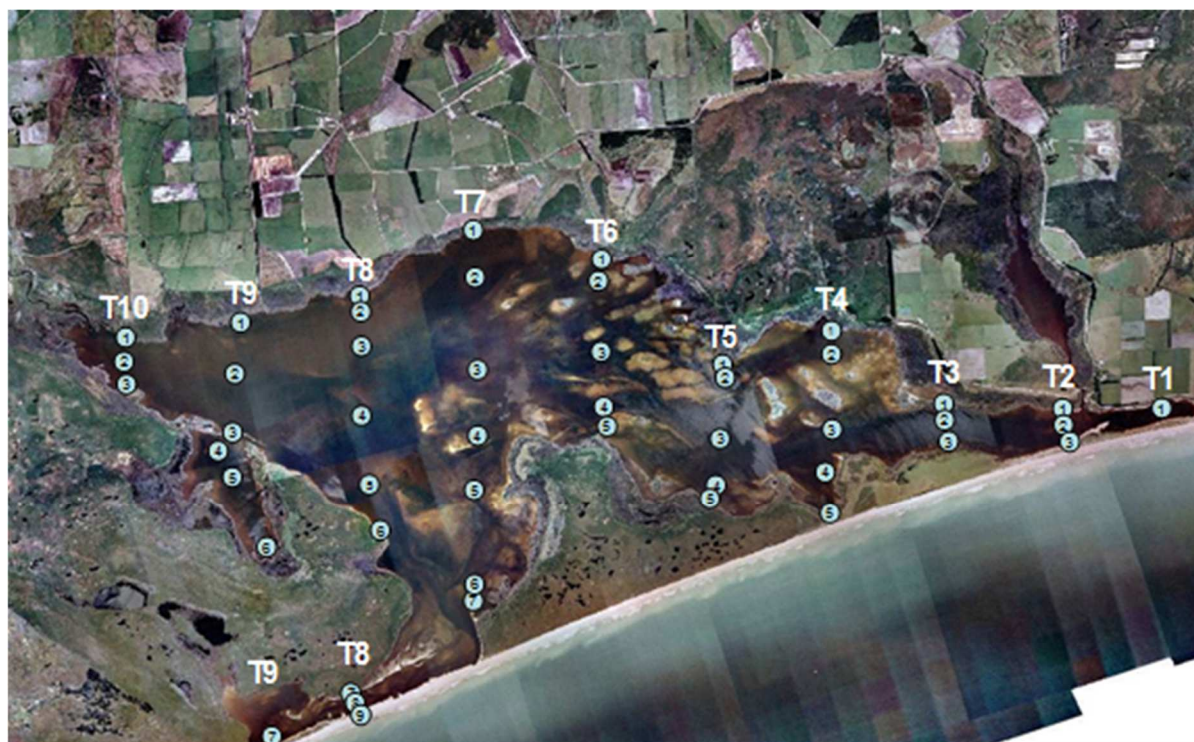
**Figure 2-1: Geo-referenced survey sites located in Waituna Lagoon.** Transects are numbered 1 to 10 from East to West and numbered on each transect in ascending order from North to South.
