Vegetation Status in Waituna Lagoon: Summer 2024

This report was commissioned by The Department of Conservation (DOC) and based on work under Project DOC24203.

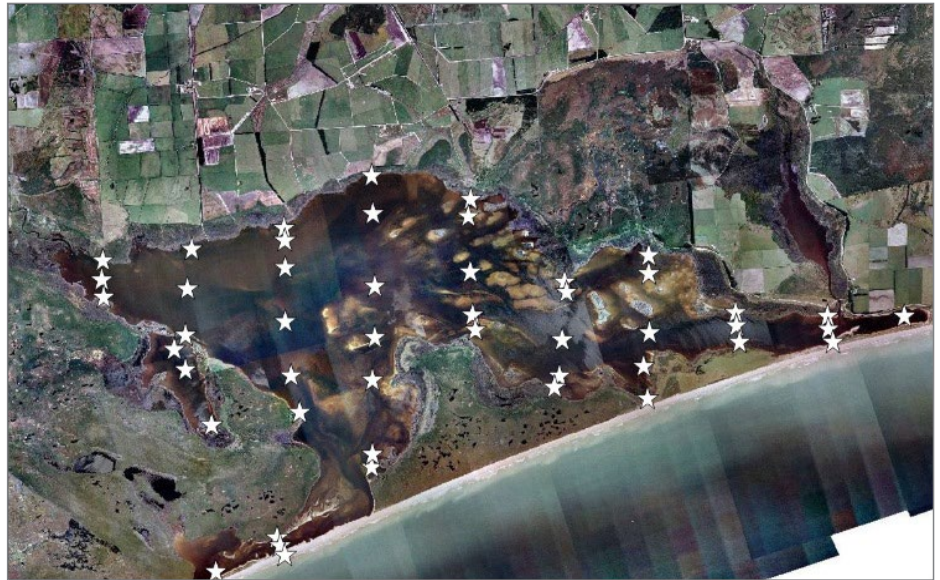
Figure 3a: Map showing the location of sampling sites (47-48).

The lagoon is monitored each year in late summer at 47-48 sites (Figure 3a). At each site, an assessment of environmental quality includes depth and water quality measurements (Figure 3b). Substrate characteristics are measured in four samples of the lagoon bed retrieved using a garden hoe, and the composition and abundance of vegetation is also described, including *Ruppia* life-stage as flowering or vegetative. Submerged native plants and dominant macroalgae are shown in Figure 4.

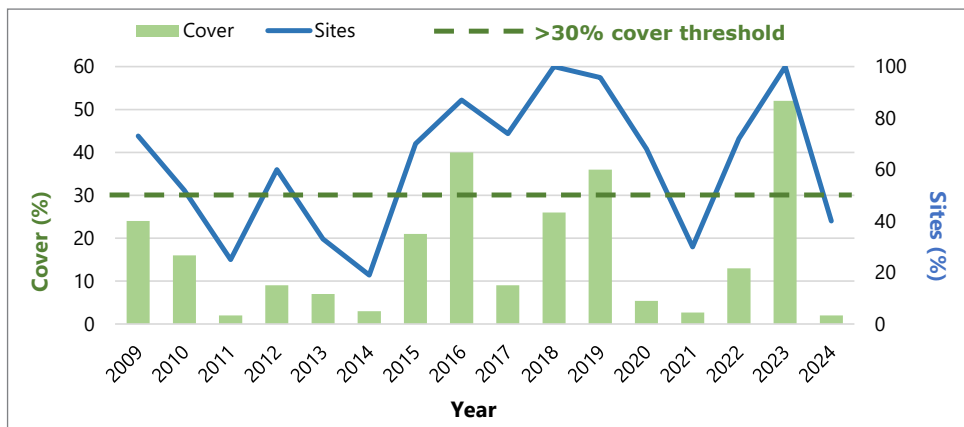
Figure 5: Lagoon-wide cover of *Ruppia* is shown as green bars and percentage of sites at which *Ruppia* was present as a blue line.

In 2024, lagoon-wide cover of *Ruppia* was only 2% (Table 2) and did not meet the ecological target. *Ruppia* was recorded at fewer than half of the monitoring sites and cover exceeded 30% at only one site. The occasions when the *Ruppia* cover target has been met are shown as bold, in highlighted cells in Table 2. The years 2016, 2019 and 2023 that met this target (Table 2, Figure 5) were the second of two consecutive years of lagoon closure during the critical spring-summer growth period for *Ruppia*.
