# Vegetation Status in Waituna Lagoon: Summer 2021

This report was commissioned by The Department of Conservation (DOC) and based on work under Project DOC20203.

DOC commissioned NIWA to undertake the 2021 summer-time Waituna Lagoon survey to document the health of submerged vegetation and to provide an inter-annual comparison of its condition. This report summarises the key findings to guide further ecological management of the lagoon.

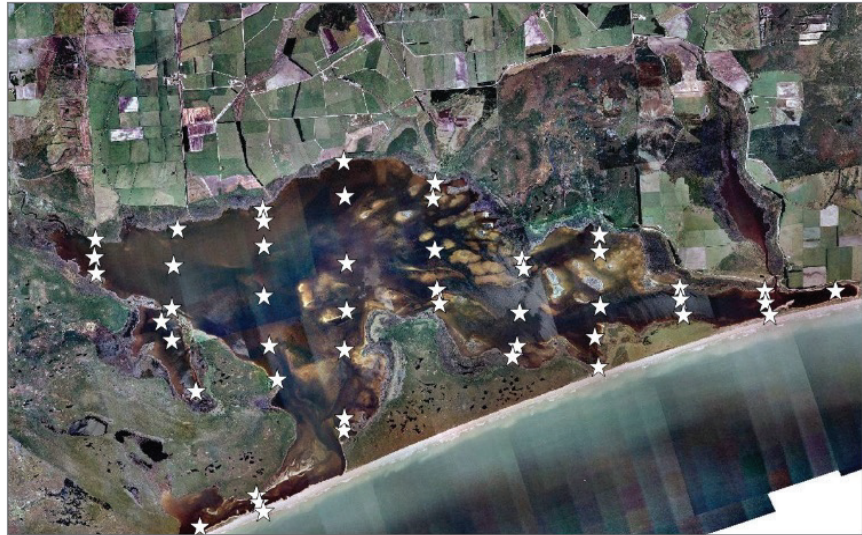
The lagoon is monitored each year in late summer at 47-48 sites (Figure 3a). At each site, an assessment of environmental quality includes depth and water quality measurements (Figure 3b). Substrate characteristics are measured in four samples of the lagoon bed retrieved using a garden hoe, and the composition and abundance of vegetation is also described, including *Ruppia* life-stage as flowering or vegetative. Submerged native plants and dominant macroalgae are shown in (Figure 4).

Figure 3a: Map showing the location of sampling sites (47-48).

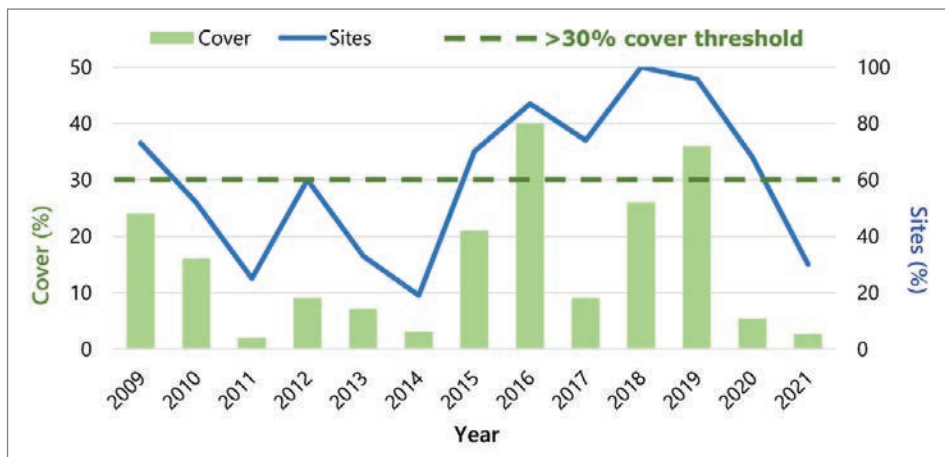
A healthy *Ruppia* community occupies a large habitat area in Waituna Lagoon. This is measured by calculating the percentage cover of *Ruppia* across all sites in the Lagoon. In 2021, the lagoon-wide average cover did not meet the ecological target (Box 1) of >30–60% (Table 2, Figure 5). Lagoon-wide cover in 2021 was amongst the three lowest values recorded, with *Ruppia* present in only limited sites (Table 2, Figure 5). This low *Ruppia* cover value is the second recorded in consecutive years, with low cover also recorded in 2020.

Figure 5: Lagoon-wide cover of *Ruppia* is shown as green bars and percentage of sites at which *Ruppia* was present as a blue line.
