Lessons Learnt 002

Installation of mussel spat rope to retrofit a perched culvert to improve passage for climbing fish

April 2020 V2

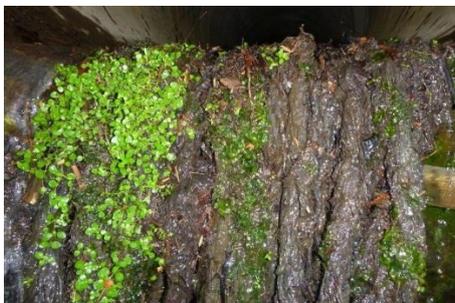
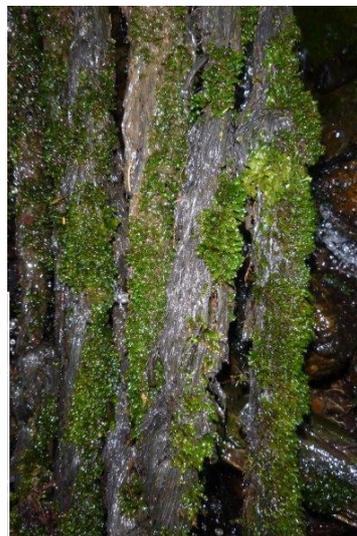
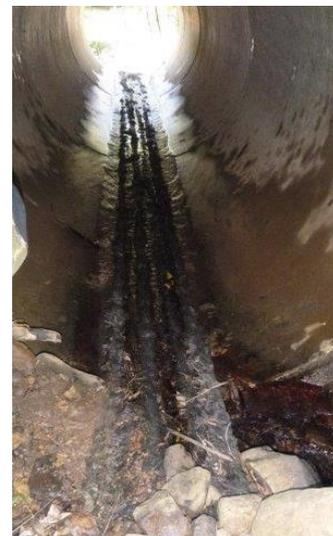
Figure 3. Photos from follow up visits to the perched culvert, showing that the ropes were still in excellent condition and remained taut with biological growth of mosses and filamentous algae covering (2015 and 2019. Photo: Bruno David).

Two follow up visits, in 2015 and in 2019, found the ropes to still be in excellent condition, remaining taut with biological growth of mosses and filamentous algae covering the ropes around the inlet and outlet areas where more light was available (Figure 3).
