Lessons Learnt 009

Ford removal and replacement with a bridge at Wainora Stream (Kauaeranga Valley), Coromandel

February 2020

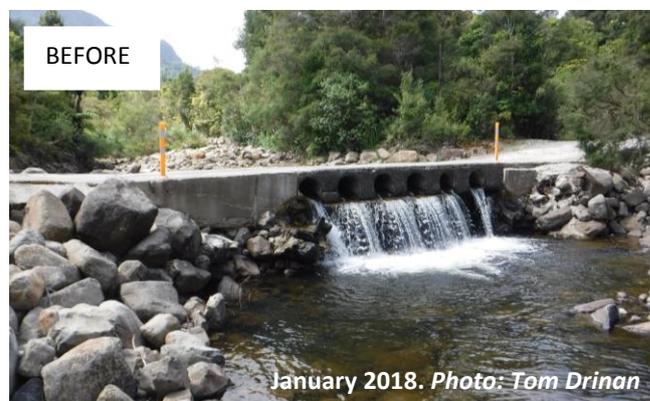
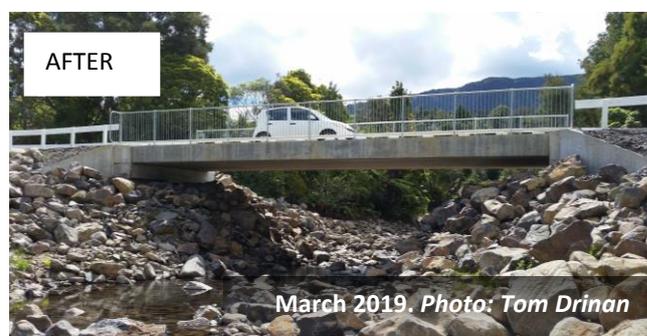
A new single-span bridge was constructed 3 m upstream of the ford between May and June 2018, and once completed, the ford was removed. The total project costs were \$535,000 (bridge \$469,000), including all costs involving contractors to build the bridge, other resources and building consents. The bridge installed was pre-cast concrete construction (14.5 m span and 5.4 m width).

Figure 1. Top – Roadway ford prior to removal. Bottom – Single-span bridge replacement.

1. Single-span bridges represent the best practice approach to maintaining/improving fish passage at river crossings.
2. Significant down-cutting of the channel occurred following the removal of the ford, as the stream channel reassumed its natural gradient.
3. This project demonstrates how quickly improvements to fish passage can occur when barriers are removed.
