# 9 Appendices

## **APPENDIX 5: EVALUATION OF RESTORATION OPTIONS: MATATA WILDLIFE REFUGE RESERVE RECOVERY**

**APPENDIX 6: EXTENT OF THE PROPOSED RESTORATION WORKS AND PLANTINGS, AS PREPARED FOR THE RESOURCE CONSENT**

**APPENDIX 7: COMPARISON PHOTOS TAKEN  
BETWEEN 2005, 2006 AND 2010**

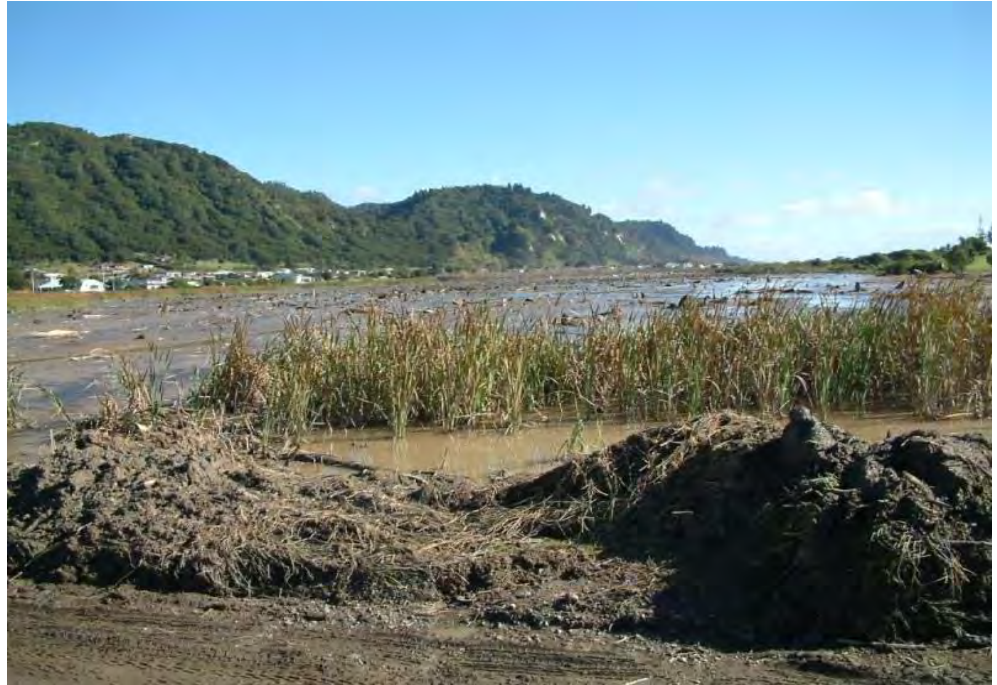
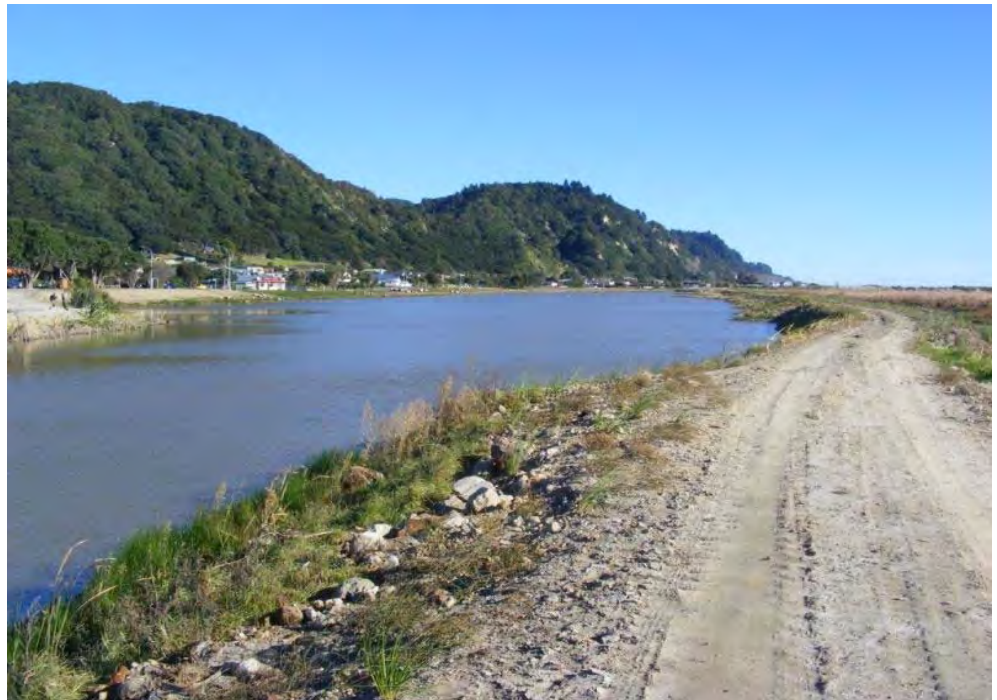
Photos of the western lagoon from the central causeway road at the Reserve. Immediate post-flood May 2005 (above) and post-rehabilitation works July 2010 (below).

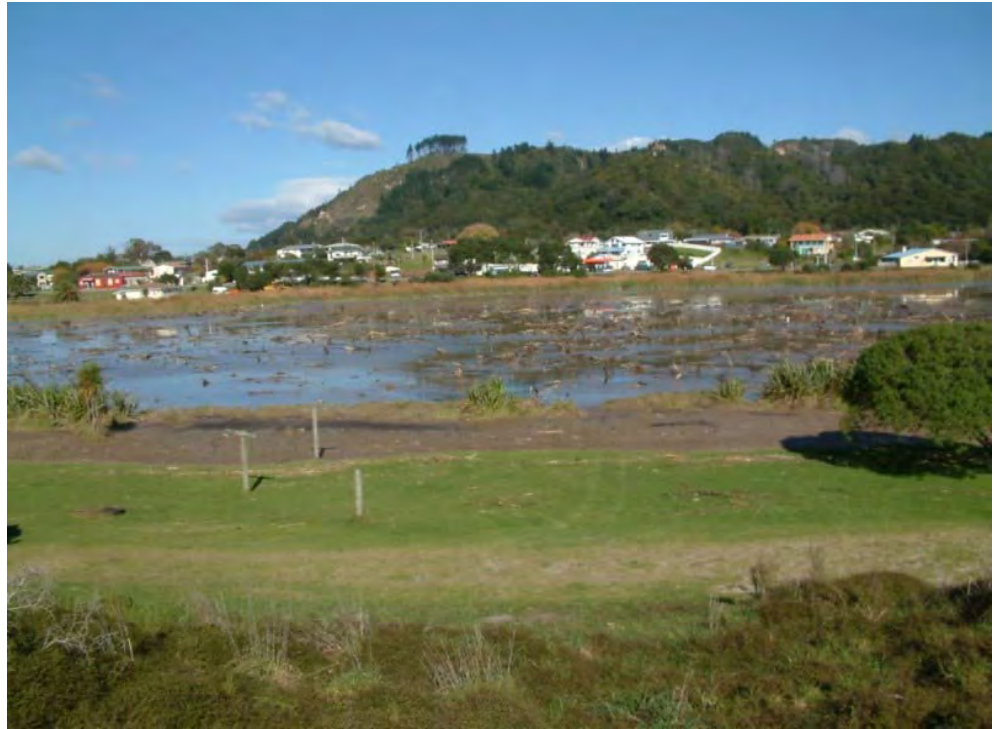
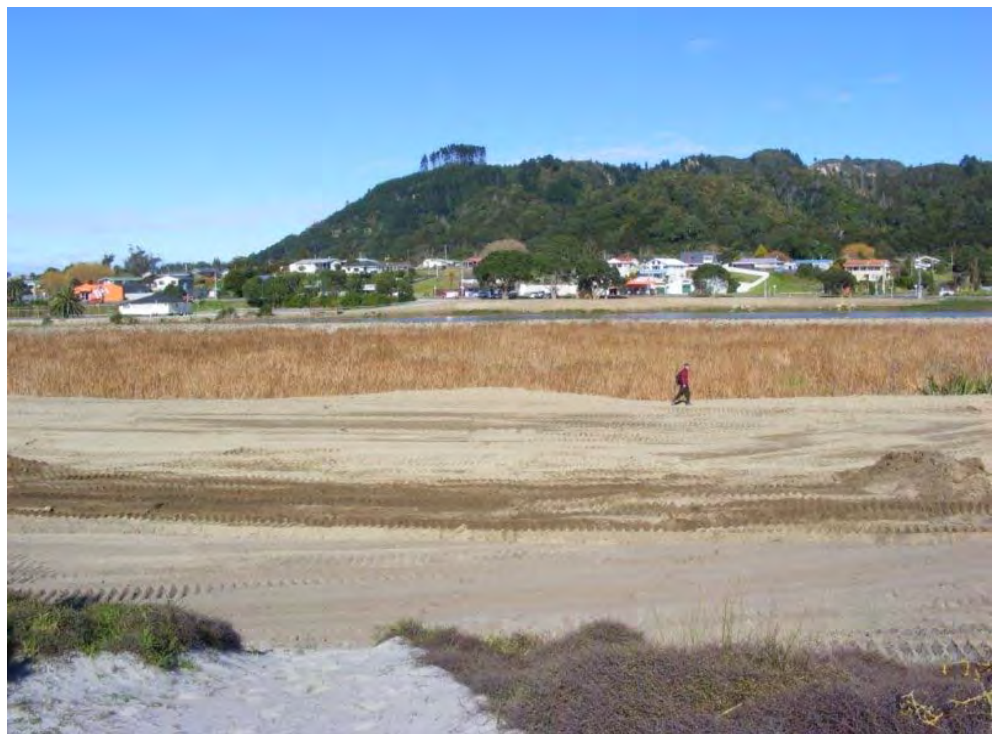
Photos looking back south towards Matata from the sand dunes above the Matata Domain Campground. Immediate post-flood May 2005 (above) and post-rehabilitation works July 2010 (below). The area of graded bare dirt in the foreground of the photo below is part of the re-development to enlarge the Matata Campground.

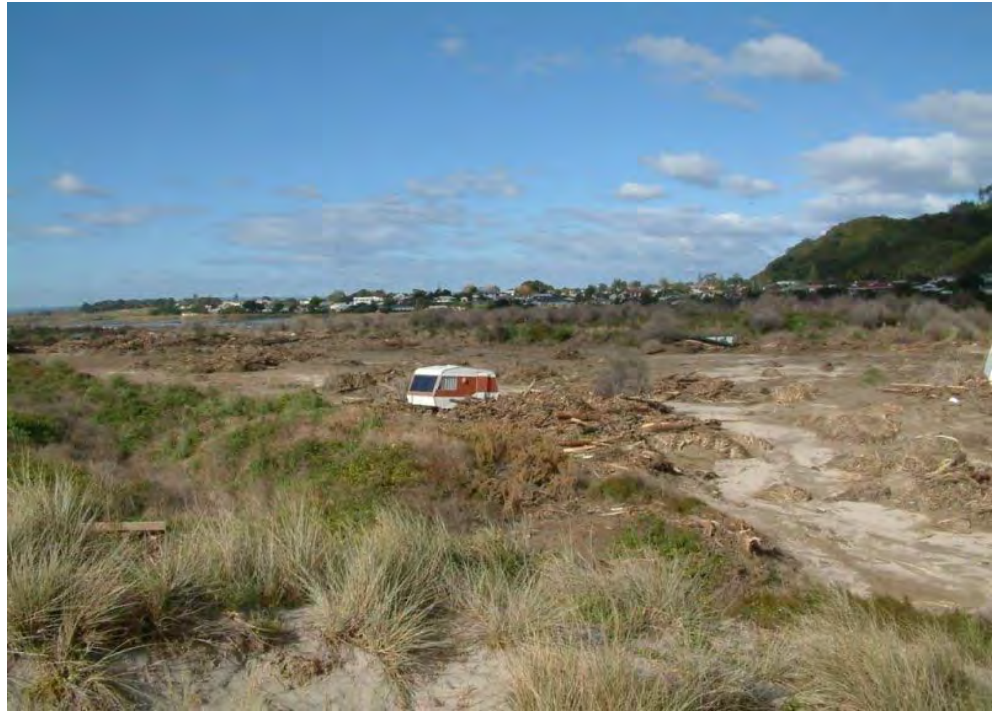
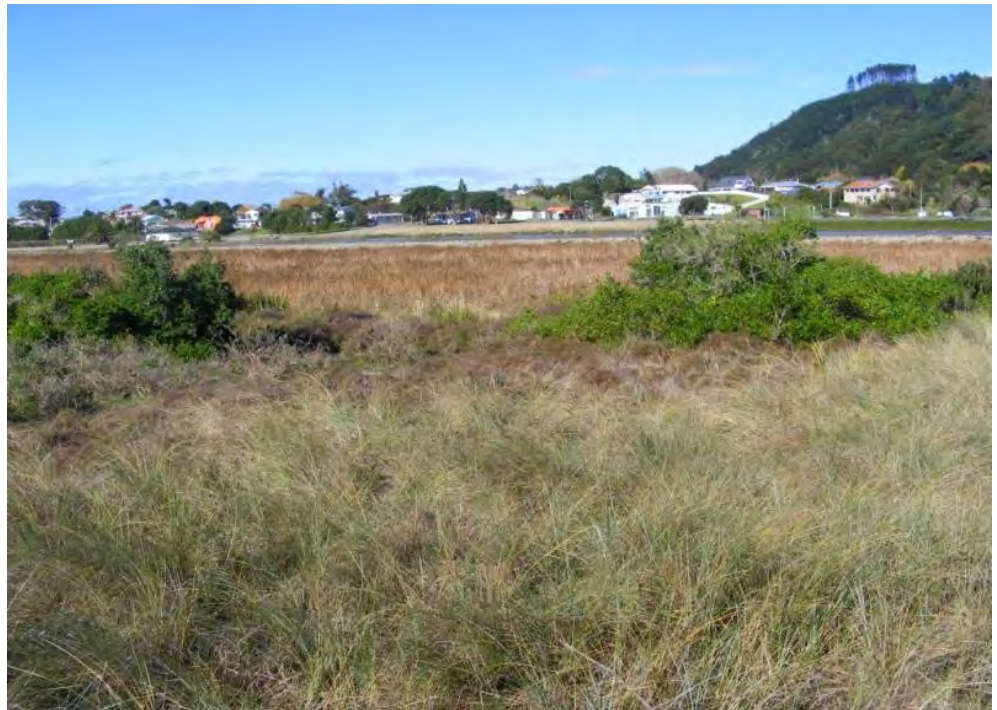
Photos looking back over the Matata lagoon from the western end of the western lagoon. Immediate post-flood May 2005 (above) and post-rehabilitation works July 2010 (below).

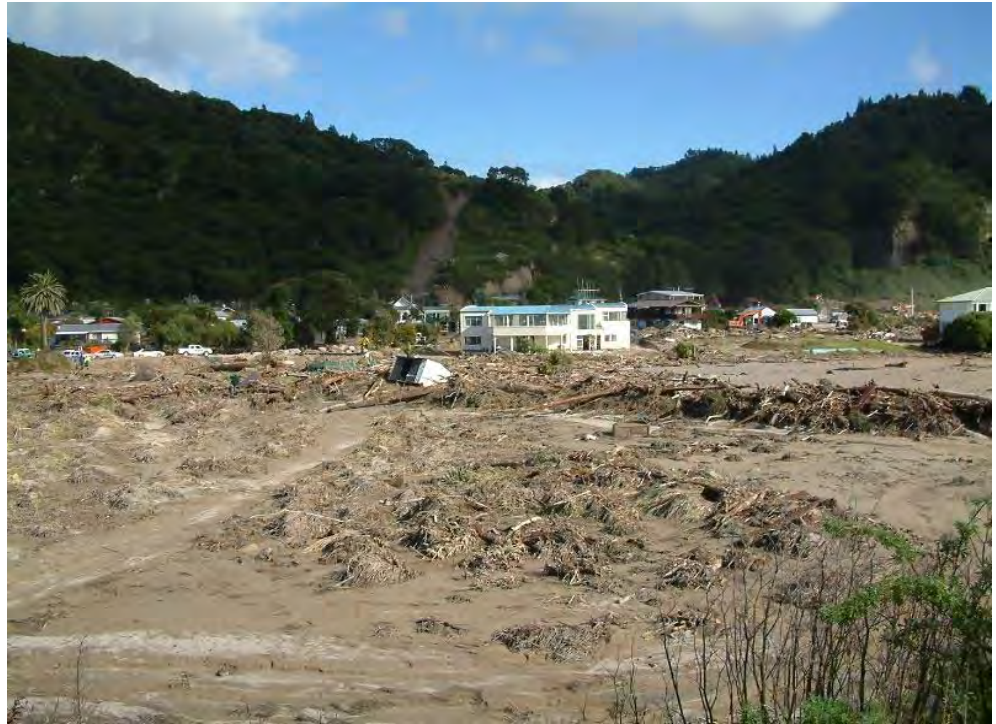
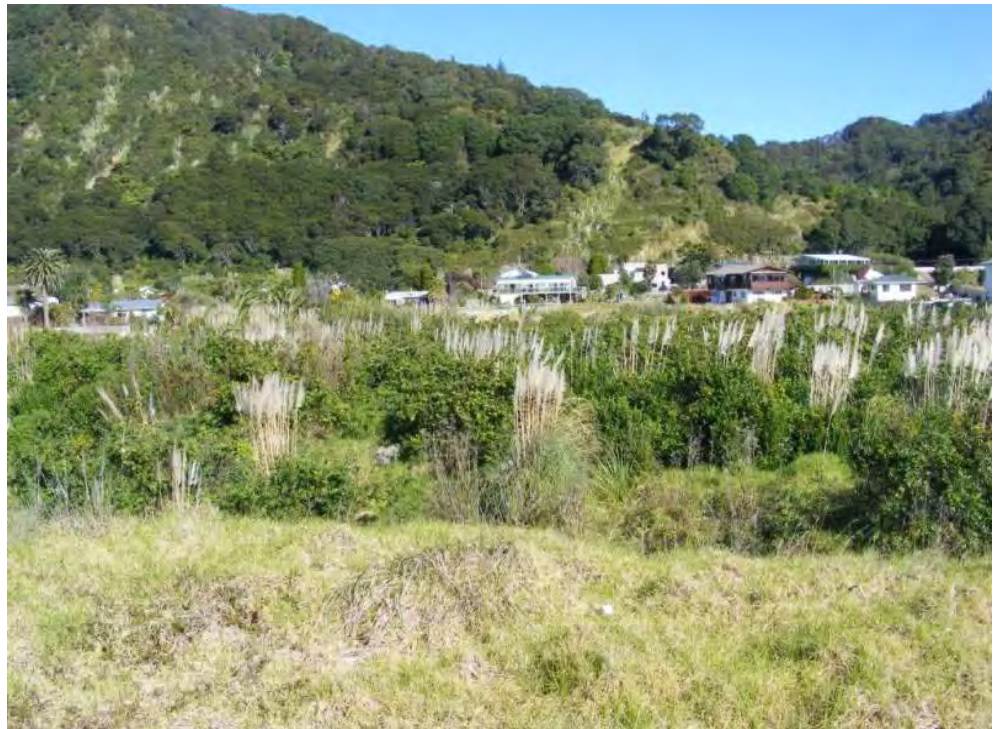
Photos showing the west end of the western lagoon, with fresh slip on hill in background and damaged house. Immediate post-flood May 2005 (above). Note: the large house in foreground of photo above was removed along with several others, due to structural damage caused by flooding. Note: how well the site had re-vegetated naturally by July 2010 (below).

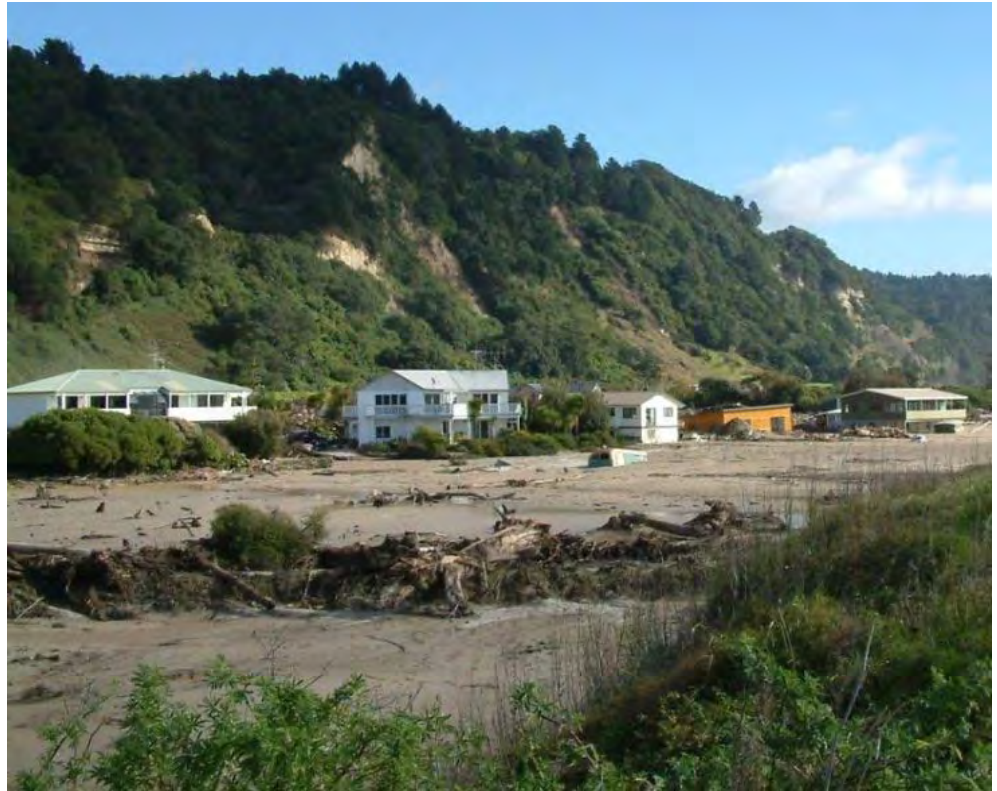
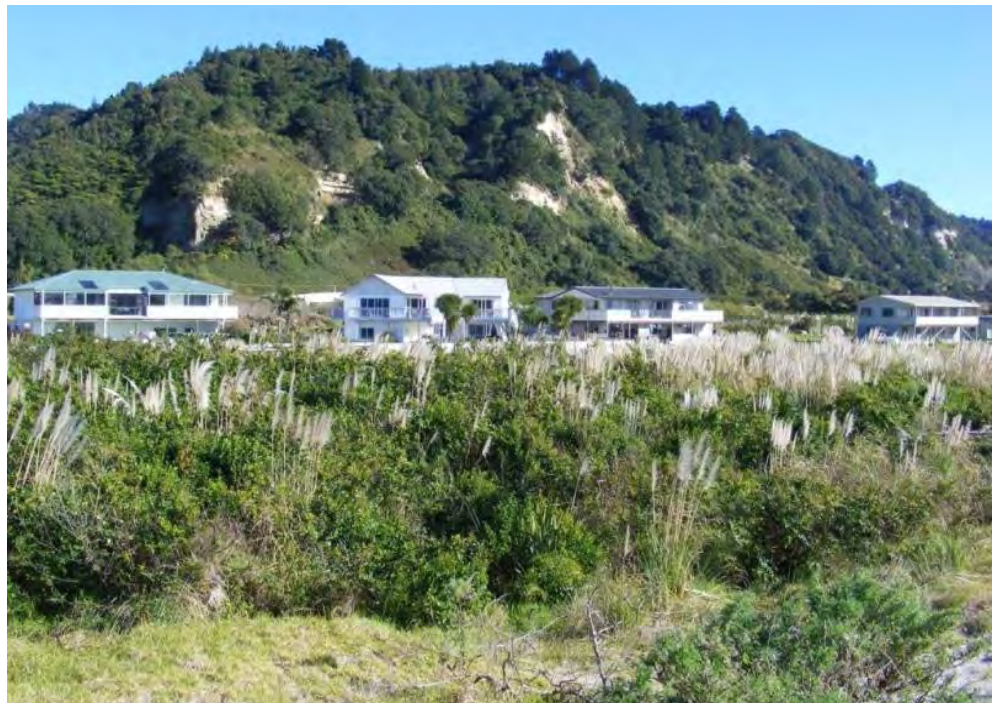
Photos of the western end of the western lagoon showing damaged houses immediate post-flood May 2005 (above) and showing naturally regenerated vegetation of the foreground area by July 2010 (below).

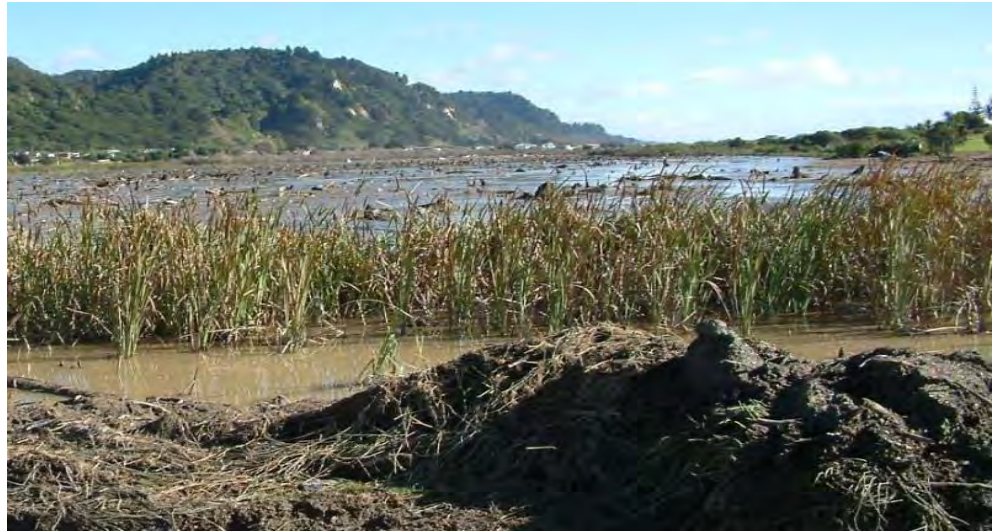
View looking west from causeway road, of the western lagoon. Immediate post-flood May 2005 (top photo),

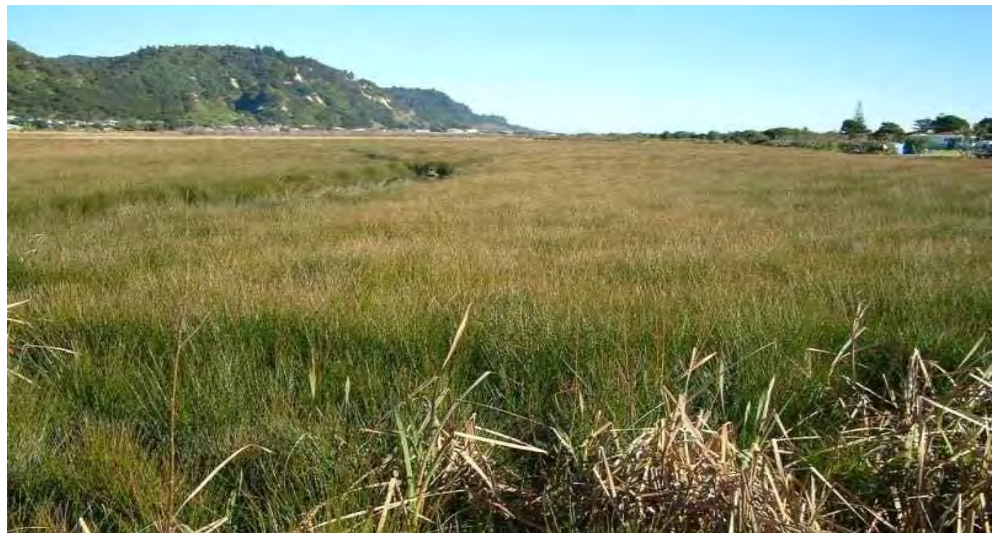
Naturally regenerated vegetation August 2006 prior to rehabilitation works proceeding (middle),

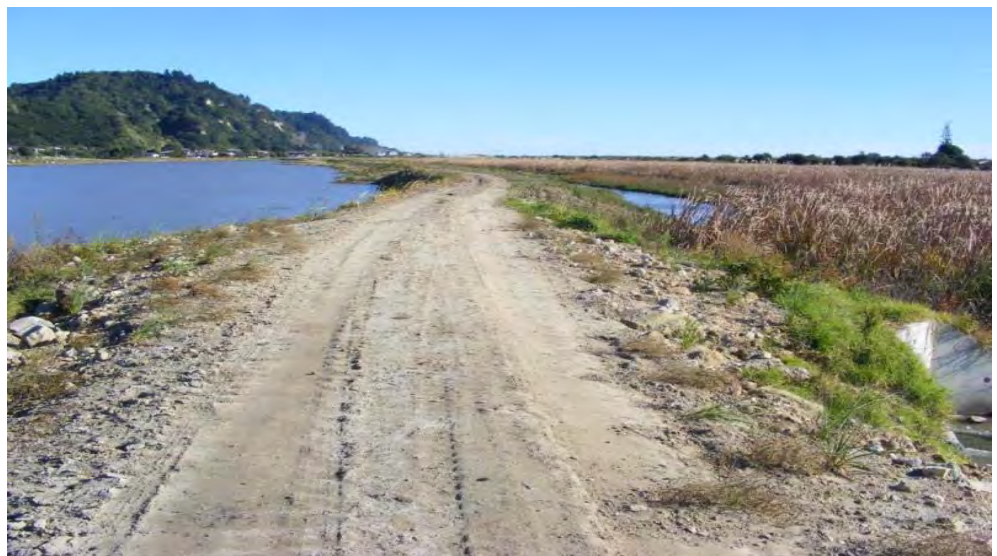
Post completion of rehabilitation works July 2010 (bottom).

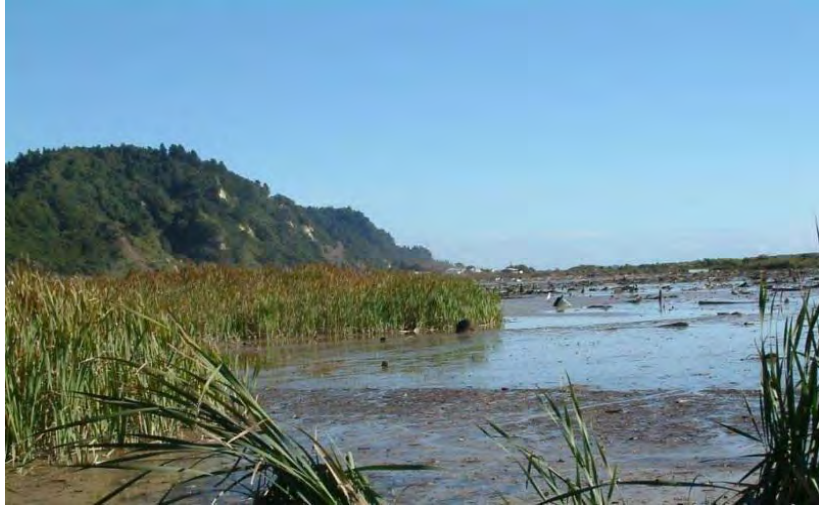
View looking west from Matata campground entrance, of the western lagoon. Immediate post-flood May 2005 (top photo),

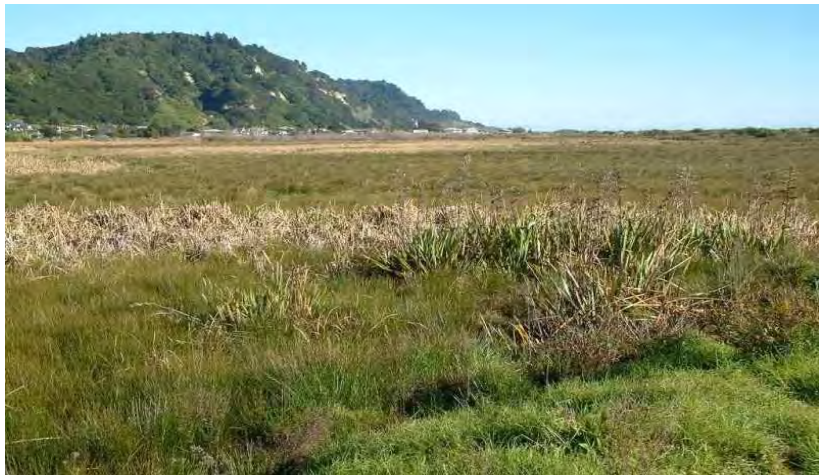
Western lagoon with naturally regenerating vegetation August 2006 prior to rehabilitation works proceeding (bottom).

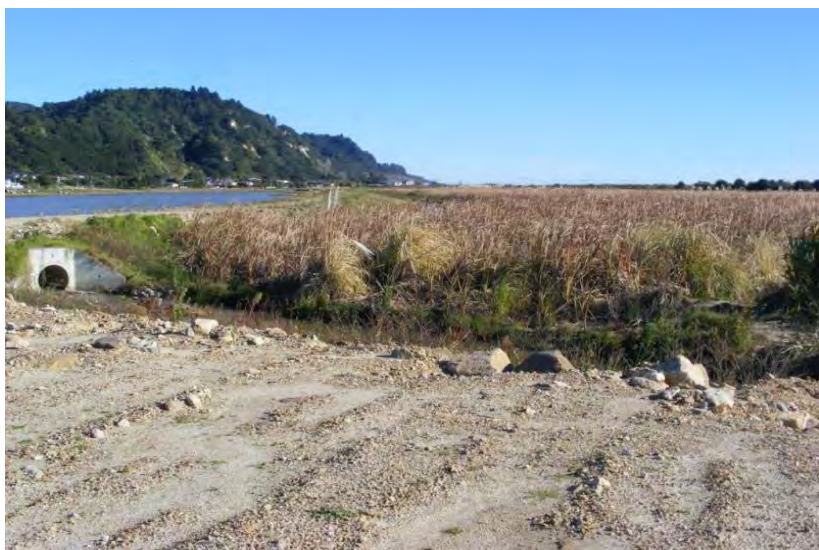
View looking north from near Matata campground entrance, of the western lagoon. Post completion of rehabilitation works July 2010.
