Re: Sounds Foreshore Reserve Licence (SFR) Application. File Ref: 93568-OTH

1. Understanding the extent of the encroachment on the SFR.

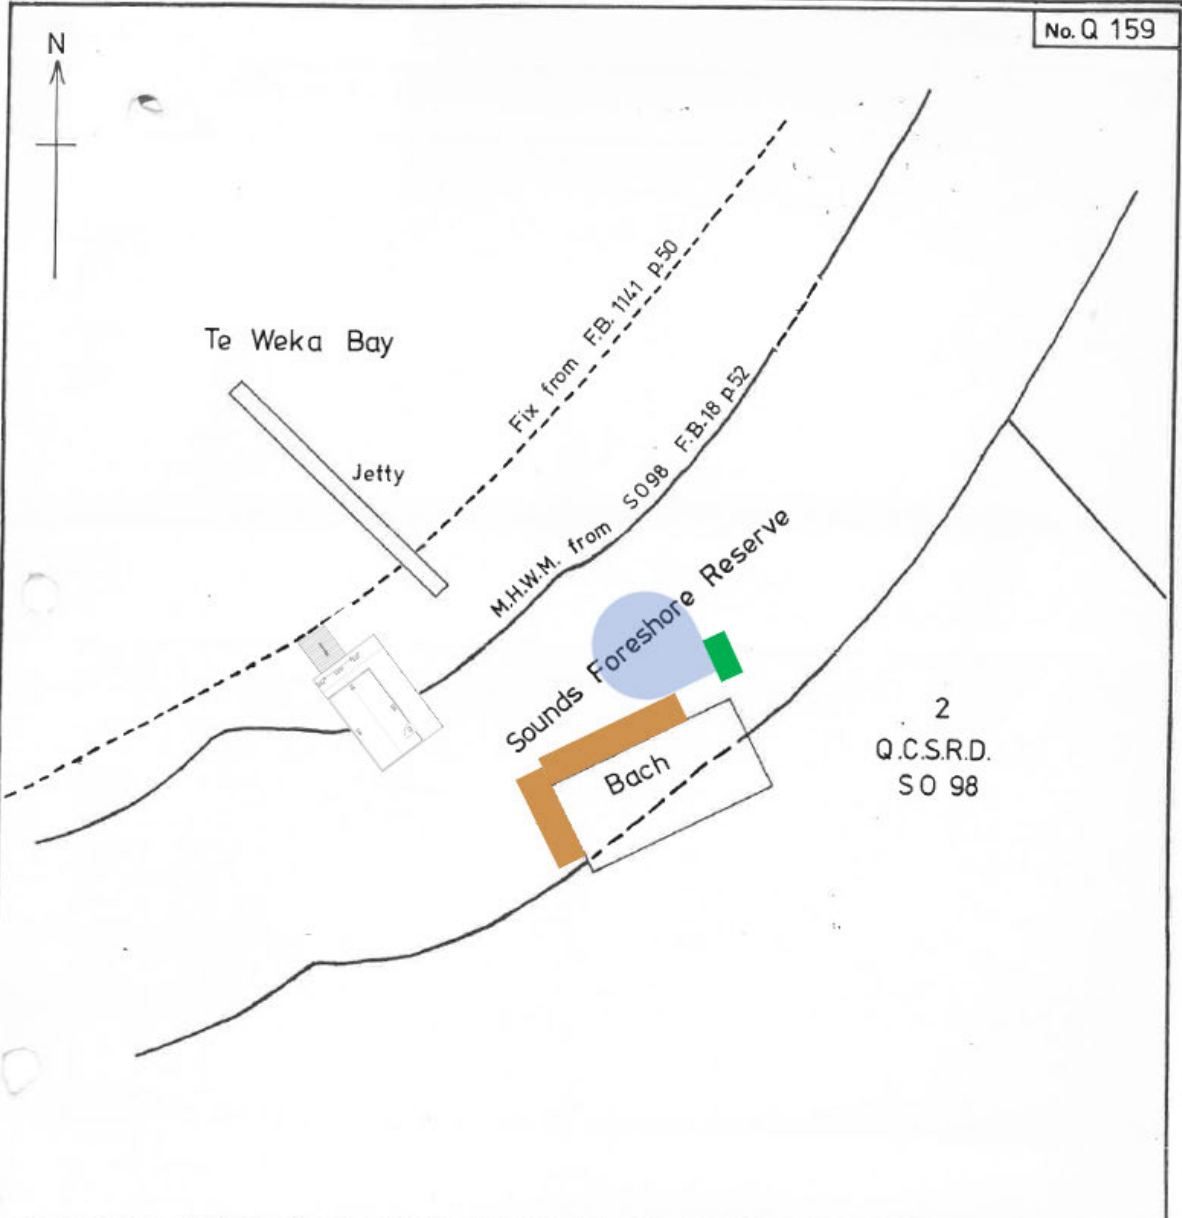
Please see below on page three a plan of the SFR at Te Weka Bay, which is based on the diagram from the 1989 survey. I have scaled an outline of the boatshed in proportion to the outline of the bach on the survey, and placed it with the front of the ramp on the current shoreline, which the photograph of the new boatshed in the application shows is at the highwater mark. I have measured the proportion of encroachment of both the bach and the boatshed on the SFR and calculated the area that encroaches based on measurements of the bach undertaken by an architect, and measurements of the boatshed from the plans submitted for building consent.

Please note that the concrete pad next to the bach shown on the 1989 survey has since been replaced with a wooden deck, which extends partway around the front of the house, and is shown in brown on the plan on page three. The dimensions of all these encroachments are as follows.

The position of the septic tank is shown as the green square on the survey plan below. The wastewater field is shown in blue.

DRAWN BY S.B.N. DATE 22-9-89		PLANS S.O. 98, 352	SCALE 1:500	ENCROACHMENT FRONTING Sec 2, Q.C.S.R.D.
SURVEY FIX		FIELD BOOK 1141 p 50	AIR PHOTOS SN 8262 D/34	
MARLBOROUGH COUNTY			RECORD MAP P27/83 Q27/13	BLOCK IX Arapawa S.D.
FILE FR 794	RENTAL	TERM	LICENSEE J.A. Harrison.	
STRUCTURE		SIZE	FOUNDATIONS	
COLOUR			FRAMING	
DATE OF INSPECTION			SHEATHING	
CONDITION			ROOF	
COMMENTS

Thank you for providing me with the survey undertaken in 1989, which shows a partial encroachment of the bach on the SFR. It also shows that the original SFR sits quite a long way back from the current shoreline. This means that the new boatshed partially encroaches on the SFR.
