To:	[REDACTED] (RCP Senior Project Manager)				
Copy:	[REDACTED] (Laura Buttimore Planning); [REDACTED] (BTW Team Leader Ecology); [REDACTED] (BTW Civil Team Leader/Associate); [REDACTED] (BTW Civil and Environmental Engineer)				
From:	[REDACTED] (Senior Ecologist, CEnvP)				
Date:	28th July 2023	BTW Job Number:	230129	Client Reference	North Taranaki Visitor Centre

Subject: North Taranaki Visitor Centre Ecological Constraints and Opportunities Memo

LIZARD MANAGEMENT PLAN FOR AN UPGRADE OF NORTH EGMONT VISITOR CENTRE MOUNT TARANAKI

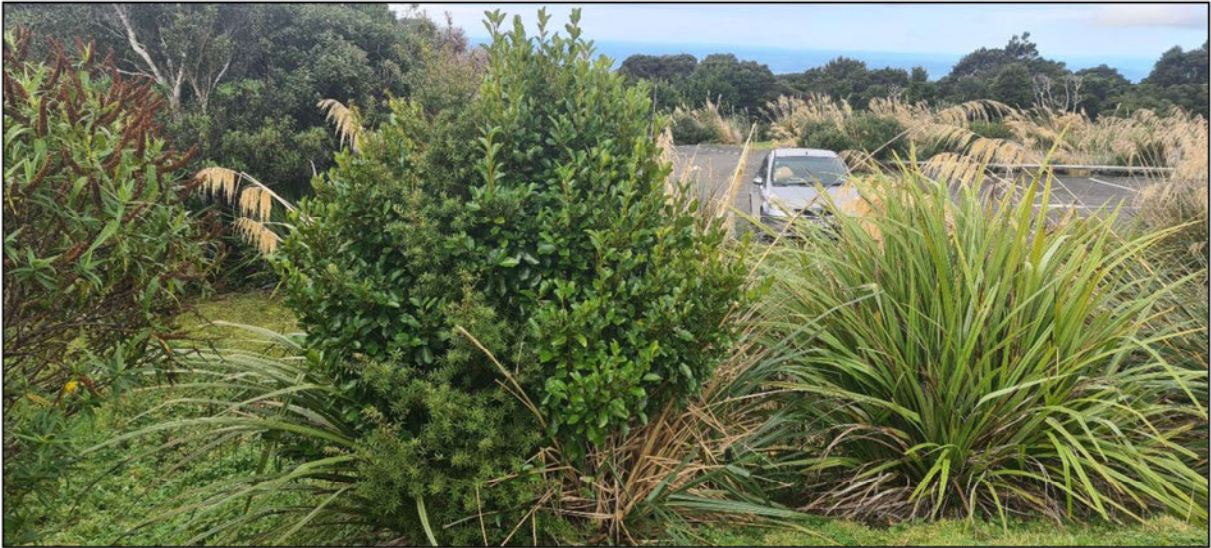
Figure 4: Representative photograph showing existing shrubs and toetoe vegetation proposed for clearance around the carparks.

The vegetation present within the subject site generally consists of isolated fragments of shrubs and groundcover species, in planted areas between and surrounding carparks, amenity bench seating, lawn and the building. Mountain toetoe (*Austroderia fulvida*) is arguably the most distinctive shrub species at the site, punctuating carpark areas and amenity planting around the existing building. Along with mountain toetoe, prominent shrubs surrounding the building include koromiko (*Veronica stricta*), New Zealand broadleaf, bush flax (*Astelia fragrans*), kanono (*Coprosma autumnalis*) and the common tree daisy (*Olearia arborescens*) (Figure 4). Less frequent species include hakeke (*Olearia ilicifolia*), *Cassinia vauvilliersii* and *Dracophyllum filifolium*. Clusters of red tussock grass (*Chionochloa rubira*) are common in disturbed areas at the site, along with clumps of *Juncus* sp. on open, grassy banks.

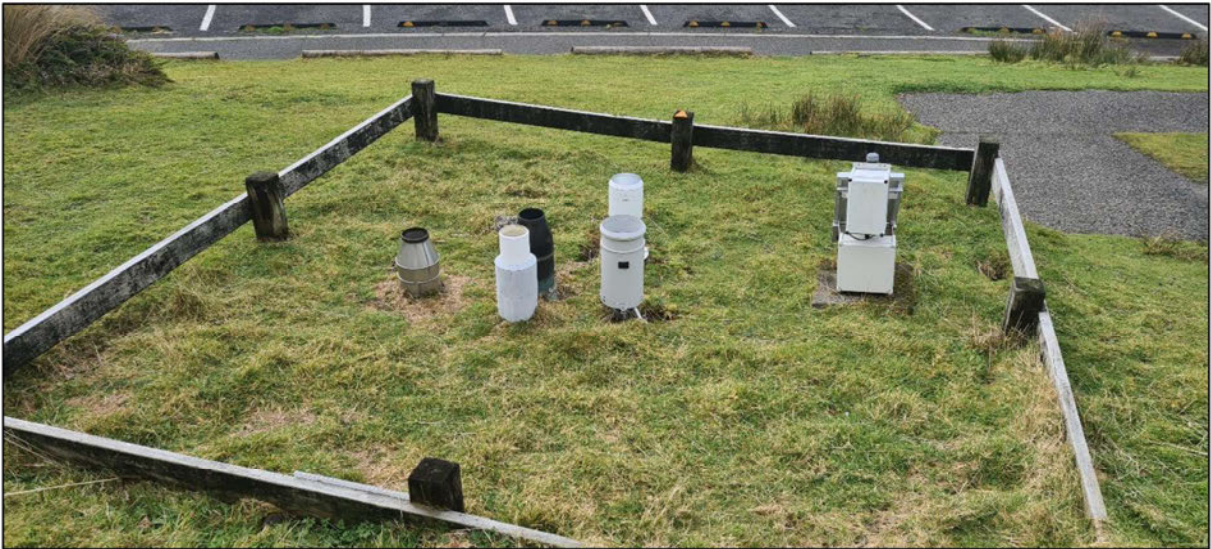
Figure 5: Meteorological monitoring instruments and setup.

In summary, early ecological recommendations have been integrated into engineering design in that, based on current preliminary design drawings, vegetation clearance is to be limited to the marginal bush/shrubbery and pockets of toetoe (substantially lower ecological value relative to the intact forest interior). Infrastructure is proposed to be positioned in cleared areas with existing shrub, herb, gravel or grass cover, generally avoiding tree clearance altogether. Vegetation clearance associated with the proposed earthworks is likely to be very minimal. Innovative ideas are being considered to minimise the extent of wastewater soakage trench required e.g., recycling greywater for toilet flushing, positioning trenches beneath carparks, and utilising a wastewater holding tank. Multiple, smaller soakage fields are also being considered, to maximise available, cleared landscape and avoid vegetation clearance for the purposes of wastewater treatment. It should be noted that the meteorological recording and Geonet stations (for GNS volcanic and TRC weather monitoring purposes) coincide with one example of available land near the entrance to the visitor centre; appropriate planning measures should be taken to identify constraints around the locations of these instruments (Figure 5).

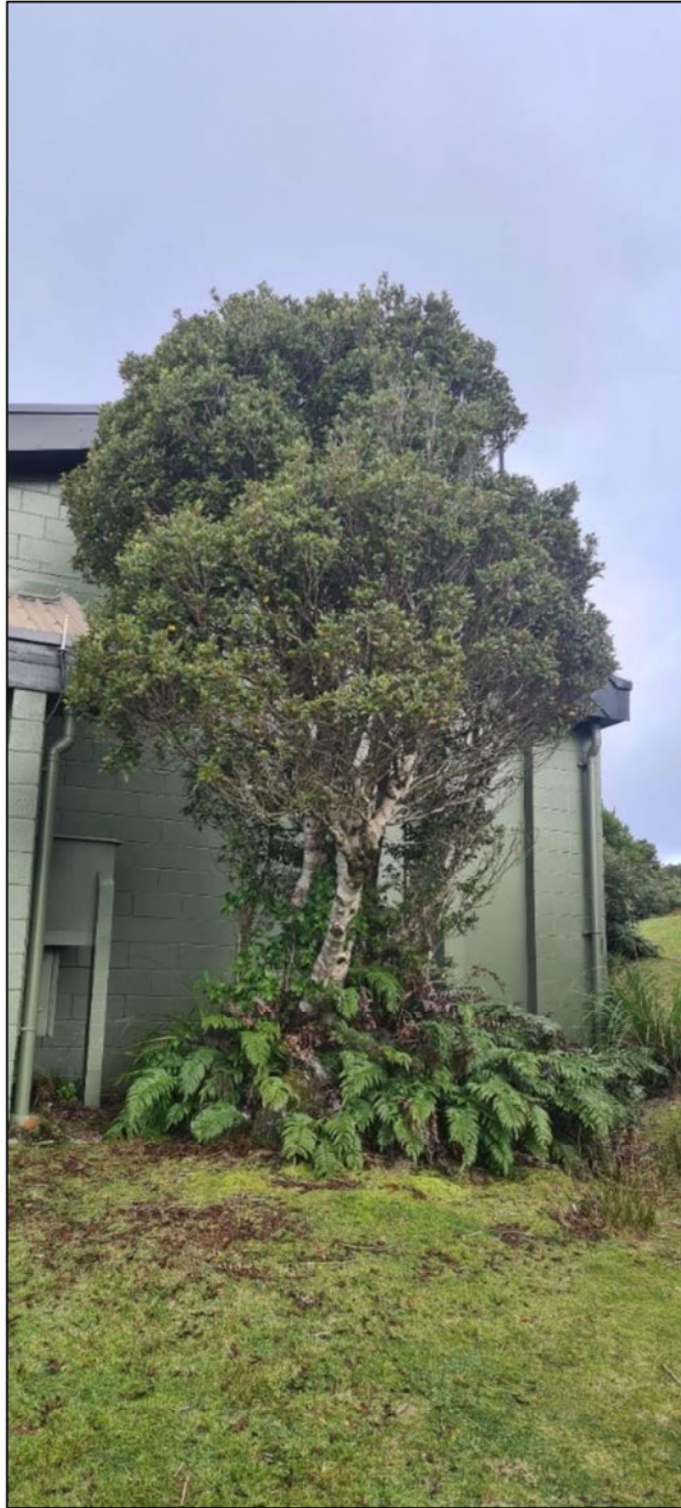
Figure 6: Solitary kāmahi tree on the western side of the building, proposed for clearance.

An isolated kāmahī tree, approximately 4 m tall, was observed on the western side of the existing building (Figure 6) and is proposed to be removed prior to earthworks. The vegetation fragment supports an impressive assemblage of flora, including a dense mat of kiokio (*Parablechnum novae-zelandiae*), New Zealand broadleaf and a Hall's tōtara sapling, and provides ecological connectivity with the surrounding forest, in a "stepping stone" effect. Although kāmahī is a Not Threatened vascular plant species, it is recommended that the tree and groundcover are relocated if practicable. Transplanting mature trees is best undertaken in autumn or in late winter/early spring, and root pruning (to encourage new growth) six months prior to relocation is recommended. Once the root ball (including root regrowth) has been dug out, the bound roots should be left in place for a few weeks prior to removal. Mulch and a continuous water source (e.g., water bags) is required following transfer. Expert advice (e.g., a relocation plan) from an arborist would be required.

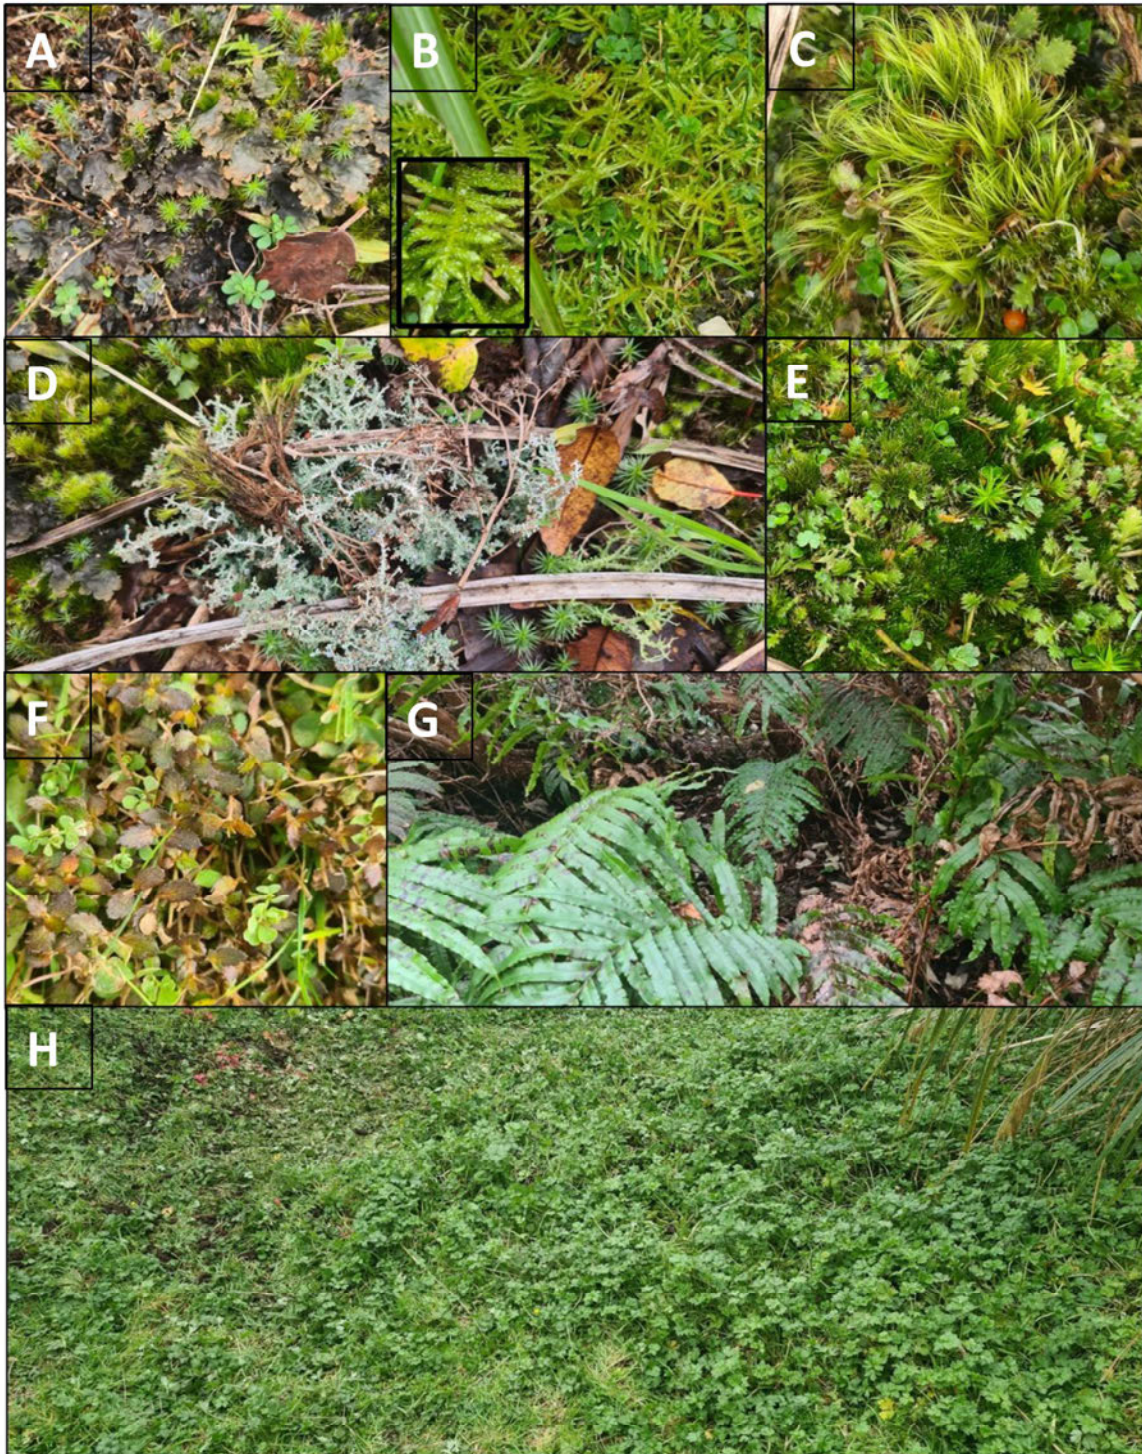
Figure 7: Ground cover at the site includes A) Juniper haircap mass (*Polytrichum juniperinum*), with *Machantia* sp; B) *Camptpchaete* sp.; C) *Dicranoloma* sp. ; D) *Stereocaulon ramulosum* with Juniper haircap mass (*Polytrichum*

juniperinum) mosses to the right of the photo; E) Mix of common bryophytes; F) herb species *Gonocarpus aggregatus*; G) Kiokio (*Parablechnum novae-zelandiae*); H: exotic grass and common weed species.

The groundcover present at the site includes the non-native bryophytes Juniper haircap moss (*Polytrichum juniperinum*), *Camptochaete* sp., *Dicranoloma* sp. as well as the native, Not Threatened lichen species *Stereocaulon ramulosum*, fern kiokio (*Parablechnum novae-zelandiae*), ground herb *Gonocarpus aggregatus*, and liverworts including *Marchantia* species (Figure 7 A-G). Further ground cover at site, (shown in figure Figure 7 H) includes *Poa* grass species and creeping buttercup (*Ranunculus repens*). These species were present within the shrubbery and on exposed lawn grasses. Salvage of groundcover species is not considered necessary, given that all species identified during the site visit are either exotic or Not Threatened, and are likely to recolonise following disturbance.

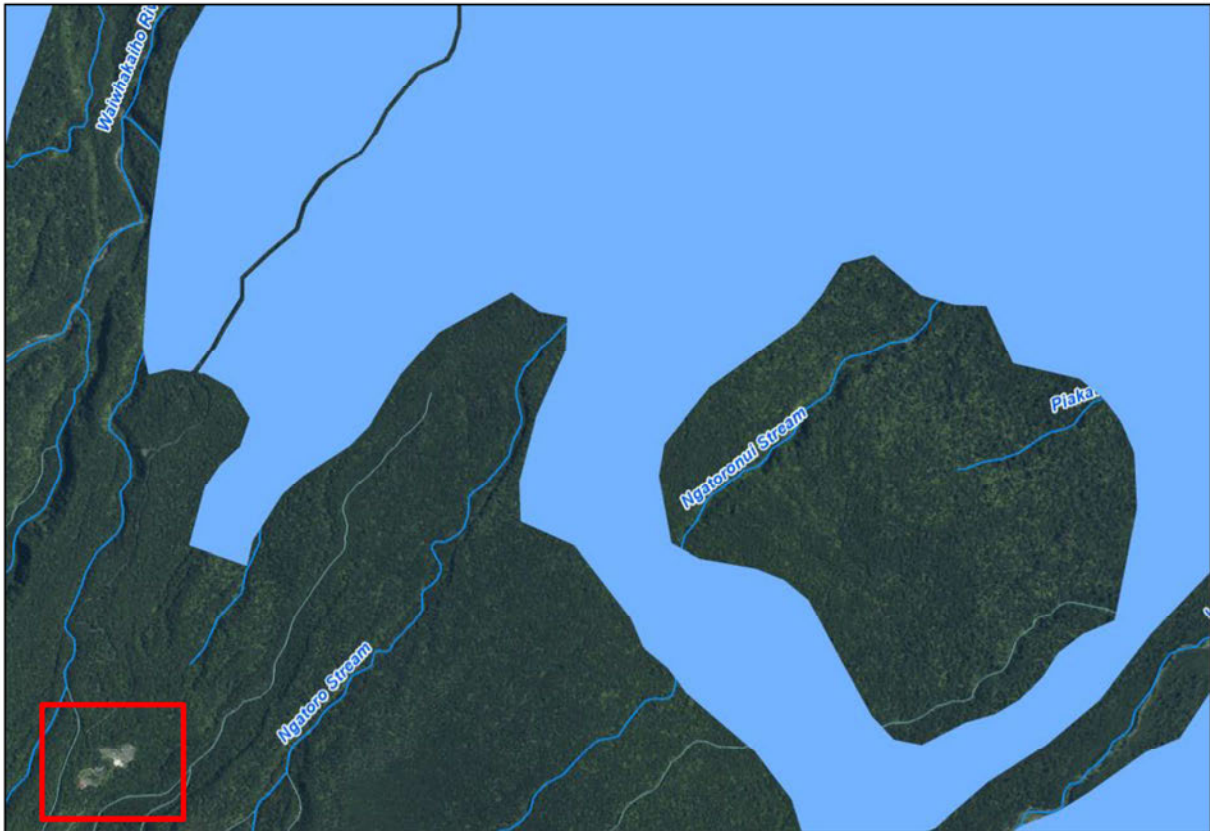
Figure 8: Extent of historical swamp identified on Taranaki Regional Wetlands Layer (source: TRC), with visitor centre shown in red.

There are no Scheduled Wetlands (TRC FWP 2001) within or immediately surrounding the site. Likewise, there are no wetlands detected on the Regional Wetlands Layer. However, a vast expanse of swamp was historically positioned within 700 m of the site, 200 m downstream of the Waiongana Stream headwaters. This extent is shown in Figure 8.

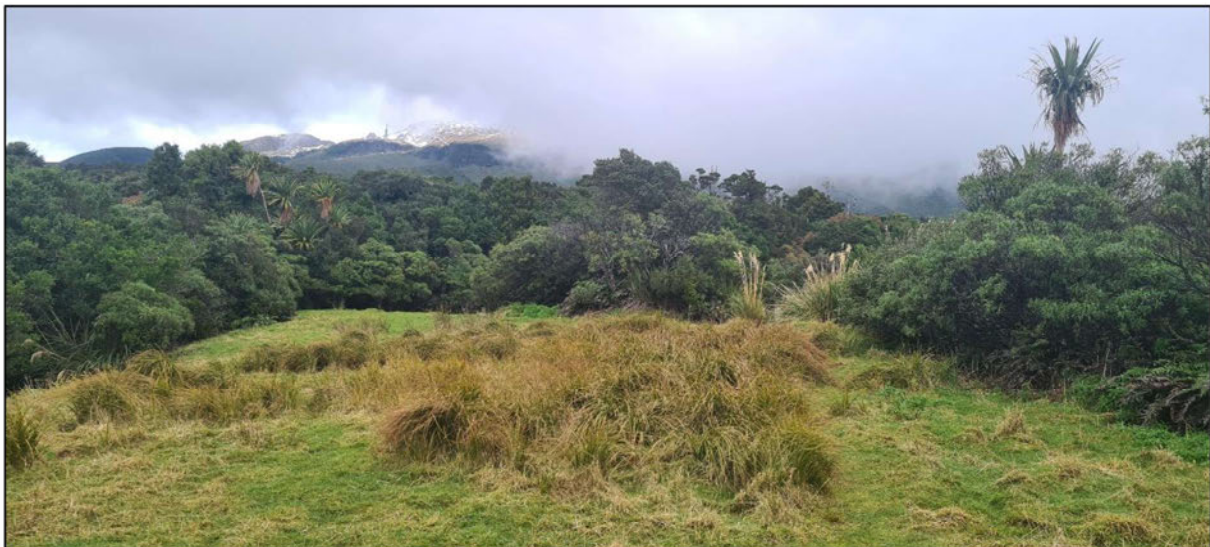
Figure 9: Cutty grass (*Carex geminata*) vegetation feature in the vicinity of the existing wastewater treatment soakage trenches, behind the existing building.

An interesting vegetation feature dominated by cutty grass (*Carex geminata*) was noted on the lawn behind the existing building, in the vicinity of the wastewater treatment soakage trenches (Figure 9). Given that cutty grass has a wetland indicator status of Facultative Wetland⁴, it appears likely that the existing trenches are overloaded and ponding, providing suitably wet conditions for cutty grass to persist. This, and the fact that tangata whenua prefer wastewater treatment infrastructure to be positioned downgradient of buildings, supports the redevelopment of the wastewater treatment system. The project engineers have advised that a new treatment system is being developed.

According to Section 3.21 (1) of the *National Policy Statement for Freshwater Management 2020 (updated February 2023)*, "a natural inland wetland means a wetland (as defined in the Act) that is not... a wetland that has developed in or around a deliberately constructed water body, since the construction of the water body...". Section 5.1 of the Ministry for Environment's *Defining 'natural wetlands' and 'natural inland wetlands'* guidance document⁵ says that "Wetlands constructed by artificial means includes wetlands and waterbodies that have been deliberately constructed for a specific purpose and that may require maintenance over time (for example, vegetation or silt removal) to continue to fulfil that purpose". Further in the document (Section 5.3), wetlands associated with effluent treatment and disposal systems are specifically excluded.

The vegetation feature therefore appears to not pose a risk to the project, based on the above assessment. Taranaki Regional Council Senior Planners have been consulted on the matter and agree with BTW's assessment that the feature is not a natural inland wetland.

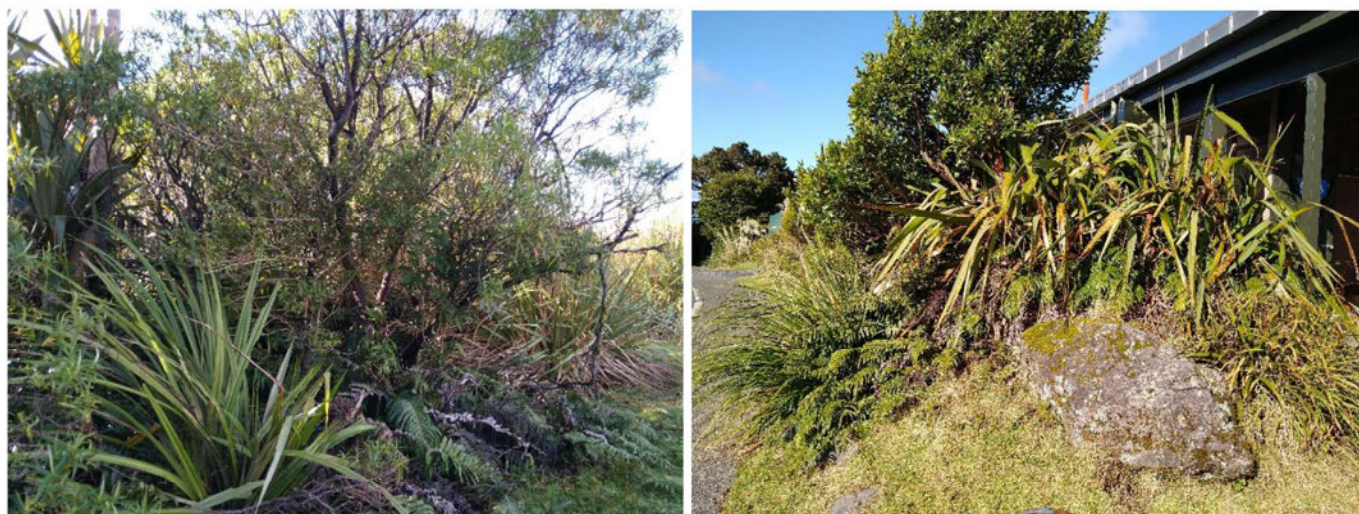
Plate 1: Forest edge (left) and established plantings (right) showing potential lizard habitat within the proposed clearance area. These are surrounded by mown grass, comprising the majority of low-value habitat in vegetation removal area.

The bush edge along the existing carpark is characterised by toetoe tussocks (*Austroderia toetoe*) and harakeke (*Phormium tenax*) growing alongside kiokio (*Parablechnum novae-zelandiae*) and low growing koromiko (*Veronica* sp.) to create a matrix of refugia for ground dwelling herpetofauna. The canopy of kamahi (*Pterophylla racemosa*), tōtara kōtukutuku (*Podocarpus laetus*) and tōi (*Cordyline indivisa*) provide abundant refugia and food resources in their bark, foliage and well-established epiphytes for arboreal geckos. Fruiting *Coprosma* spp, along with puka (*Griselinia lucida*) and māhoe (*Melicactus ramiflorus*) comprise the sapling tier, providing food resources in the form of berries. Beyond the bush edge, within the forested area, swamp astelia (*Astelia grandis*) dominates the ground tier with some wheki (*Dicksonia squarrosa*) and kiokio dispersed among rotting tree trunks and fallen branches, leaf litter and some stones. Abundant insects were noted within the ground habitat. Overall, this area provides high value habitat for both skinks and arboreal geckos (Figure 1: red hashed areas).

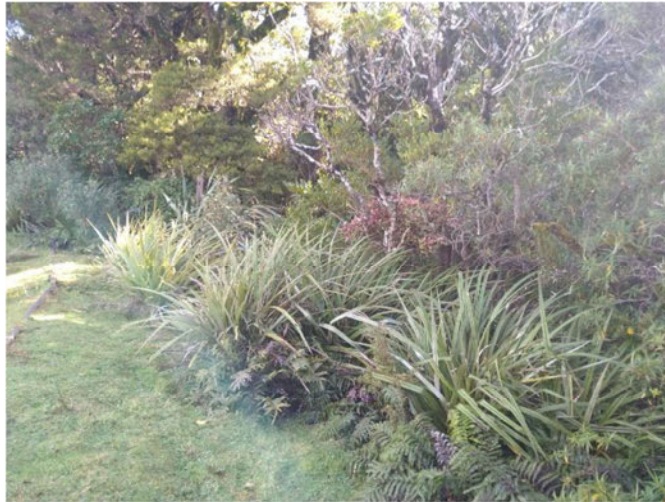
Plate 2: High value habitat for ground dwelling herpetofauna that is contiguous with wider forest; situated north of existing access to carpark.

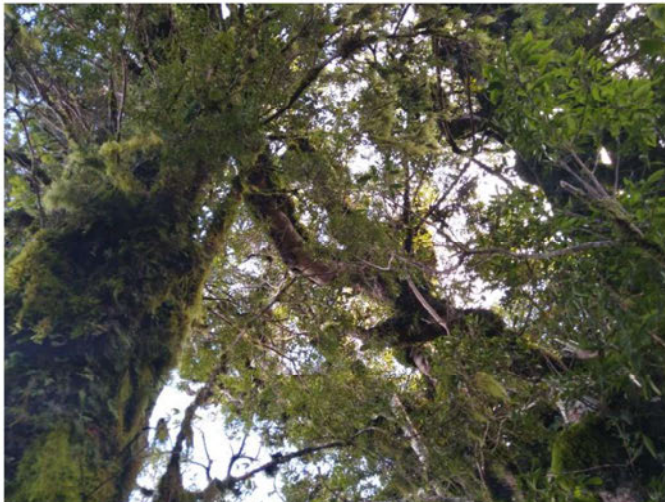
Plate 3: High value habitat for arboreal gecko in same area as Plate 1.

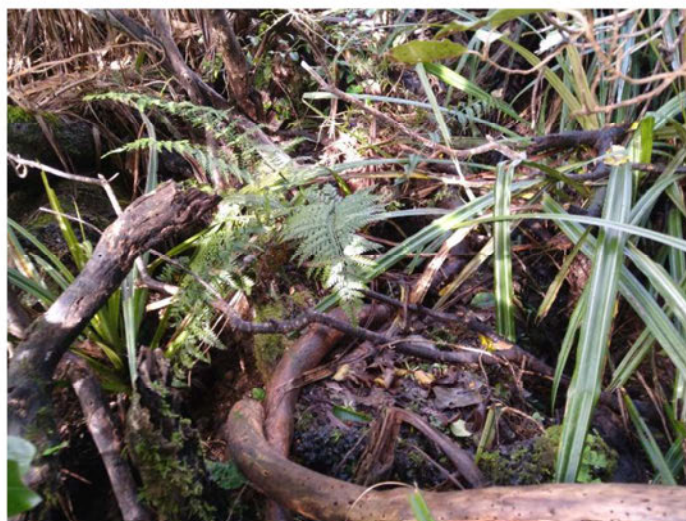
Plate 4: Understory vegetation within forested area provides high value habitat.

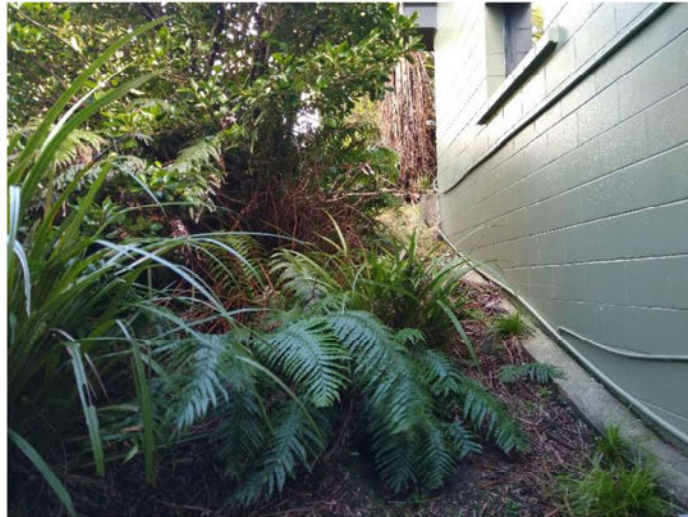
Plate 5: Discrete area of restored indigenous vegetation providing moderate value for ground dwelling lizards.

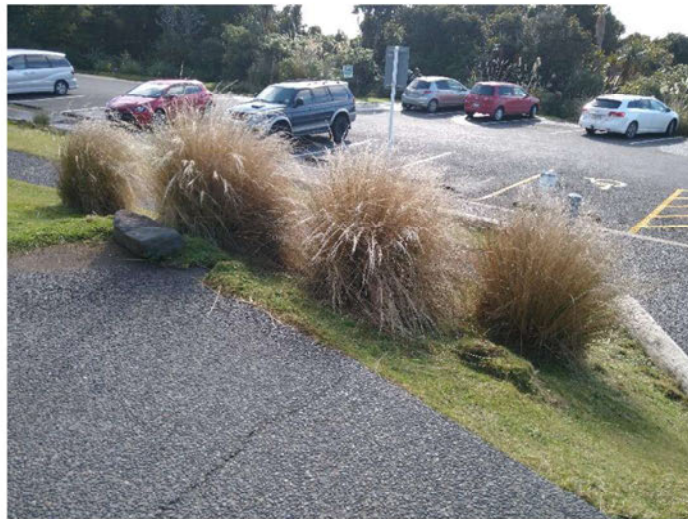
Plate 6: Low value lizard habitat due to isolation and lack of food resources.

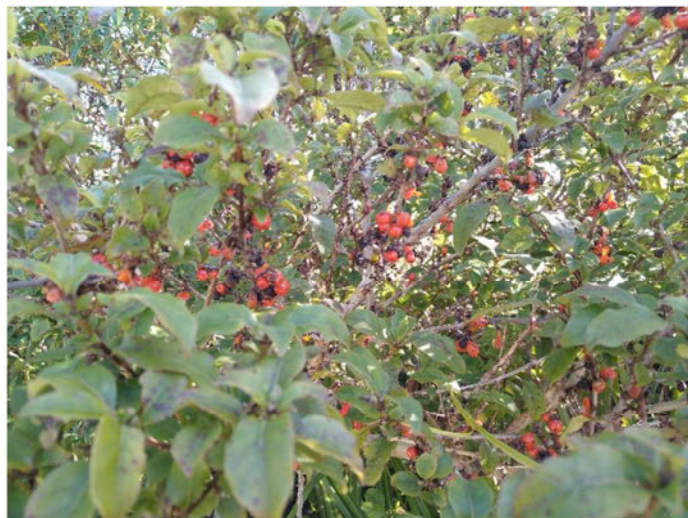
Plate 7: Fruiting *Coprosma* sp. provide food source for herpetofauna throughout vegetation proposed for removal.
