Geotechnical Assessment Report

JOB NUMBER: 23-0183

North Taranaki Visitors Centre
PROJECT

Preliminary Design - REV 1
4 July 2023

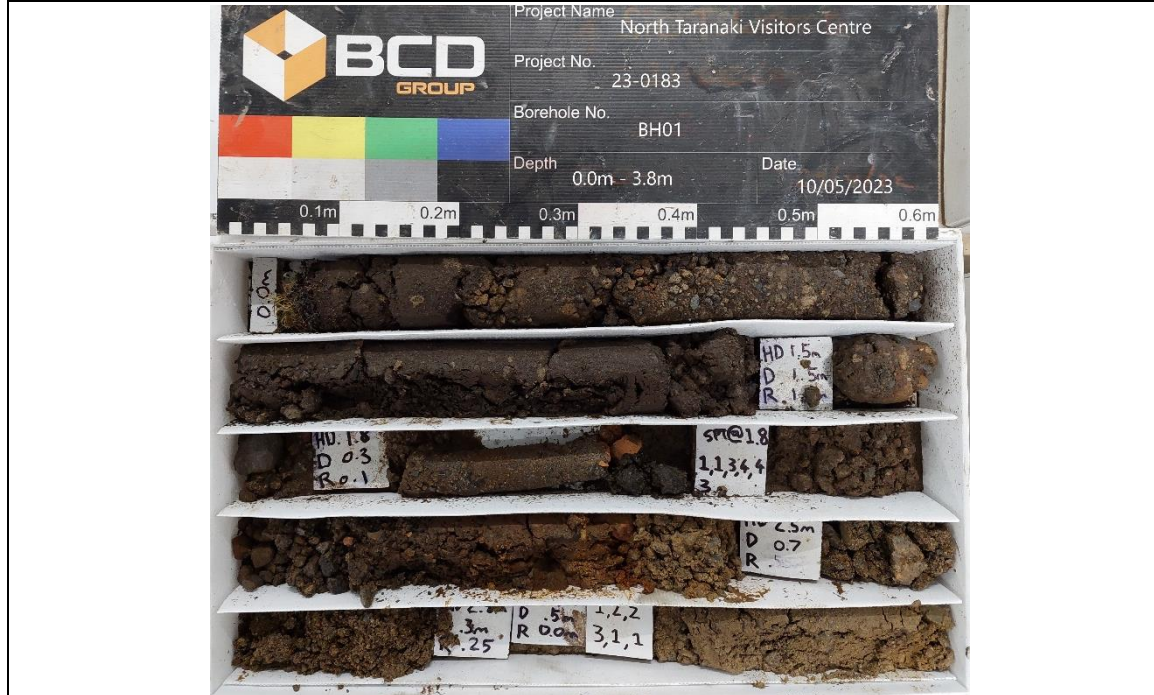
Box 1: 0.0m – 3.8m

Borehole ID	BH01	Contractor	Hardcore Drilling
Date Started	10/05/2023	Drilling Method	HQ Drilling
Date Finished	10/05/2023	Logged By	RV
Termination Depth	10.4m	Checked By	MSB
Ground Water Level	6.1m

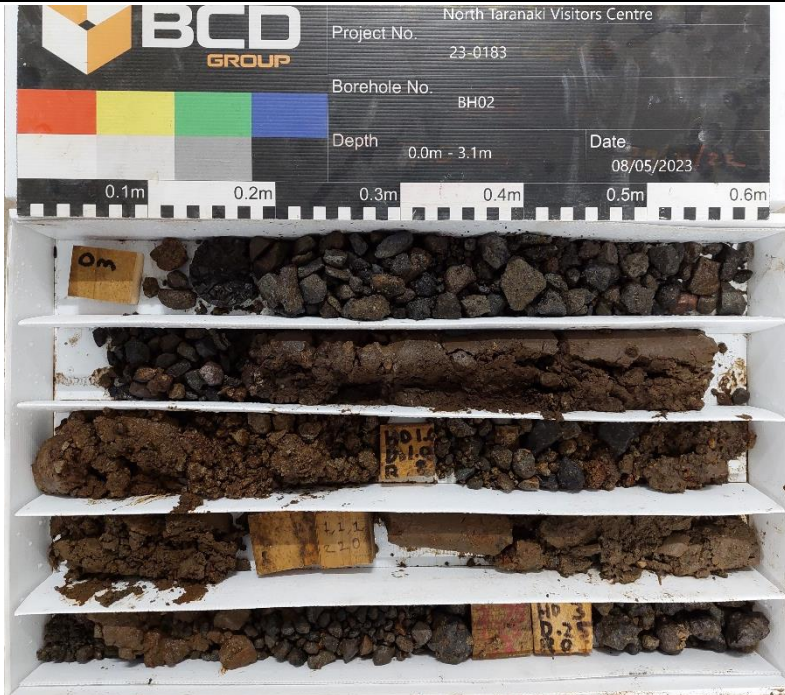
Box 1: 0.0m – 3.1m

Borehole ID	BH02	Contractor	Hardcore Drilling
Date Started	08/05/2023	Drilling Method	HQ Drilling
Date Finished	08/05/2023	Logged By	RV
Termination Depth	10.3m	Checked By	MSB
Ground Water Level	9.1m

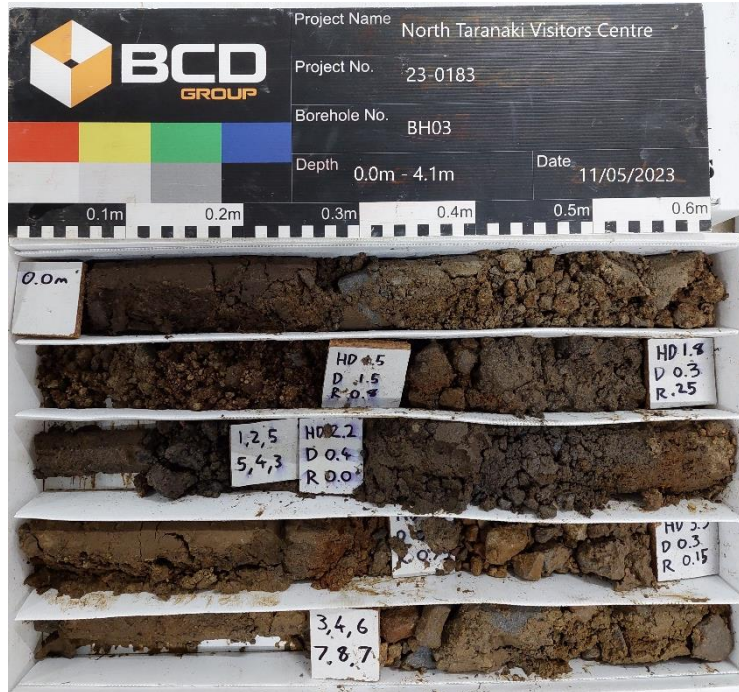
Box 1: 0.0m – 4.1m

Borehole ID	BH03	Contractor	Hardcore Drilling
Date Started	11/05/2023	Drilling Method	HQ Drilling
Date Finished	11/05/2023	Logged By	RV
Termination Depth	10.8m	Checked By	MSB
Ground Water Level	8.5m

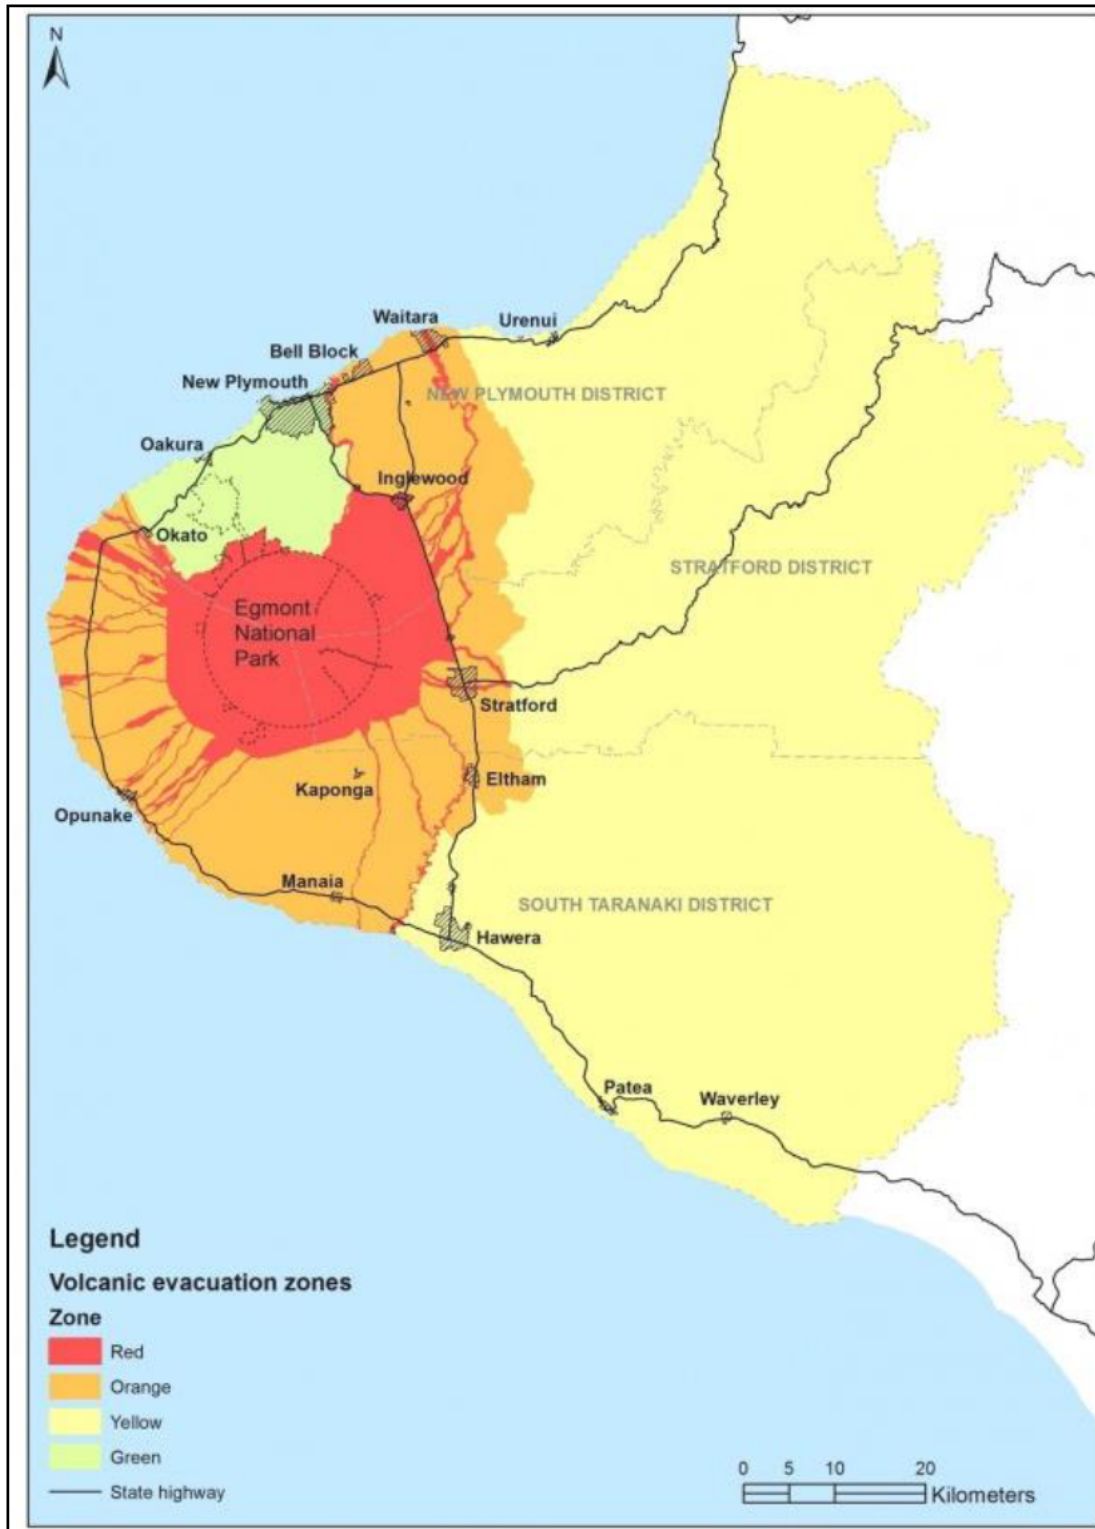
Figure 3: Taranaki Volcanic Evacuation Zones (source CDEM Taranaki)

There are various sources of information available about the volcanic hazards on Taranaki. The Civil Defence Emergency Management (CDEM) Taranaki website provides up to date infographics about the key volcanic hazards. The website also provides a detail of the volcanic activity alert levels and the evacuation zones. Figure 3 has been taken from the CDEM website and depicts the various zones set out by CDEM. The Visitors Centre is located within the Red volcanic evacuation zone. This zone comprises the area most at risk from life threatening hazards. It is stated that people who remain in this zone during a significant eruption are unlikely to survive.
