# Ōpārara Arches Project

## Assessment of Environmental Effects

Richard Nichol Ecology

Date: 2 April 2020 (final edit)

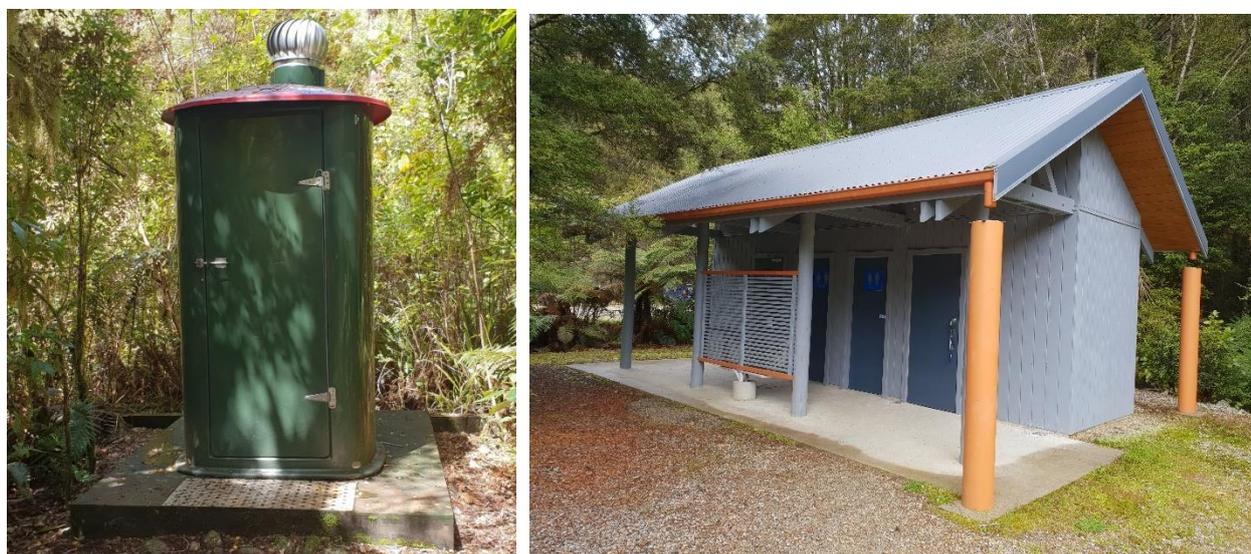
**Figure 5 Existing longdrop toilet at the Box canyon carpark.**

Whilst only a proportion of the visitors to the Oparara Basin venture as far as the road-end to embark on a short walk to the Box canyon, the numbers are increasing and could be expected to continue to do so. In addition to visits by casual day visitors, and a few overnight freedom campers, the carpark at the road-end is also the meeting point for those who wish to join on the guided trip to the Honeycomb caves<sup>21</sup>. There is therefore a need for a toilet facility at the carpark and there currently exists a long-drop or pit toilet set a short distance in to the bush (Figure 5).

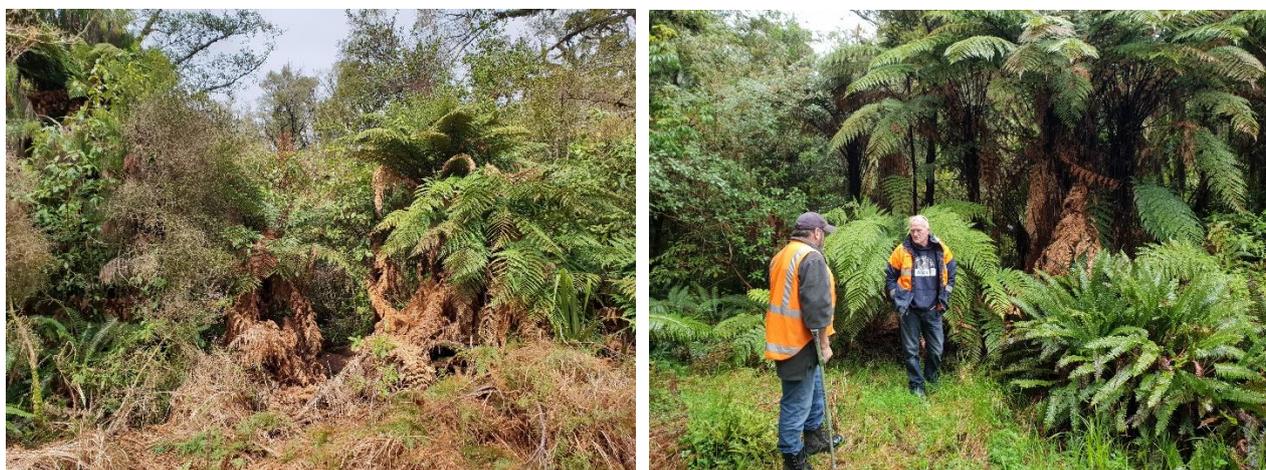
**Figure 8 Proposed site of toilet block establishment, approximately 3-4 metres back from the road edge, showing secondary forest and shrubland on the site.**

The vegetation at the site of the proposed toilet block is small stature regenerating forest and includes kanono (*Coprosma grandifolia*), soft tree fern (*Cyathea smithii*), horopito (*Pseudowintera colorata*), stinkwood (*Coprosma foetidissima*) hard tree fern (*Dicksonia squarrosa*) and broadleaf (*Griselinia littoralis*) (Figures 8 and 9).

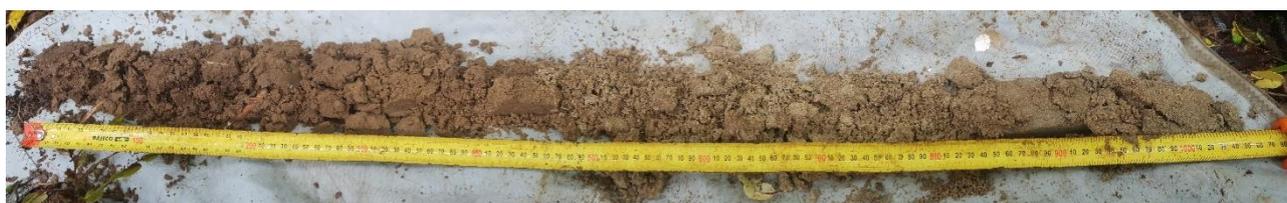
**Figure 10. Soil/subsoil profile showing loosely consolidated quartzose sediments down to at least metre in depth (i.e. tape length shown).**

Two soil core samples were taken from the site of the proposed dispersal field. These showed that relatively homogenous quartzose sediments extend to between 50cm and 1m in depth, beneath a shallow soil layer (Figure 10). This will permit drainage for waters arriving from the dispersal field and seeping outwards. The Nile formation limestone occupies the ground westward of the toilets and is not considered be affected in any way by dispersal field fluids or grey-water.

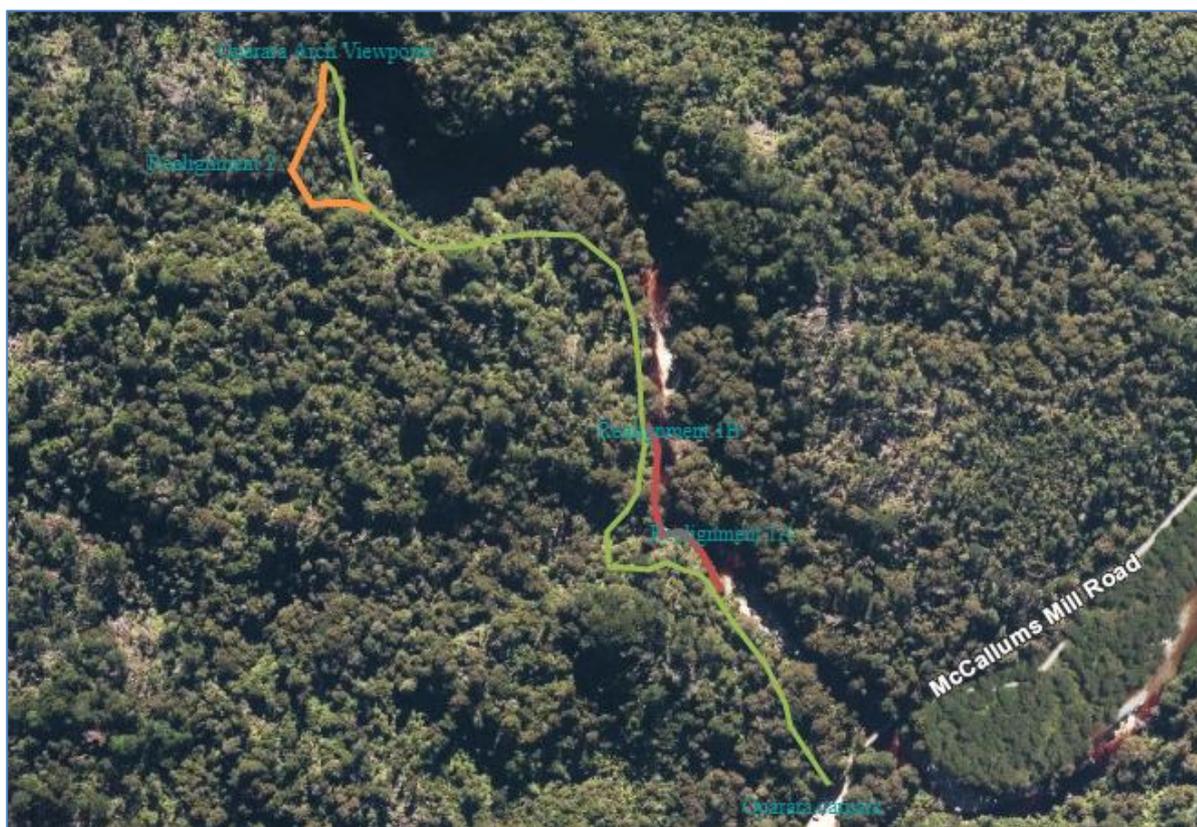
Figure 11. Oparara Arch Track upgrade, showing existing track (green) and two proposed realignment sections. Westcoast.govt.nz ‘Localmaps’ basemap is acknowledged.

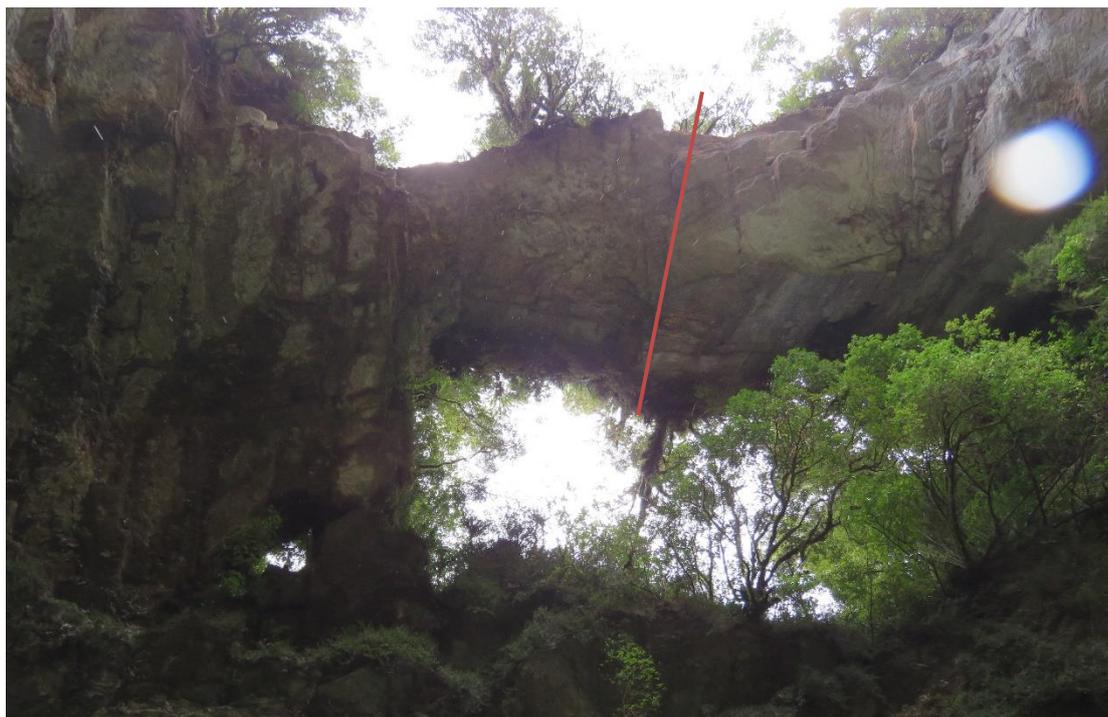
**Figure 13 showing zone of weakness that presents a rock-fall hazard to track-users. The current proposal would allow visitors to view the arch without exposing them to a direct risk from arch collapse.**

With the number of track users forecast to increase, there is a very real need to consider the associated risk to which track users are currently exposed. The realignment of this section is consistent with policy 31 of the West Coast Karst Management guidelines (Miller and Silverwood, 2018) which state that “Any physical structures and track surfacing should be installed only to manage health and safety and/or prevent damage to site values. This should occur in a way that it does not impact the values of the cave or karst.”

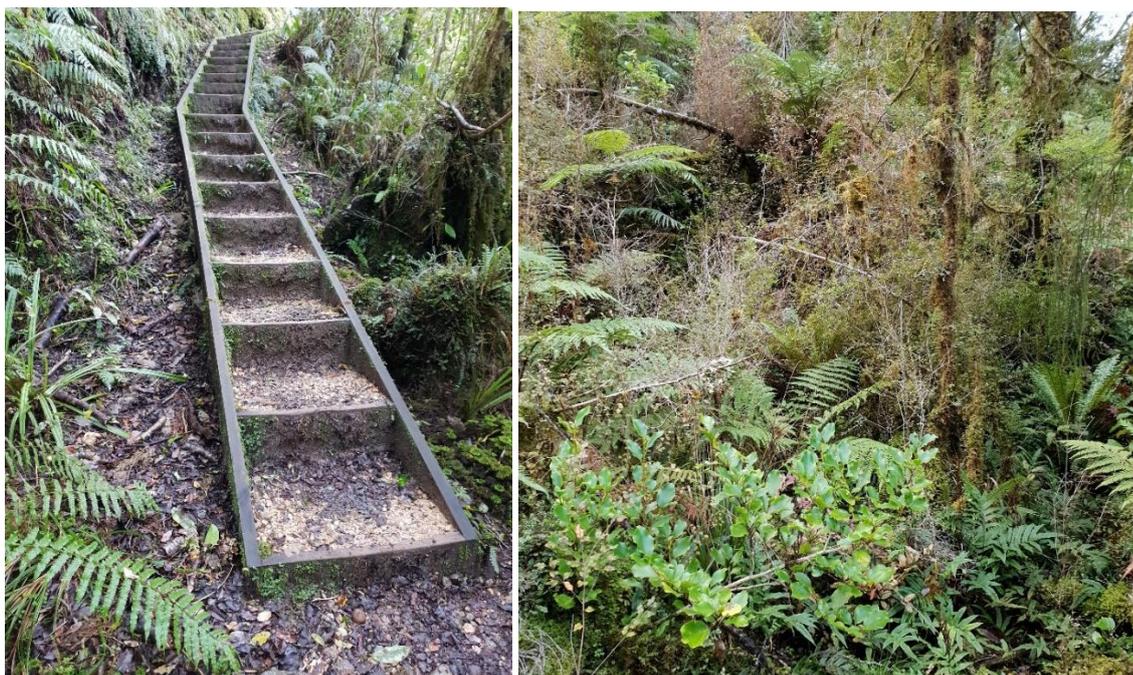
**Figure 15.** Steps lead up from the existing terrace and across the limestone bluff on which the elevated walkway is proposed. The flight of steps has an overall gradient of about 22° but are only 600mm wide compared with the existing track surface of more than a metre.

At the upper end of the terrace the track is then forced upward in order to negotiate the steep limestone face upon which the elevated walkway is proposed (this is referred to as alignment 1A and is described separately in 9.2.1.1). A series of steps gain approximately 25m in elevation (Figure 15), at the top of which is gained a view up-valley and looking out over the river.

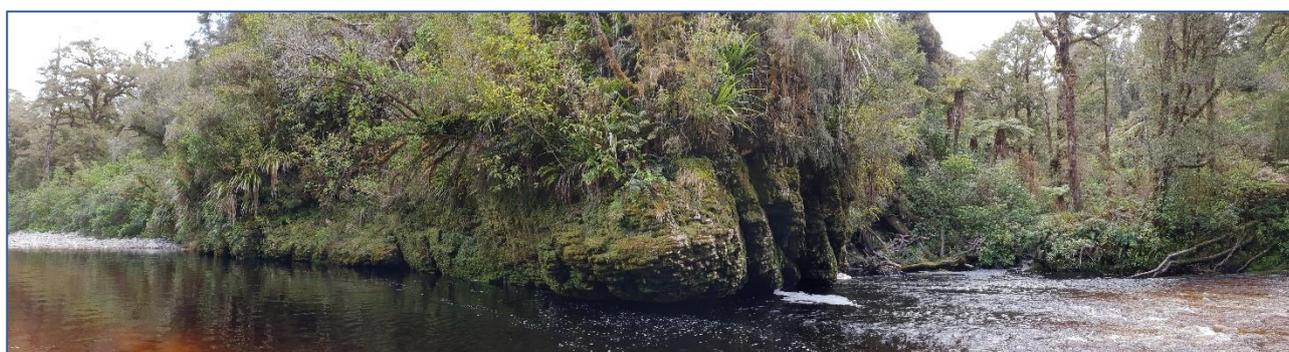
**Figure 17 showing the limestone bluff around which the elevated walkway would pass. At the right-hand end of the walkway an attachment point would provide the abutment for a 15m bridge across the backwater seen. At the head of this backwater is the confluence of a small un-named stream. The bridge would cross that piece of water in a single span and the northern abutment of the bridge would be situated within forest in the right-hand field of the panorama.**

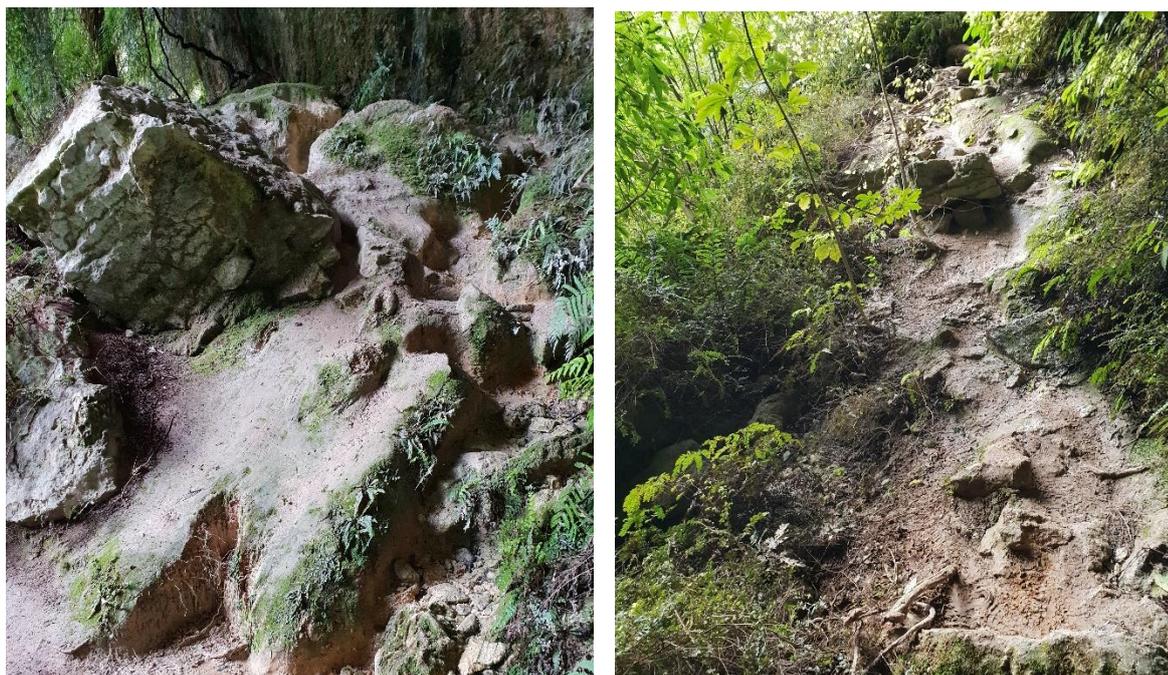
**Figure 20.** A number of slip and trip hazards exist along the proposed new route following alongside the wall of the arch. This ‘track’ exists as a result of visitors exploring further than the existing viewing area.

**Figure 21.** Some low obstacles may be broken down for the proposed track build while infilling the ruts and channels will help to reduce slip and trip hazards near the viewing area.

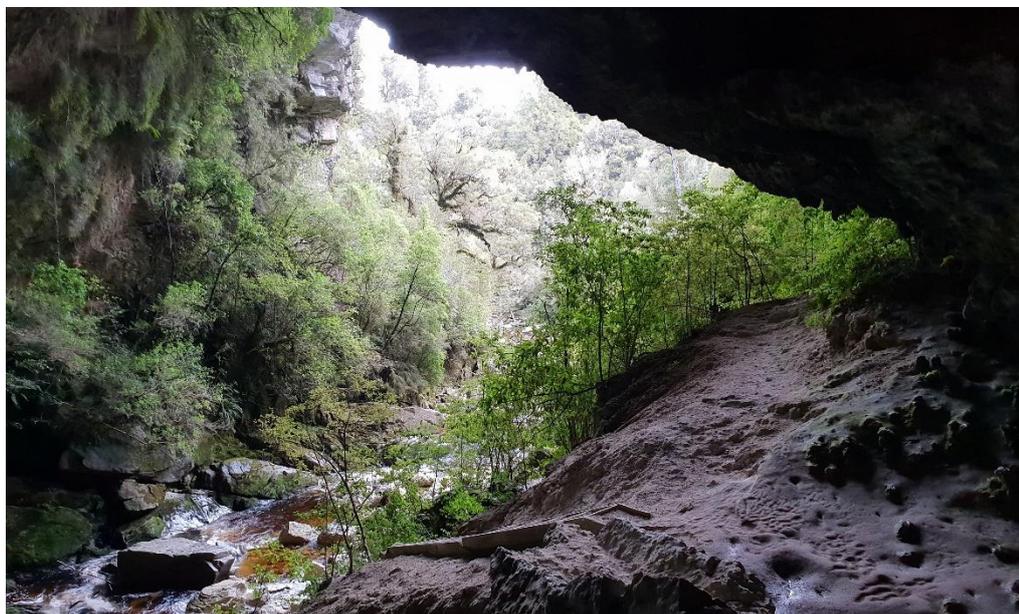
**Figure 22** Existing approach to the Oparara arch viewing area via the steps at left. The realigned track will descend from the right-hand side, with protection being afforded by more stable geology along the arch wall.

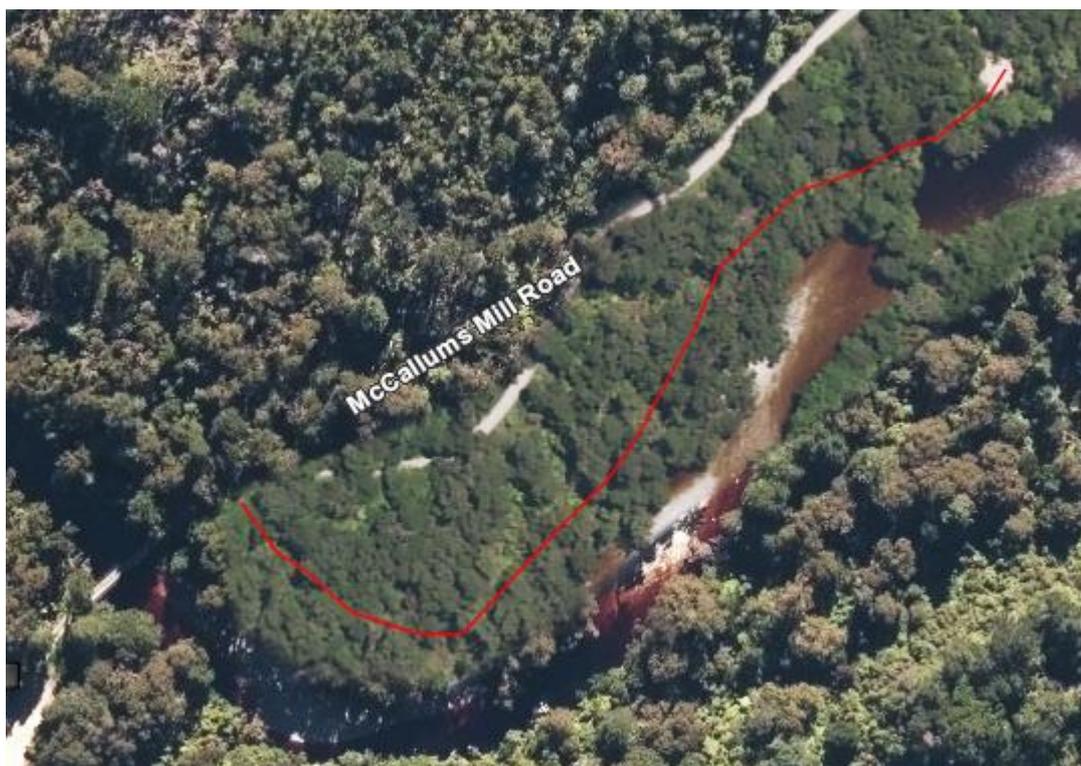
Figure 23 showing proposed alignment from existing mirror tarn carpark to McCallum's Mill Road, re-joining the road approximately 20m from the bridge over the Oparara river, seen at left. Basemap from [gis.westcoast.govt.nz](http://gis.westcoast.govt.nz).

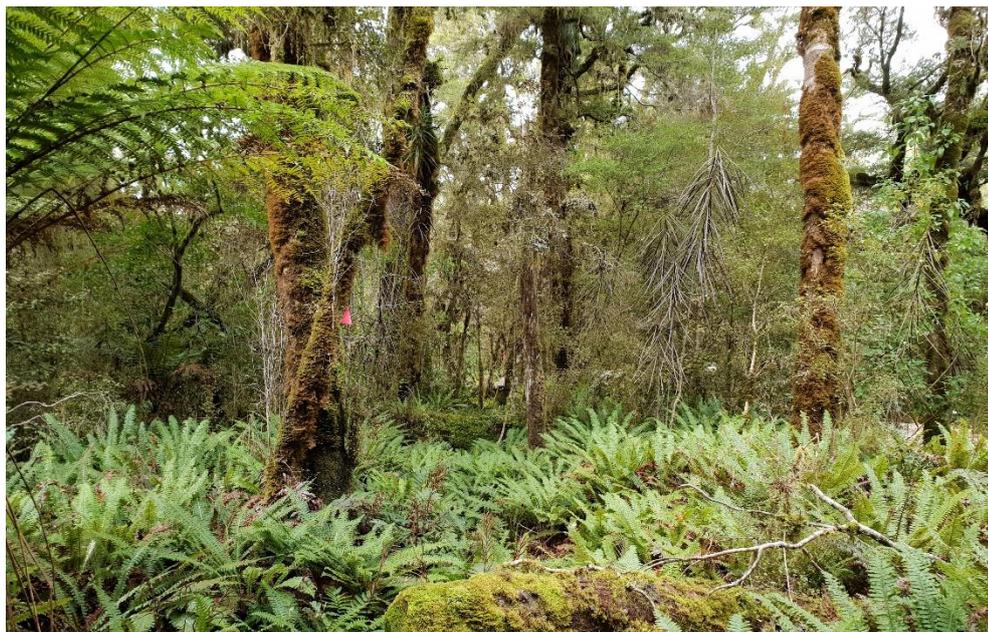
**Figure 24. Typical vegetation as seen near the northern end of the proposed trail. A pathway through the crown fern had been cleared when revisited on 31<sup>st</sup> October.**

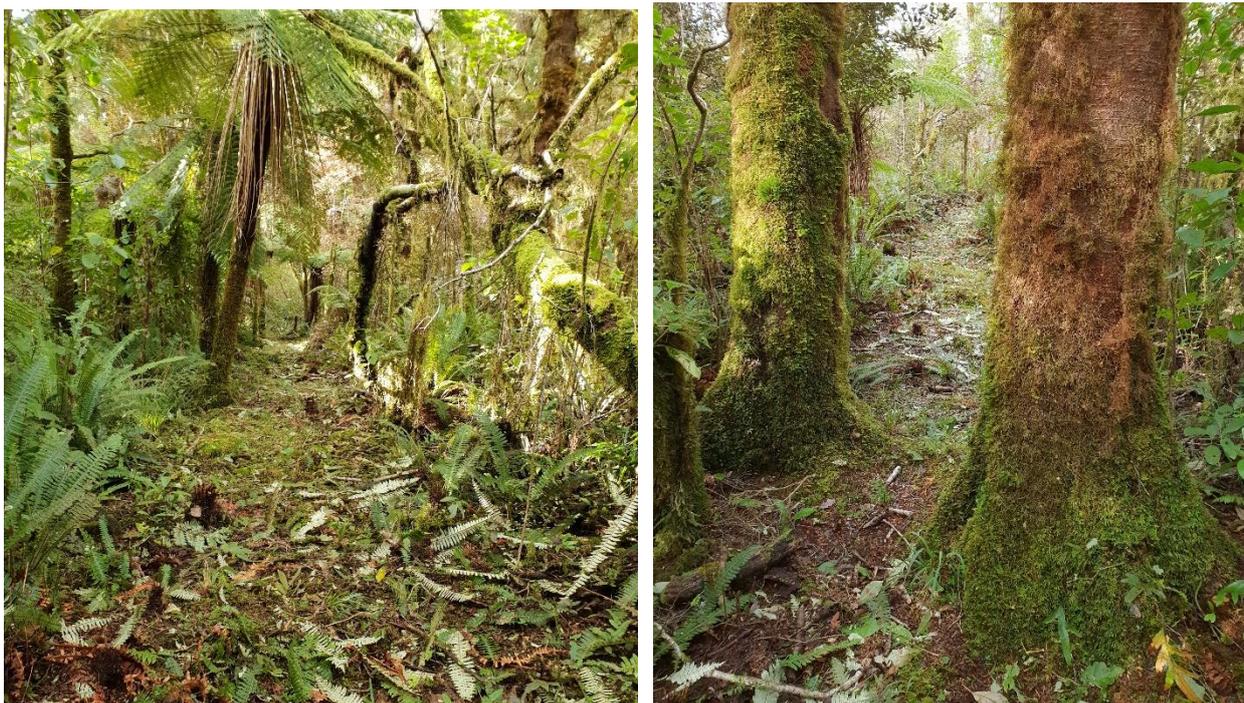
**Figure 25** showing existing vegetation clearance along maintained trapline. The proposed track will follow this alignment for at least 95% of its length.

**Figure 26** Two relatively large silver beech stature beech trees straddle the existing alignment, presenting a pinch-point on the proposed trail. The trail will pass between these trees rather than clear any additional vegetation.

There is one pinch-point, approximately 90m from the Mirror Tarn carpark, where two silver beech trees, approximately 40cm trunk diameter and 22m+ in height, straddle the existing maintained access-way. It was agreed (with M. Hansen, DOC) that this was not an obstacle to the track alignment, and that there was adequate room to pass between these trees (Figure 25).

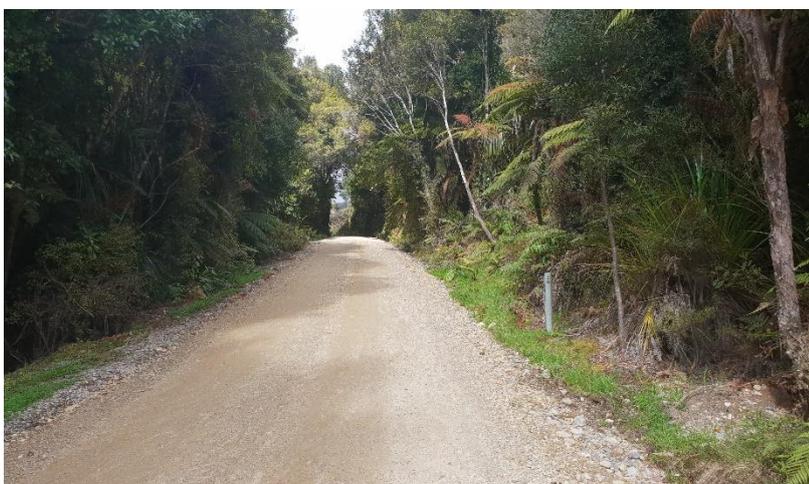
**Figure 32.** The climb up to the top of the rise on section B. the gradient is about 8° and while there is generally a reasonable amount of room to extend the road width, some native trees will need to be felled to accommodate a 6m carriageway.

**Section B.** This 850m section extends from near the end of the pakihi and climbs up a steep rise and levels off for a while before descending to Break Creek No. 4. The ascent is about 9° in slope and the intention is to cut from this area and fill at the base to reduce the overall gradient (Figure 33). The descent on the northern side of the rise is of a similar gradient and a similar cut and fill option is proposed. Tasmanian blackwoods are the predominant vegetative cover on the southern side before indigenous regenerating forest is encountered. Secondary forest is the predominant cover on the northern side of the road. The vegetation within the road verge is typically composed of exotic grasses, kiokio, soft mingimingi, hard tree ferns and nearer the road edge is adventive grass, self-heal (*Prunella vulgaris*), fleabane and hard fern. It may be necessary to fell some kāmahi trees, the largest of which has a dbh of 39cm. most would be of a much smaller diameter however. This section includes 3 culverts, the last of which – Break Creek No. 4 - provides significant flow and good fish habitat.

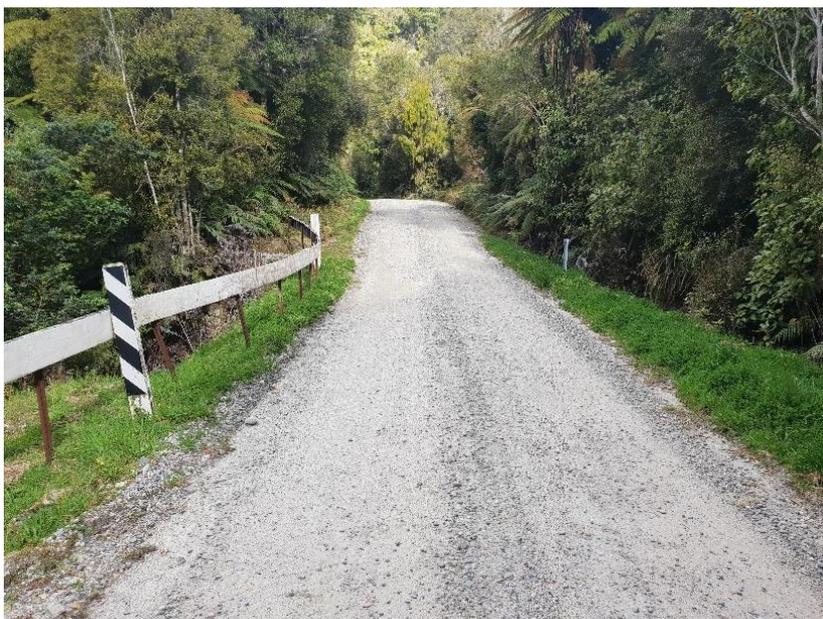
**Figure 33. showing a pinch point where a replacement sight rail will need to be installed and rock armoring may be required. The vegetation has a moderately high degree of naturalness but will likely be little affected because of an adequate amount of room to expand the road width without intruding far beyond the existing low stature vegetation/existing drainage channel.**

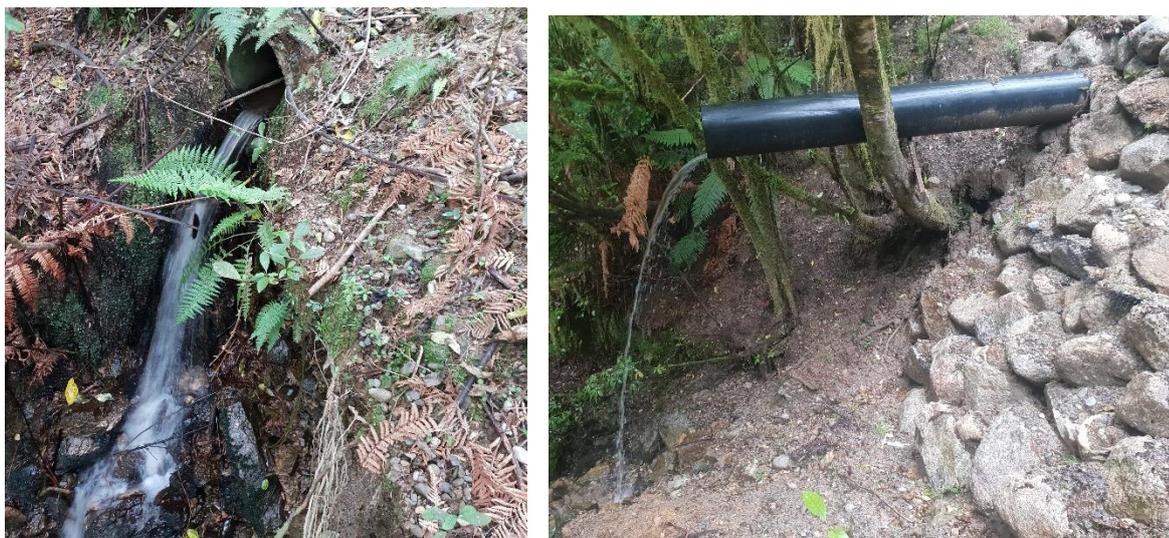
**Figure 34. Culvert 035 is perched by about 1.5m and has a very high flow, and yet surprisingly was the smallest catchment in which banded kokopu were found (as well as koura), about 50m upstream of the road within a forested catchment.**

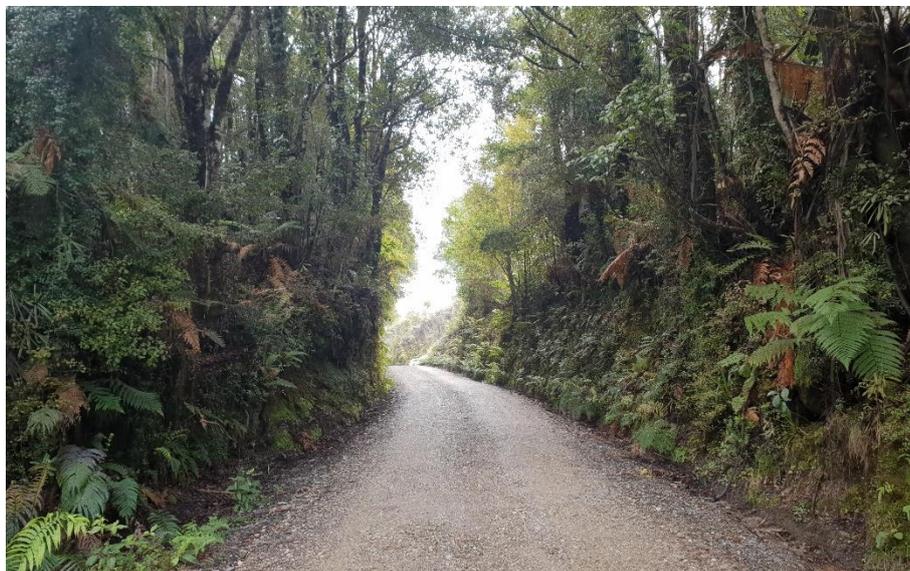
**Figure 36. Abbotsford cutting. Clearance of kiokio and some small trees, including red beech, kāmahi and northern rata would be required on this short section.**

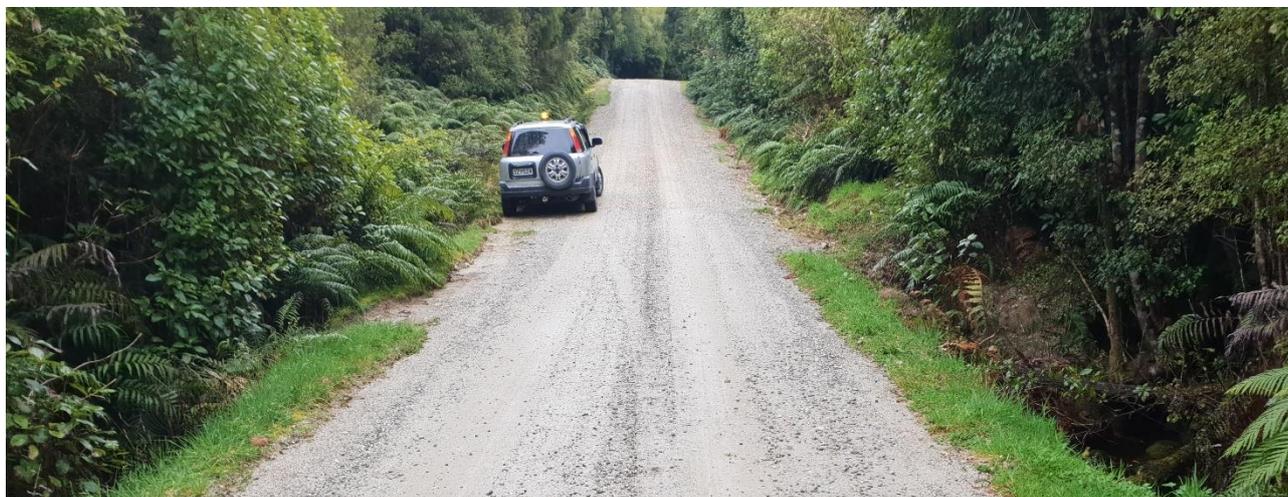
**Figure 38. Low stature forest typical of section E, with adequate road width to form a wider road surface without having to alter the drainage markedly. Most of the vegetation requiring removal would be exotic species plus kiokio and small shrubs and tree ferns.**

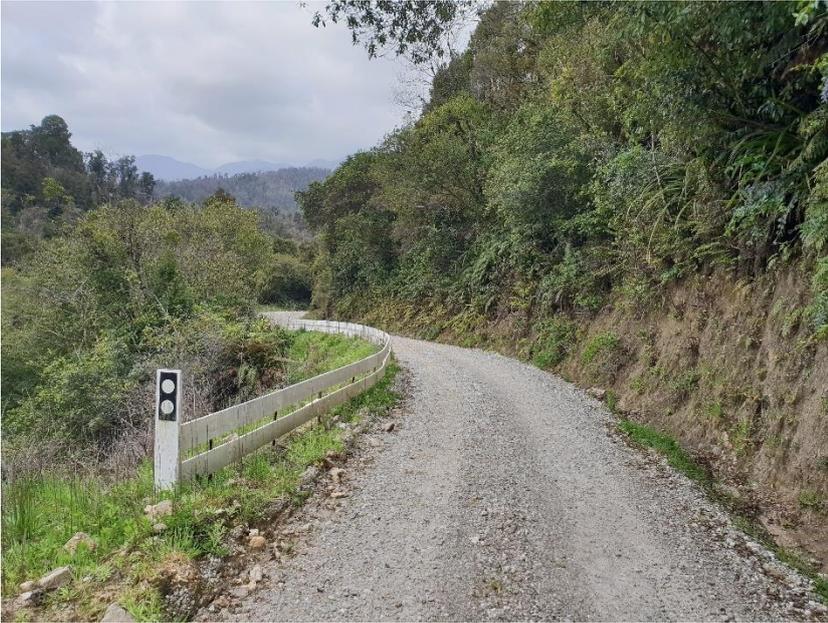
**Figure 39** where the exiting road cuts into the Nile formation limestone. No vegetation species of particular note were observed.

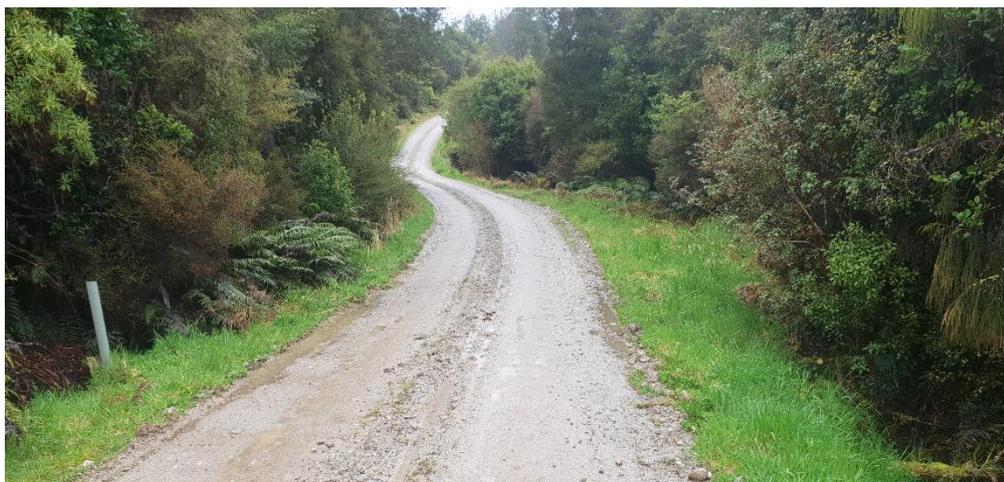
**Figure 40. Typical section of road within Section G, with widening likely to affect mainly exotic grassland on the road verge, but the need for some intrusion in to low fernland and shrubland at times.**

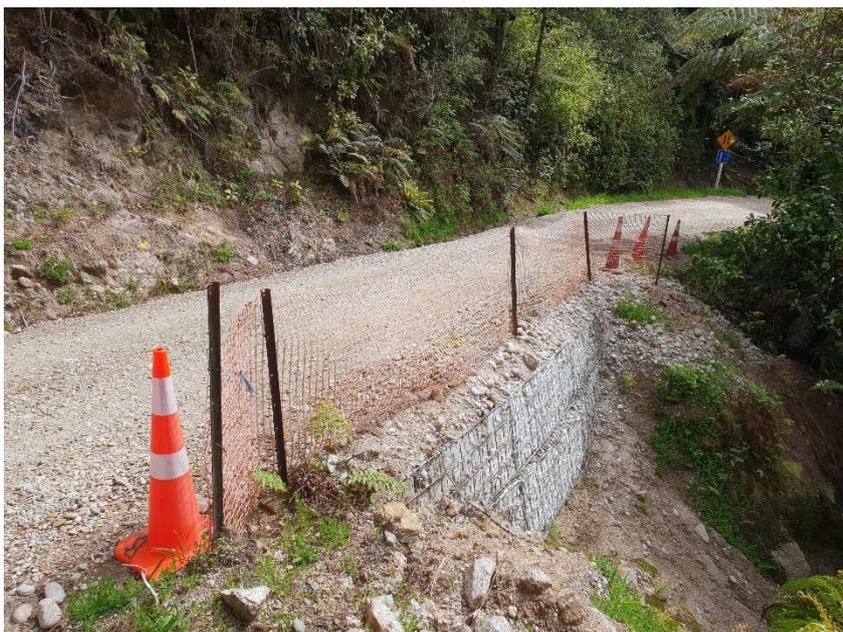
**Figure 41. A typical site where rock armouring/gabion baskets might allow better utilisation of modified habitat and reduce the amount of indigenous vegetation clearance on the opposite side of the road.**

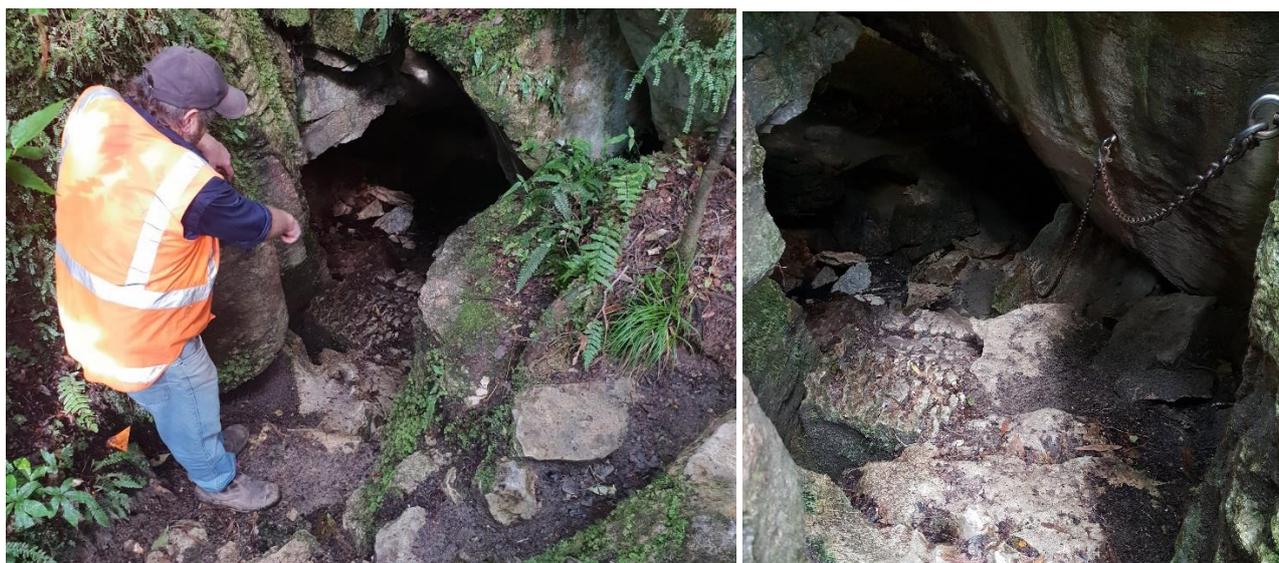
Figure 42 showing the entry point to the viewing area at Moria Gate and the clamber down over limestone slabs.

Figure 43 showing the final approach to the Moria Gate viewing area and the existing clamber down in to the viewing area.

Moria Gate is one of the key attractions that is accessed from the main carpark area in the Oparara Basin. Although most of the track to the arch is of a very high standard (day visitor standard - see appendix 4) and caters for people with a wide range of physical ability, the last few metres of the track is much more challenging and requires the visitor to hold on to a chain as they scramble (Figures 43 and 44) down to the viewing area on the true right hand side of the Oparara river as it flows through the arch (Figure 45).

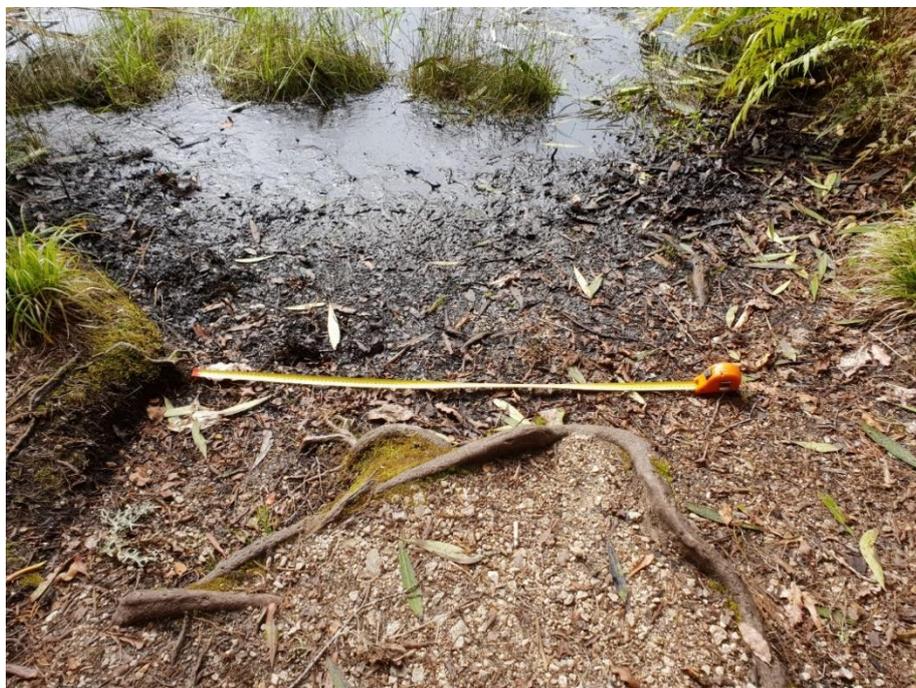
**Figure 46 showing width of proposed structure (1.2m), as well as devegetated area on lake edge with exposed tree roots.**

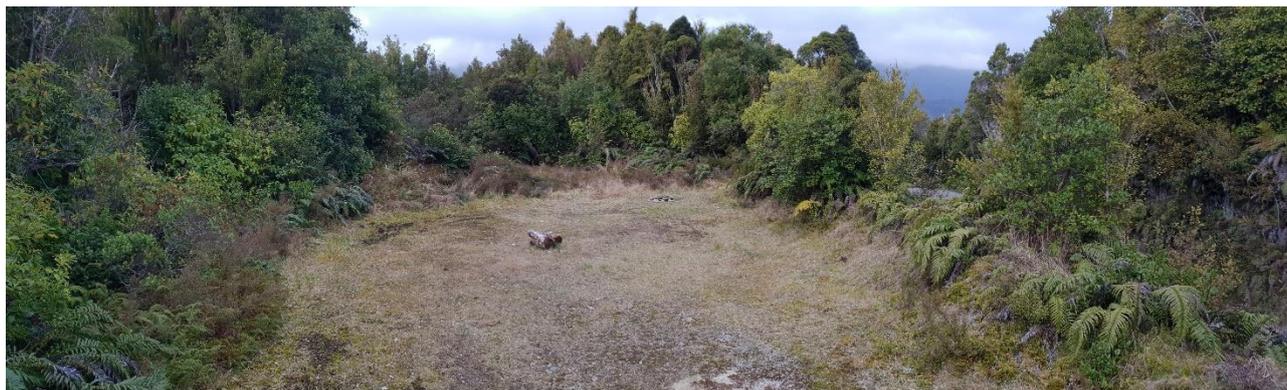
Figure 48. The existing site. Introduced species predominate in the central area with a mixed fern and shrubland around the perimeter then transitions to secondary forest beyond. The proposed interpretation area would be at the far end, while a viewing window would be cleared to the left of this.

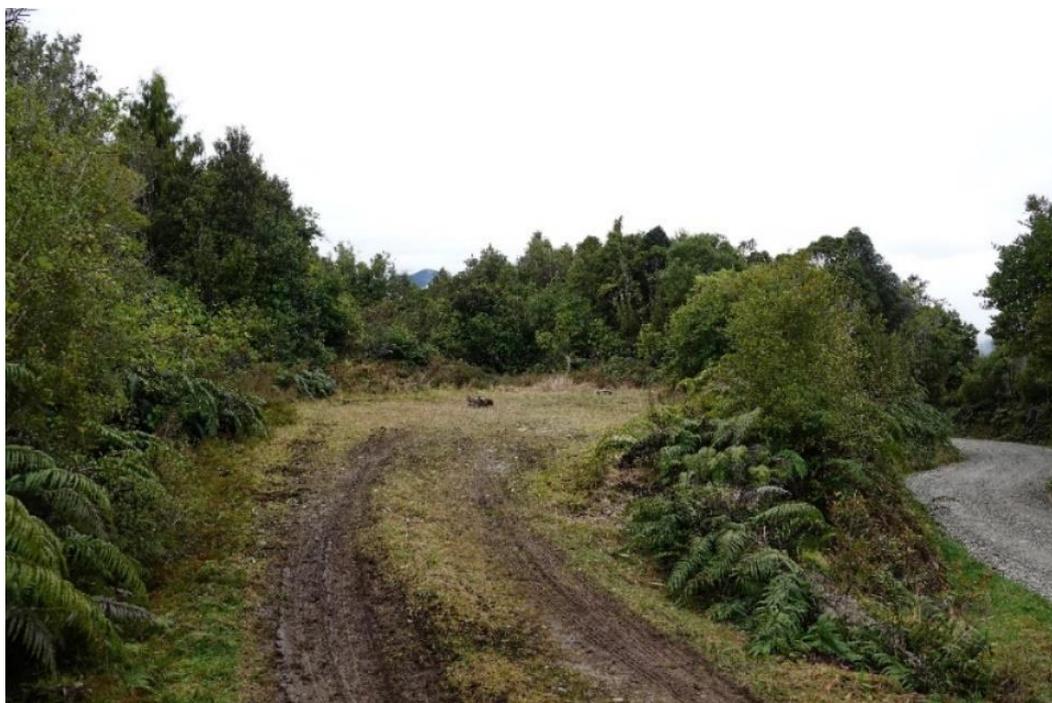
Fig 2. Photo showing the off shoot in proximity to McCullum's Road and the cleared area proposed from the car parking space, with the viewing area to be cleared approximately around where the mountain is visible in the background.

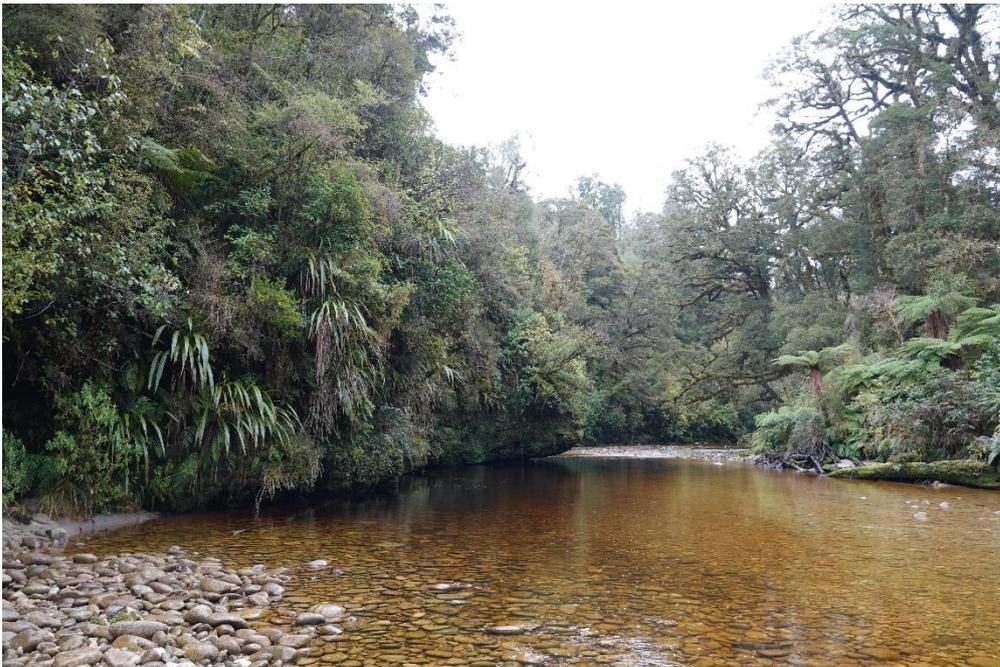
Fig 7. Image showing the limestone face on the left of the river where the elevated walkway is proposed to be located.

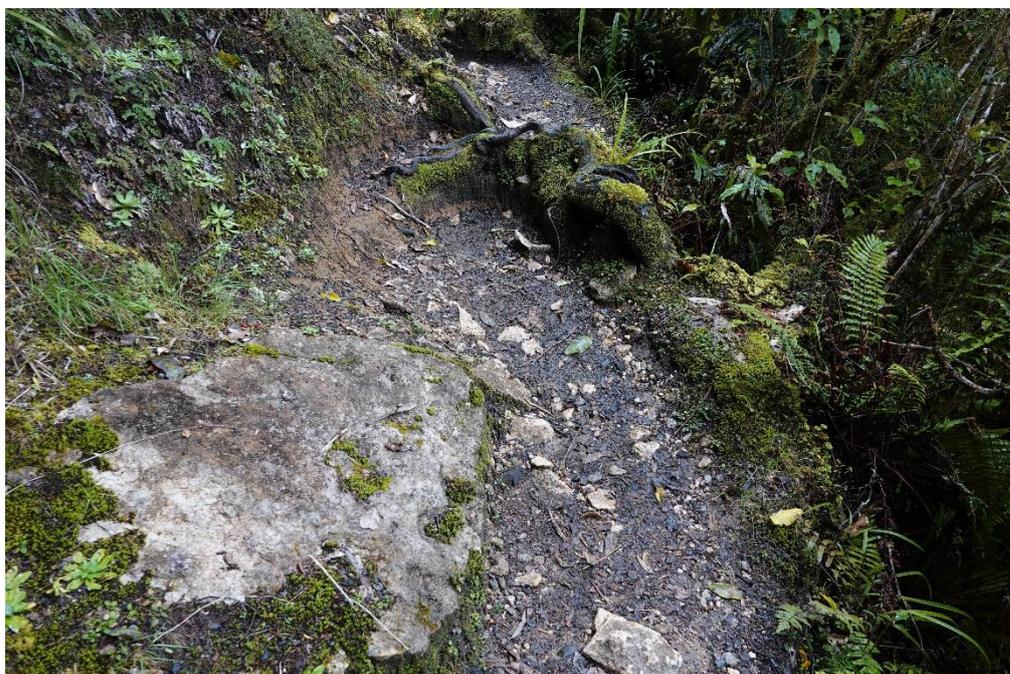
Fig 8. Image showing the limestone face to which the existing track sidles around. There is a thin strip of scrubby vegetation between the track and the steep drop down to the river.
