OBJECTIVE 2: DRAINAGE CHARACTERISTICS OF THE RANGIHAU ROAD - CHRISTMAS CREEK AREA ON WHICH THE TRACK IS ALIGNED.

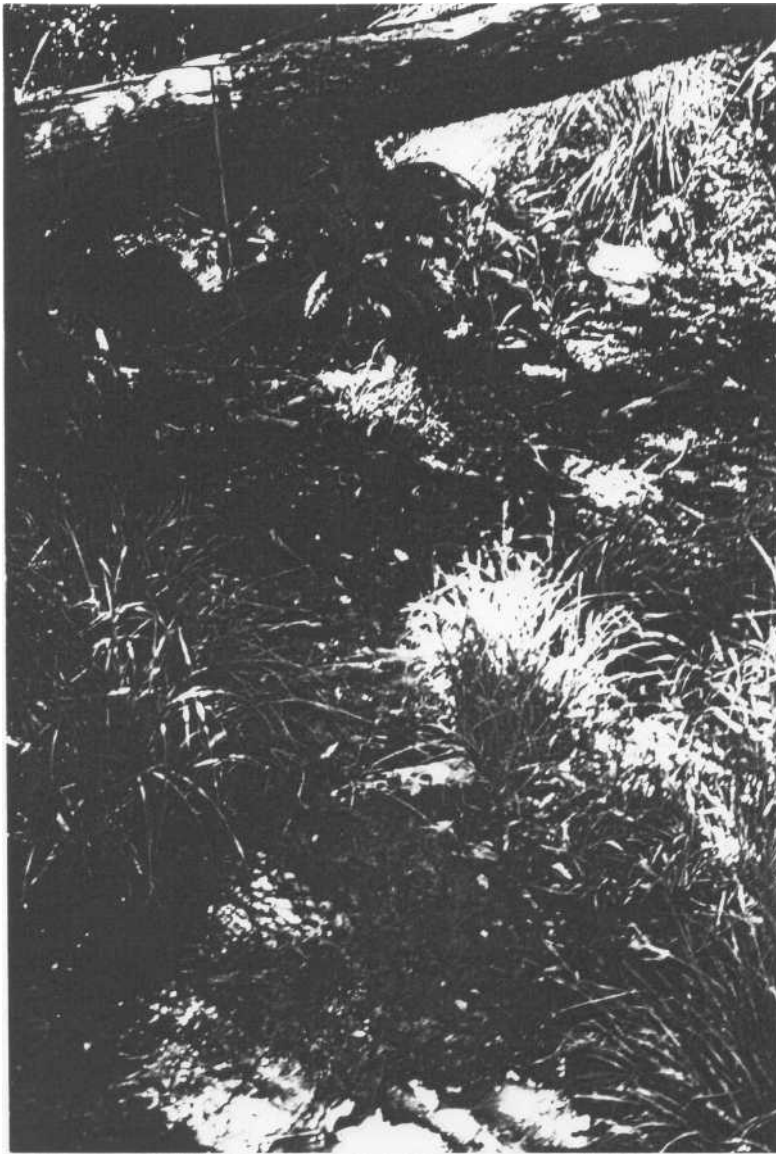
A major problem is the occurrence of numerous bog conditions which are unsuitable for walking and track construction. Boggy regions form from groundwater seepage faces that discharge out of down slope sections and pond in flat lying areas (Plates 1,2). Groundwater seepage is a permanent feature and during the winter and spring months higher rain falls can cause stream flows along the seepage zones. The diversion of groundwater seepage from the track would be a difficult and costly operation, but would be required before any future track upgrading. Ponding regions have characteristic layers of saturated muddy ash soils to depths of 1 m and are of low strength. Bedrock underlying this region is classified as Omahia Andesite, a dark basic volcanic rock that seems to provide an impermeable surface along which seepage occurs.

PLATE 2: SHOWING PONDING REGION

- * Avoid long stretches of medium gradient track ($> 1/7$) because of risk of accelerated erosion.
- * All tracks should be constructed with appropriate drainage eg : culverts, intercept pipes, mounded track design or flat construction using a base of large paved rocks overlain with smaller aggregates and infilled with coarse gravel mix with drainage channels running on either side of the track.

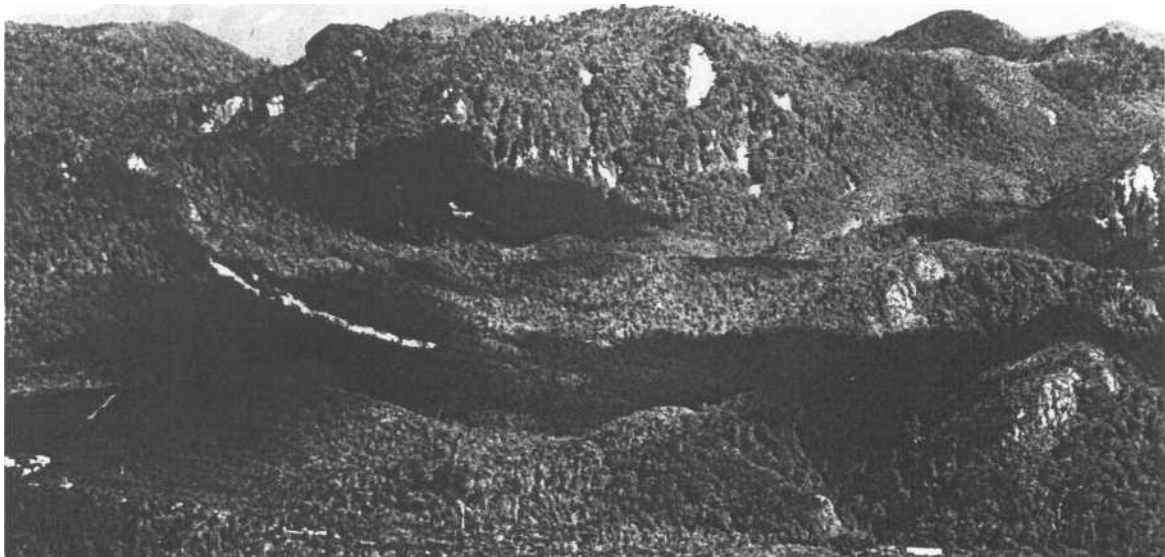
PLATE 3: SHOWING THE 'HIGH POINT', SADDLE, RIDGE LINE AND SLIPS.

- * Utilise 'corestones' for track construction. Corestones have been identified at all pit sites along the new track.
- * Bench new track around the 'high point' enabling a less steep descent onto the saddle.
