3.3 TRIAL NO. 3 - F.V. *ATU S*

The objective of trial number 3 was to set a minimum of 4000 hooks through the modified chute under the normal fishing conditions on a commercial fishing vessel, and evaluate its seaworthiness and ease of use. The trial was undertaken on the domestic longline fishing vessel F.V. *Atu S*, owned by Moana Pacific Ltd.

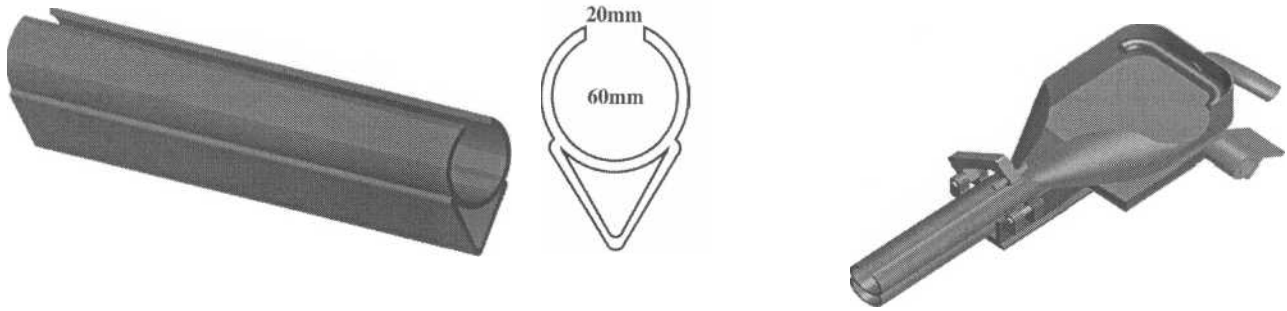
FIGURE 6. (ABOVE LEFT) CHUTE DESIGN AND (RIGHT) TROUGH USED ON F.V. *BRENDA KAY*.

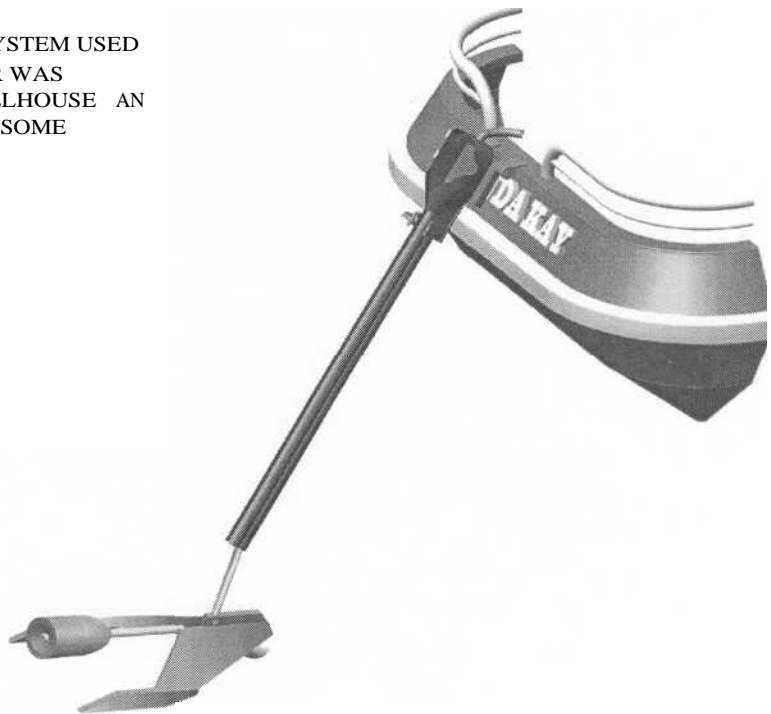
FIGURE 8. CHUTE IN USE ON F.V. *BRENDA KAY*. THE HANDRAIL HAD TO BE RECESSED TO ALLOW FOR IT.

2. For installation of the device on the F.V. *Brenda Kay*, the stern railing had to be removed. It was considered important that adequate railing "surround" the work area at the stern and that minimum amounts of railing be removed.

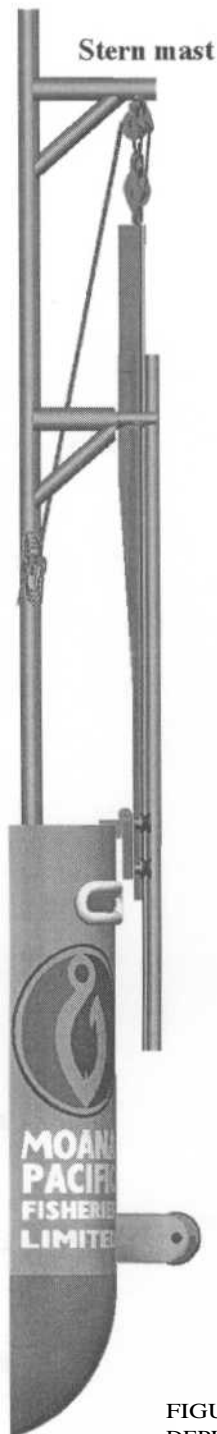
FIGURE 14. FIRST DEPLOYMENT AND RETRIEVAL SYSTEM USED ON F.V. *ATU S*.

On the first trial on the F.V. *Atu S* the chute was fitted in the centre of the stern gunwale. Recovery and deployment were achieved by fitting a pulley system to the top of the stern mast with a locating bracket mounted further down the mast (Figure 14).
