# Ruapehu crater rim inspection 13 April 1999: Developments since 1997

I A Nairn  
Geological Investigations  
45 Summit Road  
RD 5  
Rotorua

Ruapehu crater rim inspection 13 April 1999: Developments since 1997. *Conservation Advisory Science Notes No. 265*, Department of Conservation, Wellington.

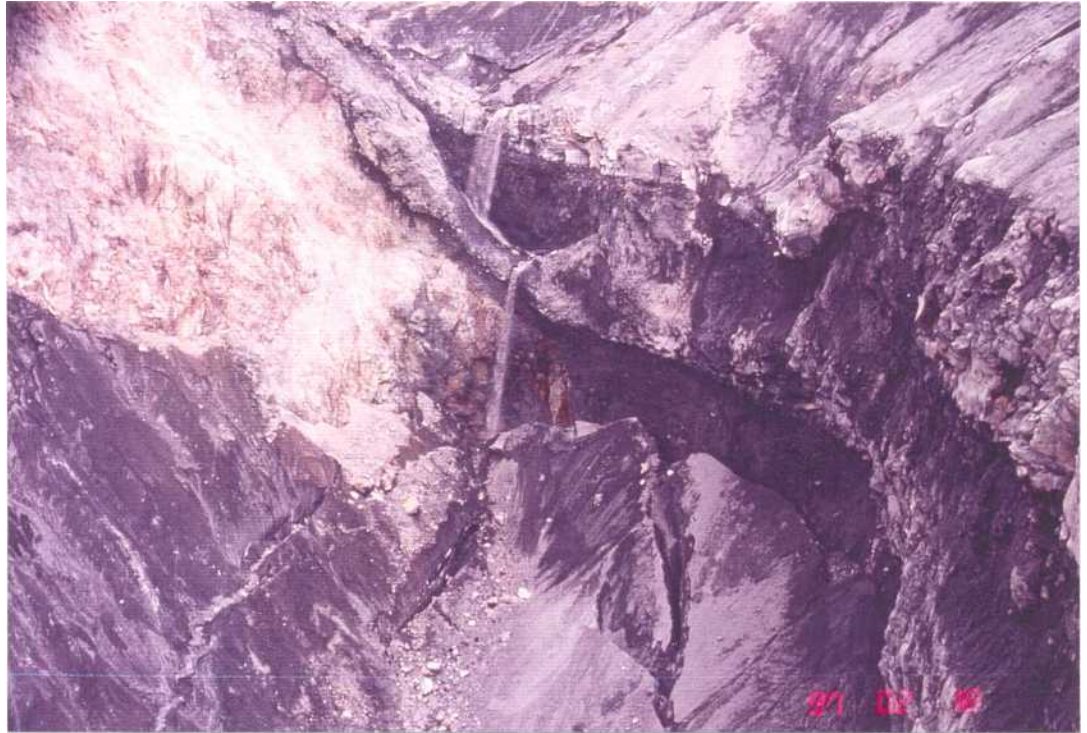
Figure 2. Closer view of the waterfalls flowing over the young lavas and interbedded scorias at the base of the Stump Saddle outer slopes. Photo taken 18 February 1997.

Comparison of oblique aerial photos (Figs. 1-4) taken on 18 January 1996, 18 February 1997, and 13 April 1999 shows that only minor erosion of the outer slopes of the Pyramid Peak-Stump Saddle-Outlet area has occurred during the intervening 39 months. [Little time was available for the overflight inspection during the 13 April 1999 visit, and my position in the helicopter prevented clear photography.] A small, apparently superficial, landslide had recently occurred from high on the outer slopes of Stump Saddle. The photographs show that the upper Whangaehu River channel cuts through the young (<2000 year) lavas, breccias and pyroclastics of the Crater Lake crater eruptives, to form the waterfalls immediately to the east of Stump Saddle (Fig. 2). These young eruptives unconformably overlie the altered older lavas of the Tahurangi Peak cone to the south, which are also exposed in the river channel downstream of the falls. Considerable erosion of the channel at and below the falls must have occurred here during passage of the 1995 lahars. The extent of the 1995 erosion cannot be quantified as all previous map contour data here have been obtained when the channel was filled with snow and ice. The effect of this erosion is to undercut the Stump Saddle and Pyramid slopes to the west and north.

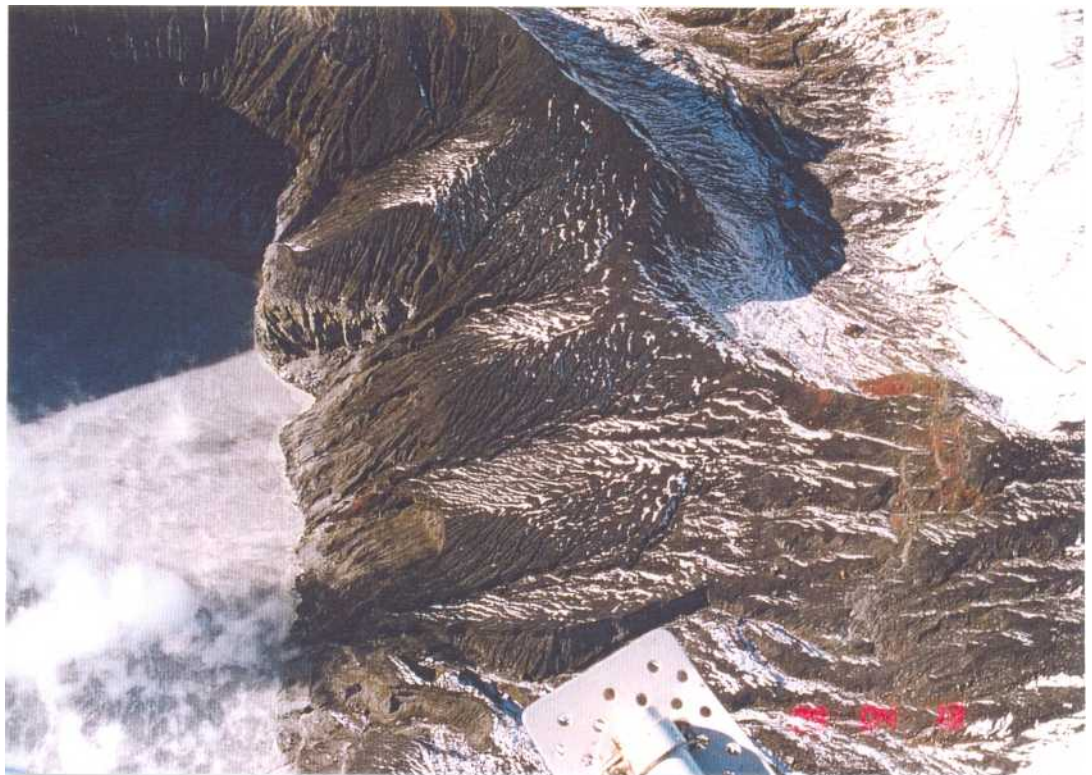
Figure 3. Aerial view of Ruapehu Crater Lake about 50 m below the overflow level controlled by the tephra-covered outlet terrace at upper middle of picture. Photo taken 13 April 1999.

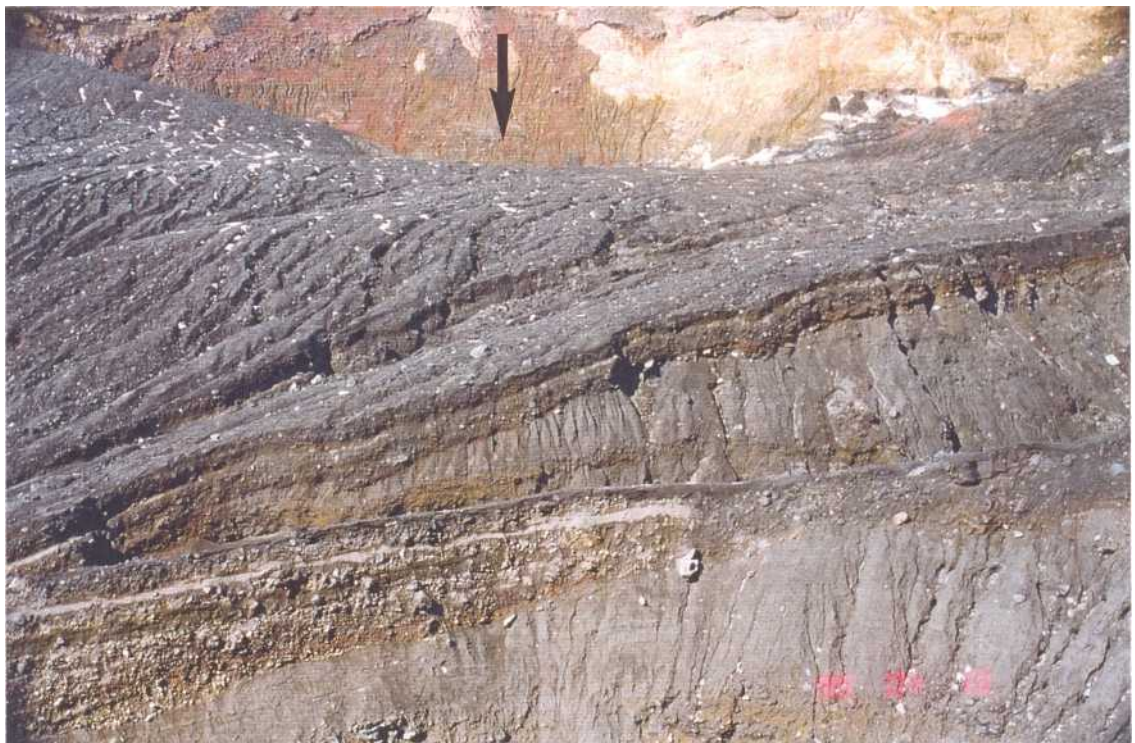
Significant gully development has occurred about 90 m to west of the overflow point, where runoff from the scoria ridge above has excavated a 1.5 m deep gully head, with most dissection to ~1m depths. At ~120 m west of the overflow area, a larger gully system has eroded to about 4 m in depth, with the gully head sited beneath the 1945 lava flow bluffs. This gully seems to have been largely excavated by meltwater and rainfall runoff from the glacier above. The gully deepens rapidly downslope north into the crater (Fig. 5), and demonstrates the ready erodibility of the 1995-96 ash and scoria deposits. When examined, the gully wall deposits were firmly cemented by ice, but this would be melted by proximity to a rising hot lake.

Figure 5. Ground view of the gullying to west of the Outlet (arrow - upper centre of photo). Coarse 1996 scoria falls overlie finer (ash-dominated) 1995 ejecta. Photo taken 13 April 1999.
