**EDMOND'S RUINS, KERIKERI INLET,
BAY OF ISLANDS:
THE STONE STRUCTURE AND
THE ARTEFACT ASSEMBLAGE**

Aidan J. Challis

Published by
Head Office,
Department of Conservation,
P O Box 10-420,
Wellington,
New Zealand

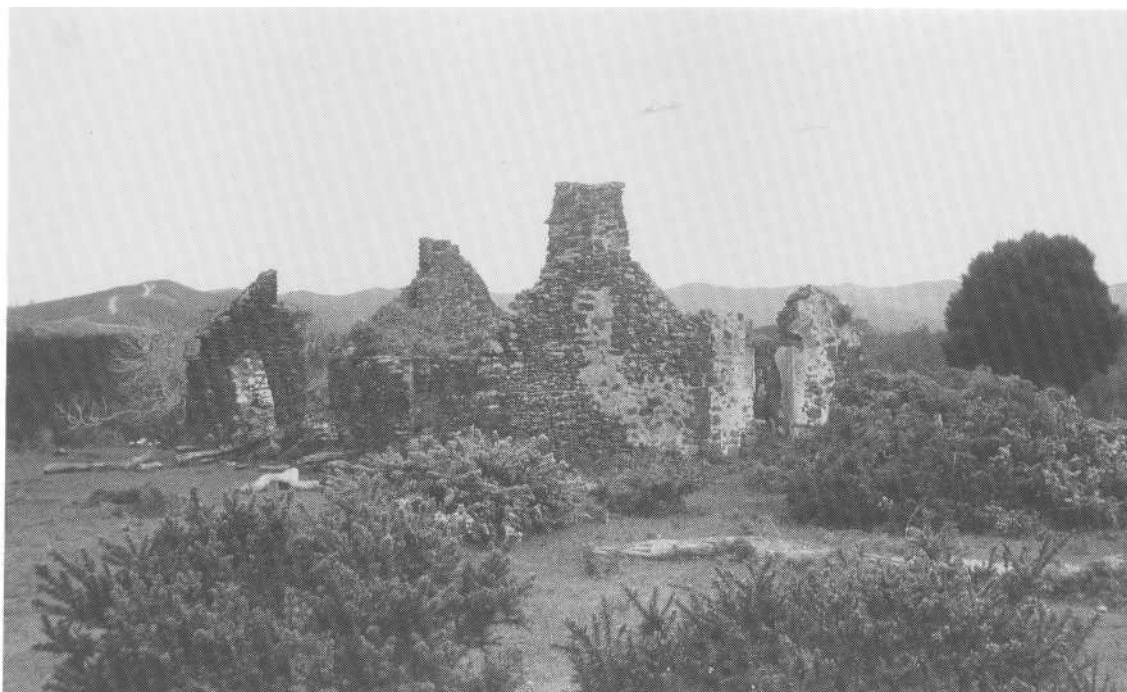
Figure 4 Edmonds Ruins from the north east, 1964 (R.I.M. Burnett; Historic Places Trust photograph collection No. 1381).

The house is built of vesiculated basalt field stone. Large blocks were available. Some quoins (external corners) have been dressed to sizes up to 1 m across, but the majority of the structure is of undressed field stones as small as 60 mm across. Cockle shell may have been burnt for use in mortar at the tidewater site 750 m to the north-west (site number P5/512, mentioned previously). None of the walls has any apparent formal foundation. The bottom stones appear to have been placed on the top of ground soil, with no built basal or lateral support. There has been an accumulation adjacent to the walls of around 250 mm on the outside and around 360 mm on the inside, of loose mortar, rubble, and other environmental material. All walls show a lack of deliberate bonding. That is, the stones were generally laid in stacks, not in horizontal layers and not with the mortared joints between the stones of one layer covered by the stones of the next (Harris 1975: 60). Dressed quoins, where they exist, are not bonded with adjacent masonry. Field stones have been stacked, heaped and tacked on to build the structure. The lack of bonding produced a relatively weak structure from which losses have occurred. Comparison of Figures 3 and 4 indicates some of the losses of the past thirty years.

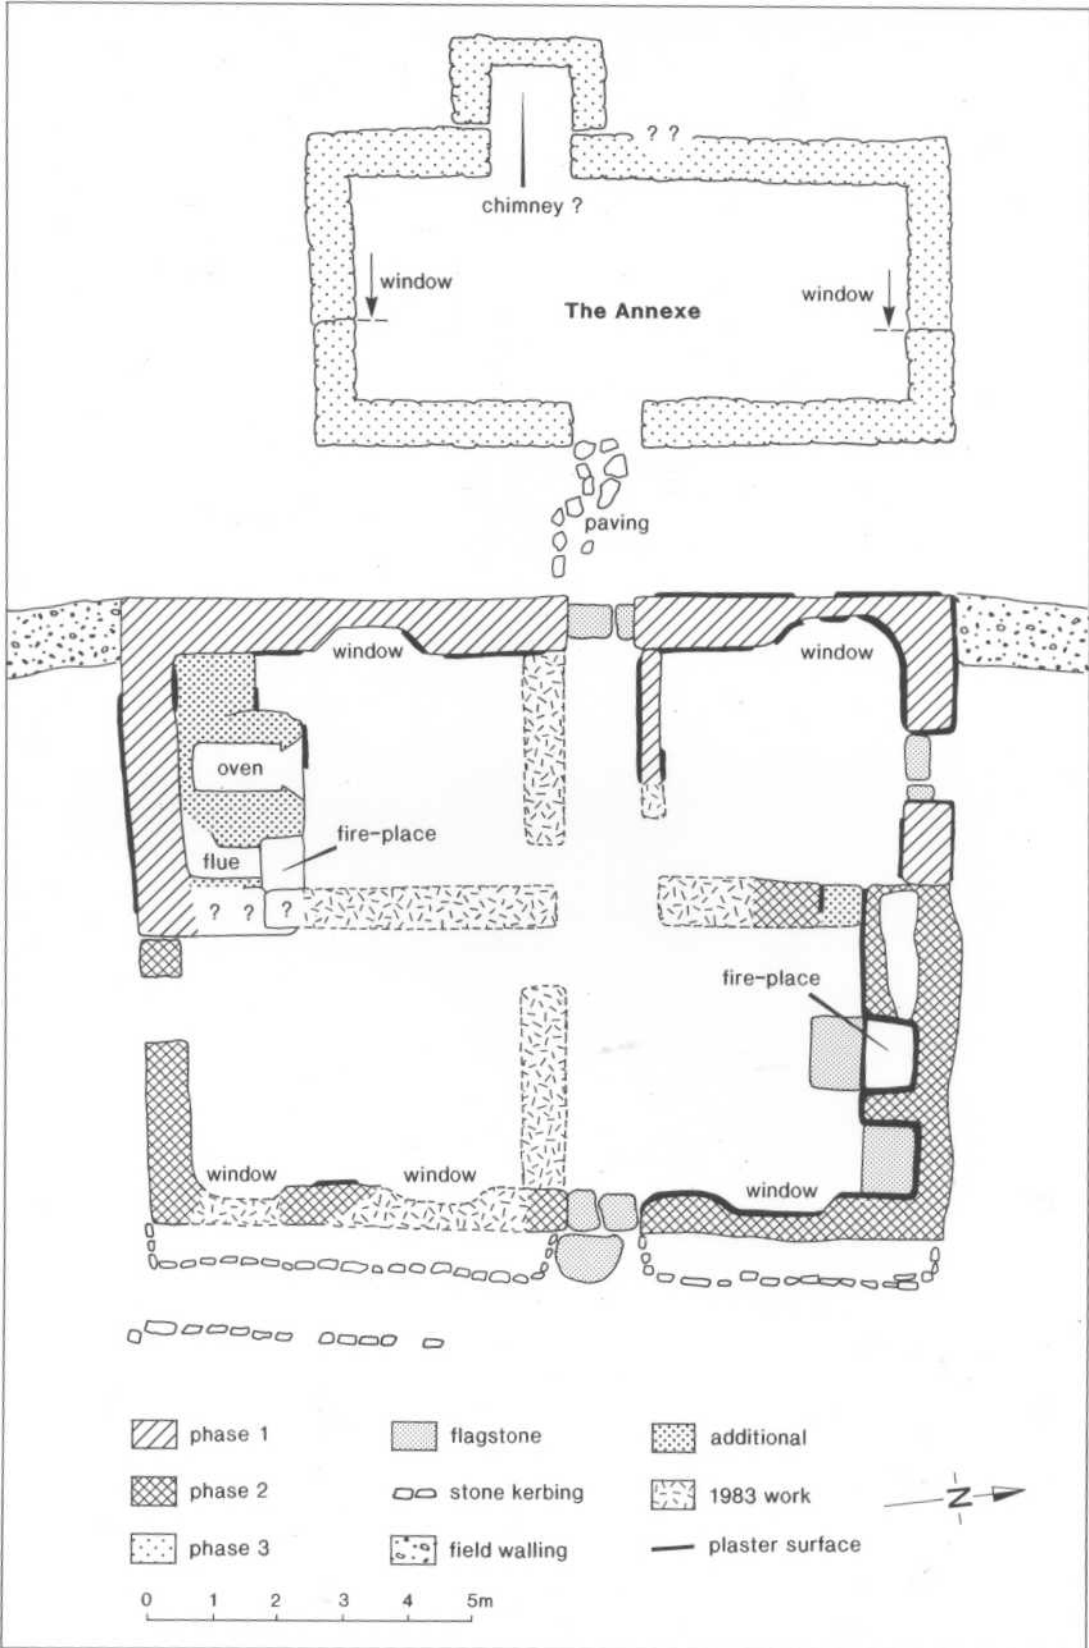
Figure 8 Edmonds Ruins, ground plan.

The 650-400 mm walls (phase 2) are additional to or later than the 750 mm walls (phase 1). On the south side of the building, the short section of 600-650 mm outside

A section of interior wall, 350-300 mm thick, extends eastwards from the north side of the western outside door (shown as phase 1 on Figure 8). Although it is not bonded with the phase 1 outside wall, it is thought to be contemporary with it because of the comparable quality of the masonry and the equal 2.2 m height. A fragment of phase 2 interior wall also survives towards the north end of the north-south interior wall line (see Figure 8). Apart from these two fragments, other interior walls appear to have been built in 1983 during the programme of masonry repairs.

Immediately to the west of the main dwelling lie the ruined remains of the annexe (marked as phase 3 on Figure 8; see also Figure 12). This is generally an unmortared loose random rubble structure (Harris 1975: 416) with walls 700-900 mm thick. Some mortar is present around the window positions in the two end walls, evidence of the eastern reveals of which survive in each case (noted on Figure 8), and in what may have been a chimney to the west. This latter structure has walls 500-600 mm thick, unbonded with the rest of the annexe. It may have closed off an earlier doorway. It remains to a height of 1.8 m, greater than the rest of the annexe structure (1.4 m or less).

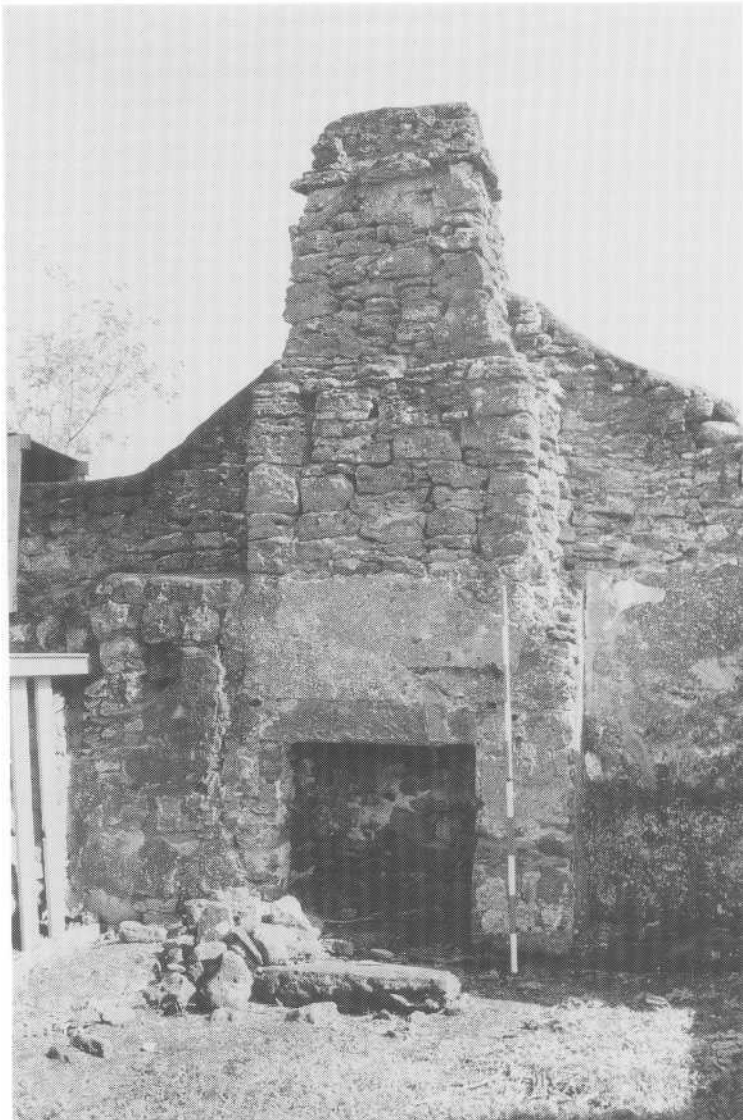
Figure 10 Phase 2 interior: fireplace and chimney, north wall, 1992.

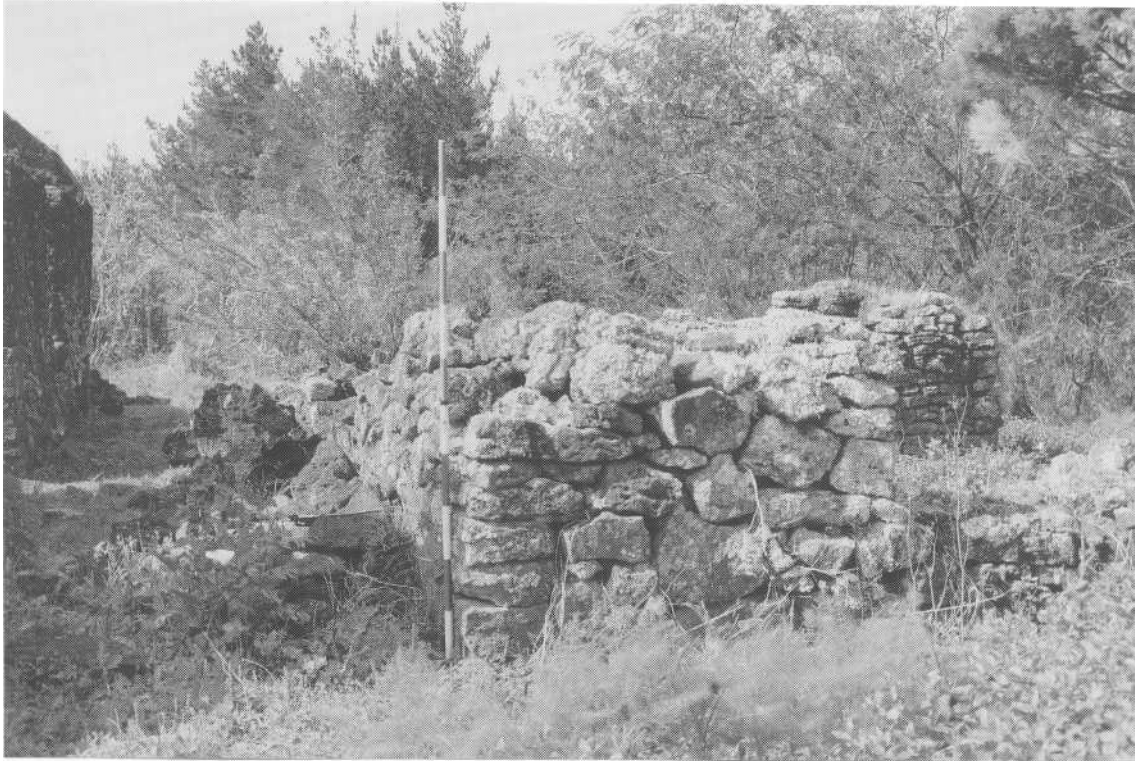
Figure 11 Bread oven structure, south-west room, 1992.

- (1) In the phase 1 south room there is a large bread-oven structure (Figure 11), with a fireplace and flue to the east and additional masonry infilling on both sides.

- Figure 29 Hand forged iron door frame of a size appropriate to the bread oven illustrated in Figure 11.

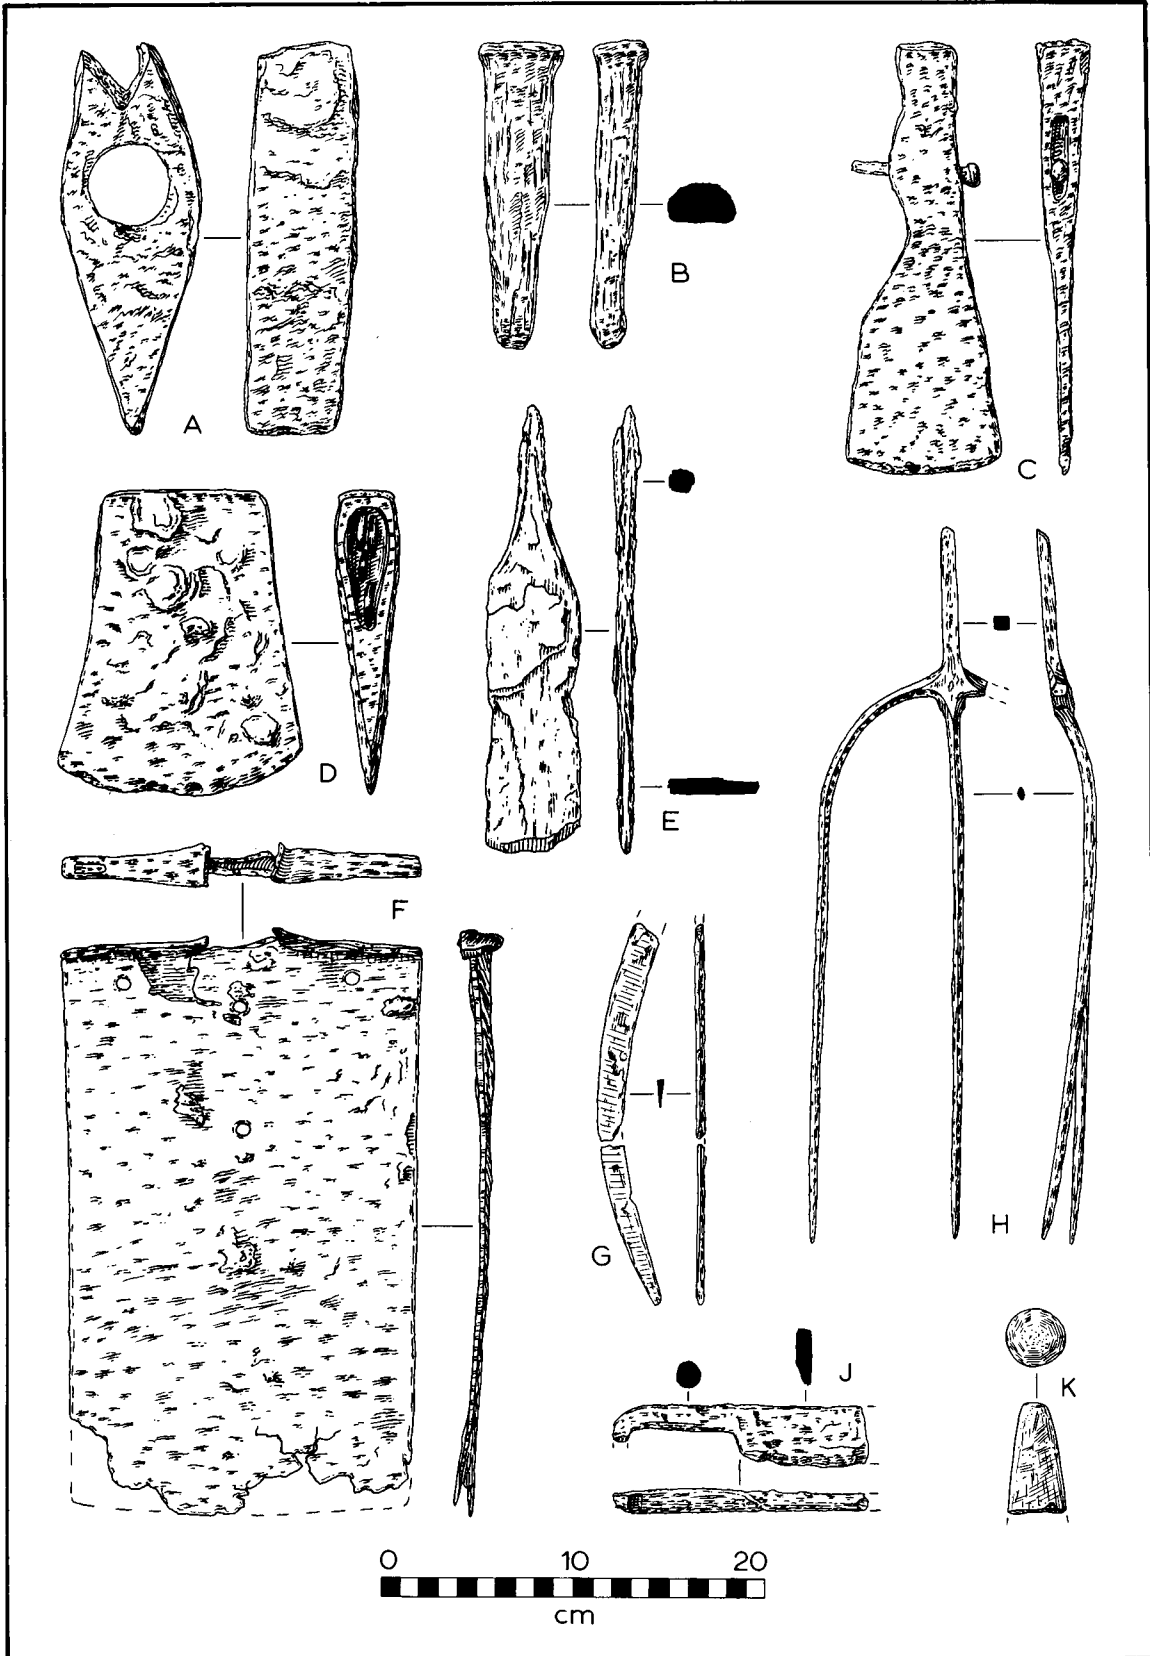
Figure 14 Hand tools. A, mason's stone-hammer; B, mason's wedge; C, lathing hatchet; D, American axe; E, chisel; F, spade; G, sickle; H, pitchfork; J, draw knife; K, whetstone.

Figure 14C Wrought iron hatchet blade, carpenter's lathing hatchet type, square poll (Salaman 1975: 238, fig. 382c; Mercer 1960: 89, fig. 85); a wrought iron nail, corroded, square headed and square sectioned, driven through the hafting hole; early to mid-nineteenth century; weight 830 g, University of Auckland Conservation Laboratory No. C96C (McPike 1984: 3).

Figure 14H Steel three-tined pitchfork, tanged, one tine missing.

Figure 14J Part of a wrought iron carpenter's draw knife (or cooper's straight stave knife), broken across the blade, and the recurved tang for a wooden handle also broken off (cf. Mercer 1960: 100, fig. 94).

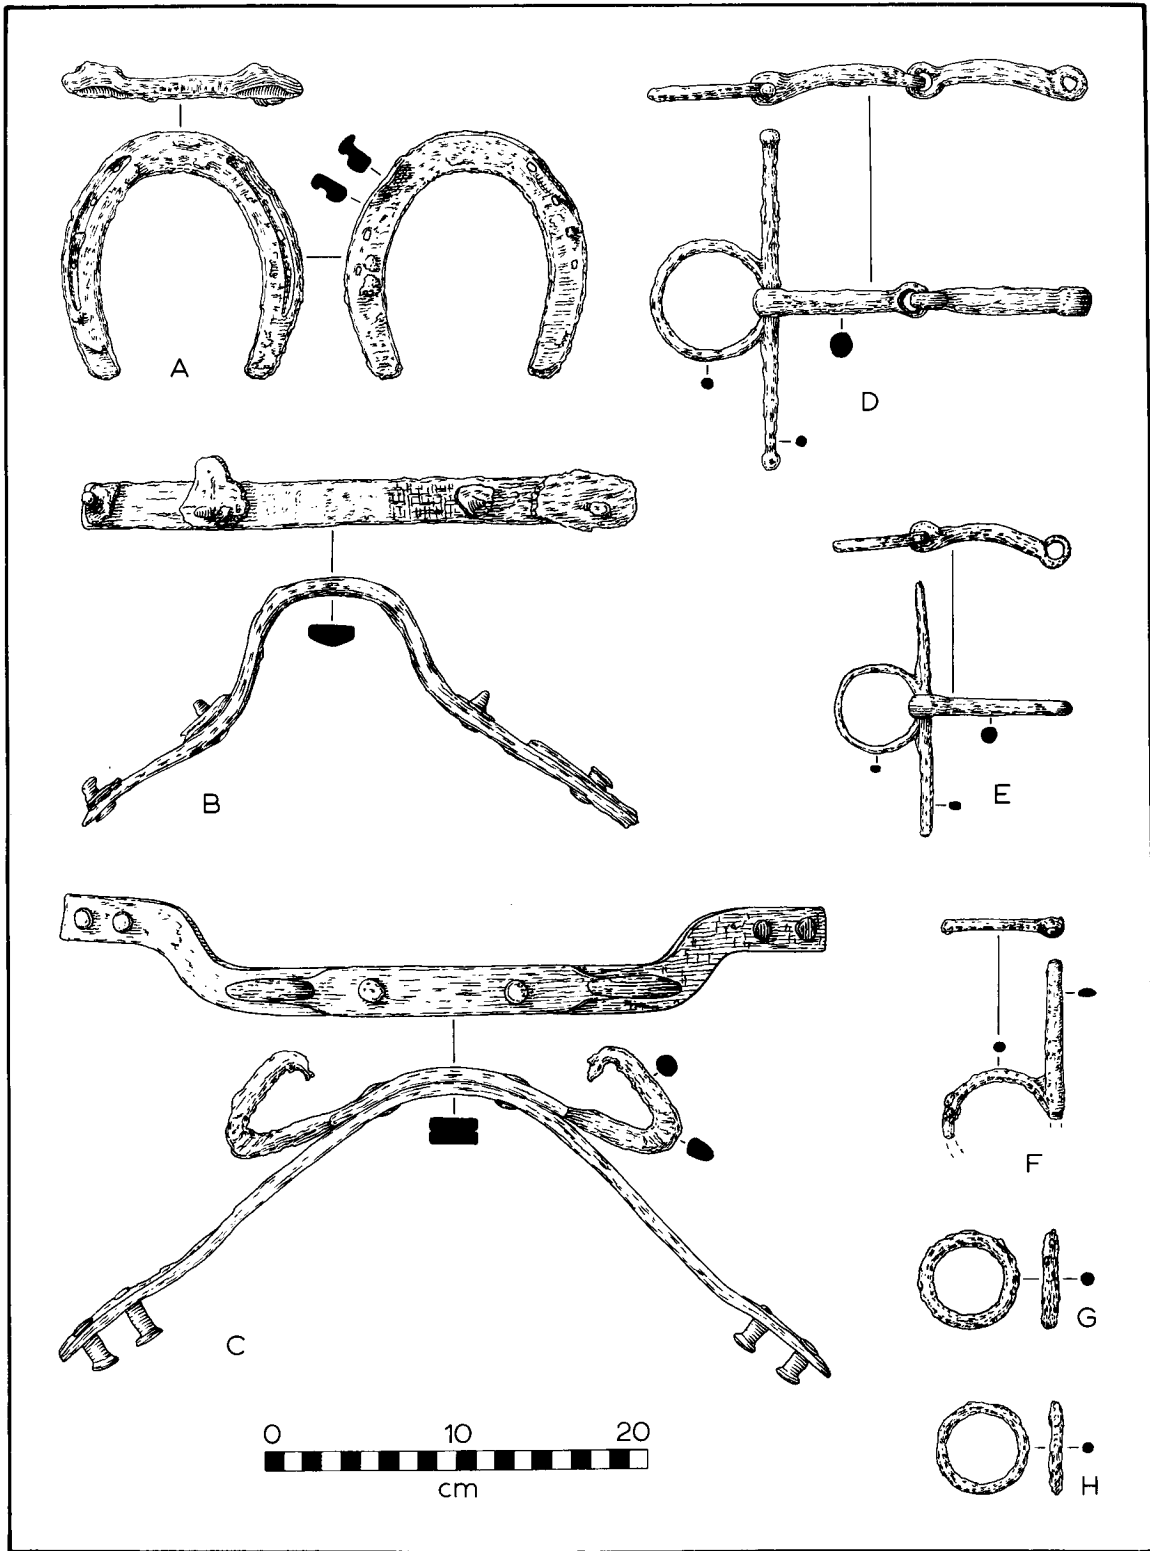
Figure 15 Iron horse gear. A, horse shoe; B, saddle tree arch; C, pack horse saddle tree arch; D, E, F, snaffle bits; G, H, harness rings.

Figure 15A Hand fullered iron riding horse shoe, weight 320 g, rim type, four nail holes each side countersunk in two channels, two side clips, probably a hind shoe (cf. Sparkes 1976: 27; A off room 3).

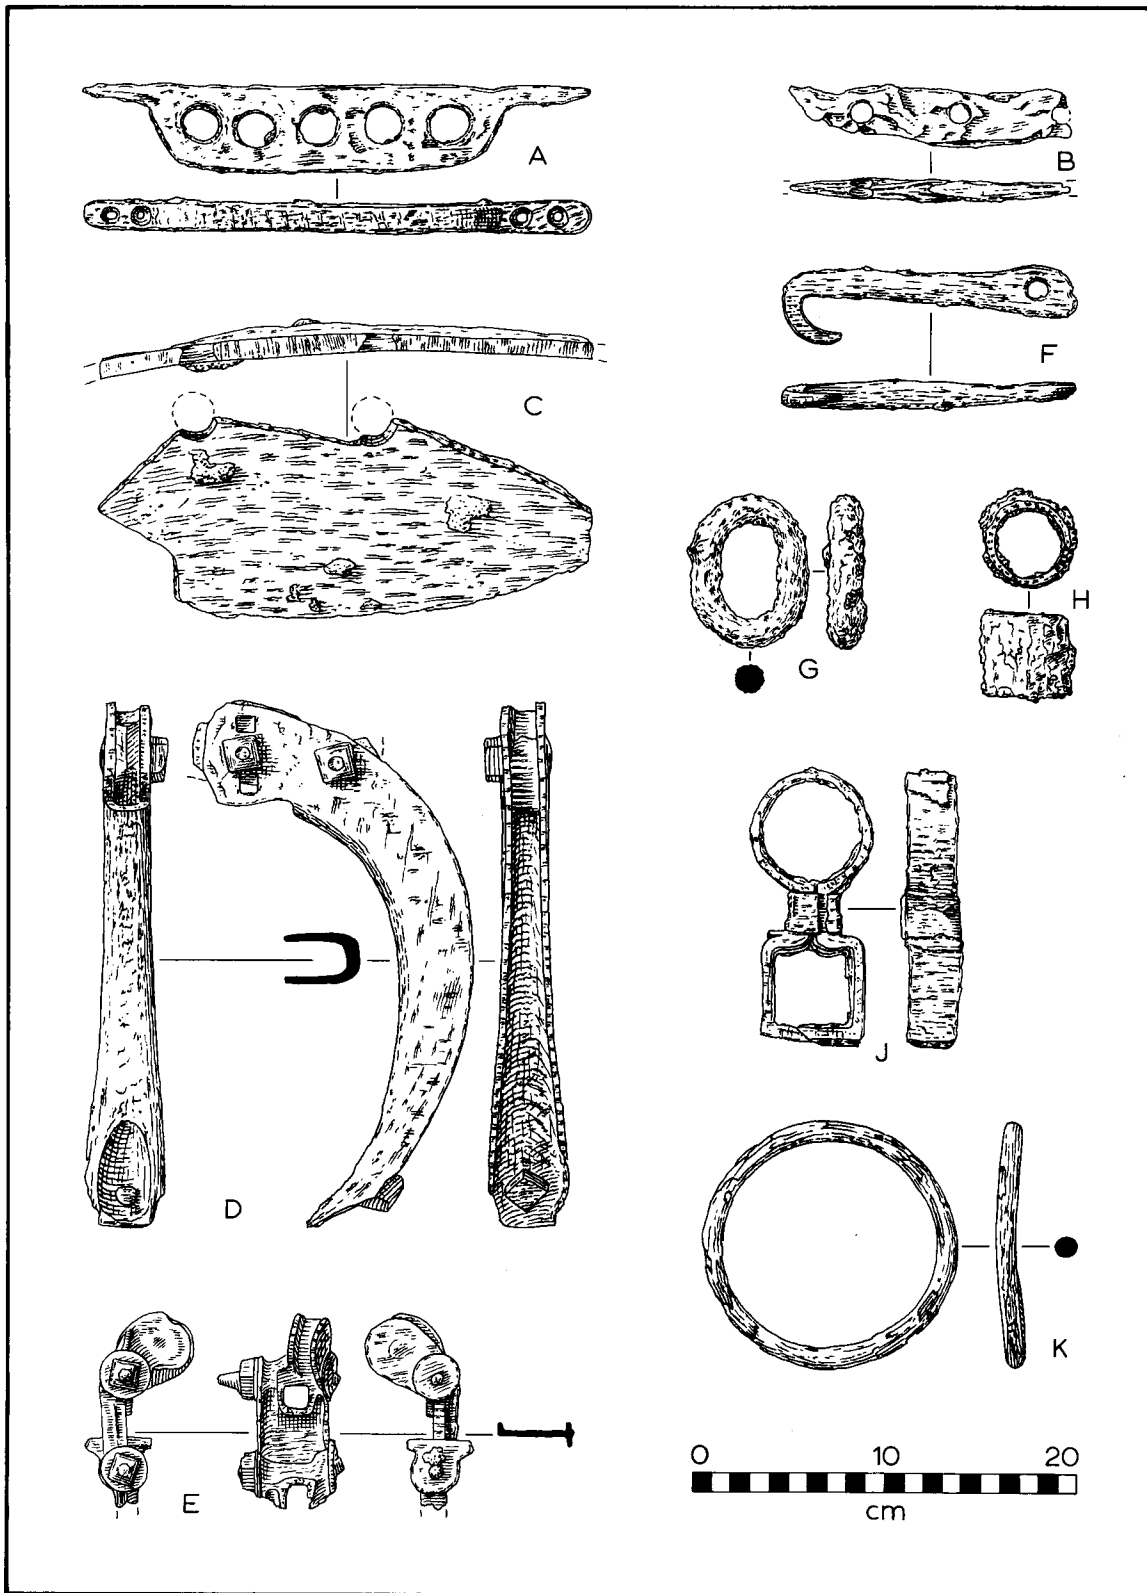
Figure 16 Iron farm machinery. A, B, draw bar fittings; C, plough mould board; D, cultivator tine; E, machine component; F, draught chain hook; G, chain link; H, ferrule; J, shaft clamp; K, ring.

- Figure 16A Wrought iron adjustable draw bar fitting or hake, countersunk screw holes for attachment to a timber-framed horse drawn implement.
- Figure 16B Very corroded iron adjustable draw bar fitting or hake, from a horse drawn implement.

- Figure 16D Heavy iron component, probably a tine from a late nineteenth or early twentieth century horse drawn wheeled sickle-tined cultivator with changeable and adjustable points; double through-bolted attachment above, and seating and single bolt for tine attachment below; tine missing, possibly arrow shaped; resembles Wallace's Universal Cultivator (Thompson 1979a: 49).

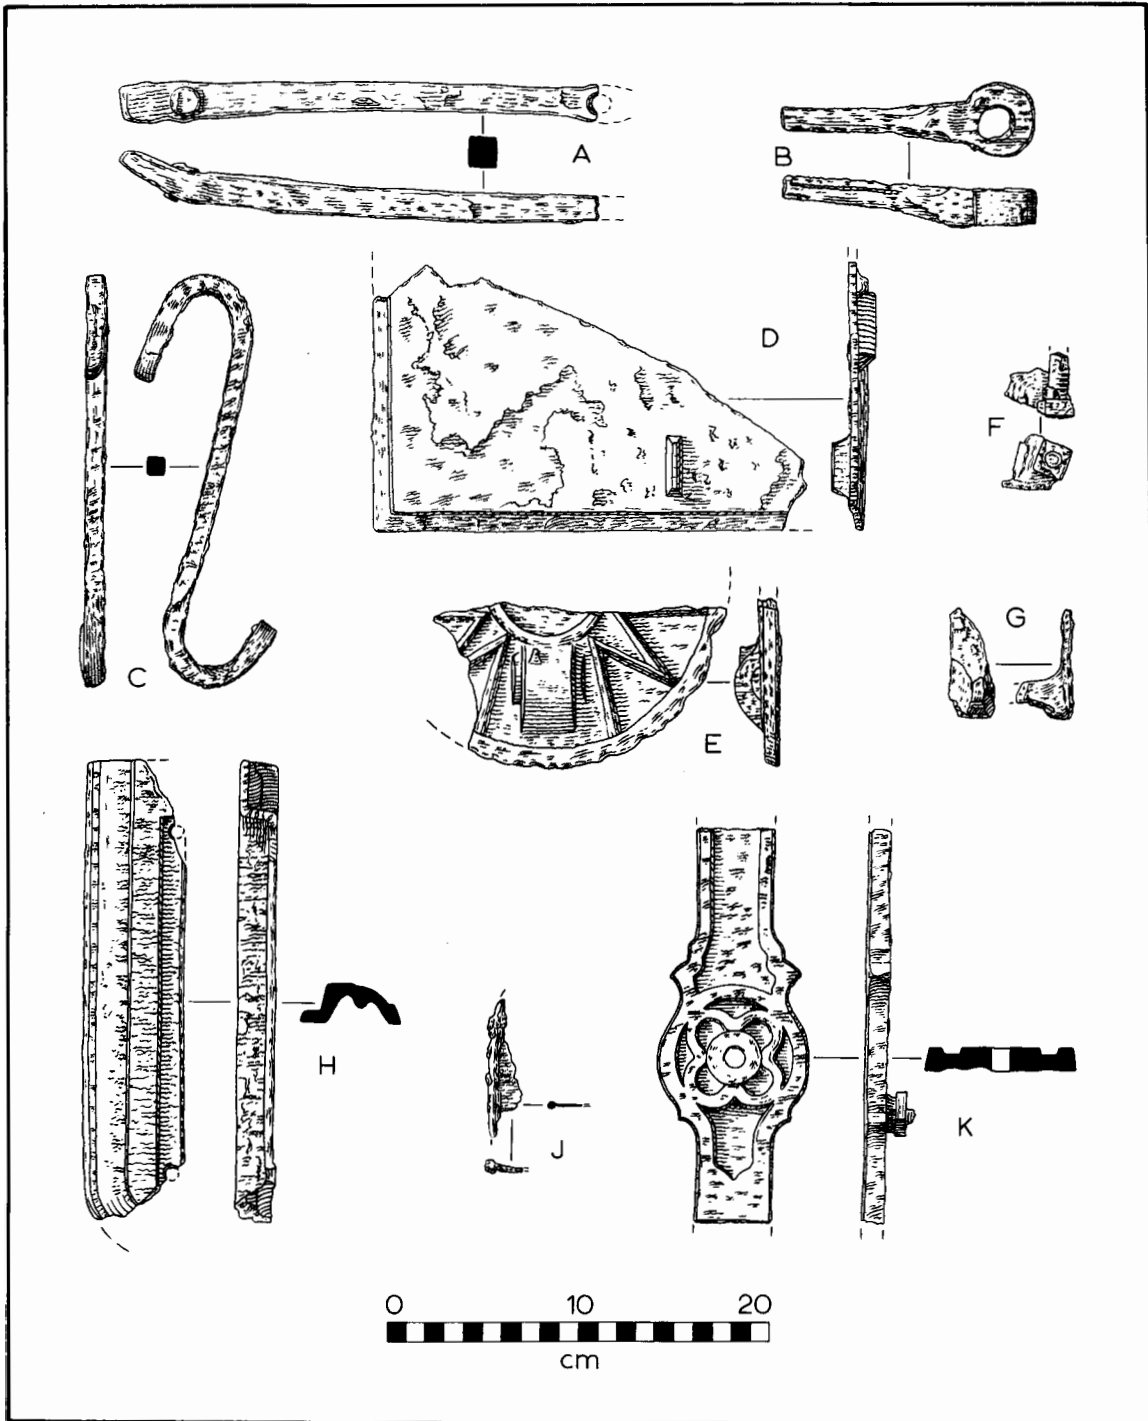
Figure 28 Fireplace hardware. **A**, firedog; **B**, crane bracket; **C**, pot hook; **D**, chimney register; **E**, ventilation plate; **F**, **G**, range fragments; **H**, curb fender; **J**, possible fireguard; **K**, possible fireplace or oven door panel.

- Figure 28A Part of a wrought iron firedog or grate.
- Figure 28B Hand wrought iron ring bracket for a jig or crane of the type used commonly in the early and mid-nineteenth century in open kitchen fireplaces for suspending pots over the fire. The bracket would have been one of two secured in the masonry of a fireplace side wall (J off room 1).

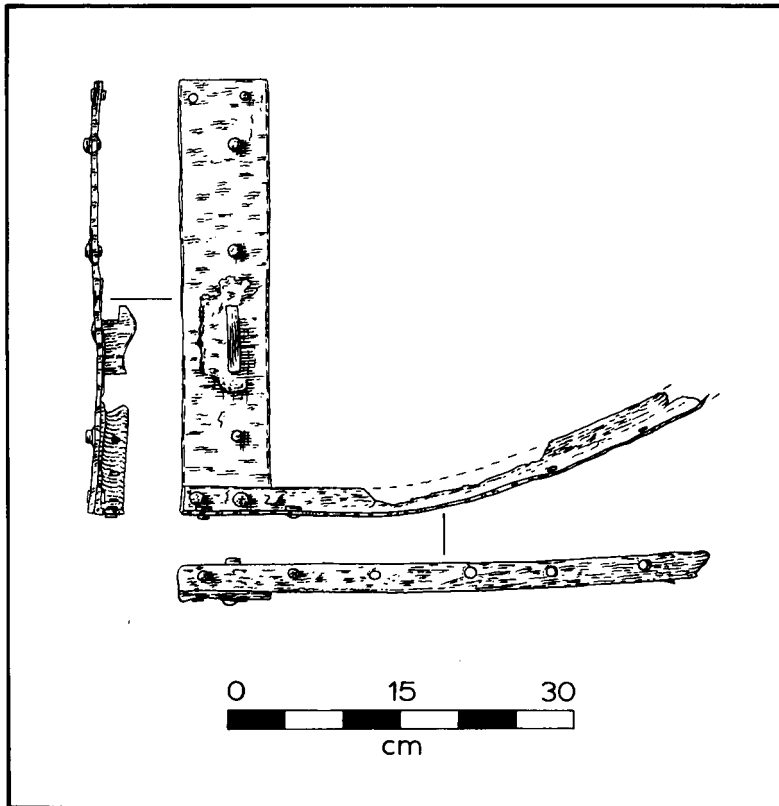
Figure 29 Door frame to bread oven.

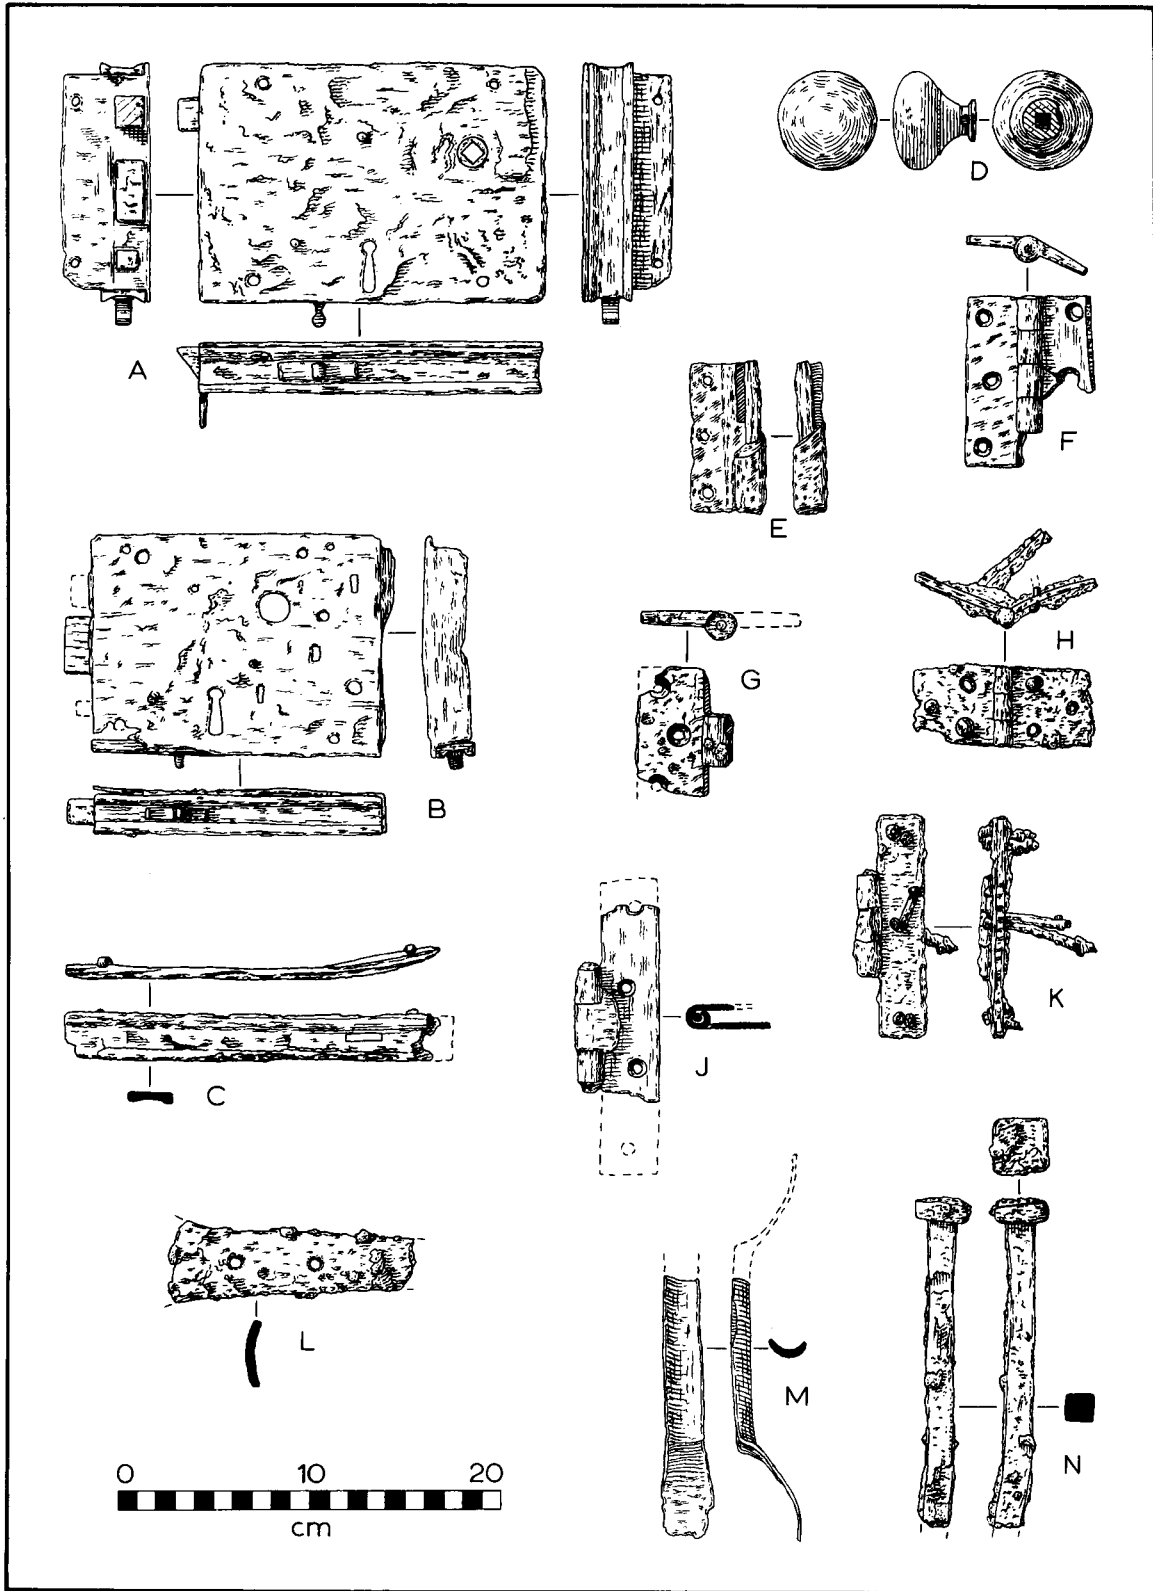
Figure 30 A-C, rim locks; D, door knob; E-G, butt-hinges; H, flat hinge; J-L, strap hinges; M, grab handle; N, truss bolt.

- Figure 30J Wrought iron T-strap hinge of light construction appropriate to a cupboard or attic door.

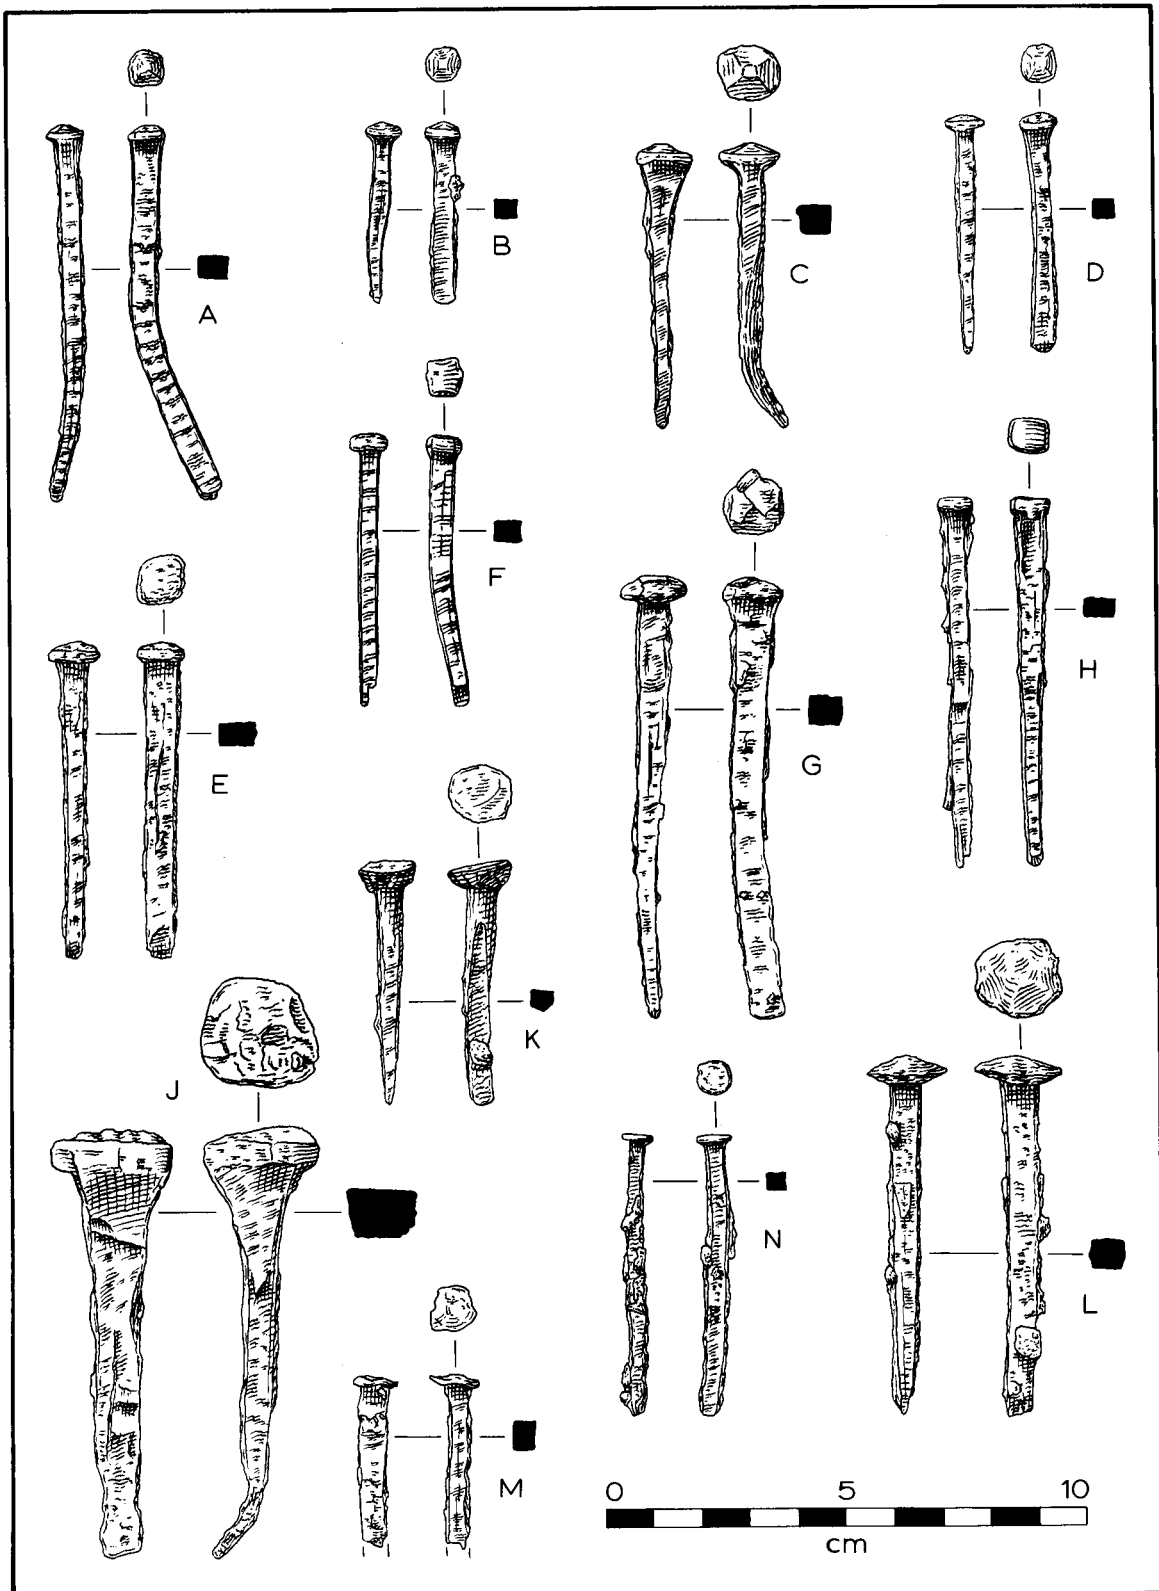
Figure 31 Iron and steel nails. A-D, wedge pointed rose heads; I's-J, square heads; K, L, clouts; M, N, flat heads.

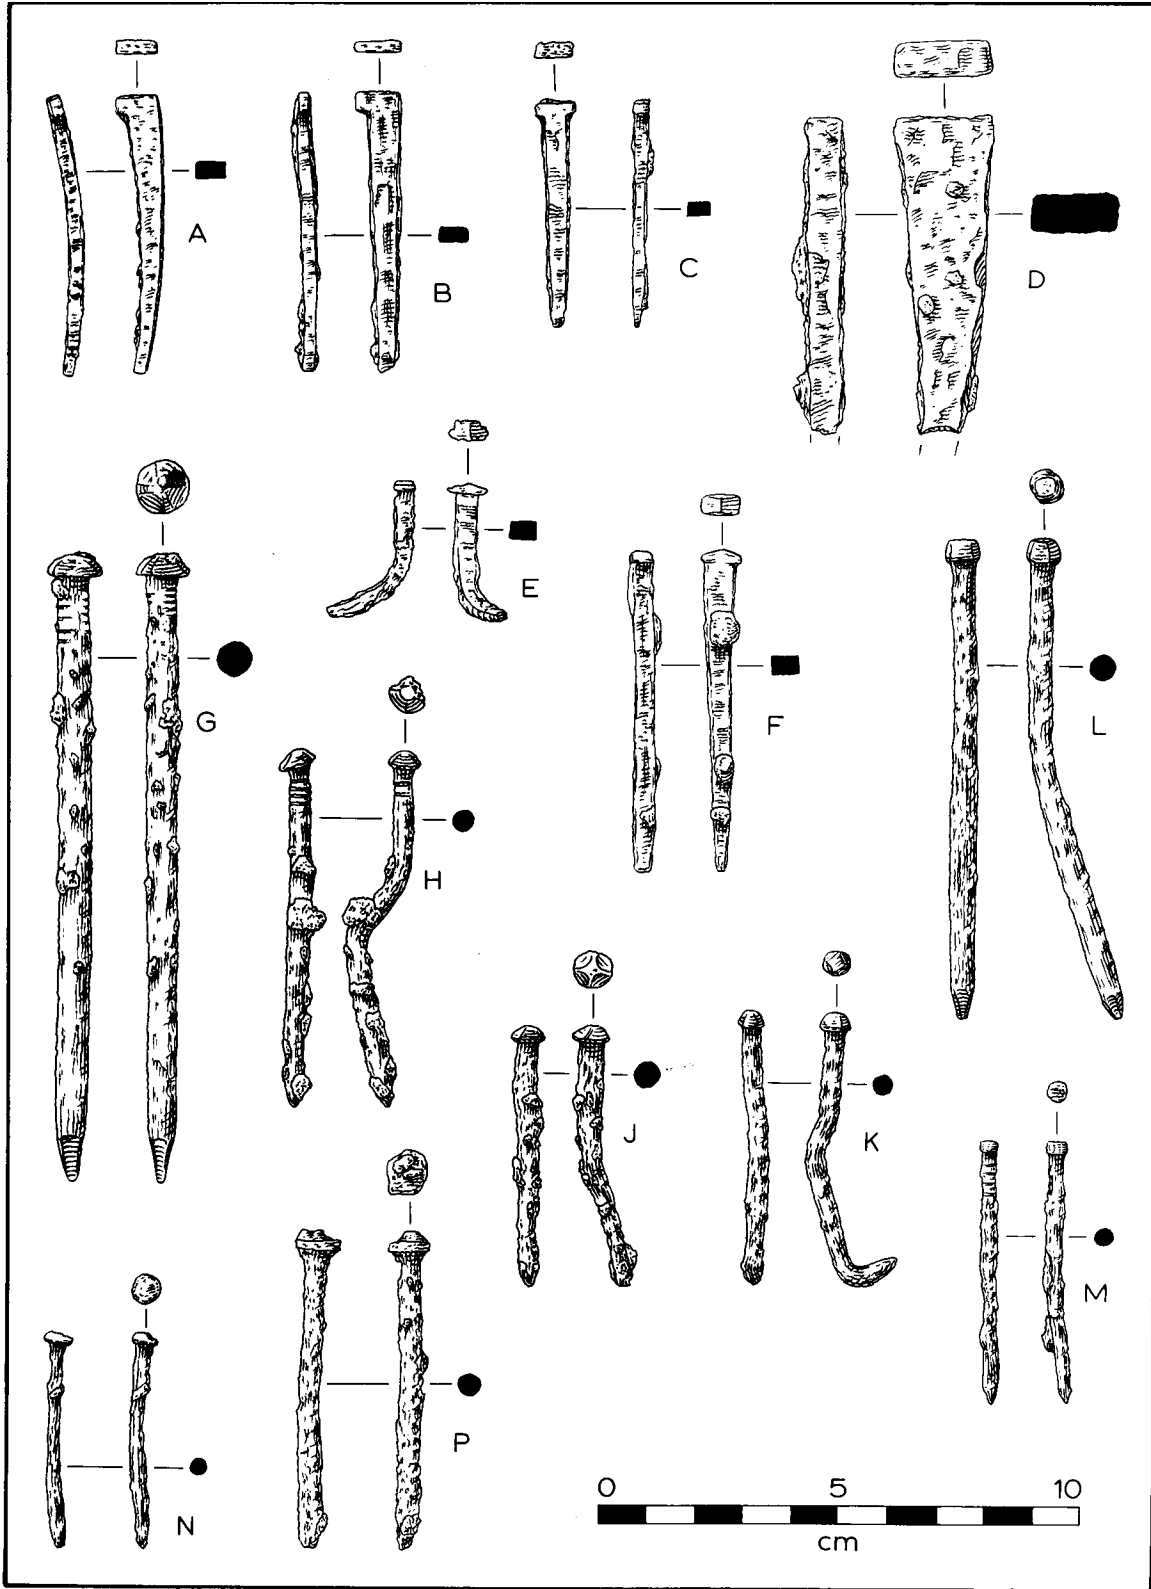
Figure 32 Steel nails. A, B, cut brads; C, cut T head; D, cut spike; E, F, cut T heads or clasp heads; G-J, wire rose heads; K, L, wire rhomboid heads; M, wire jolt head; N, P, wire flat heads.

- Figure 32B Similar to figure 32A, 59 mm (A off room 3).
- Figure 32C Steel cut T head nail (Varman 1980: 32, fig. Hc), 47 mm (A off room 3).
- Figure 32D Steel cut spike, incomplete (post hole 25).

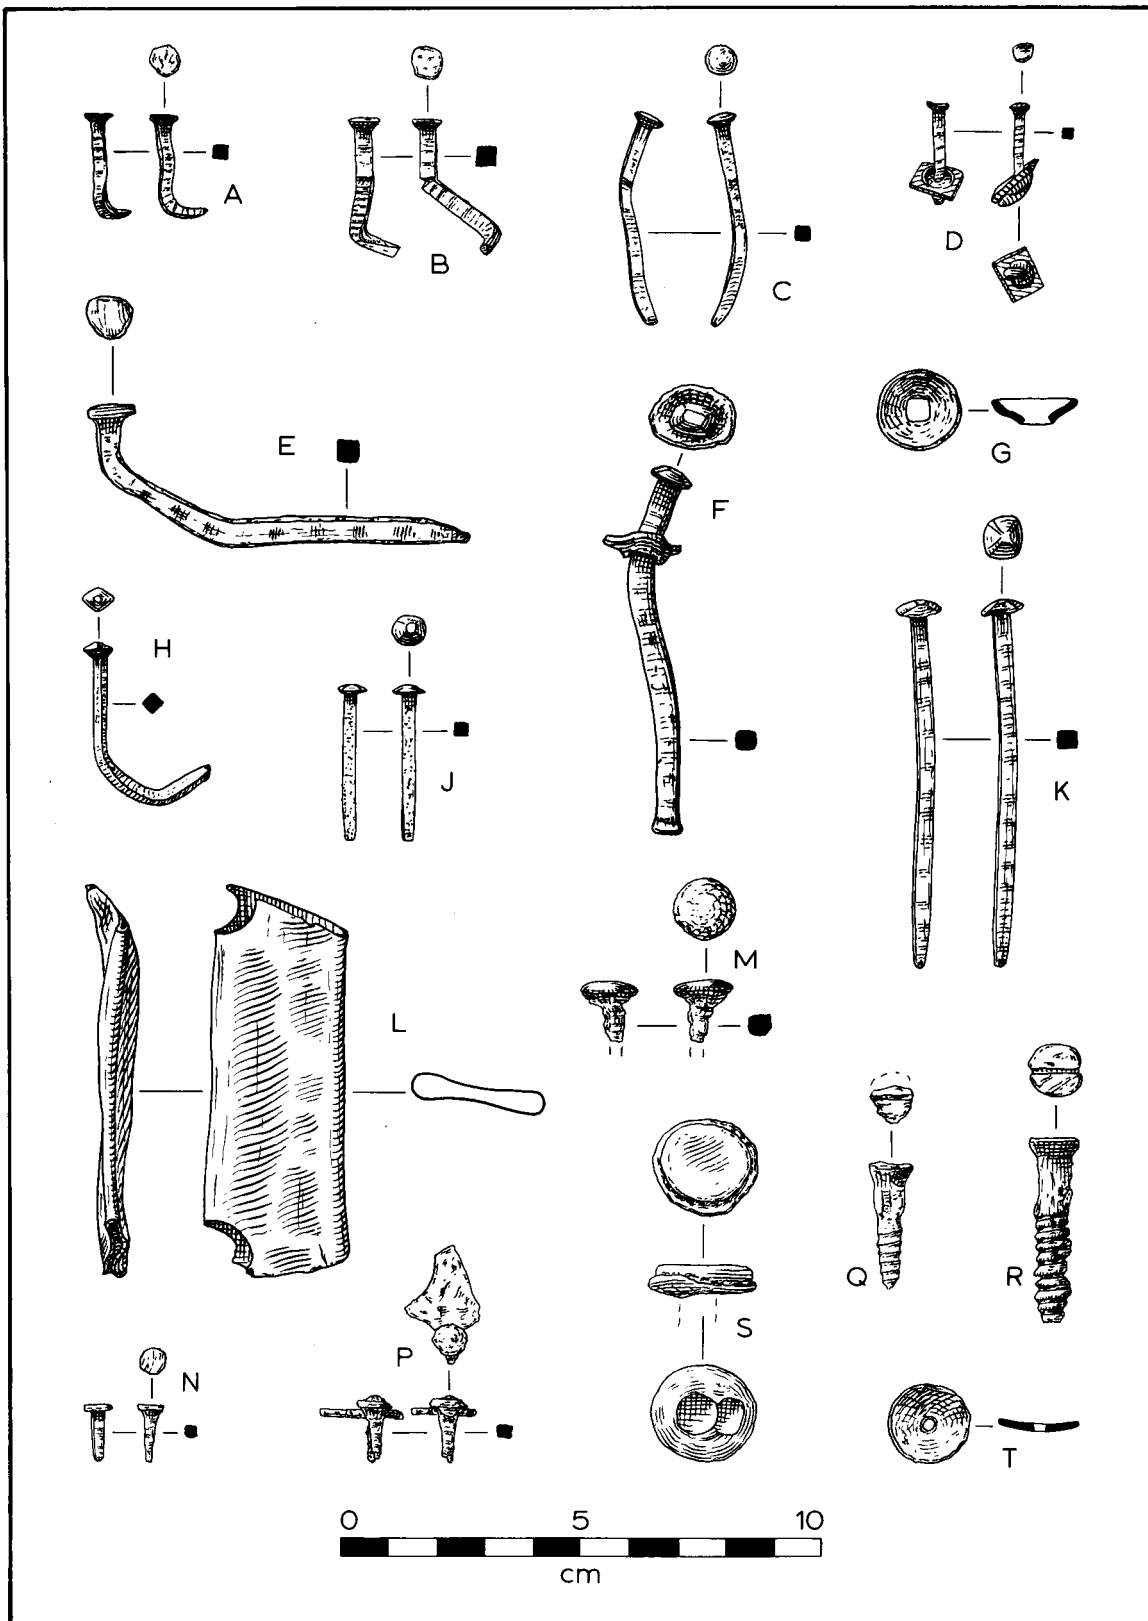
Figure 33 A-E, copper nails, flat head; F, copper bolt; G, copper washer; 11-K, copper nails, rose head; L, copper sheathing; M, iron clout with copper head; N, P, steel tacks; Q, R, iron screws; S, lead nail head; T, alloy washer.

Figure 33J Square sectioned rose head nail, point broken off, 33 mm, probably twentieth century (post hole 14).

Figure 33R Iron countersunk blunt pointed wood screw, 40 mm (J off room 3), pre-1845 type (Rempel 1980: 103).
