**EDMOND'S RUINS, KERIKERI INLET,
BAY OF ISLANDS:
THE STONE STRUCTURE AND
THE ARTEFACT ASSEMBLAGE**

Aidan J. Challis

Published by
Head Office,
Department of Conservation,
P O Box 10-420,
Wellington,
New Zealand

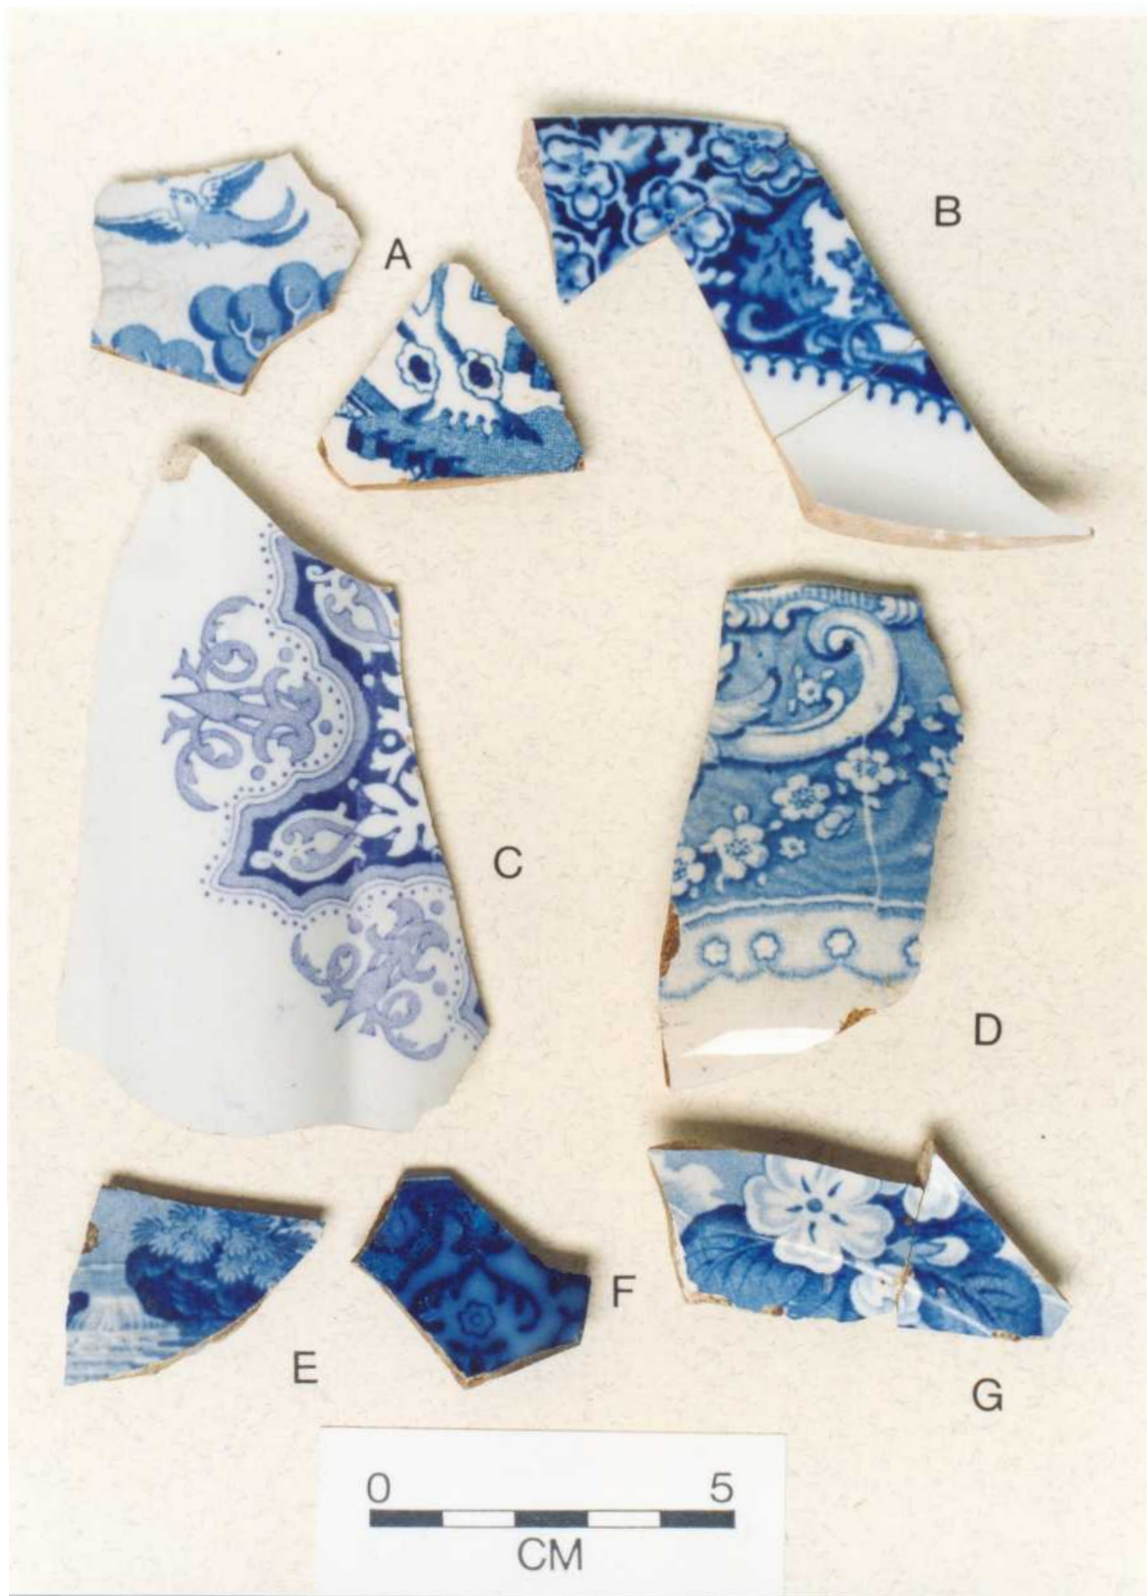
Figure 43 Blue on white transfer printed earthenware.

- Figure 43A Two base sherds of different dinner plates, pattern apparently "Willow III" (Coys and Henrywood 1982: 402; post hole 20). Sherds of an estimated 37 other vessels, mainly dinner plates (8), tea plates (9) and saucers (9), in Willow Pattern.
