SCIENCE AND RESEARCH INTERNAL REPORT NO. 65

**BLUESTONE AND BUREAUCRACY:
A project on the presentation of an
archaeological site:
Albert Barracks R11/833.**

Jan Coates

January 1990

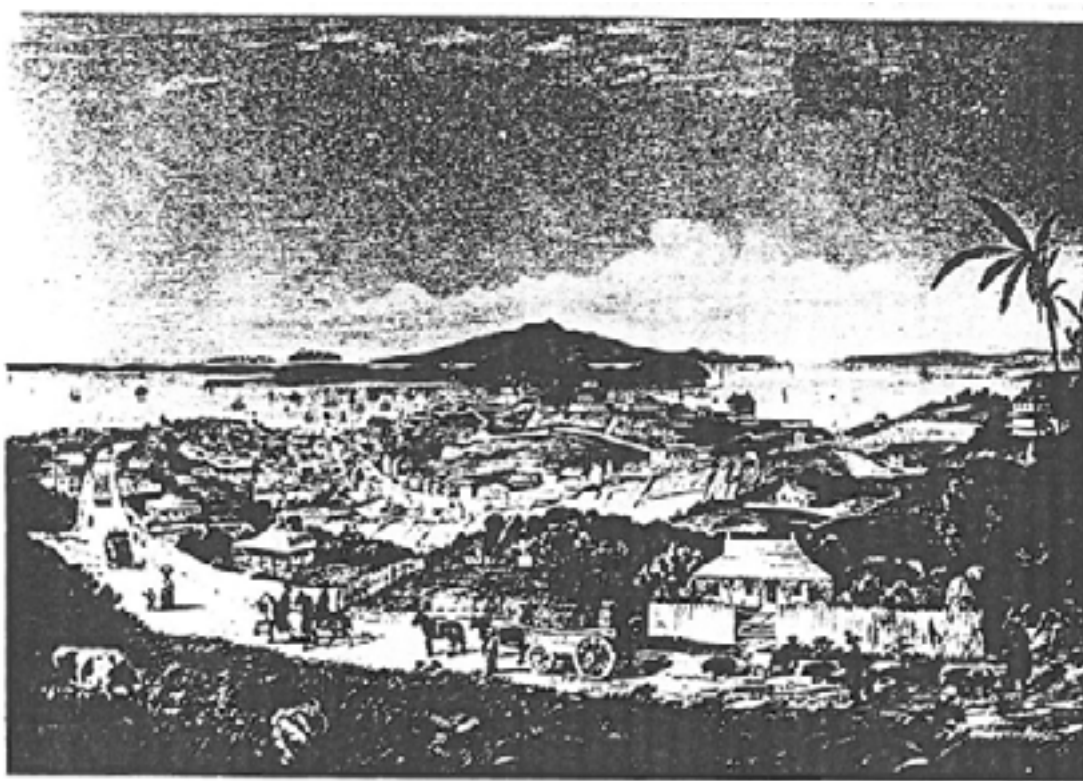
PLATE 3. Auckland from Hobson Street south.
(Albert Barraks centre)

To assist with the design and construction of the Barracks a company of sappers and miners was brought out from England. The date when the first building was completed is unknown, but a painting by an unknown artist attributed to the late 1840s shows a number of buildings and the southern perimeter wall in place (Plate 2). A J. Bunney painting of 1858 indicates that further Barracks buildings have been added with gardens inside the perimeter wall (Plate 3). The entire area of 23

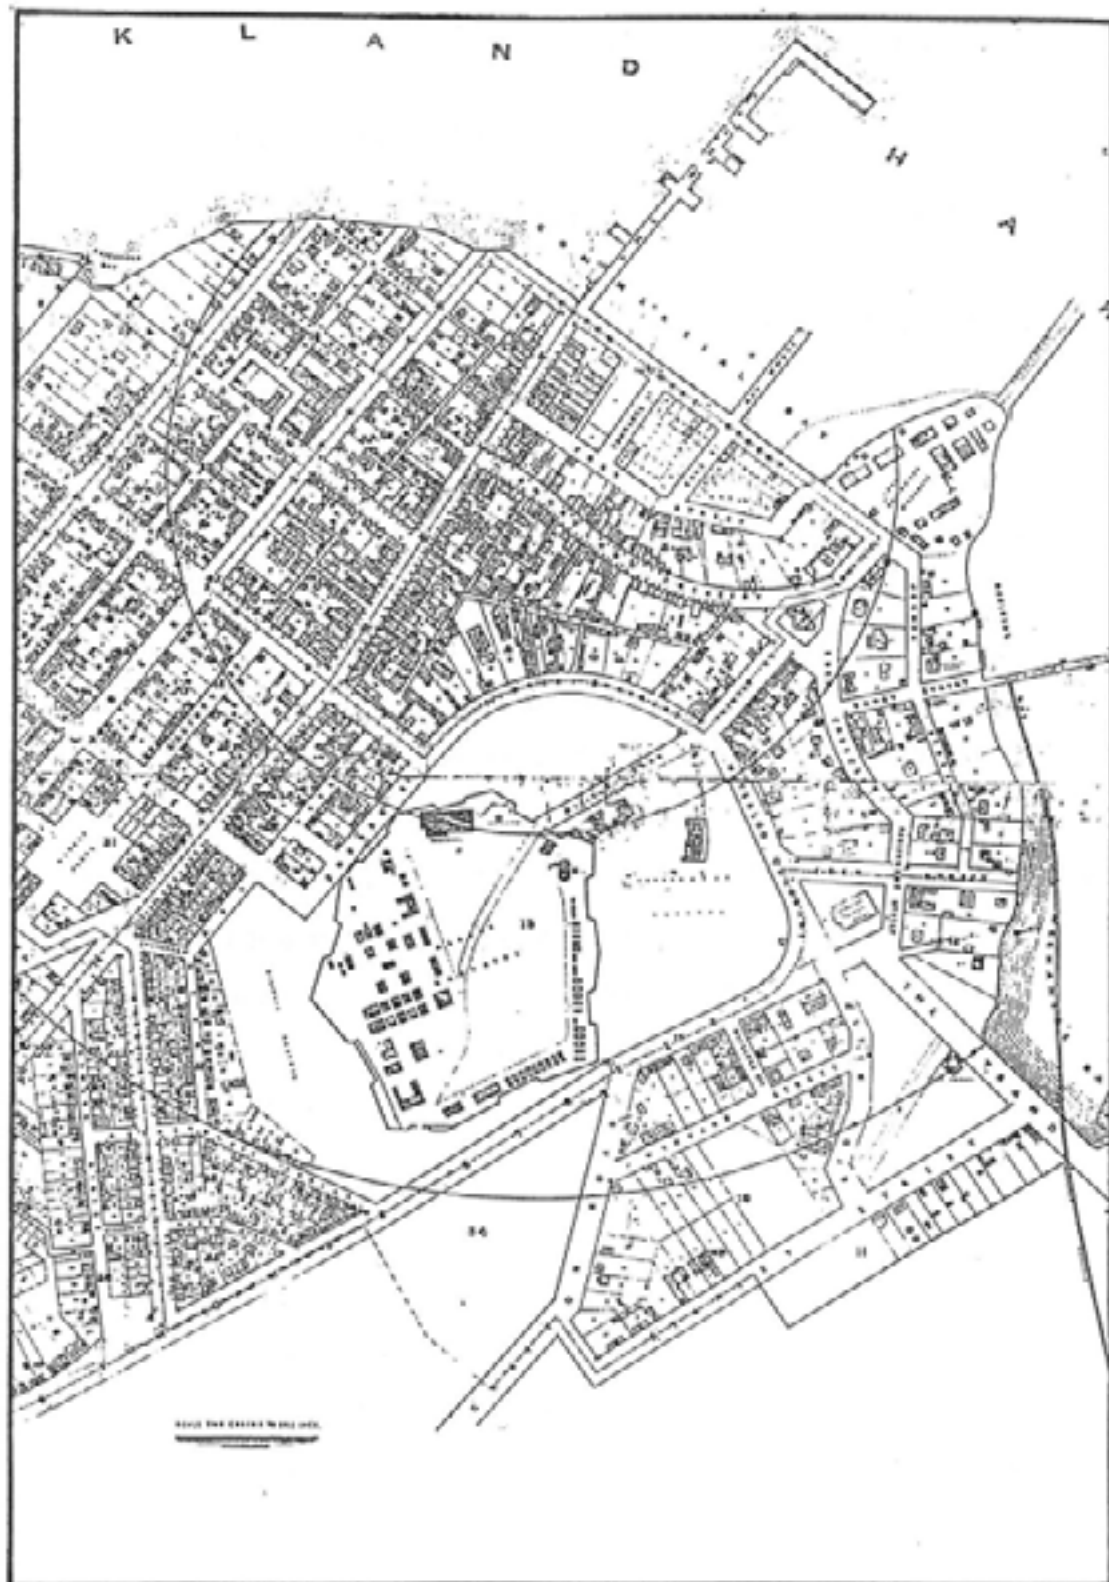
FIG. 2. Plan of Auckland - Vercoe and Harding 1866.

Few maps exist which show the layout of the various buildings within the Barracks. The earliest is the 1866 Vercoe and Harding map which illustrates that a number of buildings were in place (Fig. 2). On this plan only one building is identified - the magazine. The guardhouse was located inside the main Northern Gate. Of particular interest are the small buildings arranged inside the north-east and south-east sections of the perimeter wall. These are not shown on later plans.

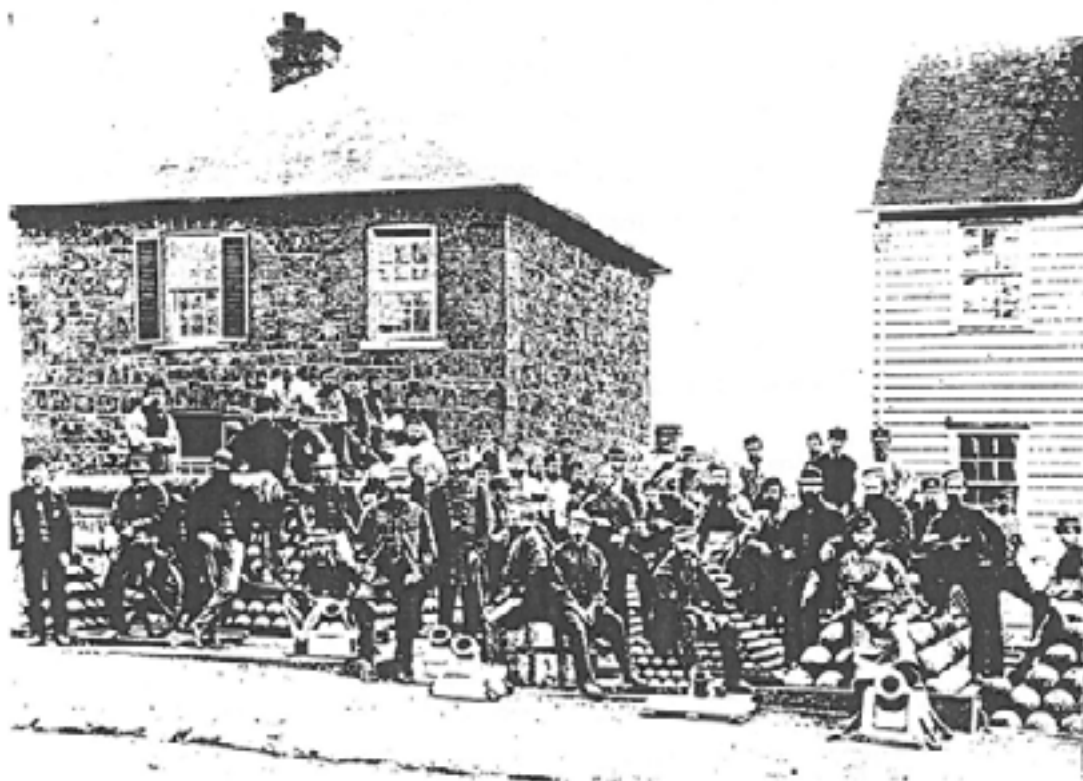
PLATE 5. Inside Albert Barracks 1860's.

Photographs of the Barracks in its completed form are difficult to find. Several shots are available within the Barracks themselves, but these generally are set pieces focusing on groups of soldiers and military hardware, with buildings forming part of the background (Plate 5). Fortunately library archives contain a series of fine panoramic views taken from the location of Partington's Mill. A search of these revealed a photograph taken 1871 (start of Barracks dismantling) which compliments and confirms the layout depicted on the 1866 Vercoe and Harding map (Plate 6). When photographic enlargements of the Barracks were obtained details of the various buildings were clear (Plates 7 and 8). The open north gate can be seen quite clearly and to the right is the main guardhouse. This small wooden building has a chimney and verandah at the front. As far as I am aware no other photograph of the Guardhouse exists.

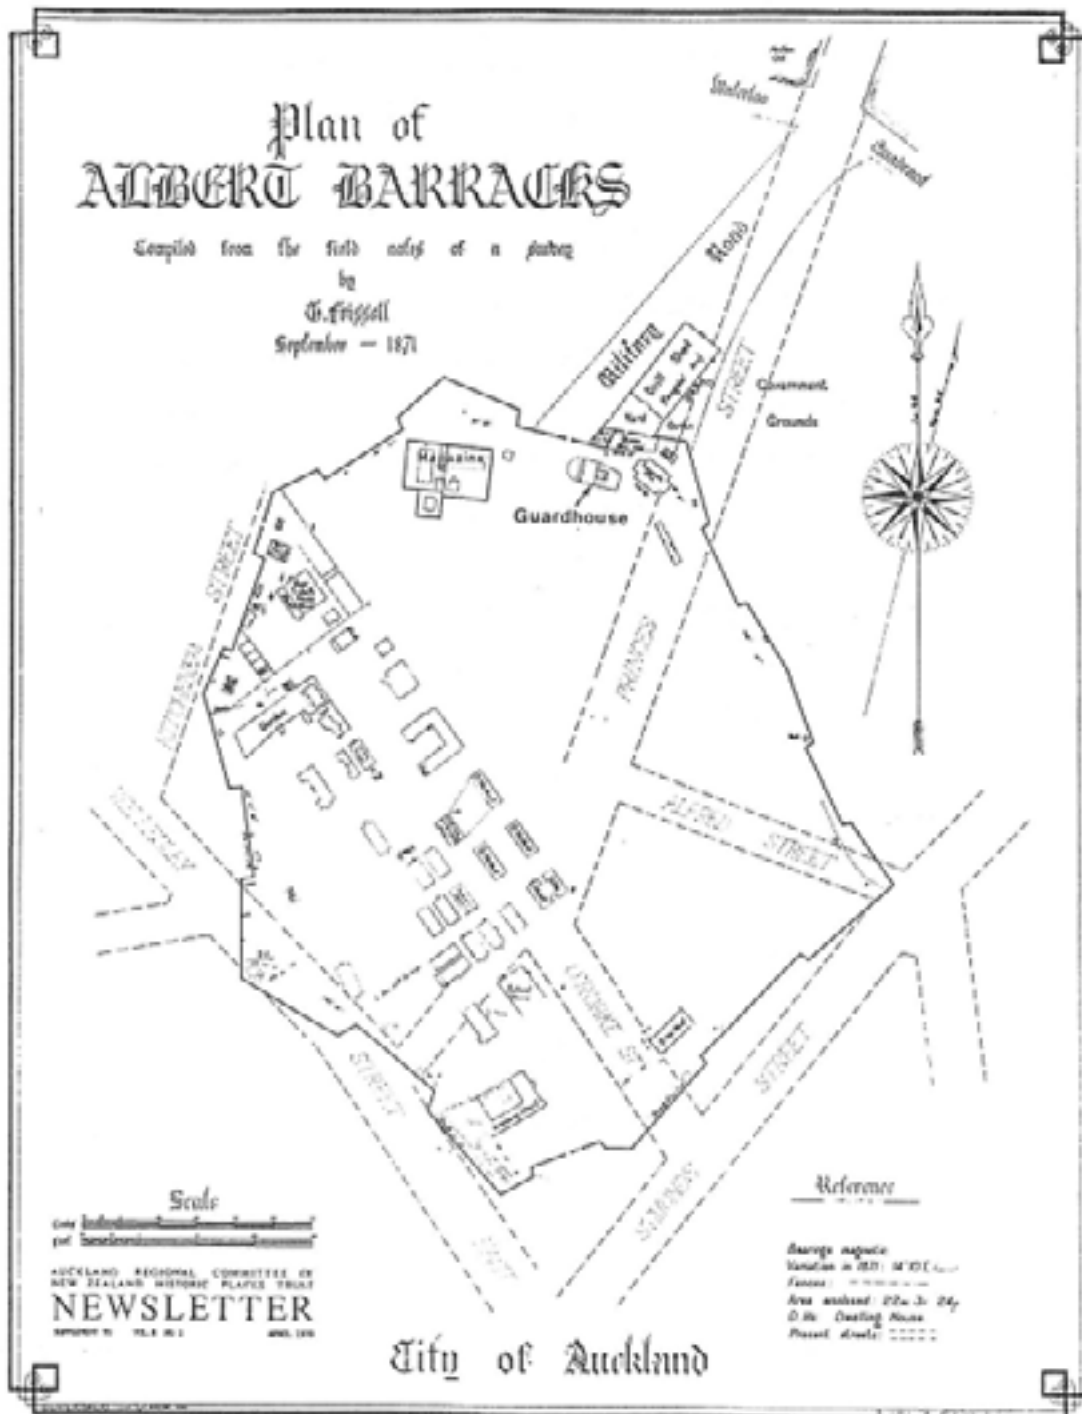
FIG. 3. Plan of Albert Barracks - Frissell 1871.

Details of the layout of the internal buildings and wall surrounding the Barracks were recorded by F. Frissell during demolition work in 1871. The survey fieldbooks containing these notes were discovered in 1936 by Mr R. S. Fletcher of the Lands and Survey Department. There was no evidence to show that the notes had been converted into a map or plan. Realising the importance of these notes Mr Fletcher spent many months reconstructing from pages of calculations a plan that gave the precise measurements of the Barracks wall and the configuration of the buildings left within the boundaries (Fig. 3). The wooden huts along the north-east and south-east sectors had gone, but the remaining buildings and in some cases the materials with which they were constructed, are recorded in detail. Without doubt, the revelation of the contents of Frissell's notebook and the translation into map form, filled a crucial gap in early colonial history.

In 1980 the Lands and Survey Department re-checked the measurements and configuration of the Frissell 1871 survey map of Albert Barracks. This map was then overlaid onto the 1980 aerial photograph of Albert Park. The photograph shows the full extent of Albert Barracks, the location of the major buildings within the confines of the surrounding wall, and the relationship of the structures to the

By using the measurements of the Frissell 1871 plan the line of the wall was continued across Princes Street to fix a point (A) at the centre corner of the

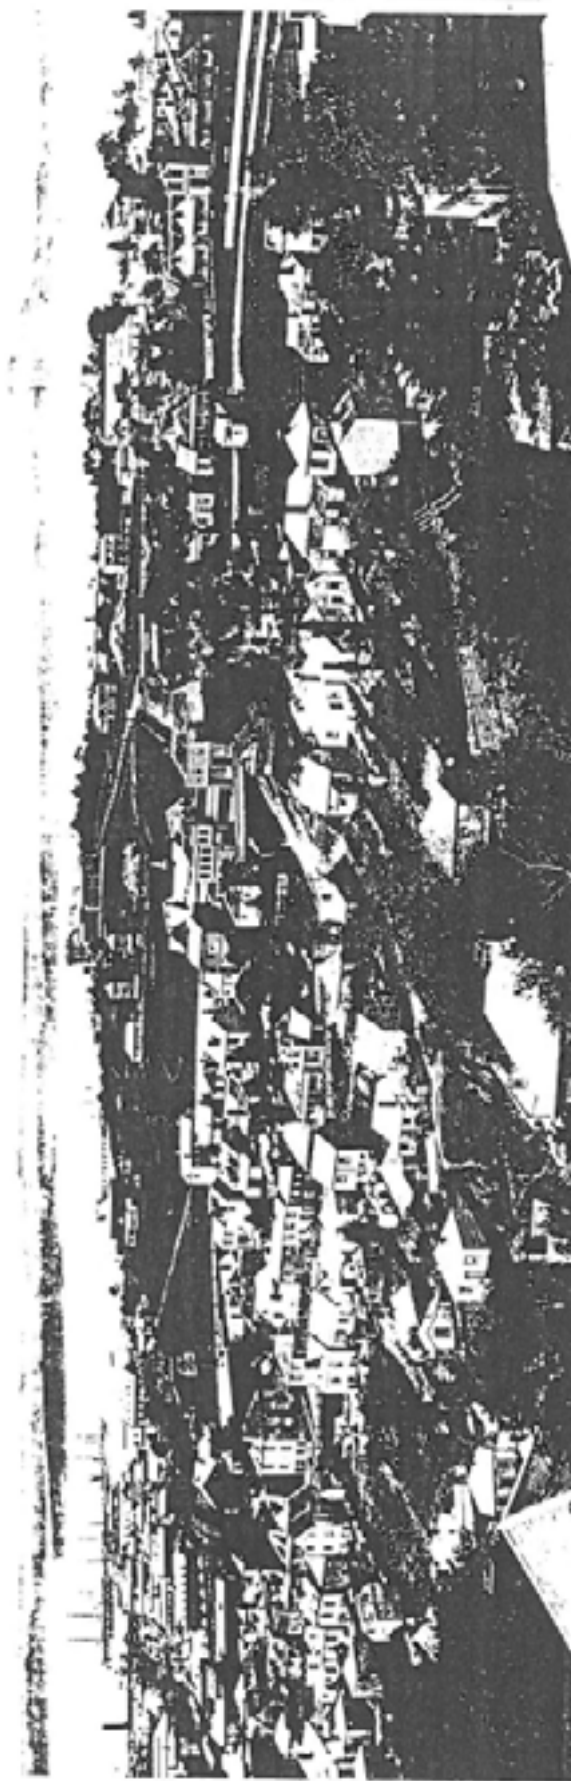
PLATE 13. Auckland early 1830's. Albert Barracks centre back.
Note new Princes Street properties.

A panorama photograph taken in the early 1880s shows the Princes Street extension with a number of impressive houses opposite Government House. Buildings in the former Barracks reserve are still apparent. These were in use as a barracks for the police (Plate 13).

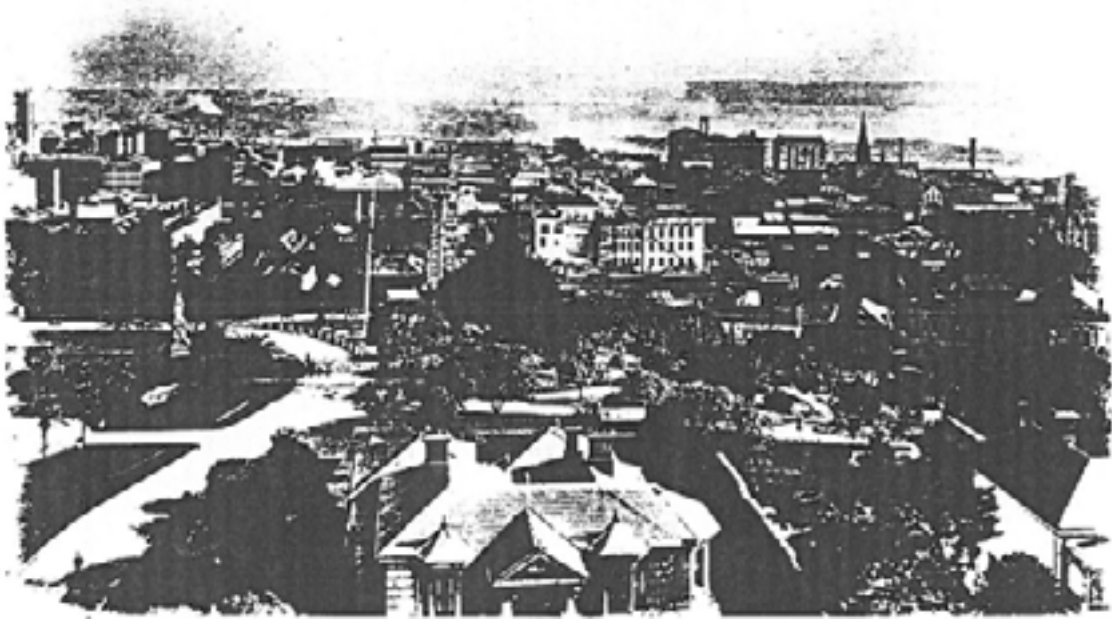
Plate 15. View across 31 Princes Street, "Pembroke" - 1930's.

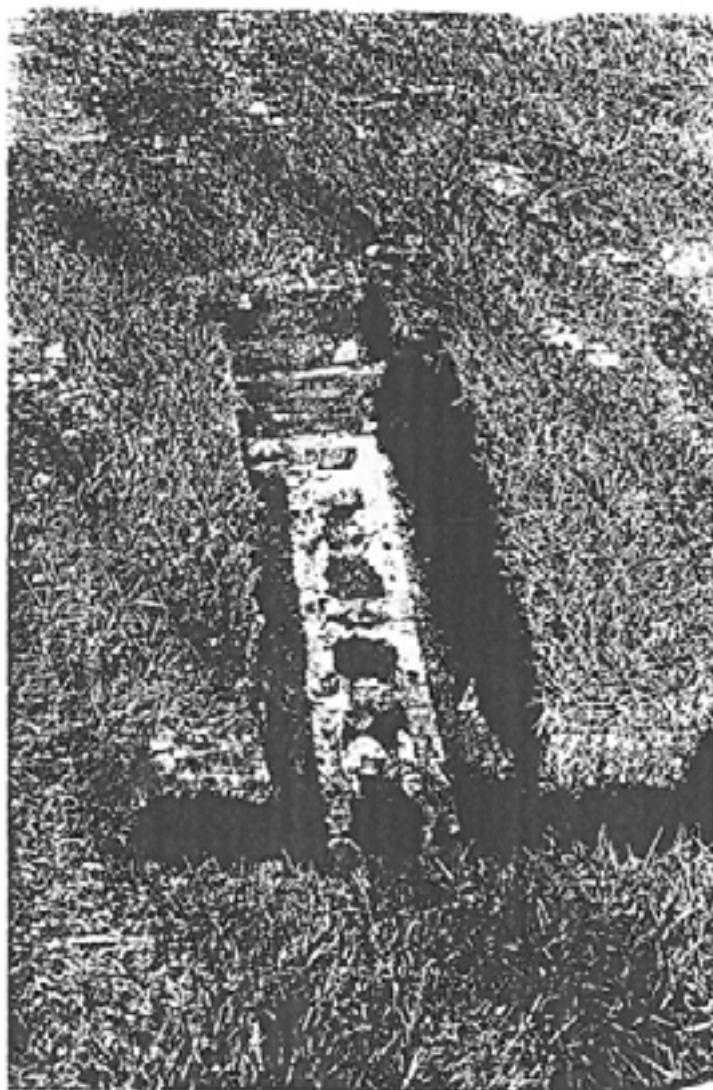
PLATE 20. Site R11/833 - modern concrete block foundations.

This feature was first uncovered in Trench B. A subsidiary trench dug to the east confirmed the existence of modern concrete blocks measuring 400 x 200 mm and 180 mm in depth (Plate 20). These blocks formed part of the foundations around the north prefabricated building erected by the University of Auckland.
