SCIENCE AND RESEARCH INTERNAL REPORT NO. 79

NORTH HEAD: THE DEVELOPMENT OF A FORT

D G Veart

Historic Investigation Team,
Auckland Conservancy,

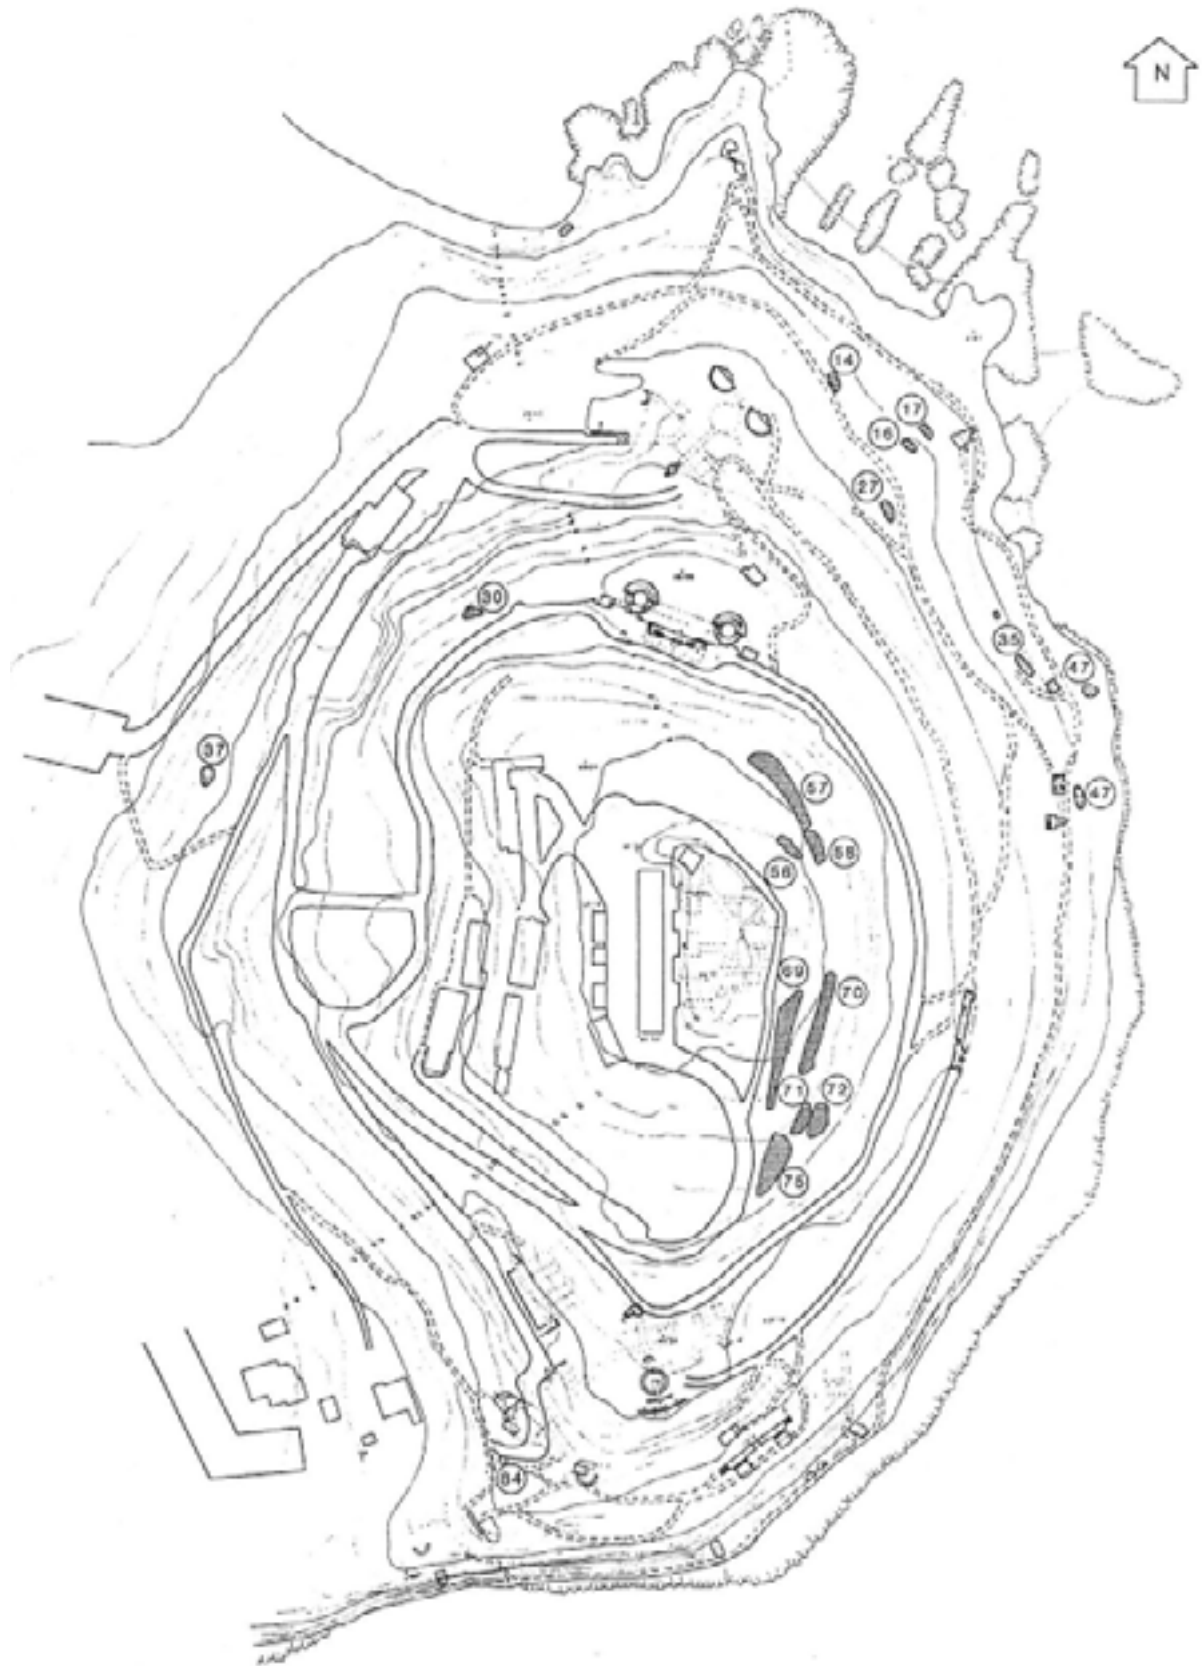
Figure 3: North Head showing areas where prehistoric features may remain.

Terraces
 Midden
 Feature Nos. from Phillips rd (see Appendix)

The eastern flank is the least modified area, the damage being limited to the roads linking North and South Batteries and the road associated with the 6" Mk VII Battery (see Fig 3 & 5 below). It is in this area that the terracing recorded by Phillips is the most likely to be of prehistoric origin. These terraces were recorded by Phillips as features Fig 3). The other main area is on the north-east corner where features 14, 16, 17 and 27 may be of prehistoric origin (see Fig. 3). Another obvious sign of occupation at other cone pa in Auckland is the presence of shell midden. For example at R11/109 Takaranga pa (Mt Victoria) there is an extensive shell midden eroding from a road cutting near the summit. Phillips's survey located only four, possibly five small midden deposits features 35, 37, 47 and 84 (Fig. 3).

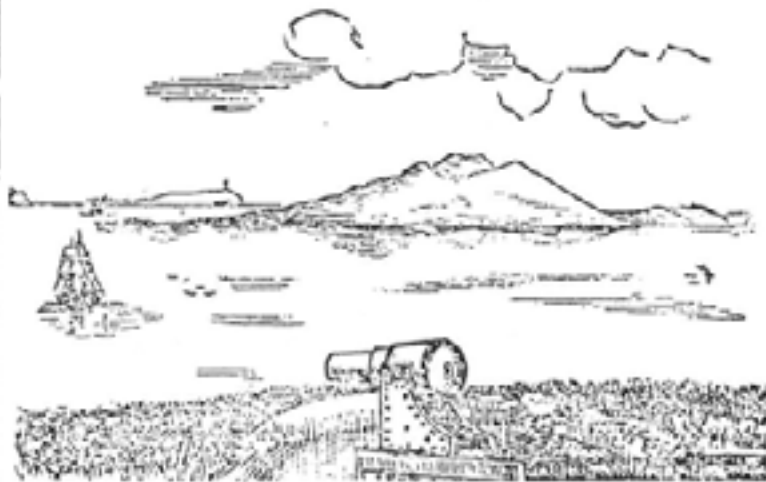
Figure 10: Auckland Fortifications from Auckland Weekly News 25 April 1885

This view gives a general sketch of the 7-inch gun to be mounted in the position facing Challenham Beach. This, like all the other guns, is mounted "en barbette." This is a phrase which may be new to some of our readers, and we may explain that barbette is an earthen terrace inside the parapet of a rampart, serving as a platform for heavy guns. It has such an elevation that the guns may be fired over the crest of the parapet instead of through the embrasures; to give them freer scope by swivelling round into different directions. This class of battery has disadvantages and advantages. The former consist mostly in the fact that the gun is necessarily partially exposed, but on the other hand it has the advantage of a wider sweep, and greater command of space. Indeed its angle is so great that it may almost form the diameter of a circle. With stone work protections of course the gunners would be limited only to the embrasures. After the gun en barbette is discharged, it is run back, and the muzzle depressed for loading, after which it is again run out to the rampart ready for action. With these guns there are adequate appliances, winches, &c., and on a piece six men can work the gun, although the complement is twelve. Our sketch is taken from the rear of the fortification on the side of the hill, and overlooking the Rangitoto Channel. The gun has full command of the Channel outwards through the Whangaparua Passage, and inwards to the point of Rangitoto Keel.

The second sketch is a section showing the gun on its carriage looking over the parapet, with the ammunition chamber and passage at the rear.

The third sketch is the most important, being the actual plan of the fortification. The two black lines, one running through the gun and the other at an obtuse angle from it, show the line of angles on which the gun can be brought to bear. The octagonal frame shows the platform, and the dotted ground inside and outside the platform is concrete. No better idea as to the great variety of range of these guns can be given than that which is conveyed in this cut, and in this respect its great advantage over casemate guns must be apparent. In regard to the present fortification works, no doubt as soon as the more important work is completed, the loose earthwork thrown out from the excavations and roads will be sloped off and planted with grass or soda, and this will be all the more necessary with respect to the fortifications themselves, so that there should be nothing to distinguish the position of the guns from any other part of the hill.

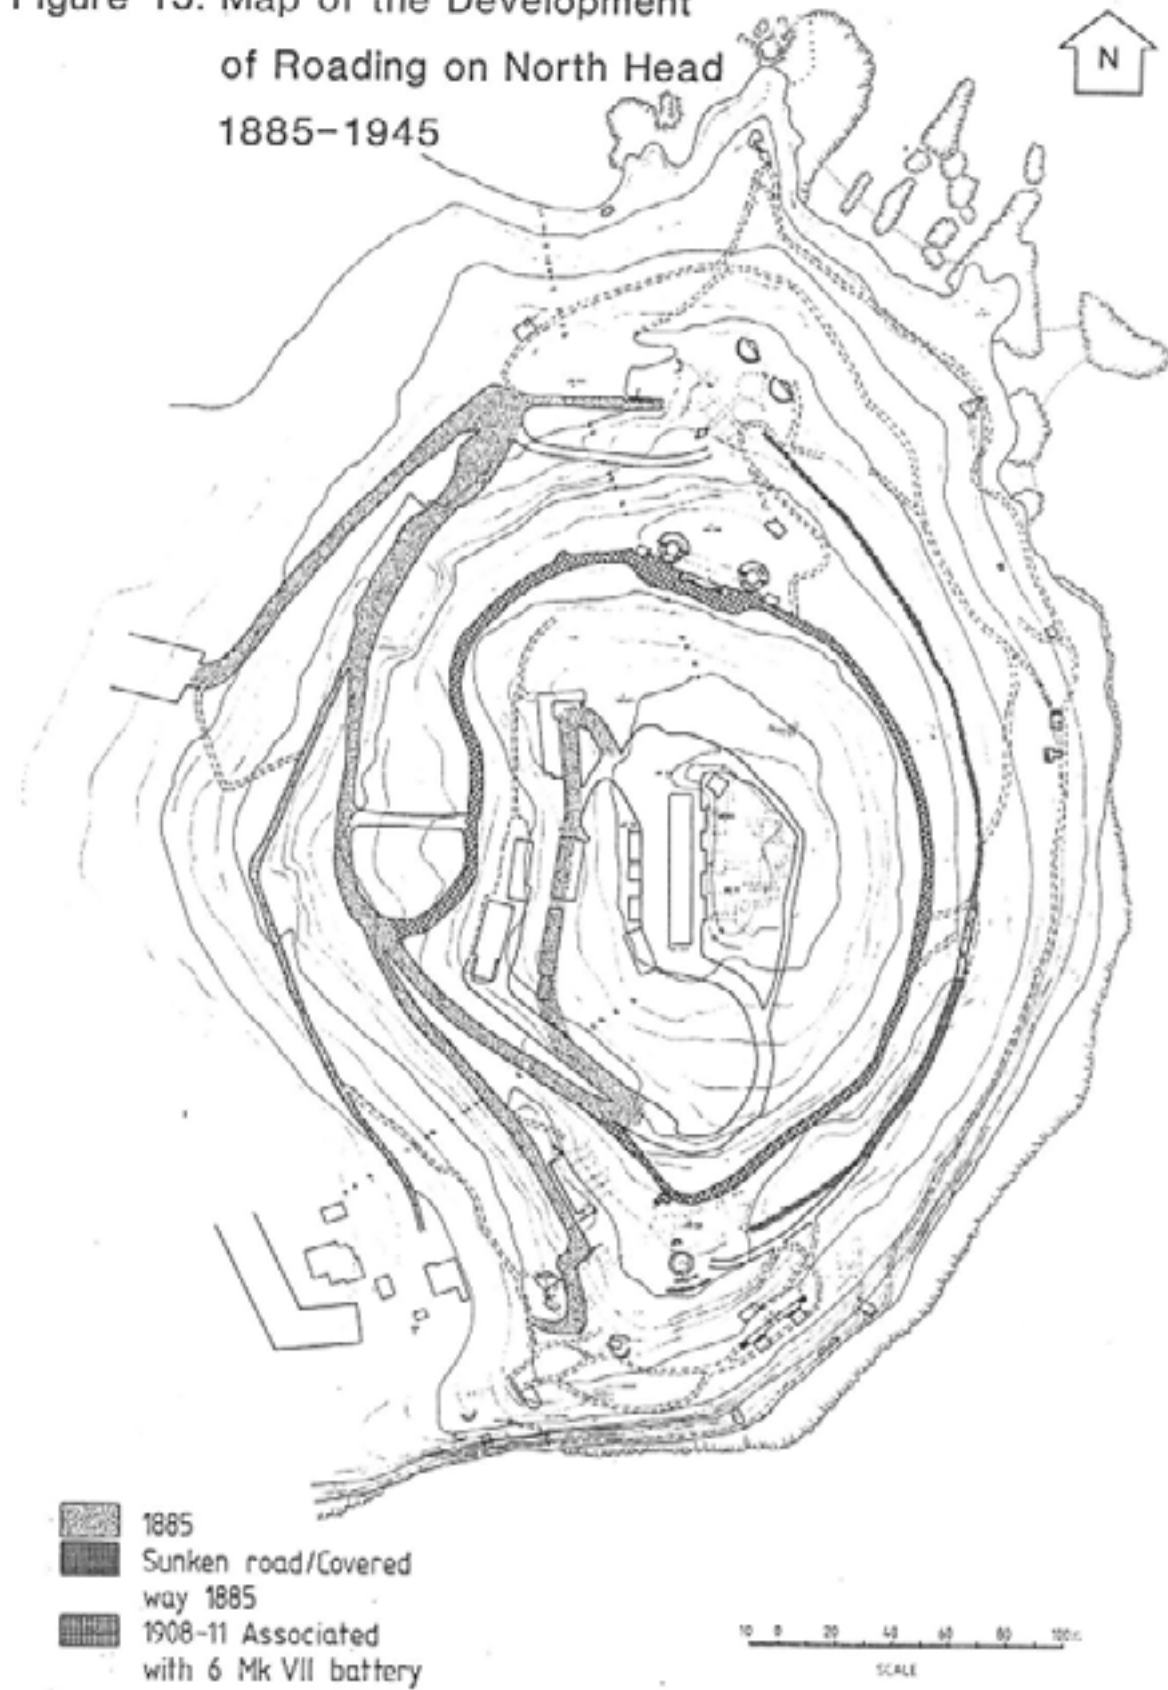
Figure 15: Map of the Development
of Roding on North Head
1885-1945

5.0 ROADS (Fig. 15)

The earliest maps and photographs (Plates 1 & 2) show Takuranga Road running up to the boundary of the North Head Defence Reserve. At that time it was called North Head Road. No roads are visible on the Head itself although there may have been a track following approximately the route of the modern road to the summit.

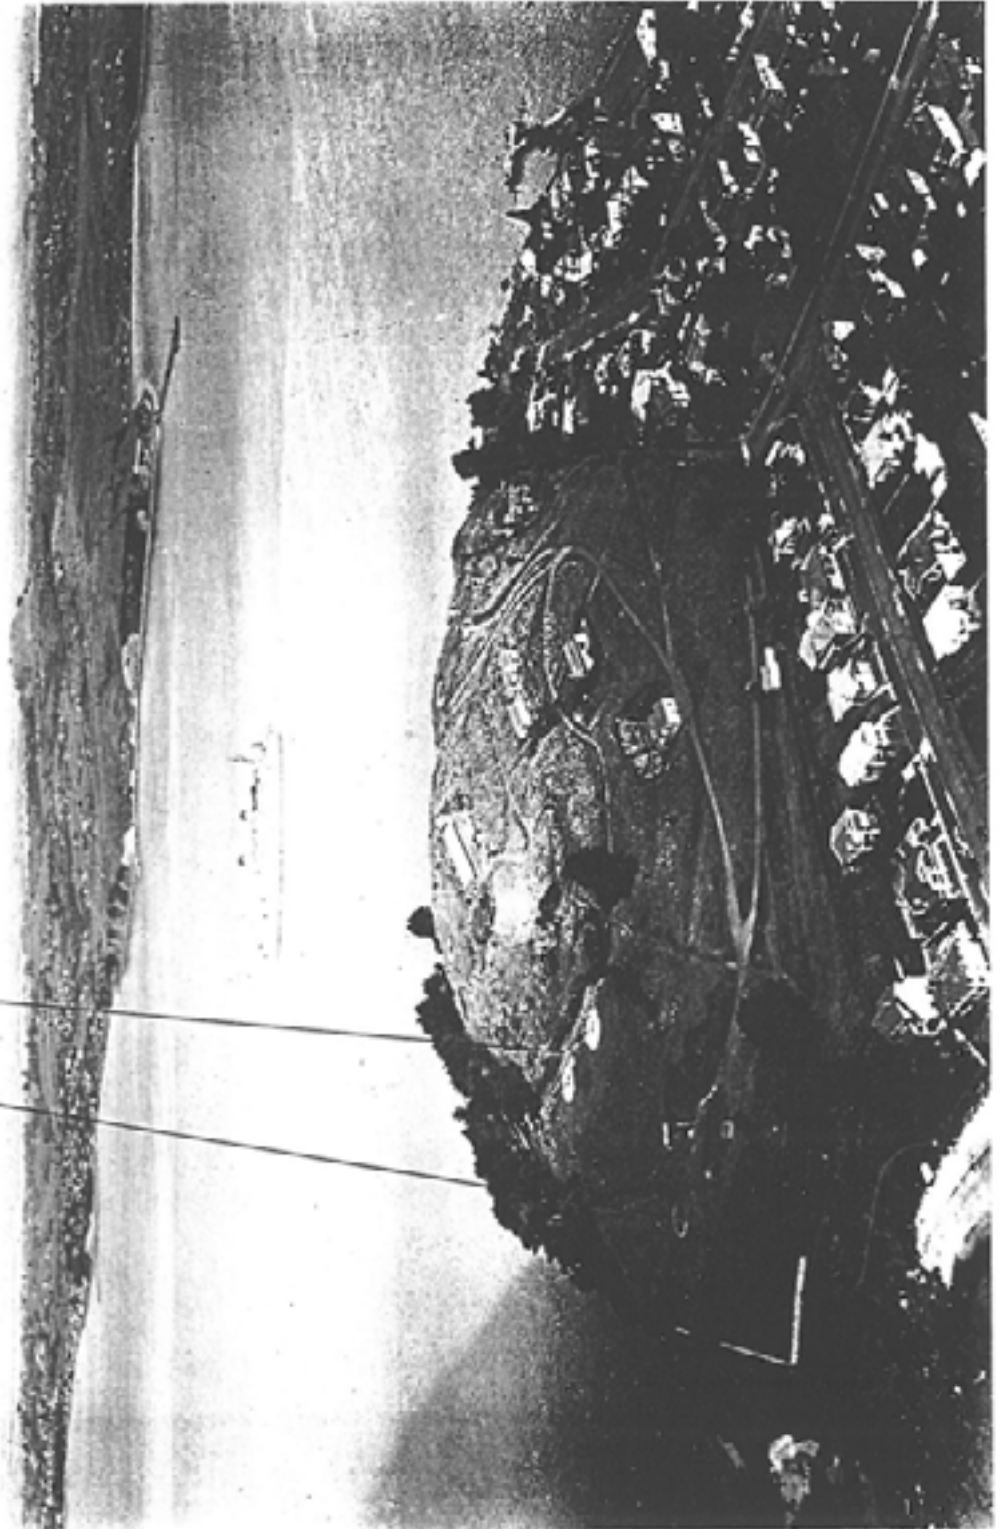
Plate 7: North Head Aerial View 1939.

Old 8" BL H-P emplacement
6" Mk VII gun emplacement
