FOX GLACIER — ROAD ACCESS

ENGINEERING REVIEW

*Report prepared for Department of Conservation
by Matthew Gardner and Gary Williams*

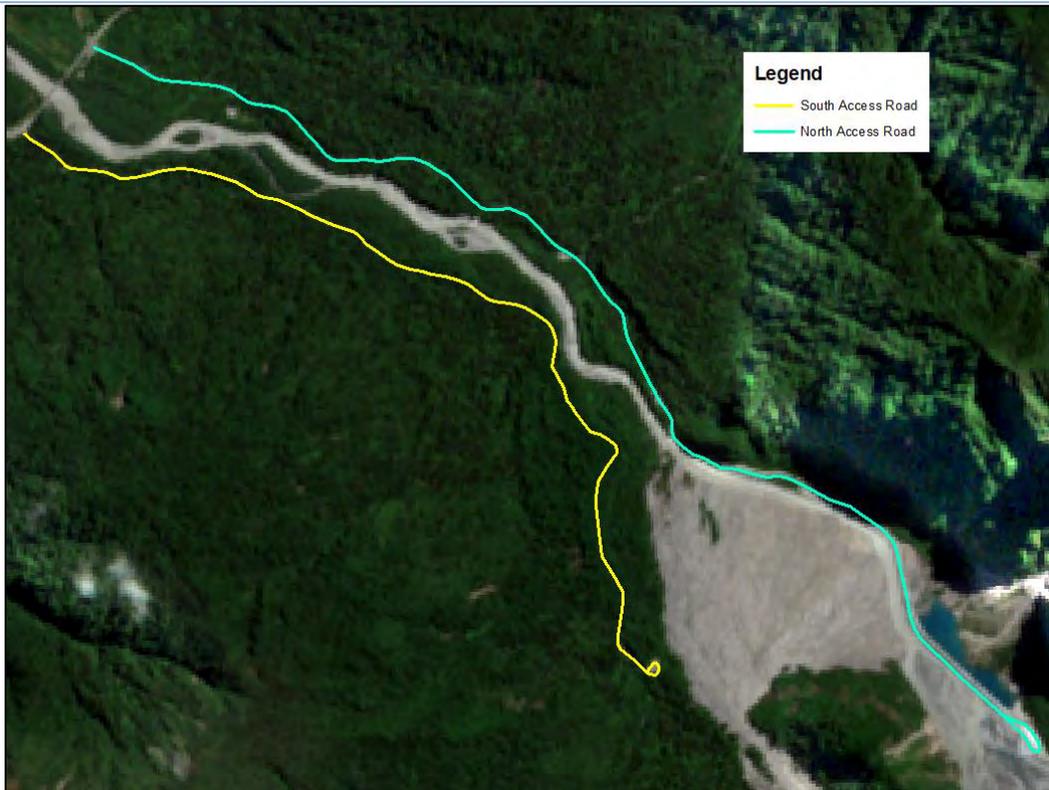
This widening of the river channel and build up of the Mills Creek fan is very clearly visible in the available satellite imagery, which has been obtained from the Sentinel 2 satellite system operated by the European Union Copernicus programme. Figure 1-2 and Figure 1-3 on the following page compare the satellite imagery taken on the 1st of February 2019 with imagery from 28 March 2019 immediately after the flood event. Figure 1-3 also highlights the location of the road washouts. Measurements of active channel width taken from the satellite imagery show that the river has approximately tripled in width for much of its length.

Figure 1-2 - Sentinel 2B Satellite Imagery taken 1 February 2019

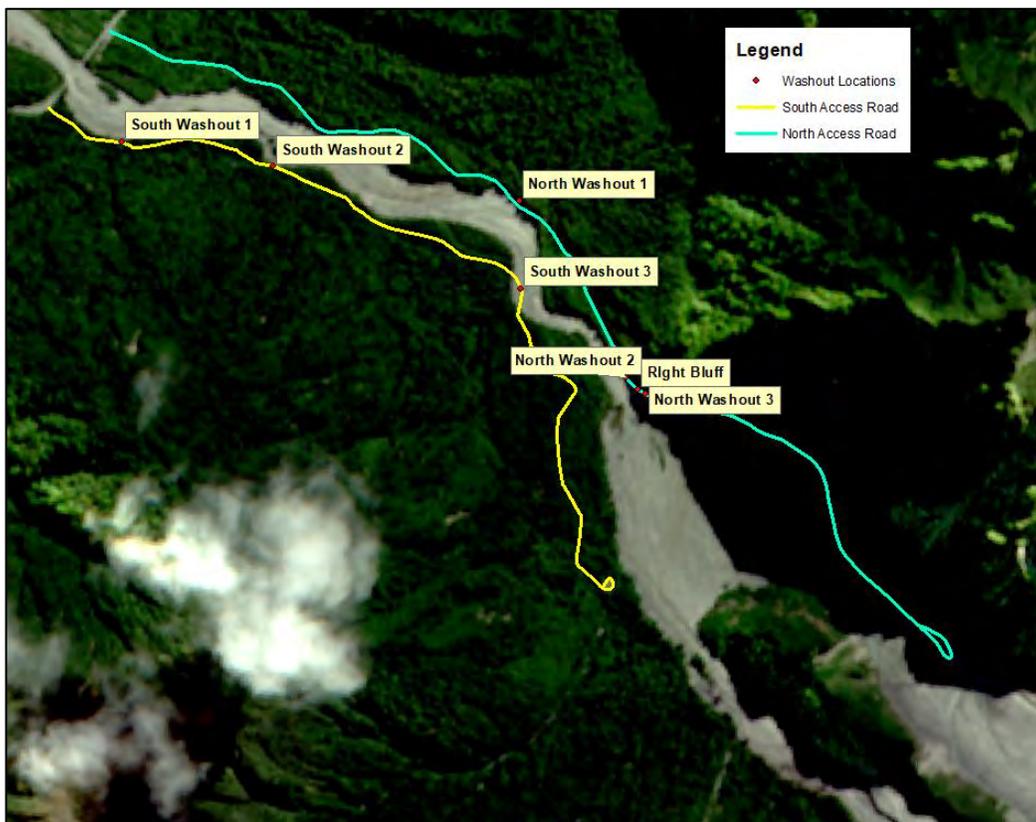
Figure 1-3 - Sentinel 2B Satellite Imagery taken 28 March 2019

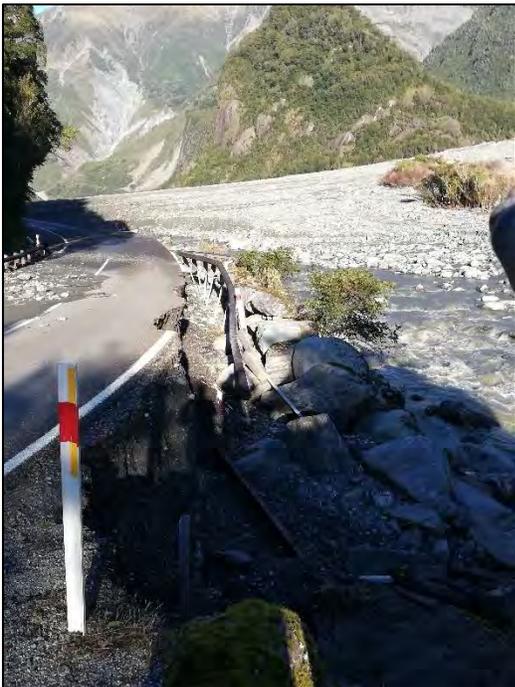
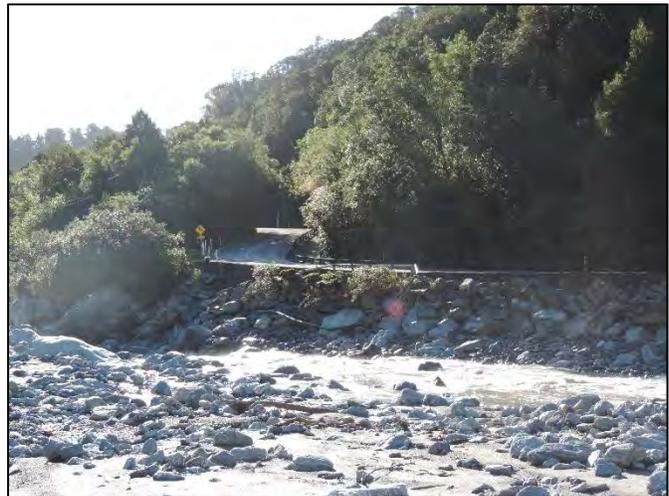
North Washout 2 – In this location flood flows have overtopped the road, causing scour behind the rock lining, which was protecting the road on the river side, and also taking out a large portion of the road.

Figure 1-5 – Photos of the North Washout 2 – looking upstream & from the fan opposite

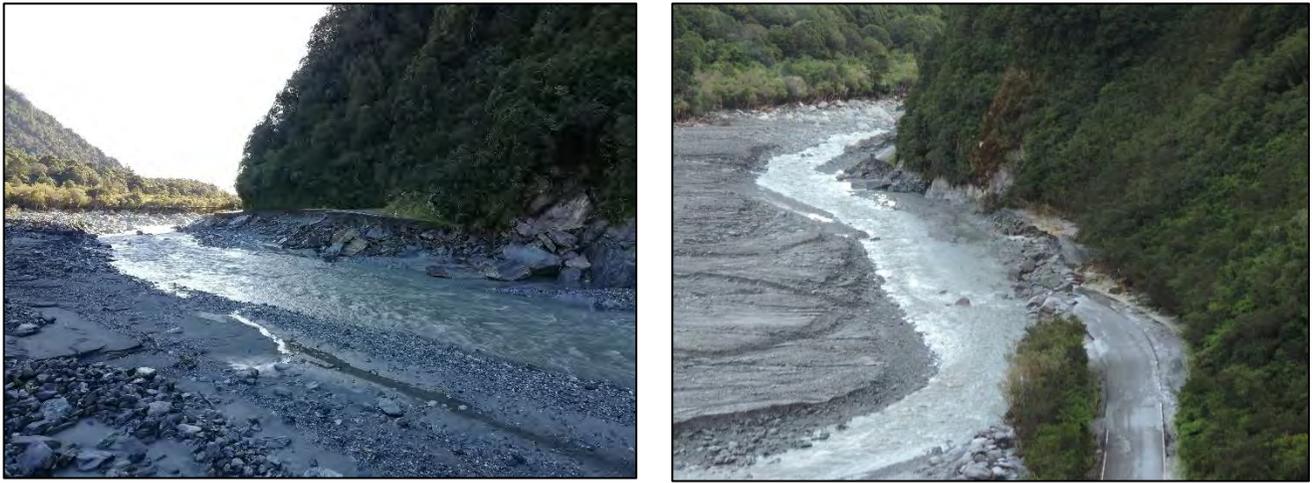
North Washout 3 – The road went around a high bluff at this point, and the roadway has been completely removed for around 100 m. This section of the road has also been overtopped by floodwater due to fan material building up against the road and then bursting during flood flows.

Figure 1-6 – Photos of the North Washout 3 location – looking downstream

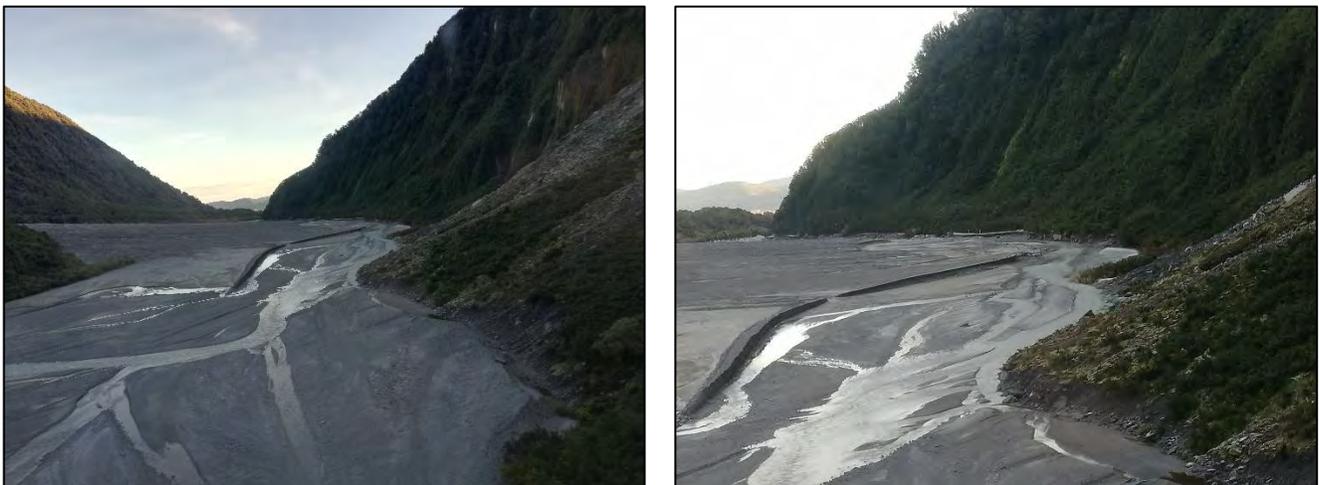
The remainder of the road upstream from this location has been largely destroyed, with a remnant of the rock-protected embankment remaining in the river bed. The main river flow is now on the north side by the Undercite fan.

Figure 1-7 – Photos of the upper section of the road, now destroyed – looking downstream

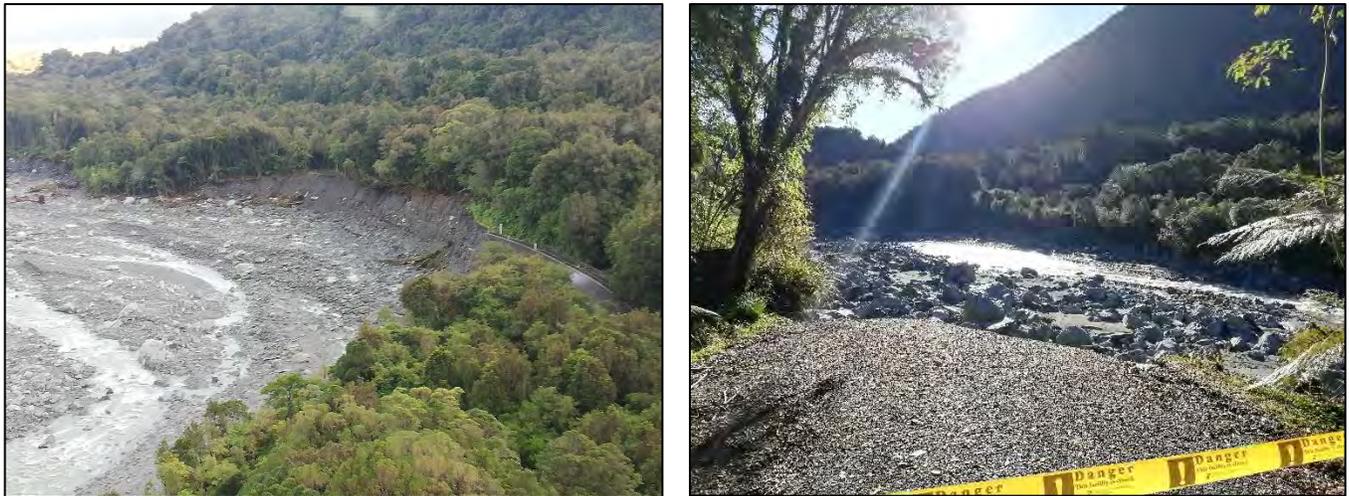
South Washout 3 – Approximately 140 m of this section of road has been destroyed by a large embayment from the river that extends into the moraine material left behind from the 1750 glacier terminus. The active channel width of the river has about tripled in this location, leaving a very rough river bed with large boulders.

Figure 1-10 – Photos of the South Washout 3 location – looking upstream & downstream

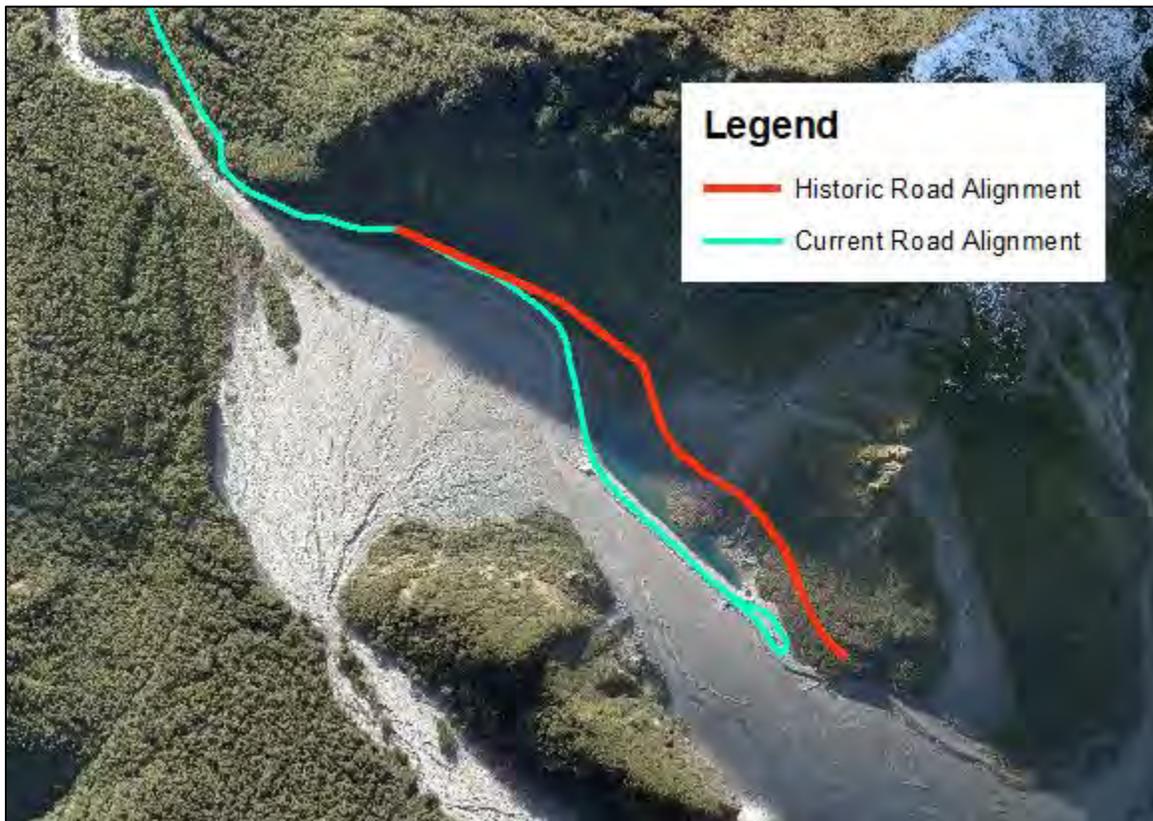
used to maintain the road embankment, and the road was set back towards the fan sometime prior to 2012. This made the embankment somewhat less intrusive into the river bed, but it remained a pronounced restriction within the river. Appendix C has a series of aerial plans of the area of the roads, showing changes over time, including the recent formation and expansion of the Mills Creek fan.

Figure 2-1 – 2018 imagery, with comparison of historic road alignment (pre 2000) and existing alignment that protruded into the river bed.

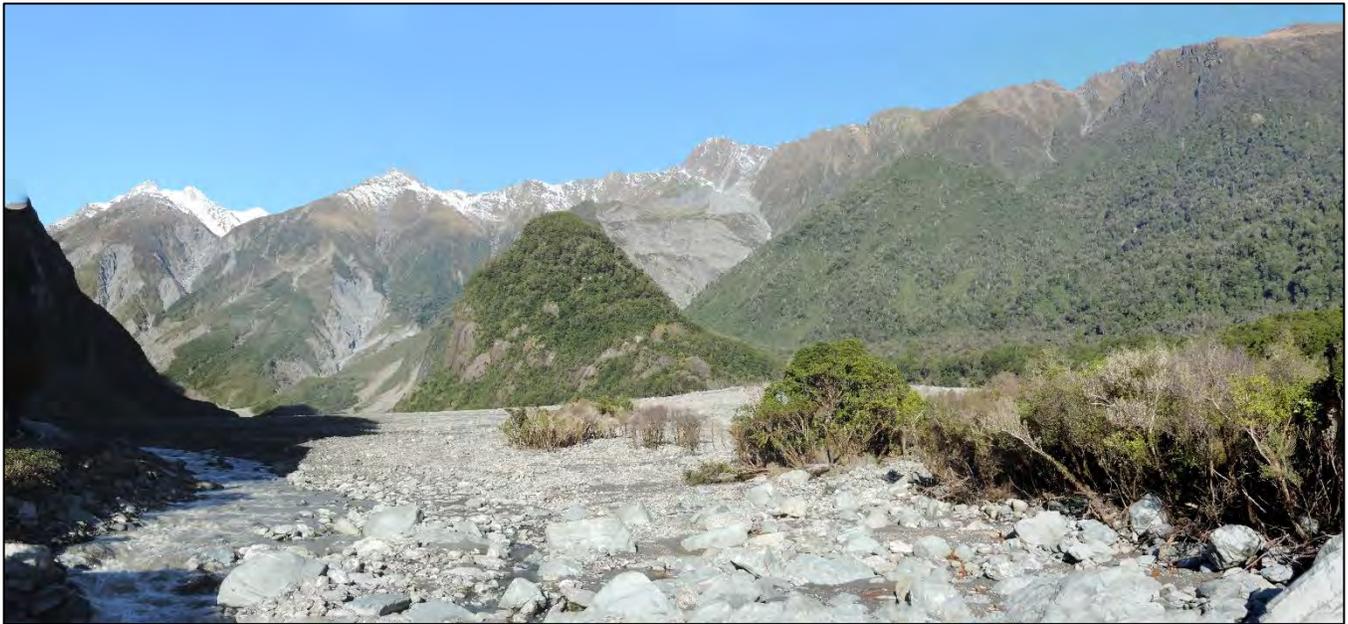
Figure 2-7 – The Mills Creek system, from the fan on the valley floor to the Alpine Garden debris accumulation above Cone Rock, and up to Craig Peak.

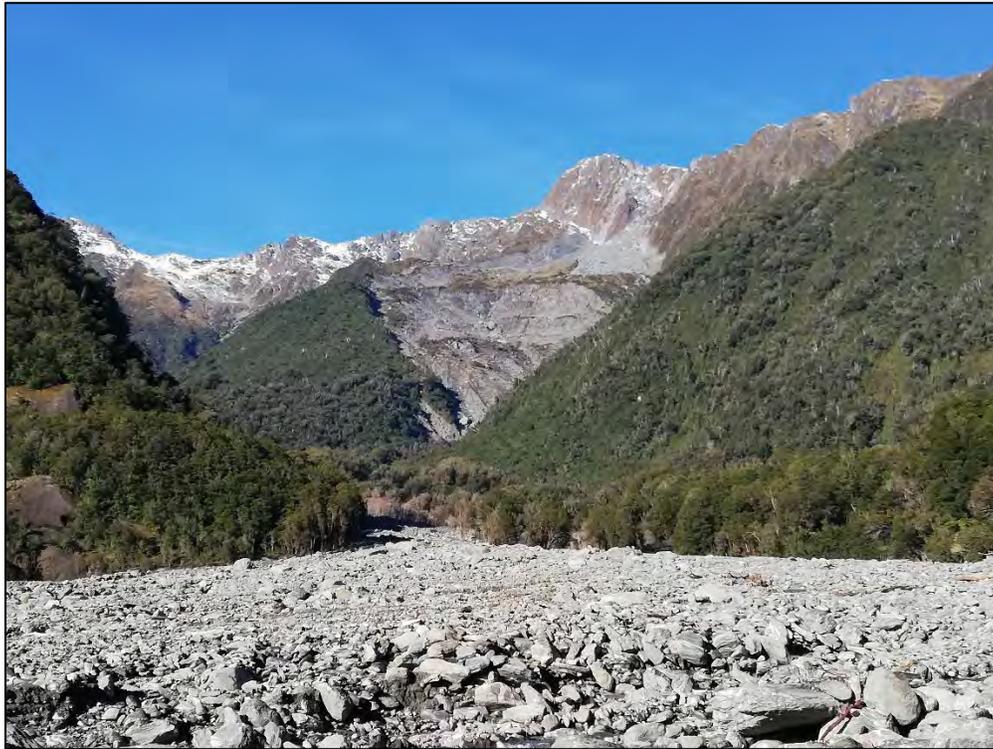
Figure 2-8 – The top of the fan with the Alpine Garden above to Craig Peak

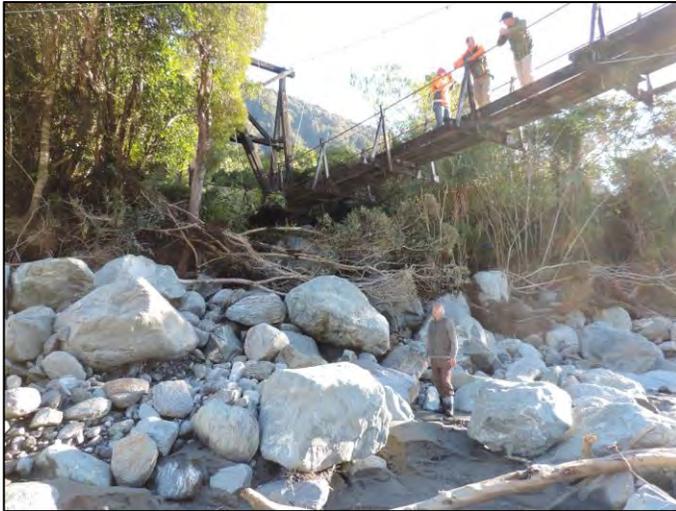
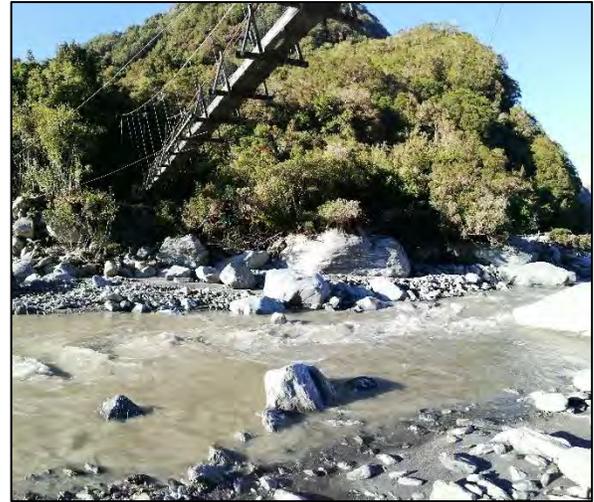
The river has widened with a very rough boulder channel at the bridge. The mass of boulders on the left side would provide some deflection and hence protection to the left side bridge tower. The confining of river flows to the right side does, however, increase the erosion hazard on this side, and the present bank is right at the outer side of the tower footings.

The tower footings are simple concrete blocks, with no apparent under-piles. The right side tower is, thus, likely to fail from underscoring by the river. The height of the bank, its closeness to the bridge towers, the loose bank material and the boulders in the river bed, all add up to a very difficult site for any protection works.

Figure 3-2 – True right bridge abutment protected by boulders. Left abutment exposed and vulnerable

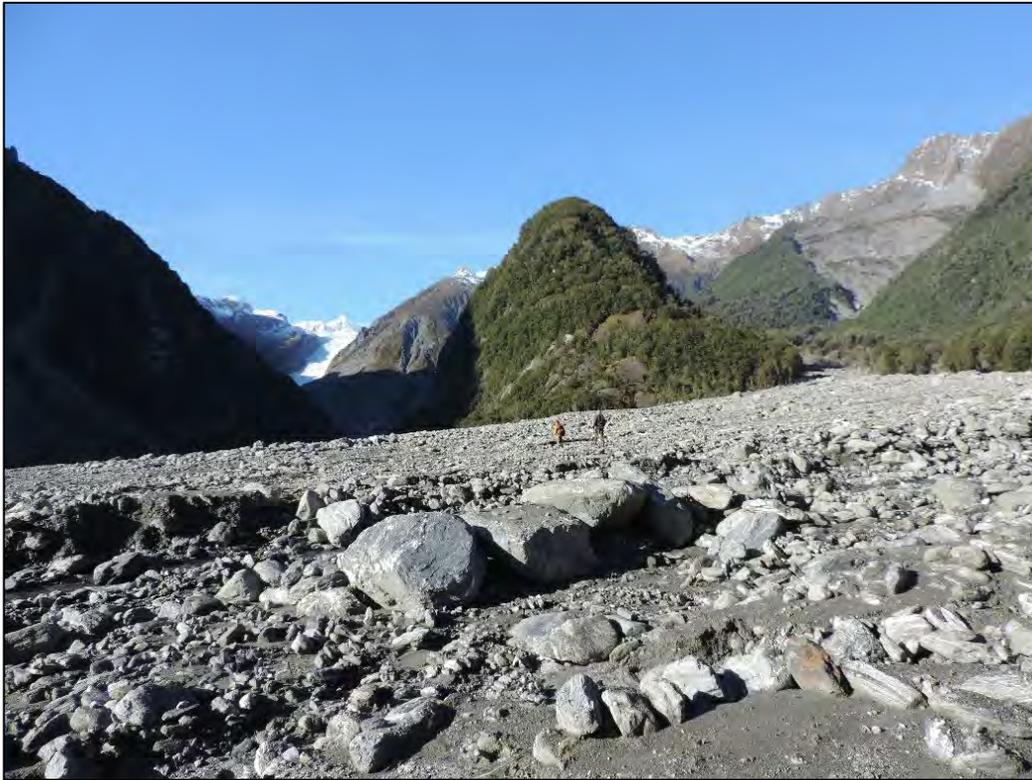
Photo 1 - Valley floor fan, with Fox Glacier to the left of Cone Rock and Alpine Garden and Craig Peak to the right. Note the size of boulders and general roughness of the fan surface.

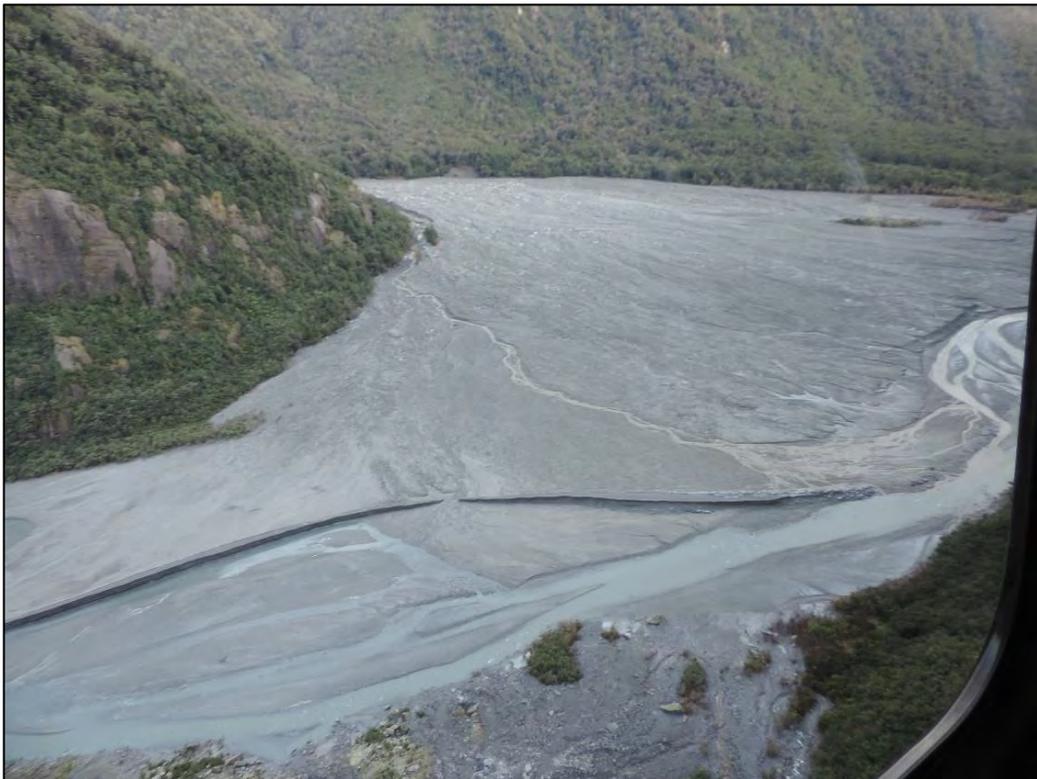
Photo 4 - Shows the extent of the fan, with Cone Rock on the left, and the road remnant in the river bed – looking downstream.

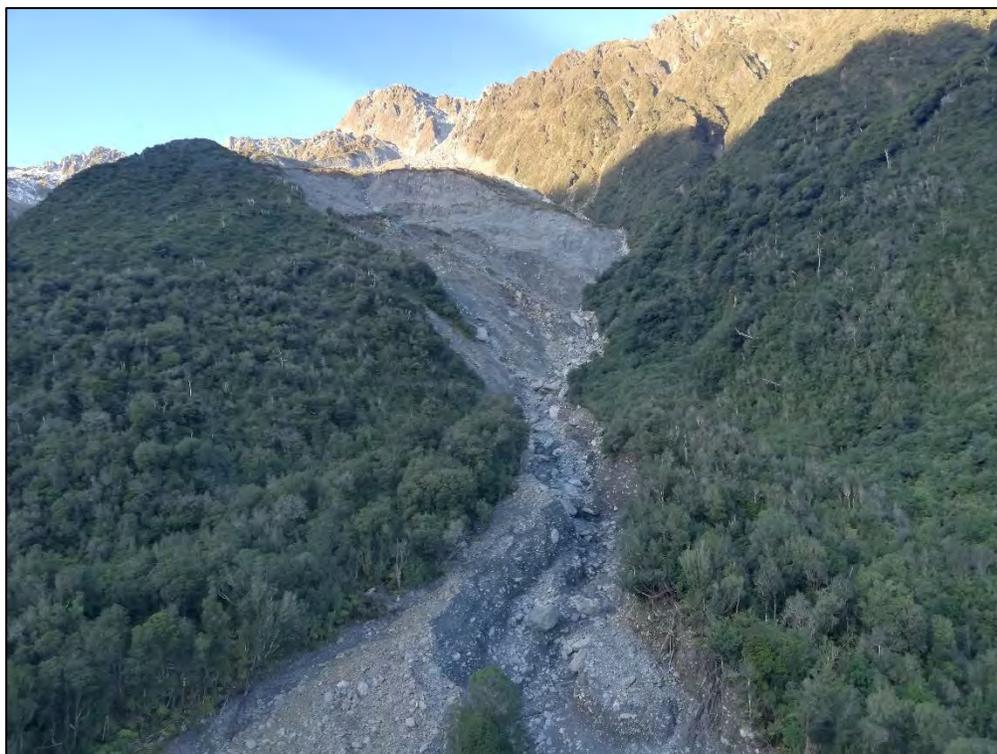
Photo 7 - The bottom of the Alpine Garden debris accumulation, and the start of the transport reach through to the valley floor fan.

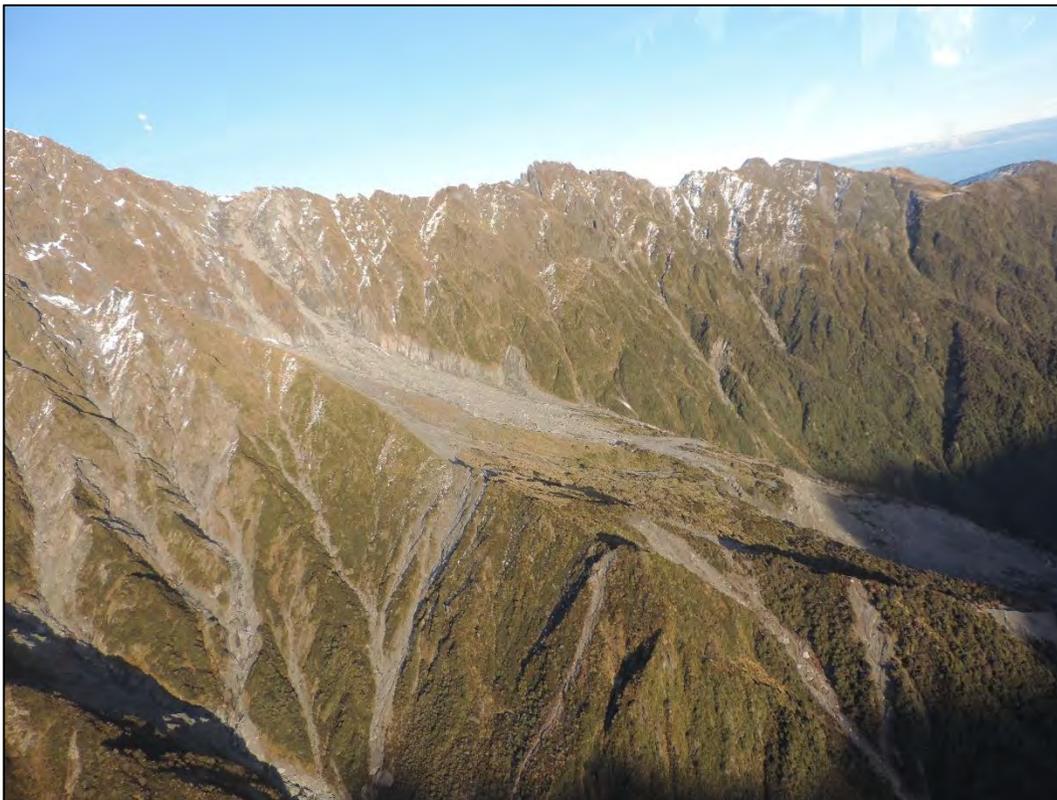
Photo 12 - Looking southwest over the Alpine Garden, to the steep mountain face above, which could be destabilised in large earthquake events.

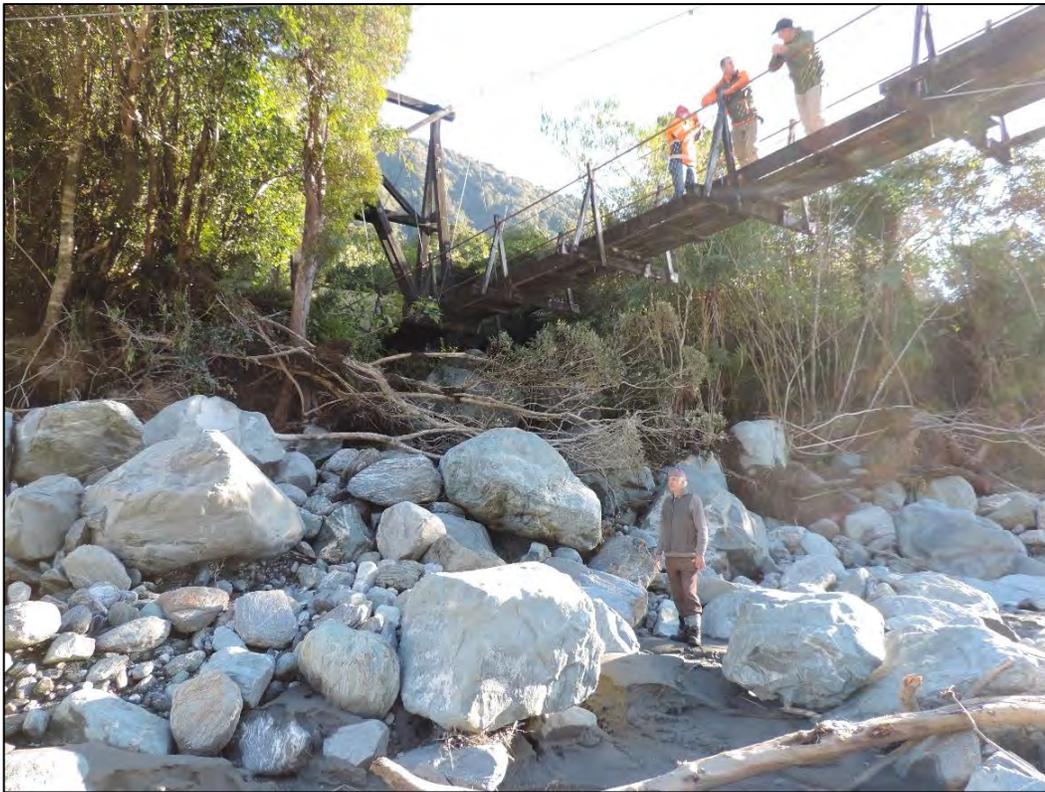
Photo 17 - The left (south) side of the bridge, showing the large boulders that are stacked on this side of the river channel.

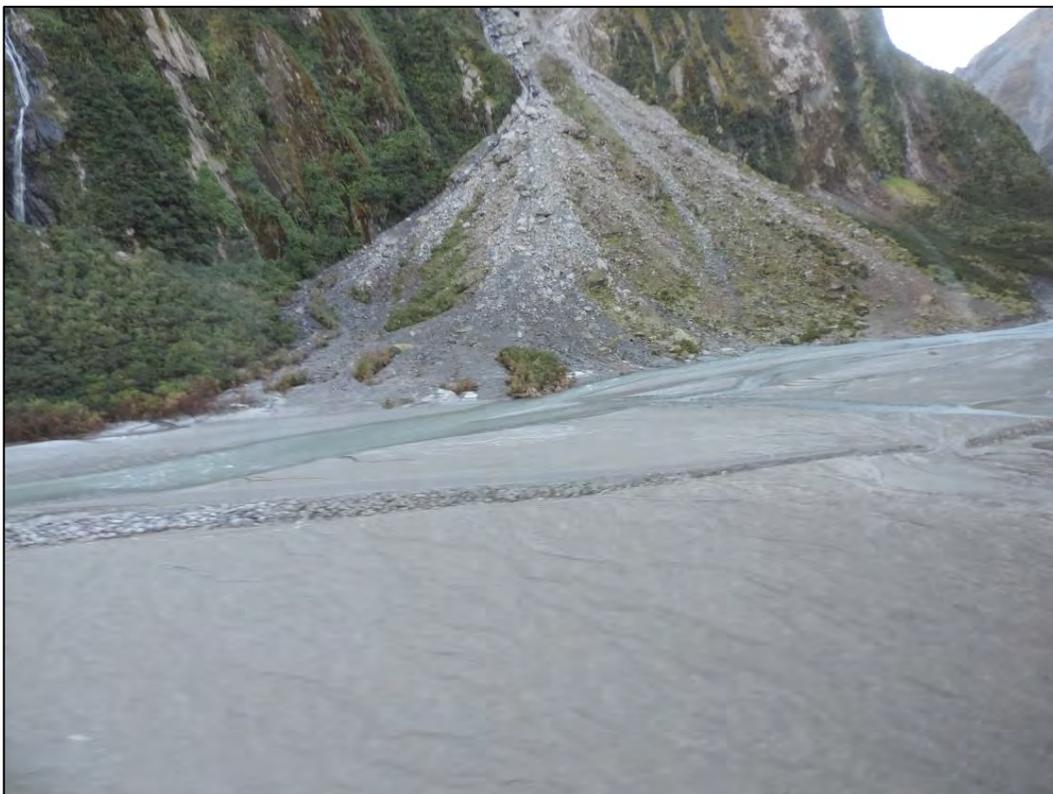
Photo 18 - The Undercite fan on the right (north) side, which is still active. The road was re-aligned into the river bed to go around this fan after it first formed.

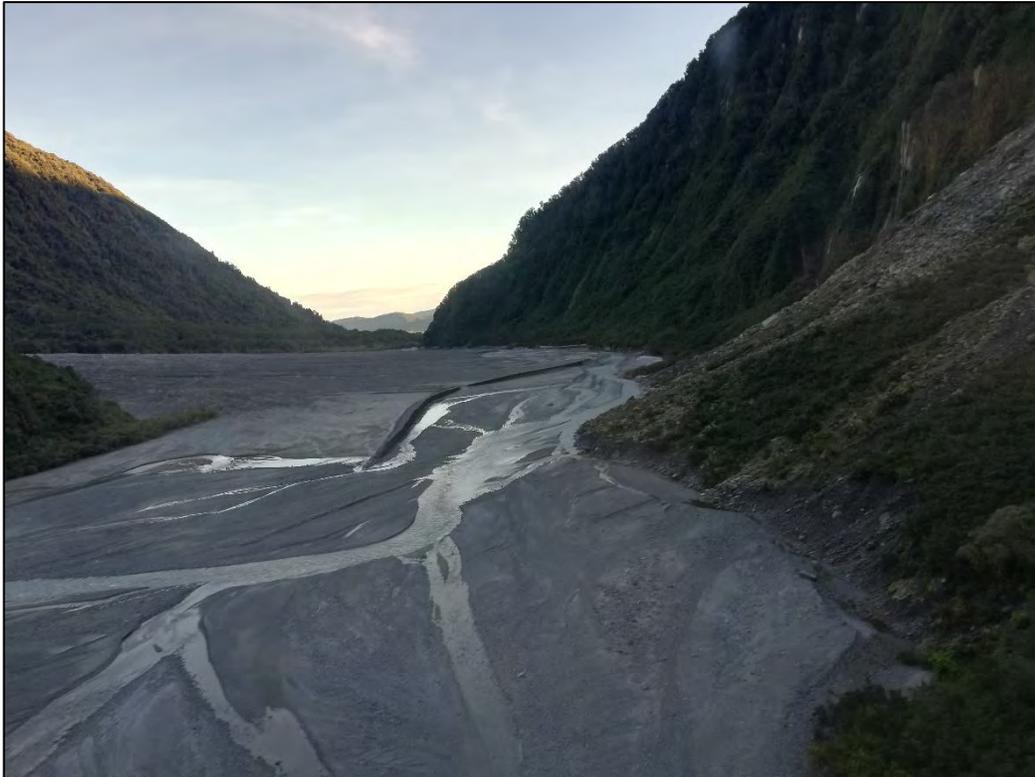
Photo 19 - Looking downstream in front of the fan, with the river now flowing between the fan edge and the remains of the roadway in the river.

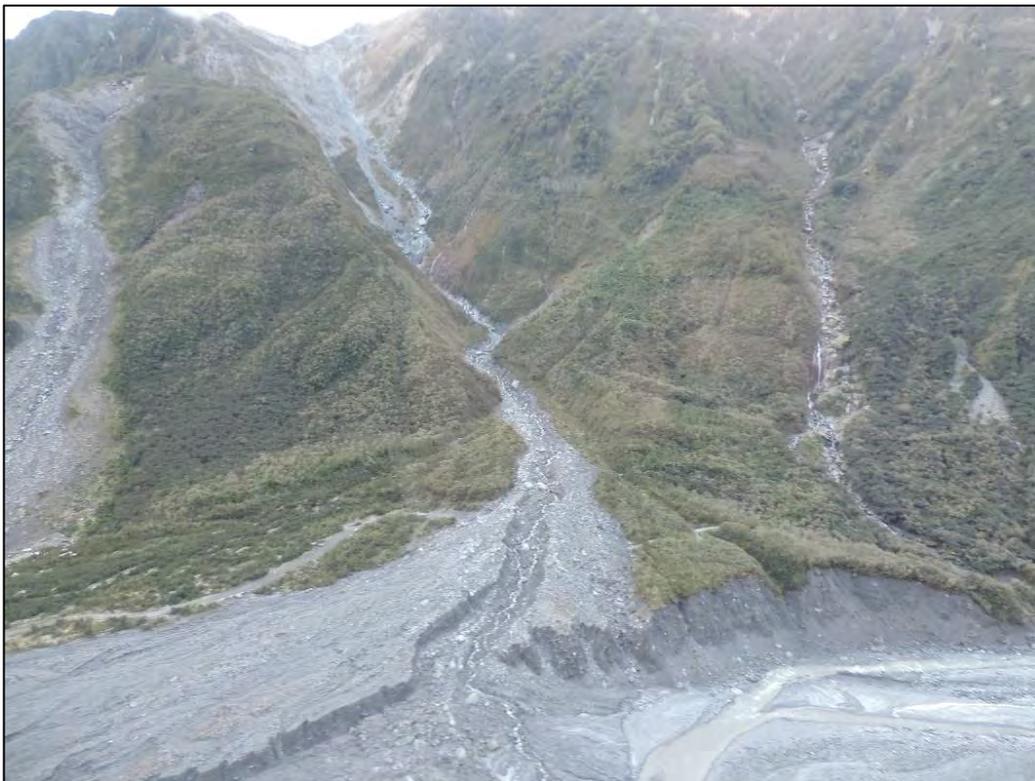
Photo 20 - The Yellow Creek valley and fan, showing the deposition and erosion activity at the fan. The Gunbarrel valley is on the left side of the photo.

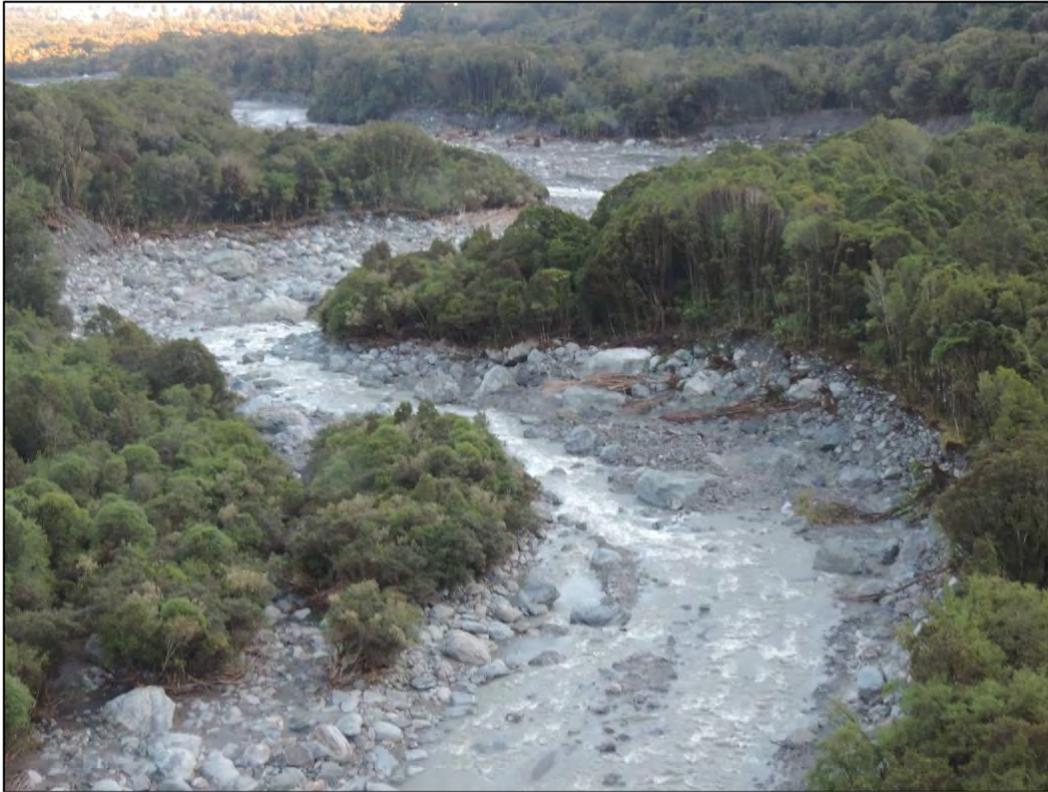
Photo 25 - From above the Swing Bridge, showing the back and forth meandering of the river bed, with large erosion embankments being formed.

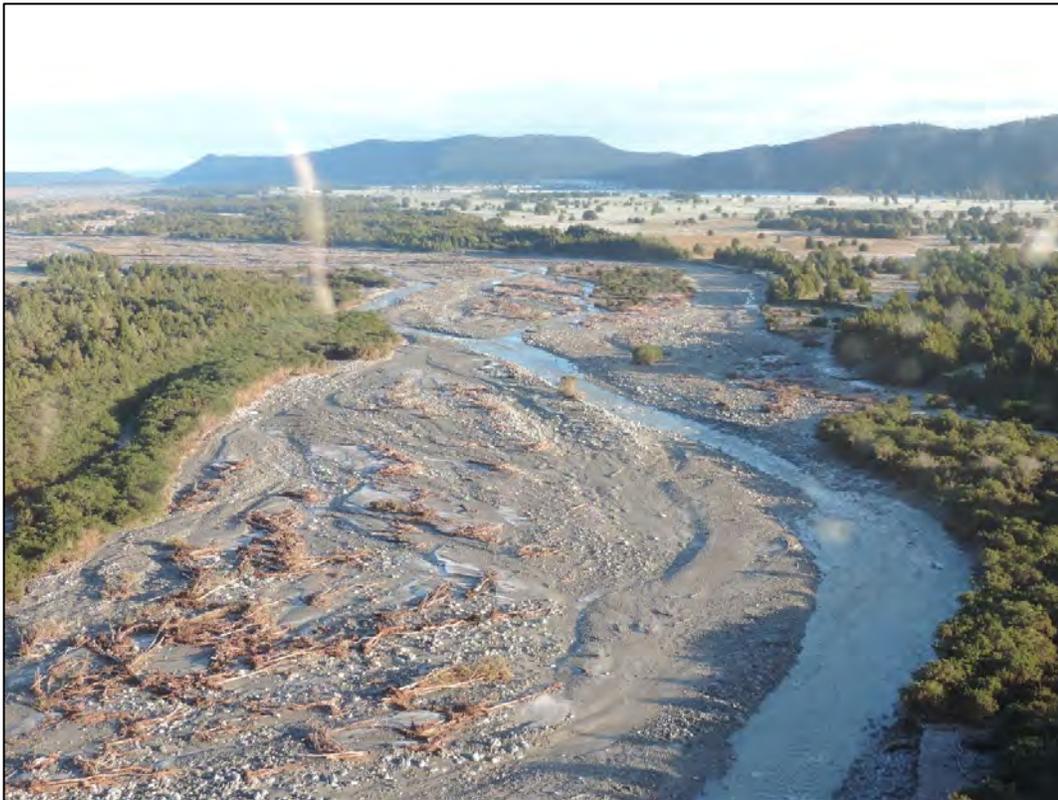
Photo 28 - Downstream of the State Highway, where the river widens and braids. Note the vegetation debris from the recent river erosion and sediment transport activity.

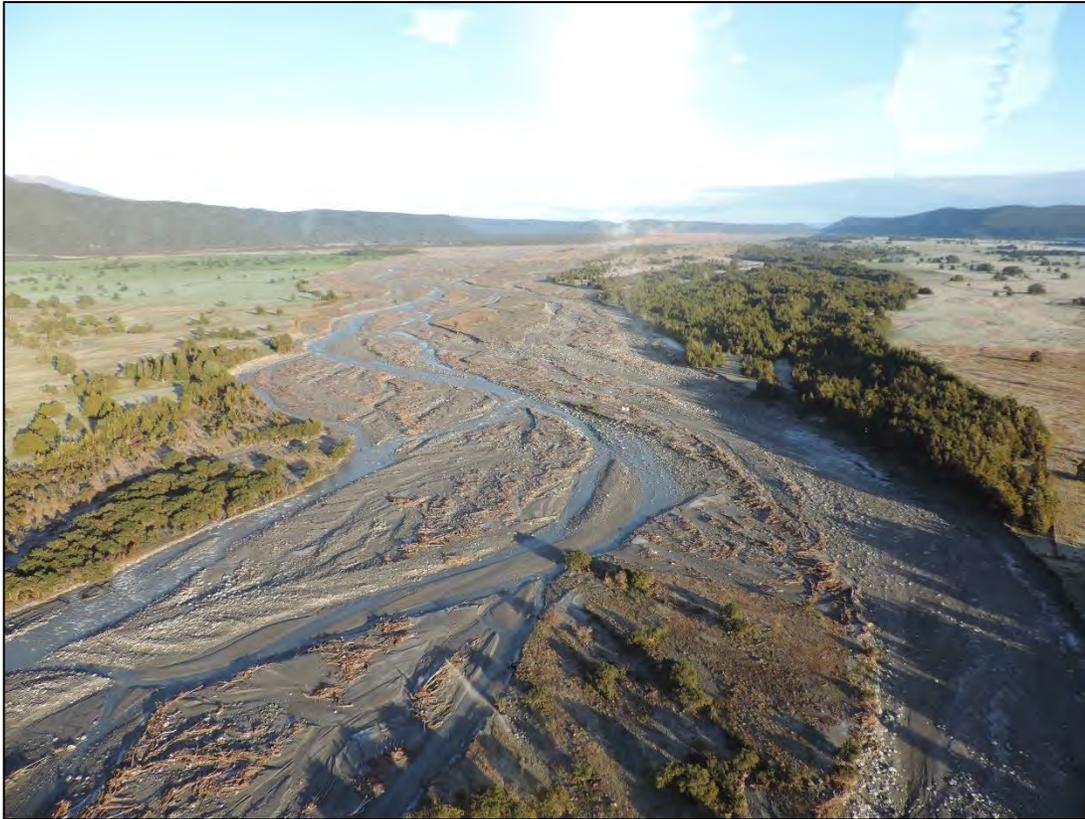
Photo 29 - The fully braided reach of the Fox River, before it enters the Cook River, showing the recent re-working of the river bed and vegetation debris.

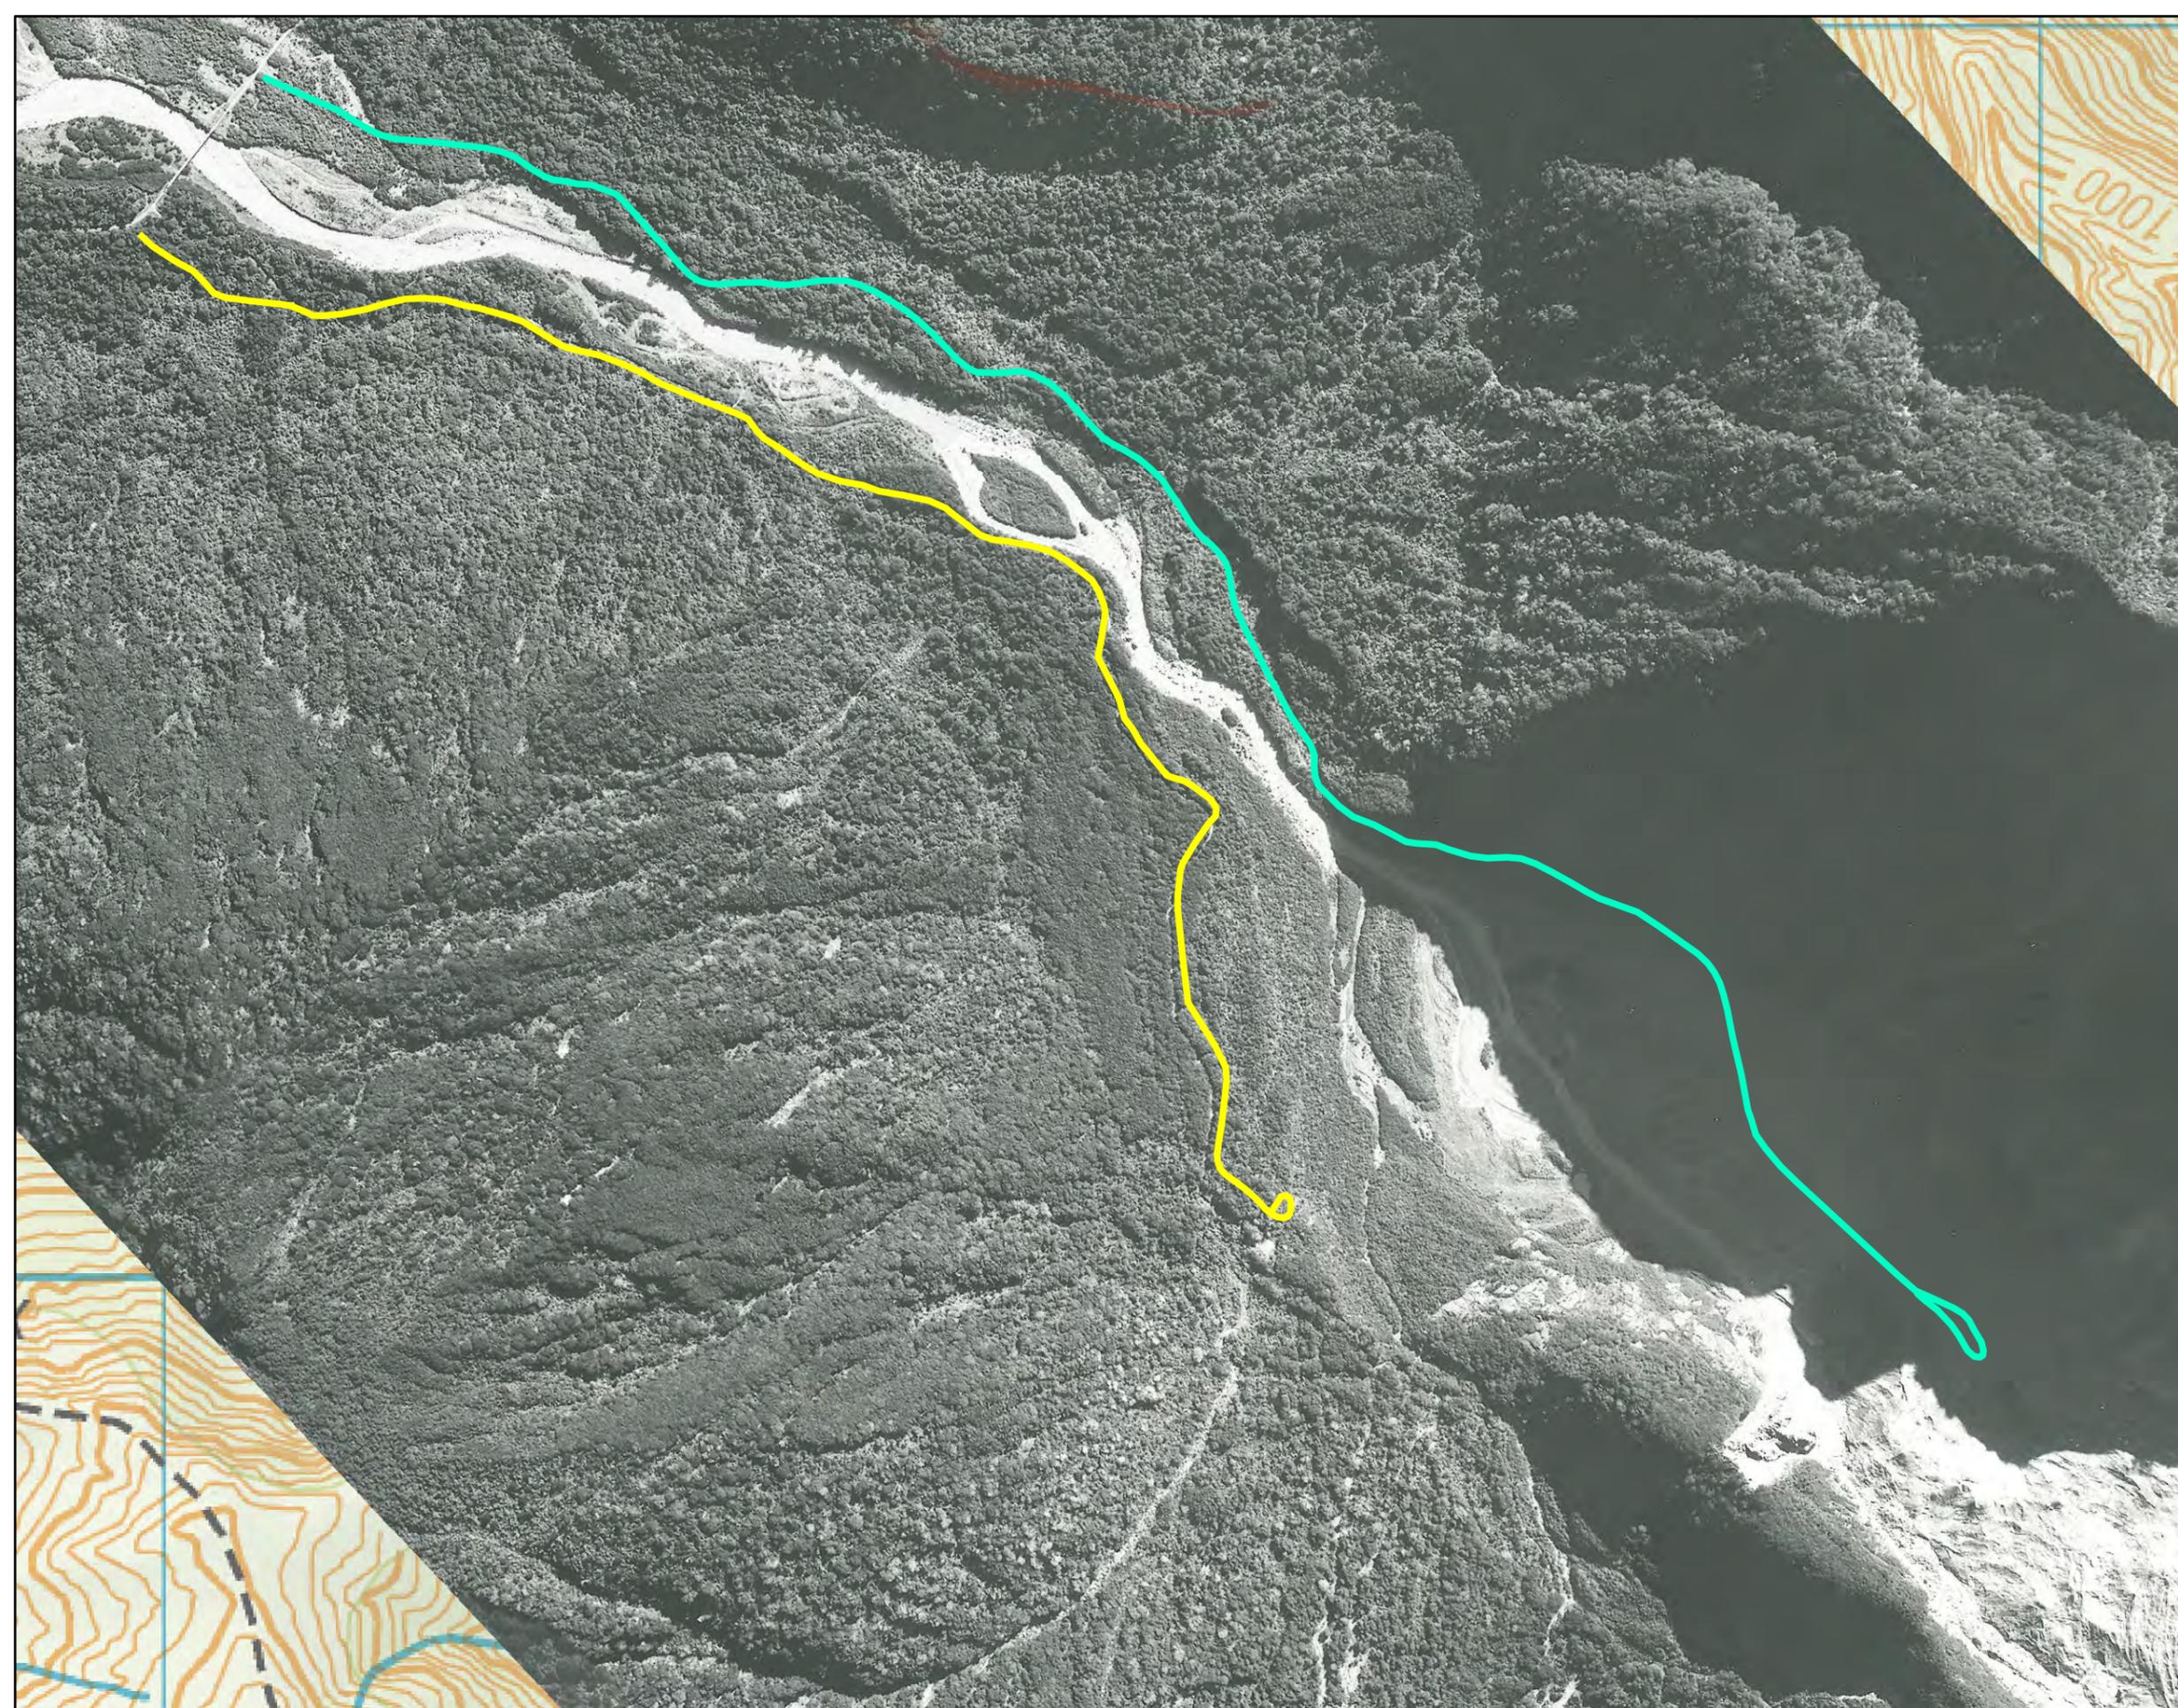
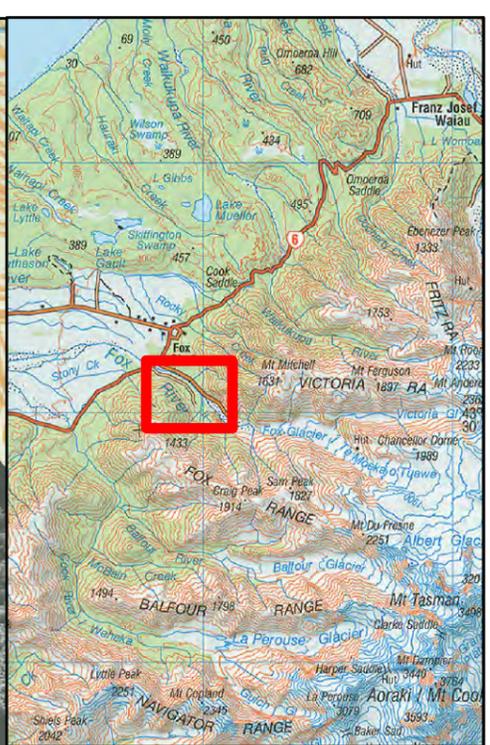
PLAN C6 - MAY 2019 - (LANDSAT SATELLITE 15M RESOLUTION)

This imagery is lower quality than the previous image, however shows the river alignment more clearly upstream, showing the complete destruction of the access road.
