**Cathedral Cove Basic Level  
Landslide Risk Assessment**

**Prepared for**  
Department of Conservation  
**Prepared by**  
Tonkin & Taylor Ltd  
**Date**  
July 2023  
**Job Number**  
1007838.3000 v3

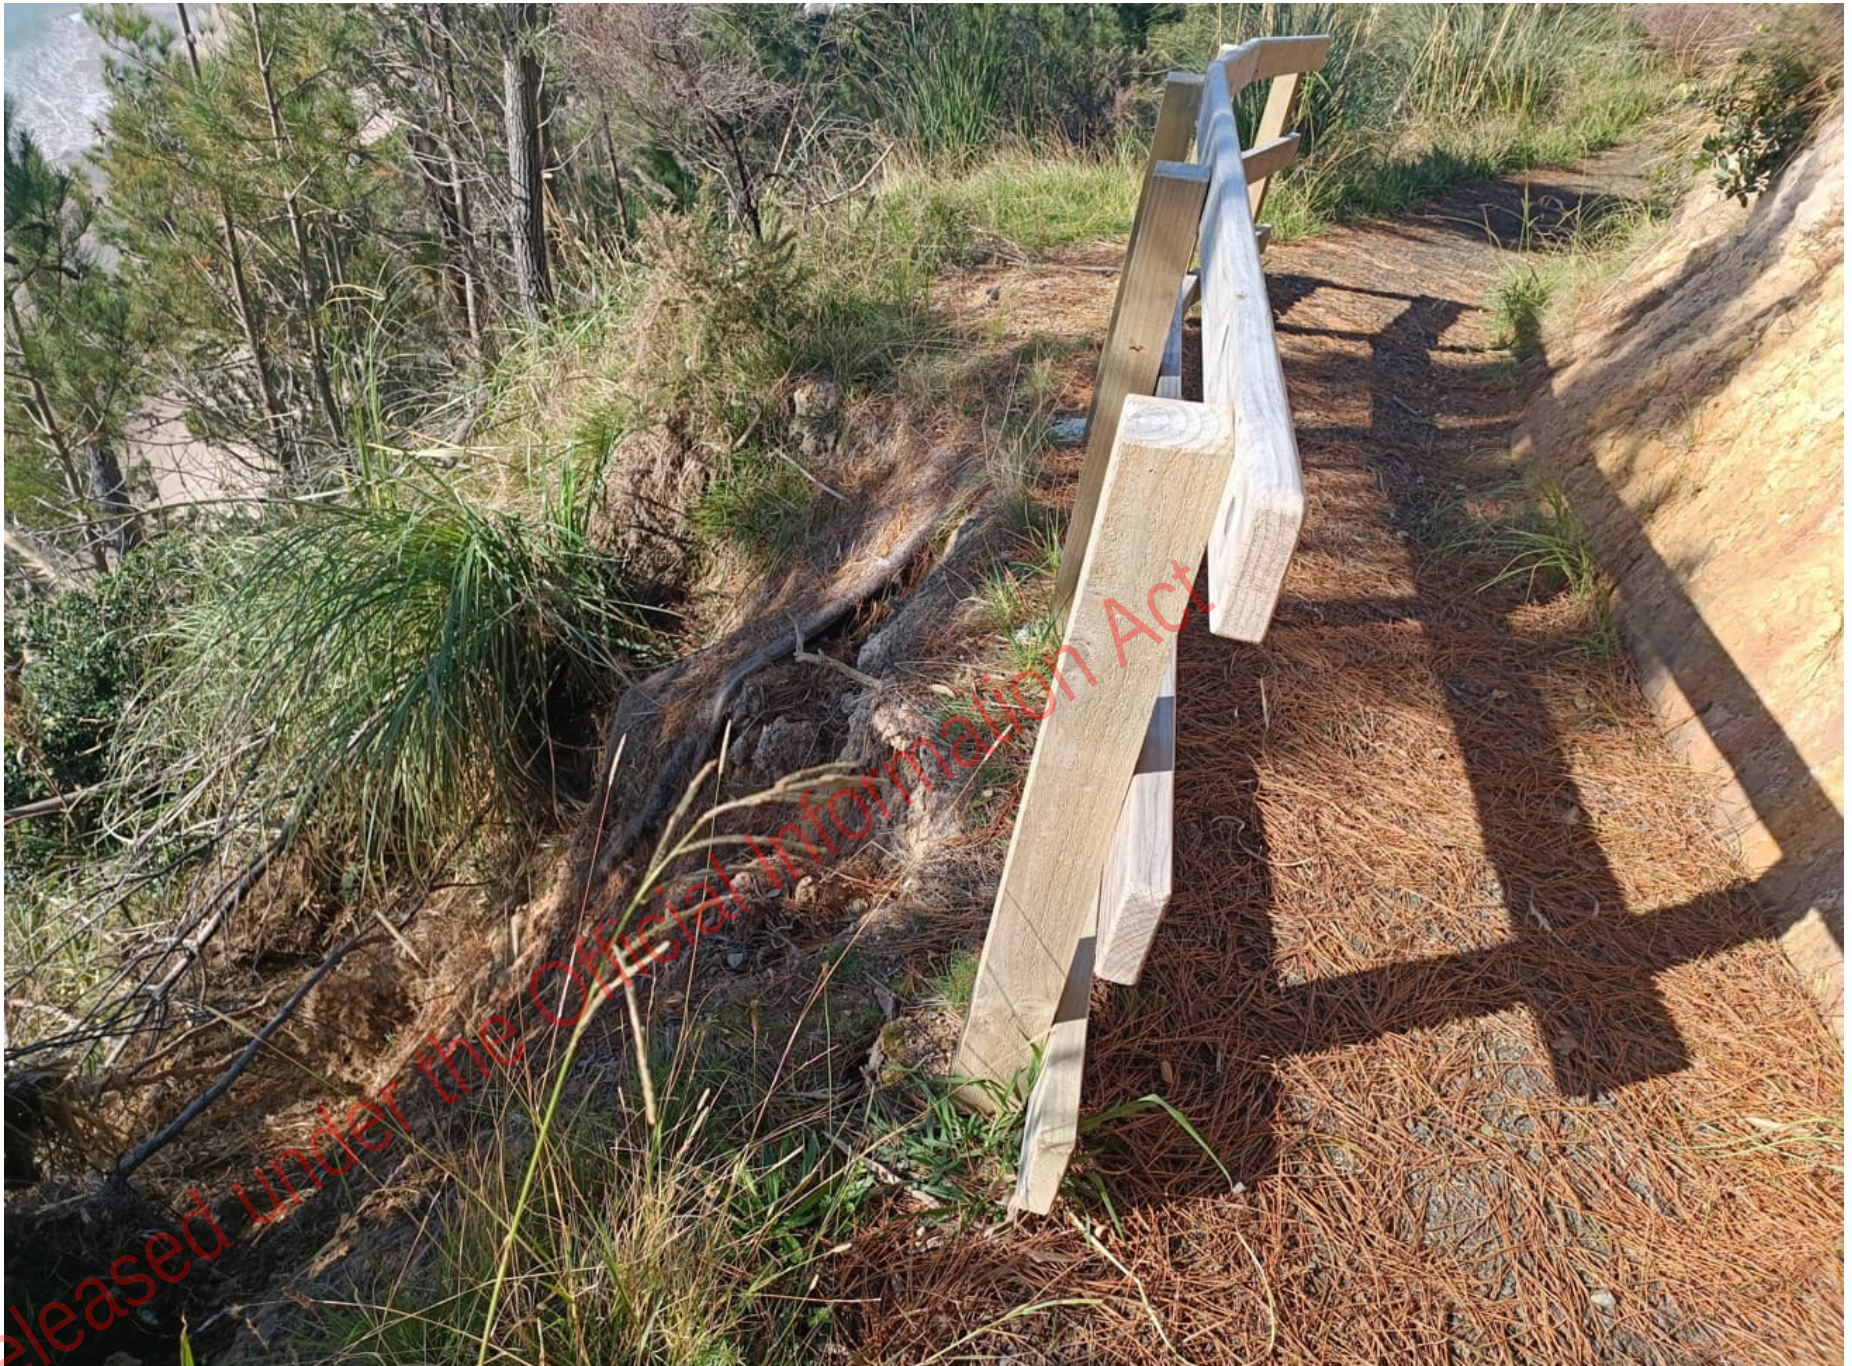
Figure C14 Landslide scarp close to Hahei Track

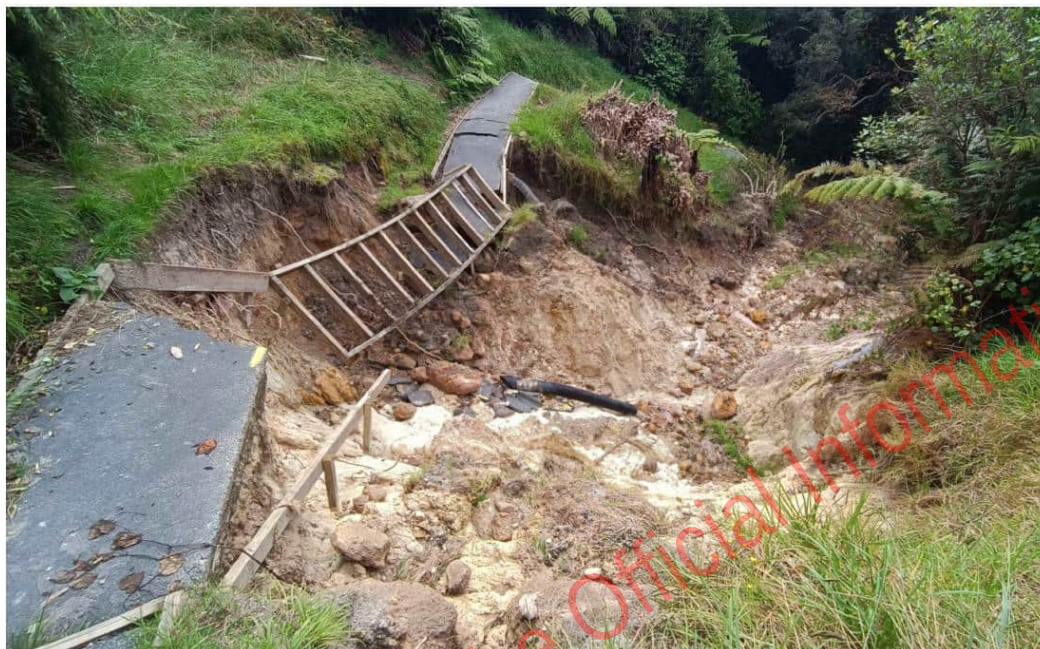
Figure 2.1: Cathedral Cove lower track landslide damage.

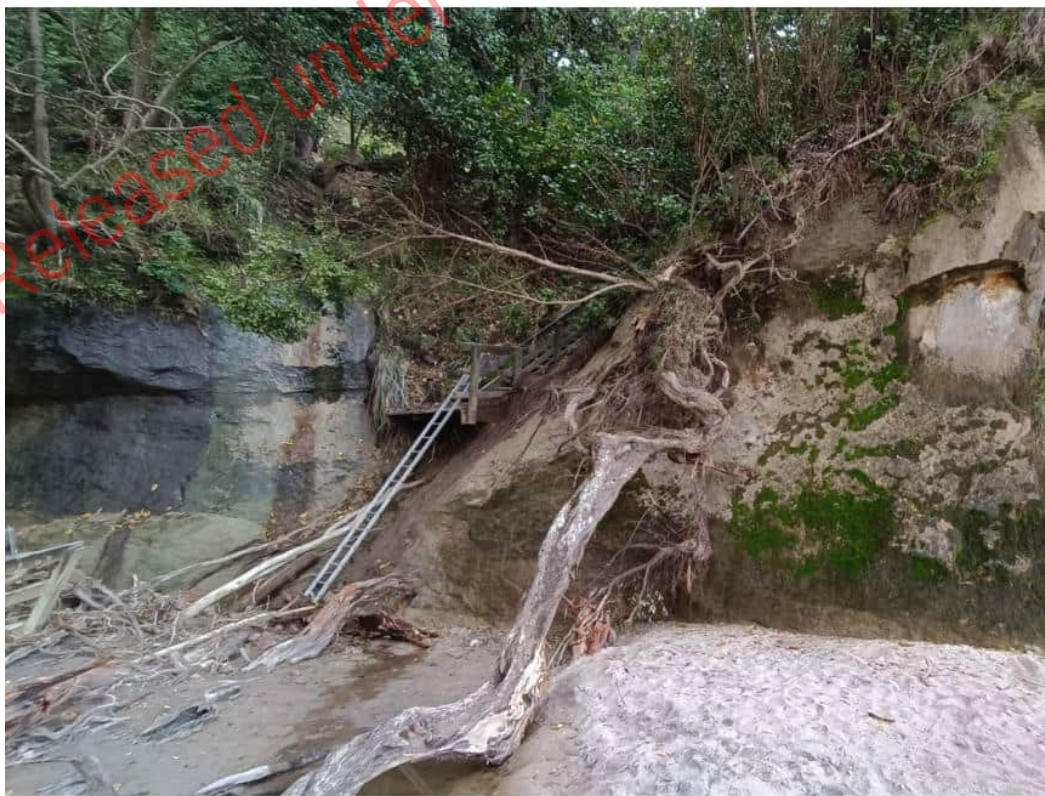
Figure 2.2: 2023 storm event destroyed the stair structure leading to Cathedral Cove Beach.

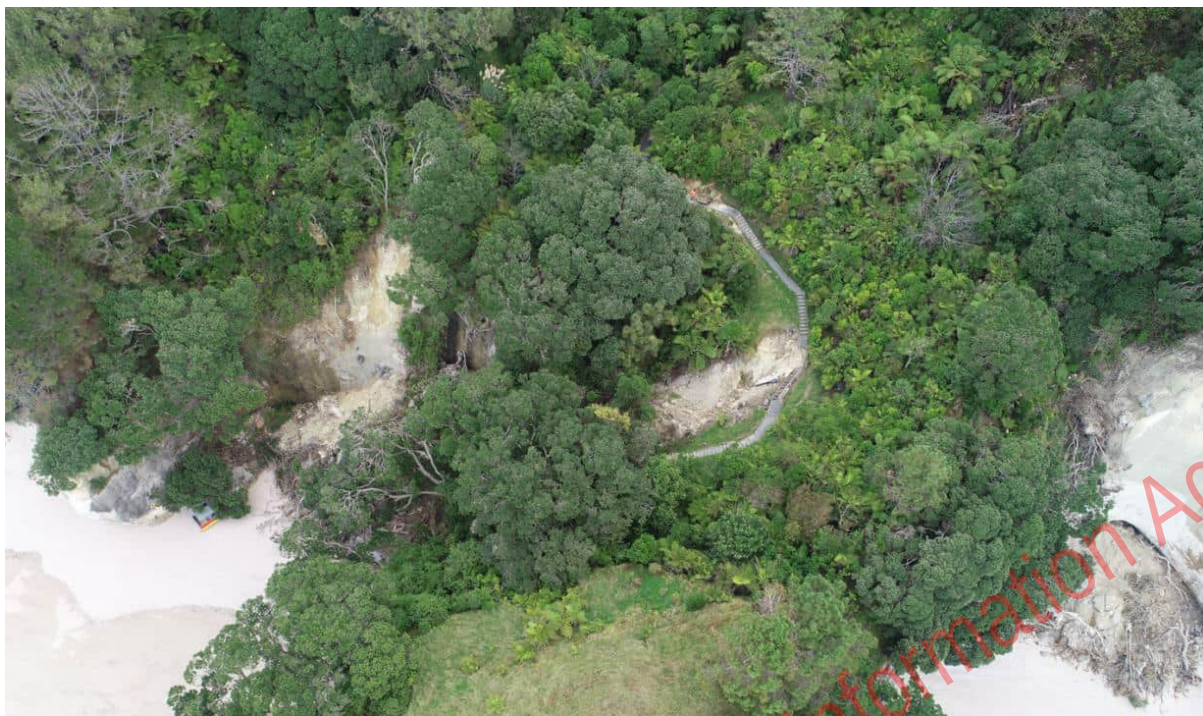
*Figure 2.3: Aerial view showing landslides and rockfall around the track.*
