Lessons Learnt 011

Floating fish ramp provides passage for inanga in Irongate Stream

May 2021 V 1

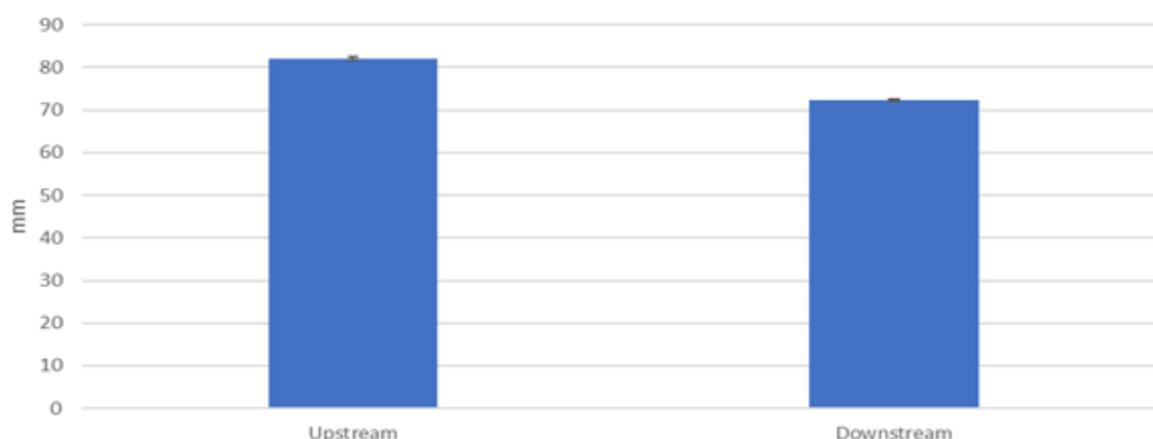
The higher abundances of inanga downstream relative to upstream reaches in the April 2019 survey (Table 1) suggest the ramp may still be acting as a partial barrier, and could be favouring larger inanga with stronger swimming abilities (Figures 2 & 3). Inanga caught in upstream reaches were on average 10 mm longer than in downstream subreaches (Figure 2), and inanga <70 mm were less abundant in upstream reaches relative to downstream reaches (Figure 3).

Figure 1. Average size (mm) of inanga upstream and downstream of the ramp in the second post-remediation monitoring, April 2019.

Post-remediation monitoring showed the sealed ramp had enabled passage for inanga, although the higher abundance and smaller average sizes in the downstream reaches suggest the ramp may still be acting as a partial barrier for smaller fish with reduced swimming ability. Interestingly, in lab trials for these ramps, and at a parallel study site in the Awanui Stream, Hawke's Bay, inanga size did not affect passage success (Fake 2018). In addition, post-remediation monitoring in the Awanui Stream found inanga abundance was similar upstream and downstream. Perhaps the highly aerated and turbulent plunge pool at the Irongate Stream site (Figure 1) posed additional challenges to fish attempting to locate and navigate the barrier. By comparison, the Awanui Stream barrier has a lower perch height and a less turbulent plunge pool.

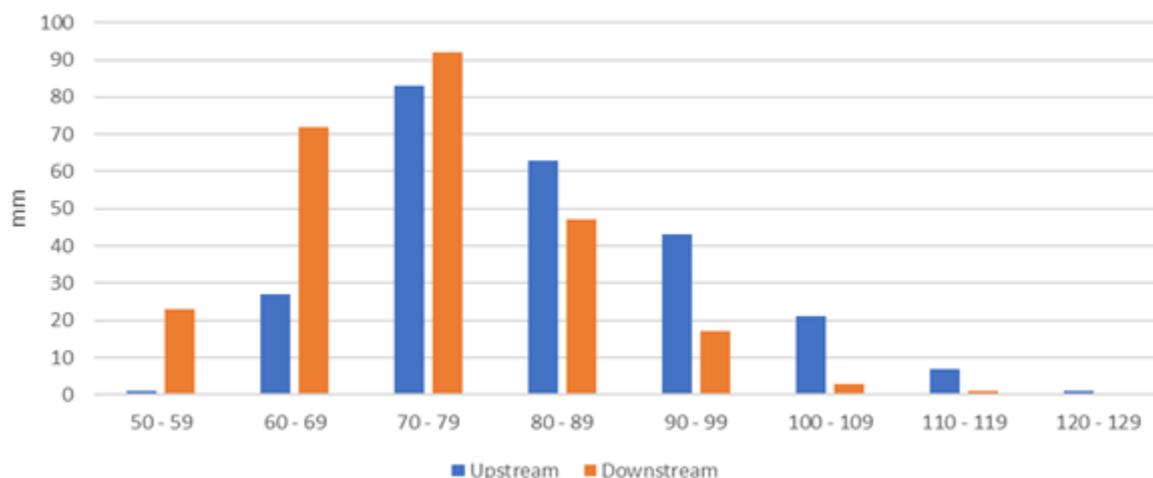
Figure 2. Size classes of inanga upstream and downstream of the ramp captured in the second post-remediation monitoring, April 2019.
