Ohau Snow Holdings Chairlift Application: Additional Information for Concession Variation Application 2018-19

Prepared by Rob Young, Te Manahuna Consulting, February 2019 for OSHL

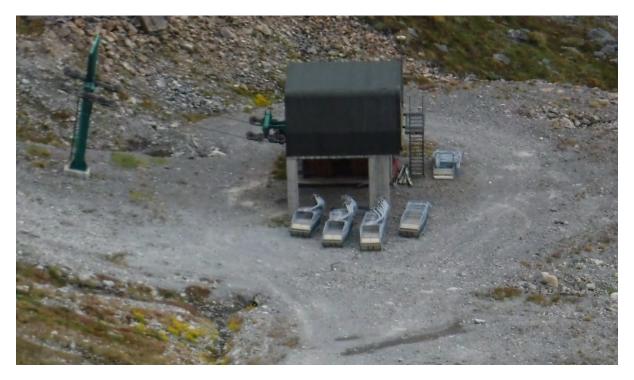
Figure 1: Existing drive station and base building.

The drive terminal and base facility will be constructed in a similar style as the existing chair. There will be four concrete footings, placed 2.1m deep which will be backfilled and landscaped to existing ground level. The excavation of the footings will be undertaken with a 1.8 tonne digger. The outside dimensions of the footings area will be 12 x 12m. Steel towers will be bolted to the footings and the drive station building constructed on a platform on top of these towers. The finished dimensions of the four towers will be 8.25 x 8.25m. The lift operators' shelter will be constructed under the platform and between two of the towers. The towers and buildings will be painted in the current colour scheme (Figure 1). The attached engineering drawings (Appendix 3: Engineering Drawings) provide the detail on this facility. The finished height of the drive terminal will be 6.8m.

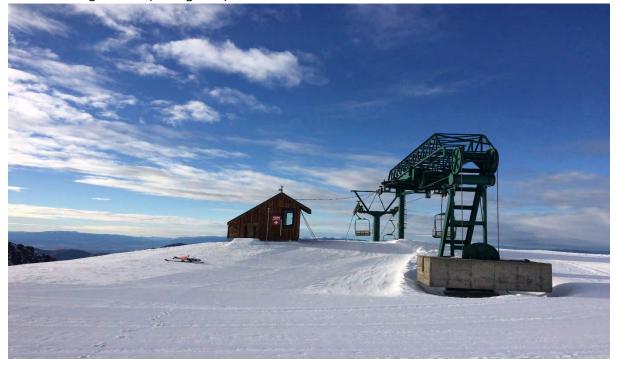
Figure 2: Existing return terminal and "Top Shack".

A small, but suitably engineered top lift station hut (<10m²) will be constructed in the vicinity of the return terminal for the lift operator and ski patrol. This building will be like the existing "top shack" on the existing chairlift (see Figure 2).

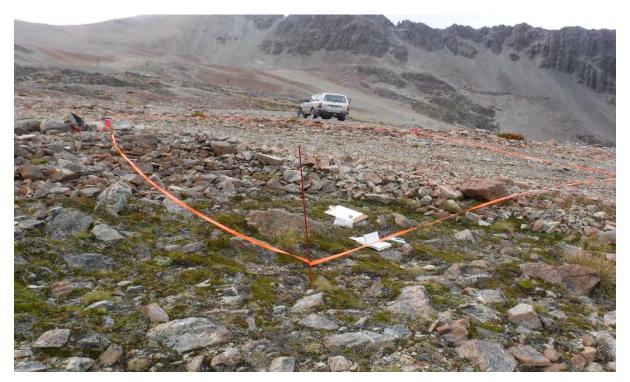
Figure 3: Base area – tape around the area of the disturbance.

The base site has a vegetation cover of approximately 10 per cent with 17 plant species present. The most dominant plant is *Dracophllum pronum*. Around 80 per cent of the site is already modified by the Sun Run trail works which were completed many years ago.

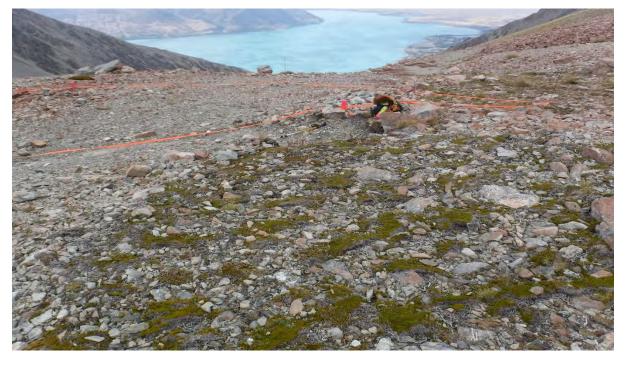
Figure 4: Base area – mostly modified ground.

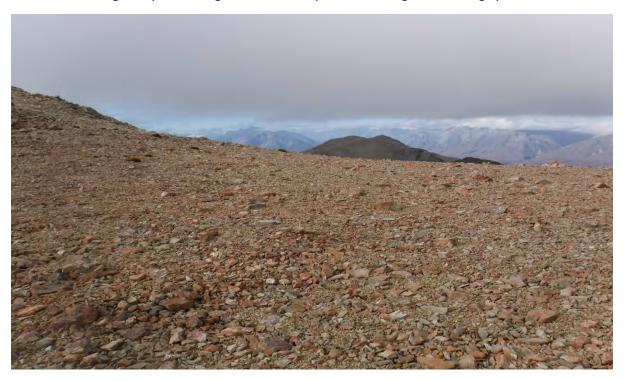
Figure 5: Top return terminal area – Tower 9 is just over lip.

The return terminal which is on the top of the ridge below peak 1980m is relatively barren site, covered in small to medium scree with a few scattered *Aciphylla dobsonii* plants, within or close to the area that is part of the footprint and disturbance area of the structure. The rock and scree in this location shows signs of patterned ground due to repeated freezing and thawing cycles.

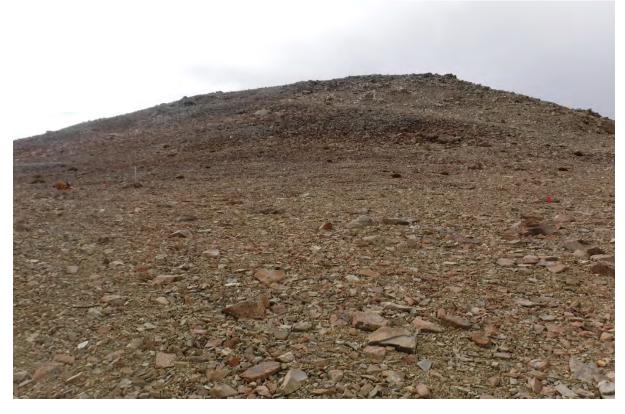
Figure 6: Top terminal return area – lift comes up from the right. Peak 1980m in background.

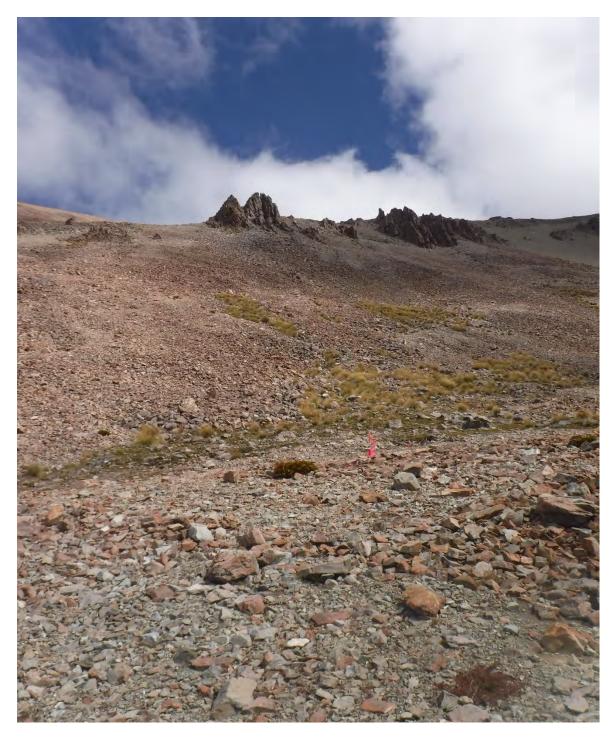
Figure 8: Tower 1 (at pink peg) - 40% vegetation cover.

The remaining four tower sites (see Figure 8: Tower 1 (at pink peg), Figure 9: Tower 2, Figure 12: Tower 5, Figure 13: Tower 6), have vegetation cover ranging from 20-50 per cent and between 15 and 20 different species at each site.

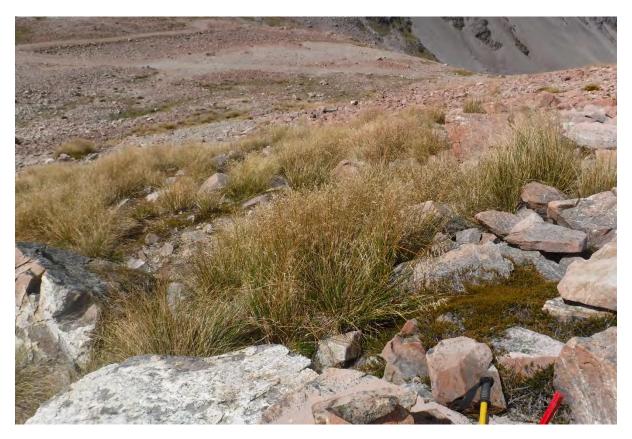
Figure 9: Tower 2 – 50% vegetation cover.

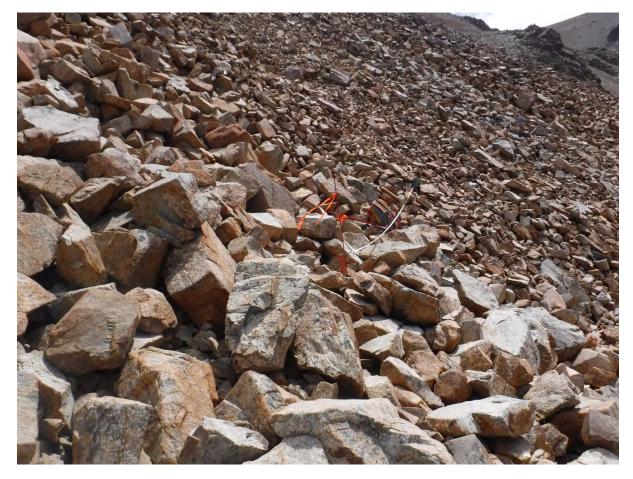
Figure 10: Tower 3 - 0% vegetation cover.

Three of the tower sites (see Figure 10: Tower 3, Figure 11: Tower 4, Figure 15: Tower 8), have no vegetation within the area of the foundations or the area which will be disturbed or modified during construction. The surface is either medium size to large rock and scree. A further two sites (see Figure 14:Tower 7, Figure 16: Tower 9), have less than 5 per cent vegetation cover with similar type of scree cover over the rest of the site.

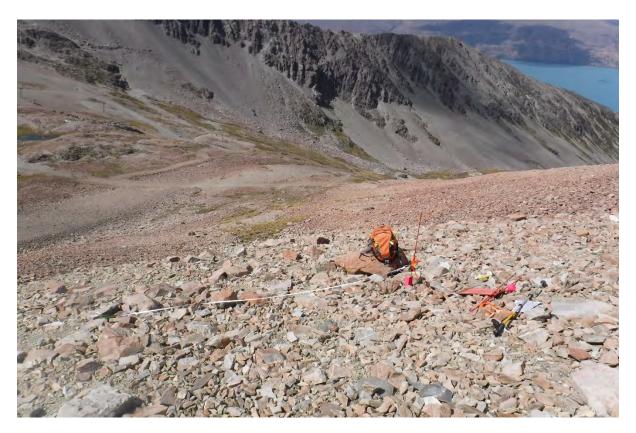
Figure 11: Tower 4 - 0% vegetation cover.

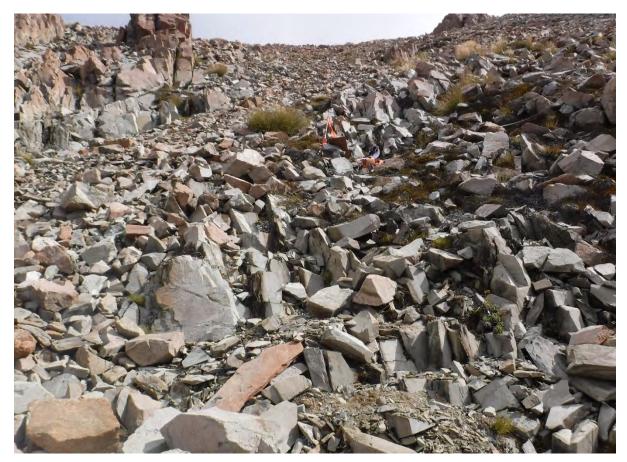
Figure 12: Tower 5 - 25% vegetation cover.

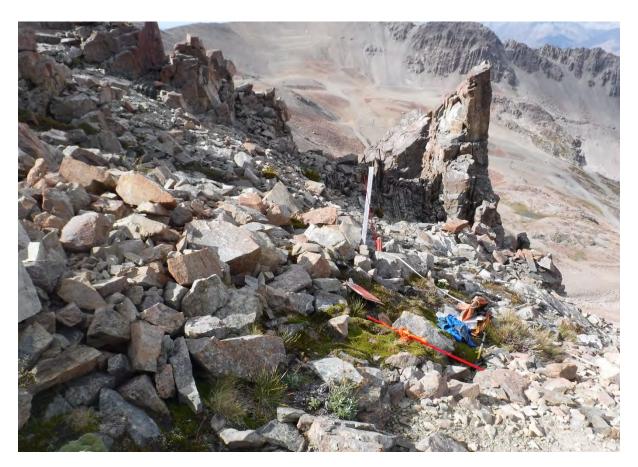
Figure 13: Tower 6 - 20% vegetation cover.

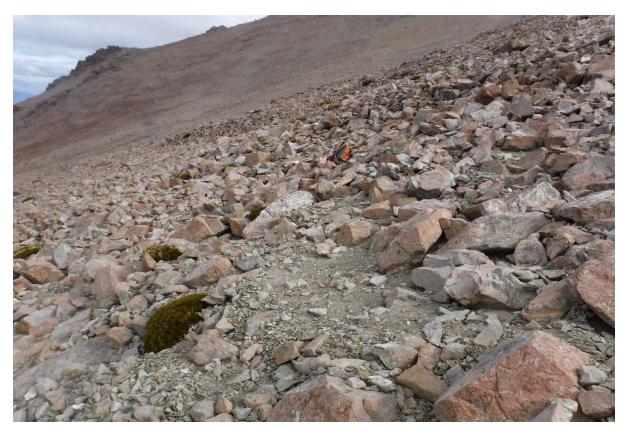
Figure 14:Tower 7 - < 5% vegetation cover.

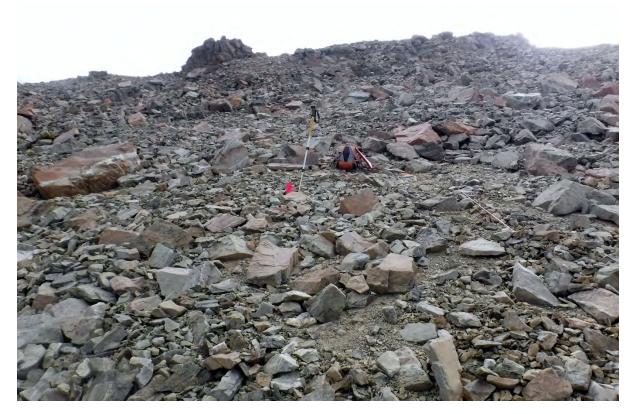
Figure 15: Tower 8 - 0% vegetation cover.

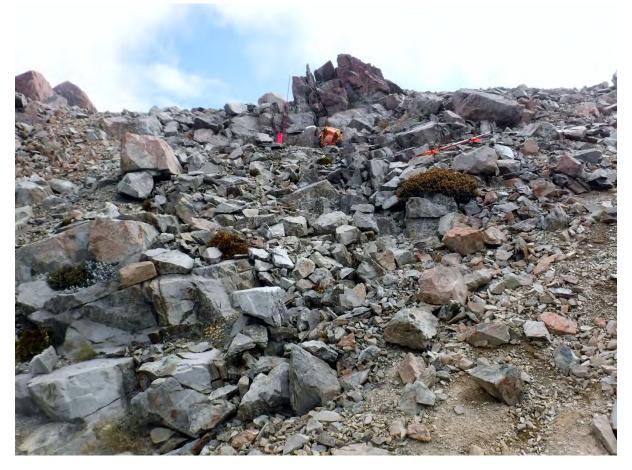
Figure 16: Tower 9 - < 5% vegetation cover.
