Milford Opportunities

# CRITICAL STRUCTURES FOR WALKING AND CYCLING CONSTRUCTION FEASIBILITY

03 APRIL 2024

## CRITICAL STRUCTURES FOR WALKING AND CYCLING – CONSTRUCTION FEASIBILITY

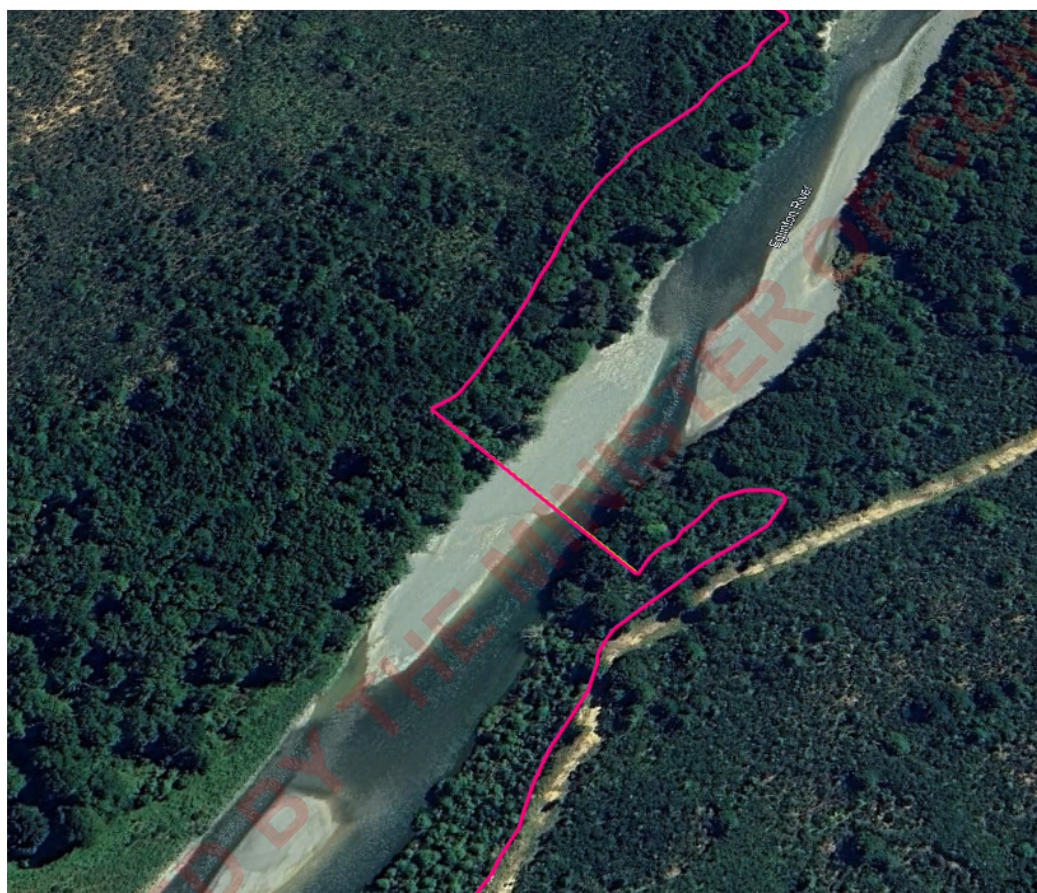
Southern Land has identified a site on the Cycle Trail, Option 1 for a suspension bridge to cross the Lower Upokororo Eglinton River. As shown in Figure 1. The site is approximately 2.4 to 2.5km from the mouth of the Upokororo Eglinton River where it flows into Te Ana-au Lake Te Anau.

Figure 1 – Aerial view of proposed site for the Lower Upokororo Eglinton Suspension Bridge (source Southern Land Report)

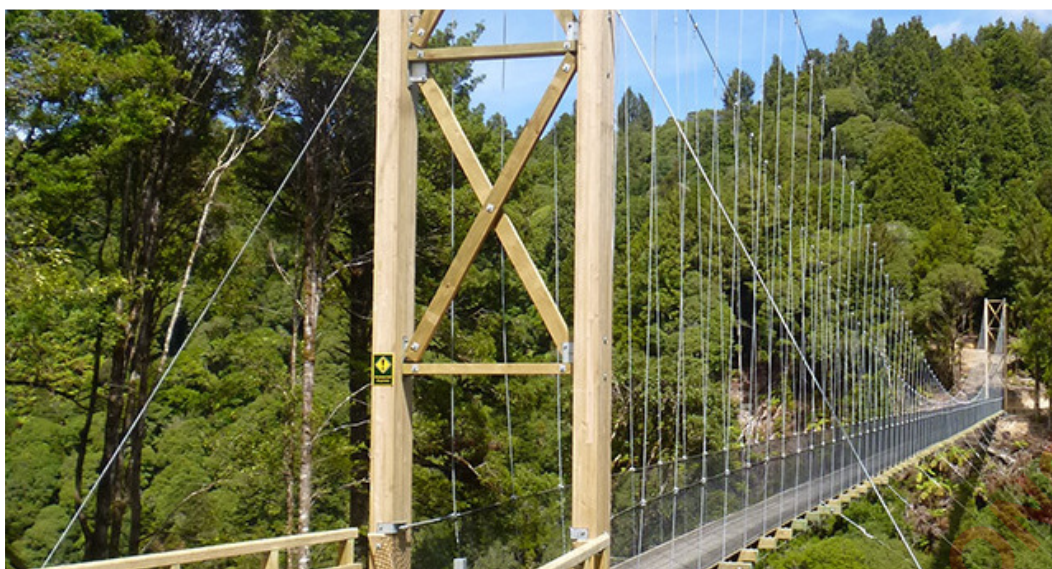
The span of the bridge identified by Southern land is 125m. This is a significant span but is achievable. The Timber Trail in the Pureora Forest Park has a cycleway suspension bridge spanning 140m (Maramataha Bridge). See Figure 2. A suspension bridge is well suited to this span and the site.

Figure 2 – Timber Trail – Maramataha Bridge – 140m (source: Timber Trail website)

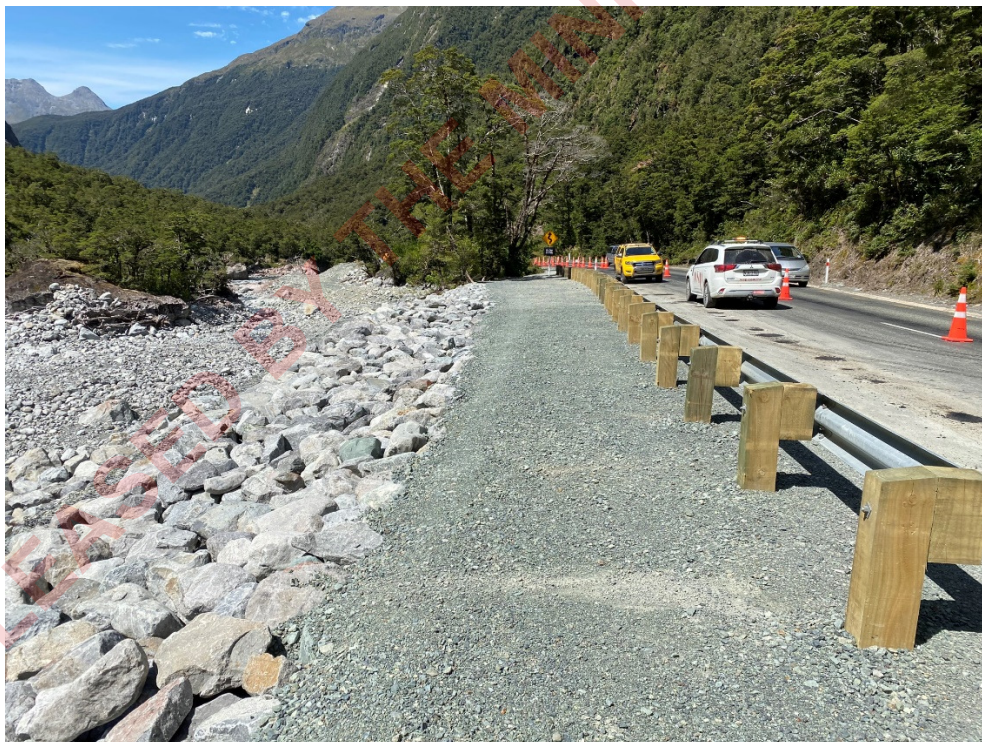
Rock armouring and revetment has been placed at numerous locations along State Highway 94-Milford Road to protect the road from scour with successful outcomes. See Figure 7.

Figure 7 – Red Slip rock armouring (Source: WSP)

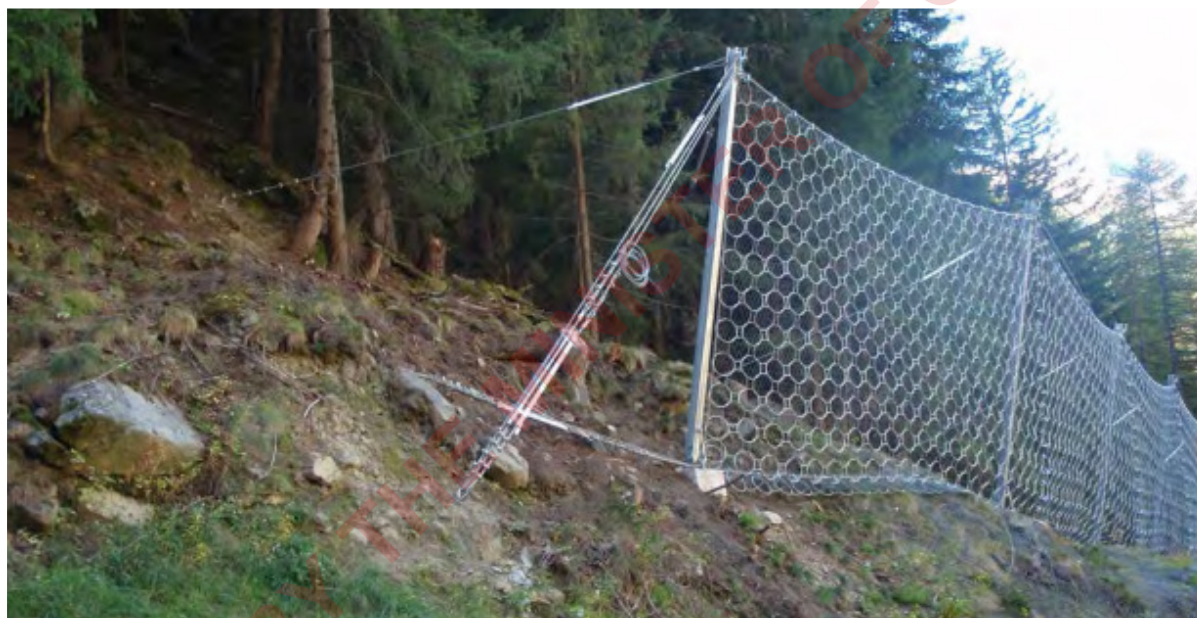
Providing protection to the cyclists from potential rockfall should be considered. The installation of a rockfall fence, like that shown in Figure 8, is considered necessary.

Figure 8 – An example of suitable rockfall fence protection (Source: MBIE website).

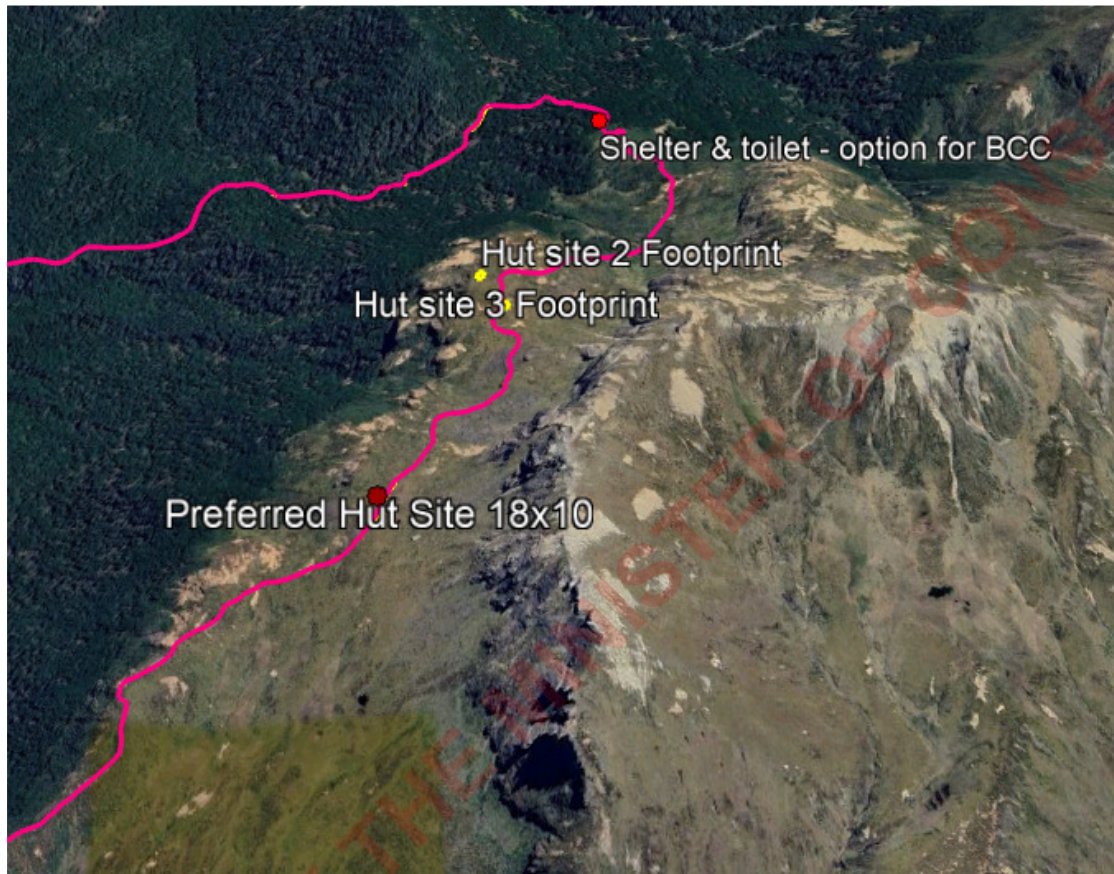
The Southern Land Report includes options for the construction of an alpine hut on the Countess Range offering an overnight tramping experience. The elevation of the proposed site is at approximately 1200m and is above the bush line. Figure 12 shows three possible hut sites that all have similar challenges. At the detailed design stage only one site will be chosen.

Figure 12 – Countess Range proposed hut locations (Source: Southern Land Report)

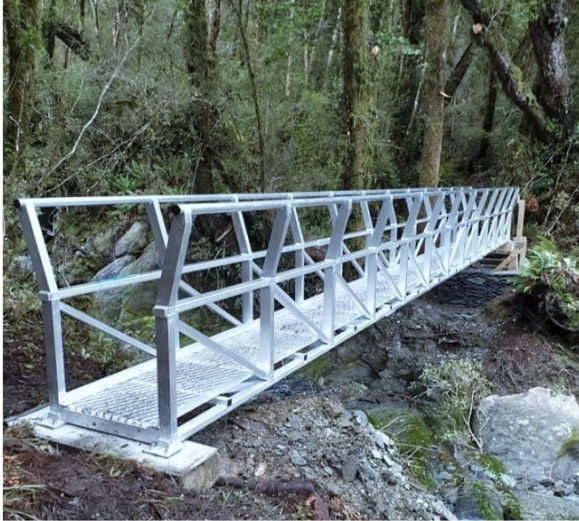
Pedestrian bridges with a single span of approximately 16 metres are widely used, offering numerous design alternatives. Among these, aluminium truss bridges are increasingly popular for such applications, favoured for their durable materials and lightweight construction. The advantage of a lightweight bridge is that it can be prefabricated offsite and then airlifted to its destination by helicopter, where it can be easily installed on straightforward timber pile and timber capping beam abutments. If heavy decking planks are chosen, they can be installed when the main span is in place. See Figure 16 and Figure 17 for examples.

Figure 16 – Aluminium pedestrian bridge.  
(Source: Monkeytoe website).

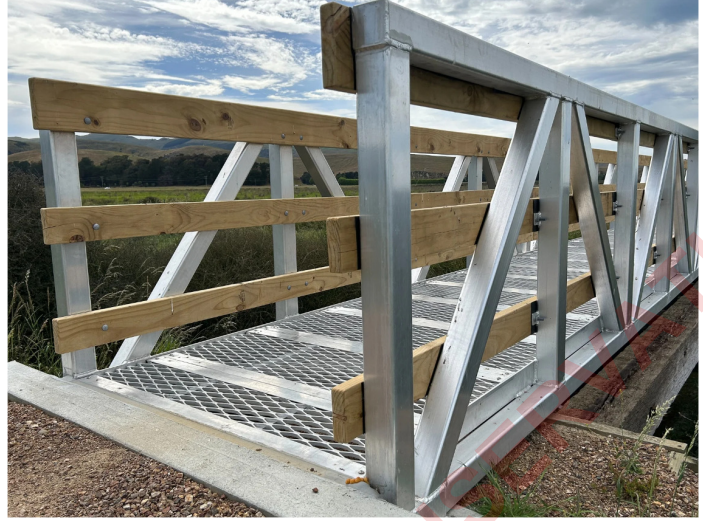
Figure 17 – Aluminium pedestrian bridge with timber railing to improve the aesthetic. (Source: Monkeytoe website).

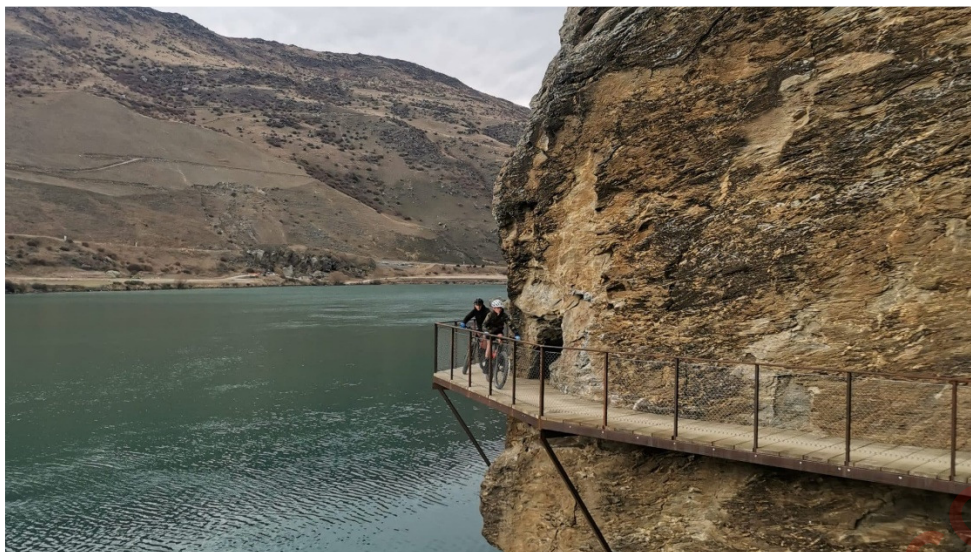
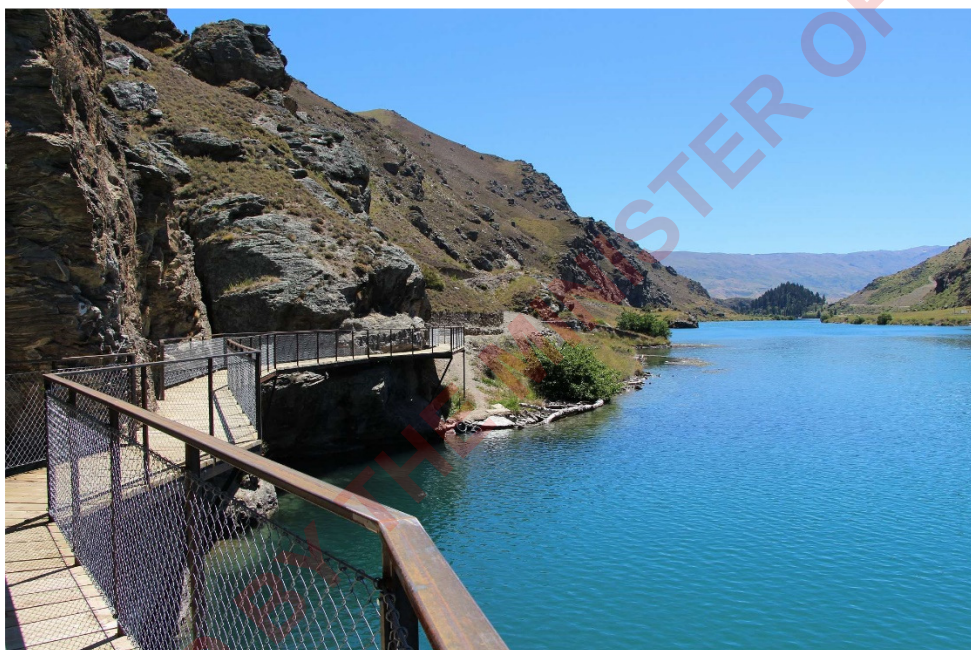
More recently, the Dunstan Trail, which was constructed in 2021, has gantries that provide cycling access around bluffs alongside Lake Dunstan, as shown in Figure 24 and Figure 25.

Figure 24 - Gantry on Dunstan Trail (source: Dunstan Trail website).

Figure 25 - Gantry on Dunstan Trail (source: Dunstan Trail website).

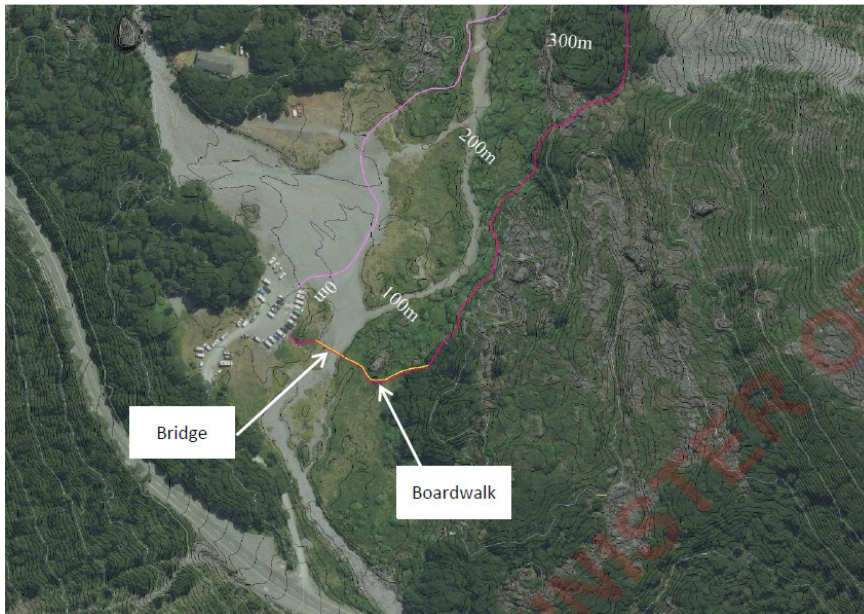
Southern Land has completed the initial scoping of a short walk at the Homer Hut in the Gertrude Valley. A bridge that is approximately 16-18m in length is proposed to cross an area of alluvium that is subject to overland flow during rainfall. The bridge will have several short spans (4-6m) and multiple piers. The walking route to access the walkway path beyond the alluvium is currently unclear to users and a bridge(s) and adjacent boardwalk will provide a clear and designated route across the shingle. See Figure 27 and Figure 28.

Figure 27 - Whakatipu-ka-tuku Hollyford River Bridge at Homer Hut (Source: Southern Land)

Figure 28 - Whakatipu-ka-tuku Hollyford River Bridge at Homer Hut (Source: Southern Land)

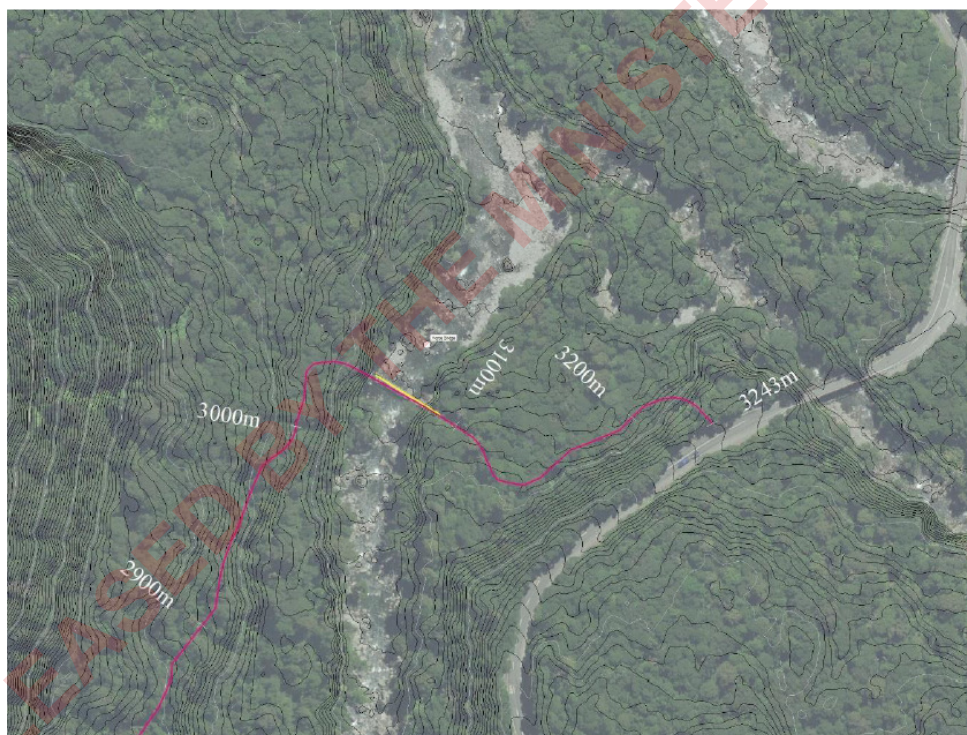
Stantec has provided DOC a Condition Assessment for the bridge titled "*Cledau Horse Bridge Condition Assessment - July 2022*". The assessment confirms that the bridge is in a significant state of disrepair and that damage has occurred at the true right side due to the presence of a large standing wave coming into contact with the bridge during flood events. The standing wave was caused by the presence of a large boulder located in the riverbed, and it is our understanding that this boulder has subsequently been removed. Other condition issues are due to the significant deterioration of the bridge elements over time. See Figure 31 and Figure 32.

Figure 31 – Horse Bridge site (Source: Southern Land)

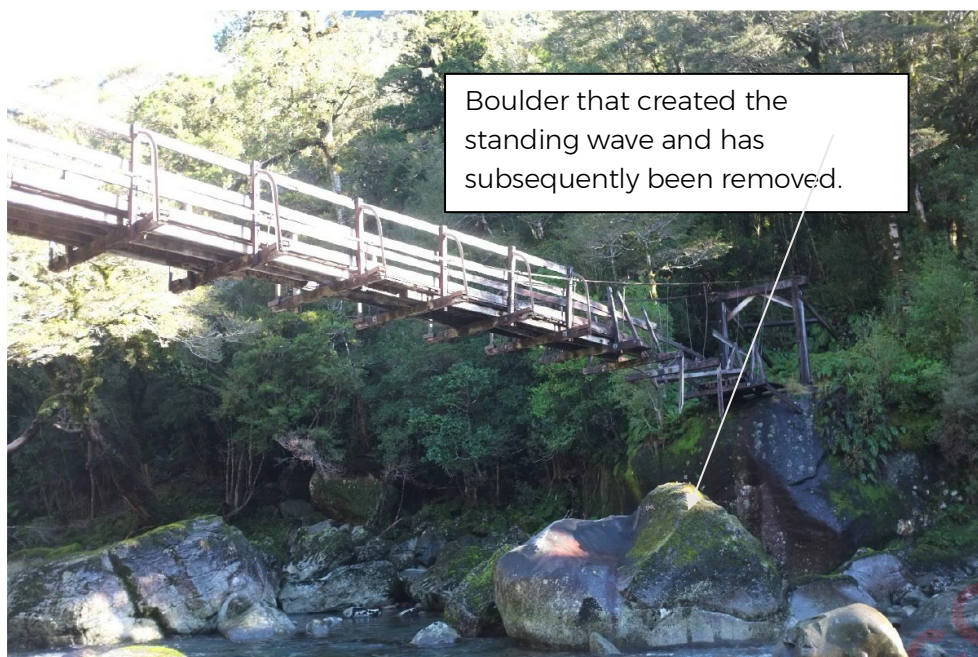
Figure 32 – Horse Bridge (Source: Stantec “Cleddau Horse Bridge Condition Assessment - July 2022”)

The existing Horse Bridge is in a poor state as confirmed by the Stantec Report Condition Assessment. It is considered that no items from the current bridge are suitable for use in a new, upgraded or strengthened bridge. A new bridge is necessary. A new bridge could be located at the current bridge site or nearby.

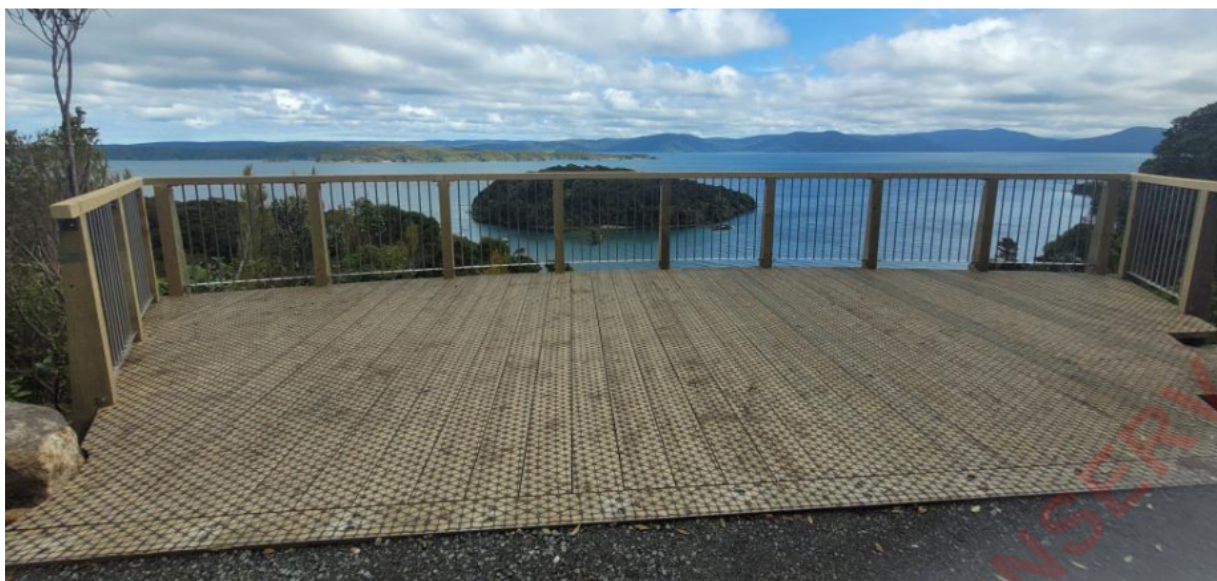
Figure 34 – Observation Rock, Stewart Island (Source: Otago Daily Times)

There are numerous examples of viewing platforms and stairs on back country walks, as shown in Figure 34 and Figure 35. The site has shallow topsoils and vegetation root mass over bedrock and the structure's foundations will require rock anchors. The preferred foundations are rock anchors embedded in reinforced concrete plinths to provide long term durability.

There are numerous examples of viewing platforms and stairs on back country walks, as shown in Figure 34 and Figure 35 of Section 2.13.1. The sites have river delta material, shallow topsoils and vegetation root mass over bedrock. The structure's foundations will include shallow piles on the delta and likely require rock anchors on the rock faces. The preferred foundations for the rock anchors will include embedded anchors within reinforced concrete plinths to provide long term durability.

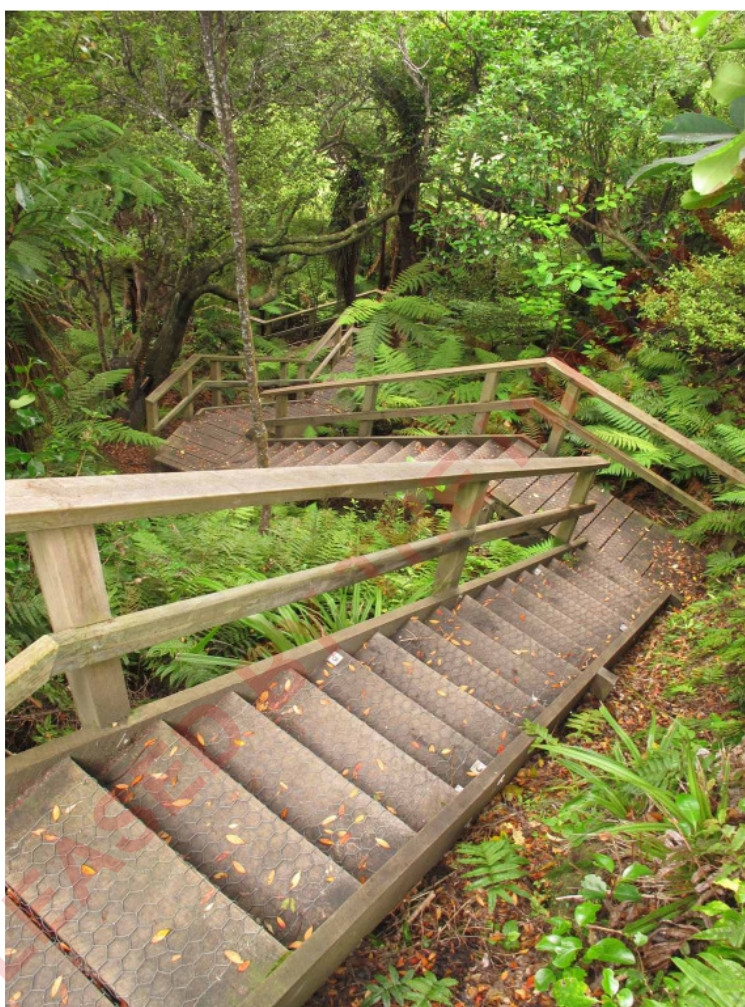
Figure 35 – Millenium Track, Bluff (Source: NZ Frenzy South Island website)

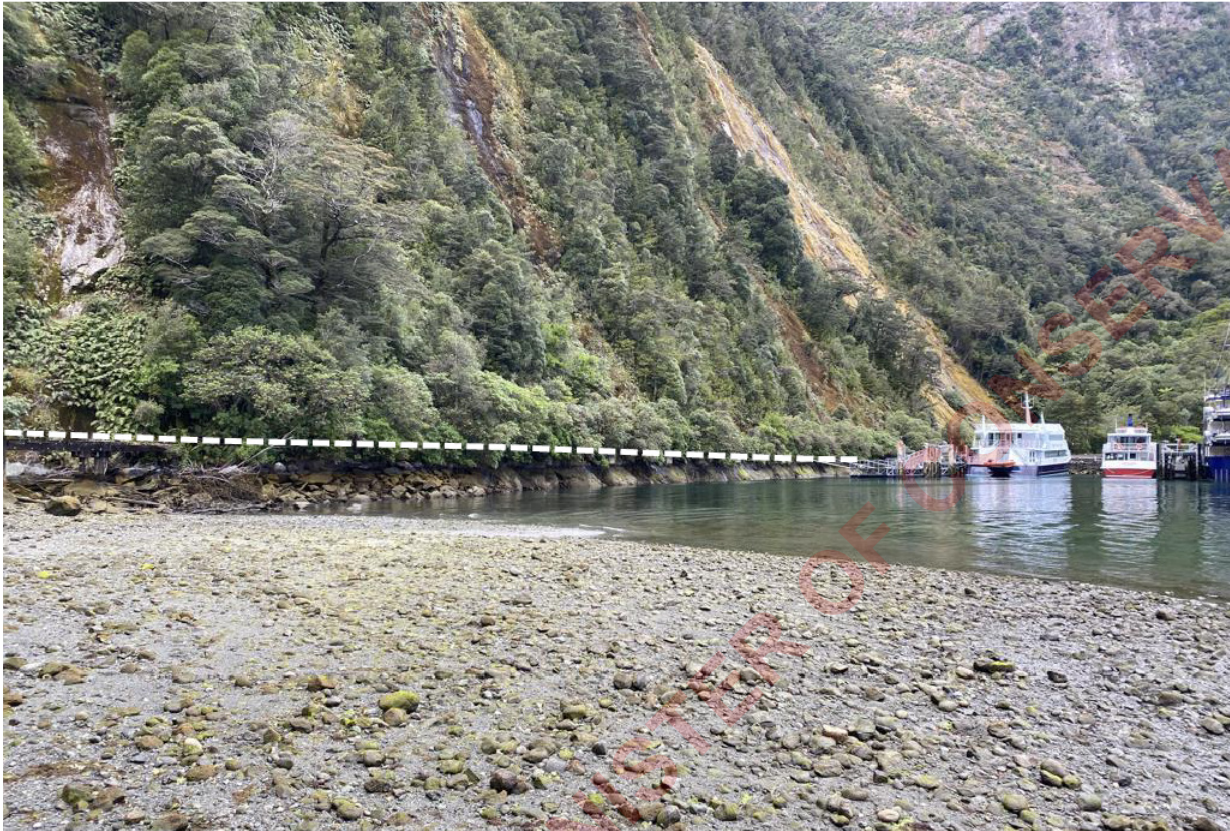
Figure 36 – Location of previous gantry – now removed.

Access to the Lower Hine-te-awa Bowen Falls walking track currently requires visitors to be transported by boat across a short distance from the Freshwater Basin vessel berthing area. The previous timber gantry walkway access across the face of the bluff has been removed due to rockfall damage to the gantry and the unacceptable risk to the users. See the route of the former gantry in Figure 36.

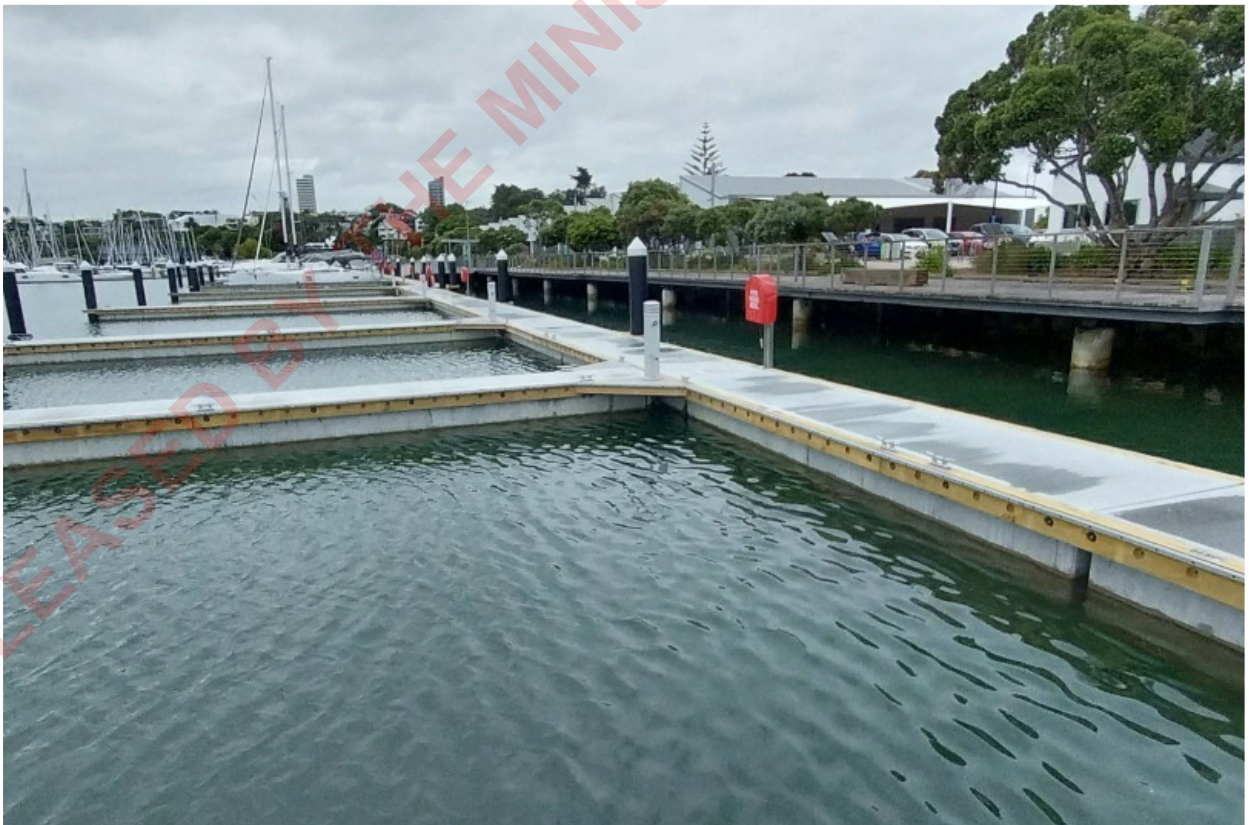
Figure 38 - Westhaven Marina Auckland - pontoon walkway without handrailing

A pontoon with appropriate separation distance from the bluff along with a roof is the preferred option. Pontoons are common in a marina setting and the design could be altered for the Milford Sound Piopiotahi location with wider boardwalks and handrails, as shown in Figure 38 and Figure 39. Landspan ramps would be necessary at each to accommodate tidal variation.

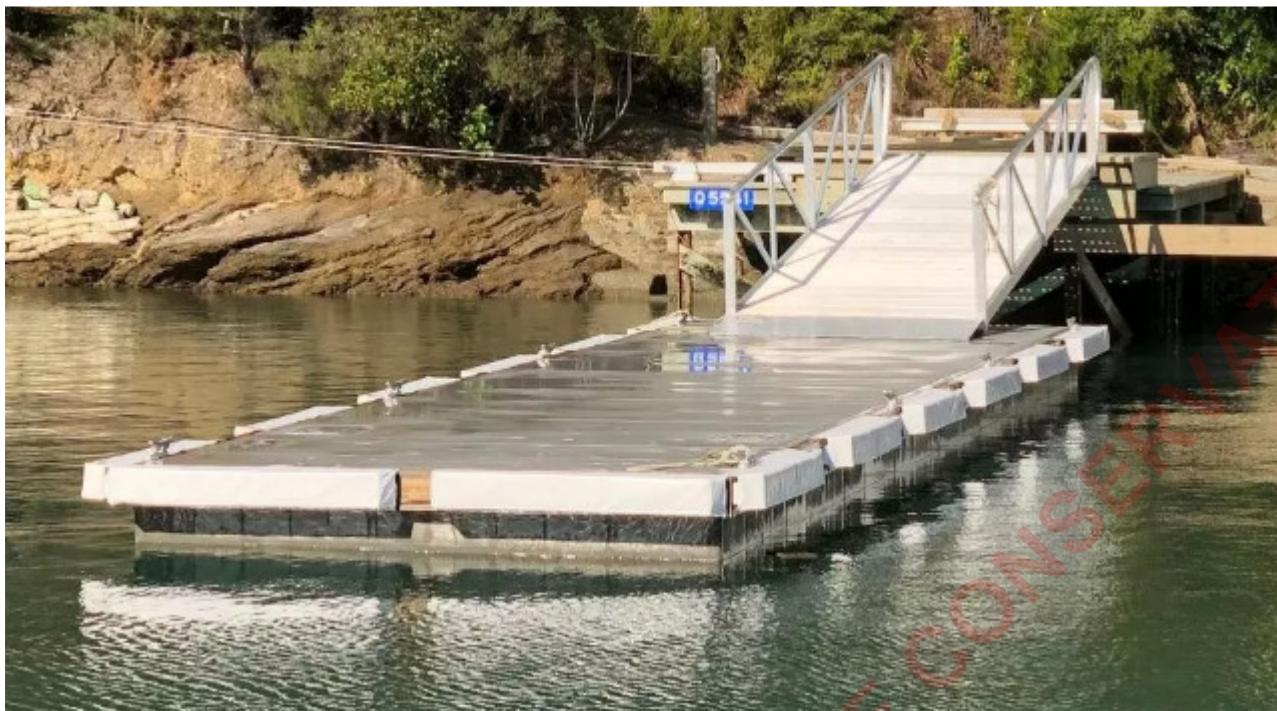
Figure 39 - Pontoon with Landspan ramp (Source: Marine Services Ltd)
