Appropriate use of mussel spat ropes to facilitate passage for stream organisms

For:
Waikato Regional Council
Private Bag 3038
Waikato Mail Centre
HAMILTON 3240

March 2014

Document #: 1990455

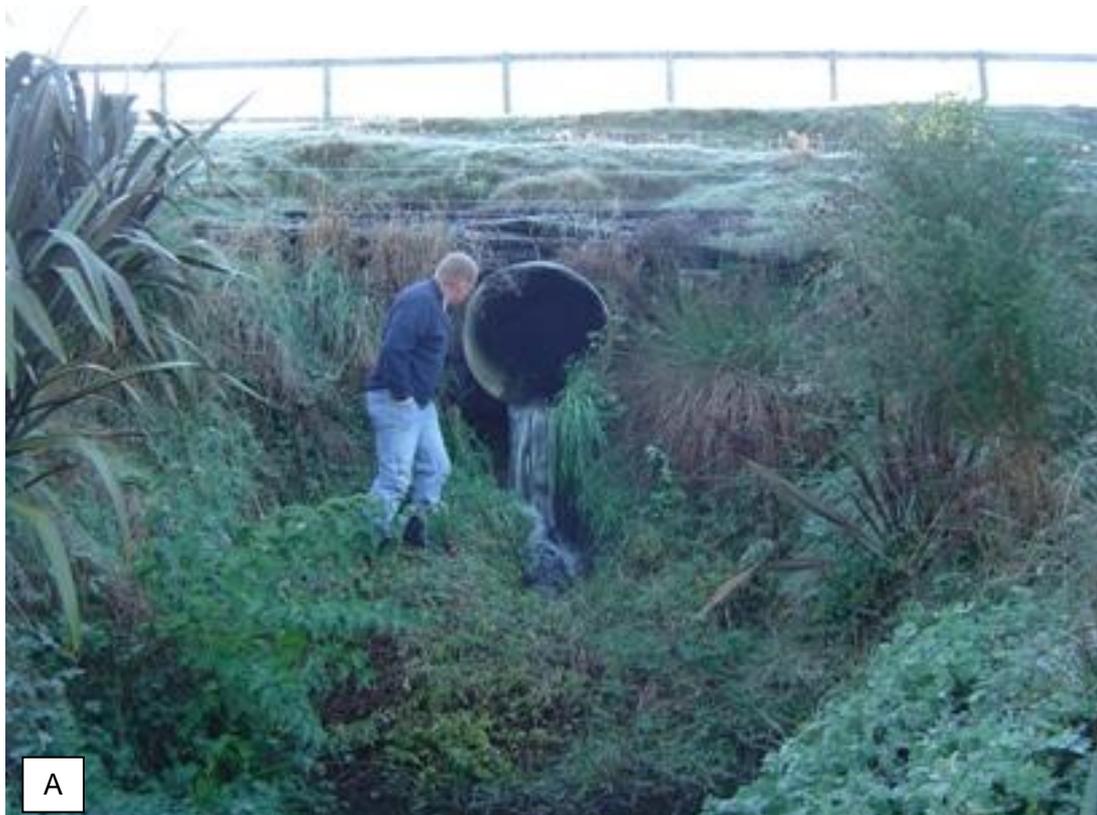
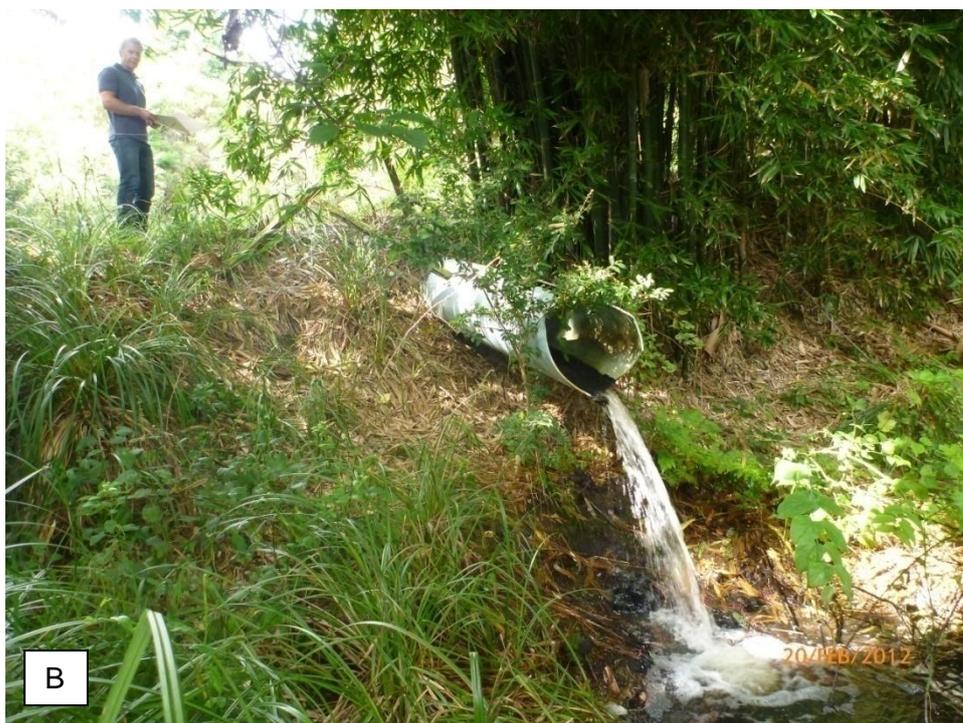
Figure 1: A,B. Poorly installed culverts on a tributary of the Mangakotukutuku stream in urban Hamilton. In the lower example a perch height in excess of 1m combined with a 12m pipe length and pipe gradient in excess of 10 makes this a formidable barrier to even the most aggressive upstream climbing species.

Over time the distance between the pipe outlet and the streambed below can increase creating a free flowing chute of water from the culvert lip to the stream below. Even if a fish is able to leap the vertical distance necessary to reach the pipe outlet, the fish then needs to negotiate the pipe itself where pipe length, gradient and laminar flows will

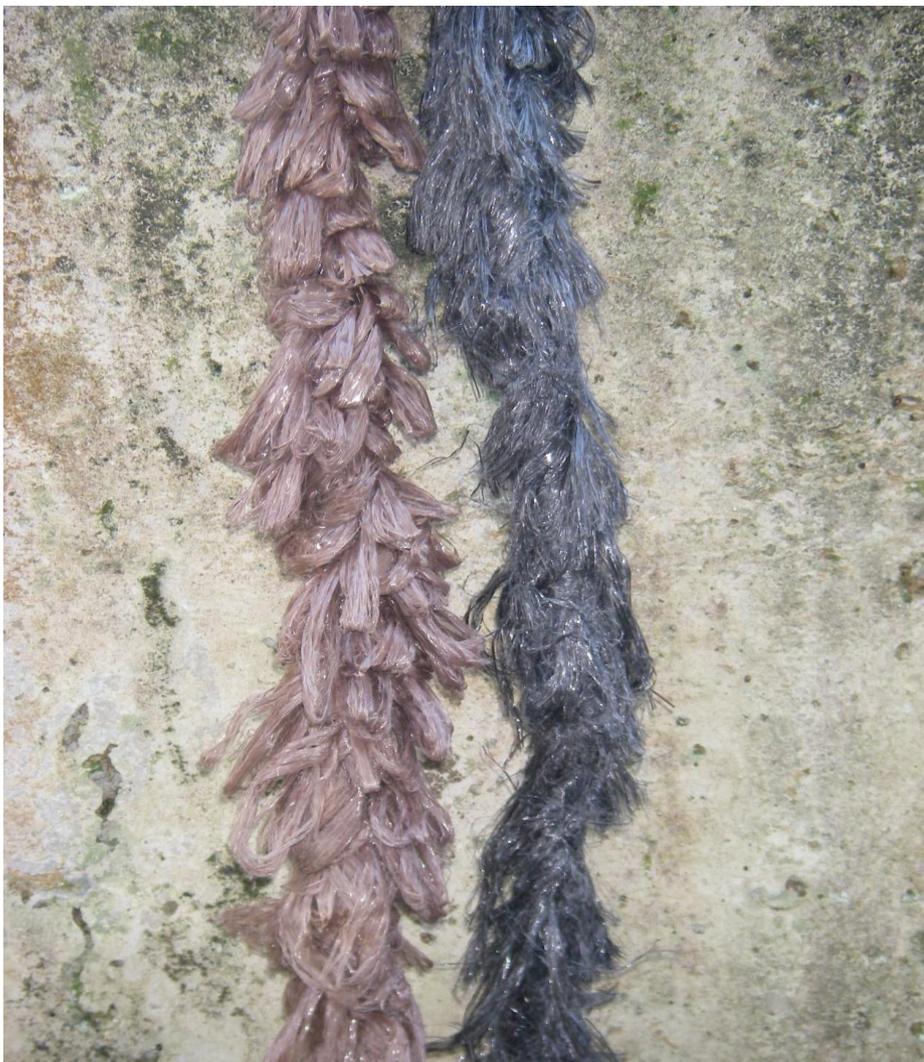
Figure 2: Example of Russet loop (left) and Super Xmas tree (right) mussel spat rope.

Russet loop type rope is not advised for use within the culvert barrel as the loops may be prone to trap sticks and debris and hence influence culvert capacity. For use within the barrel we suggest use of non-looped ropes such as the Super Xmas tree.

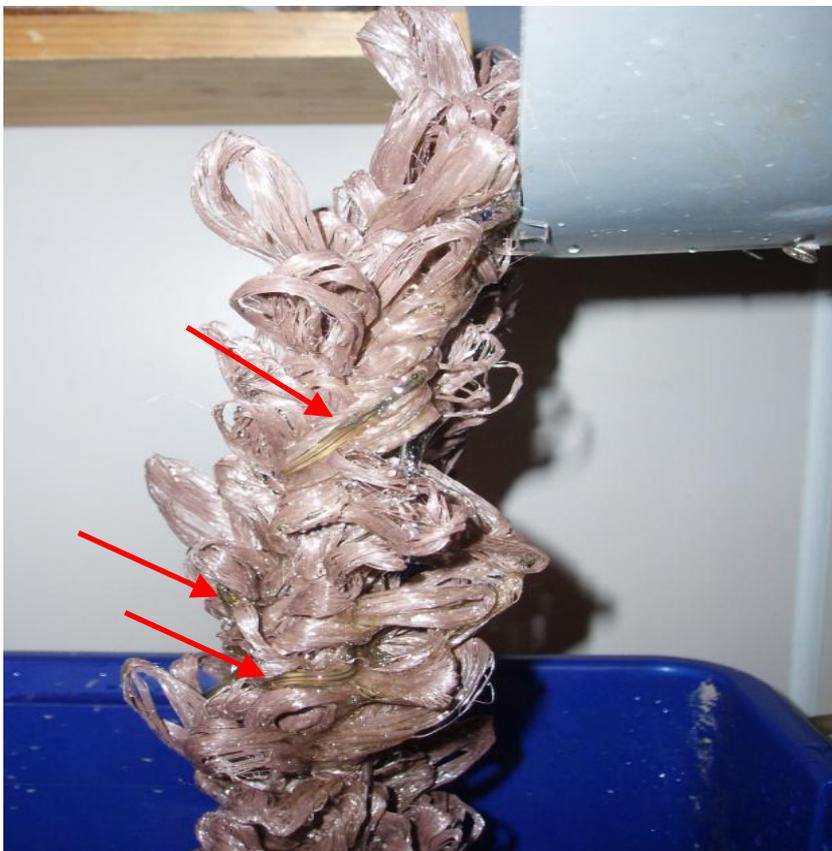
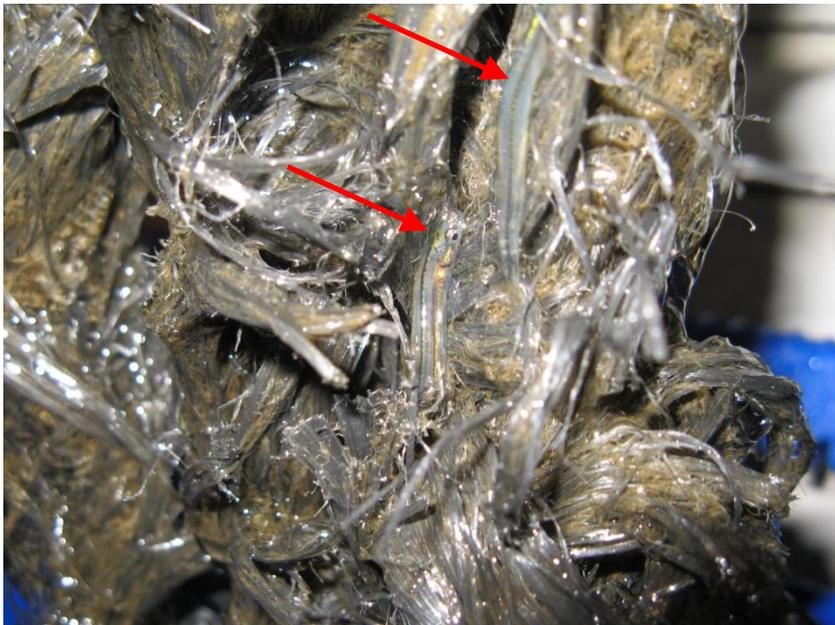
Figure 3: Banded kokopu (arrows) ascending 'Russet loop' (top) and 'Super Xmas tree' (bottom) mussel rope strands during laboratory trials

Both laboratory and field trials have demonstrated that banded kokopu can climb vertical ropes up to 2.4m but that species with lesser climbing ability such as redfin bullies (*Gobiomorphus huttoni*) cannot (David et al. 2009, David & Hamer 2012 or to see a laboratory video showing this behaviour for banded kokopu click here <http://www.youtube.com/watch?v=a-HxTLPqi6w&feature=youtu.be> and here: <http://www.youtube.com/watch?v=rdb3GTUjU8&feature=youtu.be>

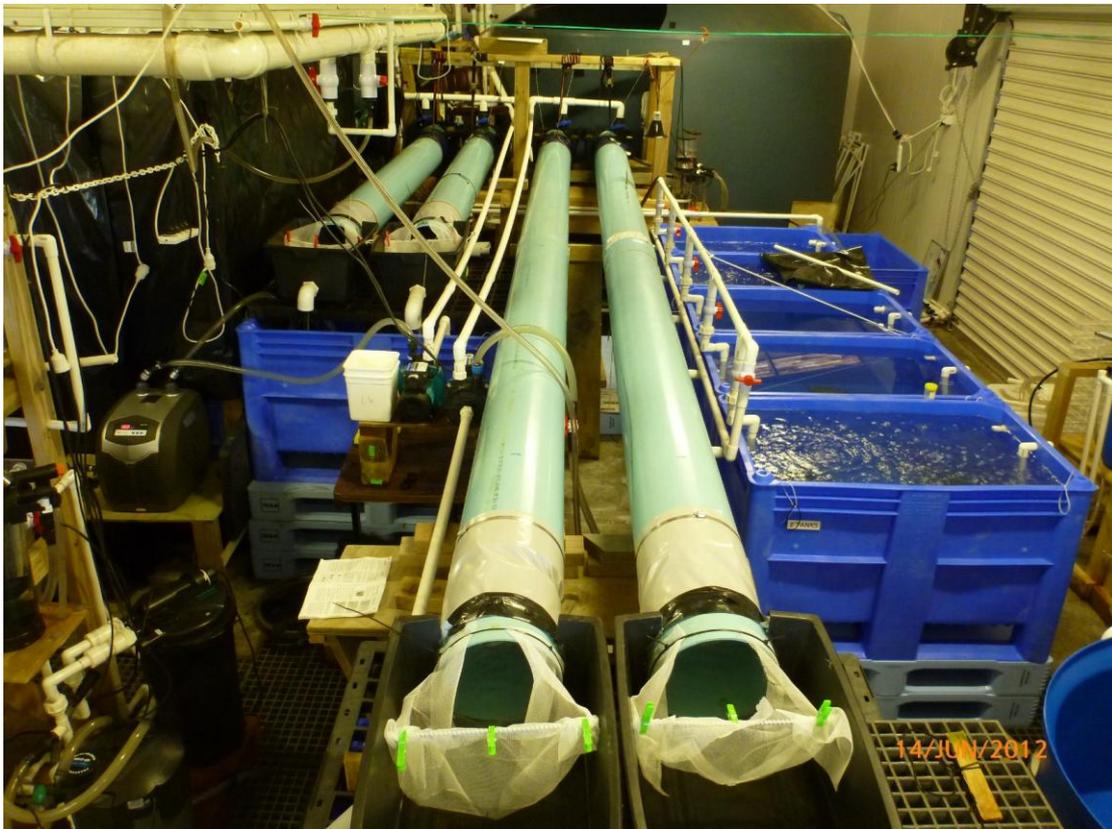
Figure 4: Paired experimental set-up for testing passage success of fish and shrimp through 3m and 6m culvert pipes with and without ropes and at varying gradients and flows.

The second study (David et al. 2013) assessed passage performance for two fish (inanga and brown trout) and one crustacean (the freshwater shrimp *Paratya curvirostris*) species. The influence of flow, gradient and pipe length on passage success through the culverts by each of these species was investigated.

Passage success for all three species was significantly improved through pipes with the addition of ropes. In particular, at extreme culvert settings (6m pipes at high flow and high slope), passage was only achieved for all three species if rope was present with no demonstrated success when ropes were absent. (see Figures 5 a - trout, b – inanga, c - paratya below and for more details see David et al. 2013).

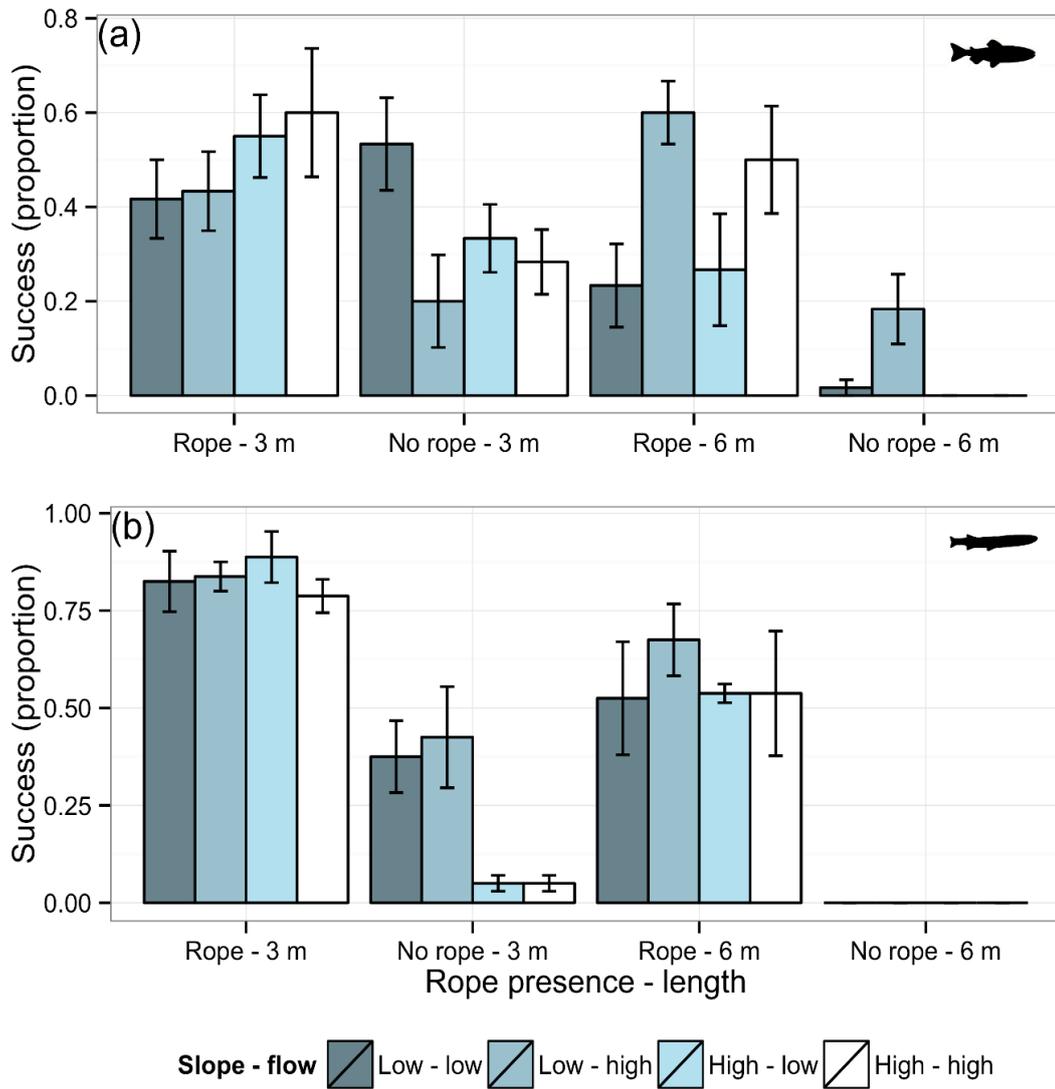
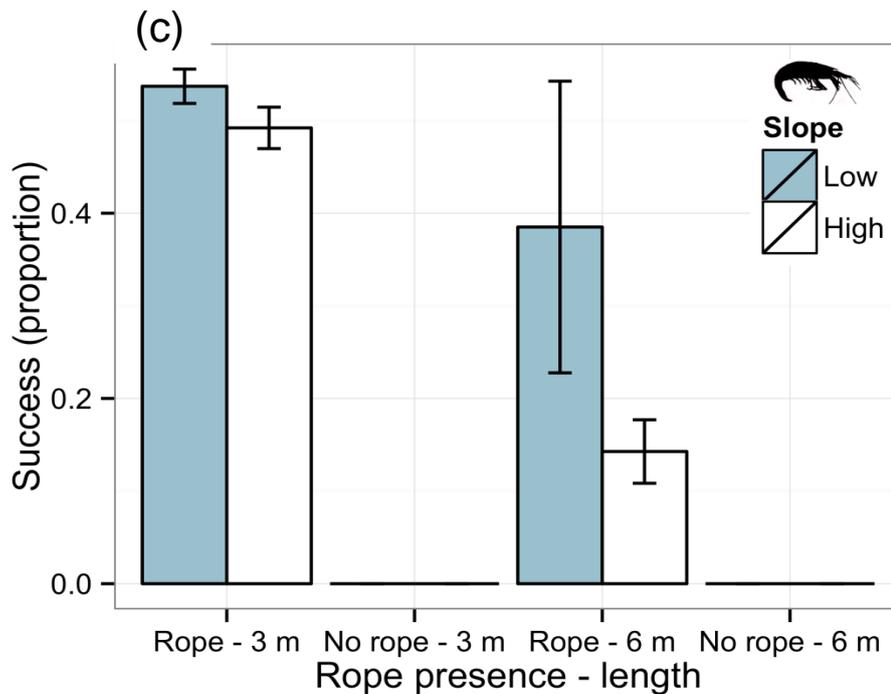
Figure 5: Successful passage of culverts of varying length with and without ropes for a - trout, b – inanga, c – paratya, Sourced from David et al. 2013.

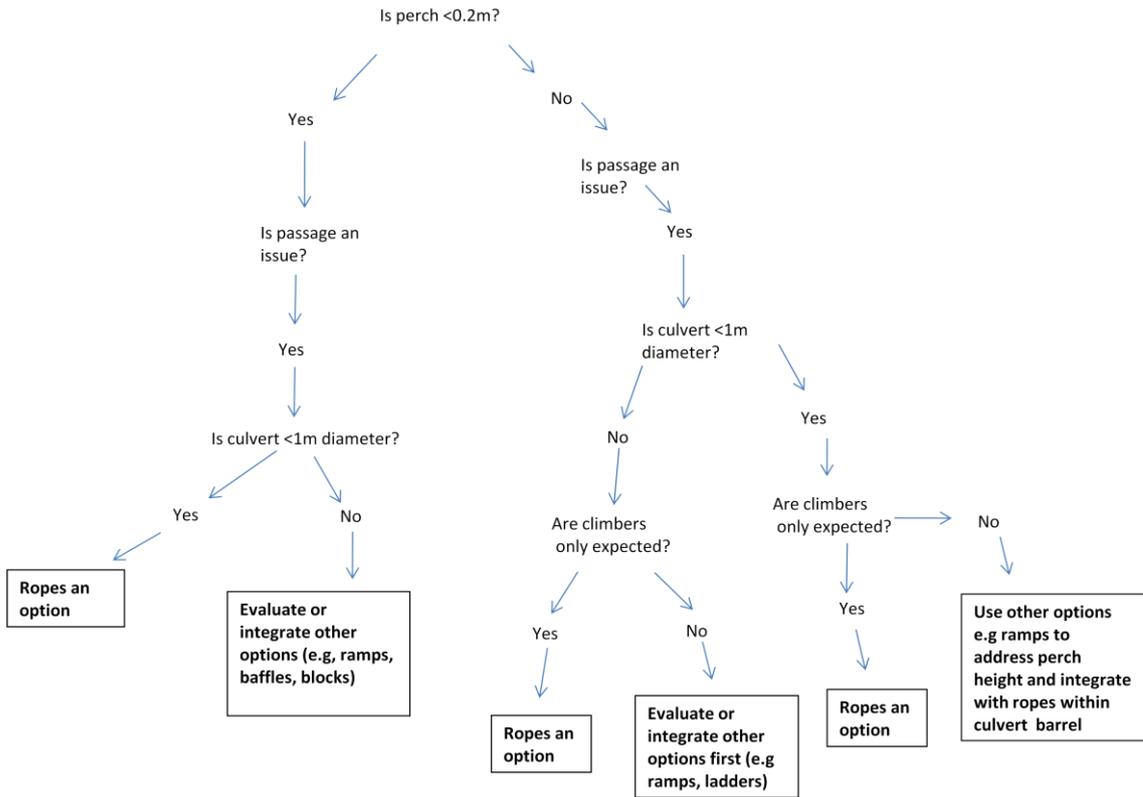
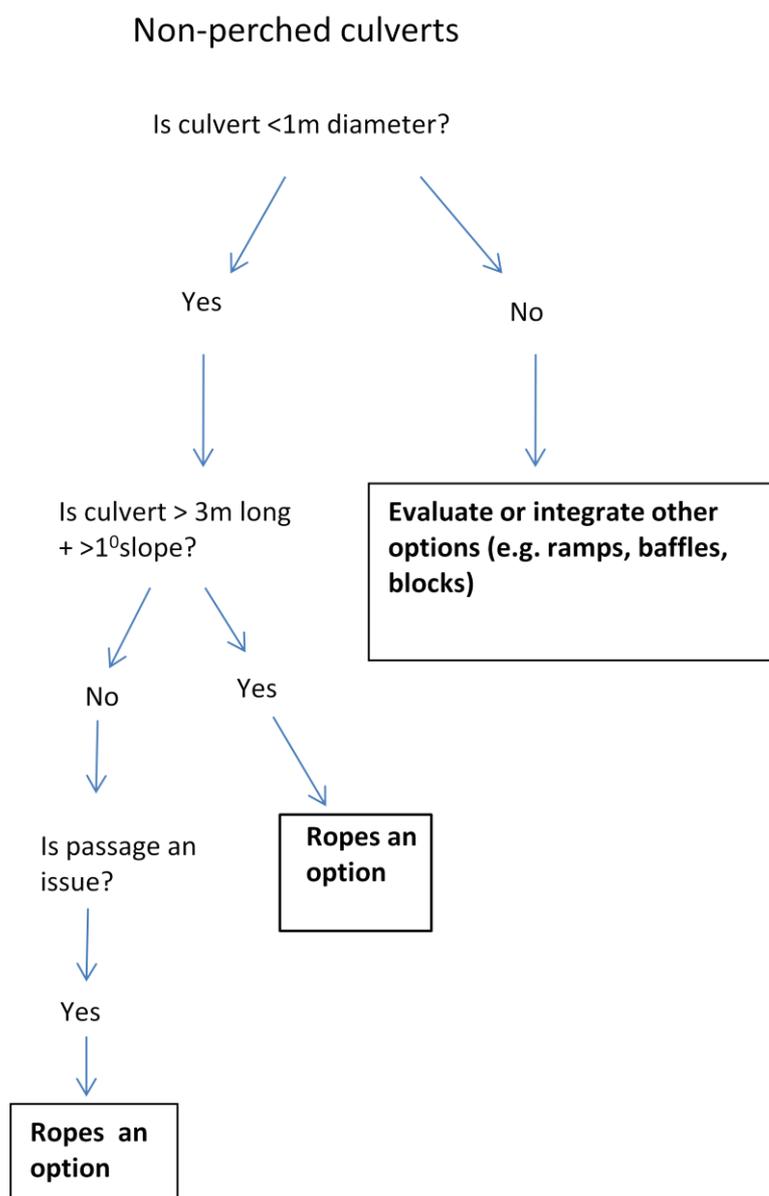
Figure 6: Are ropes an appropriate tool: simple decision tree for A) perched and B) non perched culverts.

If ropes are deemed to be a useful option (see decision trees Figure. 6), the first step is to measure the culvert length and if perched, the perch height to ascertain how much rope will be required. A little extra should be allowed for attachment above and below the culvert. There are numerous ways that ropes can be attached. The method we have most commonly used is to attach multiple lengths of rope upstream of the culvert to a metal stake hammered into the streambed (see Appendix 2) or other such structure installed in such a way to avoid debris build up. We then feed ropes downstream through the culvert and if there is a perch, tie them vertically to the streambed below. If there is no perch they can be fixed in the same way as they are upstream (i.e. by hammering metal stakes deep into the bed and ensuring a smooth transition. It is recommended that the ropes are as tight as possible and to minimise any rubbing and wear at either end of the culvert barrel and in perched situations, tight ropes give the fish a stable substrate to climb on. Multiple ropes side by side will allow greater surface area for climbing and possibly improved predator avoidance. We recommend a minimum of two rope lines through a 500 mm diameter culvert with more lines for bigger culverts.

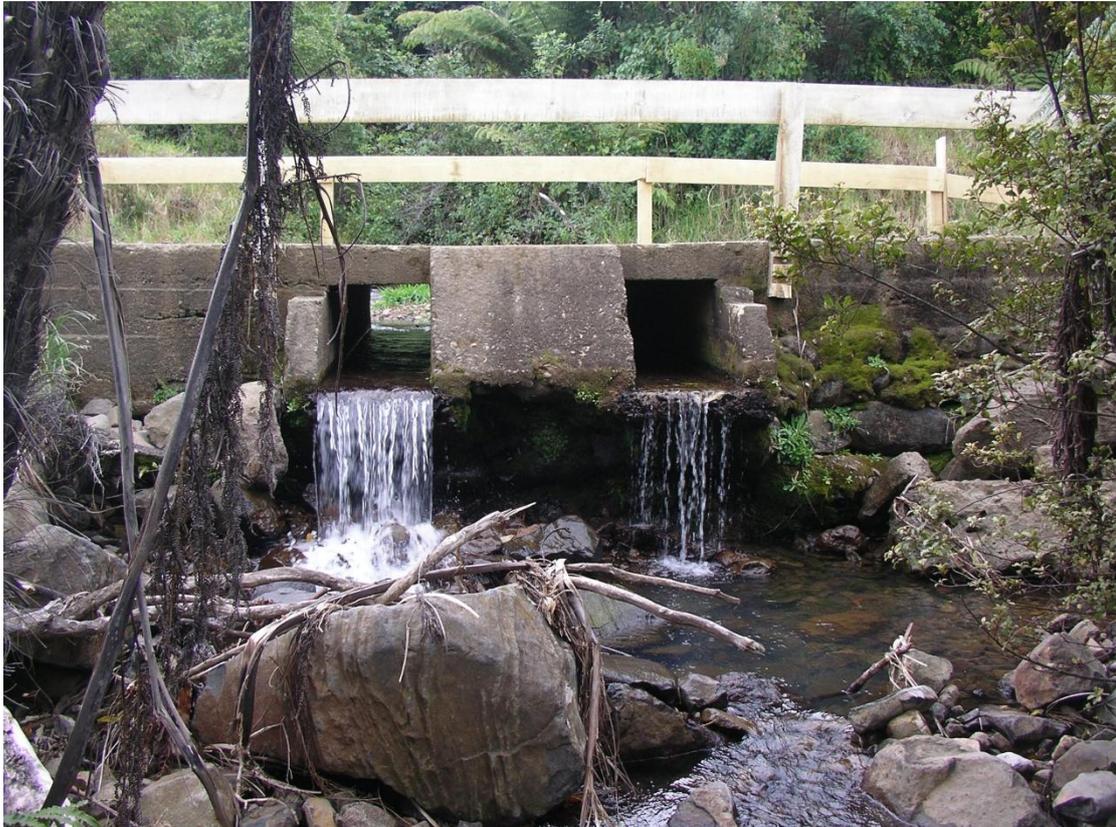
Appendix 1. Example of intermittent fish passage.

While this culvert appears to be a barrier, monitoring above this structure indicates that a full size range of banded kokopu, shortfin, longfin eels and redfin bullies are present upstream. Other species that may be expected such as inanga, torrentfish and smelt were not detected. During periods intense rainfall water can flow over the road above the culverts and at times be seen seeping through below the structure. These situations may provide short term opportunities for fish to negotiate the structure in different ways and ultimately populate upstream areas. While freedom of passage for all species at all flows would be the ideal situation, limited passage opportunities may be sufficient for maintaining some fish species in some instances.

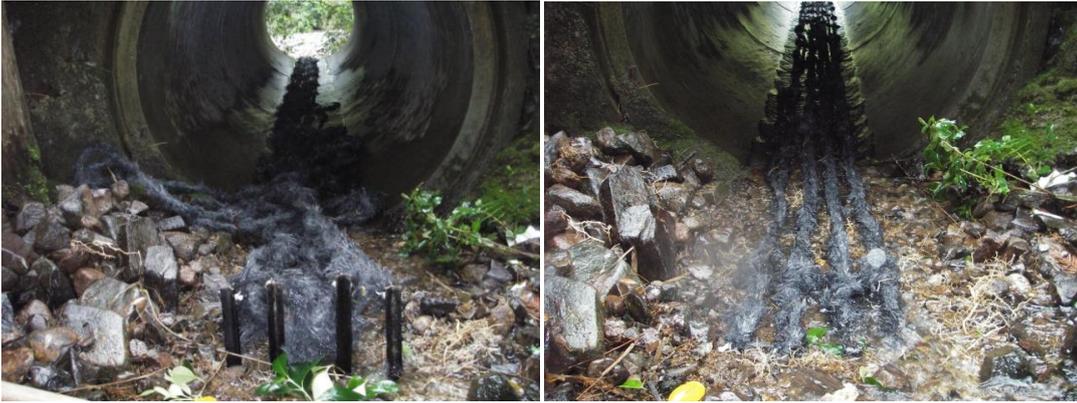
Upstream end. Install with metal stakes and thread rope through galvanised 'D' shackles that fit through top hole (left photo). Once threaded through hammer into bed and cover over (right photo)

Before the ropes are attached at the downstream end, knots (half hitches) can be tied along the section of rope located within the culvert barrel to break up the velocity in the culvert and potentially create additional rest areas for the fish. In perched situations we leave the vertical section from the culvert lip to the water below un-knotted as this could make the climbing section for aquatic taxa more difficult. If the culvert is perched we use either a gabion basket or metal stake at the downstream end and attach ropes to these (See installation photos Appendix 2).

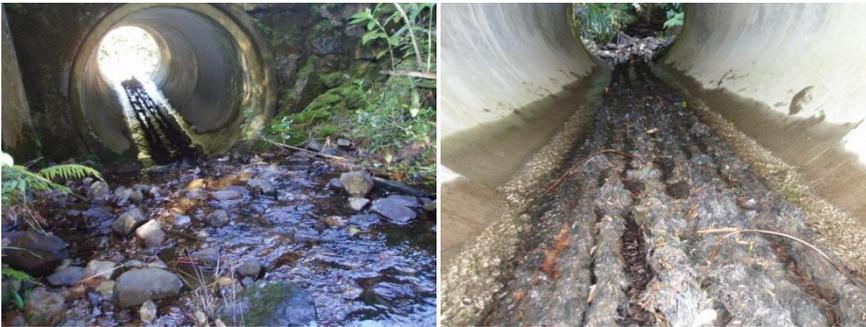
Completed retrofit looking downstream (left photo) and upstream from within culvert (right photo). Note 'swimming lanes' formed by ropes.

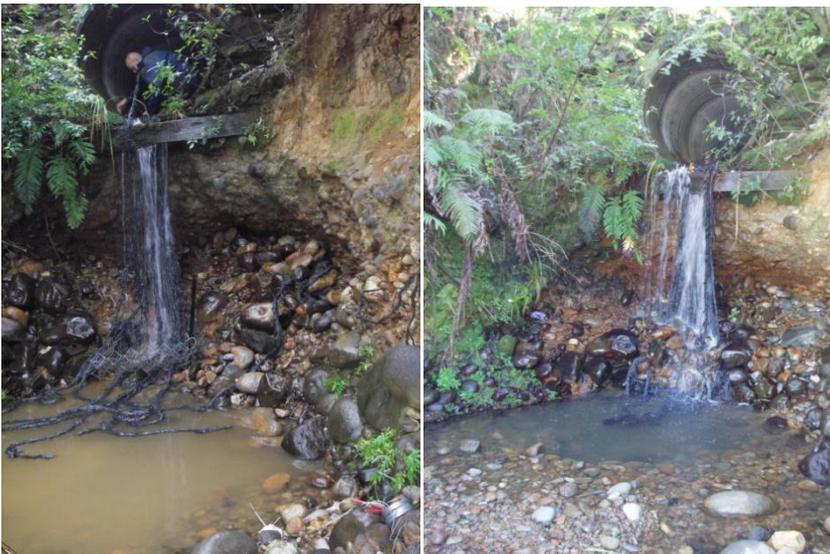
View from below the culvert during installation (left photo) and completed retrofit (right photo)

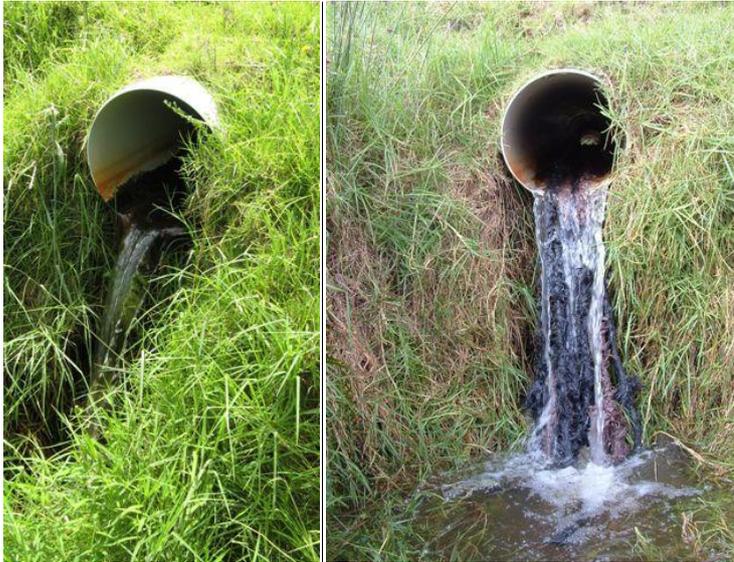
Lake Harihari culvert before (left photo) and after (right photo). Installed for improved eel passage in 2009 following a netting survey which suggested poor recruitment of elvers to this lake. Assessment of the effectiveness of this retrofit is planned to occur in 2015.
