**Cathedral Cove Basic Level  
Landslide Risk Assessment**

**Prepared for**  
Department of Conservation  
**Prepared by**  
Tonkin & Taylor Ltd  
**Date**  
July 2023  
**Job Number**  
1007838.3000 v3

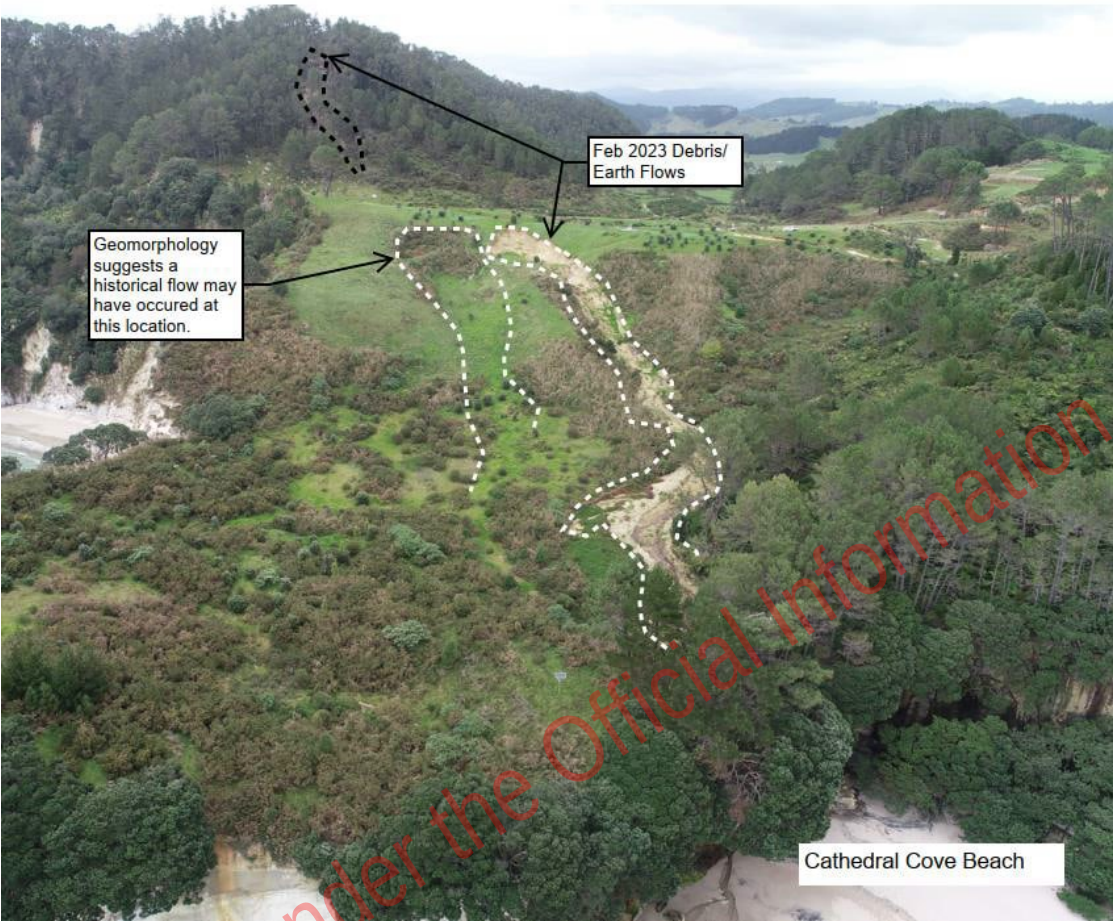
| | <p><b>Debris/earth flow</b></p> <p>Recent debris flows are observed on the saddle above Cathedral Cove Beach, and on the western side of Hahei Dome.</p> <p>The recent flow below the track (foreground in photo) initiated as a complex rotational landslide. The mobilised material appears to have reached the clifftop near the waterfall of Cathedral Cove Beach, however no debris was observed on the beach.</p> <p>DoC staff noted that they did not observe any debris on the beach following the storm event, however it may have washed away during high tide.</p> <p>Debris was typically silt and sand soil.</p> <p>Geomorphology suggests debris flows may have occurred in this area in the past.</p> |

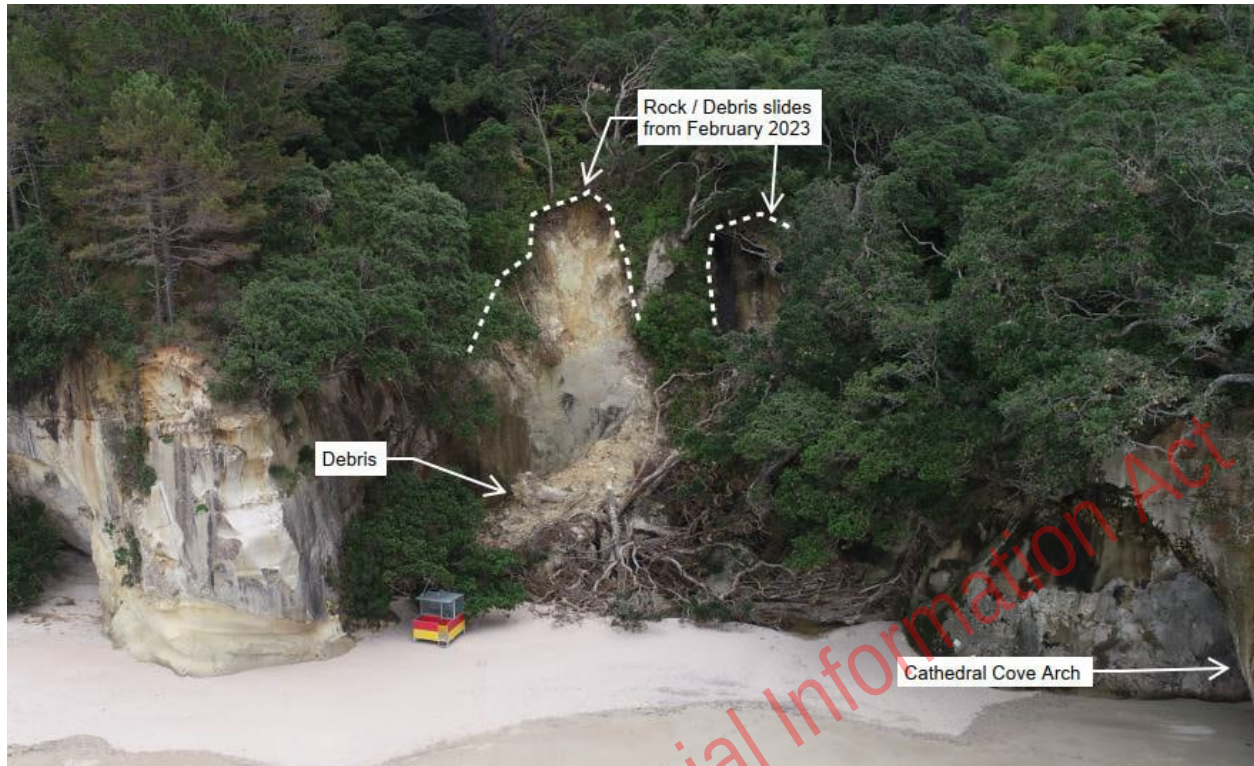
### Debris/rock slide

Common along the coastal cliffs and escarpments often within moderately to completely weathered ignimbrite and rhyolite.

Often large trees were observed within the landslide debris. These trees typically extended further from the cliff toe than the main debris.

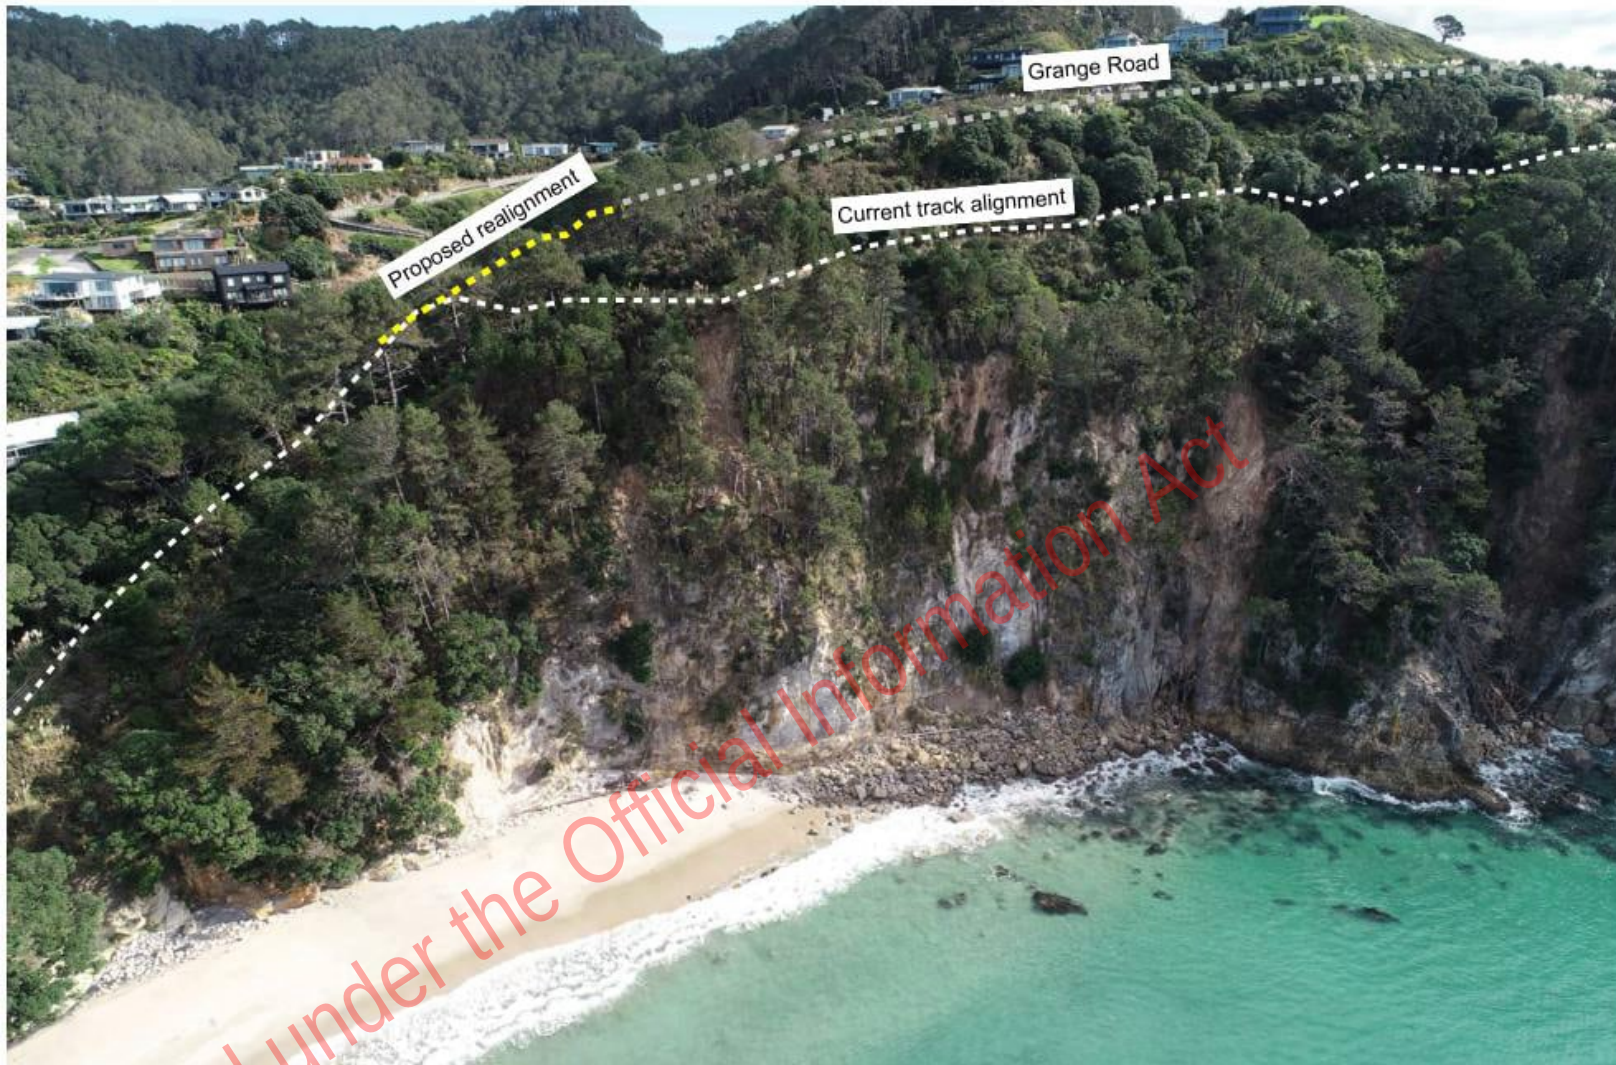
Figure 10.8: Hahei track realignment option.

| Site Location | Site details/damage | Management and mitigation options | Comments/risks |
|---|---|---|---|
| Hahei Track<br>(refer Figure 10.8, Figure 10.9) | <p>The Hahei Track passes through very steep terrain ground prone to multiple historical and recent landslides.</p> <p>Currently there are several landslides and areas of instability affecting the track.</p> <p>DoC would like to explore options to reduce landslide risks for this portion of the track.</p> | <p><b>Option 1 – Continue using current track alignment, implement stabilisation where required.</b></p> <p>To continue use of the current track alignment several locations would need stabilisation or support. This would likely entail engineered solutions such as retaining walls or soil nails.</p> <p>There are other areas along the track which are identified to have historical instability and have a relatively high change of future failure. These areas would need monitoring and future repair if required.</p> | <p>The current alignment crosses a relatively landslide prone area and it will be difficult to mitigate this risk.</p> <p>Engineer stabilisation would be relatively high cost.</p> <p>Geotechnical and structural design would be required.</p> <p>Consideration was also given to realigning the track upslope of the current track alignment and below Grange Road. However, this option would cross similar landslide hazards and not significantly reduce the landslide risk.</p> <p>Stabilisation would still likely be required.</p> |

| Site Location | Site details/damage | Management and mitigation options | Comments/risks |
|---|---|---|---|
| | | <p><b>Option 2 – alternative access via Grange Road and DoC carpark.</b></p> <p>A potential alternative route option was traversed by T+T and DoC during site visits and is shown in Figure 10.9).</p> <p>The alternative track would connect the existing Hahei Track to Grange Road, a short walk from the existing DoC carpark.</p> <p>The track would pass through a gully with moderate ground slopes and wilding pines.</p> | <p>The track would bypass the steep landslide prone hillslope reducing risk to users.</p> <p>The realigned track does not provide the same views to users.</p> <p>Fallen trees were present within the route of the new track and existing large trees may require removal.</p> <p>Areas of groundwater seepage should be avoided.</p> <p>Consideration is required for traffic safety related issues and confirm whether the current footpath is suitable for the expected visitor numbers.</p> |

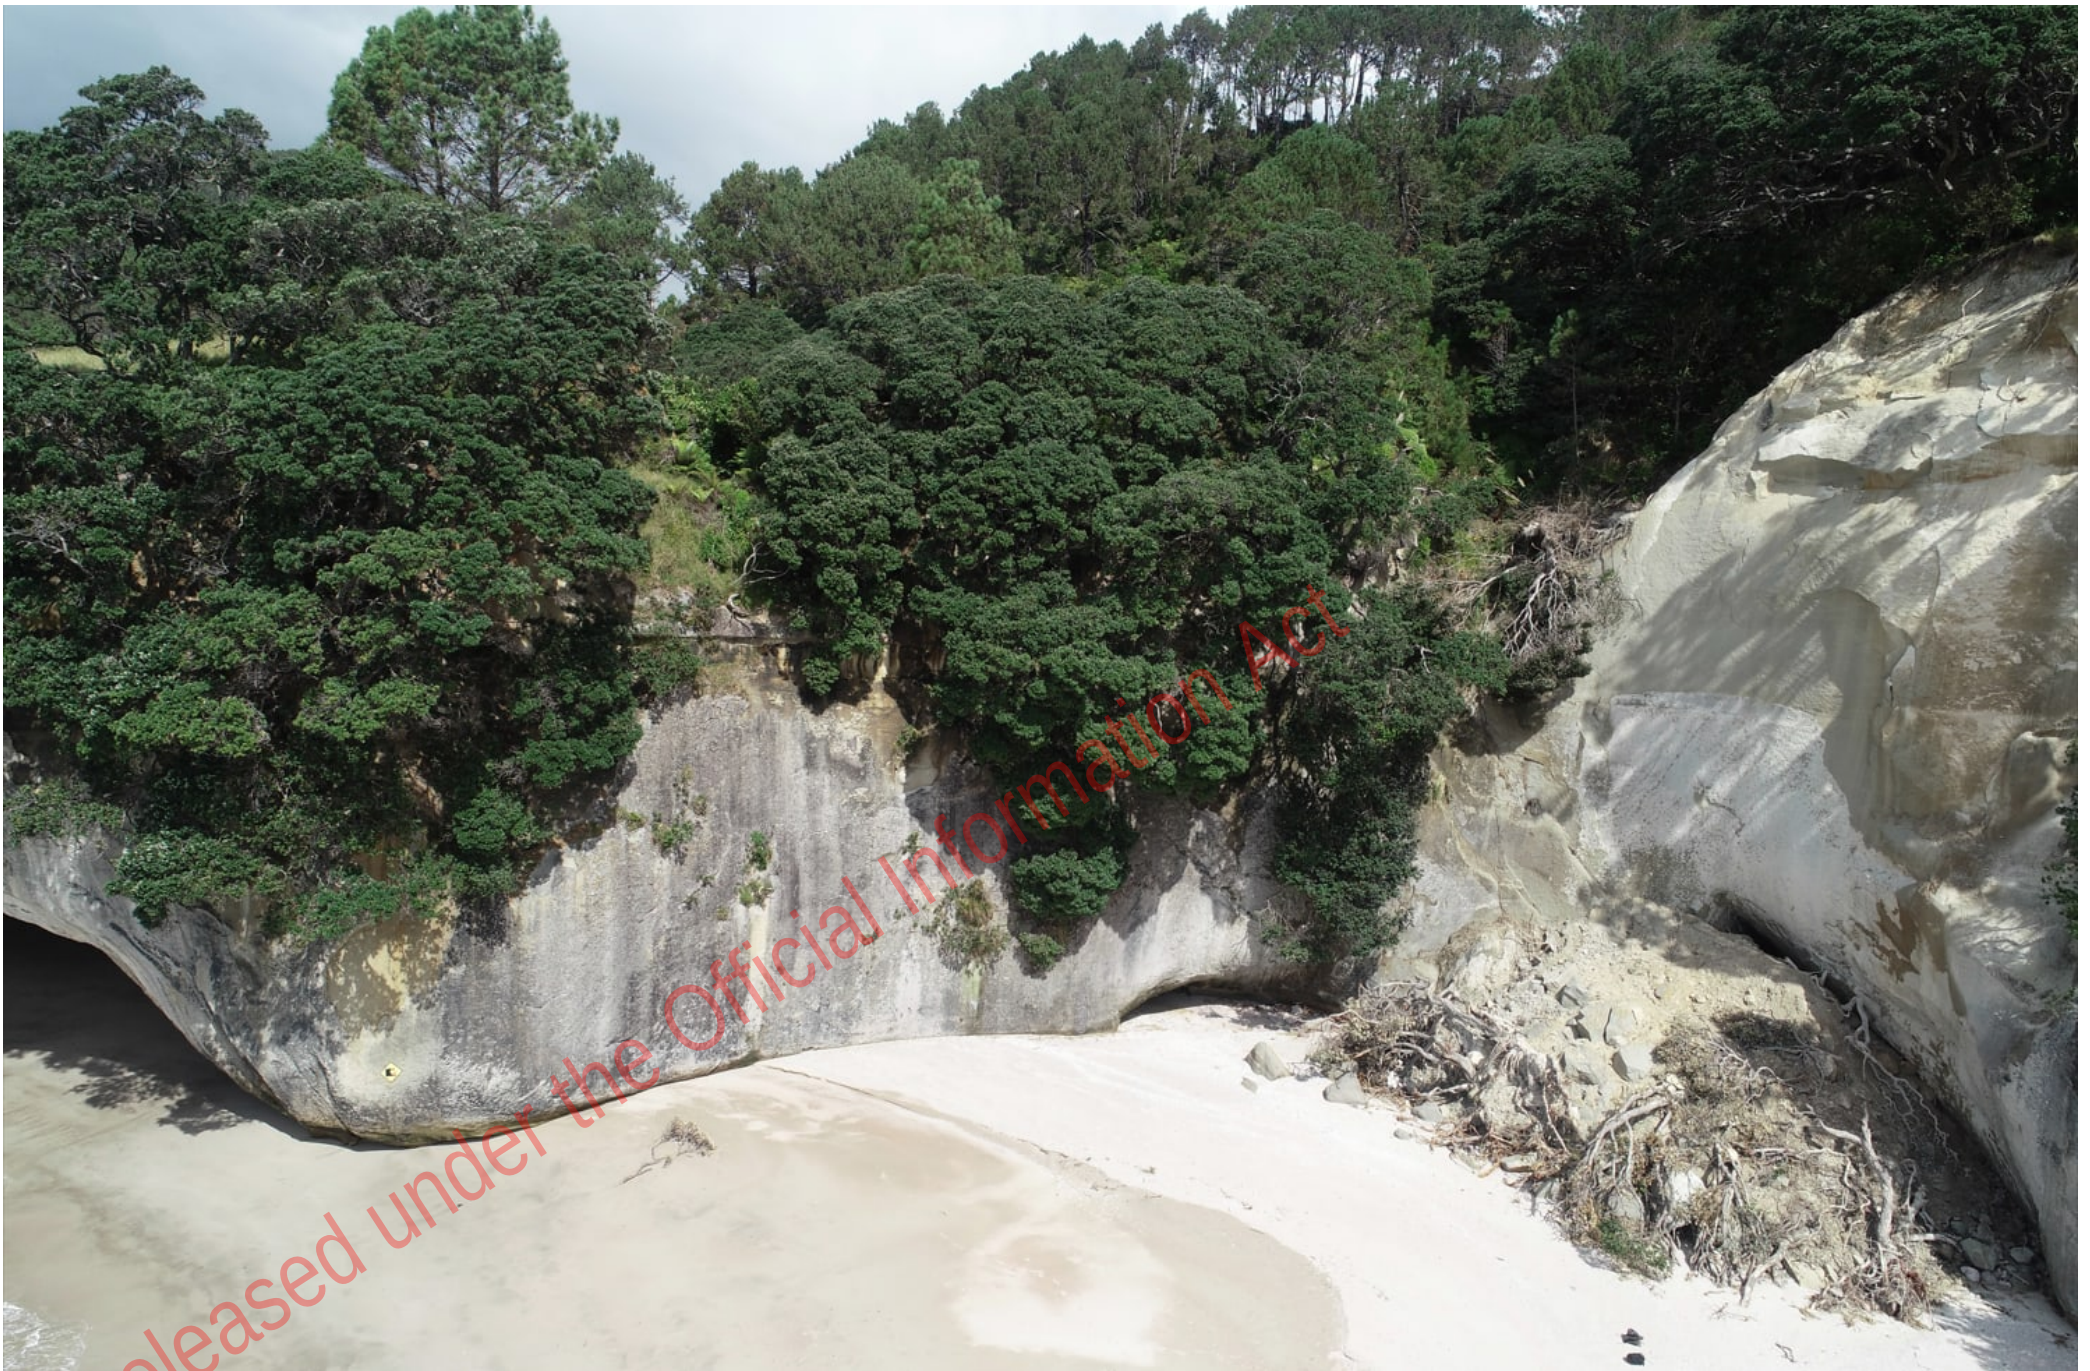
Figure C3 Recent and historical debris / talus at the toe of the coastal cliff on Cathedral Cove Beach

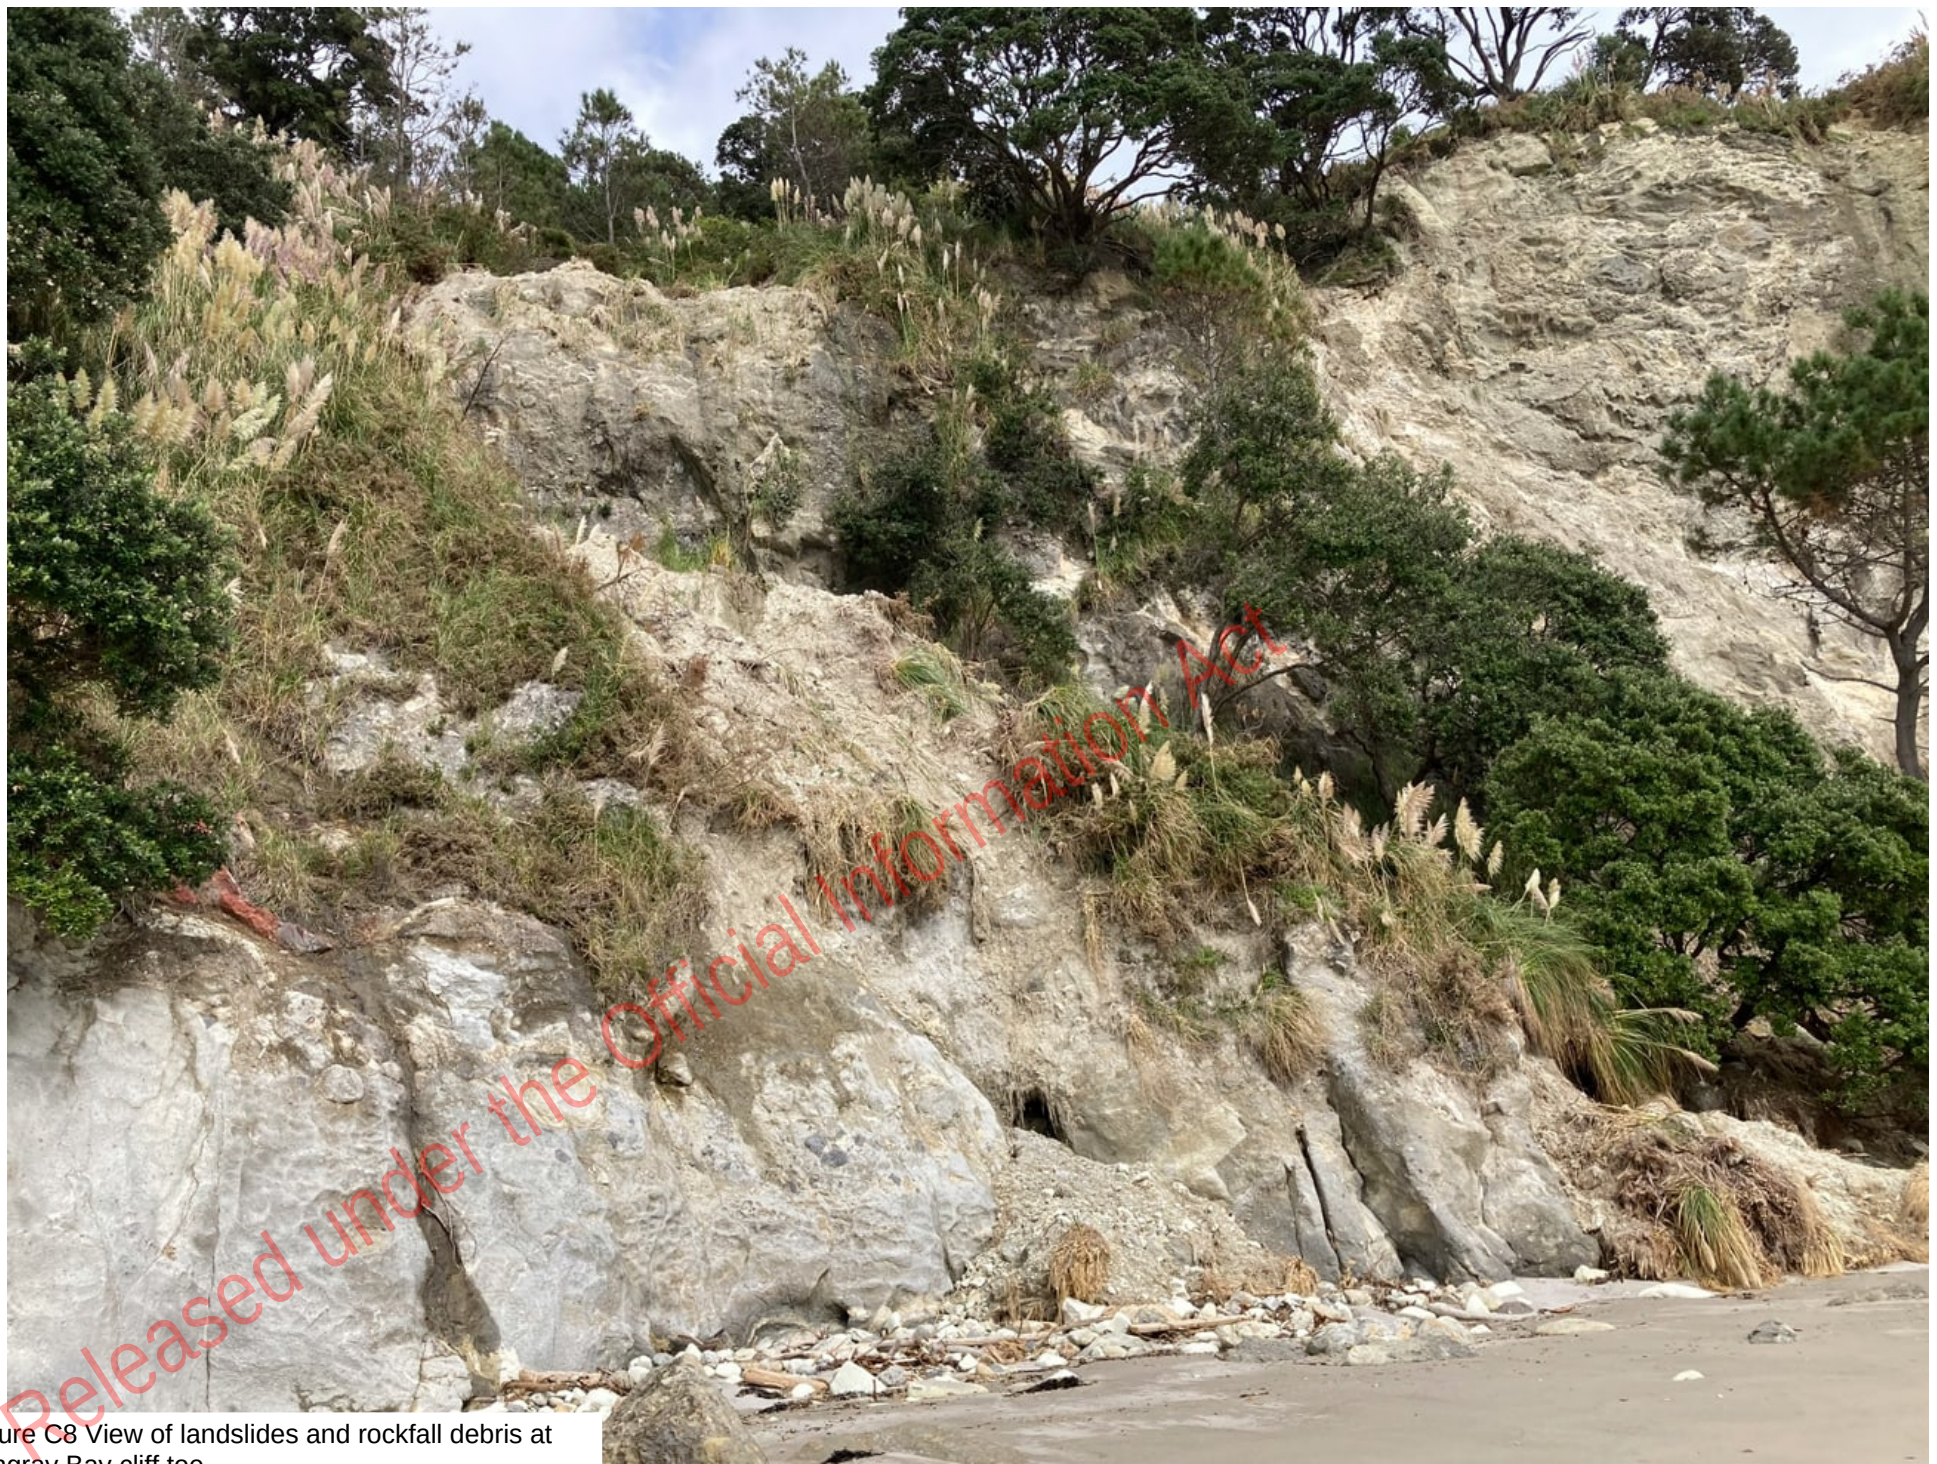
Figure C8 View of landslides and rockfall debris at Stingray Bay cliff toe

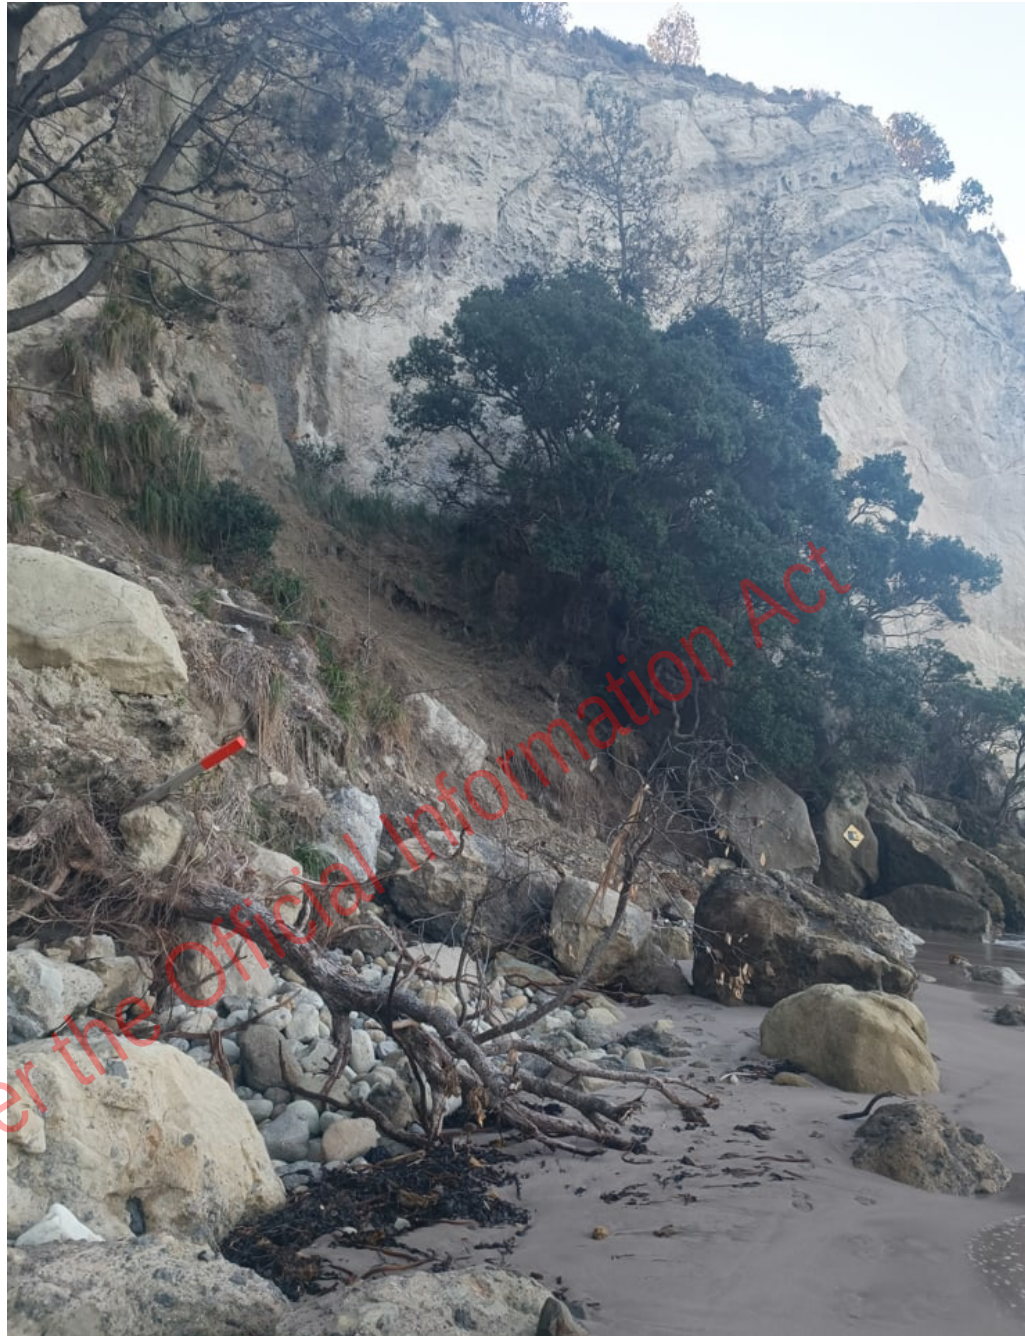
Figure C9 View of landslides and rockfall debris at  
Stingray Bay cliff toe

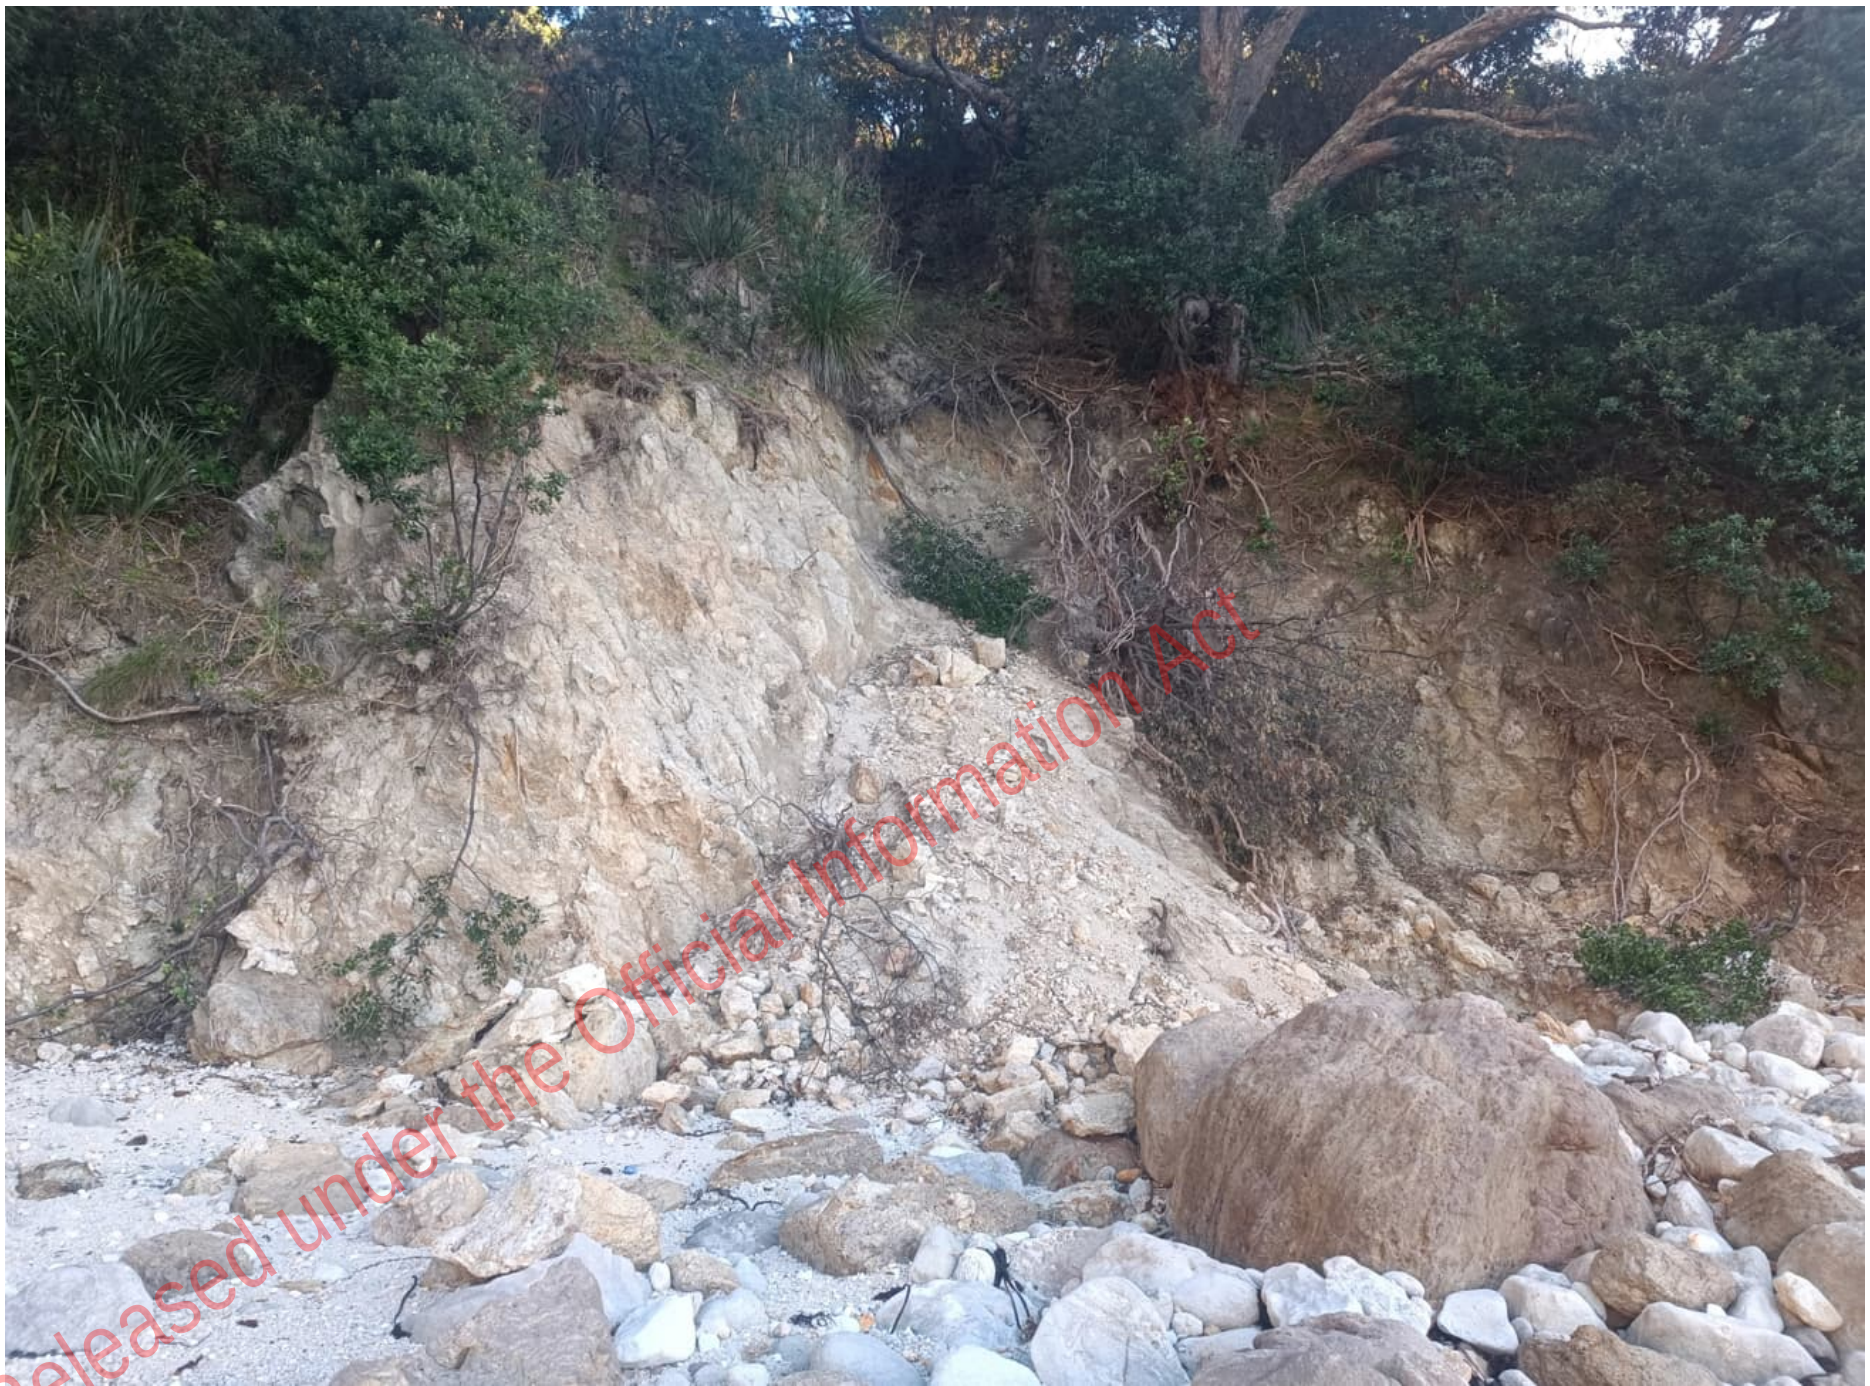
Figure C10 Rock and landslide debris at north end of Gemstone Bay

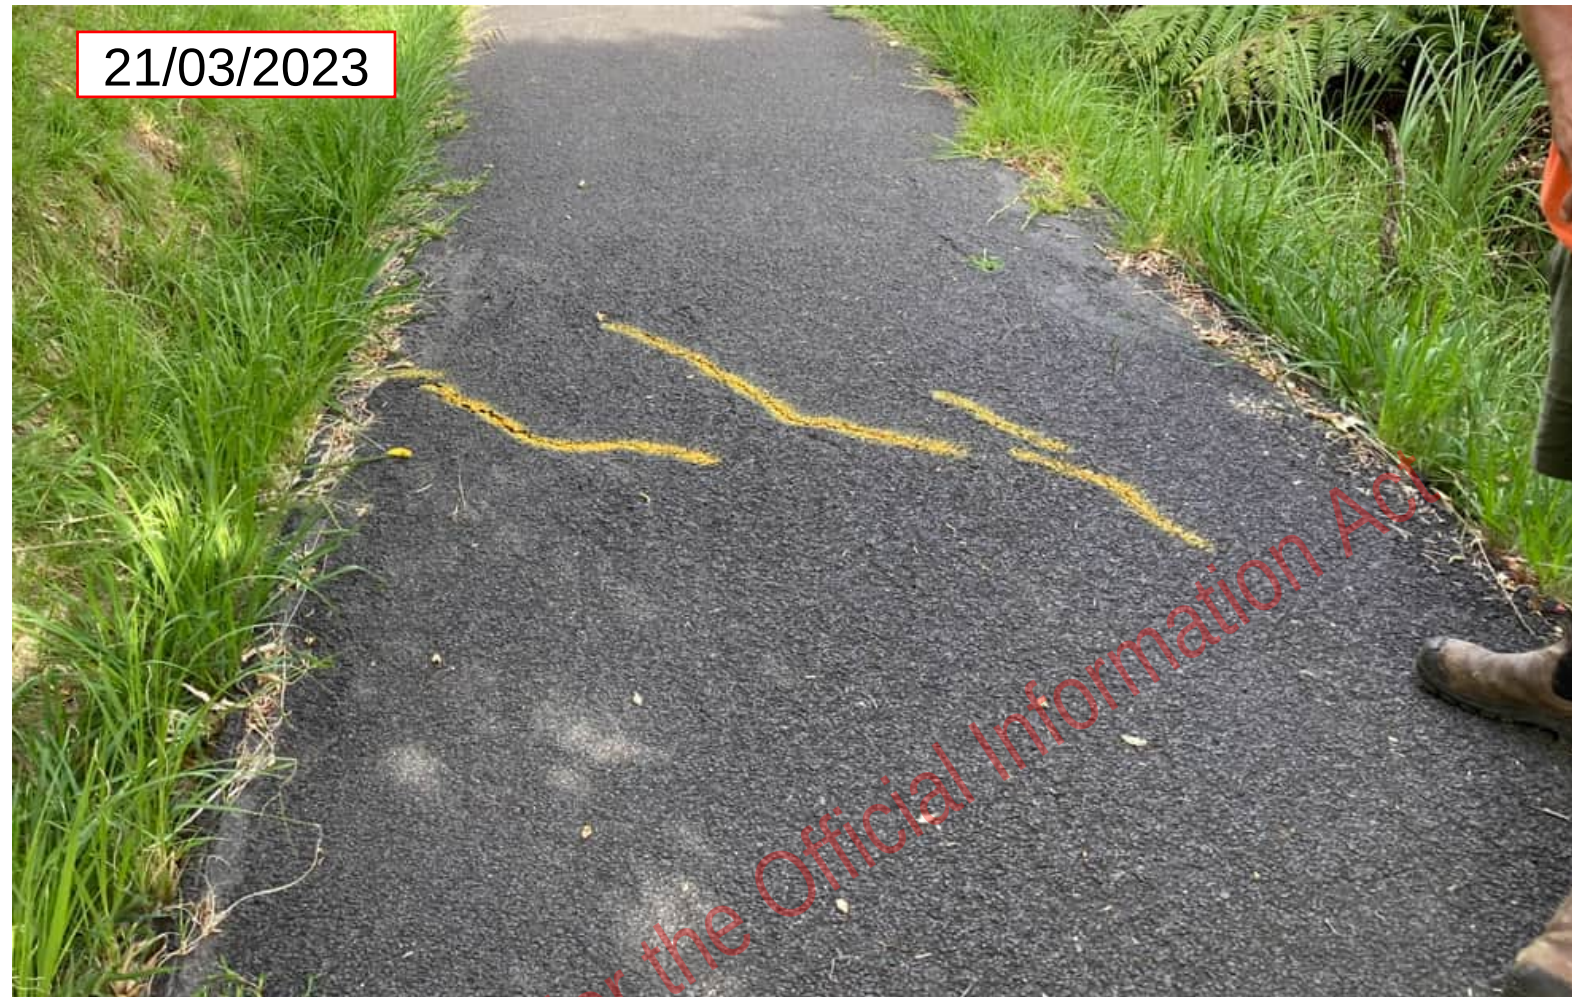
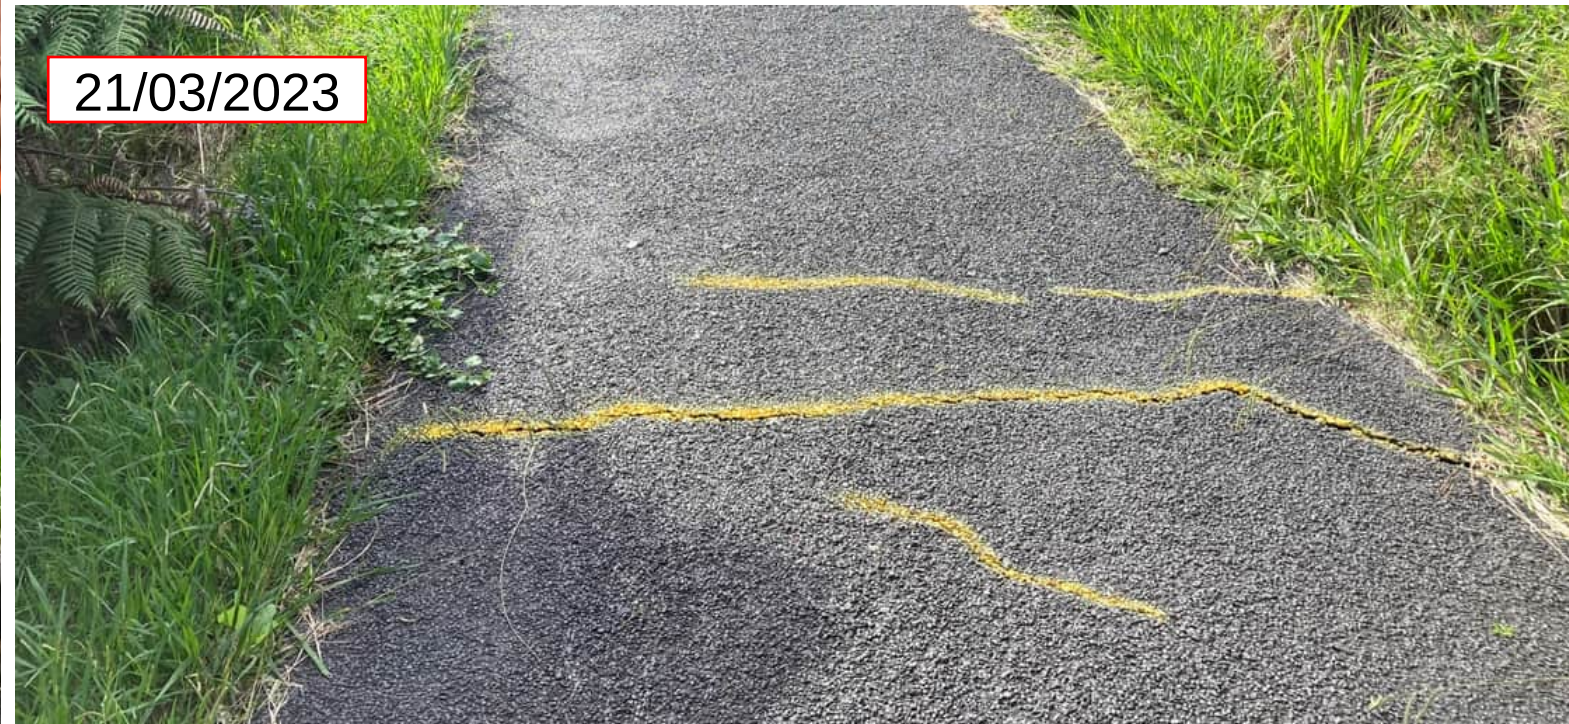
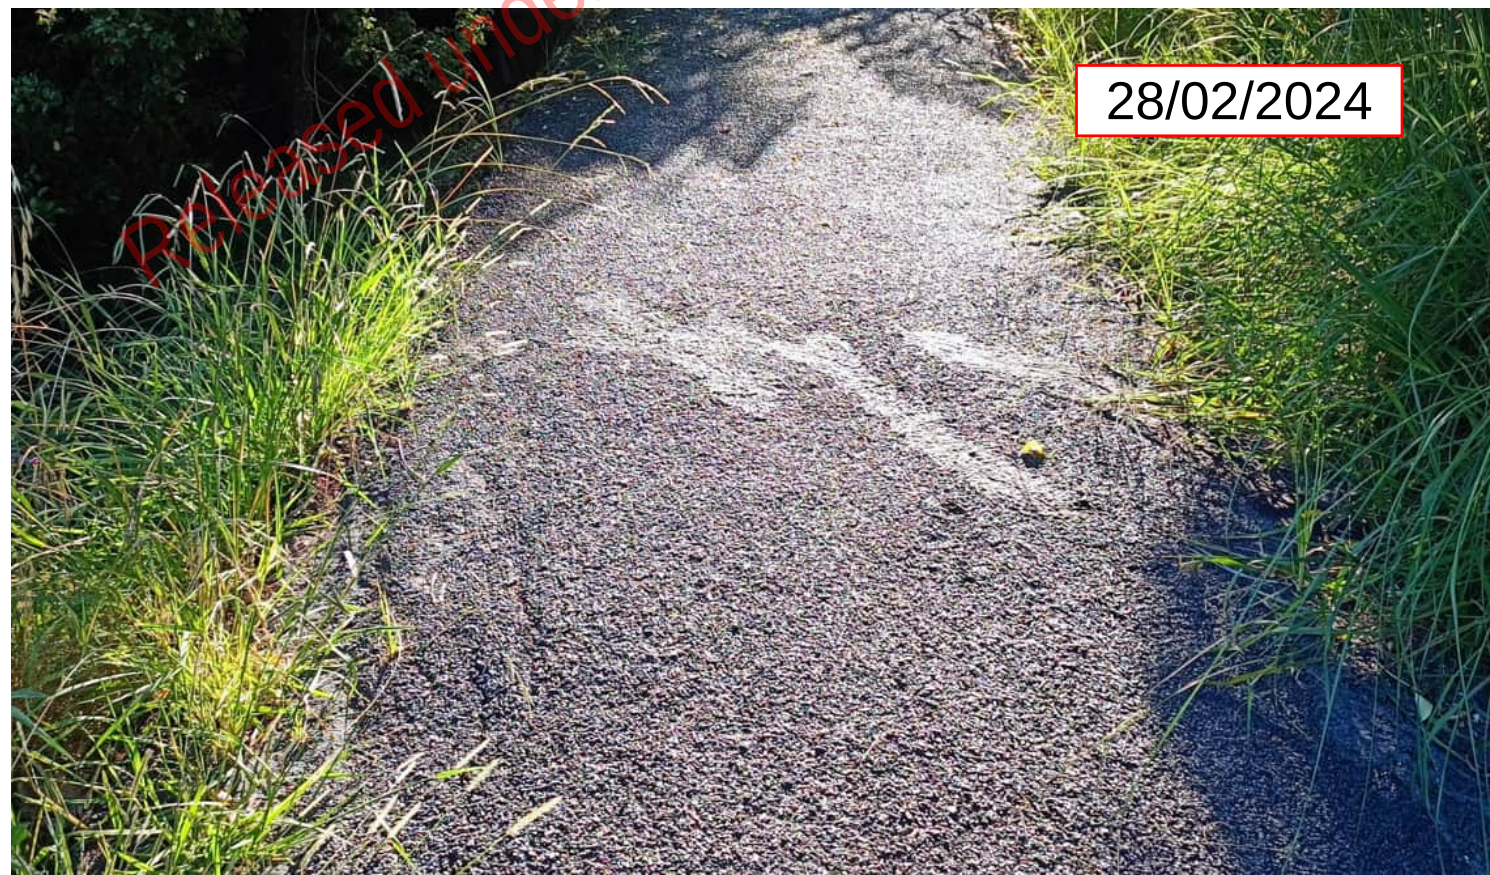
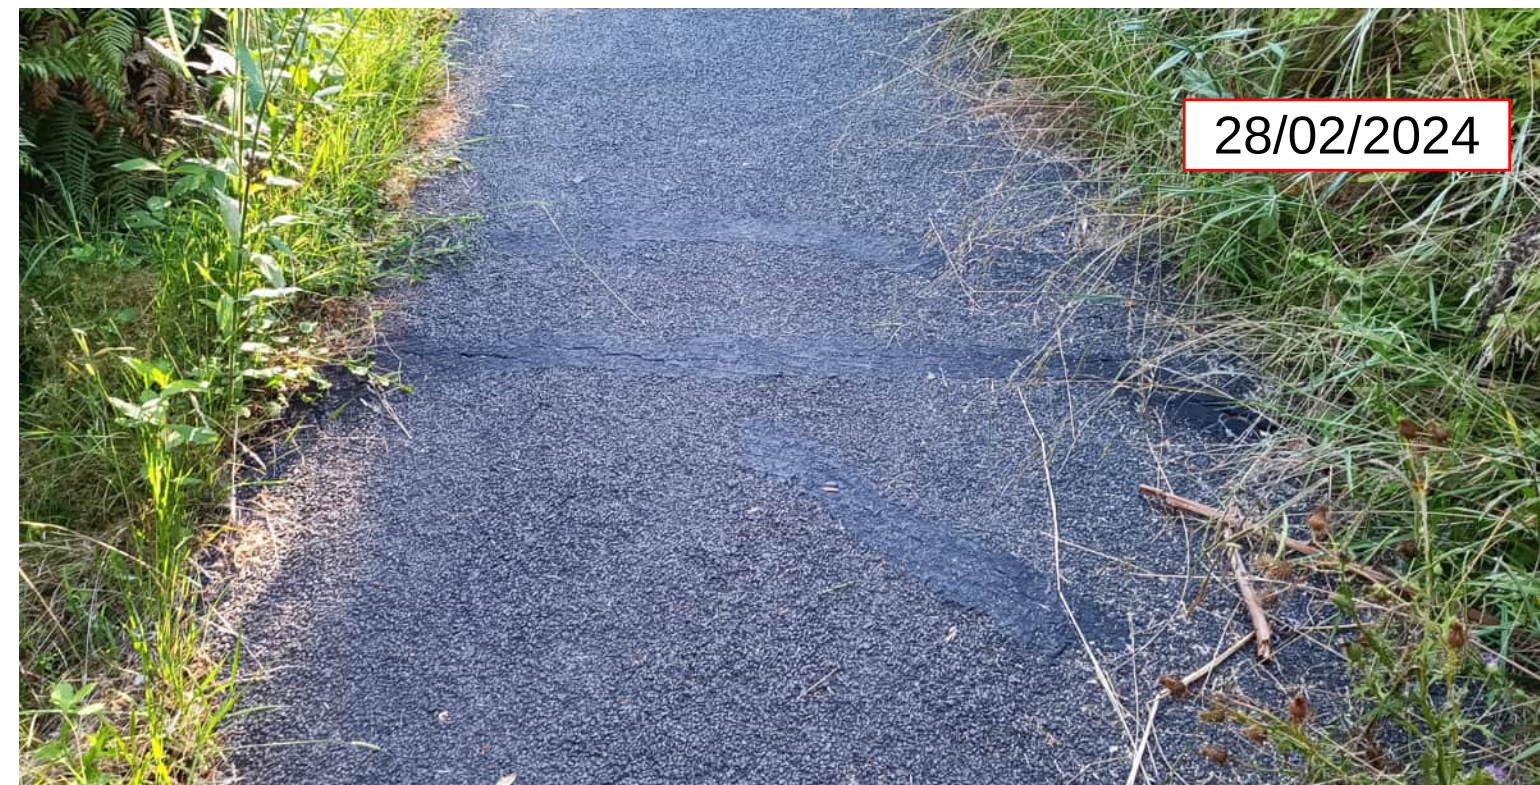
Feature 1 - Two sets of tension cracks  
No new movement

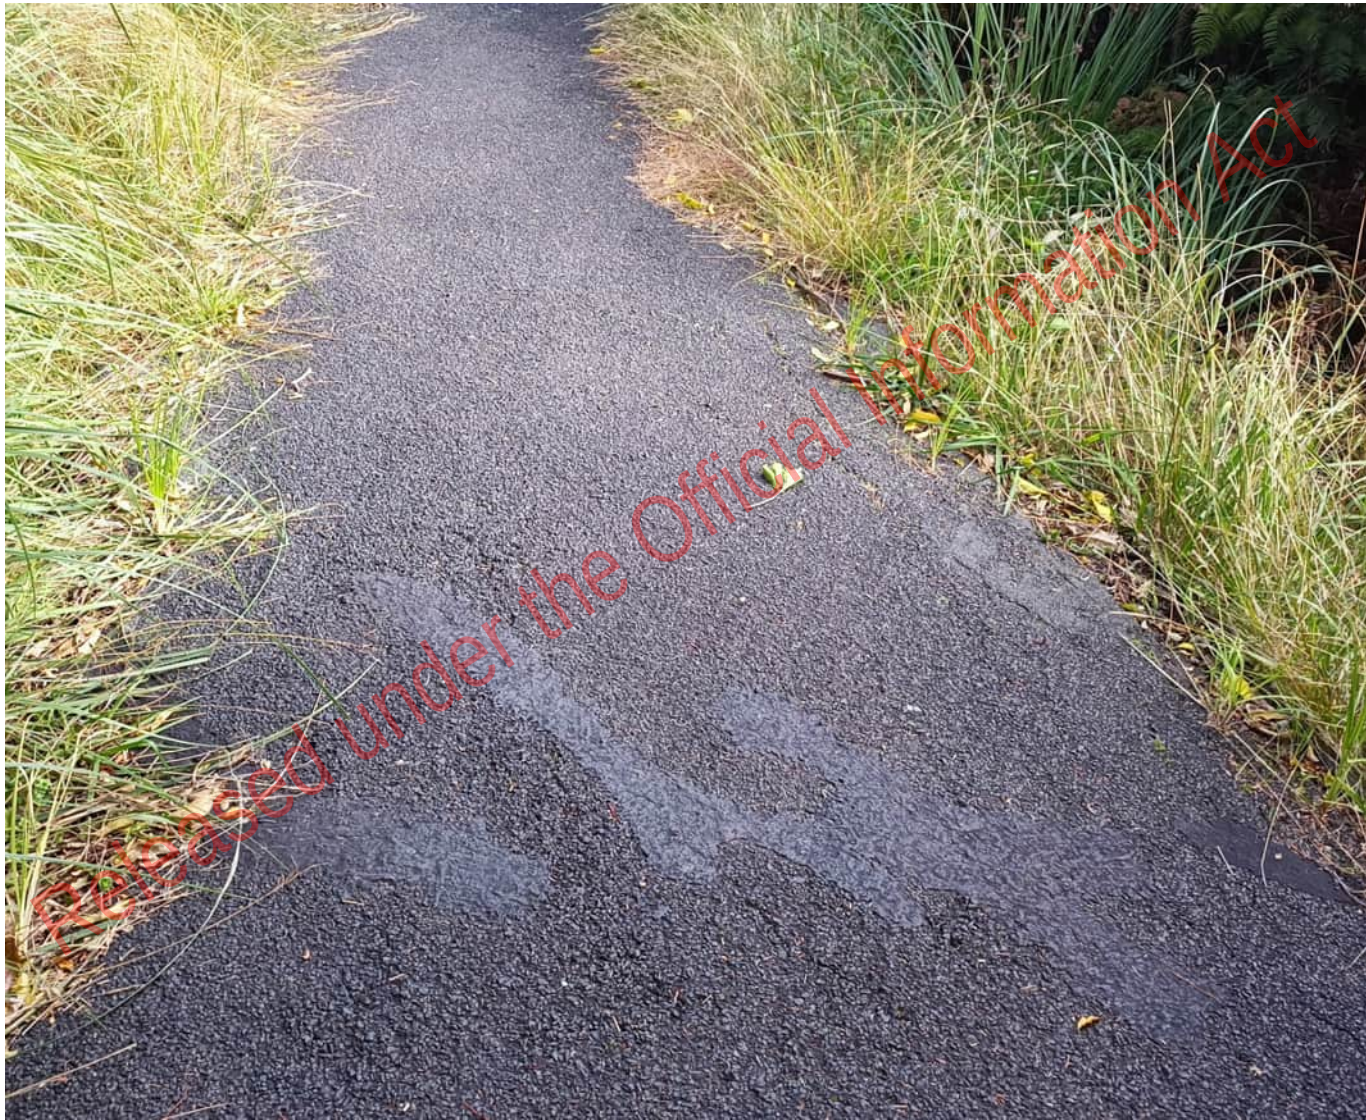
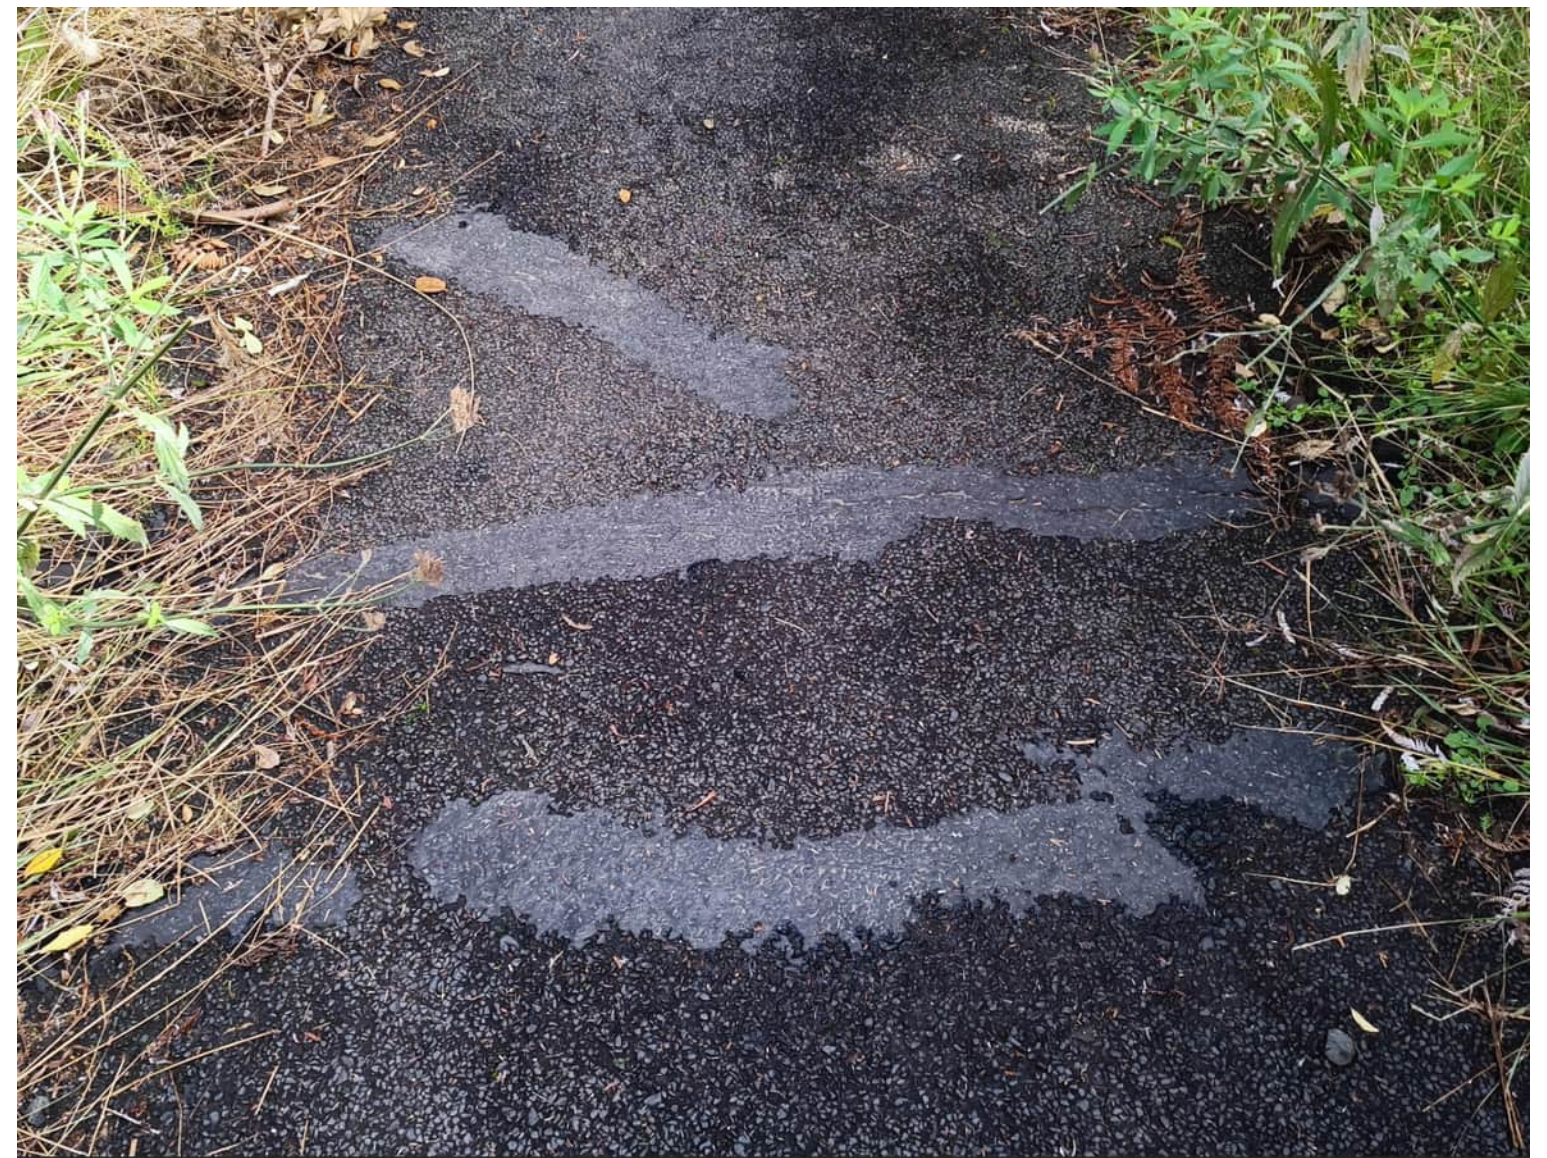
Feature 1 Continued - Two sets of tension cracks  
No new movement
