**Cathedral Cove Basic Level  
Landslide Risk Assessment**

**Prepared for**  
Department of Conservation  
**Prepared by**  
Tonkin & Taylor Ltd  
**Date**  
July 2023  
**Job Number**  
1007838.3000 v3

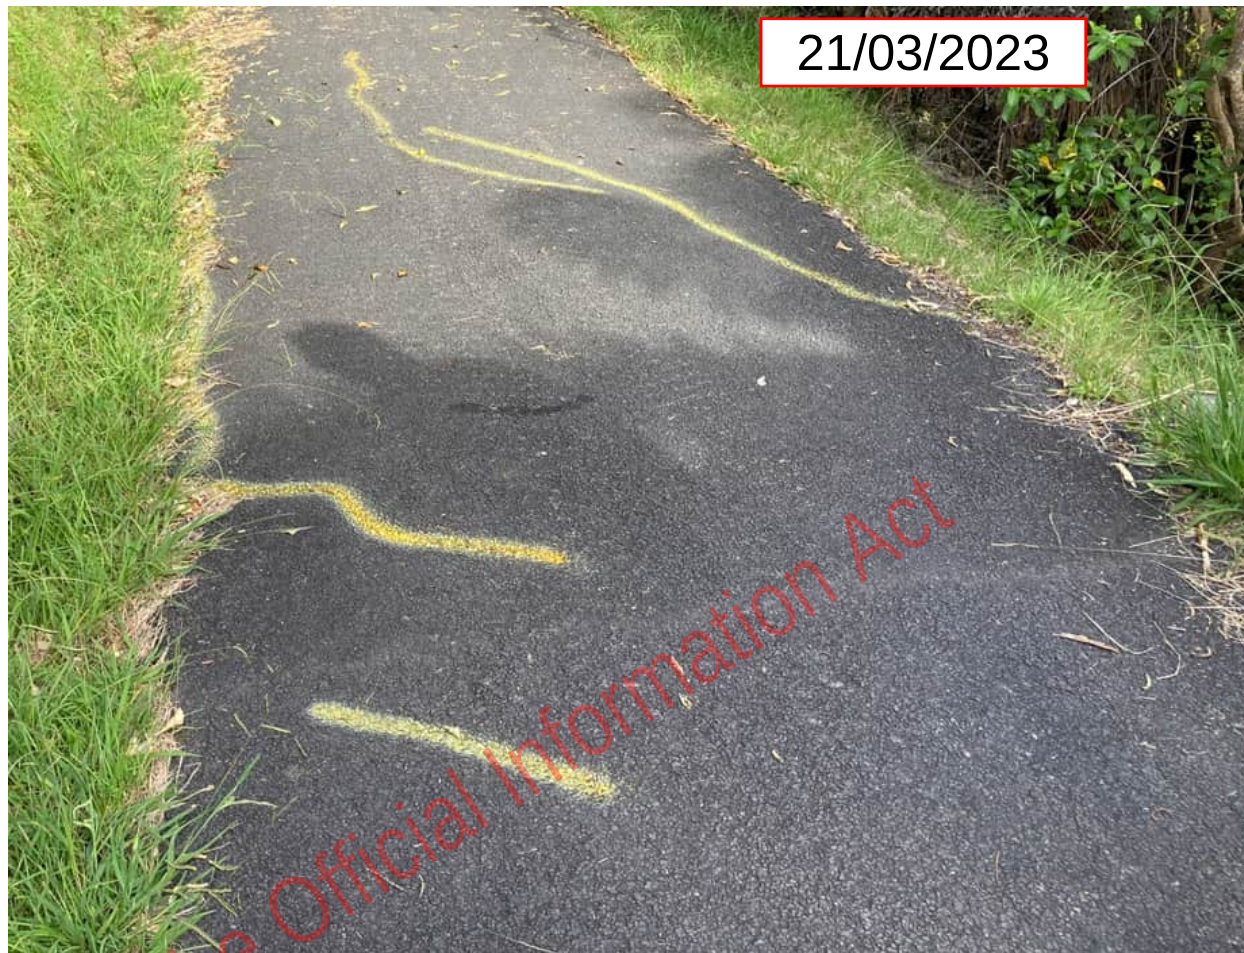
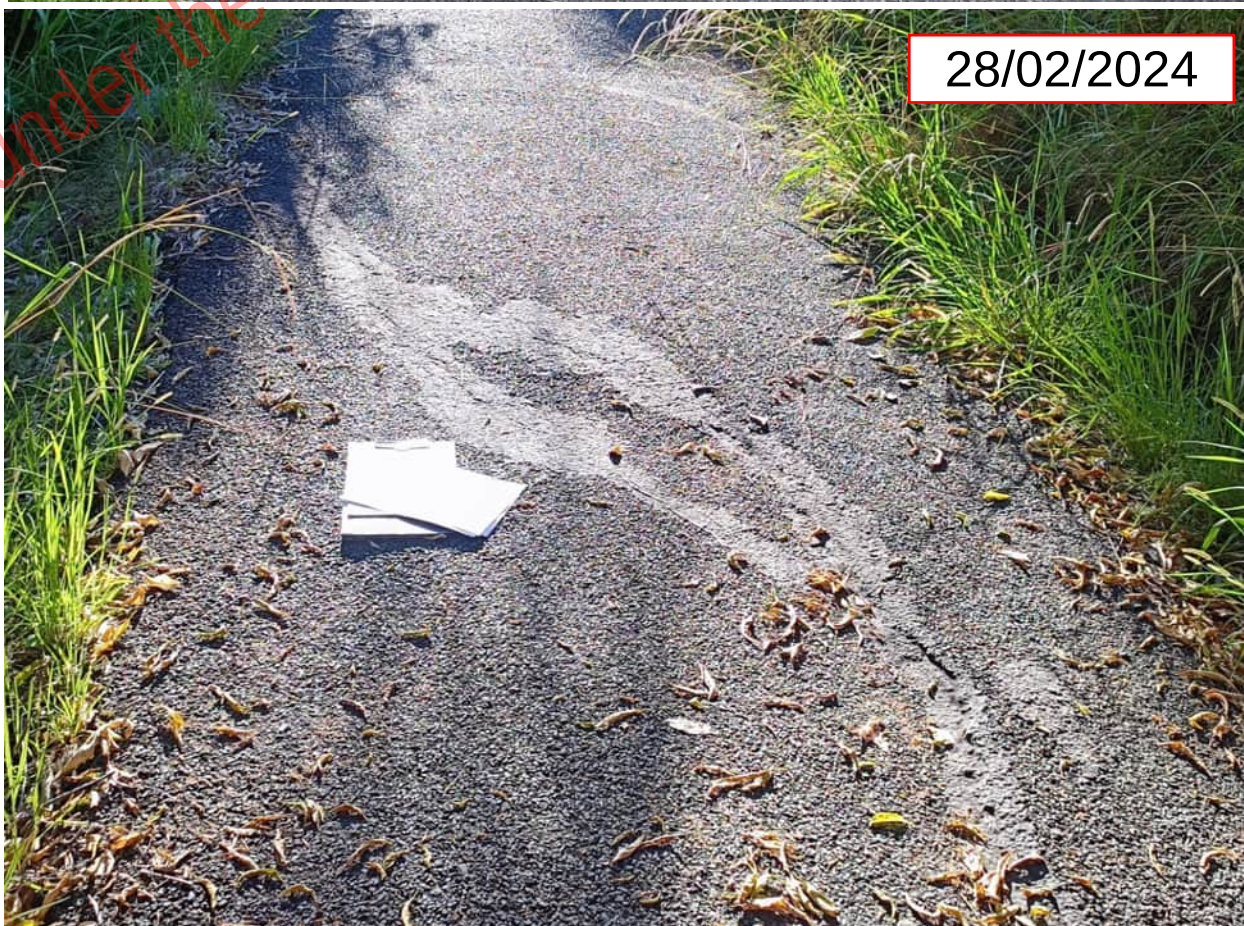
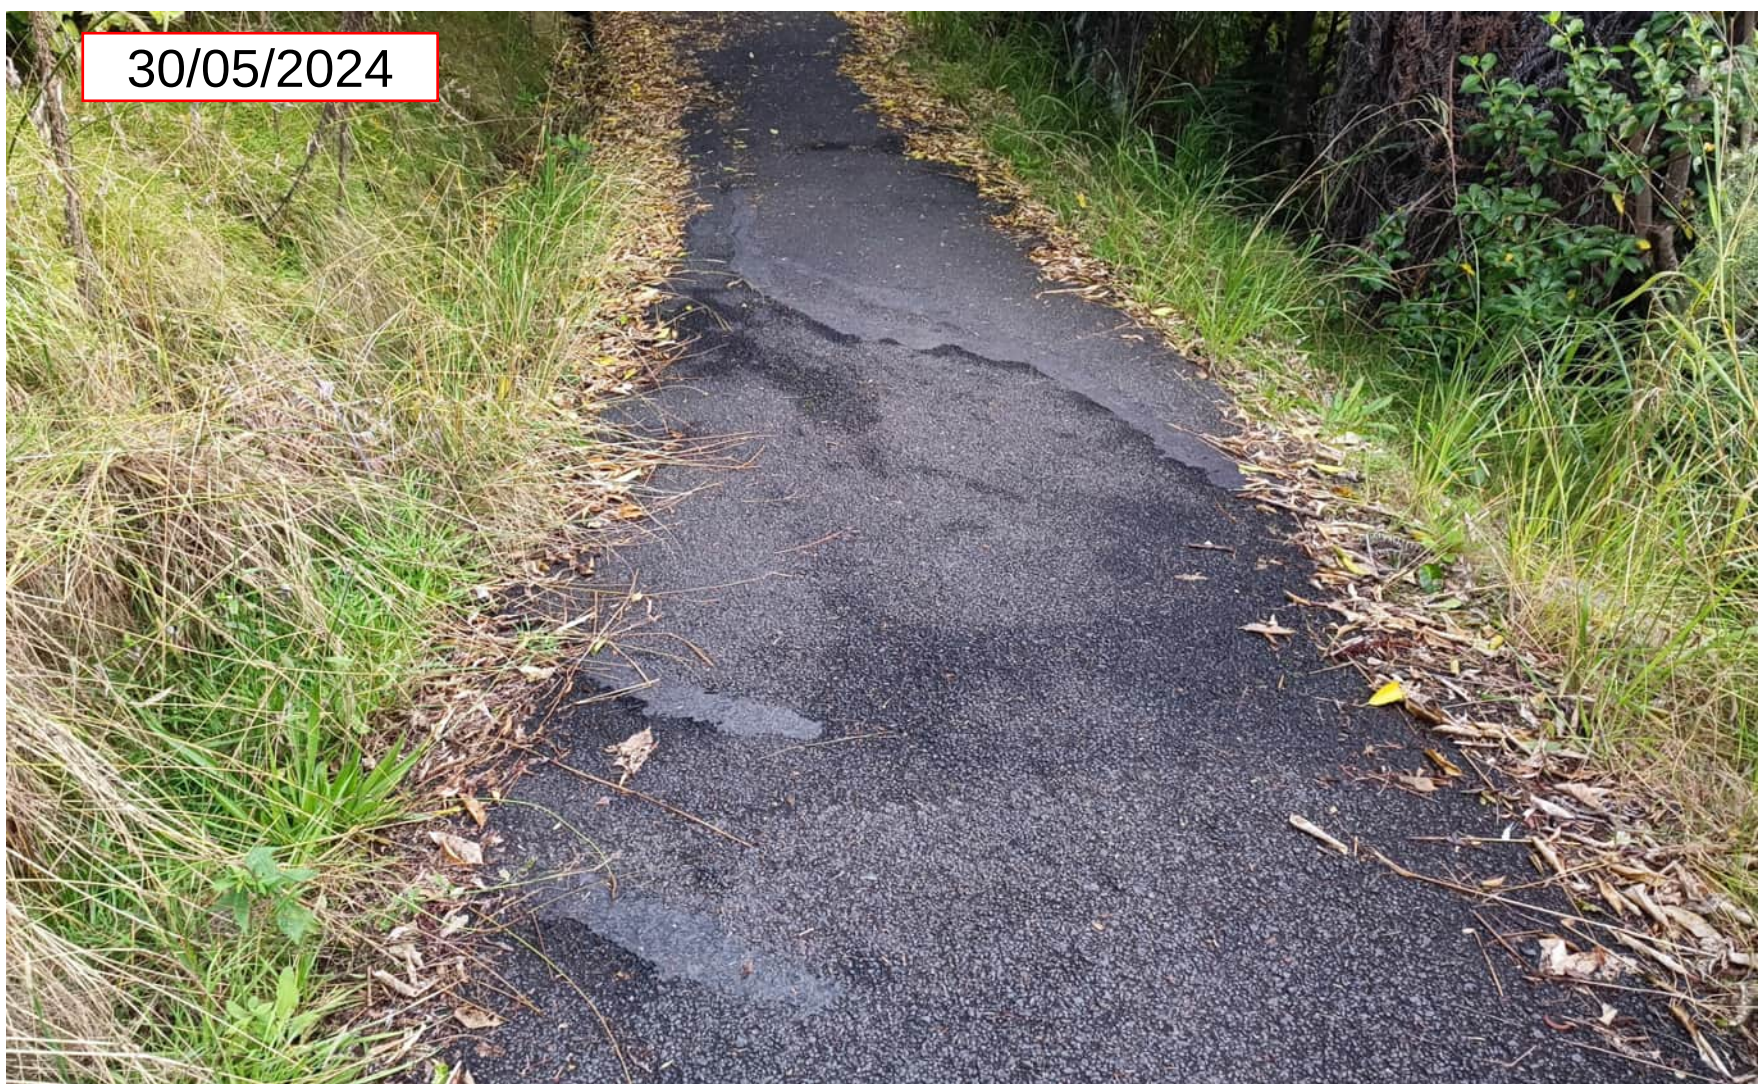
Feature 2 - One set of tension cracks. No new movement.

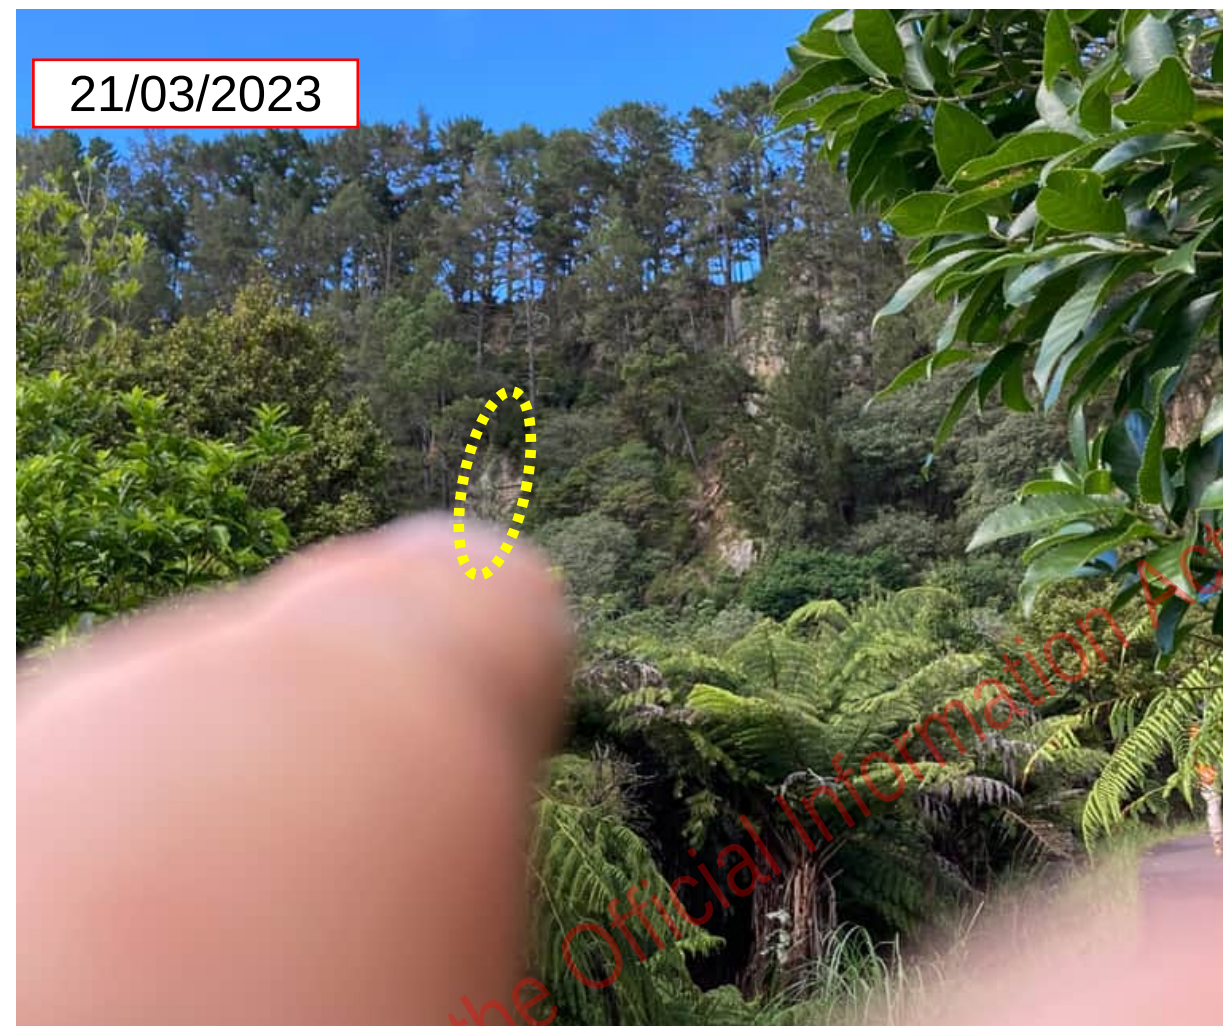
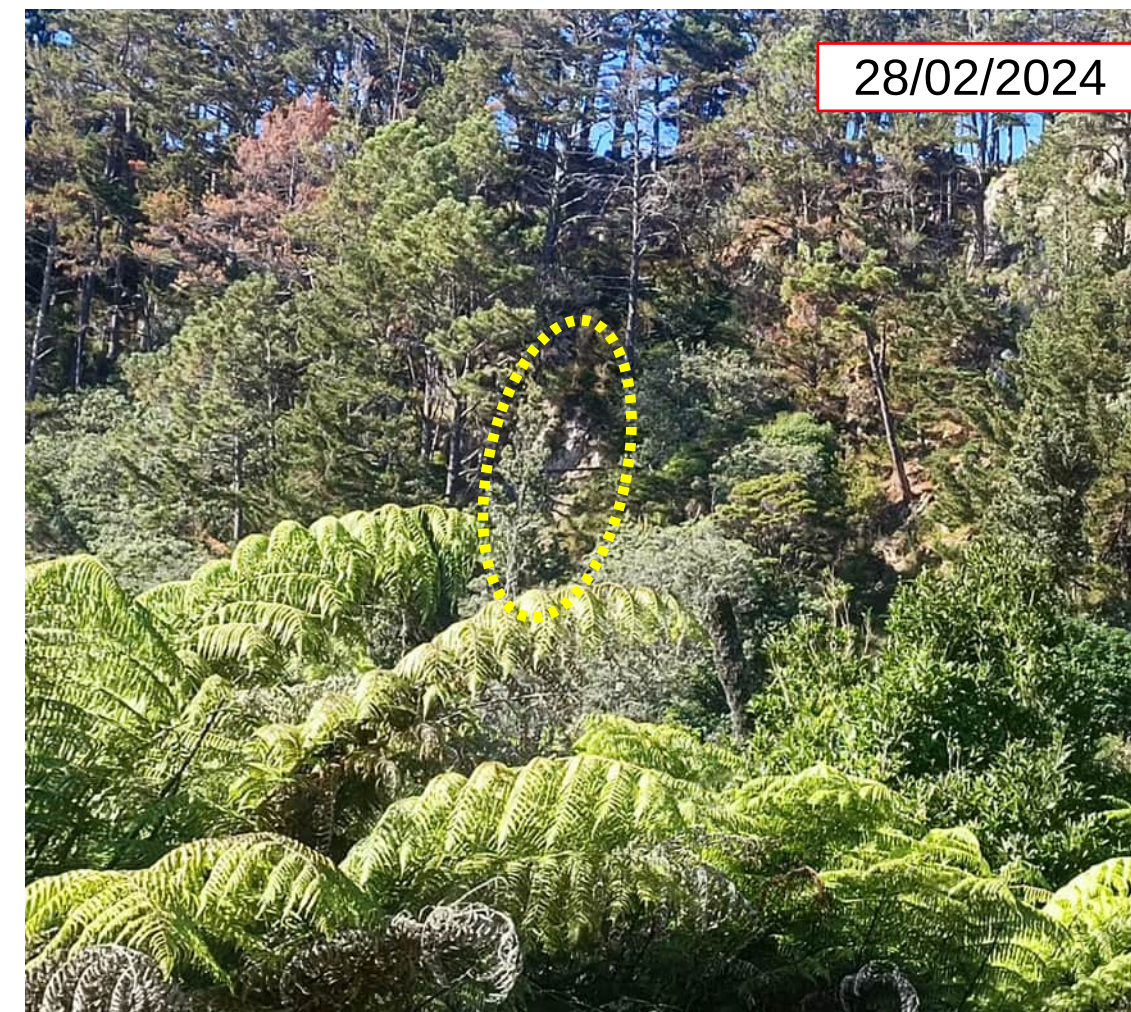
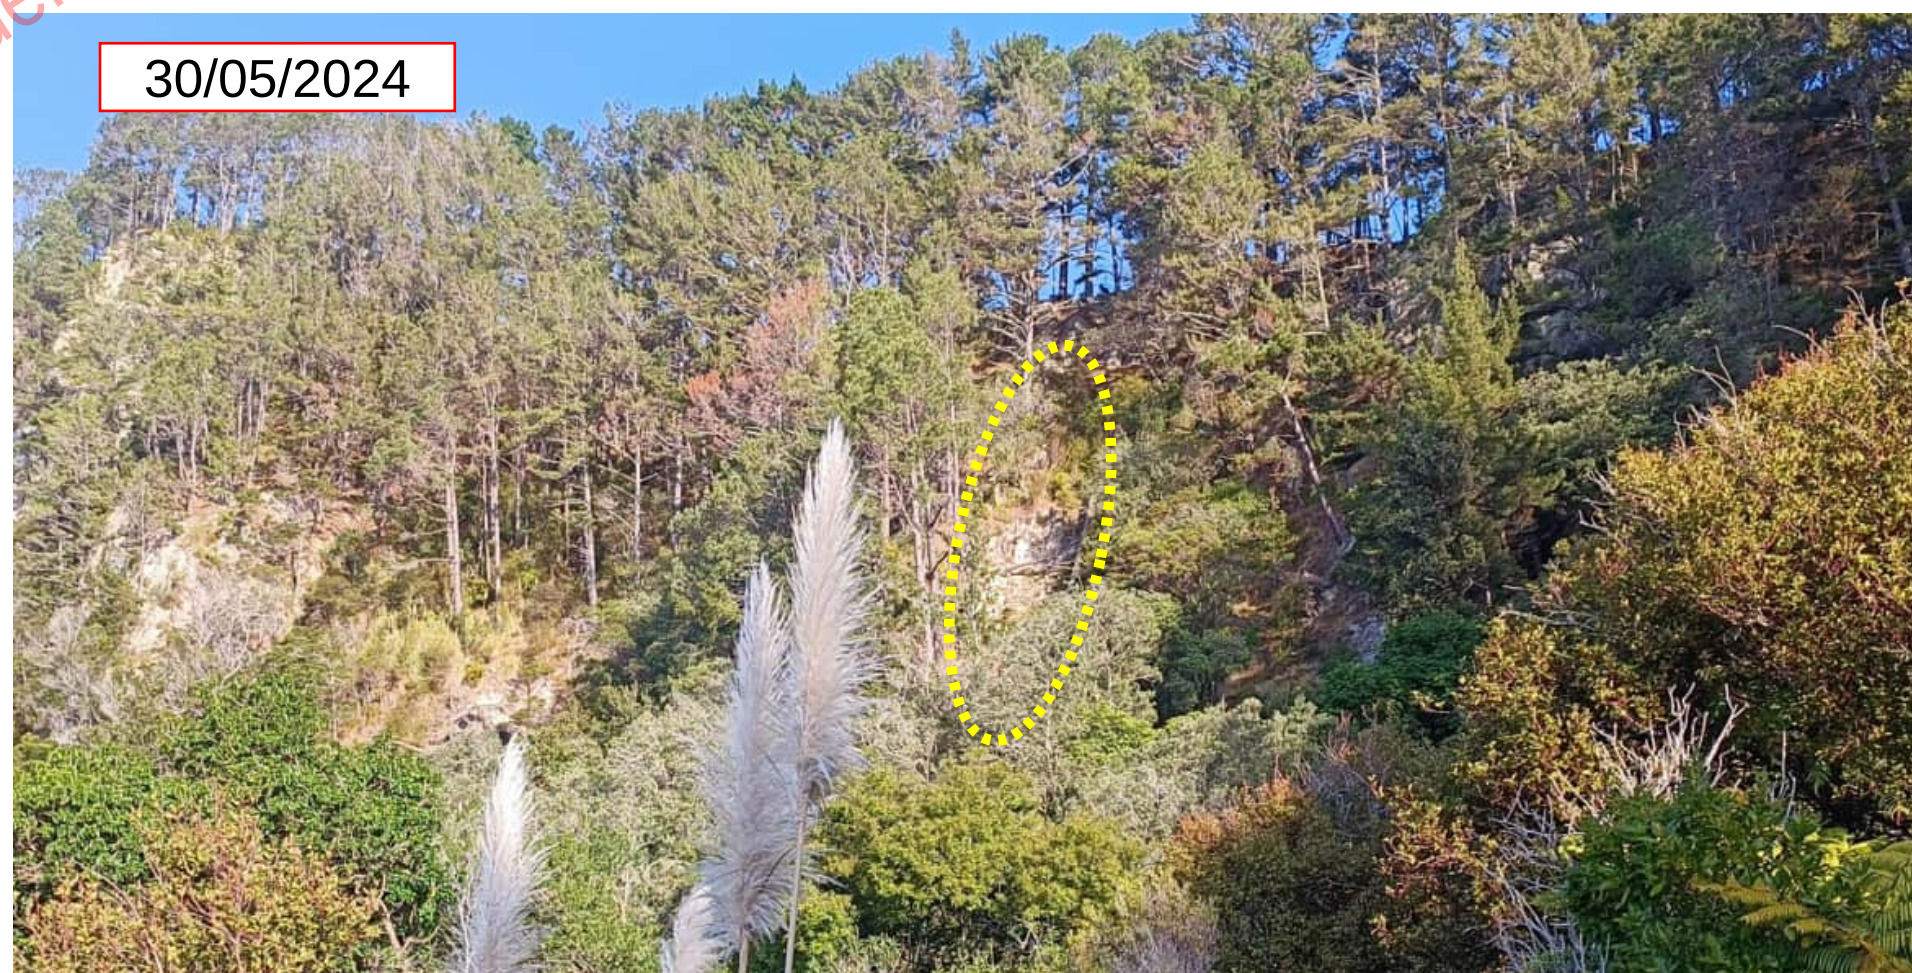
Feature 3 - Rockfall. No new movement

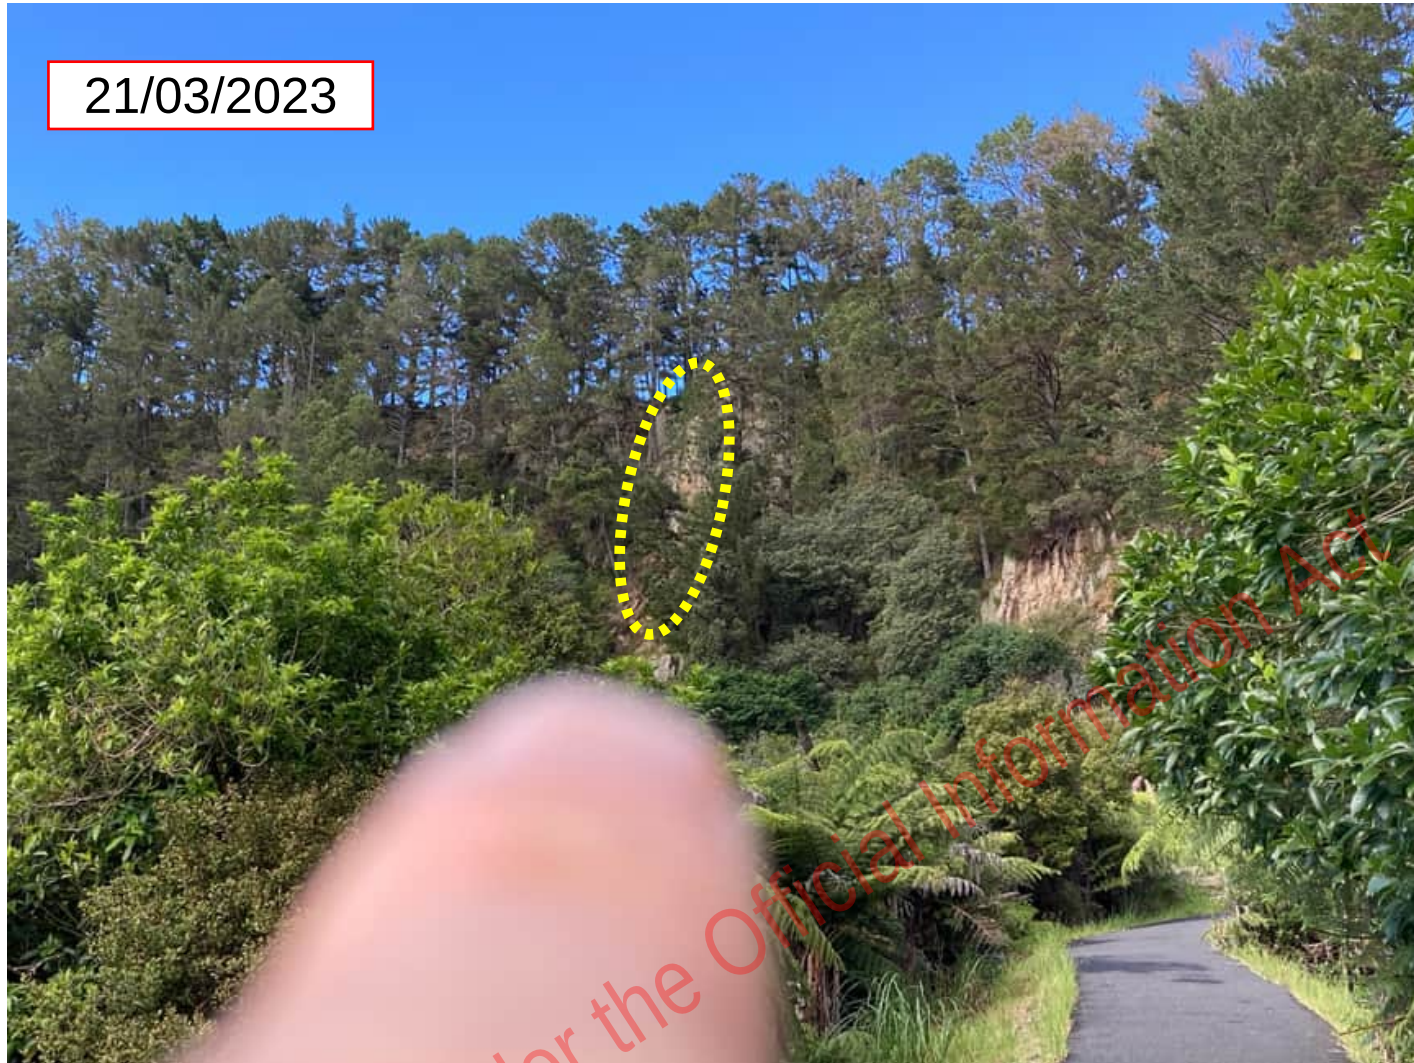
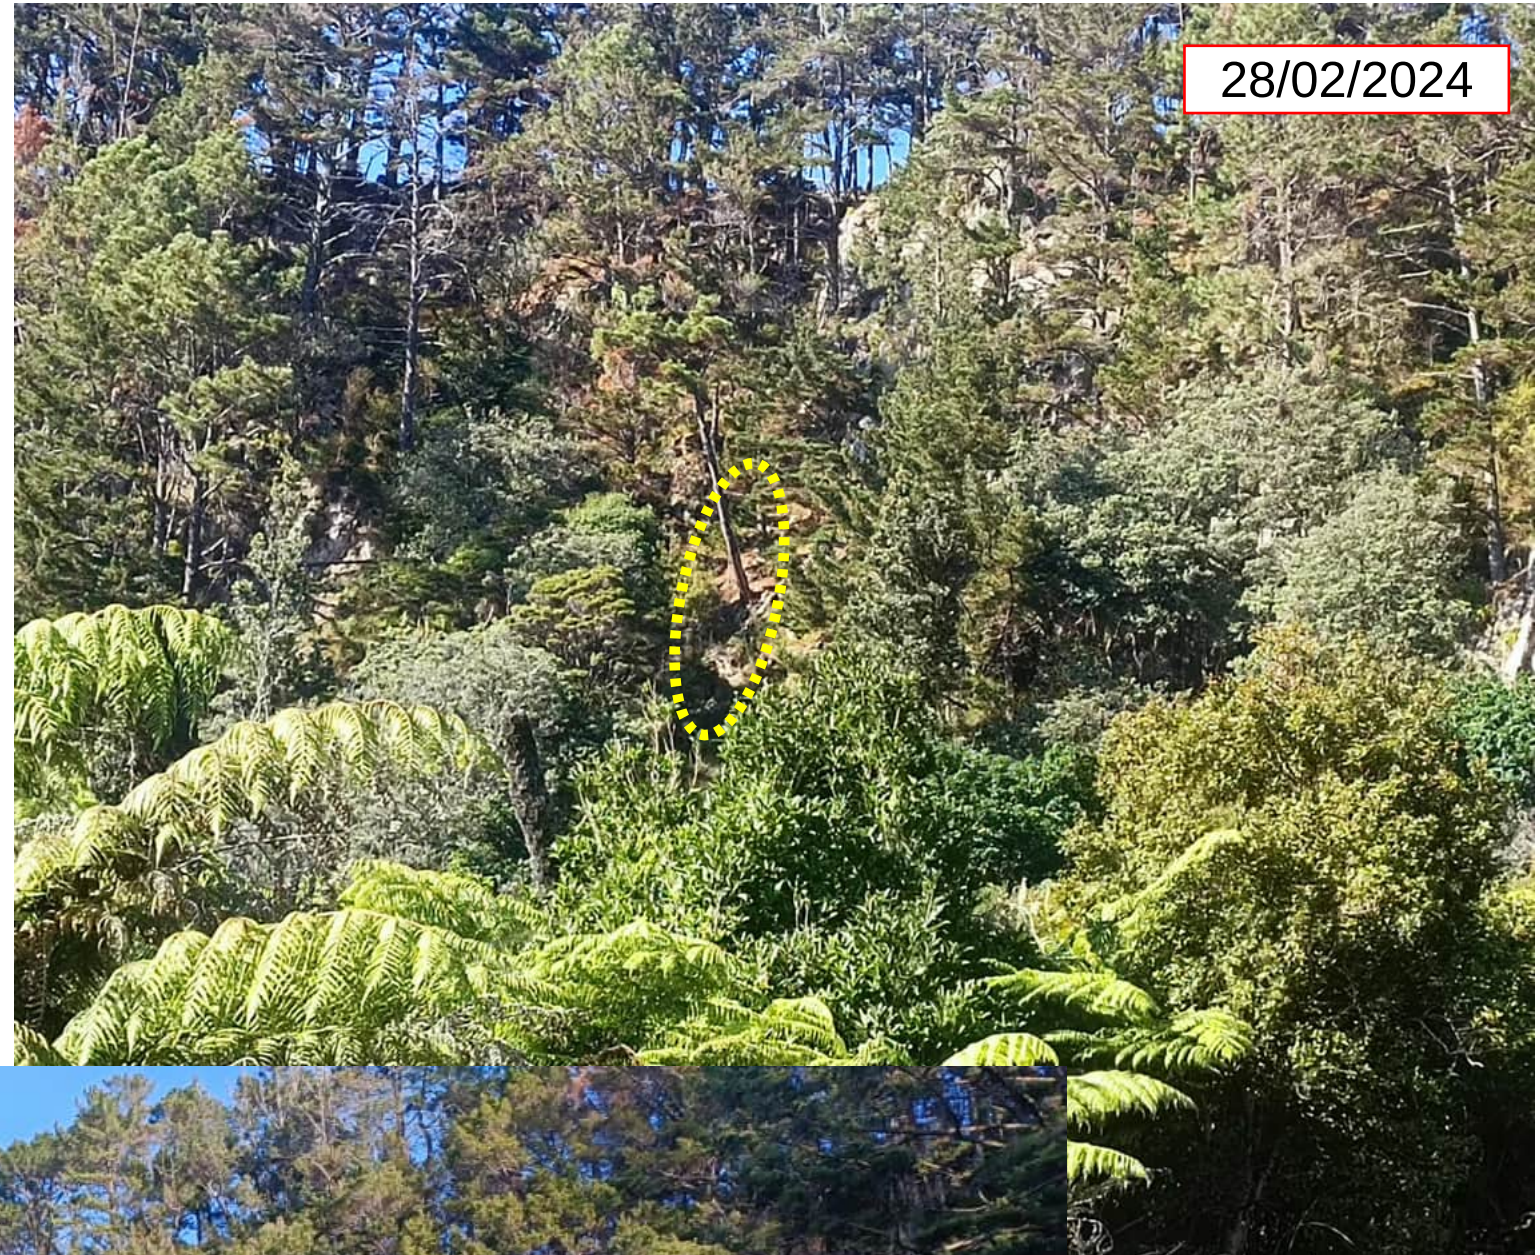
Feature 4 - Rockfall. No new movement

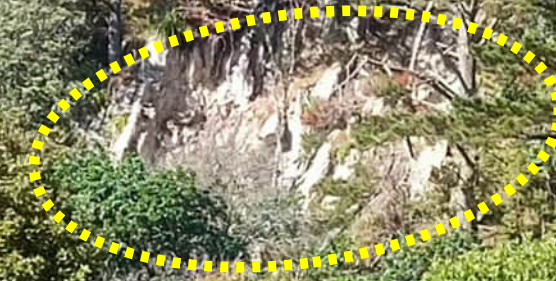
Feature 5 - Rockfall. No new movement

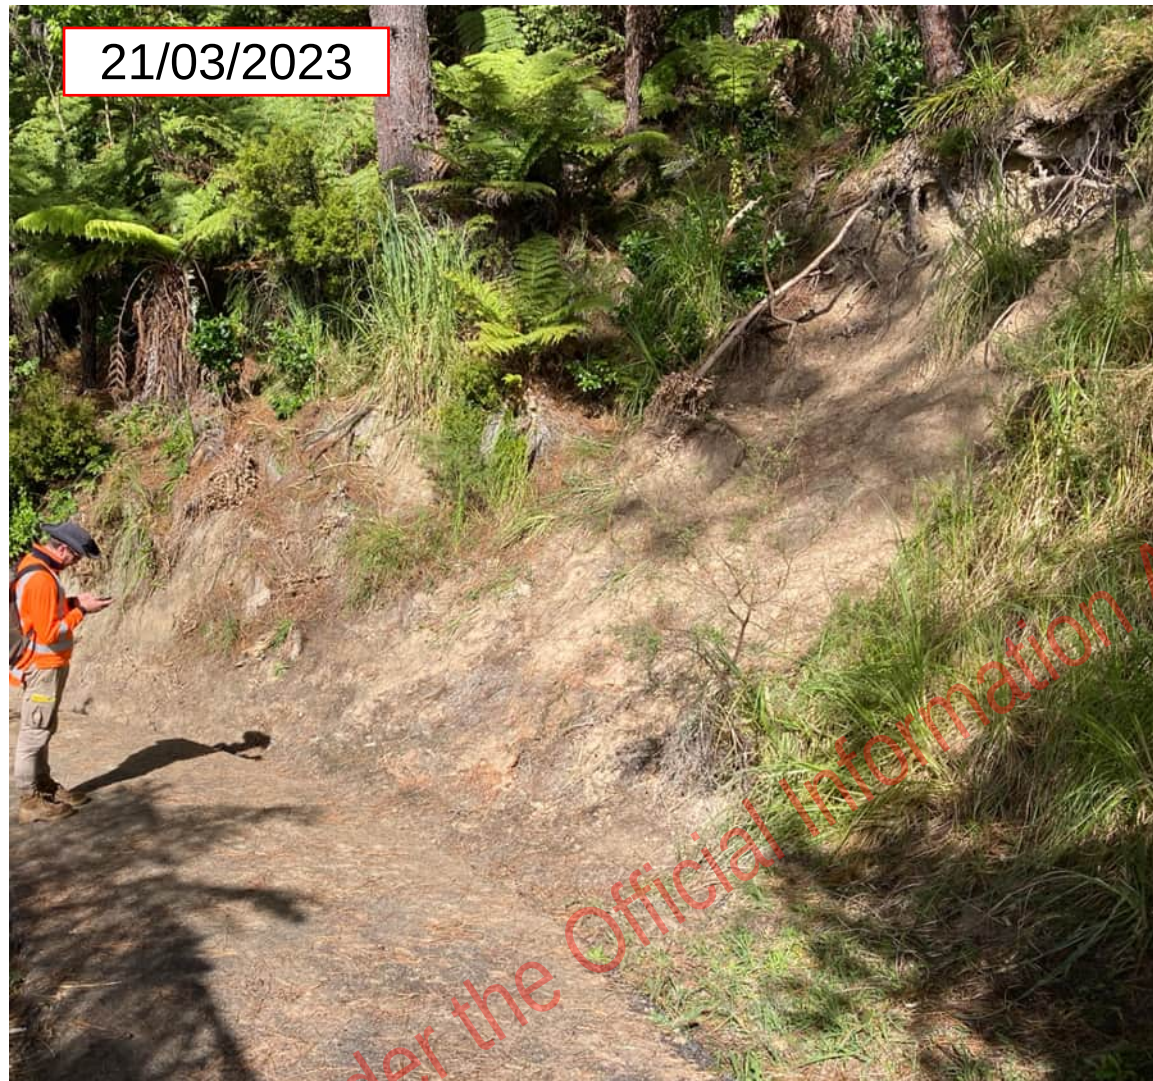
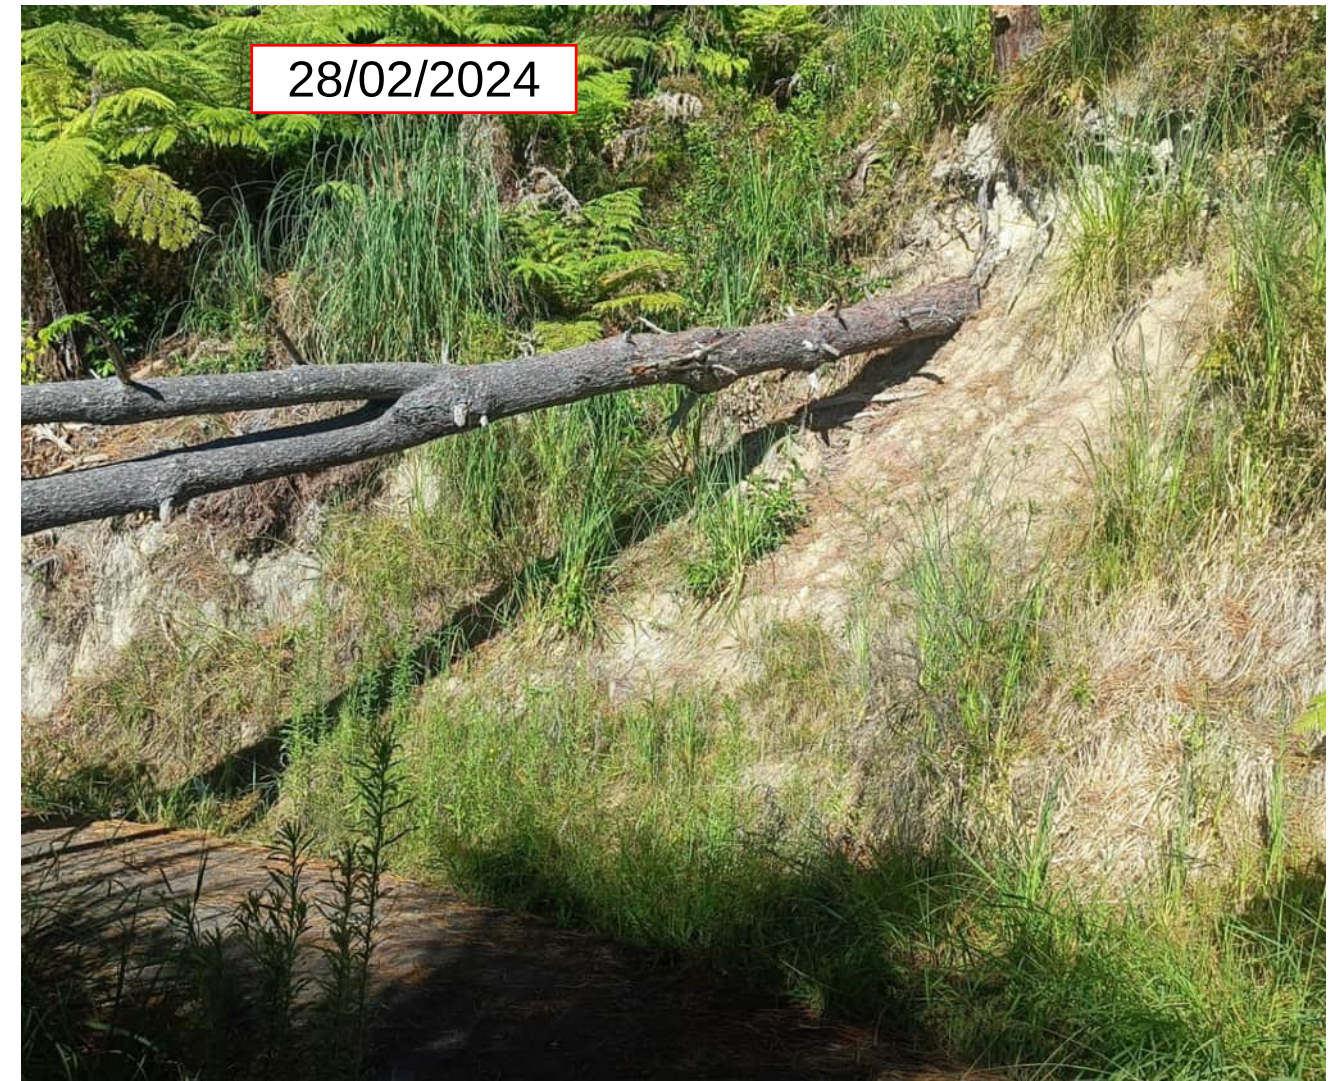
Feature 6 - Translational landslide. No new movement.

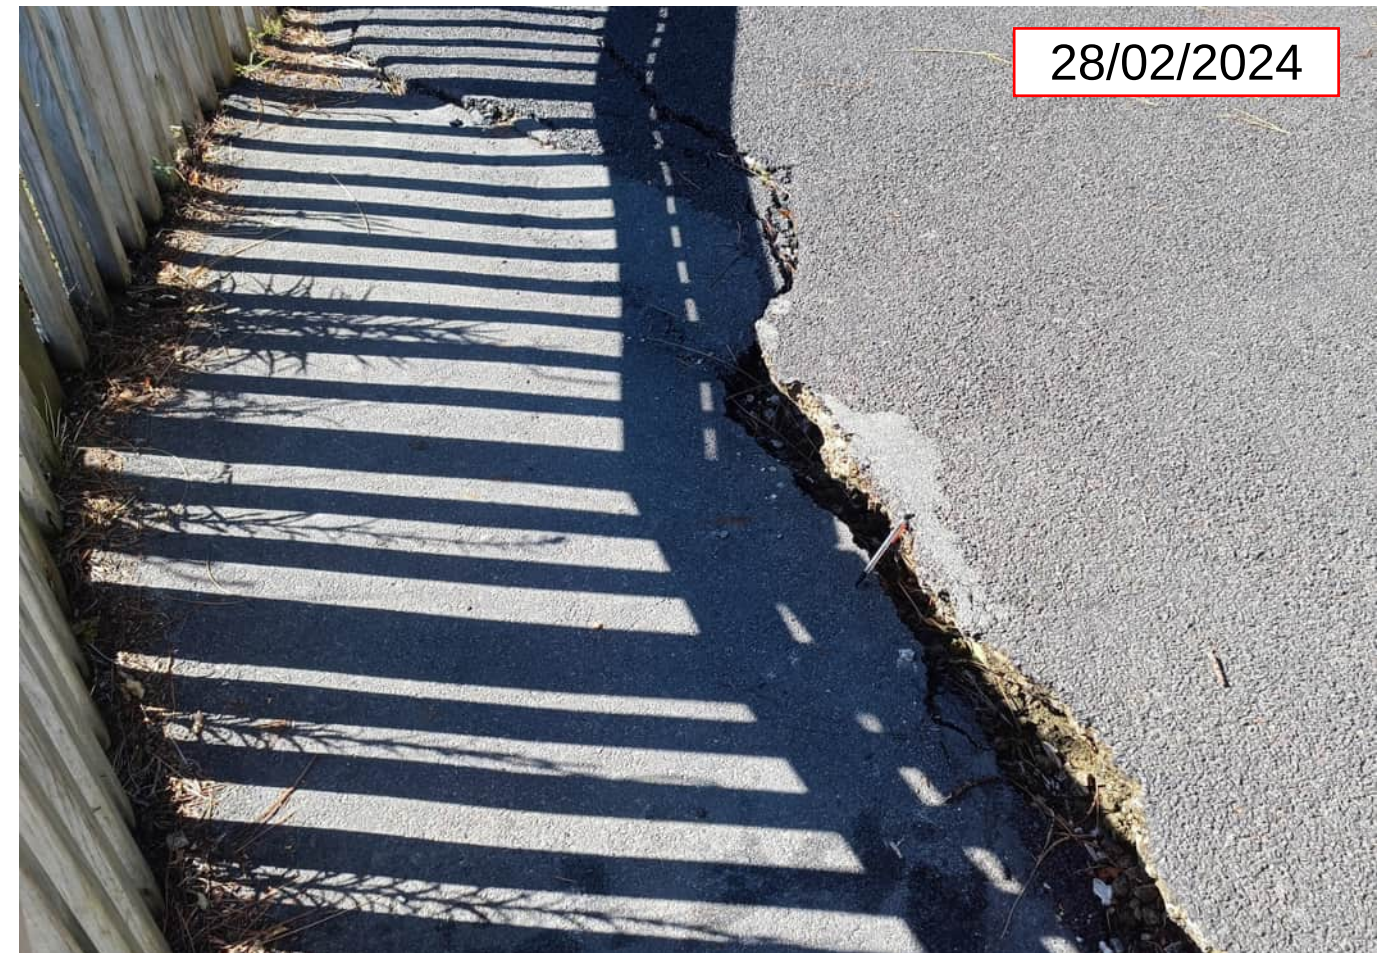
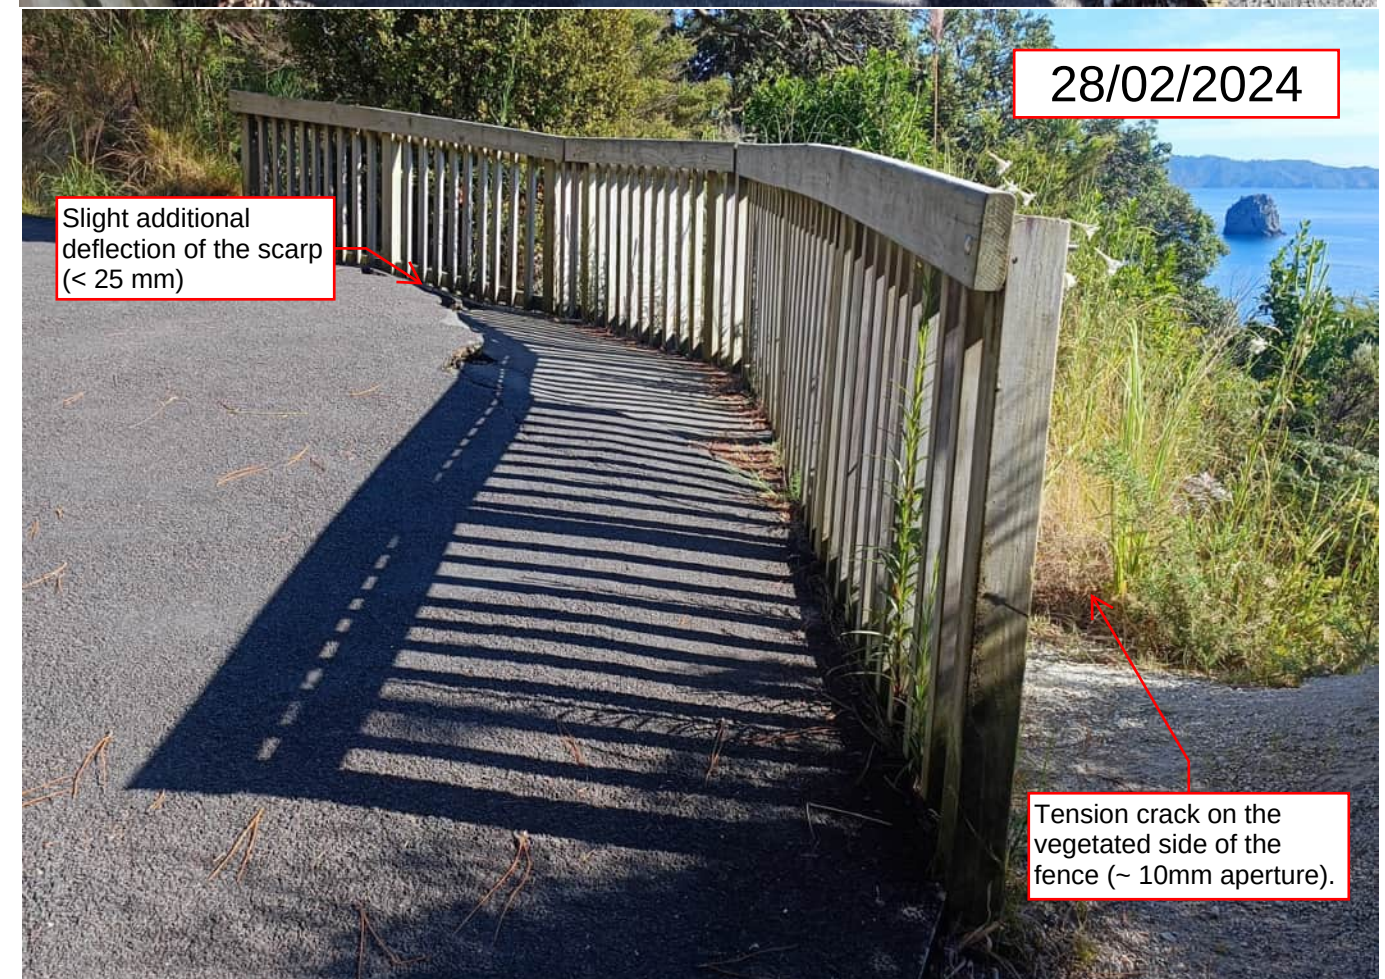
- 4 Feature 7 is continuing to move, and we expect that this slow moving landslide will continue to move downslope. A rapid failure at this location might occur, however we do not know if/when this might eventuate. Based on the ongoing movement observed to date and our judgement only (i.e., not analysed), we might expect a rapid event could occur within a short time period (i.e., next year or two).

Feature 7 - Translational landslide  
Small amounts of additional deflection  
in the scarp observed during Feb 2024  
visit.
