**Cathedral Cove Basic Level  
Landslide Risk Assessment**

**Prepared for**  
Department of Conservation  
**Prepared by**  
Tonkin & Taylor Ltd  
**Date**  
July 2023  
**Job Number**  
1007838.3000 v3

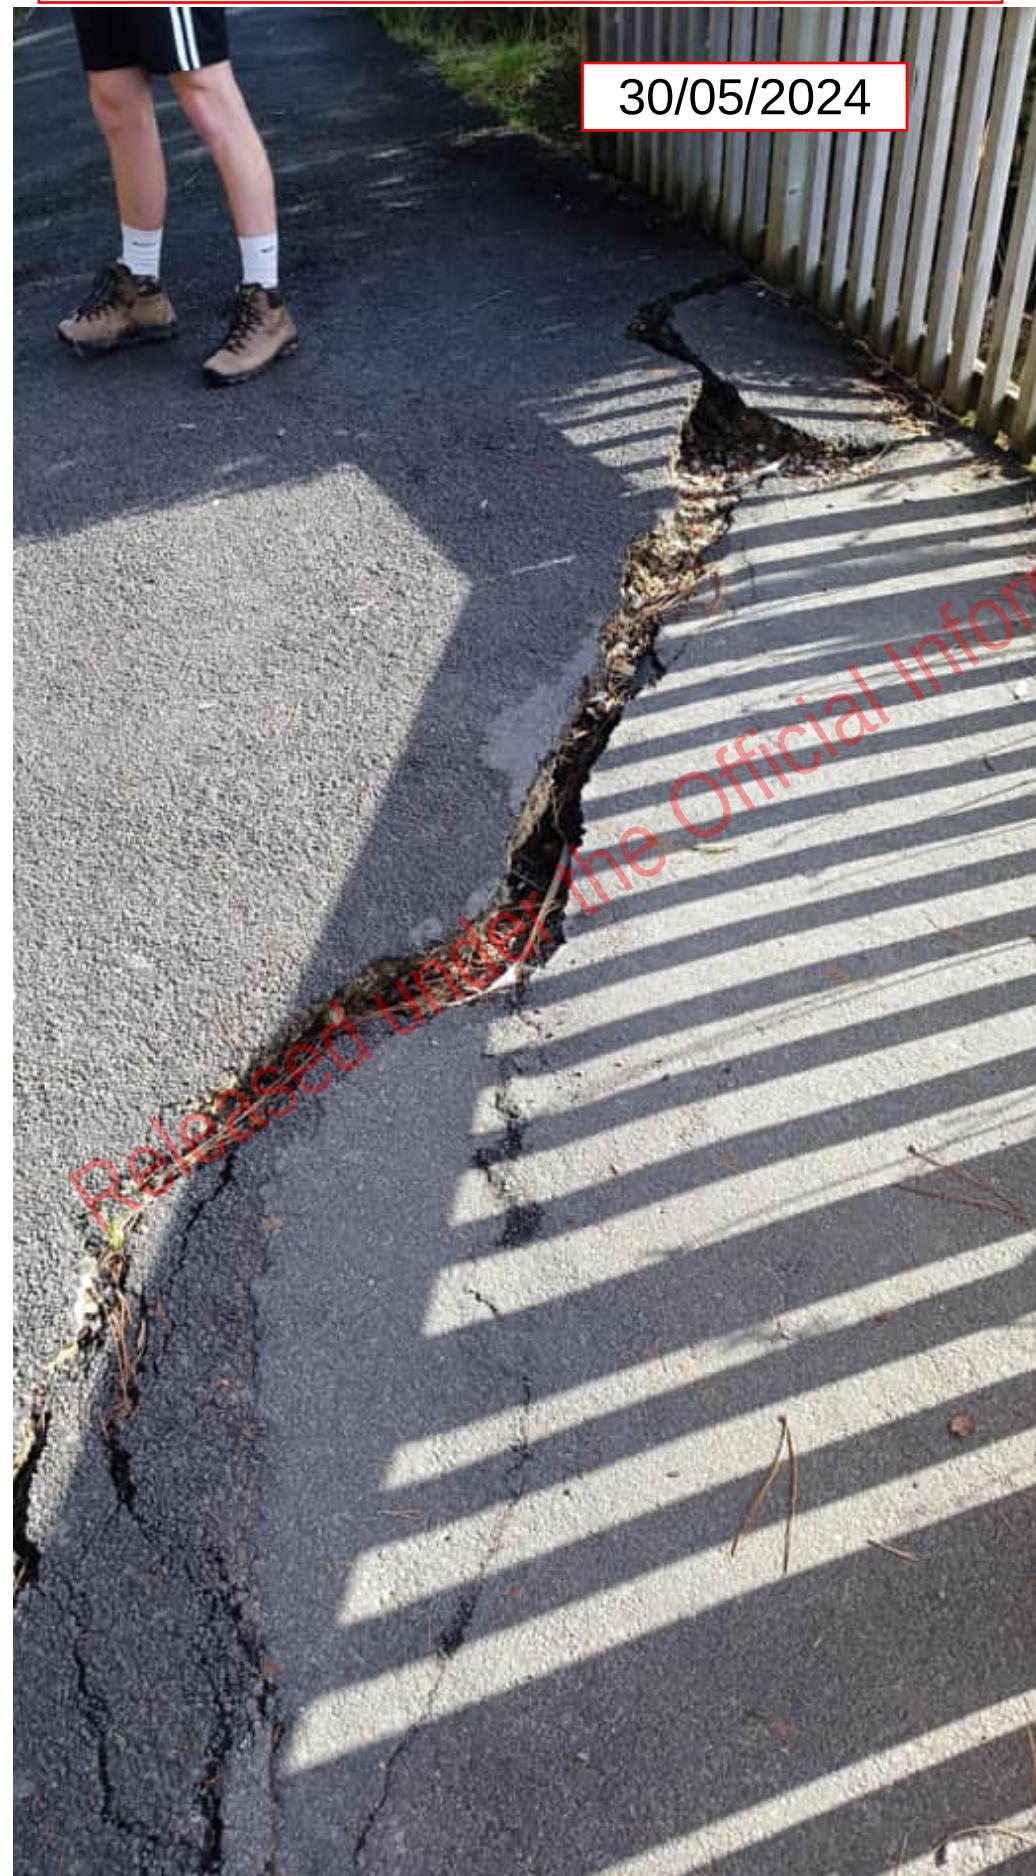
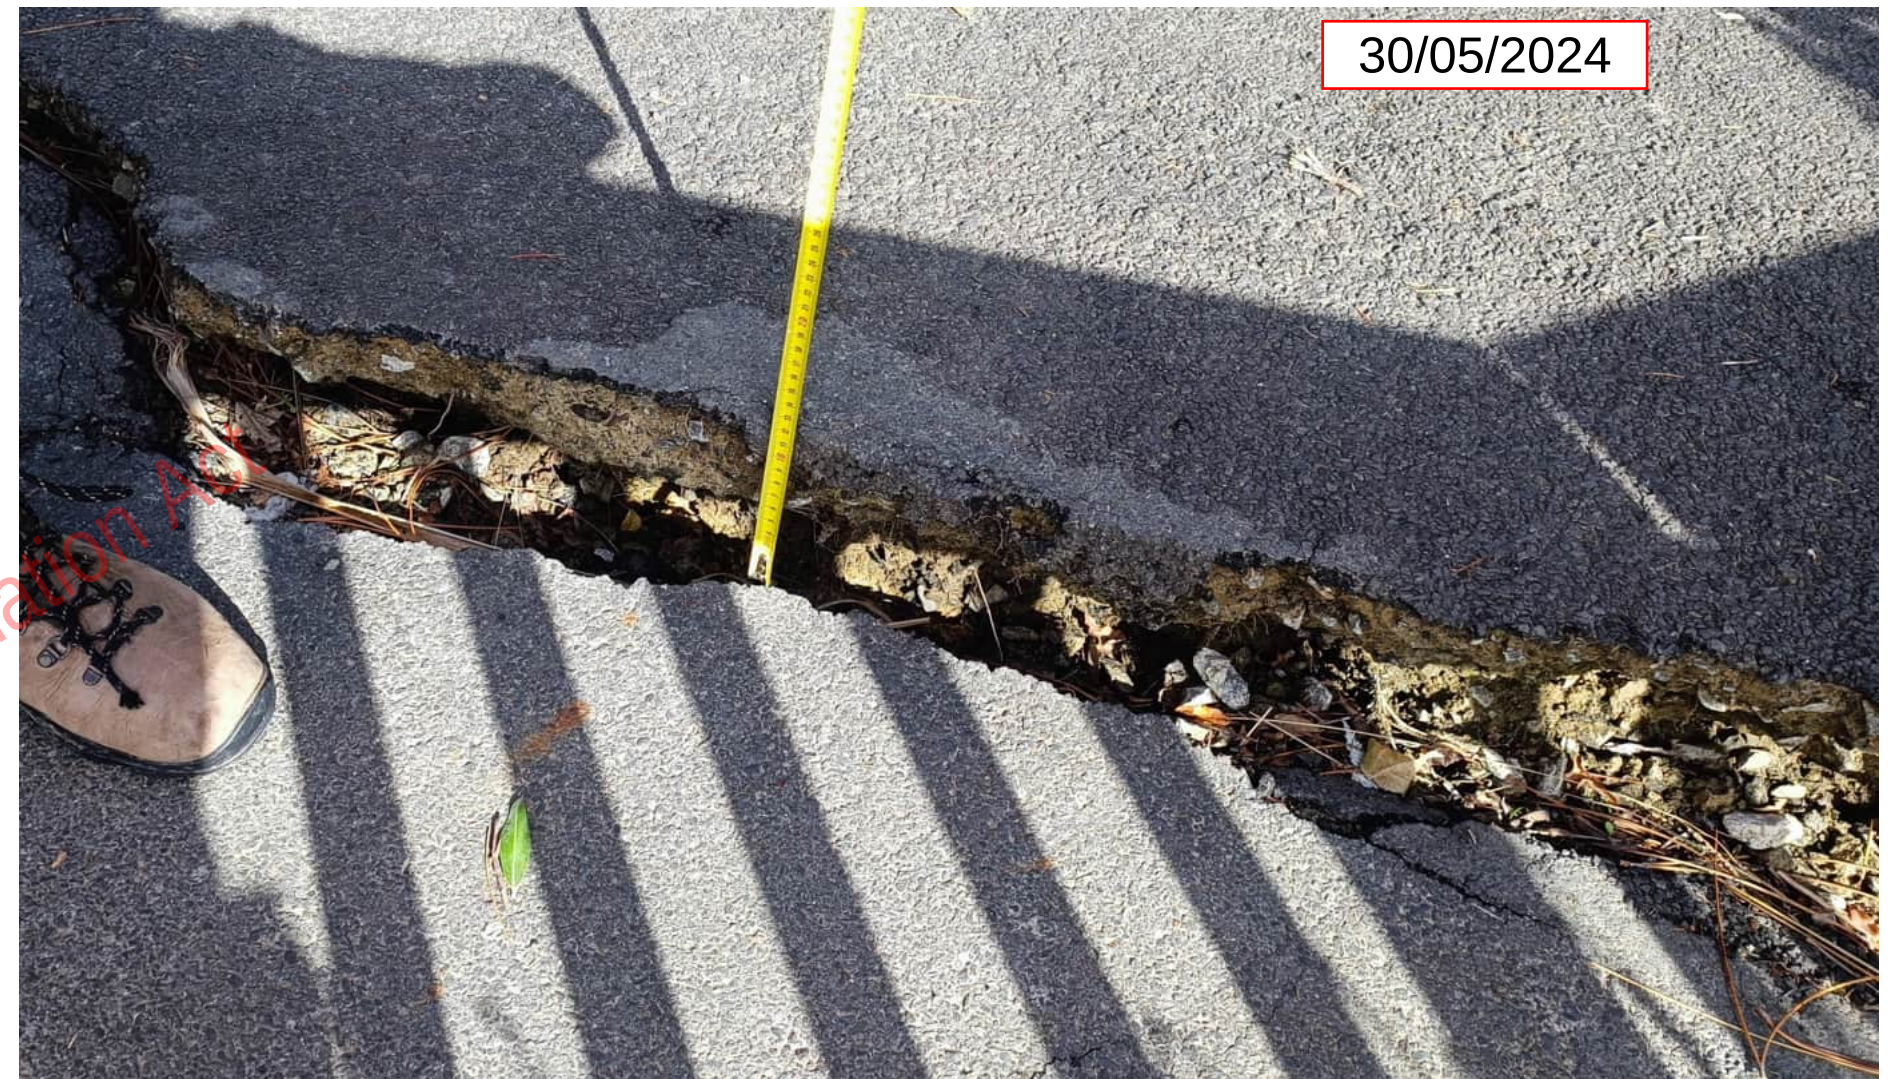
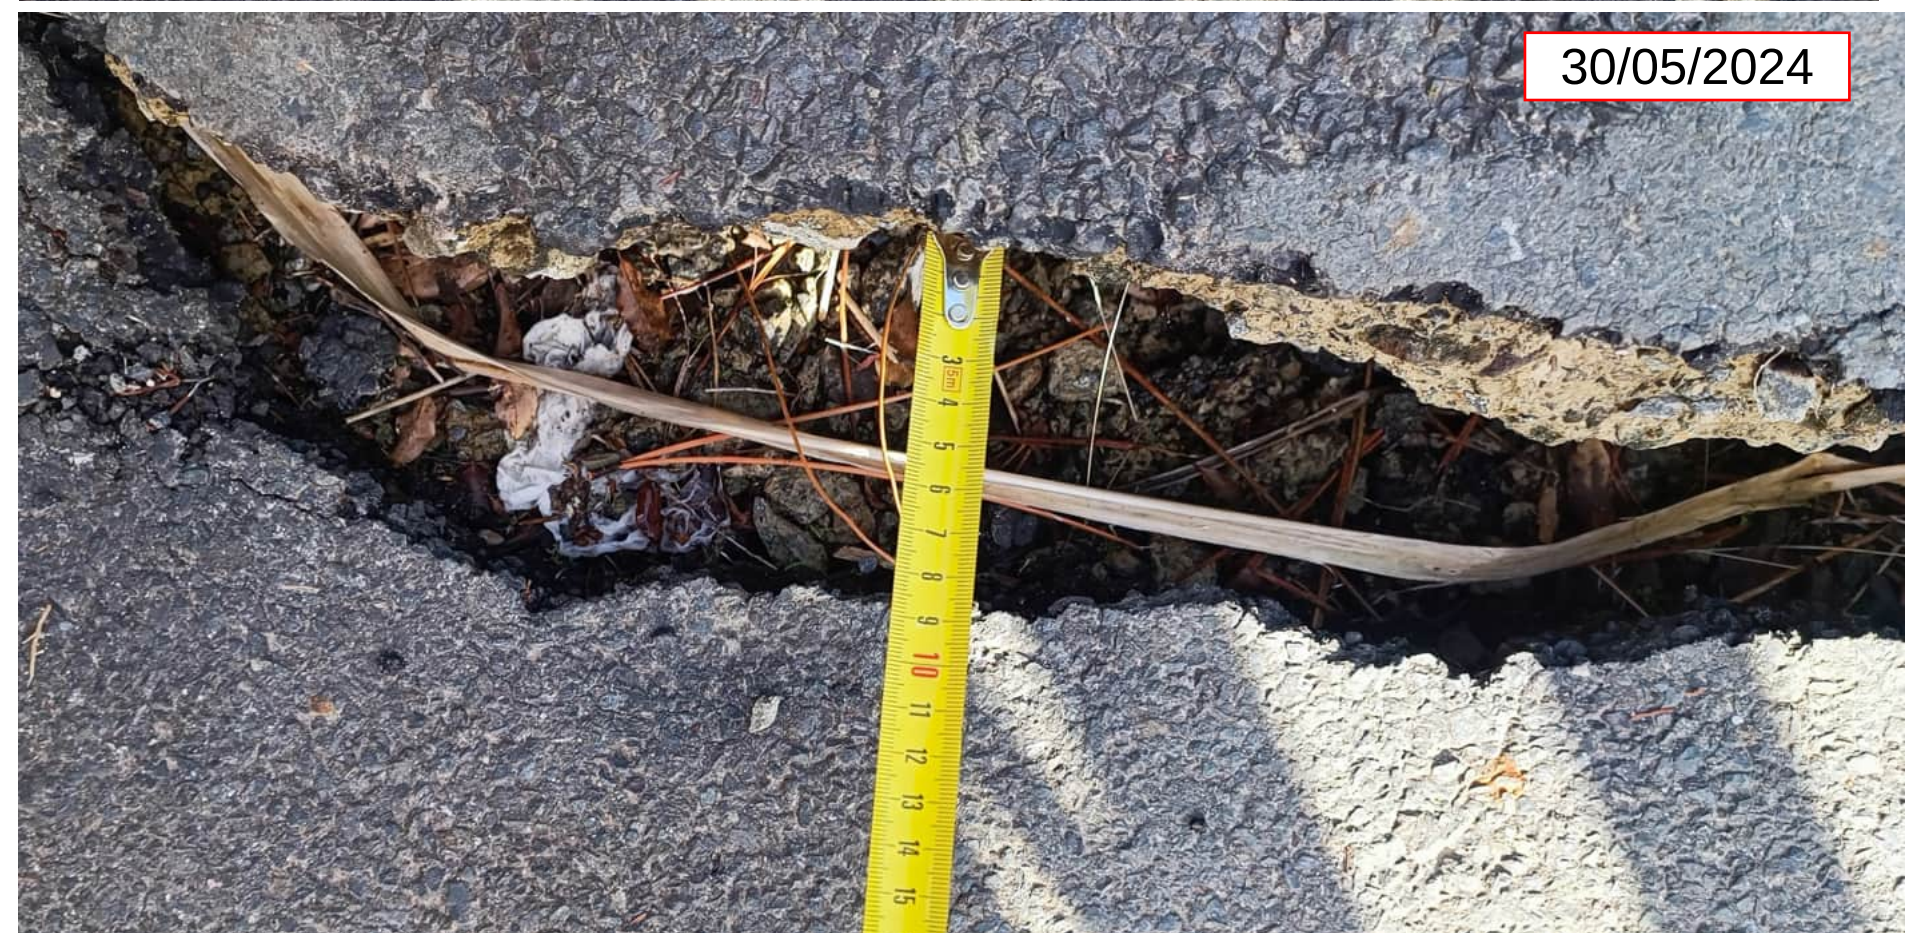
- The changes observed were as follows:
    - o Some additional small movement (< 25 mm) of the landslide headscarp near the viewing platform (Feature 7).

Feature 7 Cont. - Translational landslide  
Small additional deflection in the scarp  
observed during May 2024 visit.

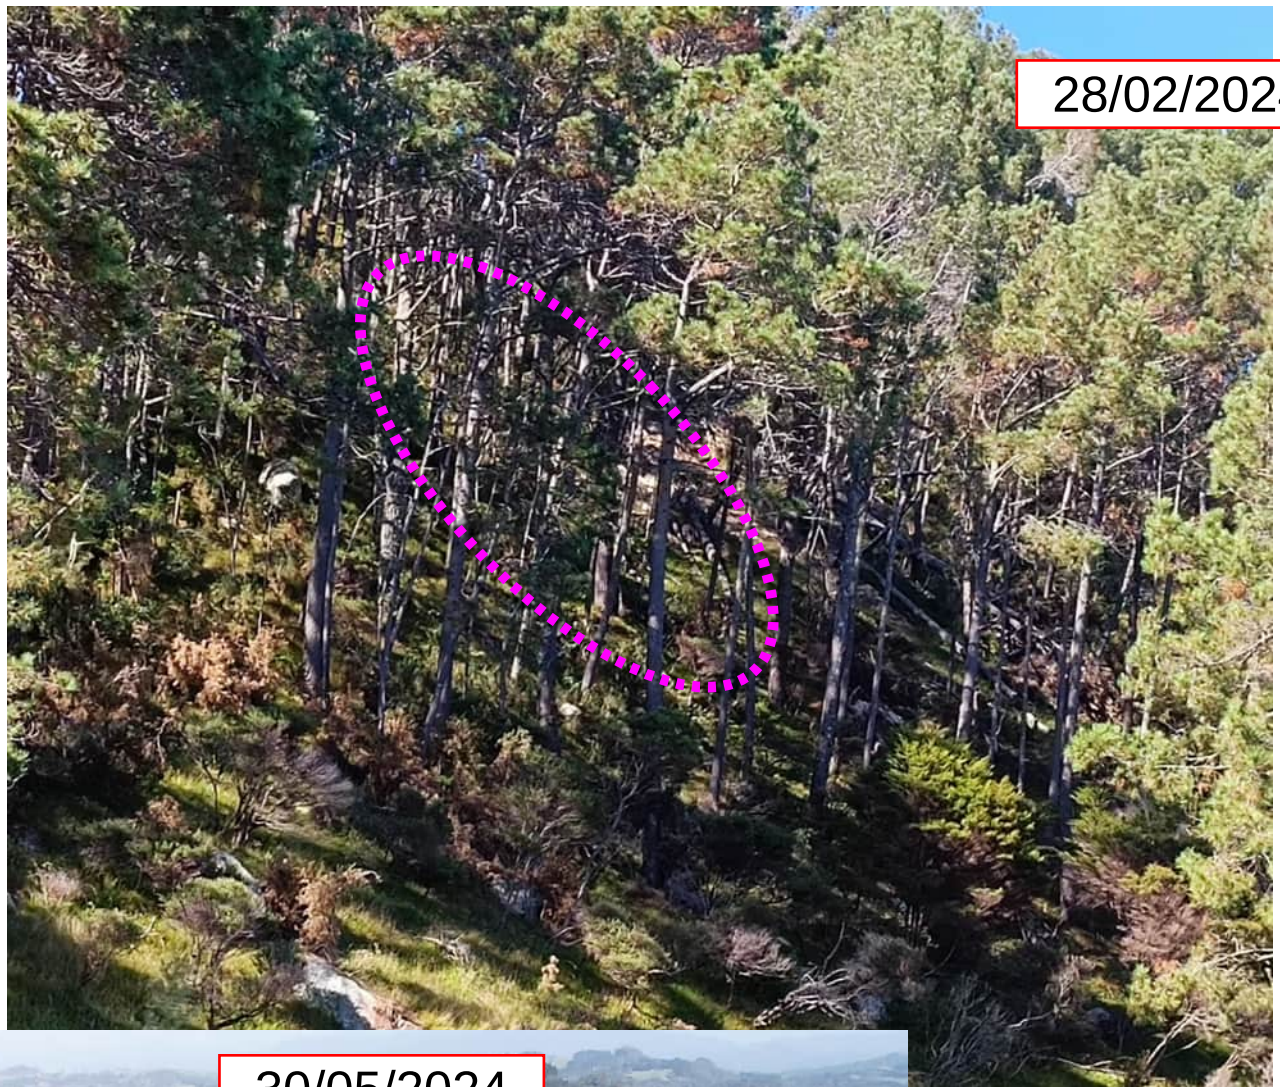
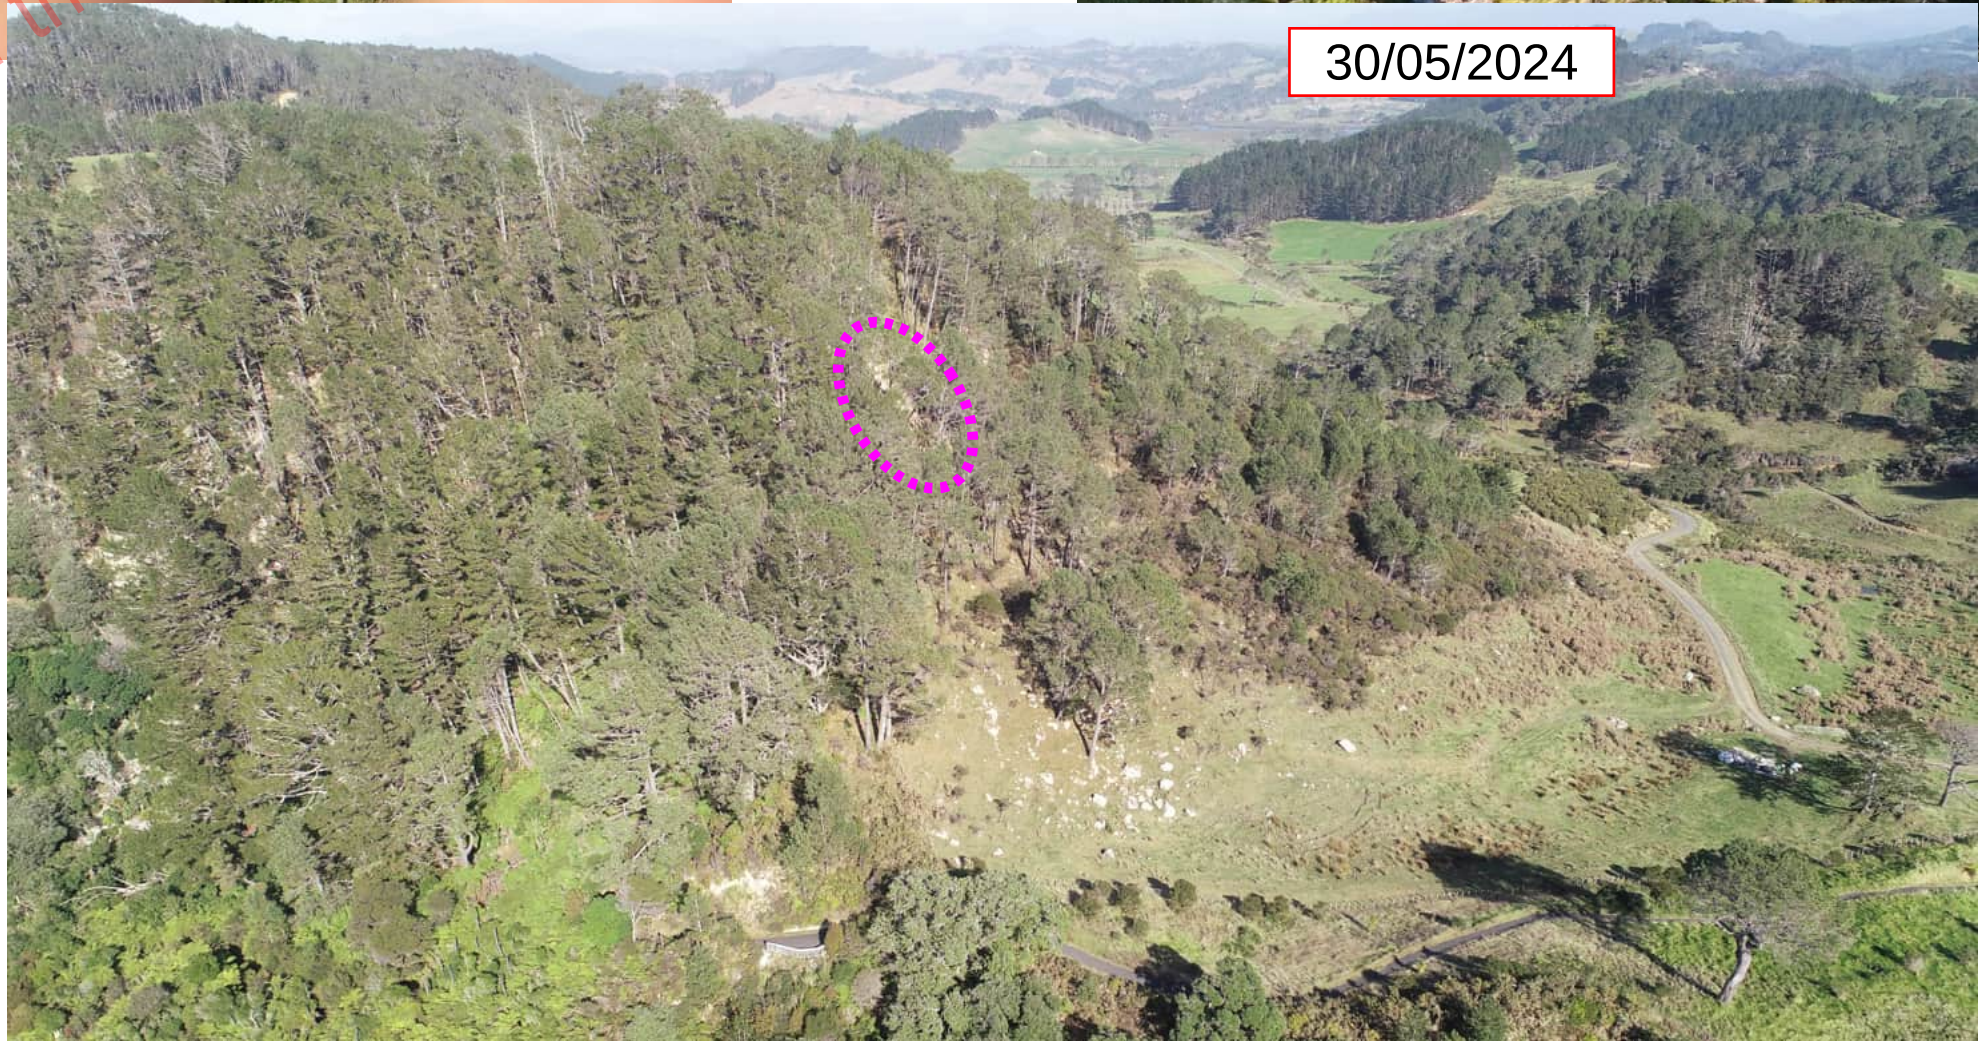
Feature 8 - Debris flow landslide. No new movement

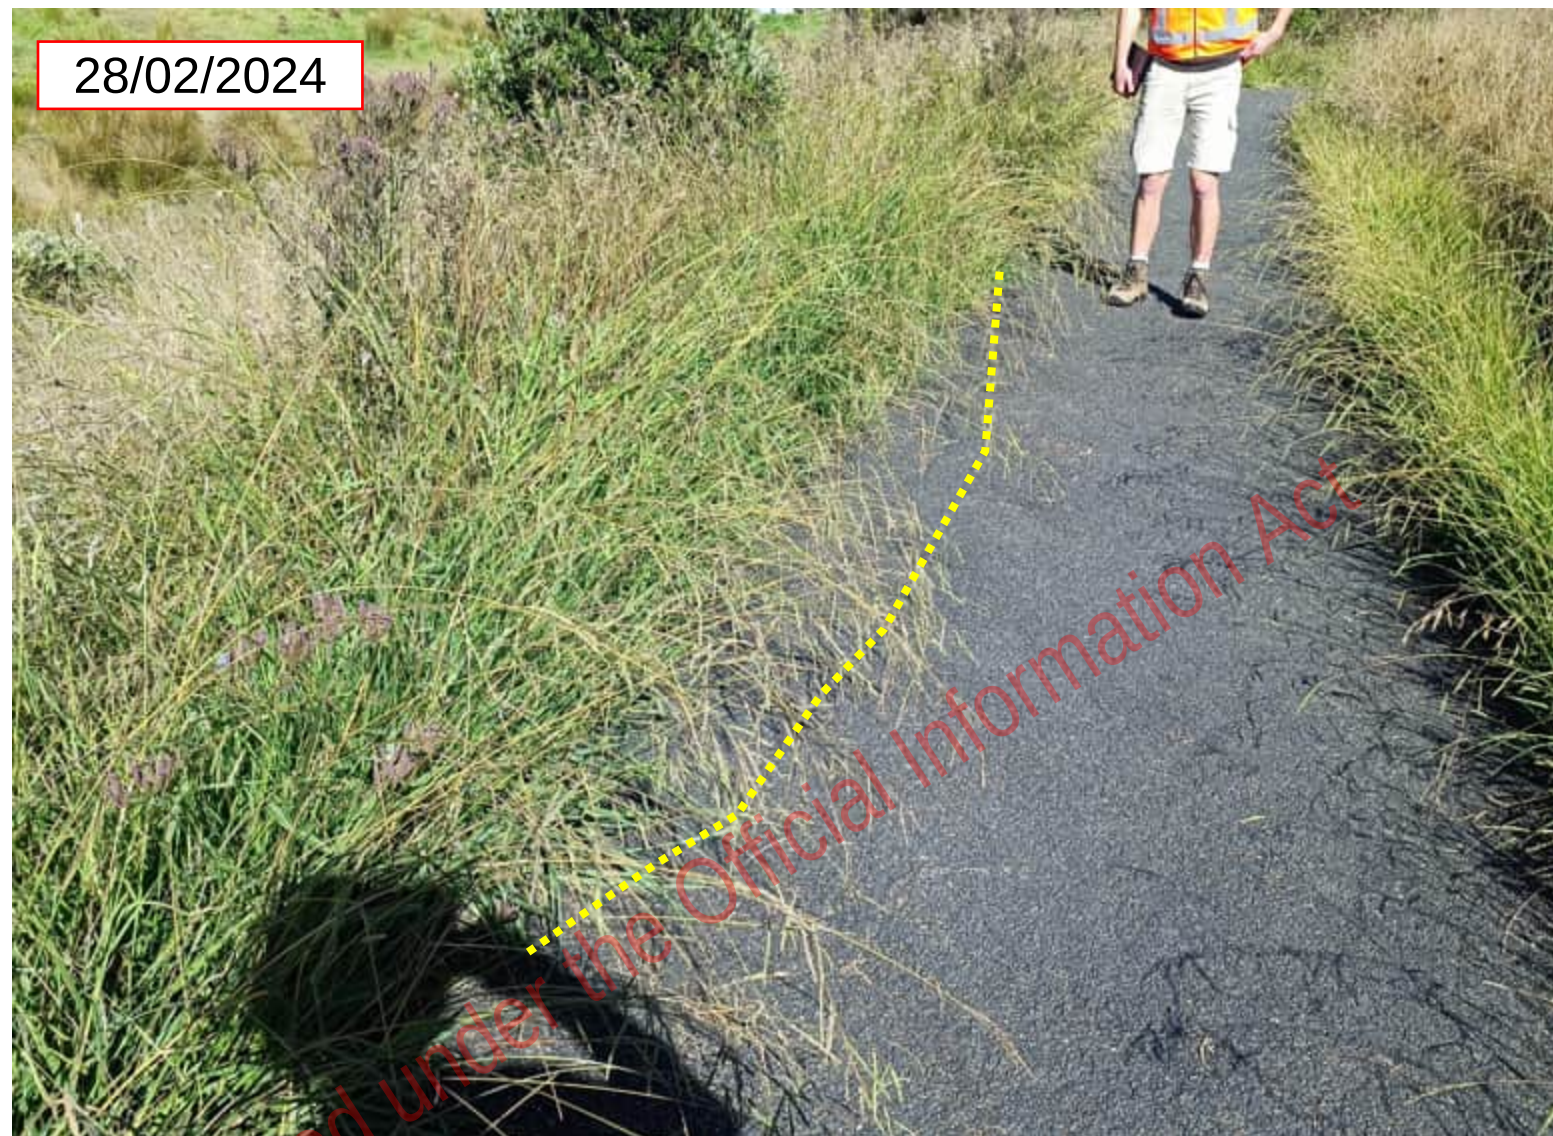
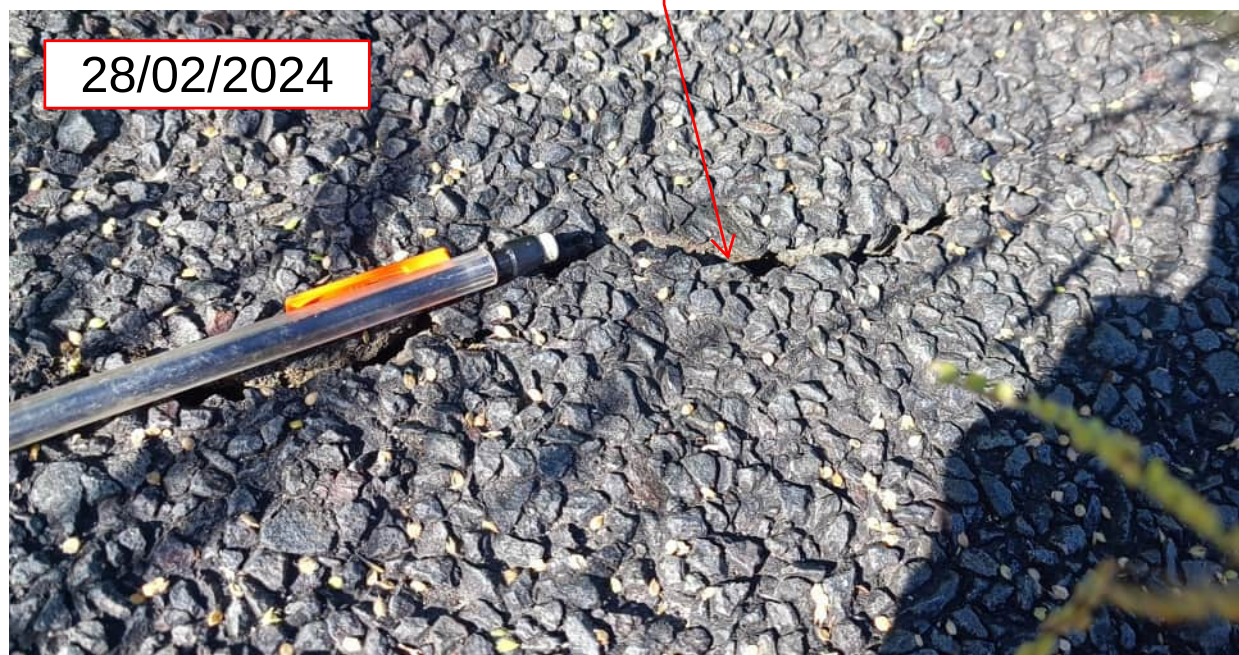
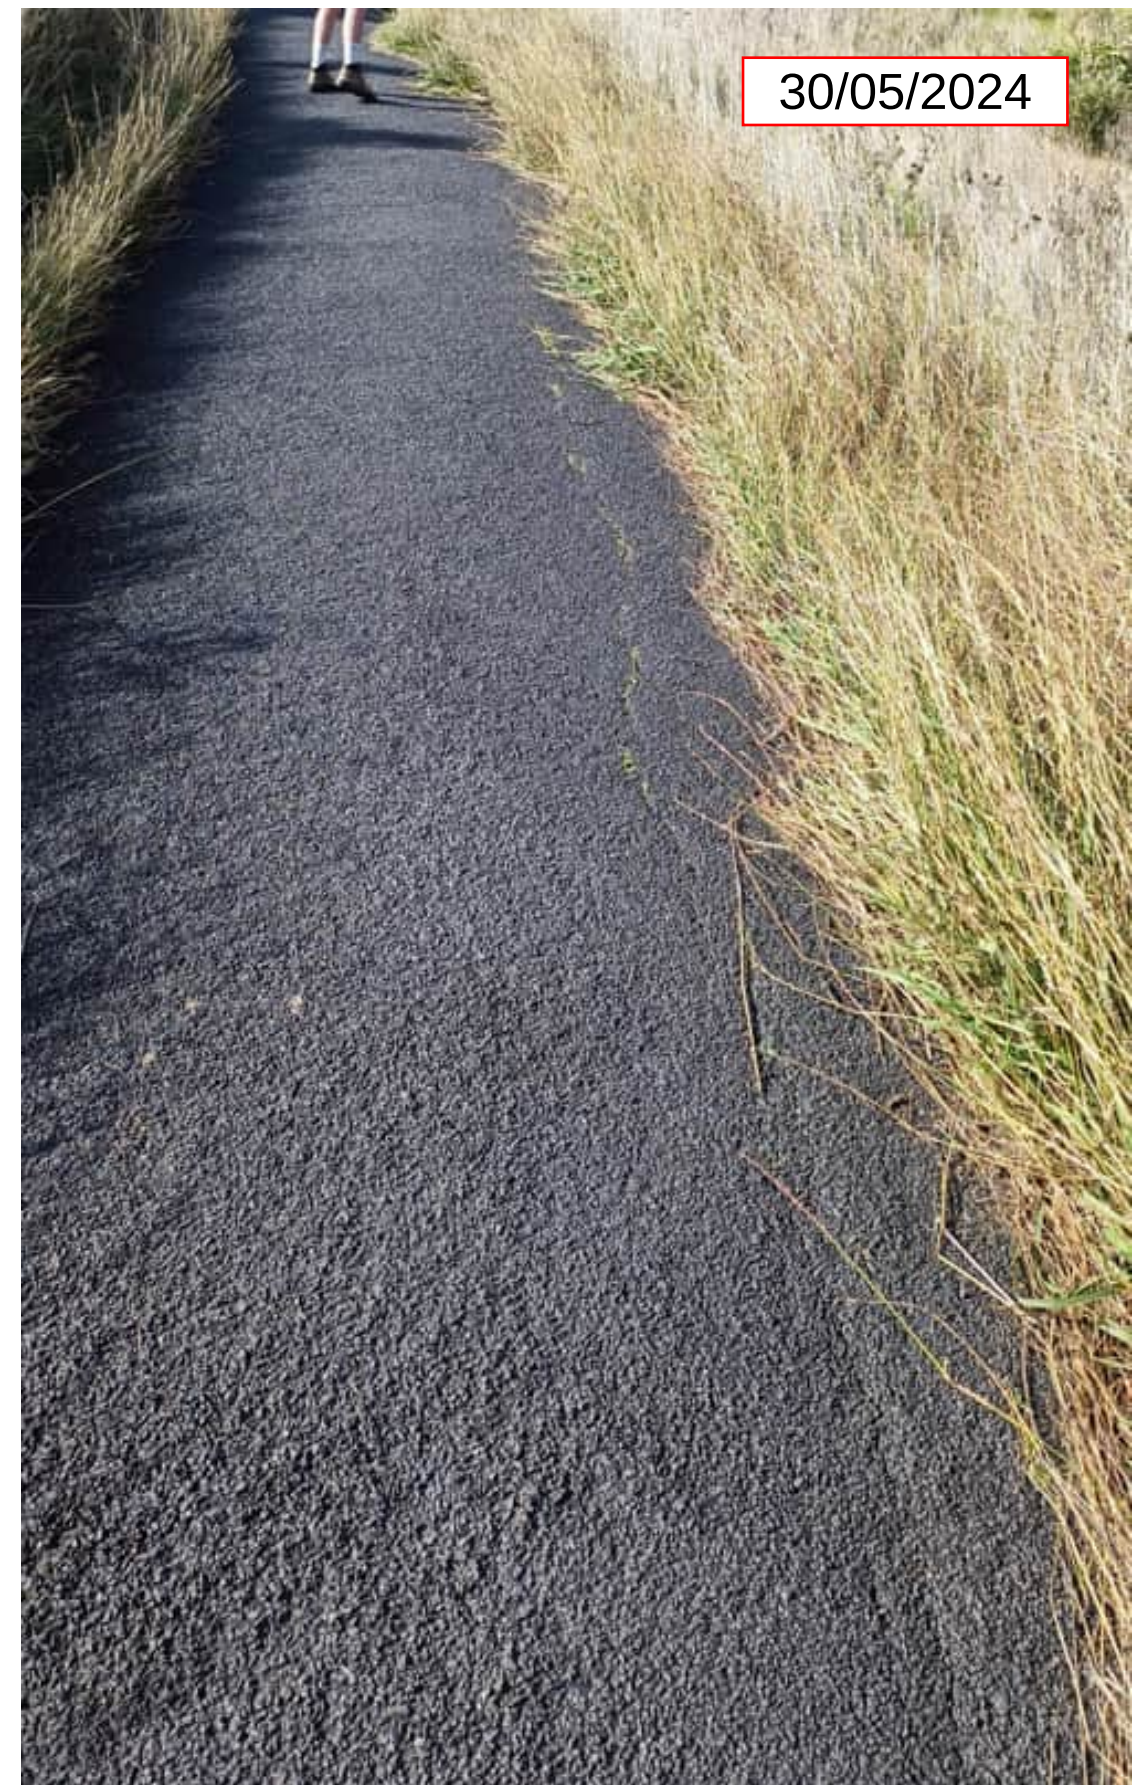
~6 m long and 1 cm aperture, does not look fresh.

184 New Feature - Tension crack on west side of track in moderately sloping ground.  
No new movement.

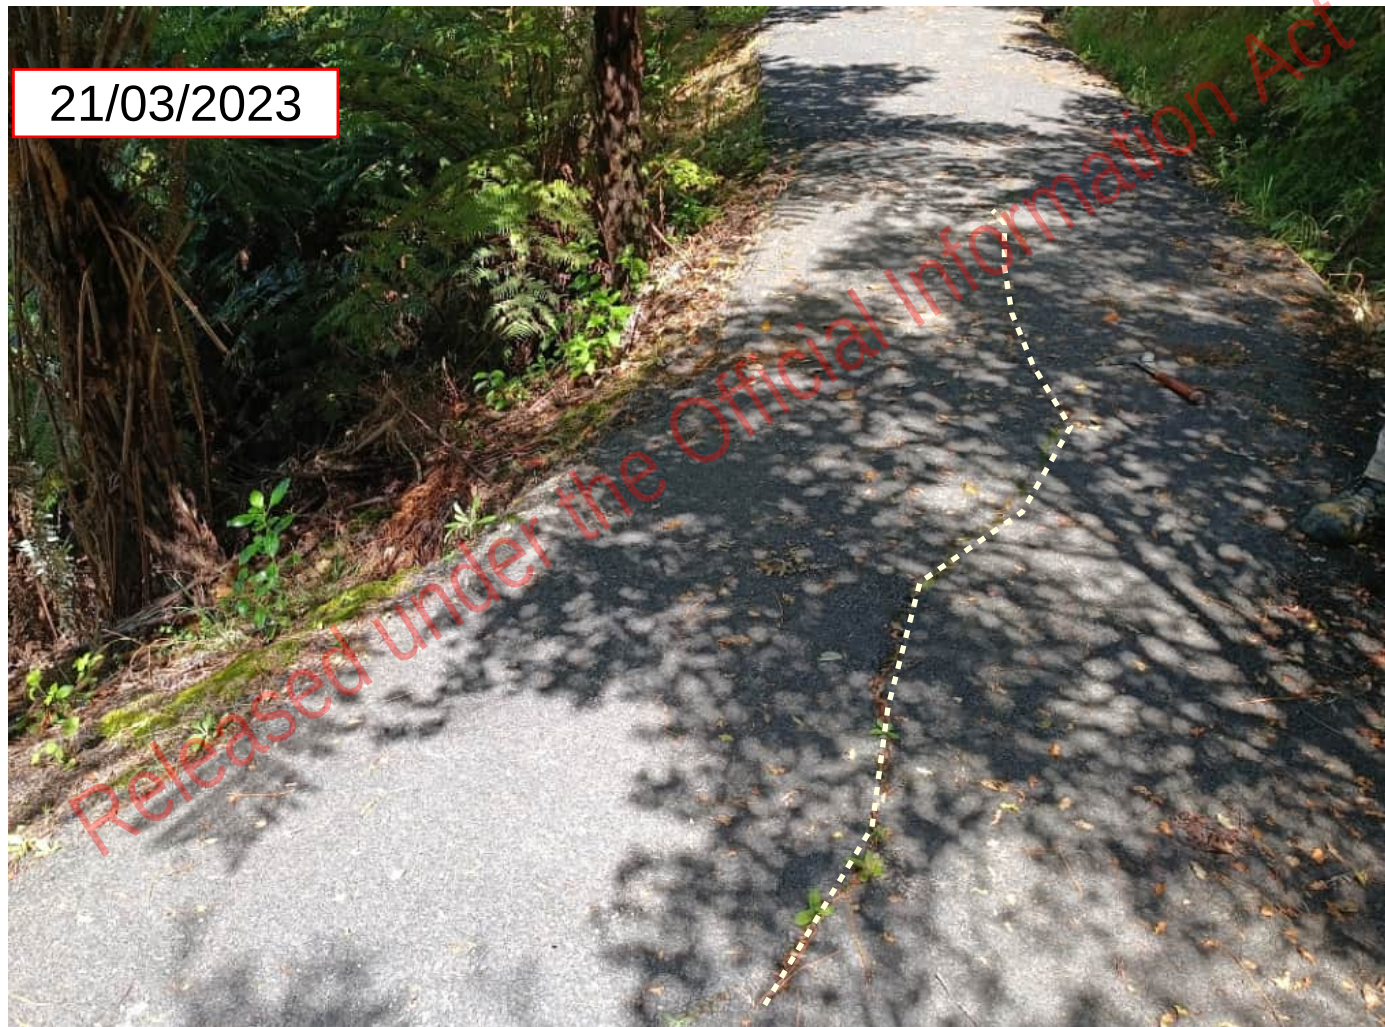
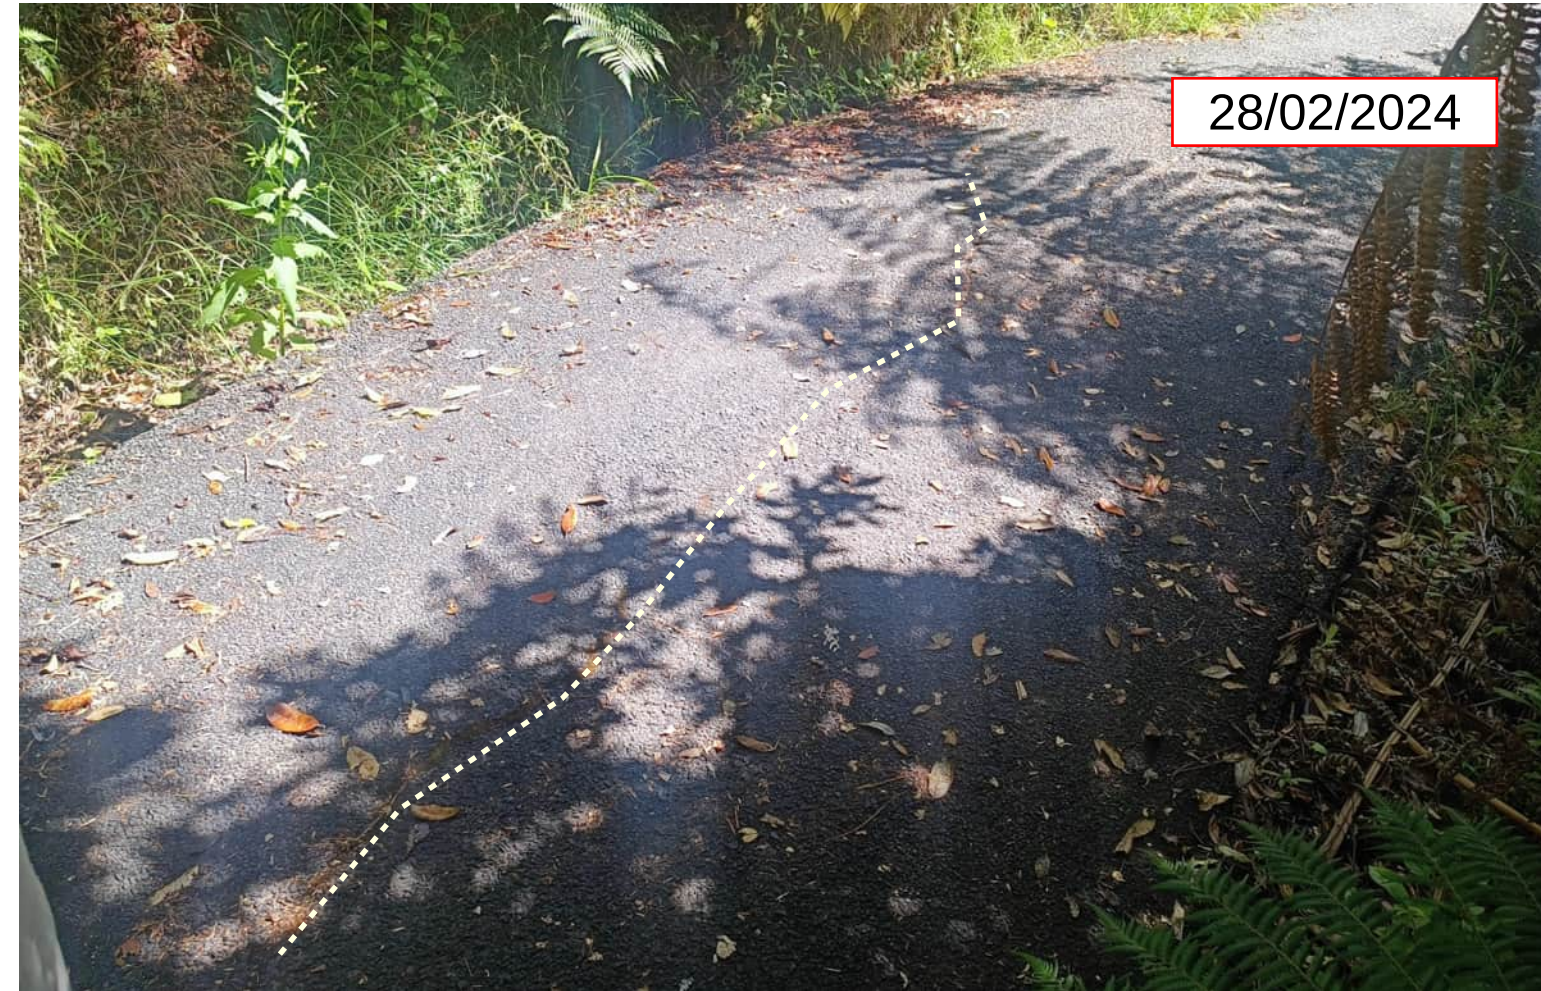
Feature 12 - Creep/tension crack  
No evidence of new movement. Total  
current aperture of ~10 mm.

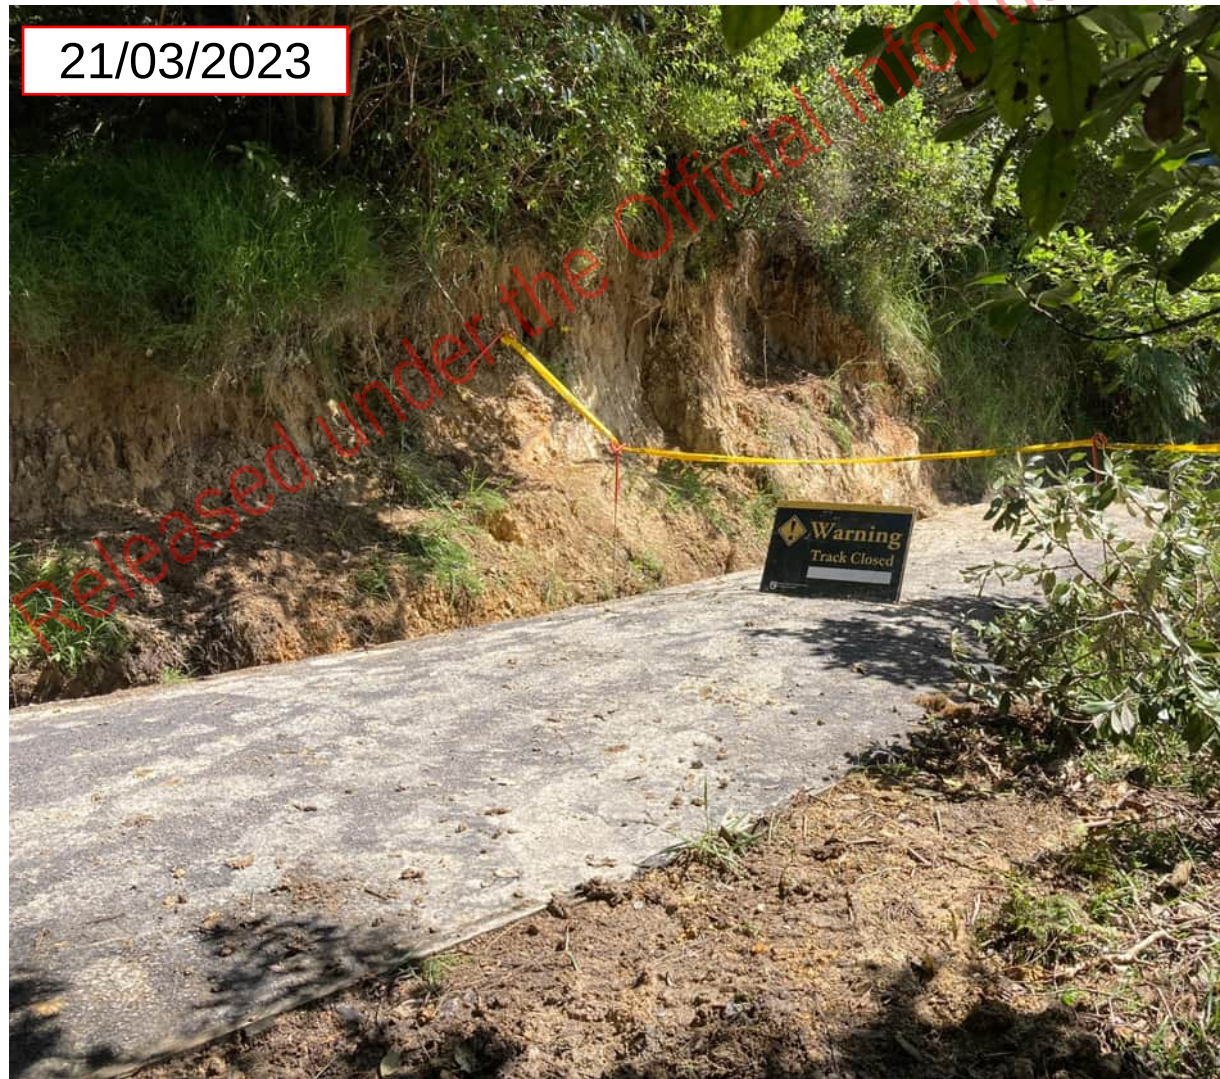
Feature 13 - Translational landslide  
No new landslide movement. Some erosion  
( $<100$  mm) of the head scarp.  
An older associated scarp was observed  
encroaching into the ground adjacent to the  
proposed new toilet block location.
