**Cathedral Cove Basic Level  
Landslide Risk Assessment**

**Prepared for**  
Department of Conservation  
**Prepared by**  
Tonkin & Taylor Ltd  
**Date**  
July 2023  
**Job Number**  
1007838.3000 v3

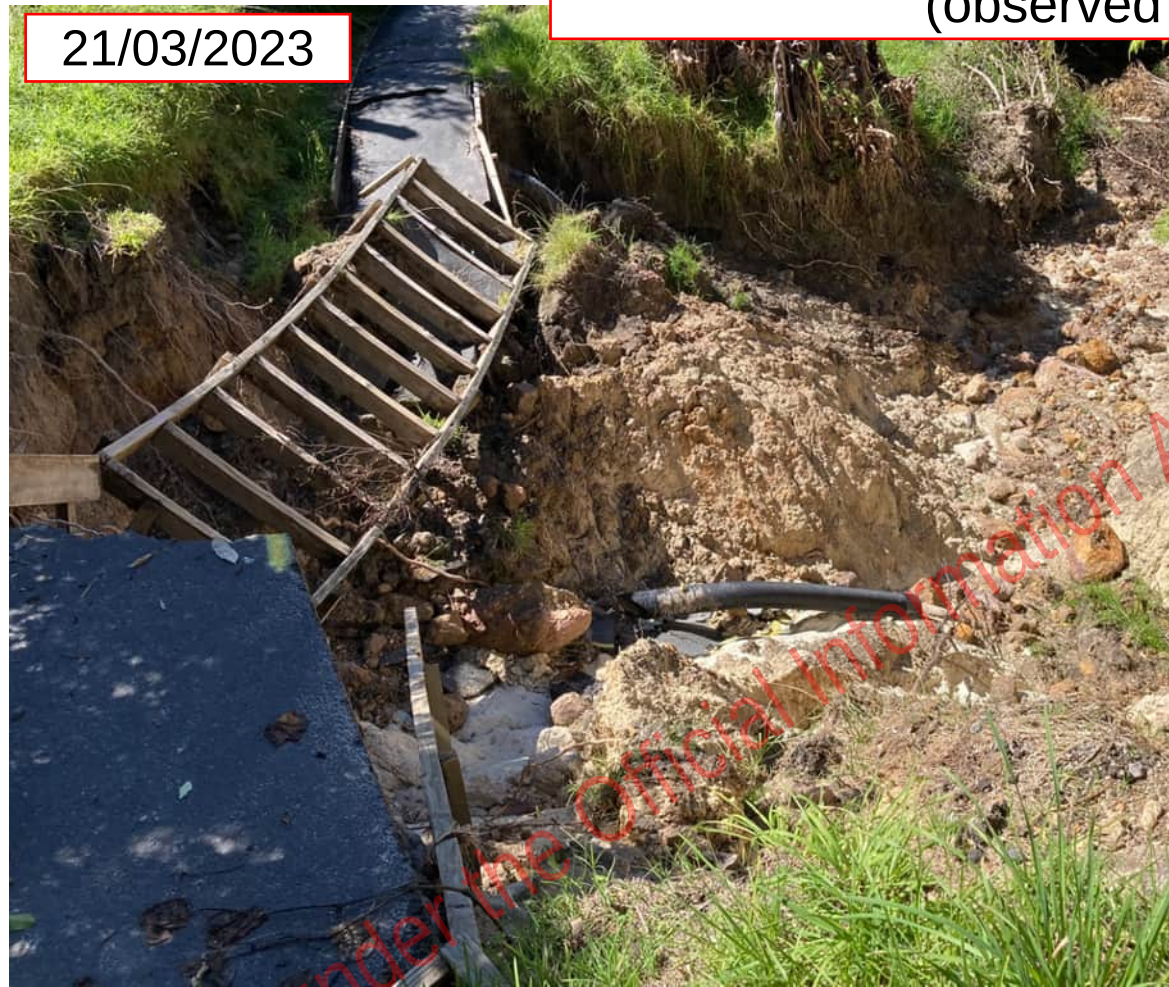
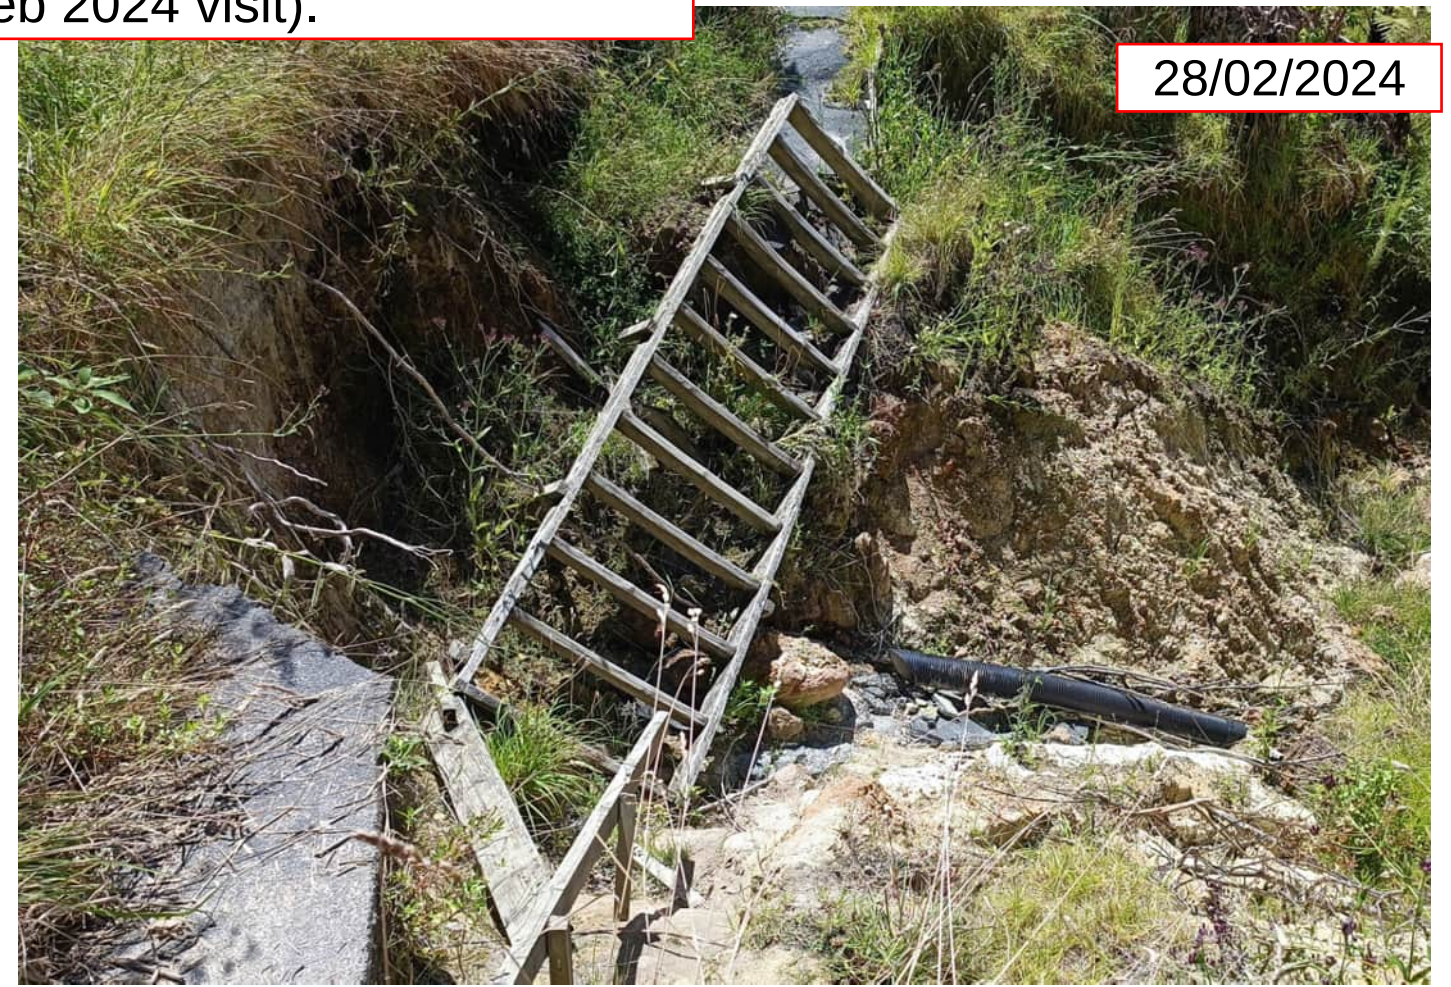
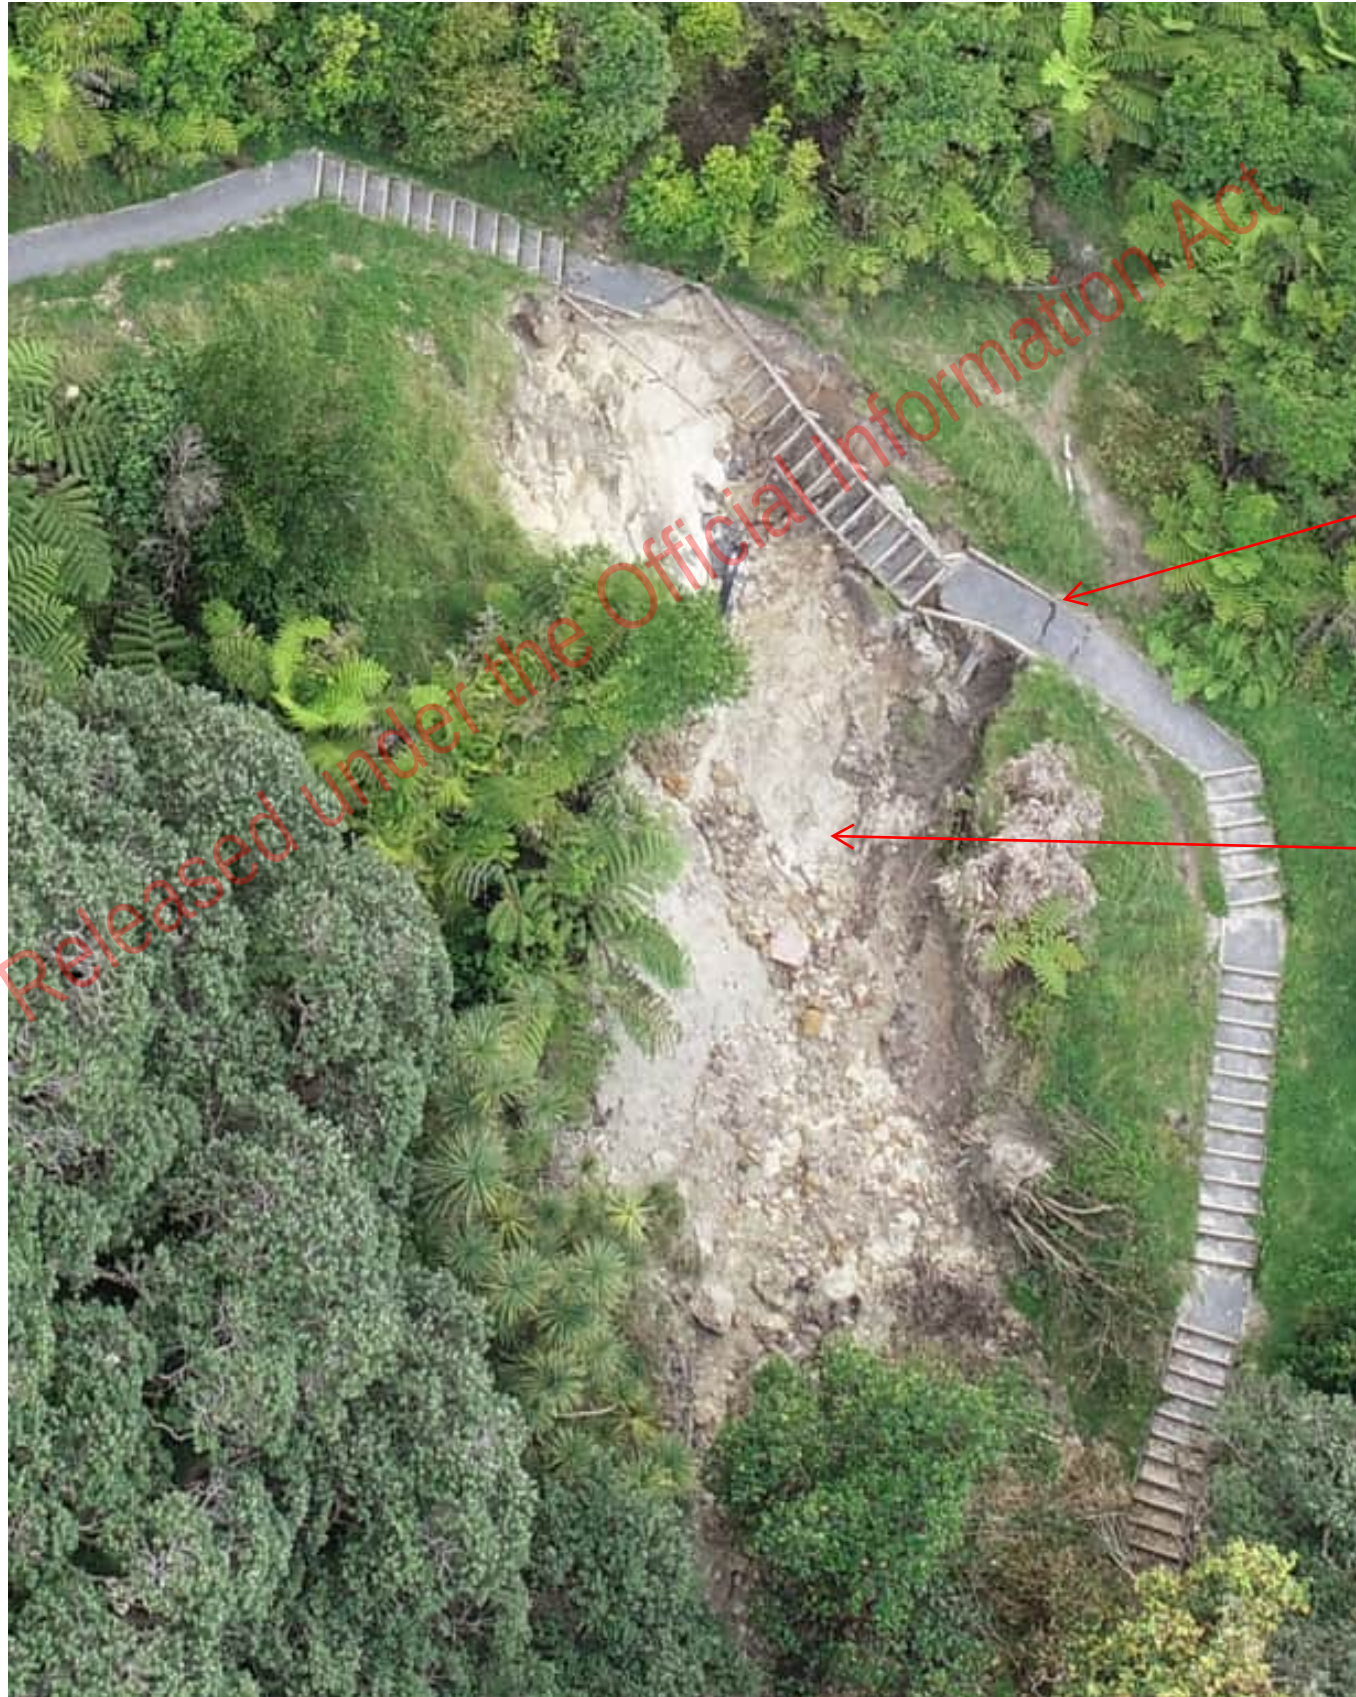
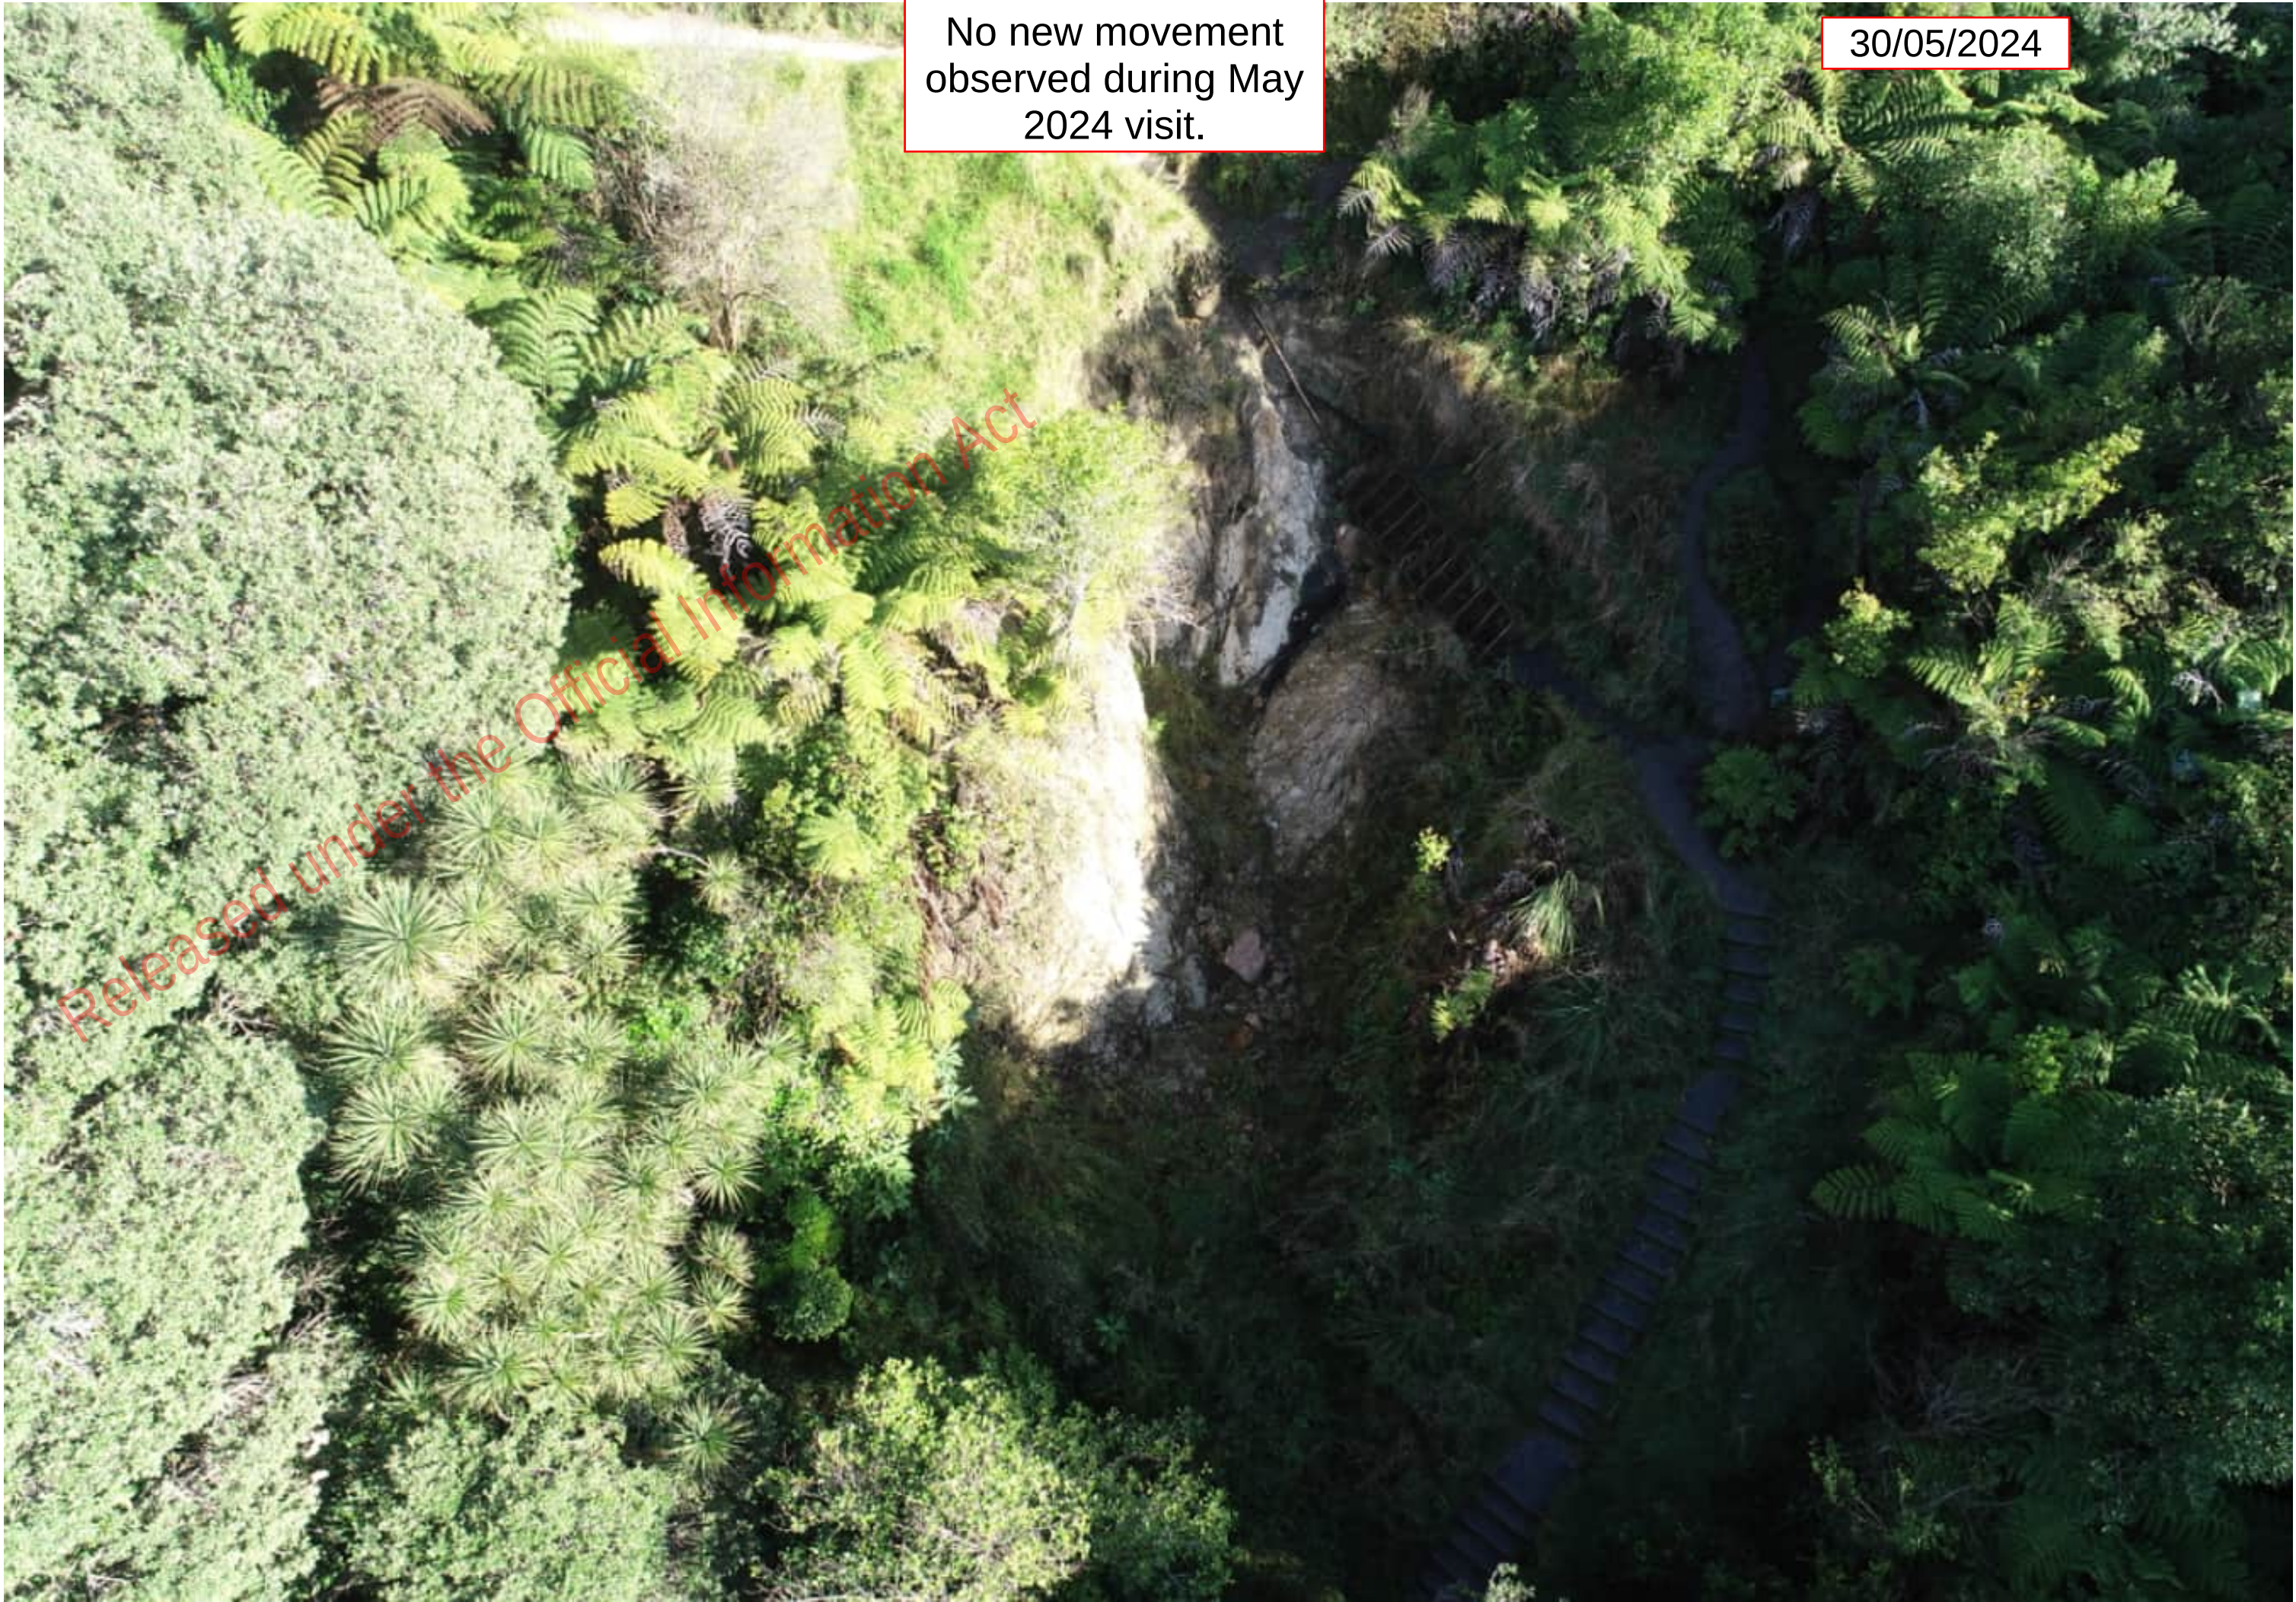
Feature 14 - Debris flow landslide  
No new significant damage. Some regression of the head scarp  
has occurred (approximately  $< 200\text{mm}$ ) due to erosion  
(observed during Feb 2024 visit).

Feature 14 continued.  
No new movement  
observed during May  
2024 visit.

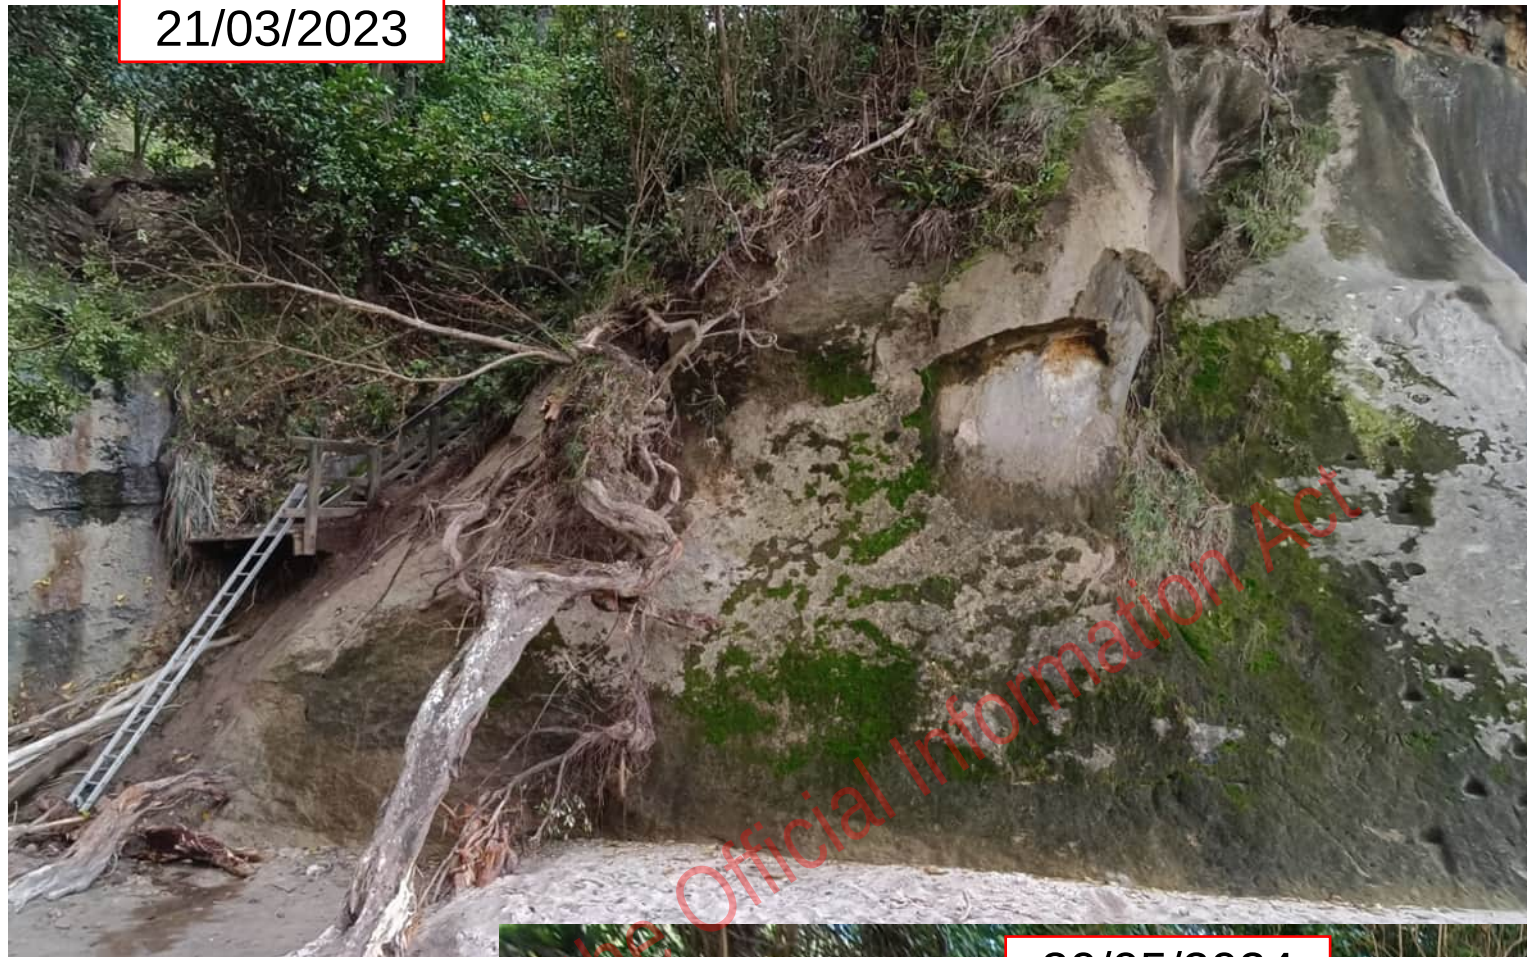
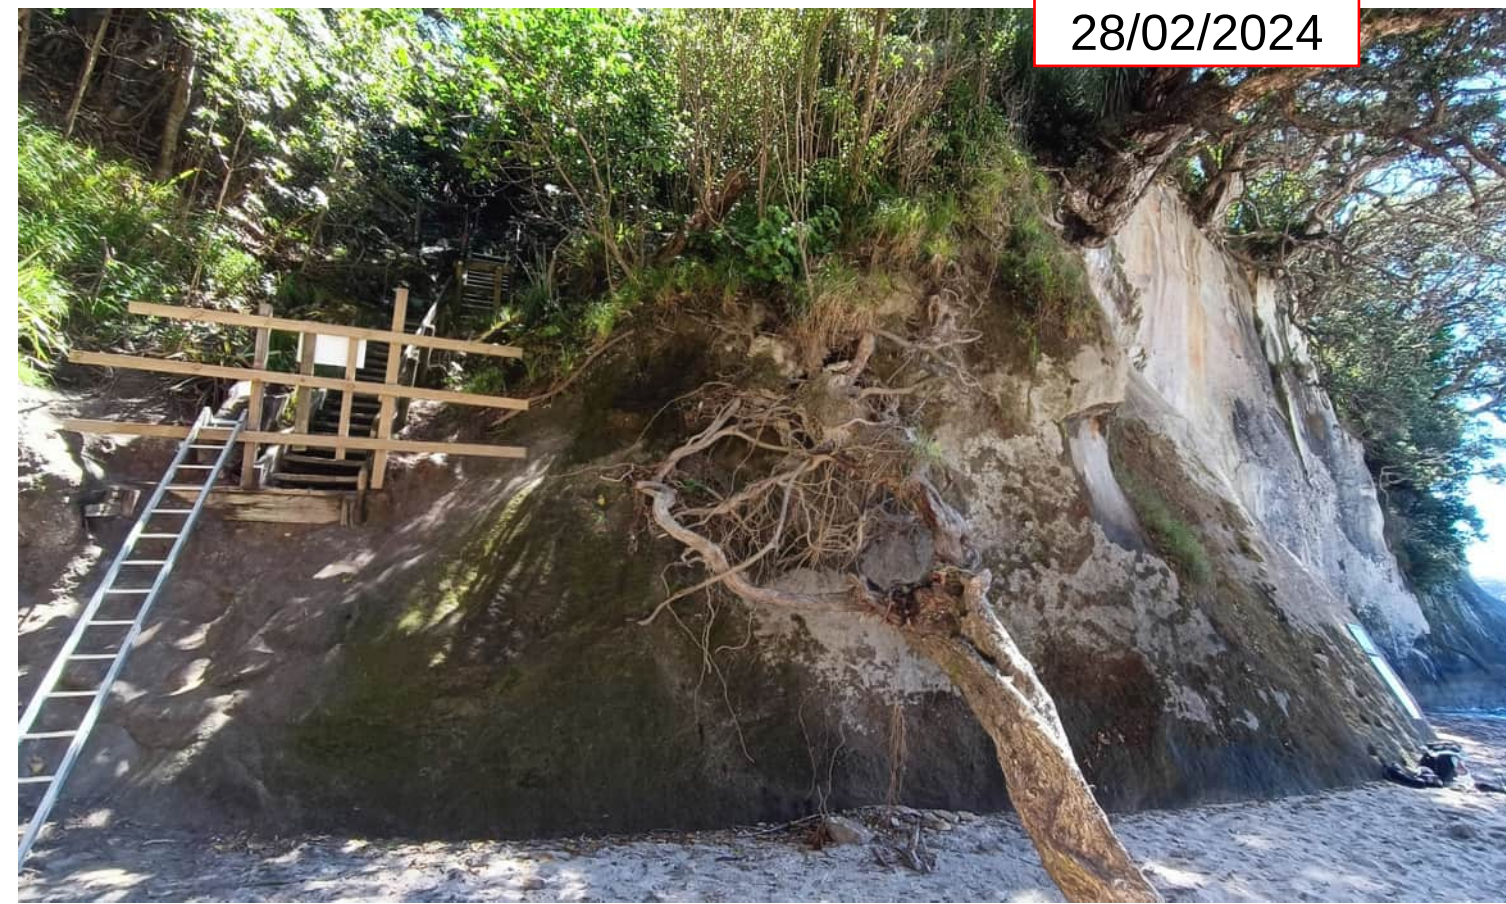
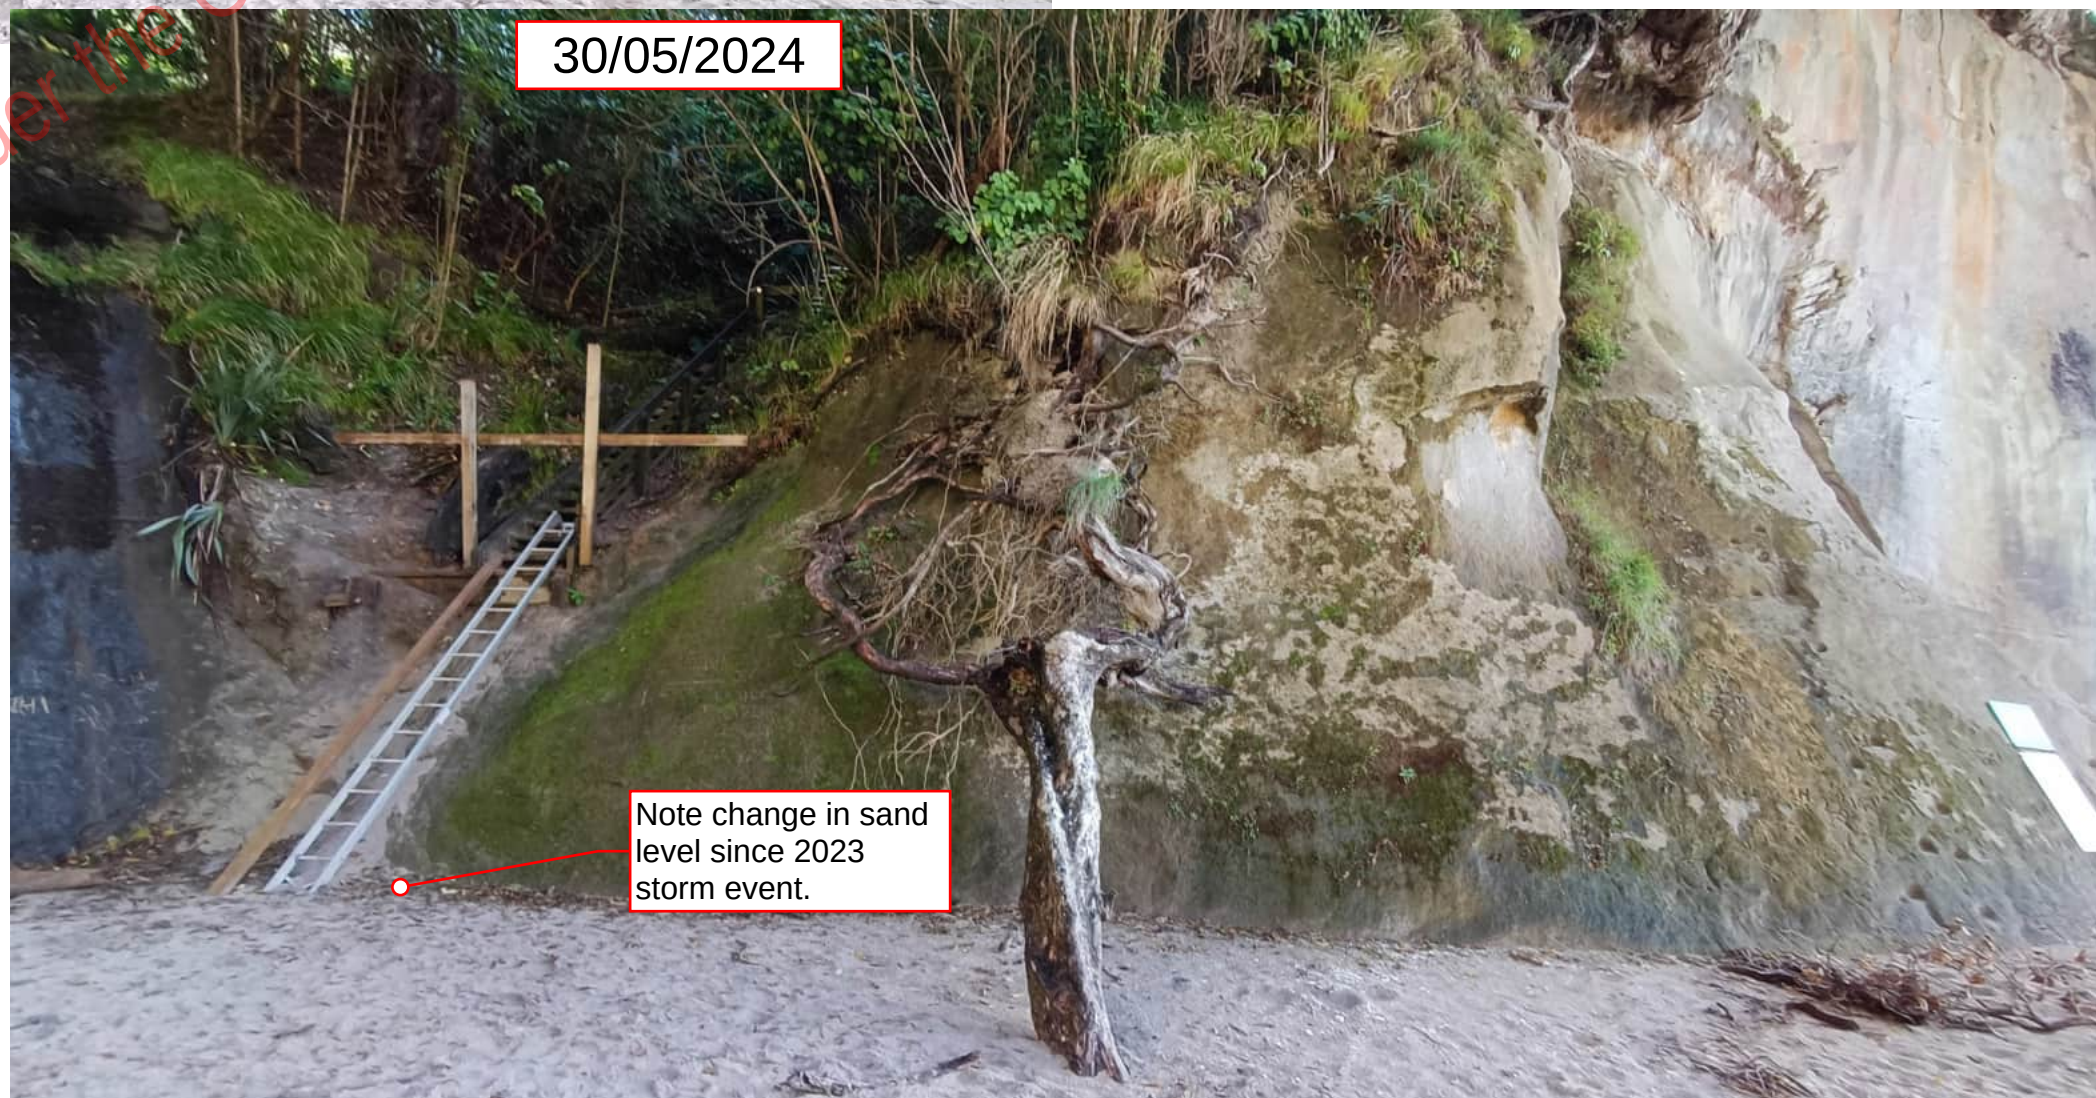
Cove access area. No significant changes observed

Note change in sand level since 2023 storm event.

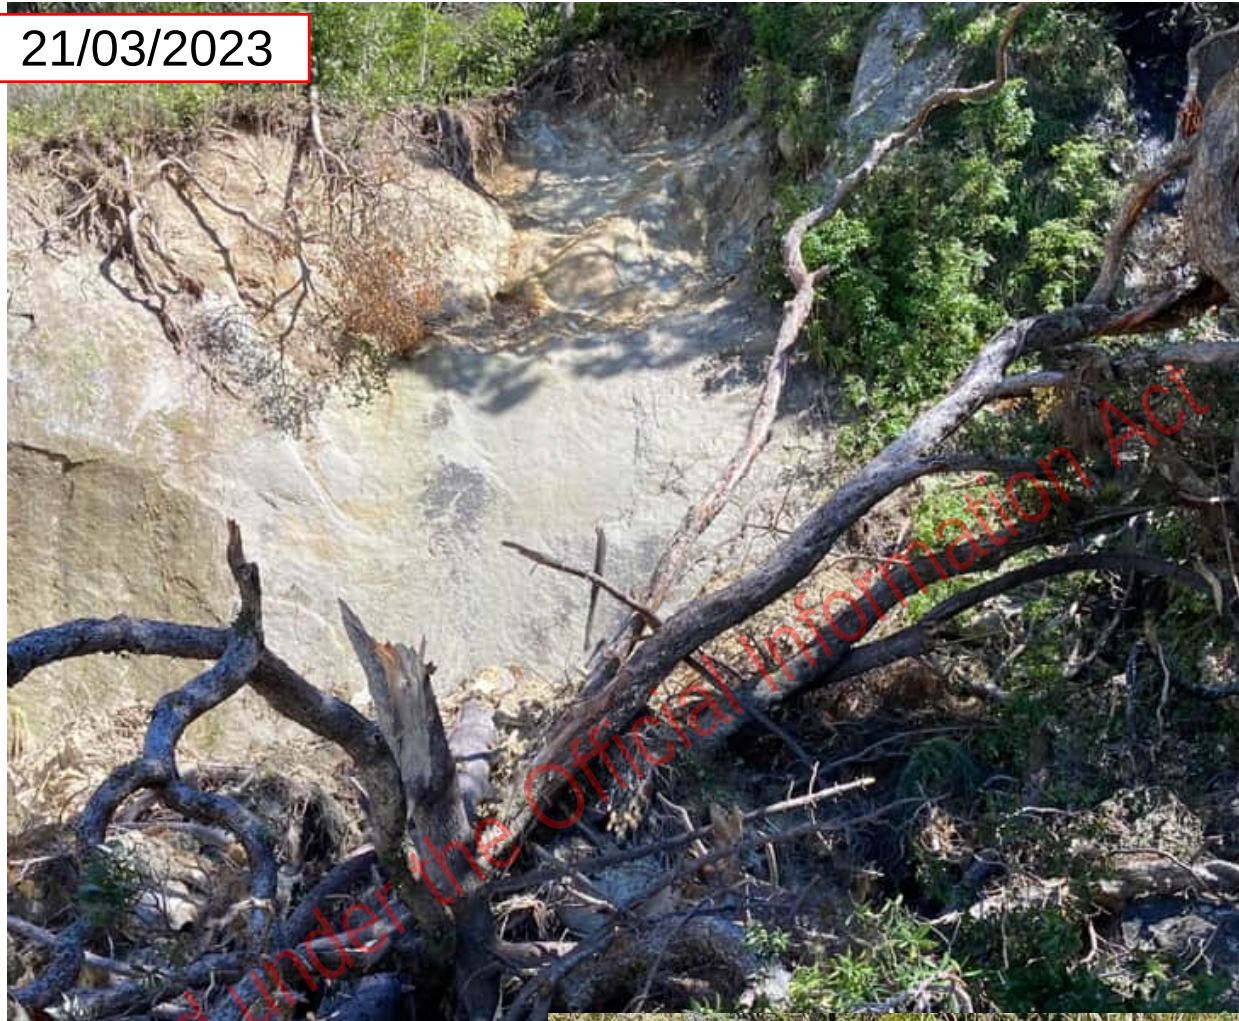
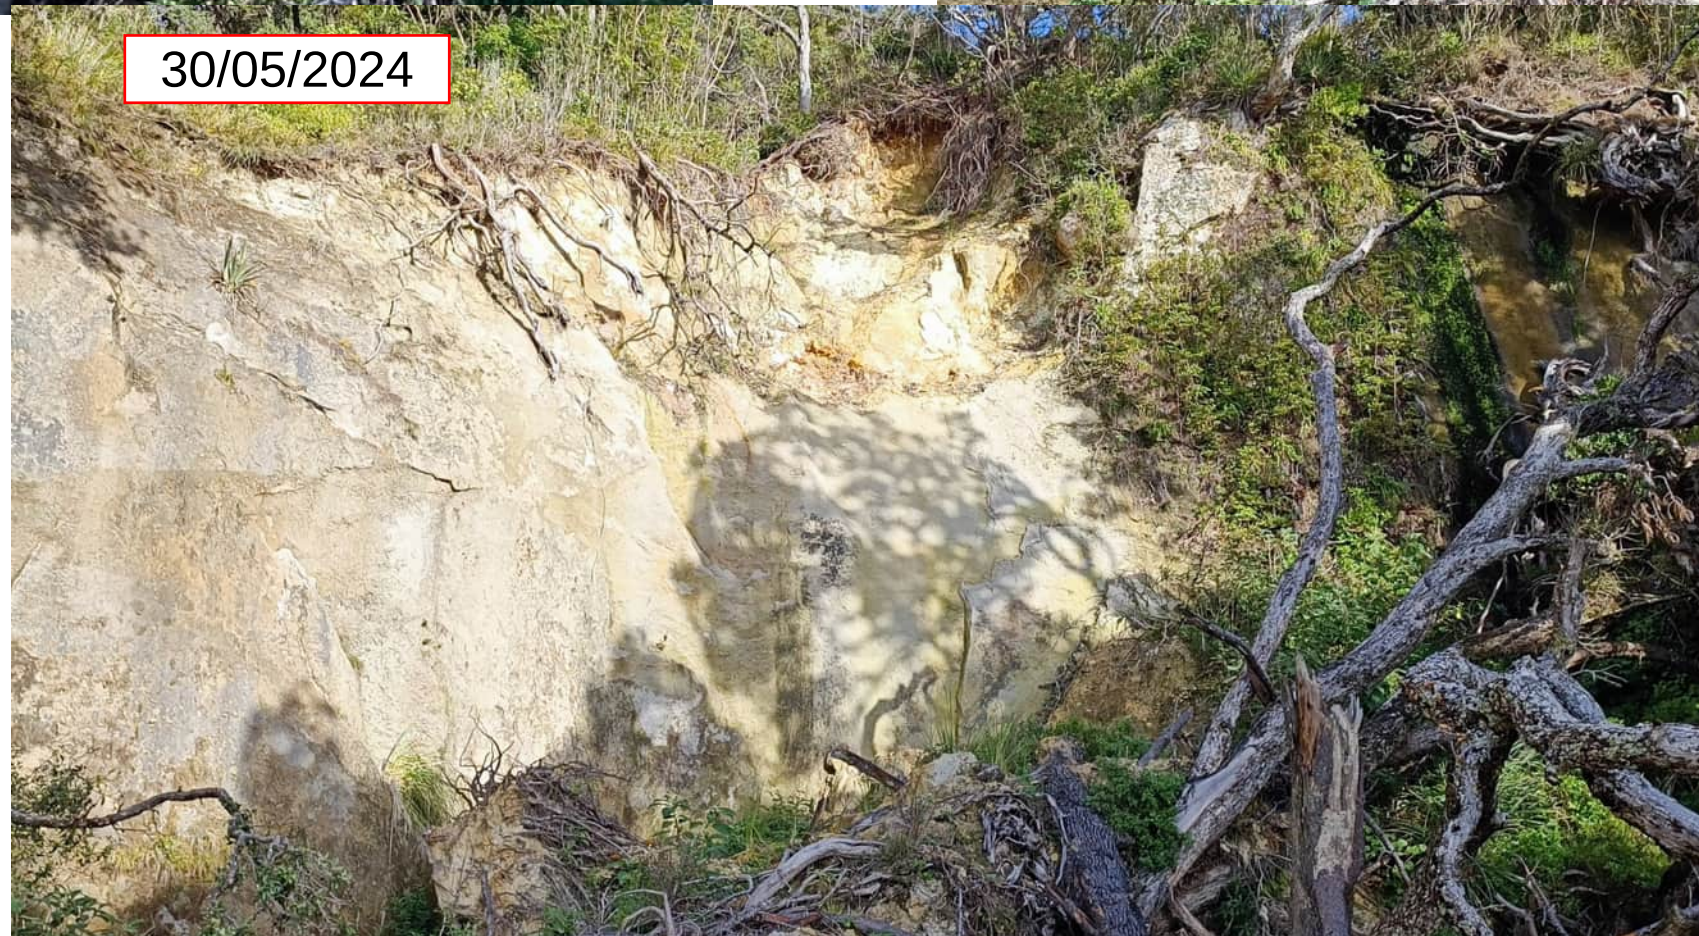
No new significant damage from landslide or rockfall movement.  
Regression of the headscarp within the soil/rock overburden due to erosion.

Some fresh patches are observed indicating some regression (< 200 mm estimated)

No new accumulations of debris are evident.

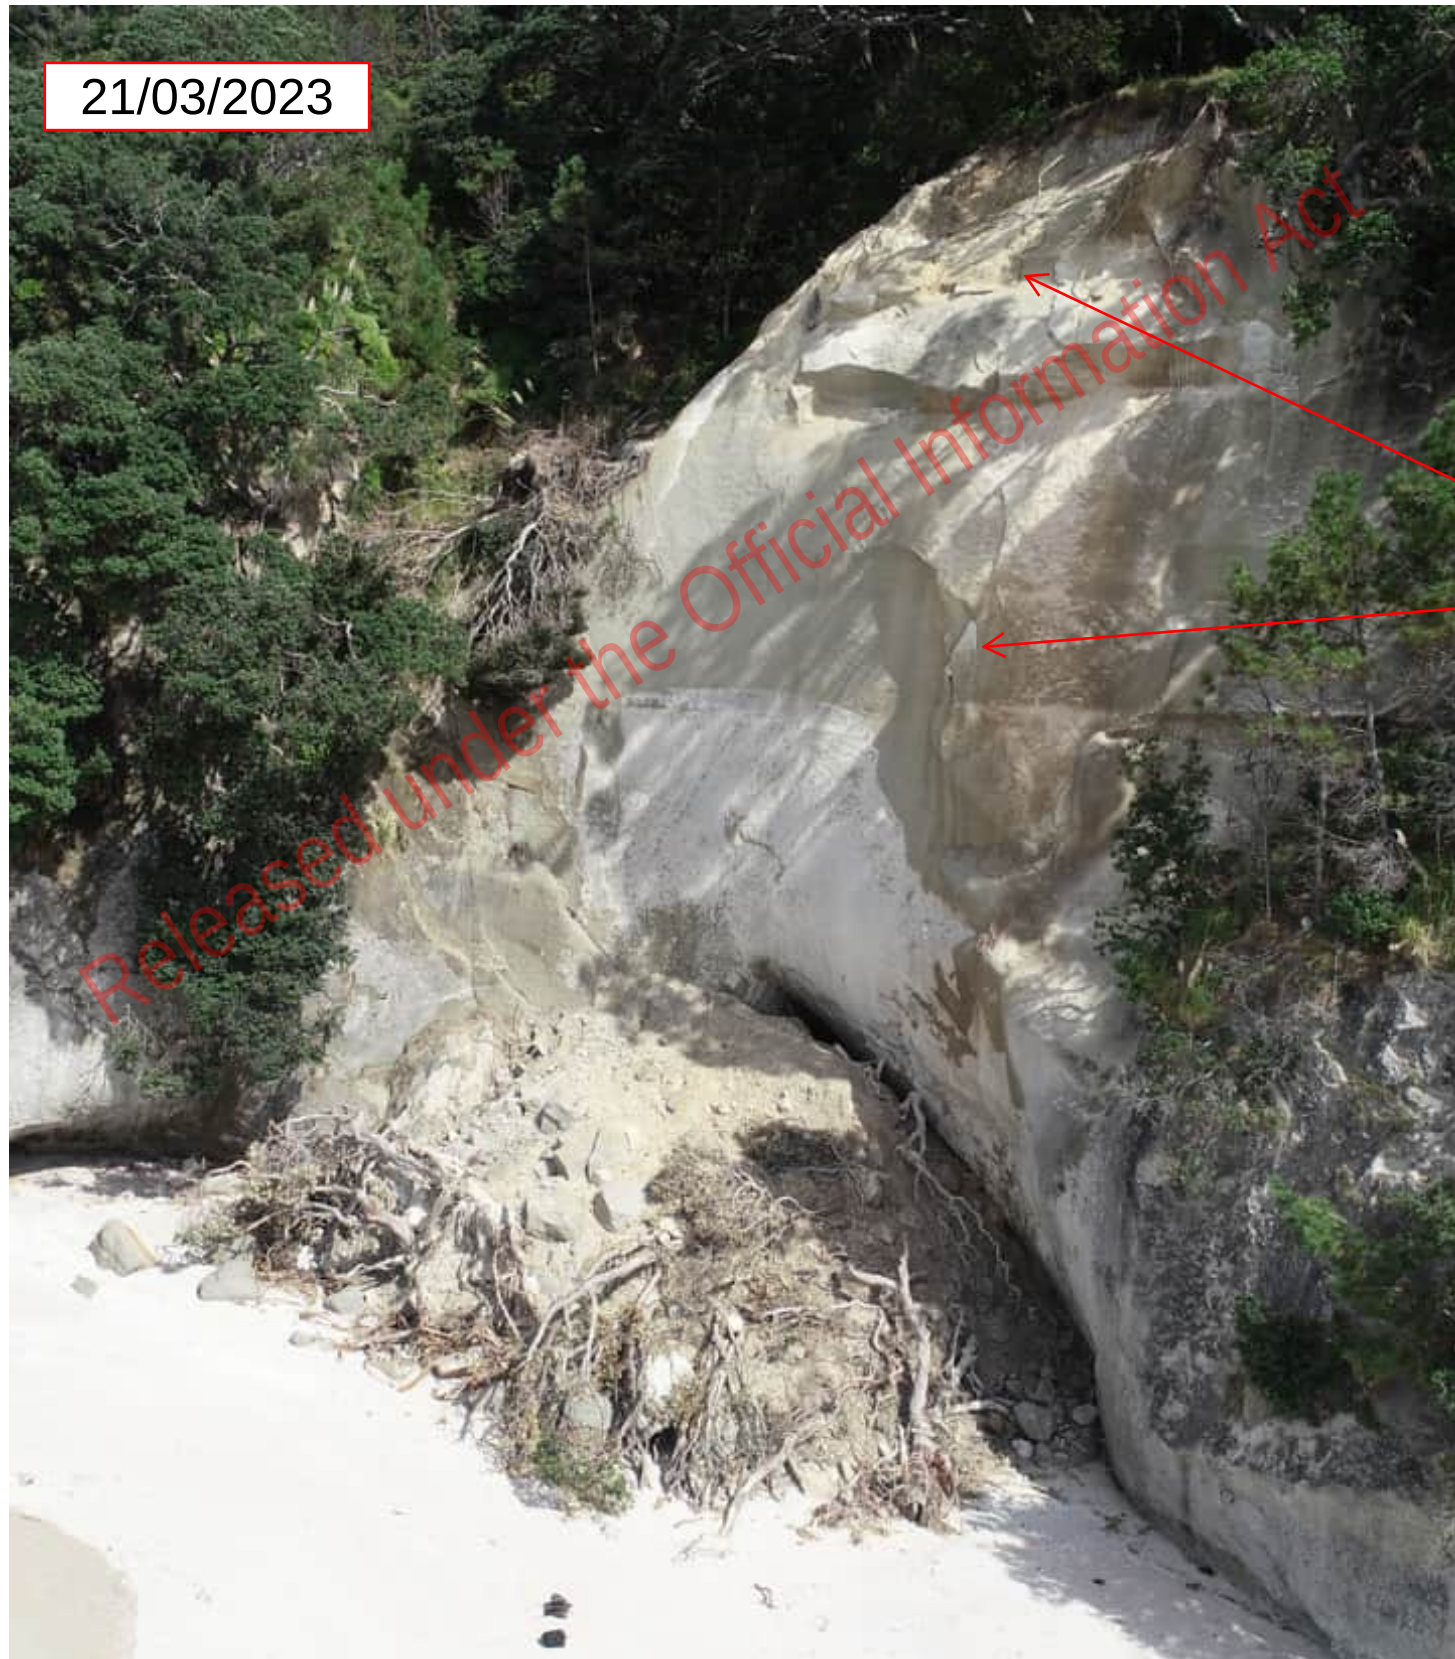
Feature 16 - Rockfall  
Regression of the head scarp at the  
overburden level due to erosion (<200 mm)  
observed during Feb 2024 visit. No  
significant new inundation.

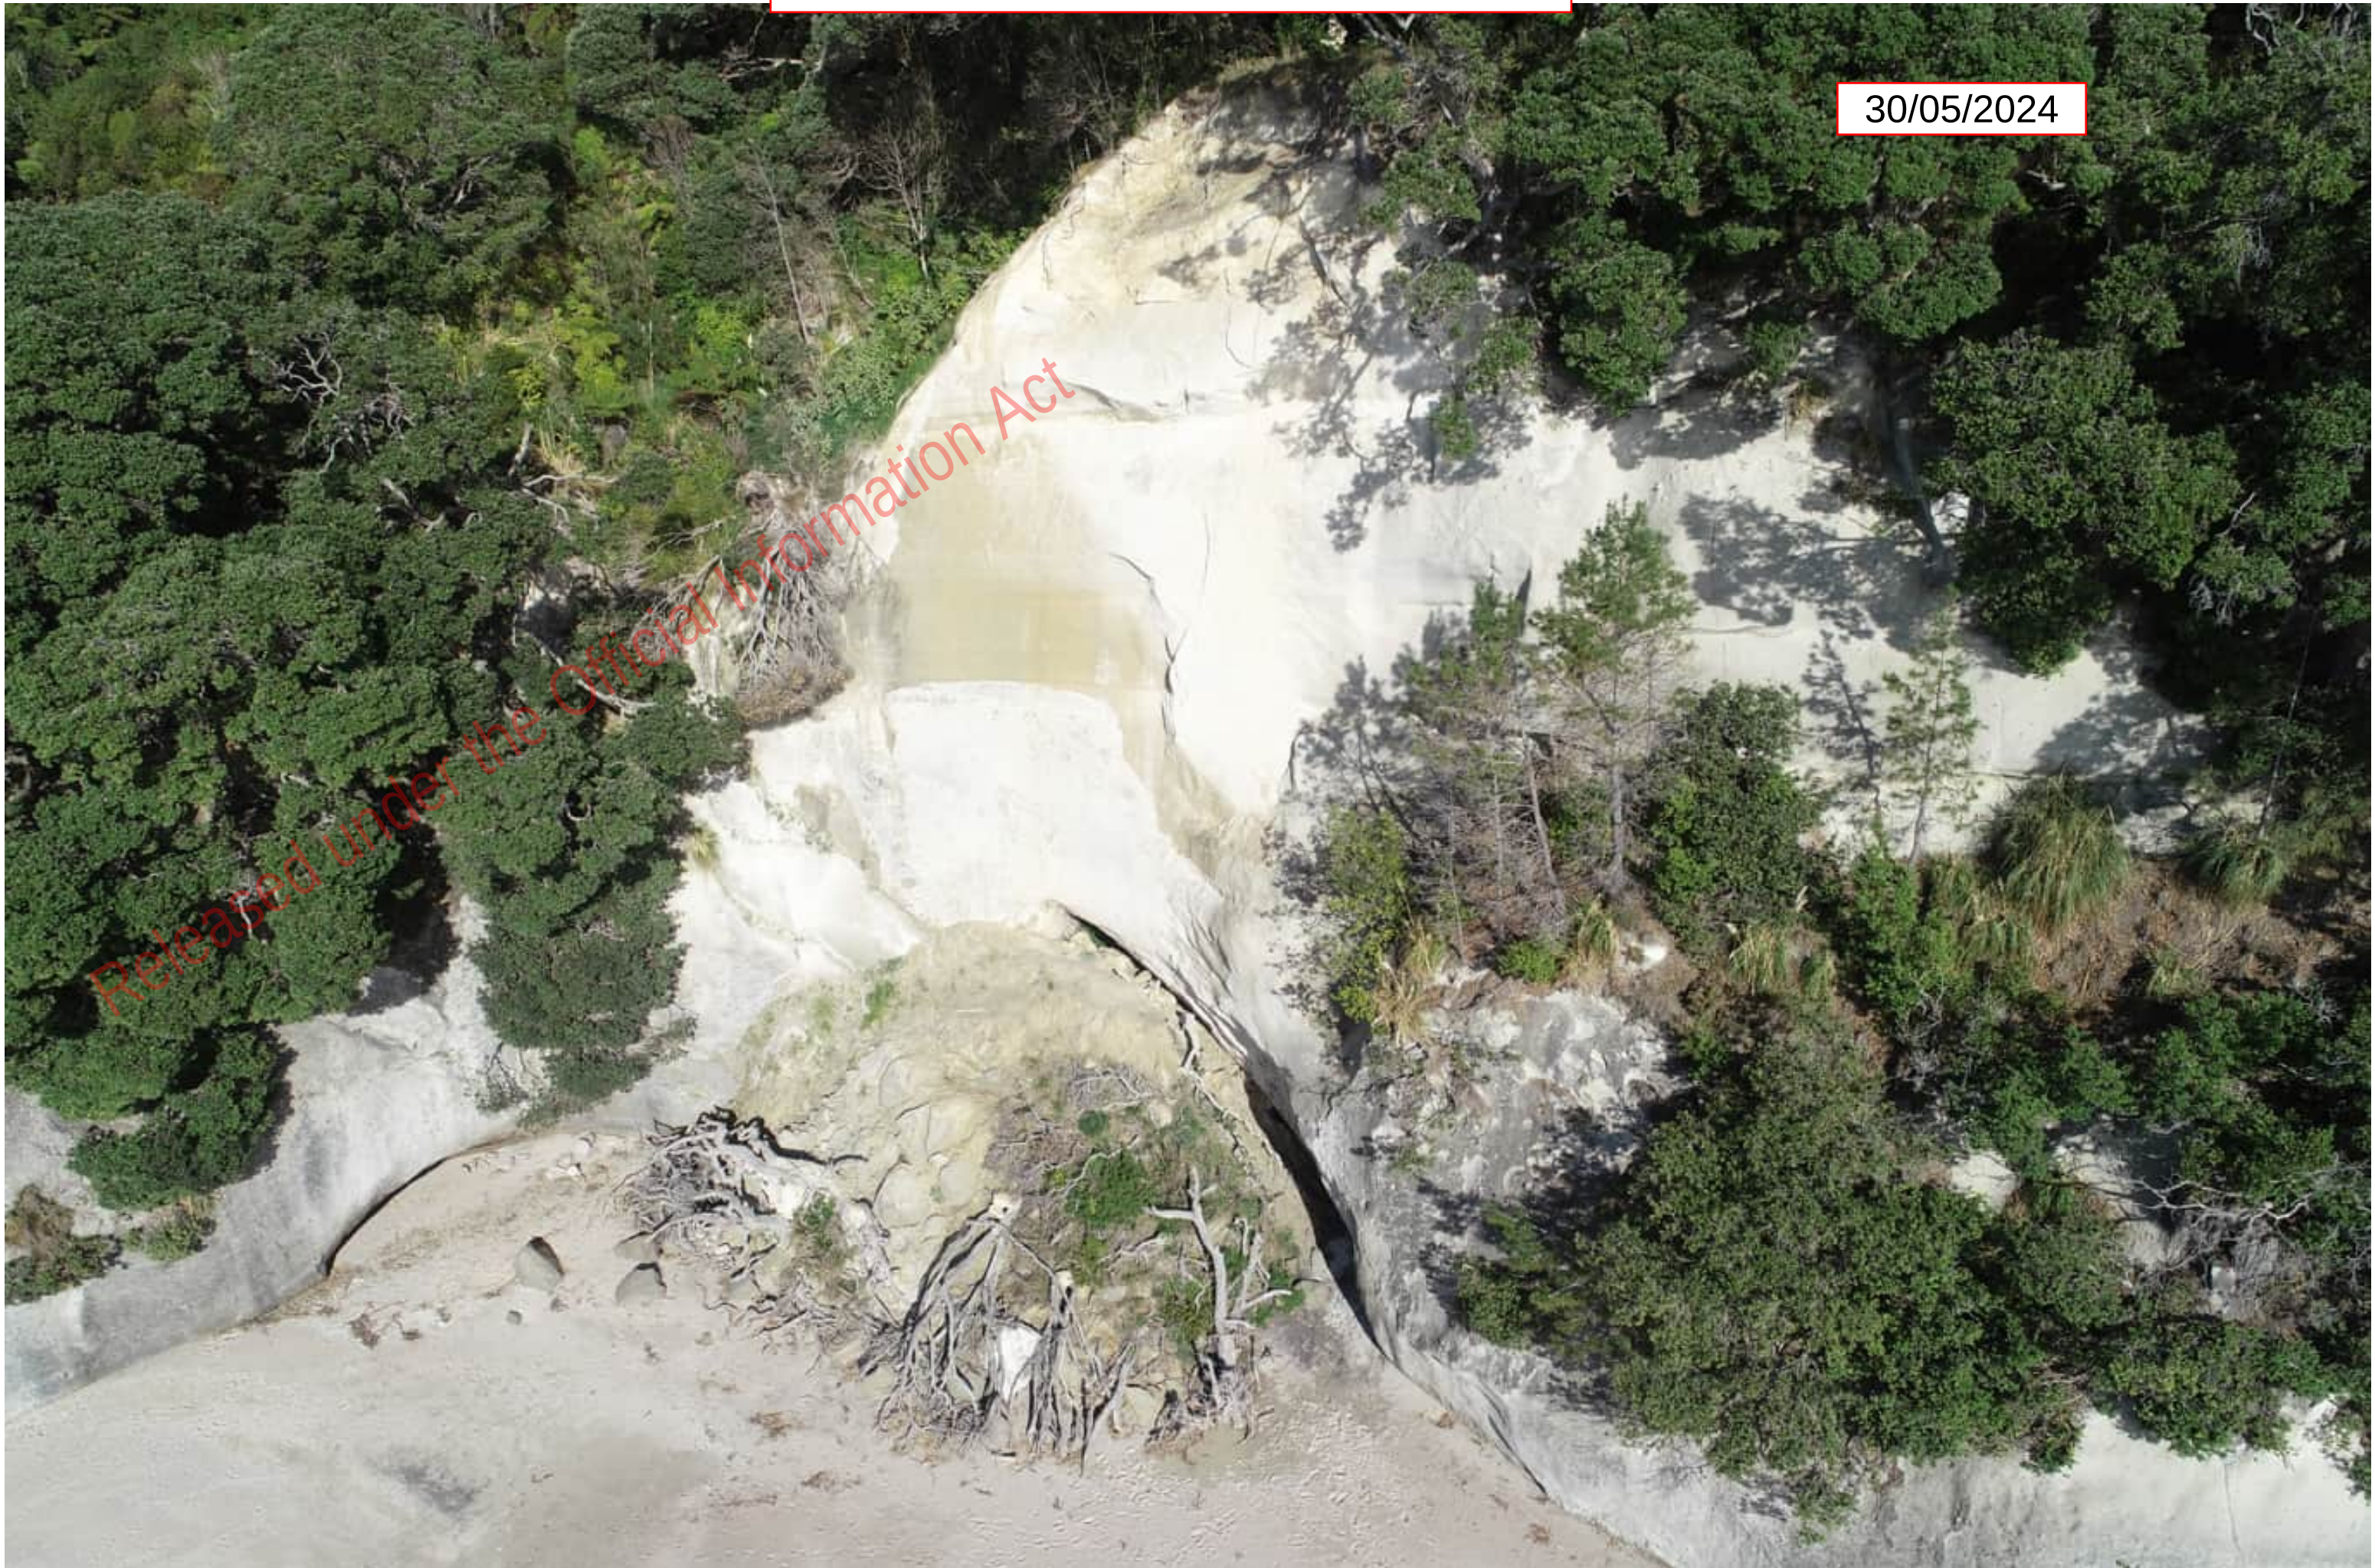
Feature 16 Continued - Rockfall  
No significant new inundation.
