**Cathedral Cove Basic Level  
Landslide Risk Assessment**

**Prepared for**  
Department of Conservation  
**Prepared by**  
Tonkin & Taylor Ltd  
**Date**  
July 2023  
**Job Number**  
1007838.3000 v3

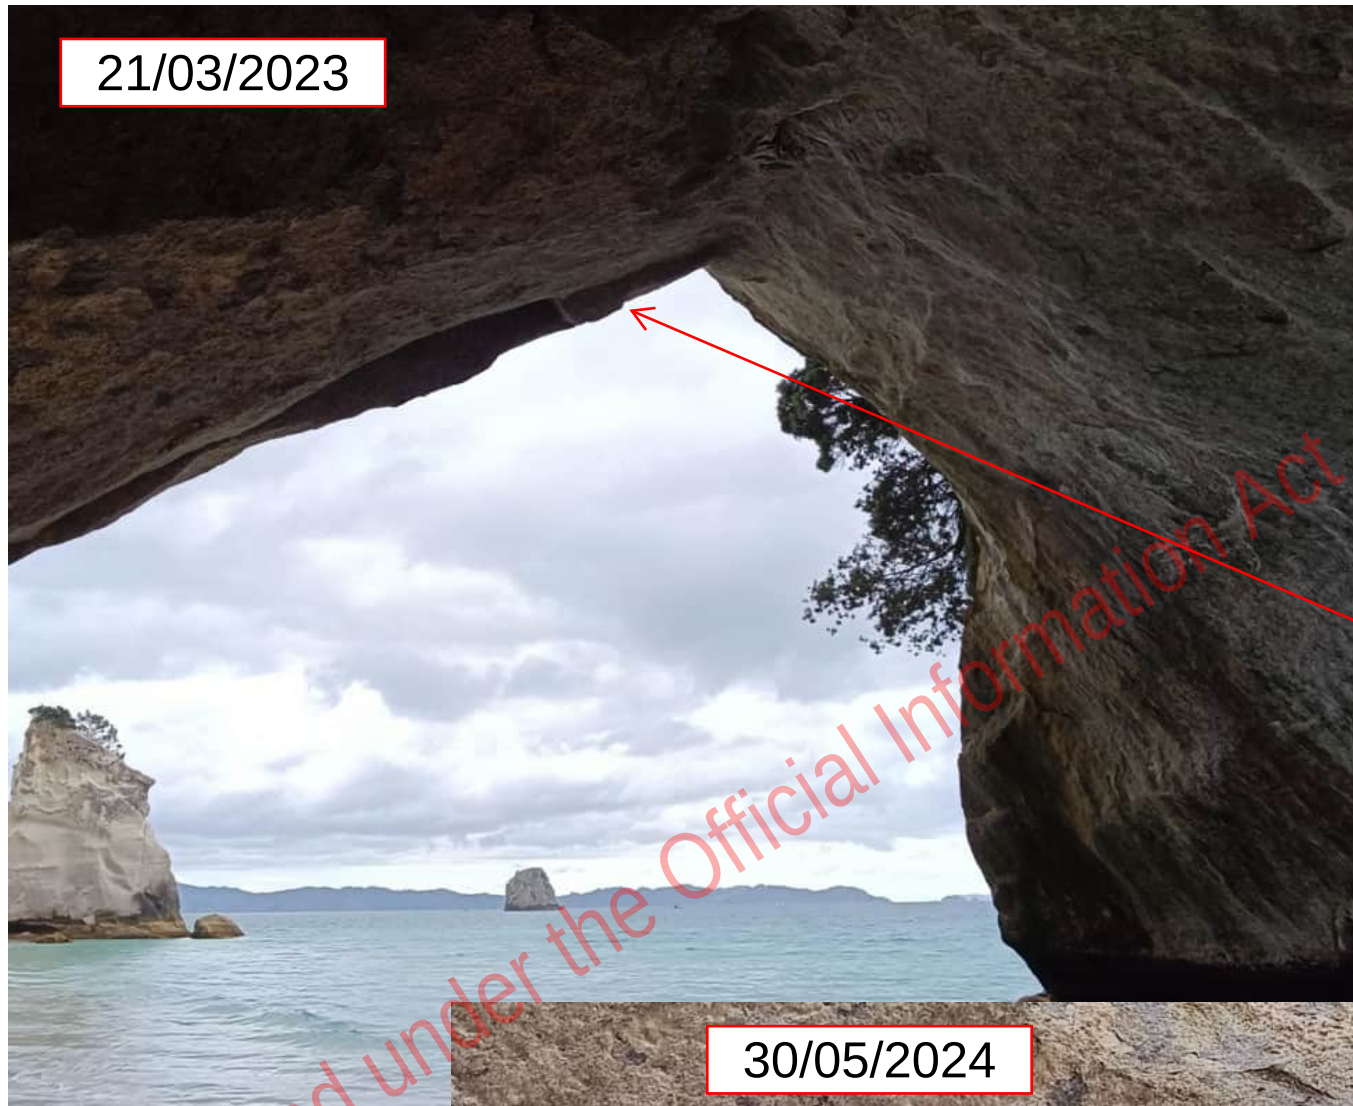
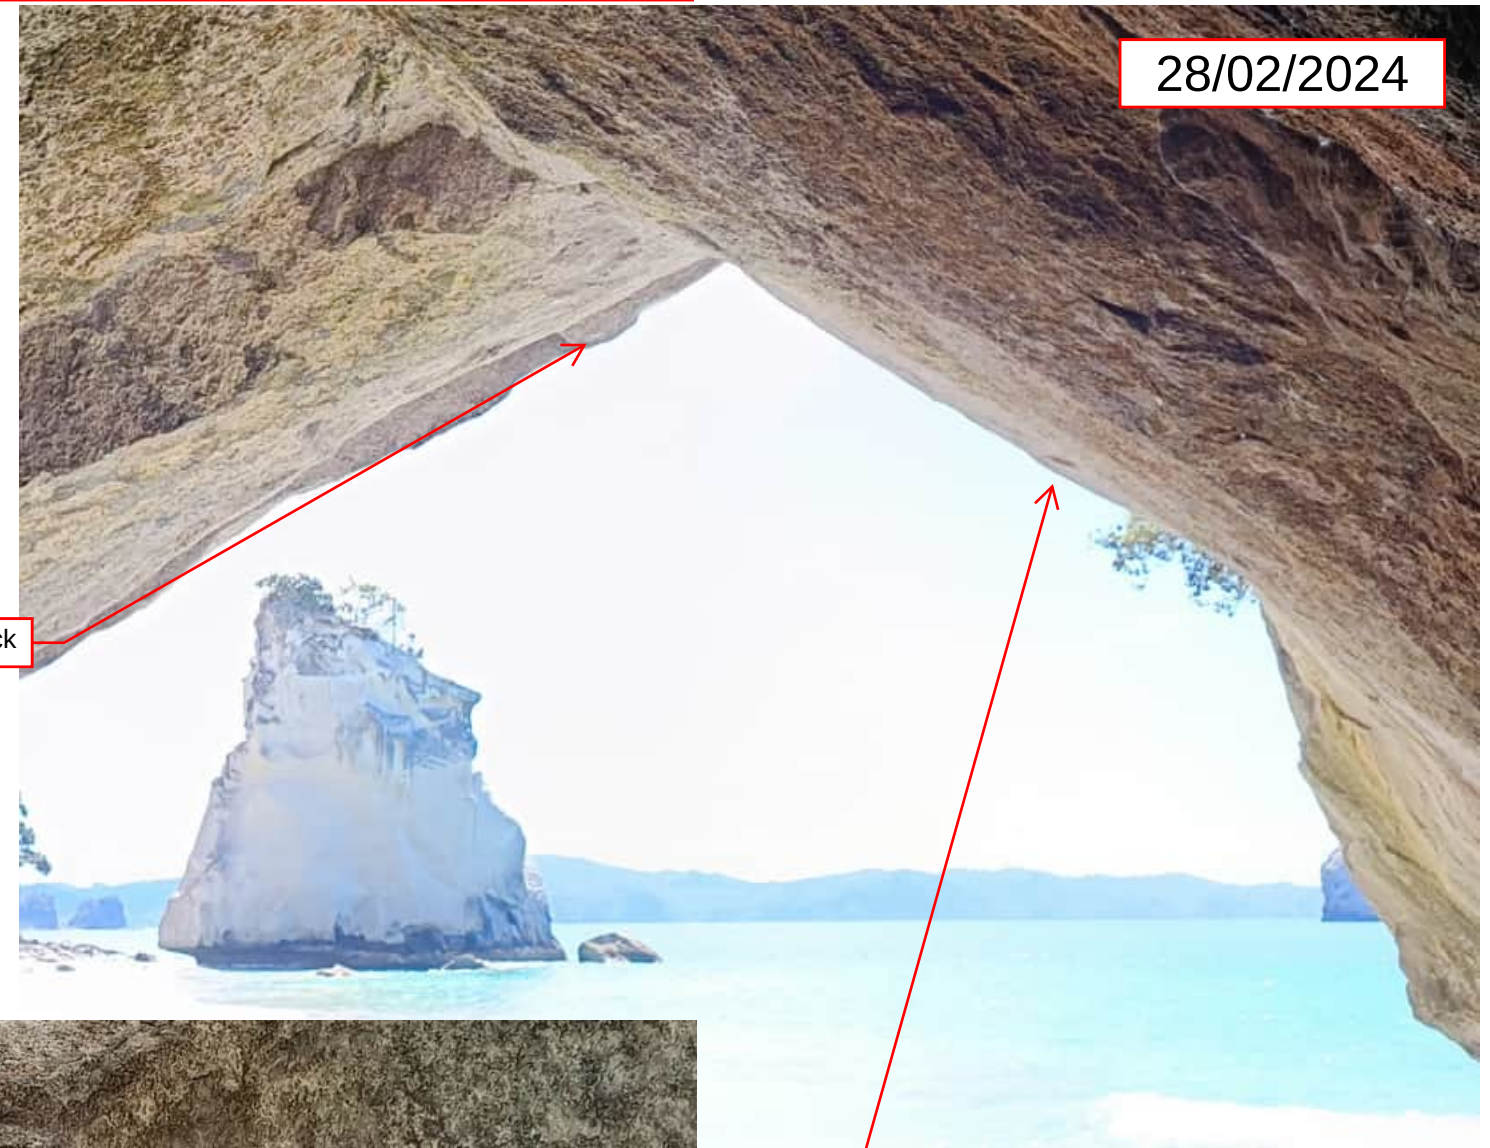
Cathedral Cove arch. North portal cubic block remains.  
Small rockfall observed during May 2024 visit.

Small rockfall - less than  
0.01m3.

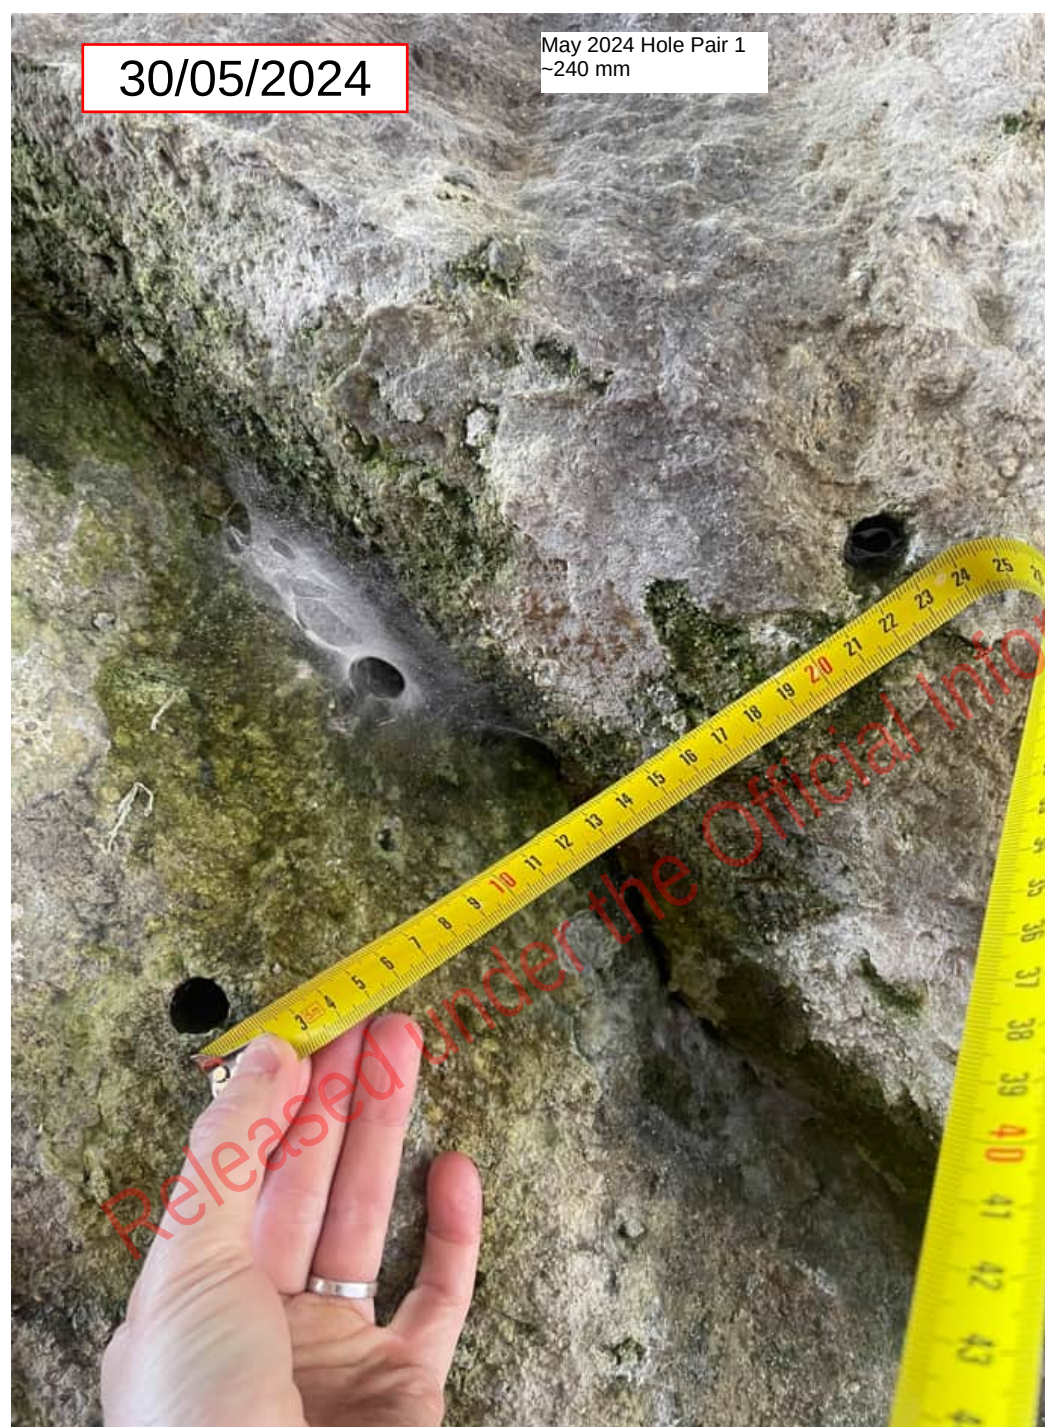
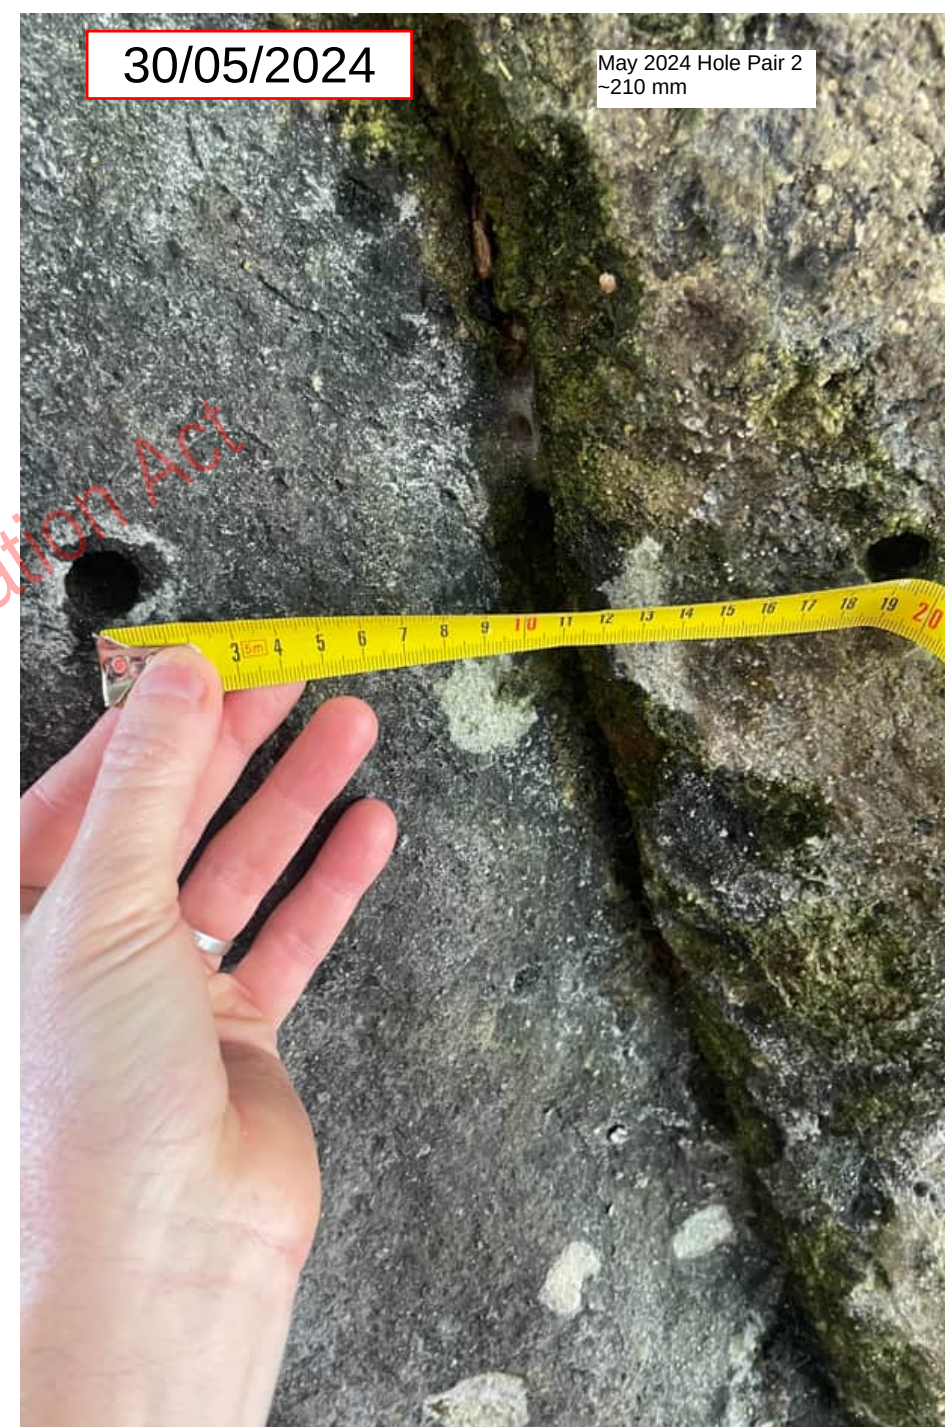
Cathedral Cove arch. Drilled holes. No change.

Notes:  
seepage on the cove apex and eastern  
wall. Lots of recent rain.

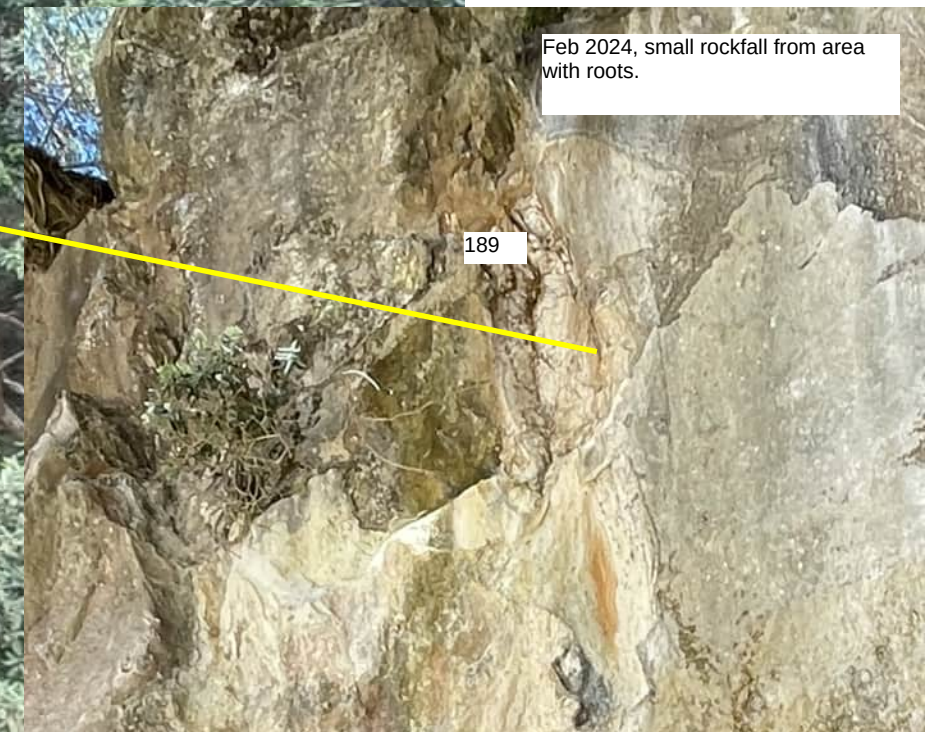
189

Feb 2024, small rockfall from area with roots.

Potential loose blocks where roots emerge from a series of small joints

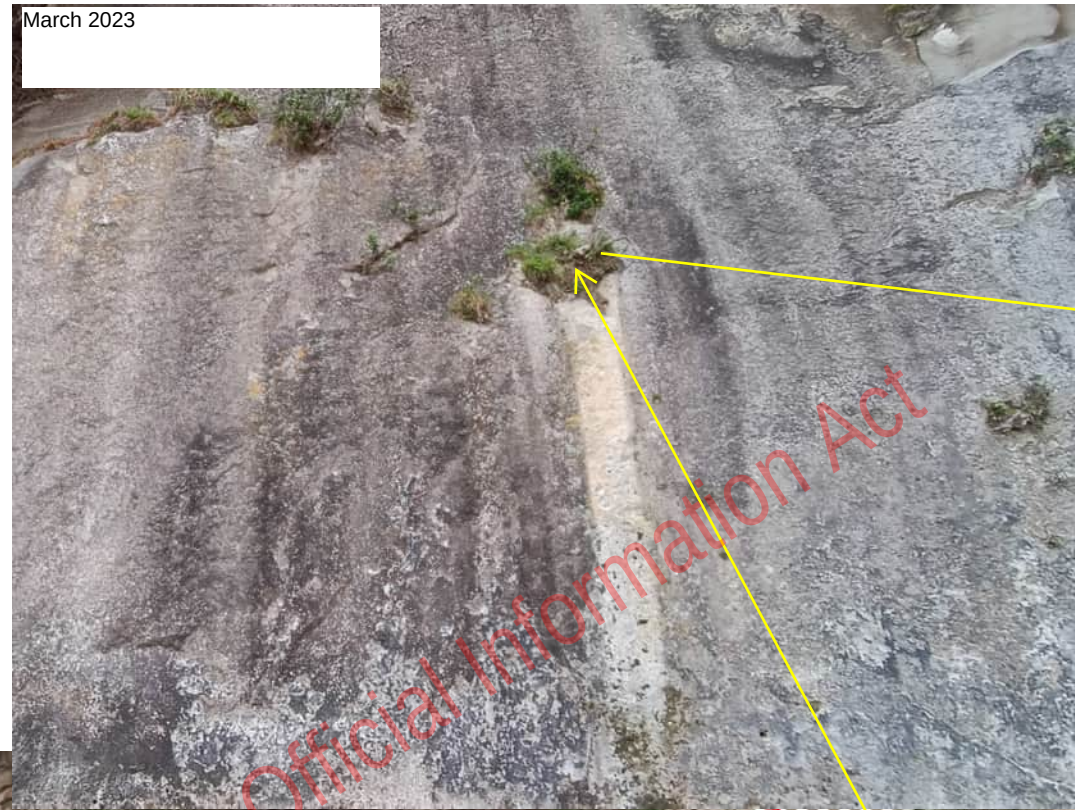
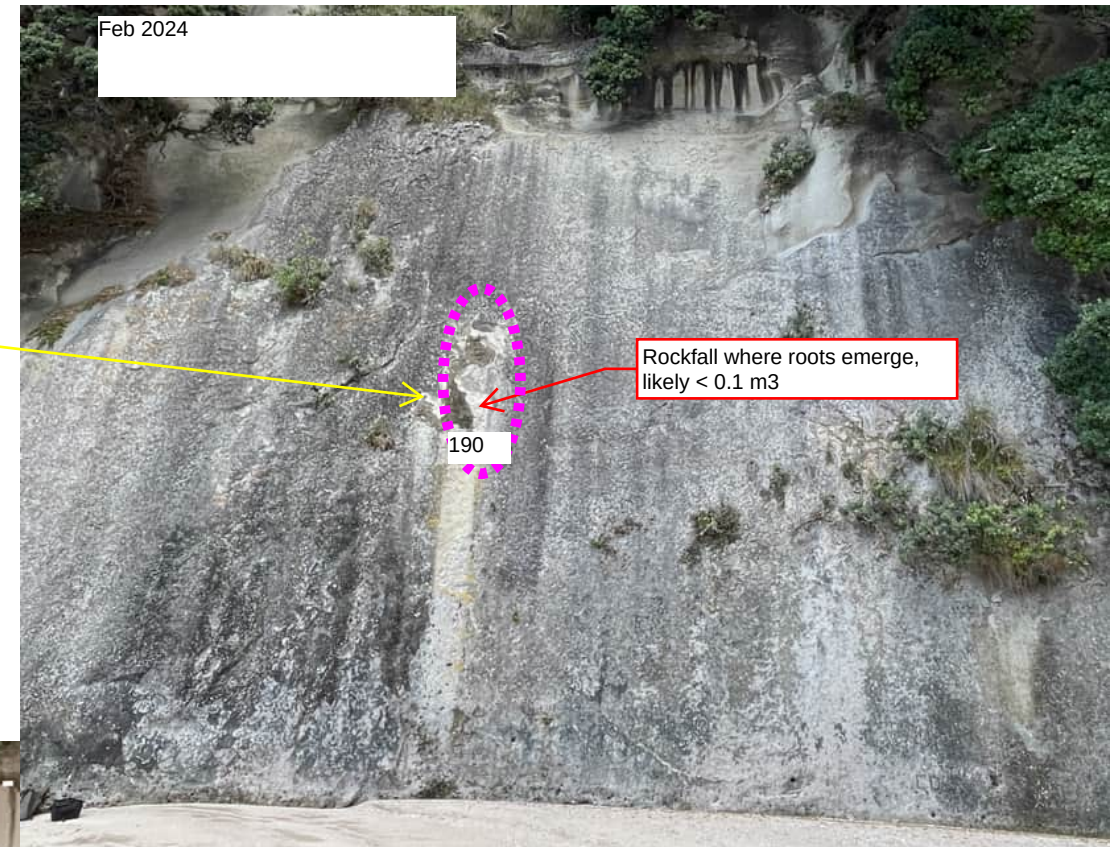
# 190 Northern Cliff Section

Subparallel Joints containing roots. Similar inferred conditions to April 2021 rock fall area.

Potential Tabular Block containing roots. Refer Figure A9

Areas of potential rock fall indicated by observed joints, which typically contain roots. Other areas on the cliff may fail without observable joints being present.

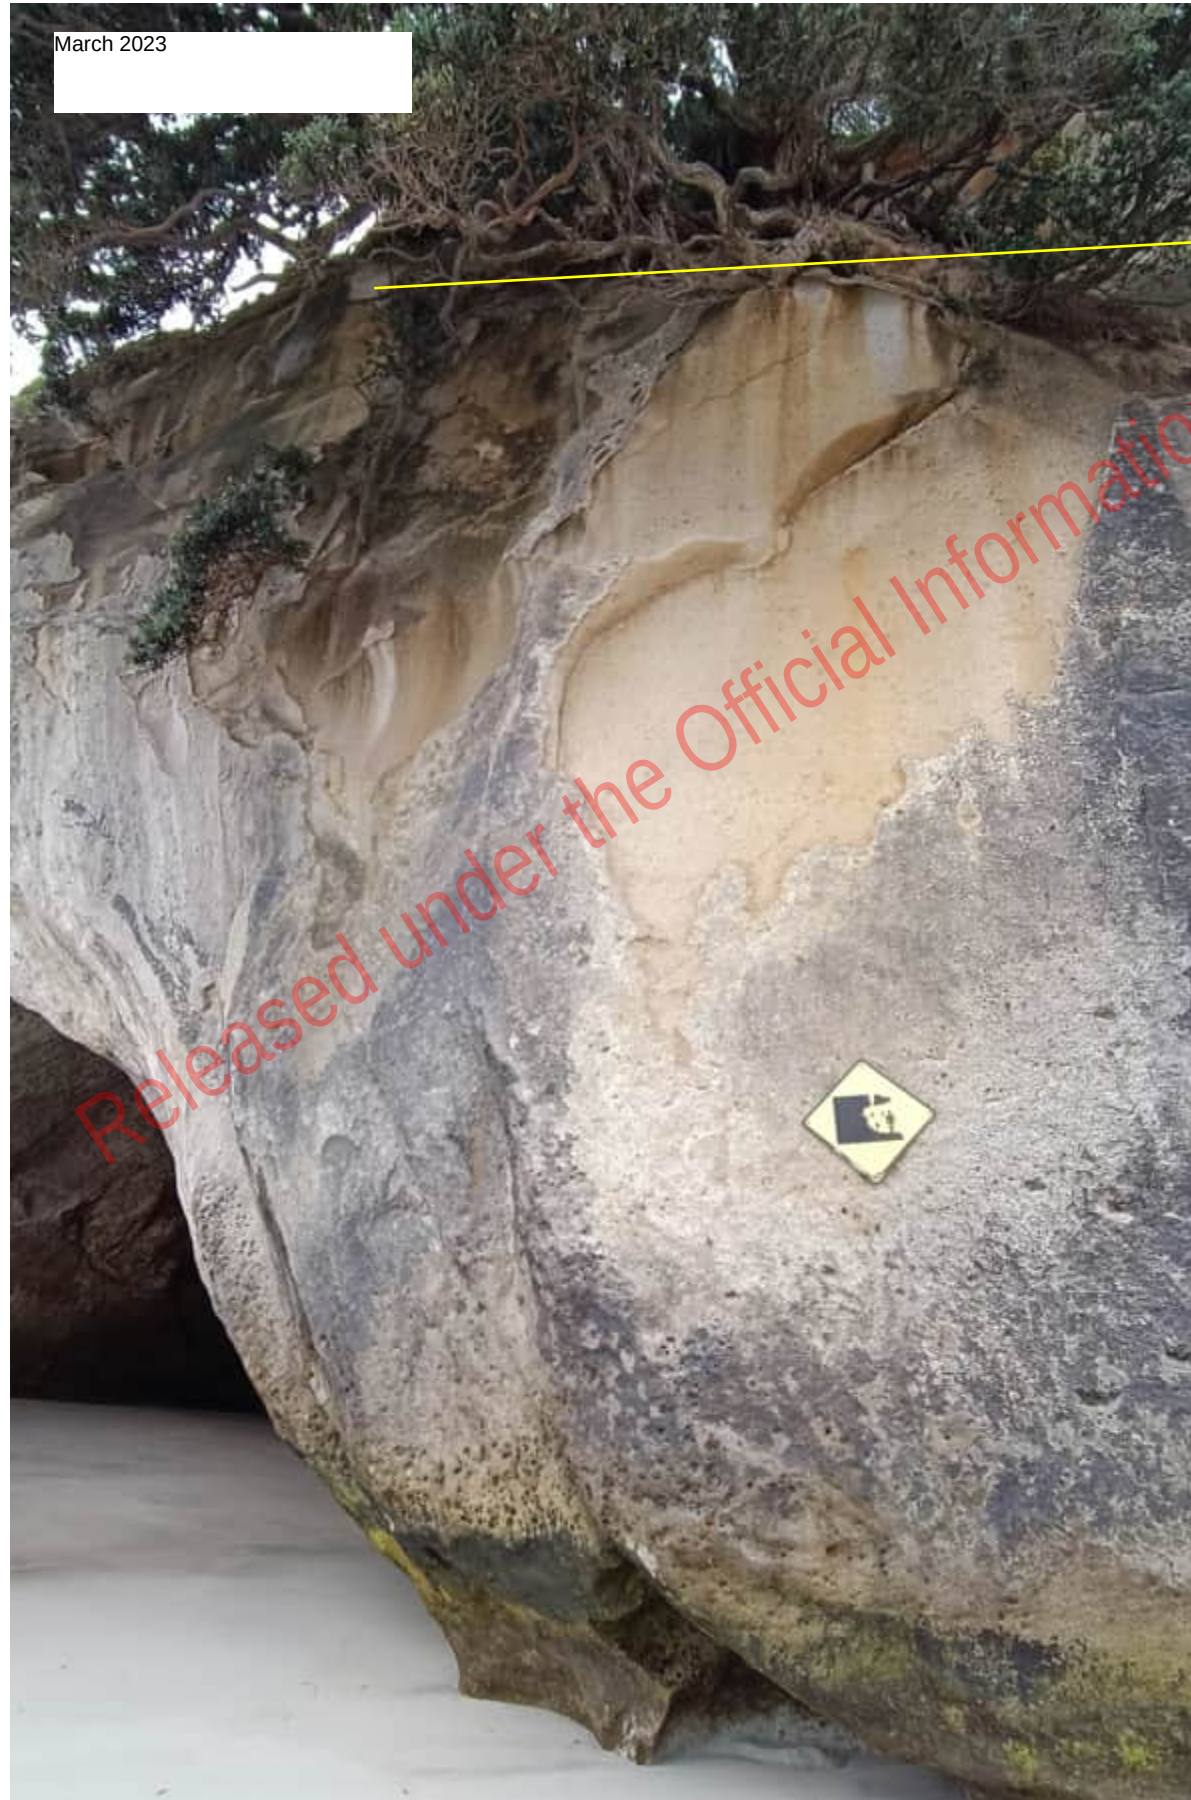
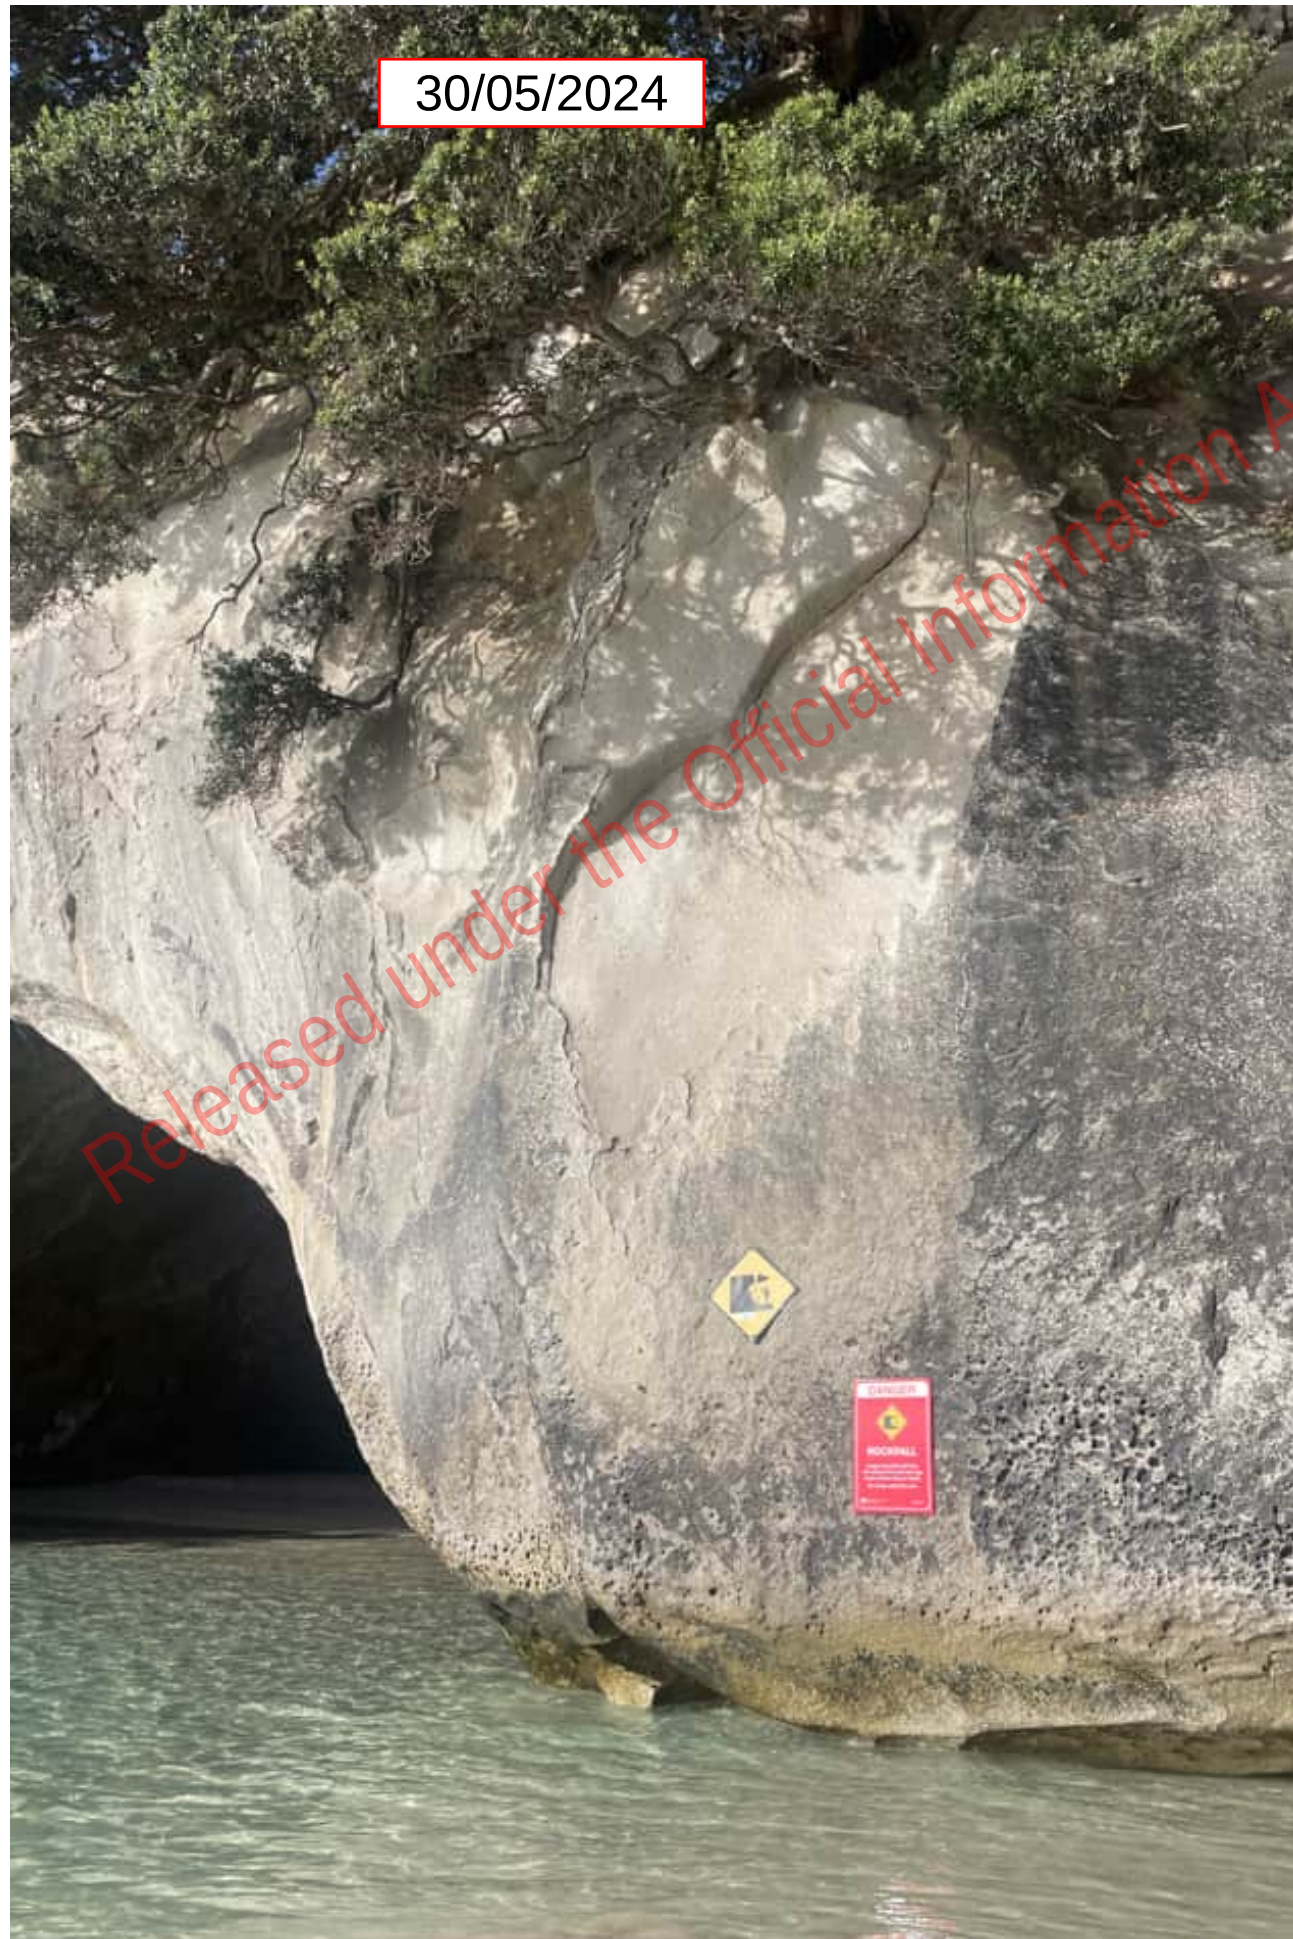
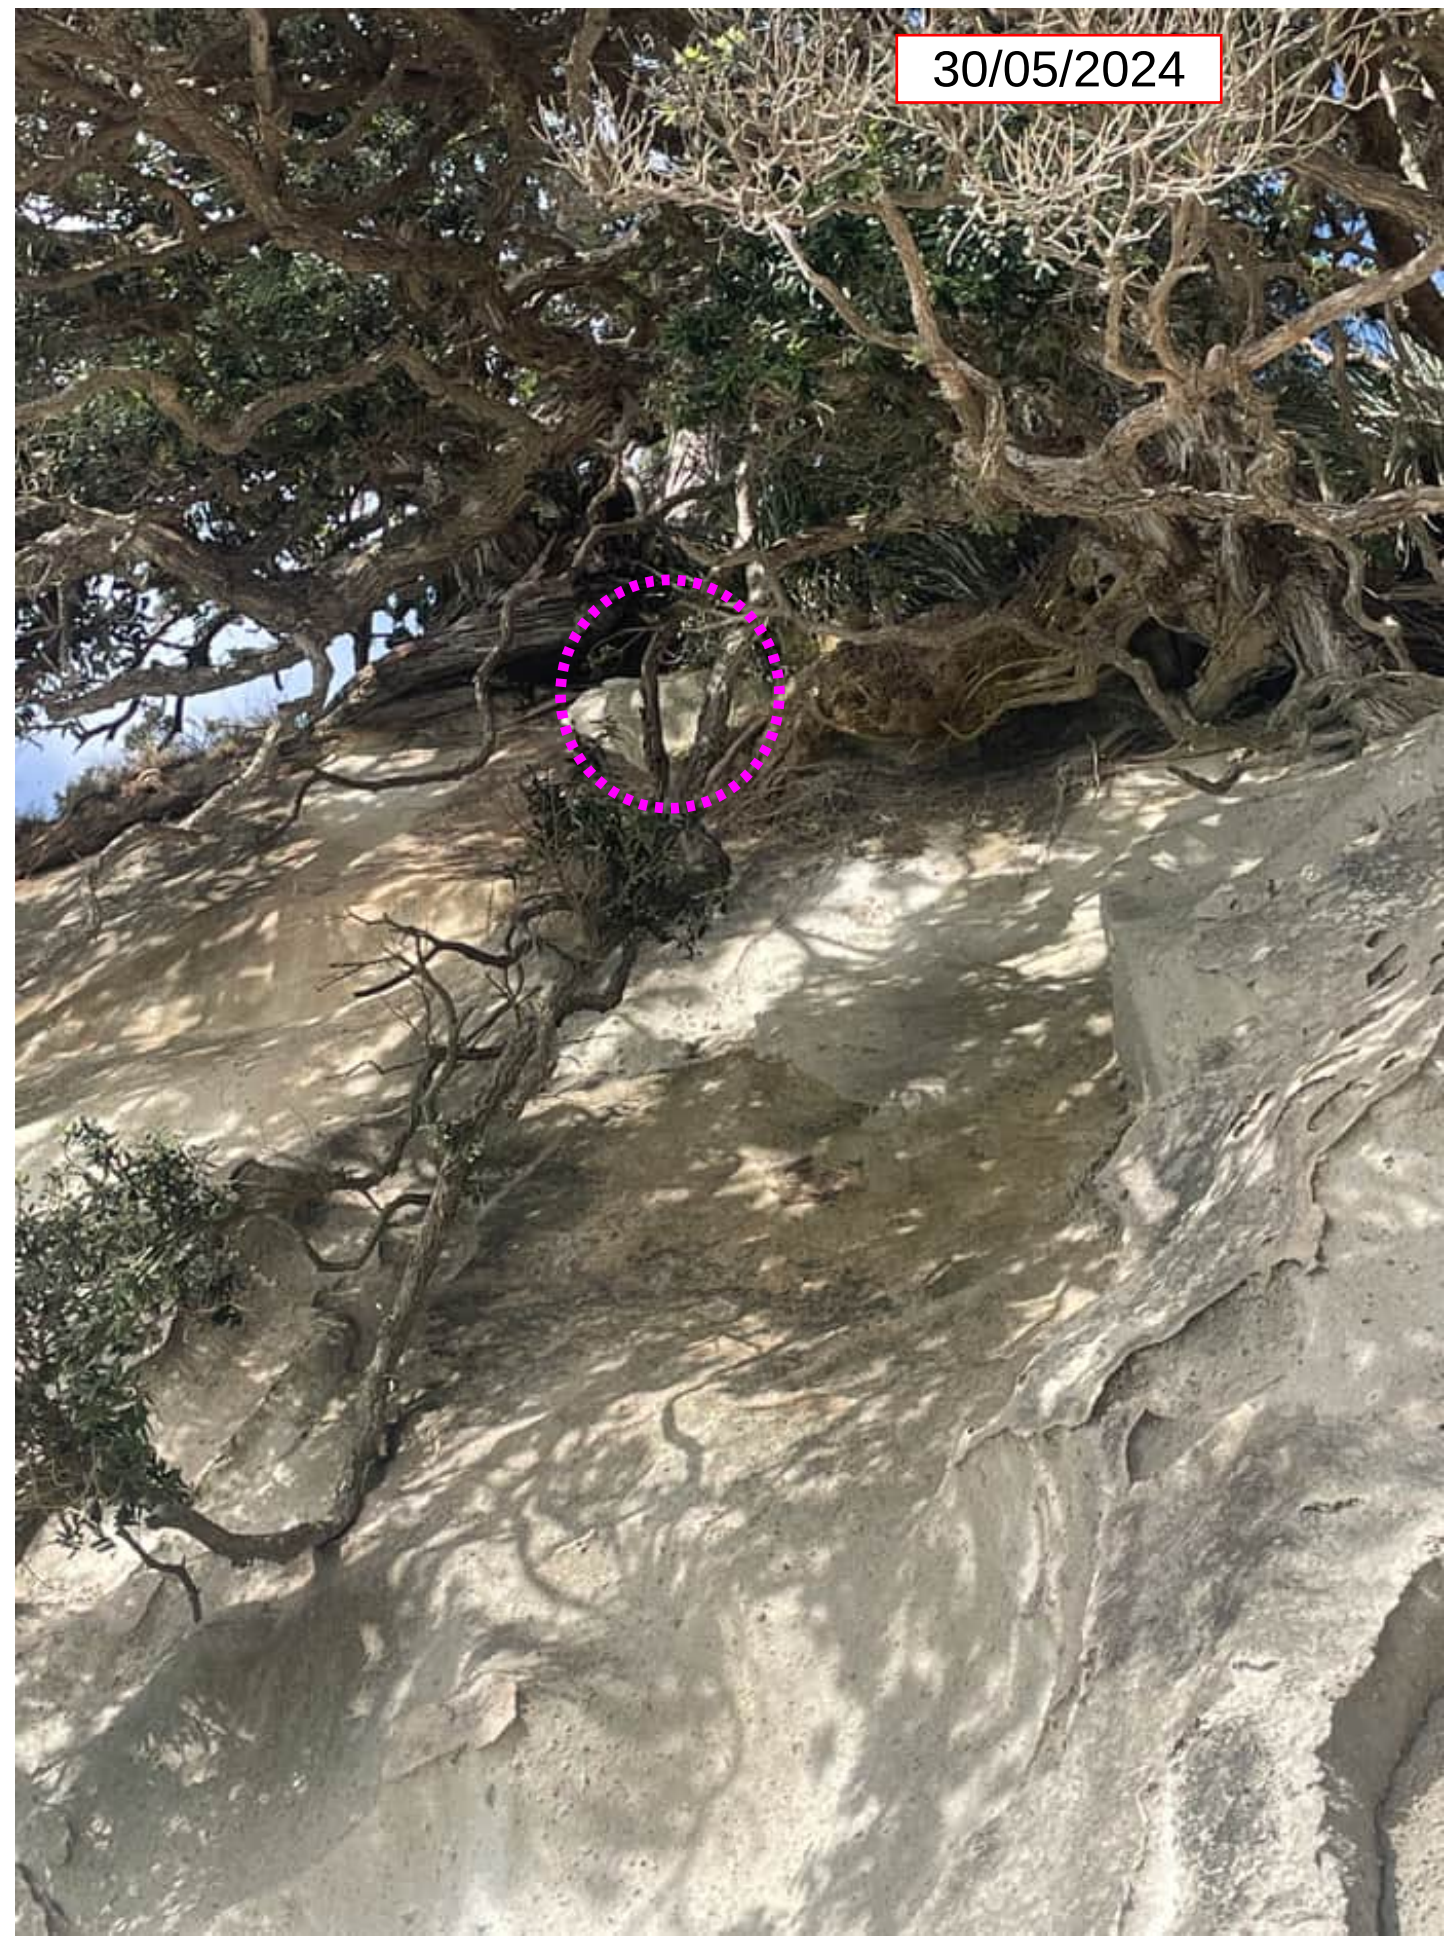
## Northern portal

Northern portal Continued. No change  
observed during May 2024 visit.

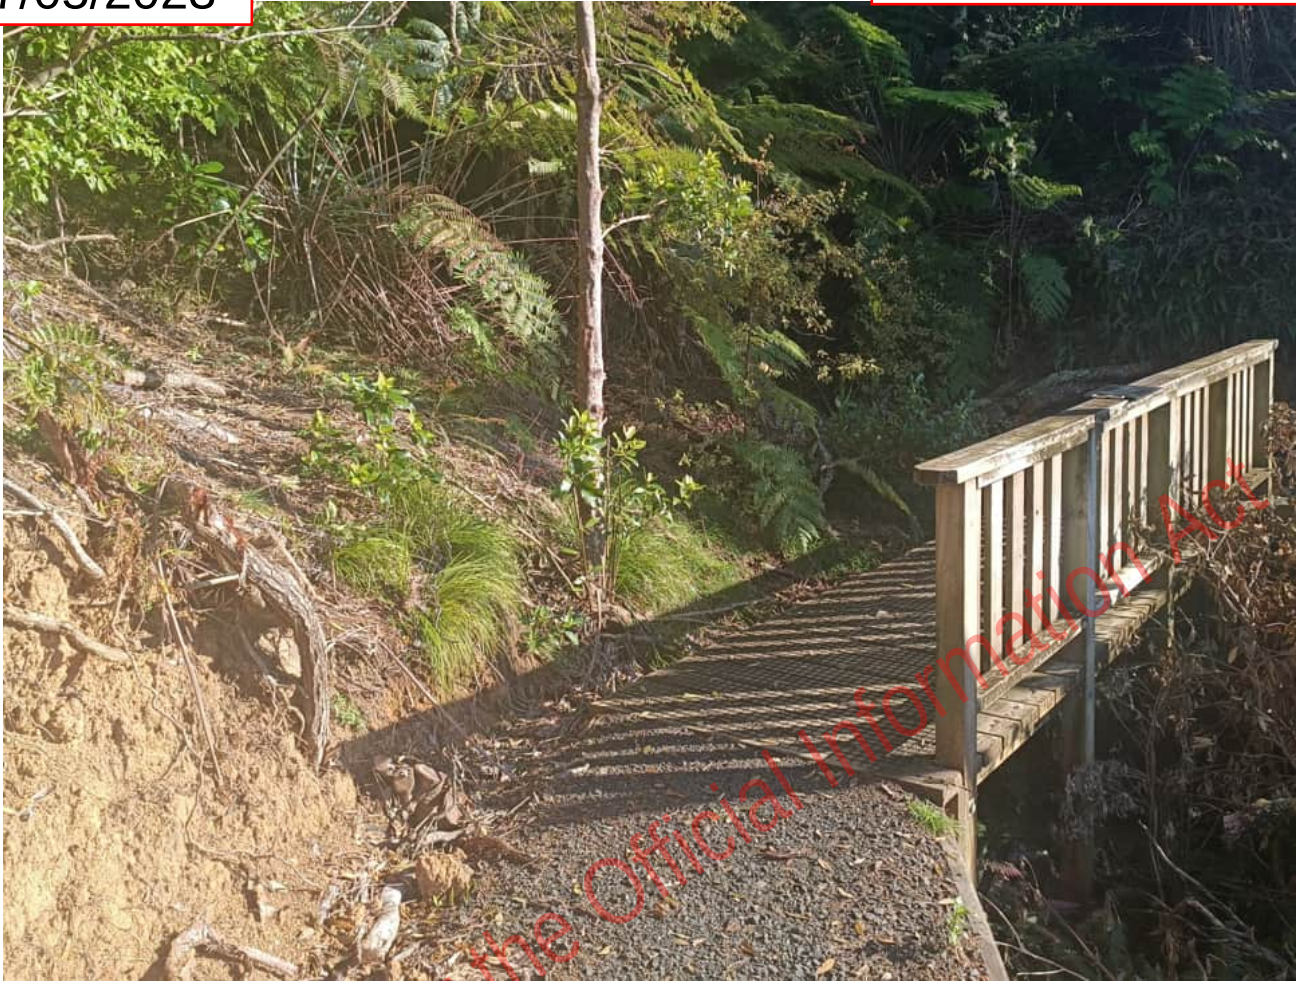
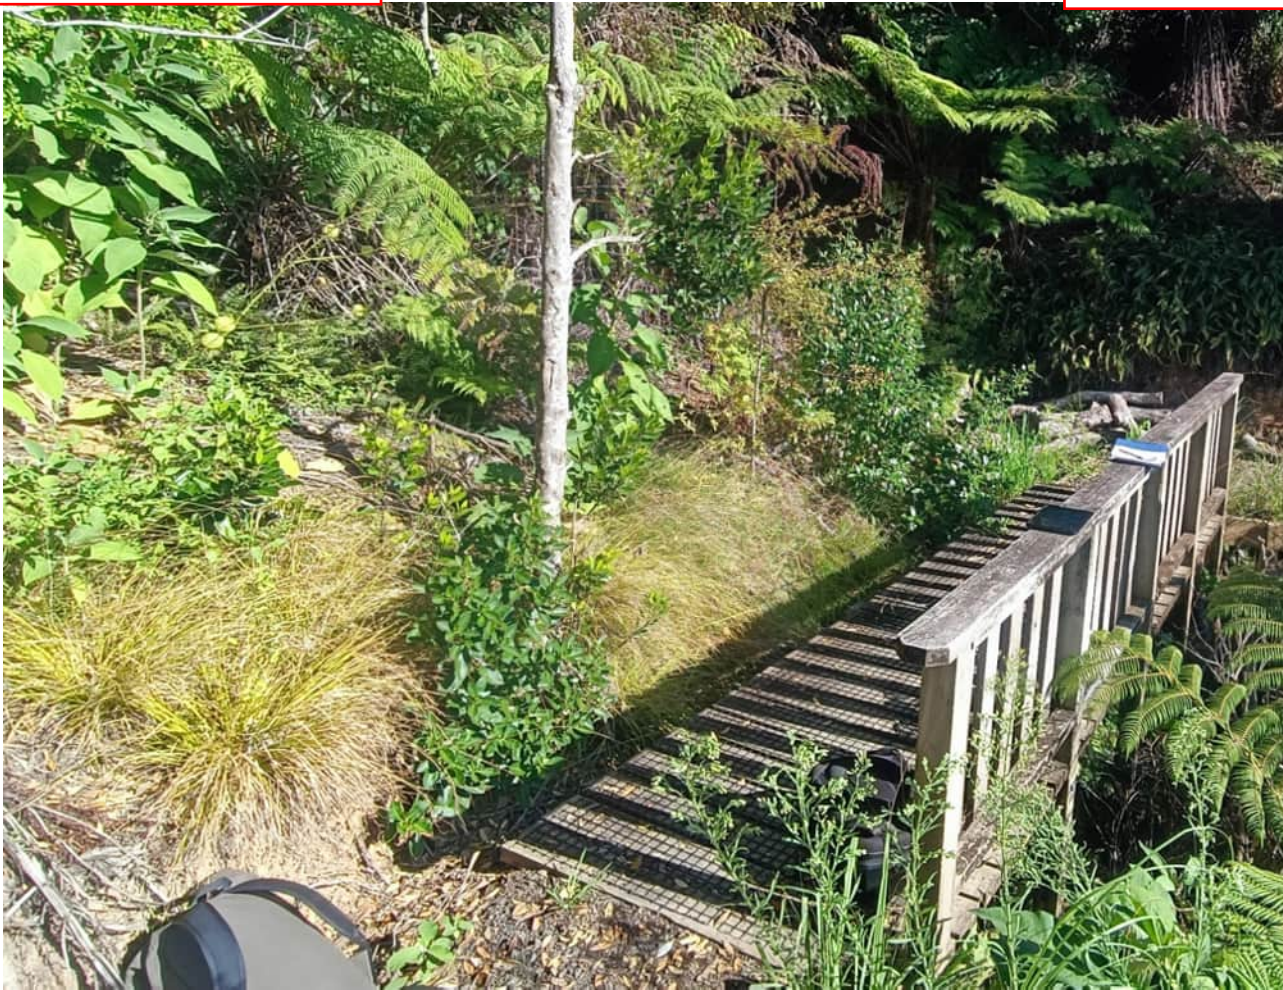
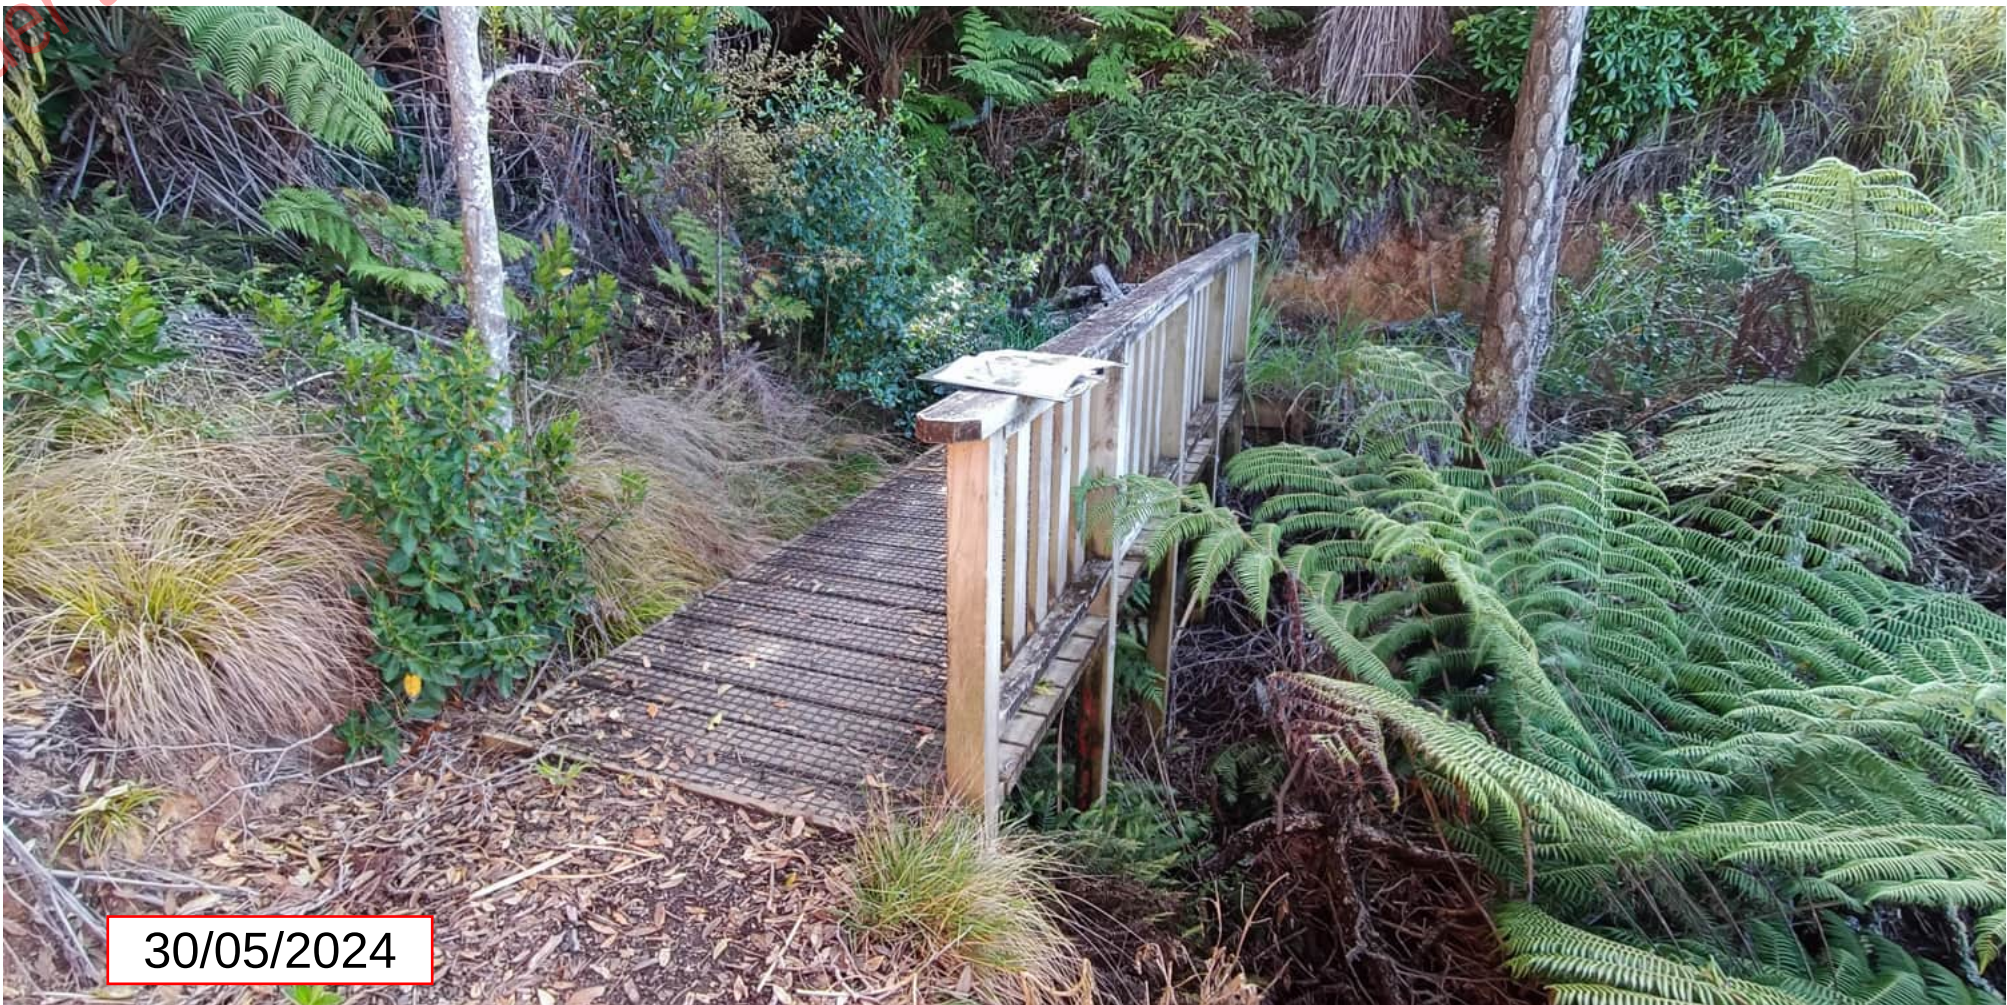
Feature 25 - Translational landslide. No new movement, historical landslide
