**Cathedral Cove Basic Level  
Landslide Risk Assessment**

**Prepared for**  
Department of Conservation  
**Prepared by**  
Tonkin & Taylor Ltd  
**Date**  
July 2023  
**Job Number**  
1007838.3000 v3

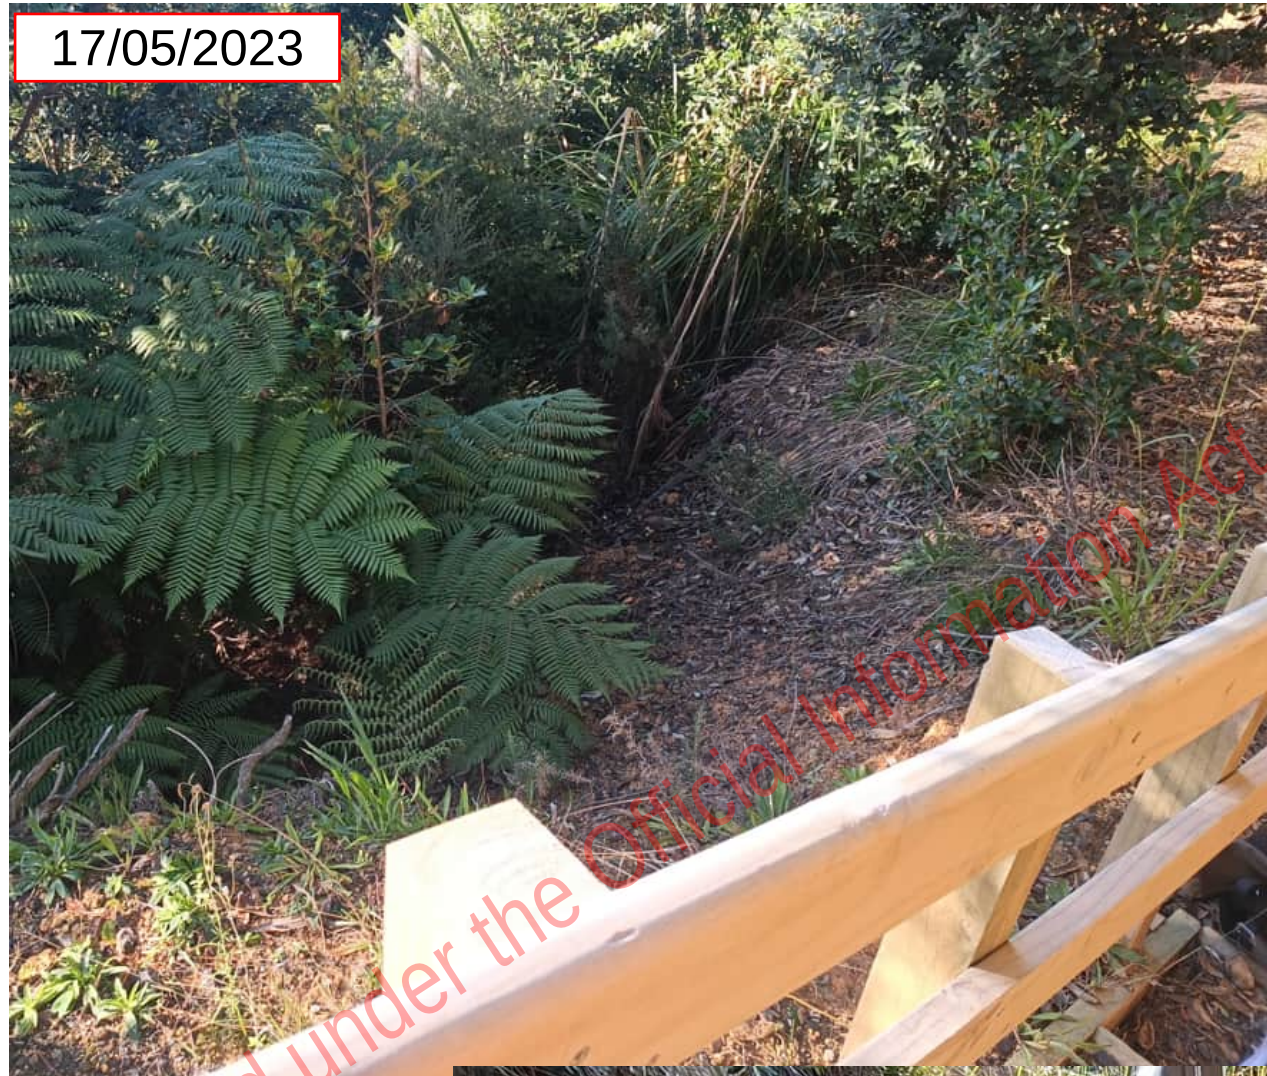
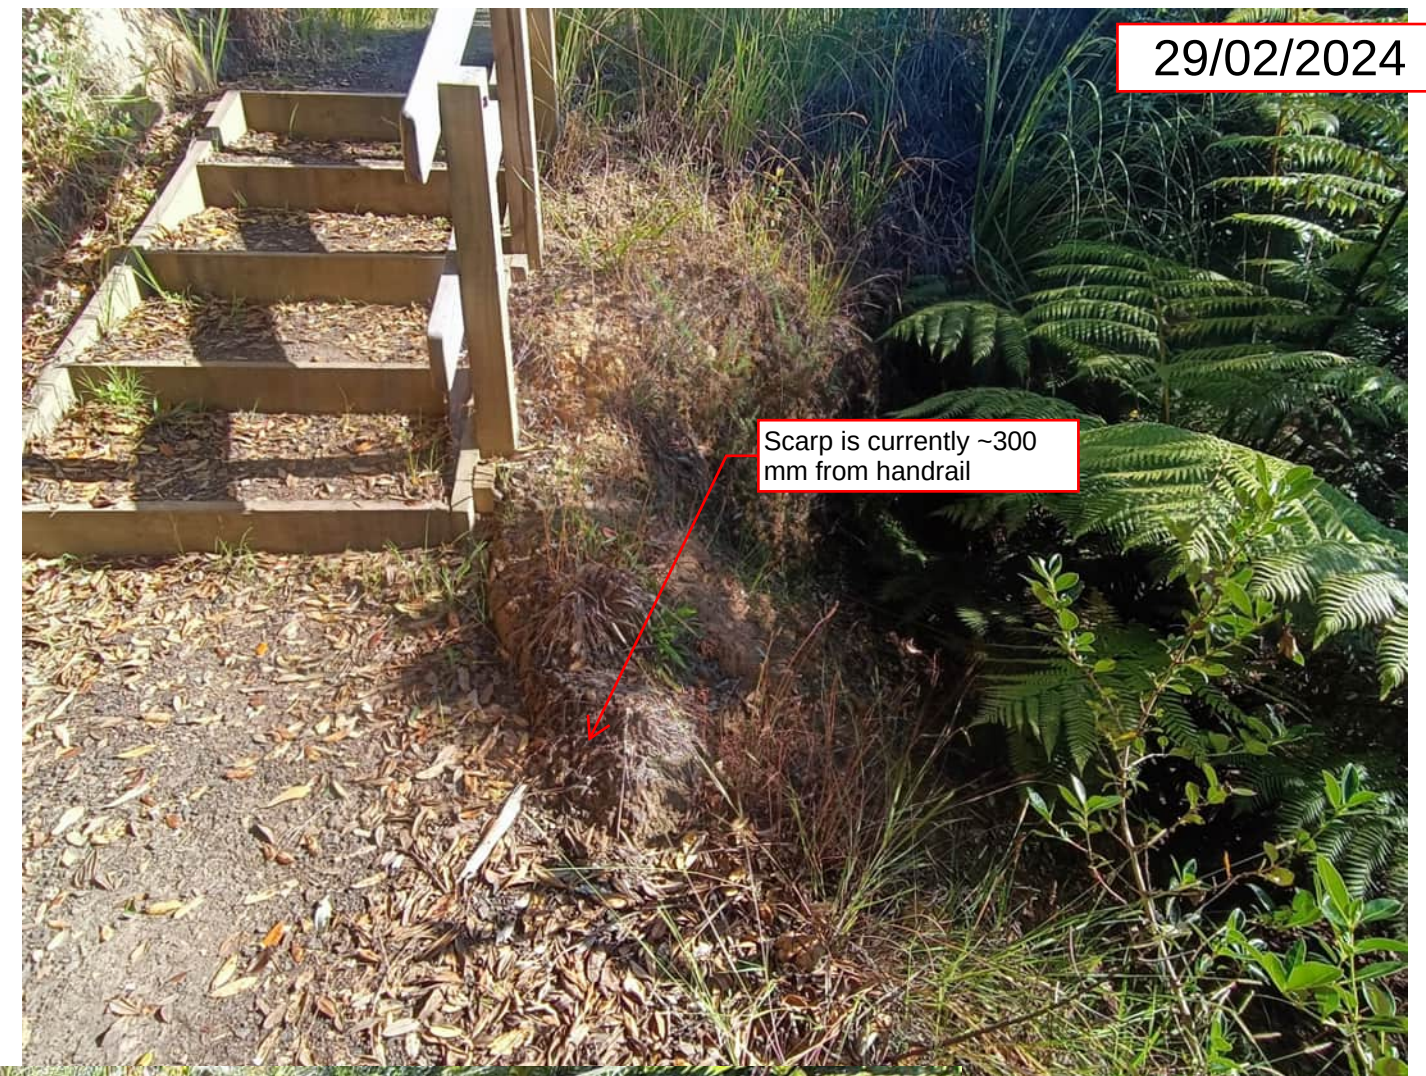
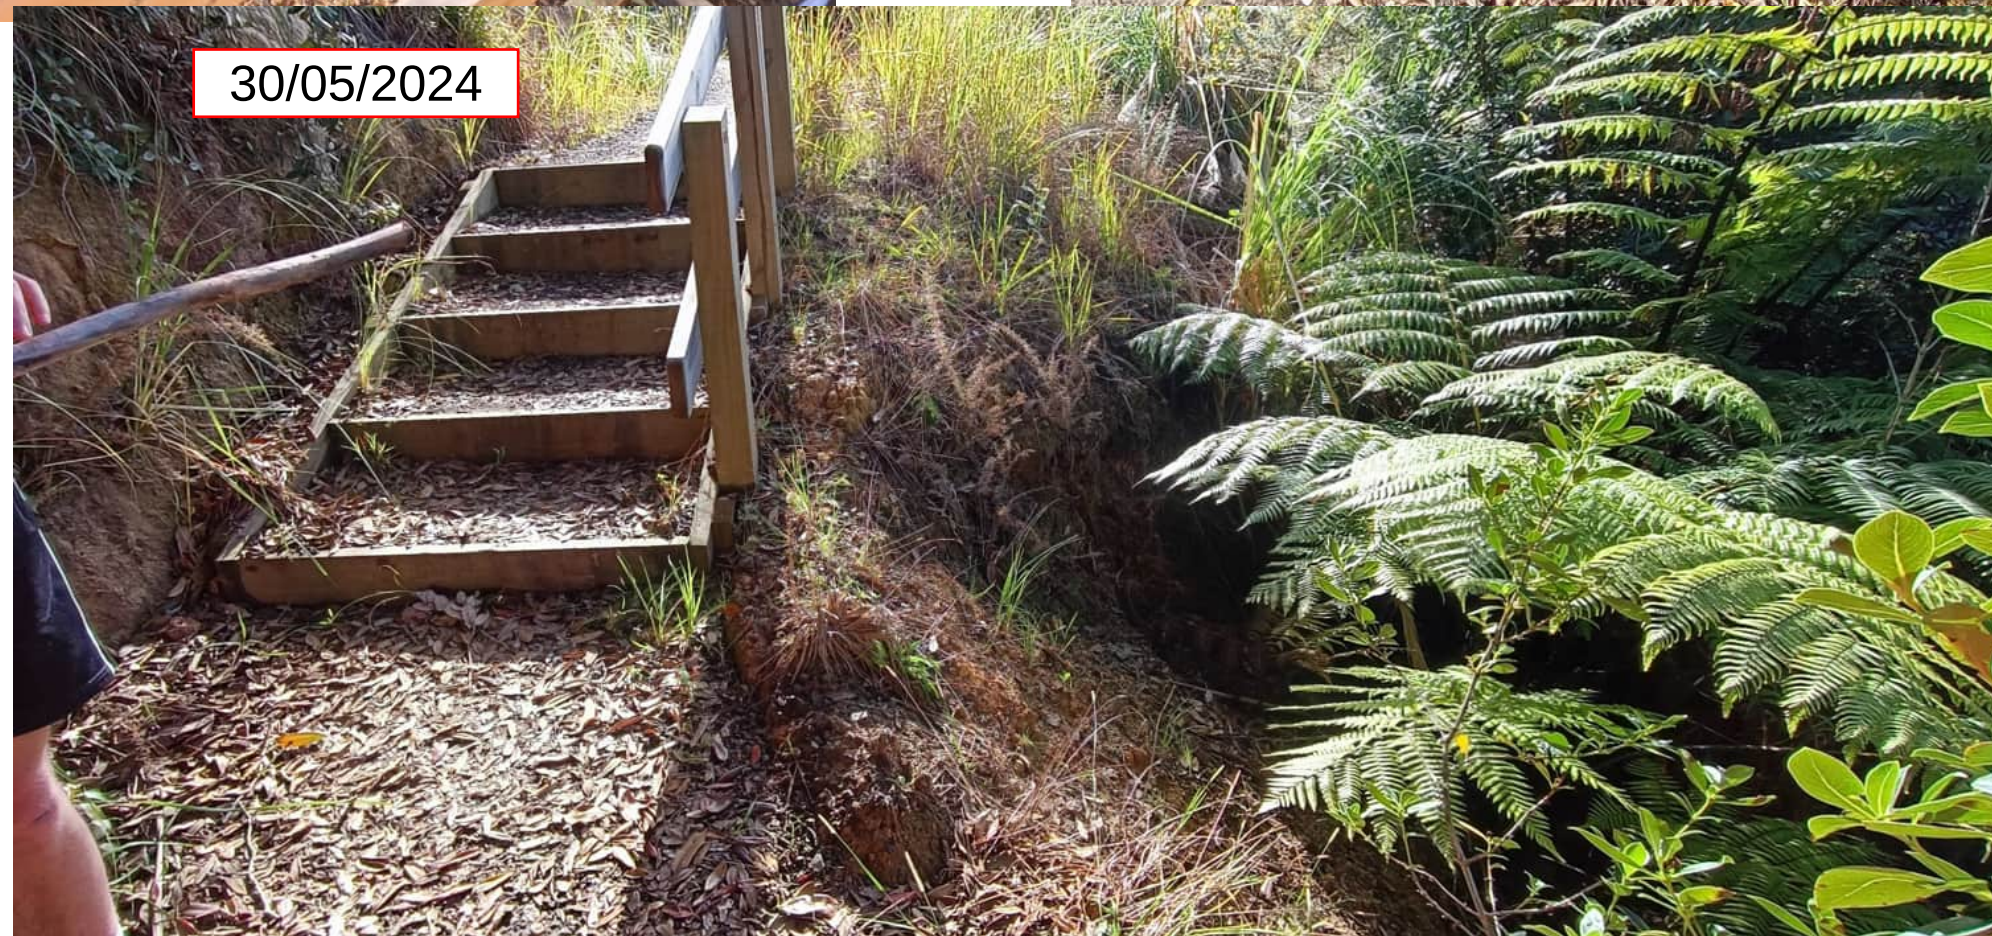
Feature 26 - Translational landslide. Some erosion (<50 mm) of landslip headscarp observed during Feb 2024 visit. No new movement observed during May 2024 visit.

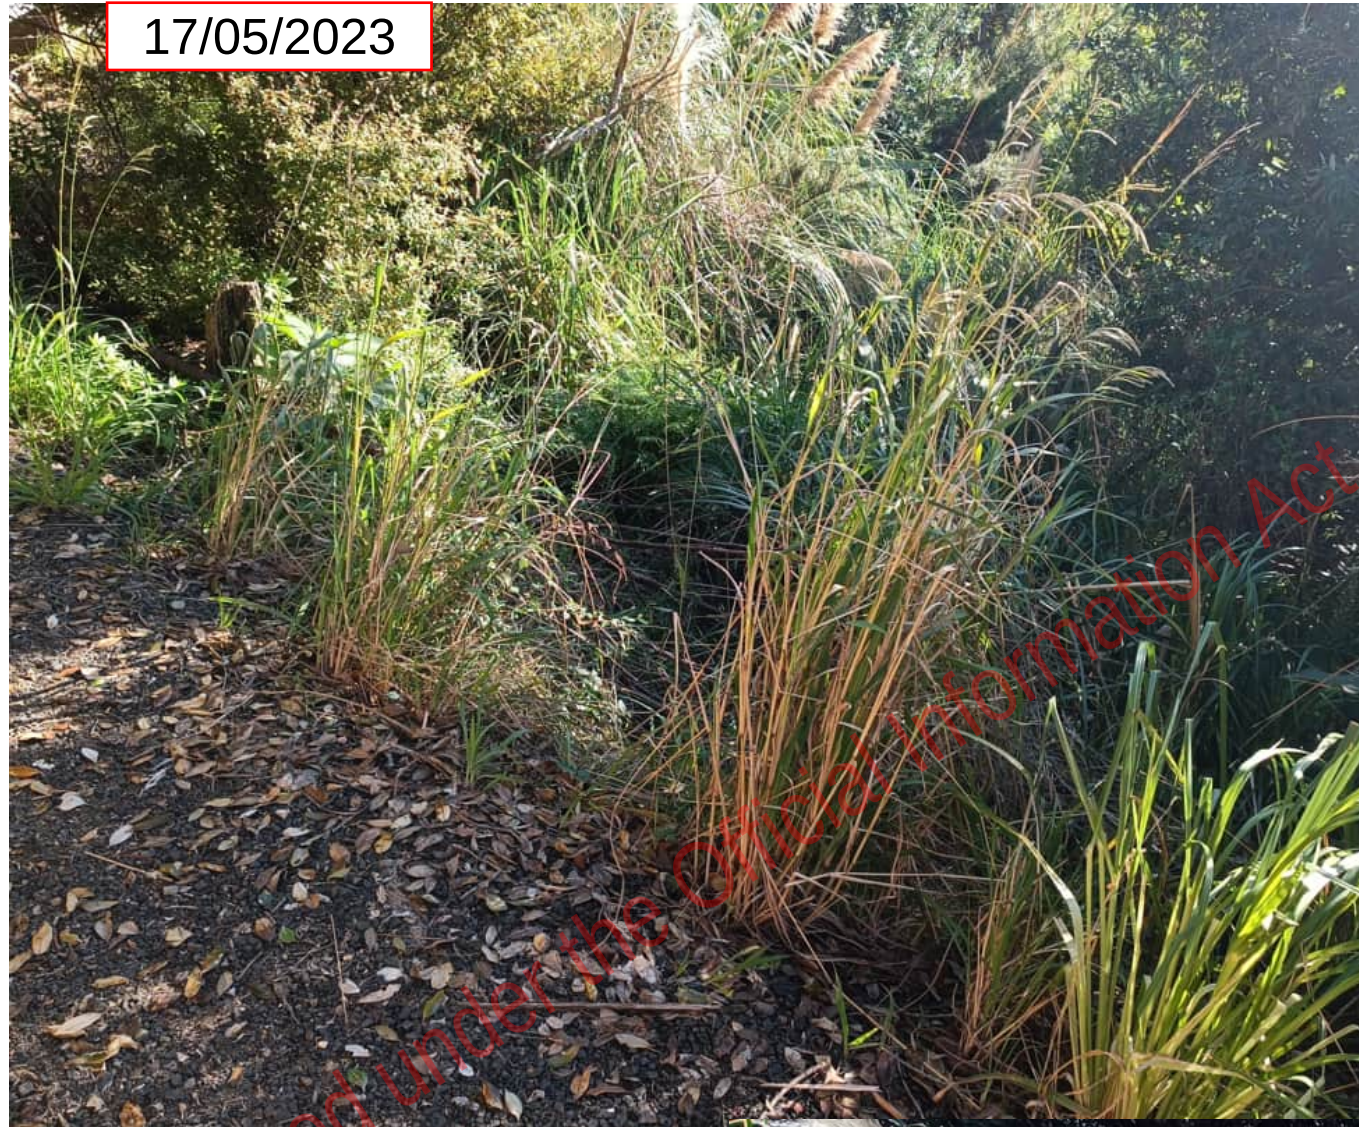
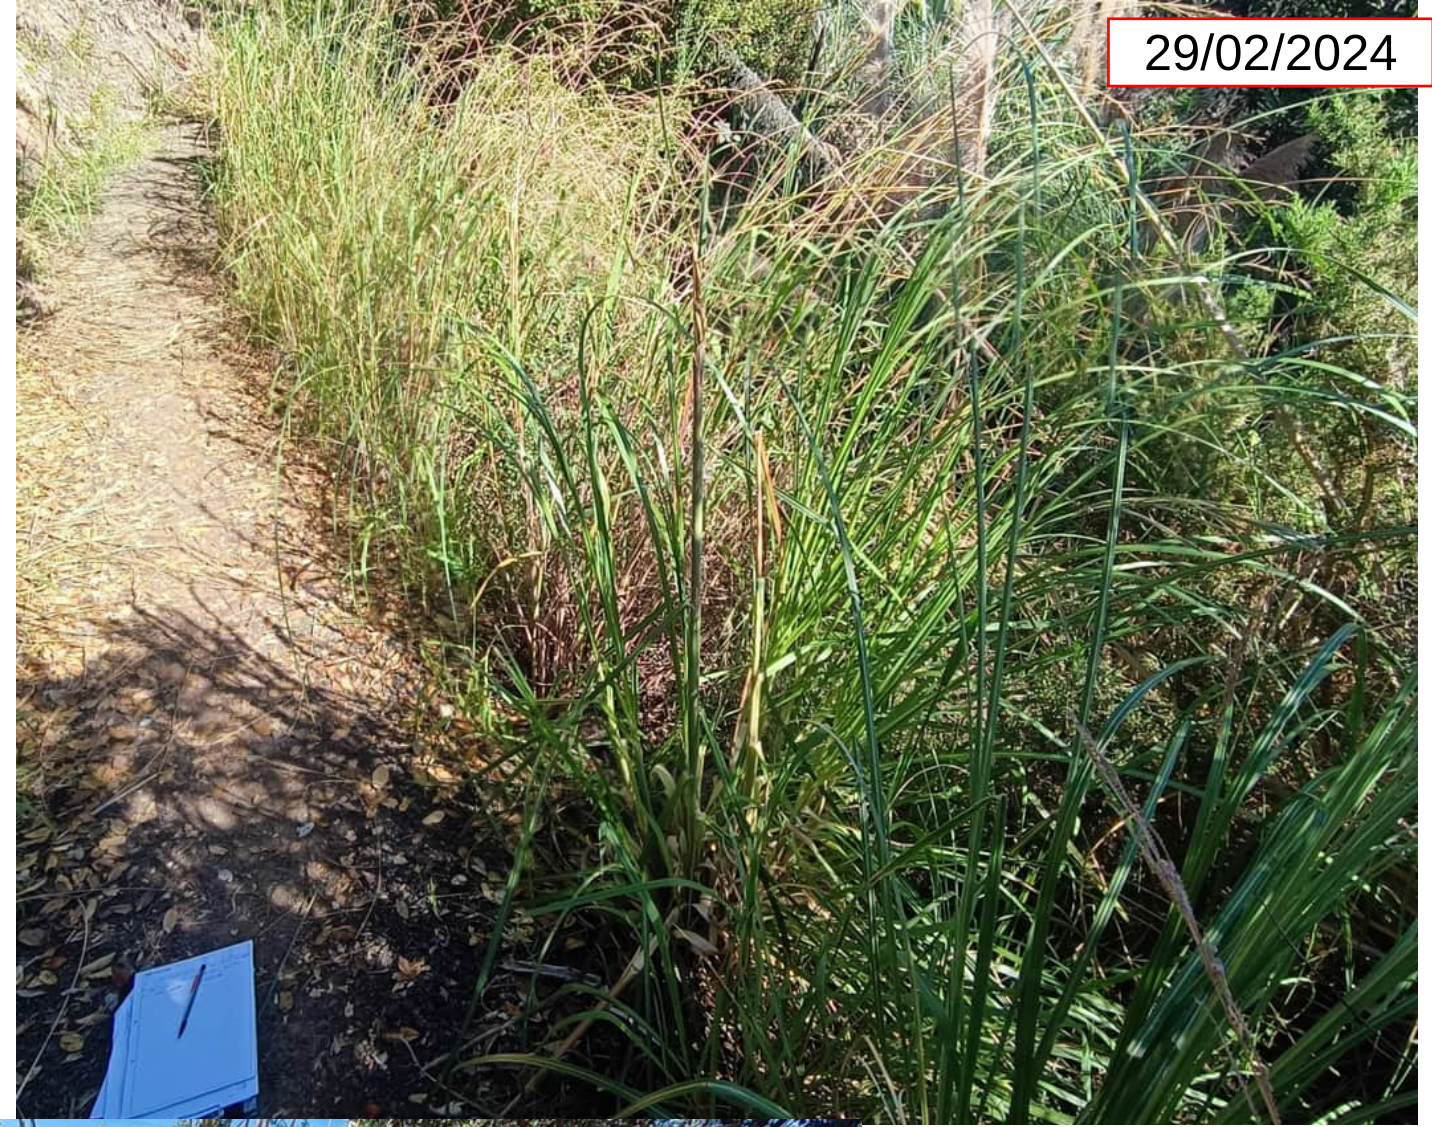
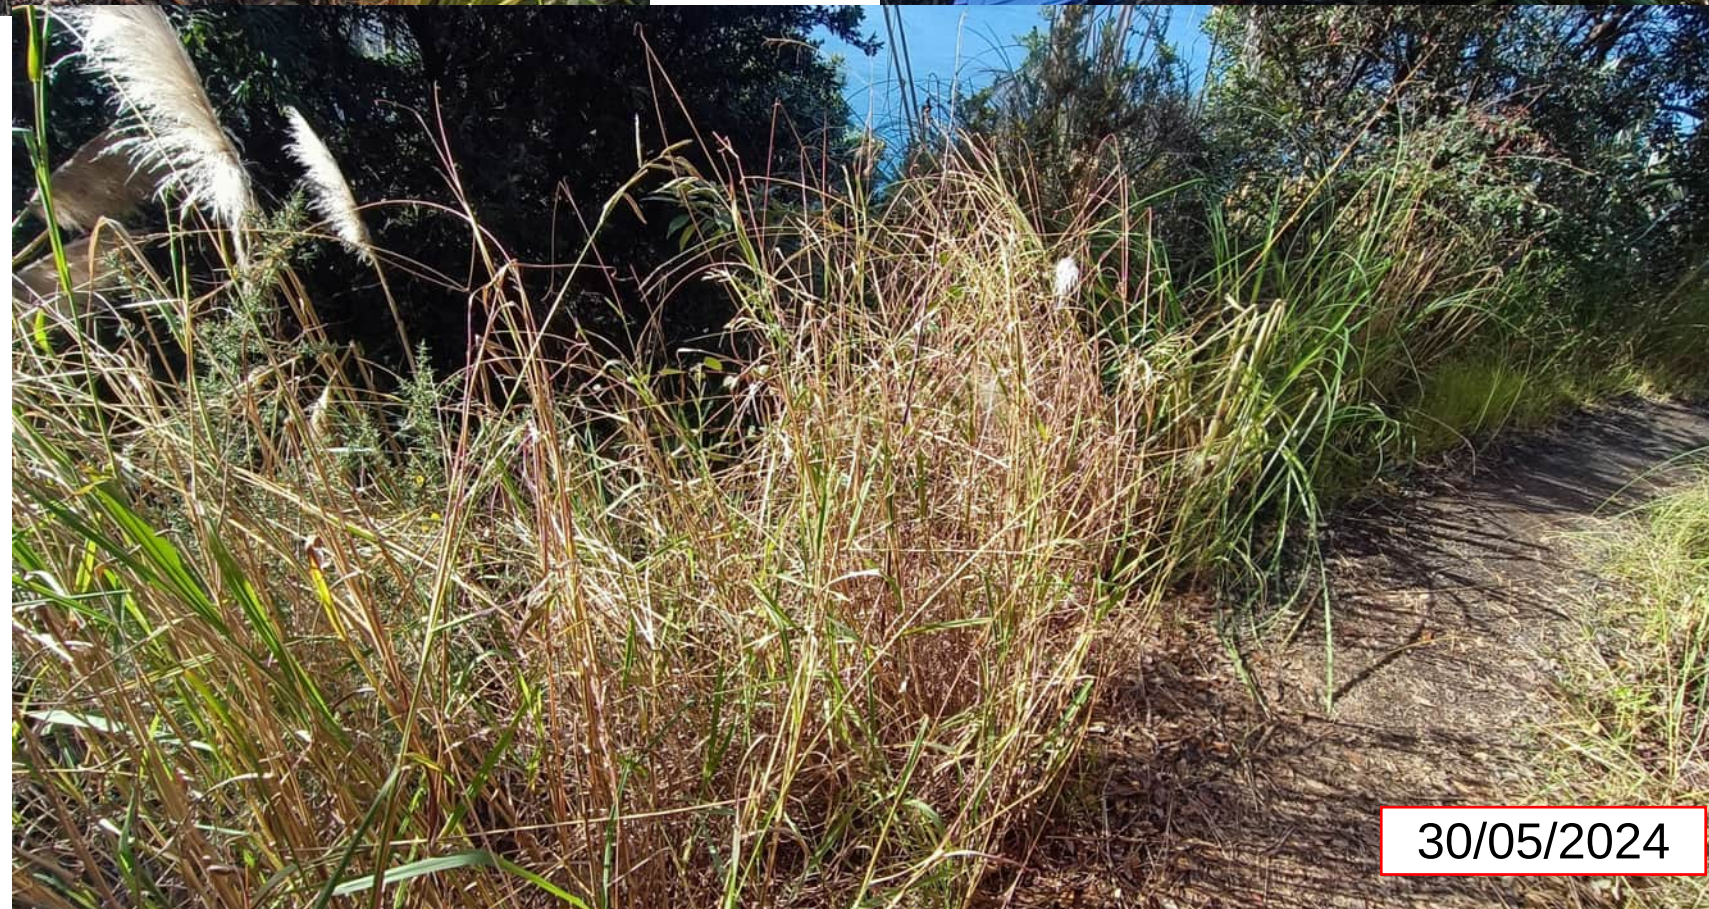
Feature 27 - Translational landslide. Very thickly vegetated, no new movement observed. Historical

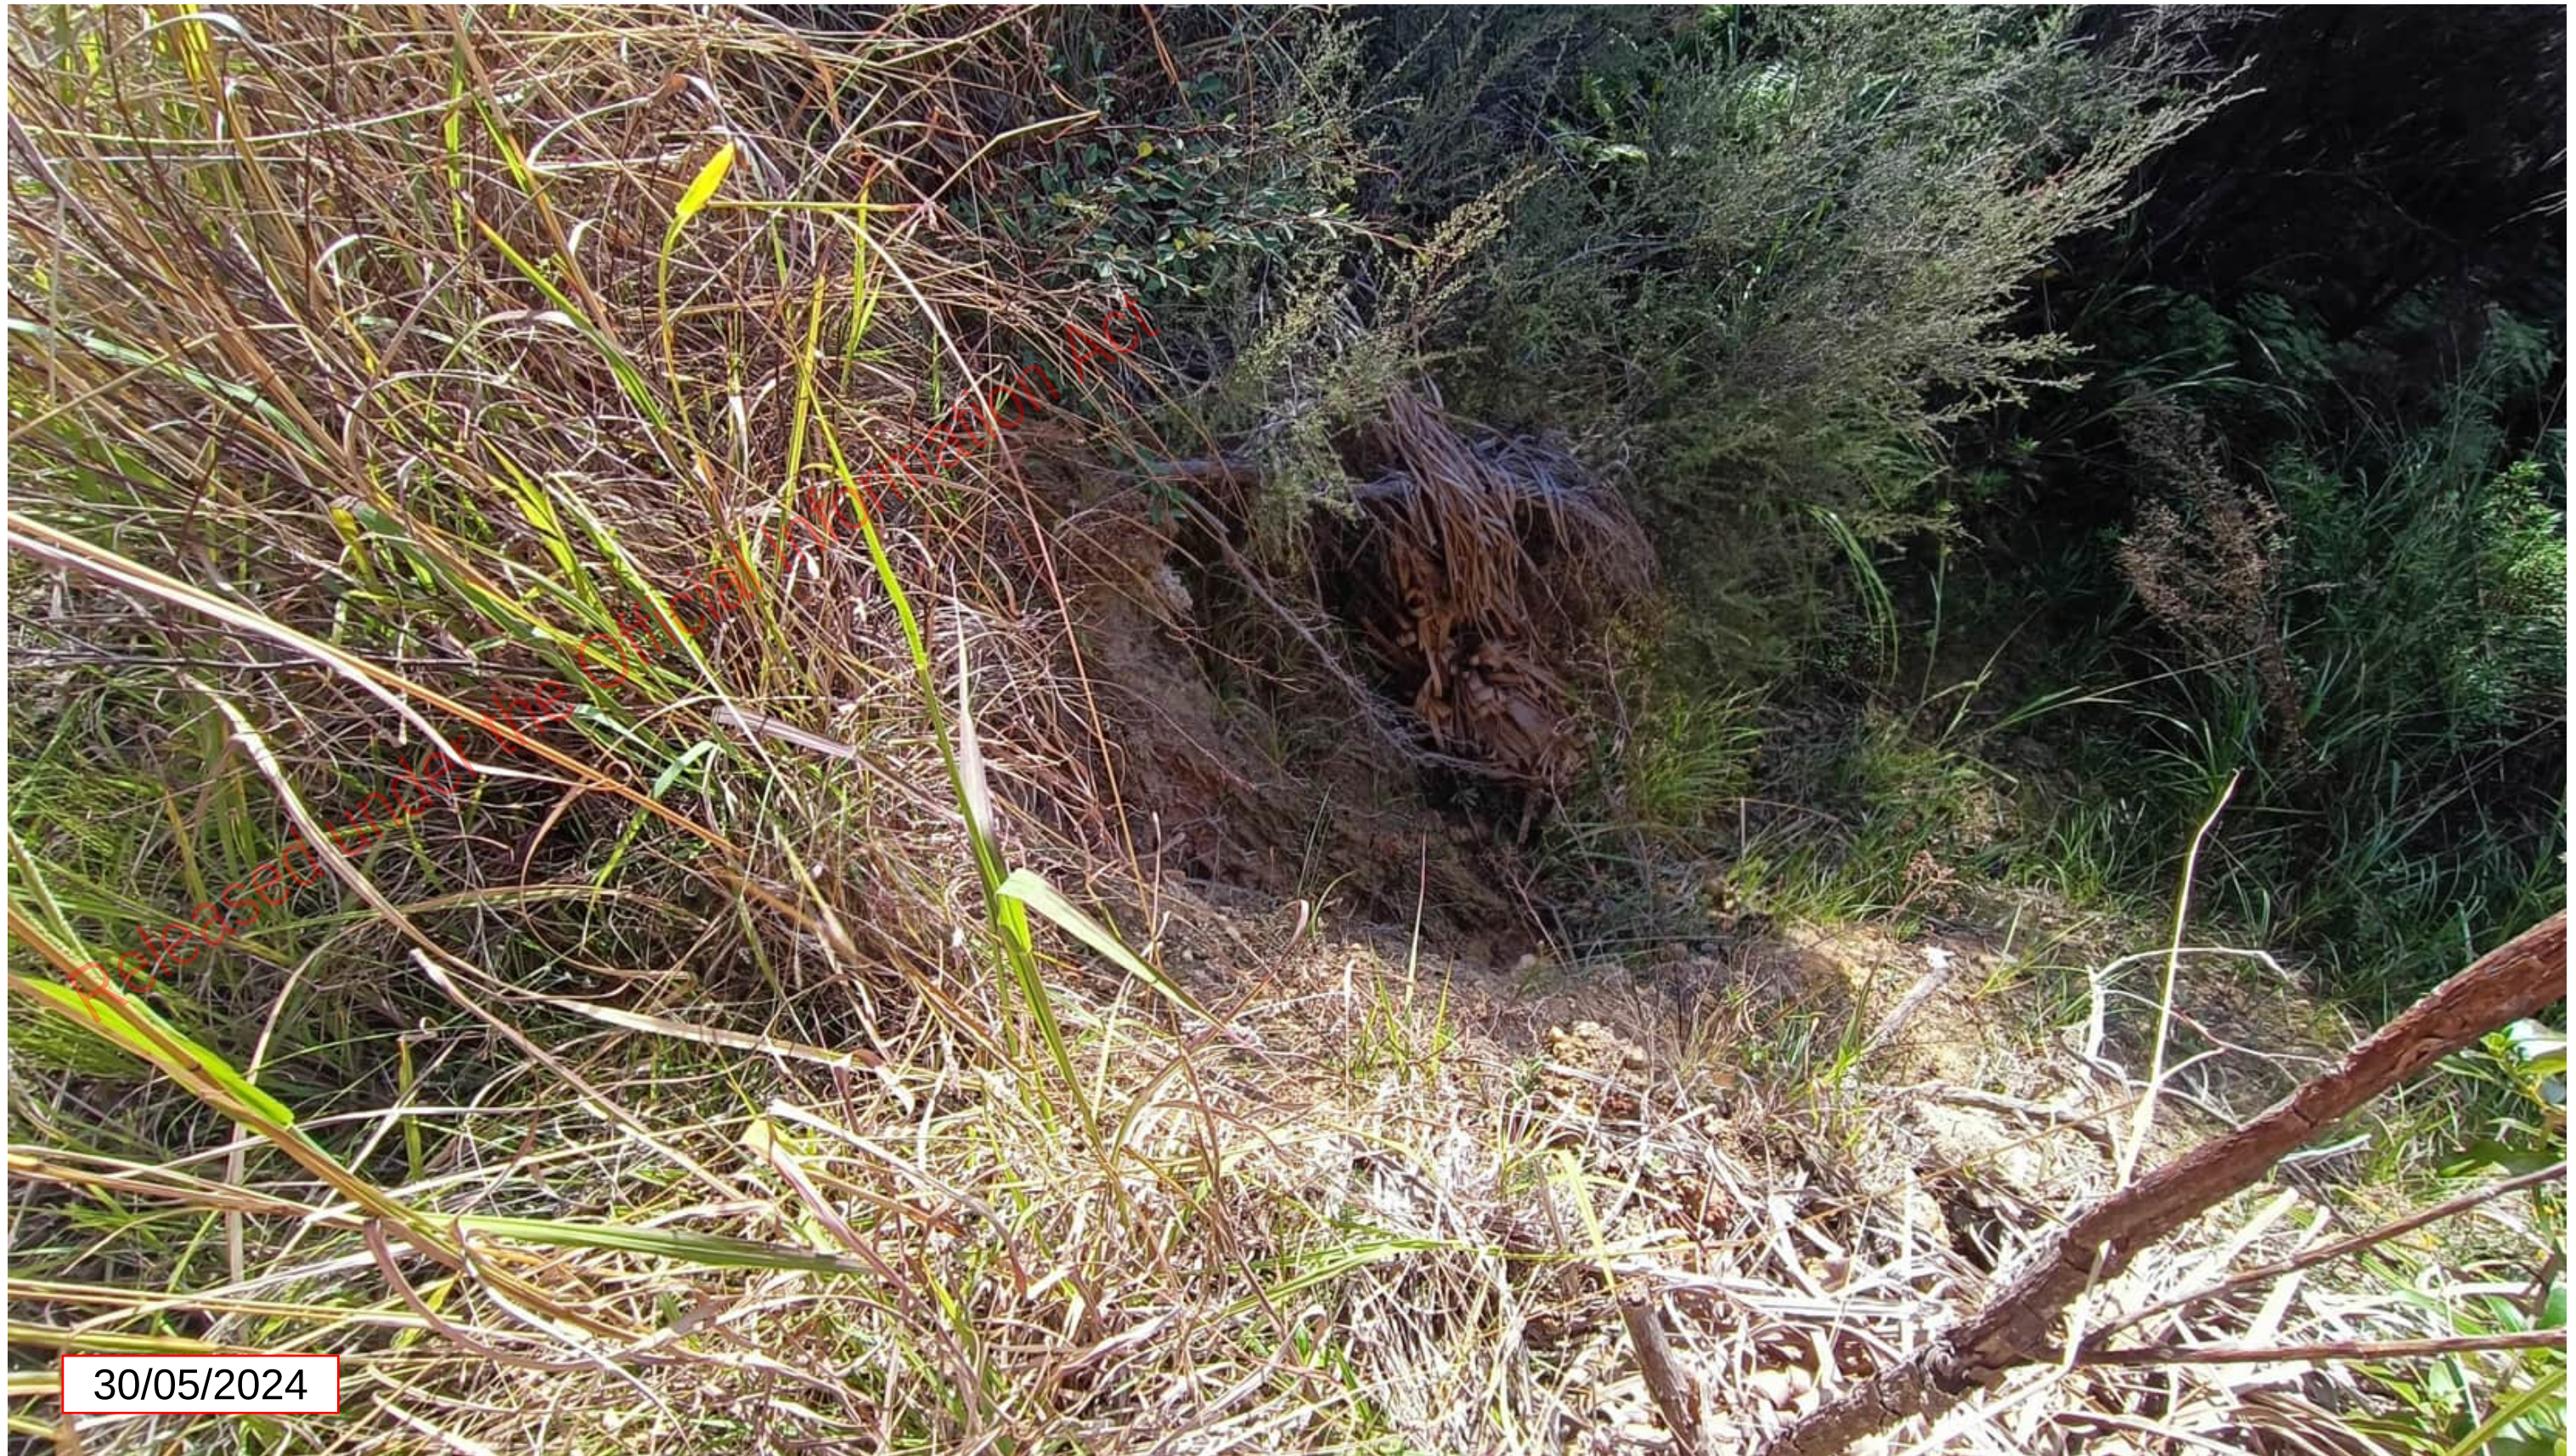
Feature 28 - Translational landslide.  
A new tension crack developed (observed Feb 2024) approximately  
300mm behind the headscarp (192)

Feature 28 Continued - Translational landslide  
No new damage observed during May 2024 visit.

| ID | Type_II_Fieldnotes | Type_II | Width_m | Length_overall | Height_overall | Height_of_scarp | Geology | Adopted_volume | Adopted_Age | Method_of_capture | February 2024 monitoring round comments | Feb 2024 Change? | May 2024 monitoring round comments | May 2024 change? |
|---|---|---|---|---|---|---|---|---|---|---|---|---|---|---|
| 28 | Translational | Landslide | 4 | 6 m visible | 5 | 1.5 | Residual soils | 25 | 28/01/2023 | Site observation | New nearby tension crack developed (refer 192). Culvert pipe discharges here. | Y | | |

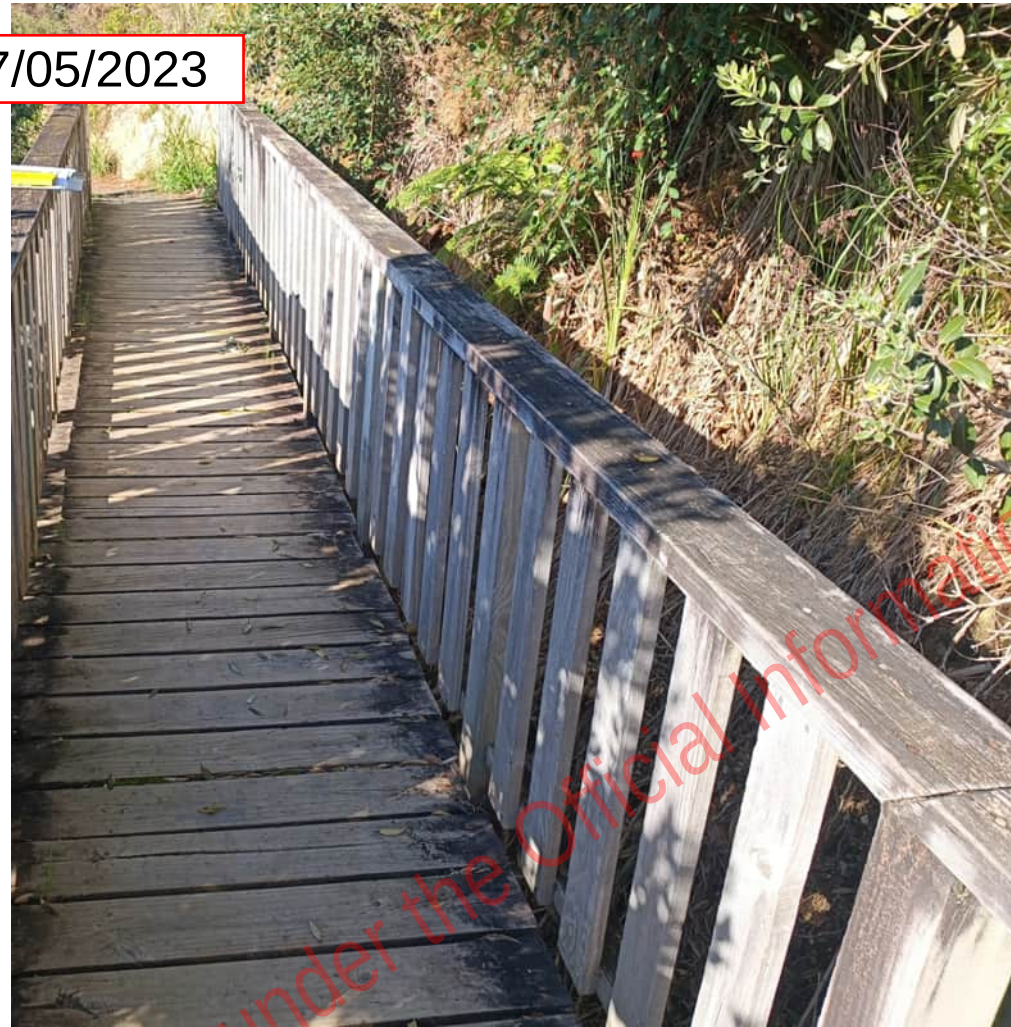
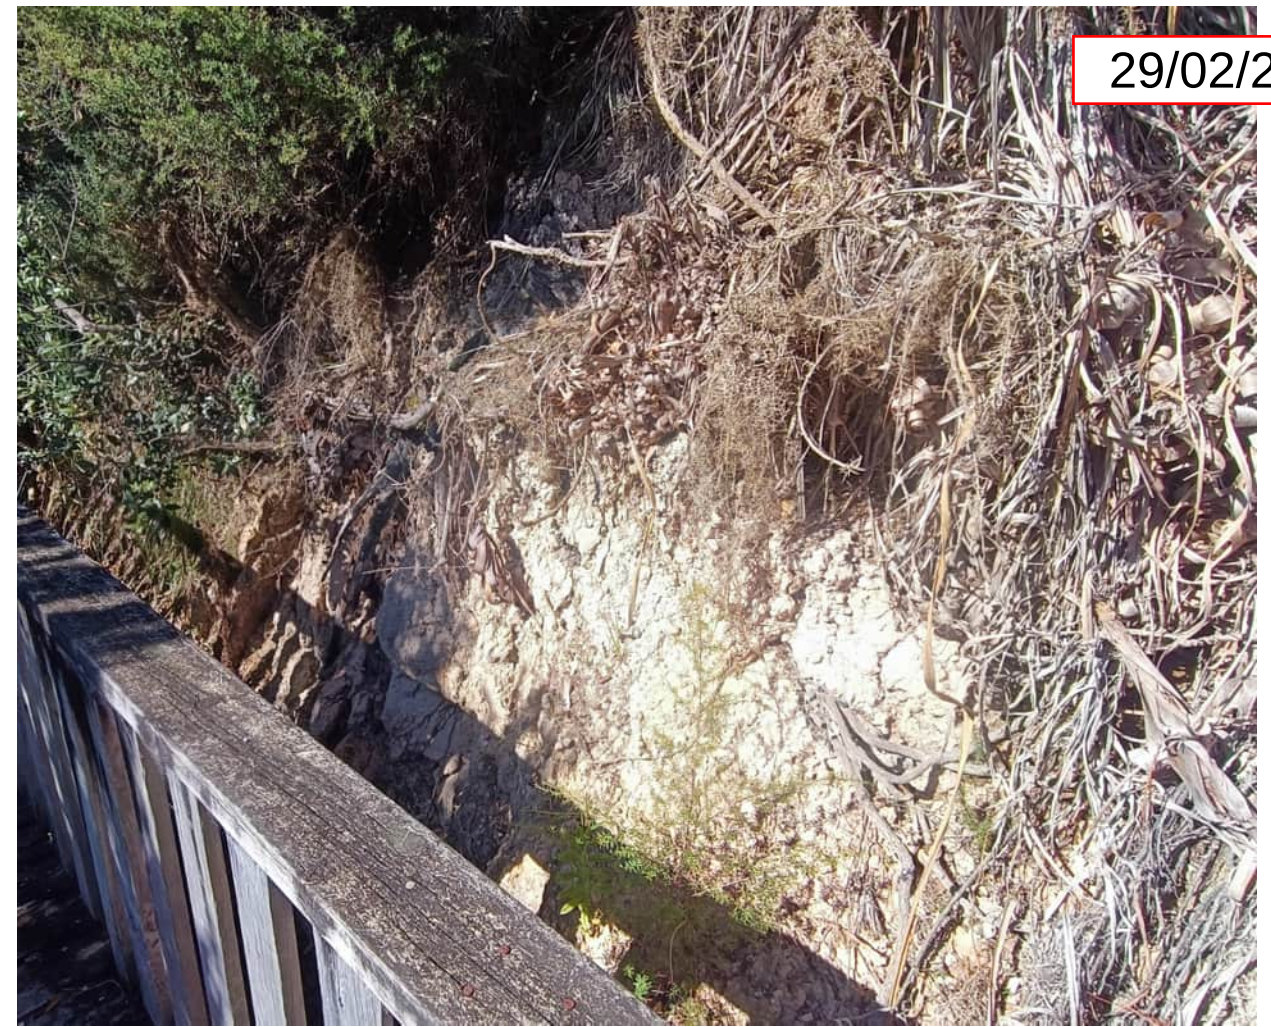
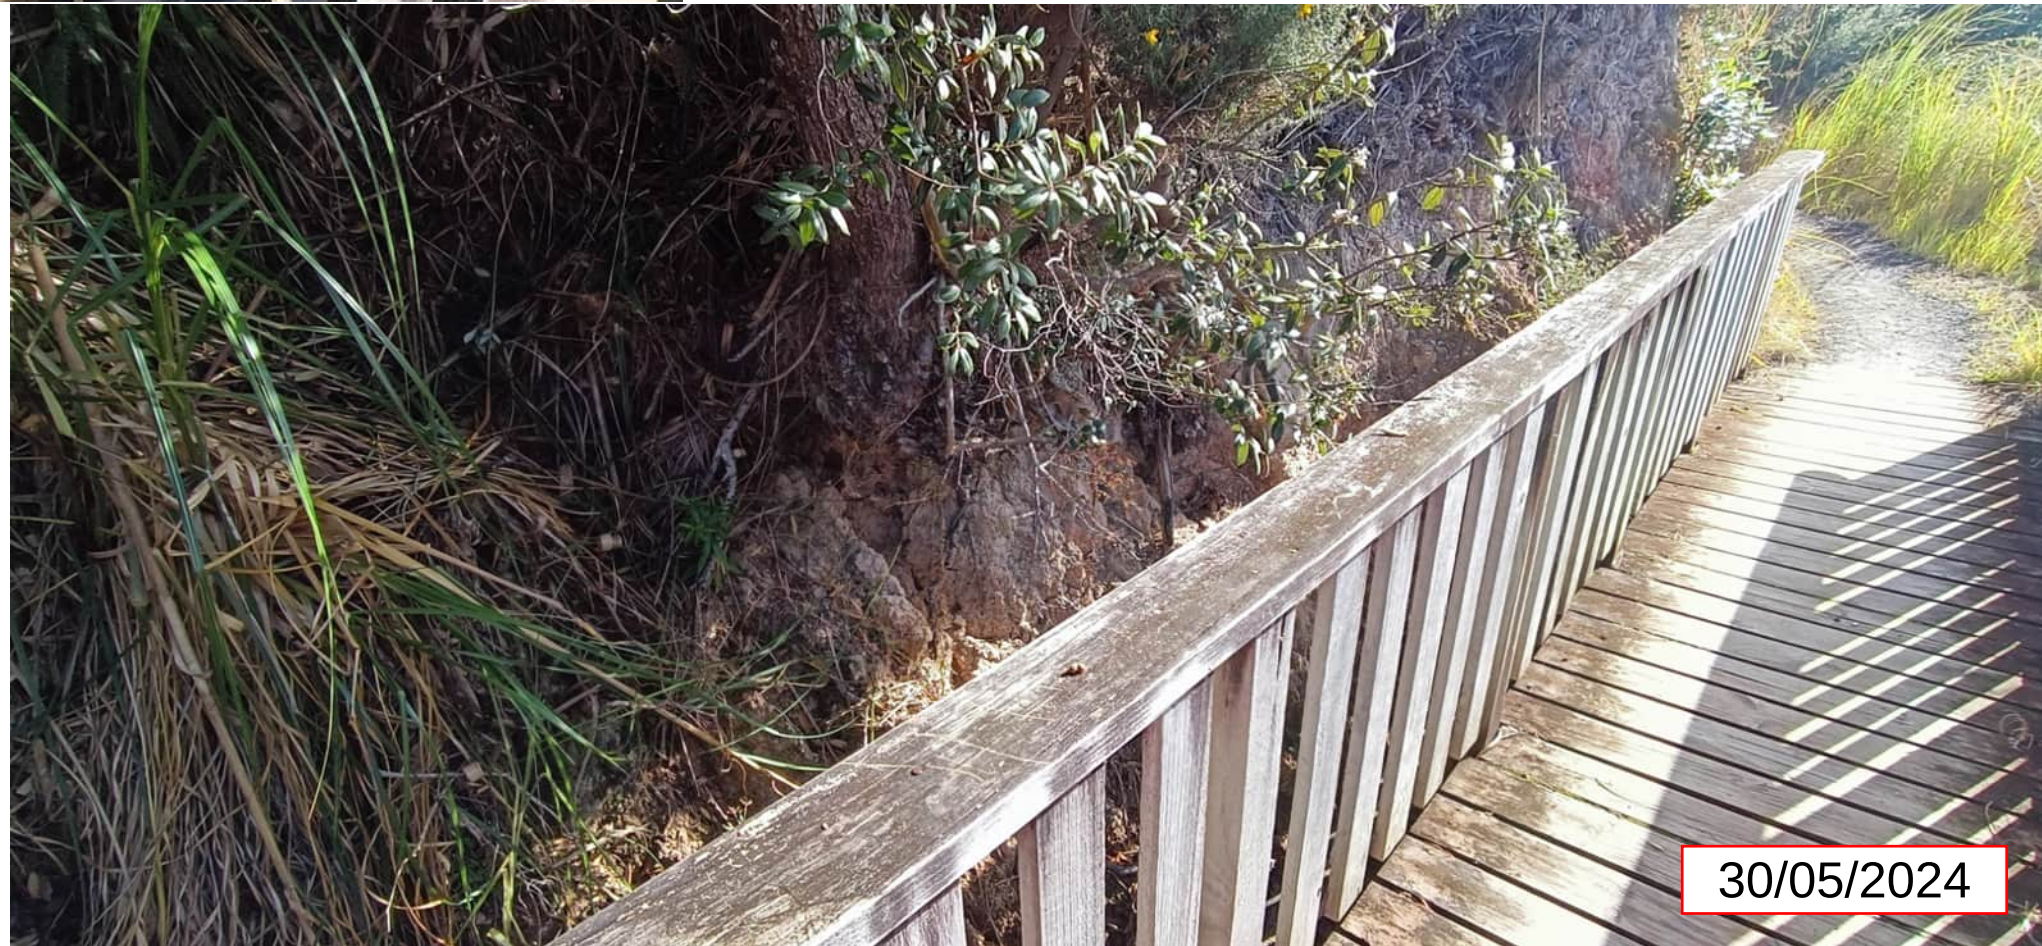
Feature 29 - Historical translational landslide. No new movement of historical landslide. Adjacent slope shows some loose roots

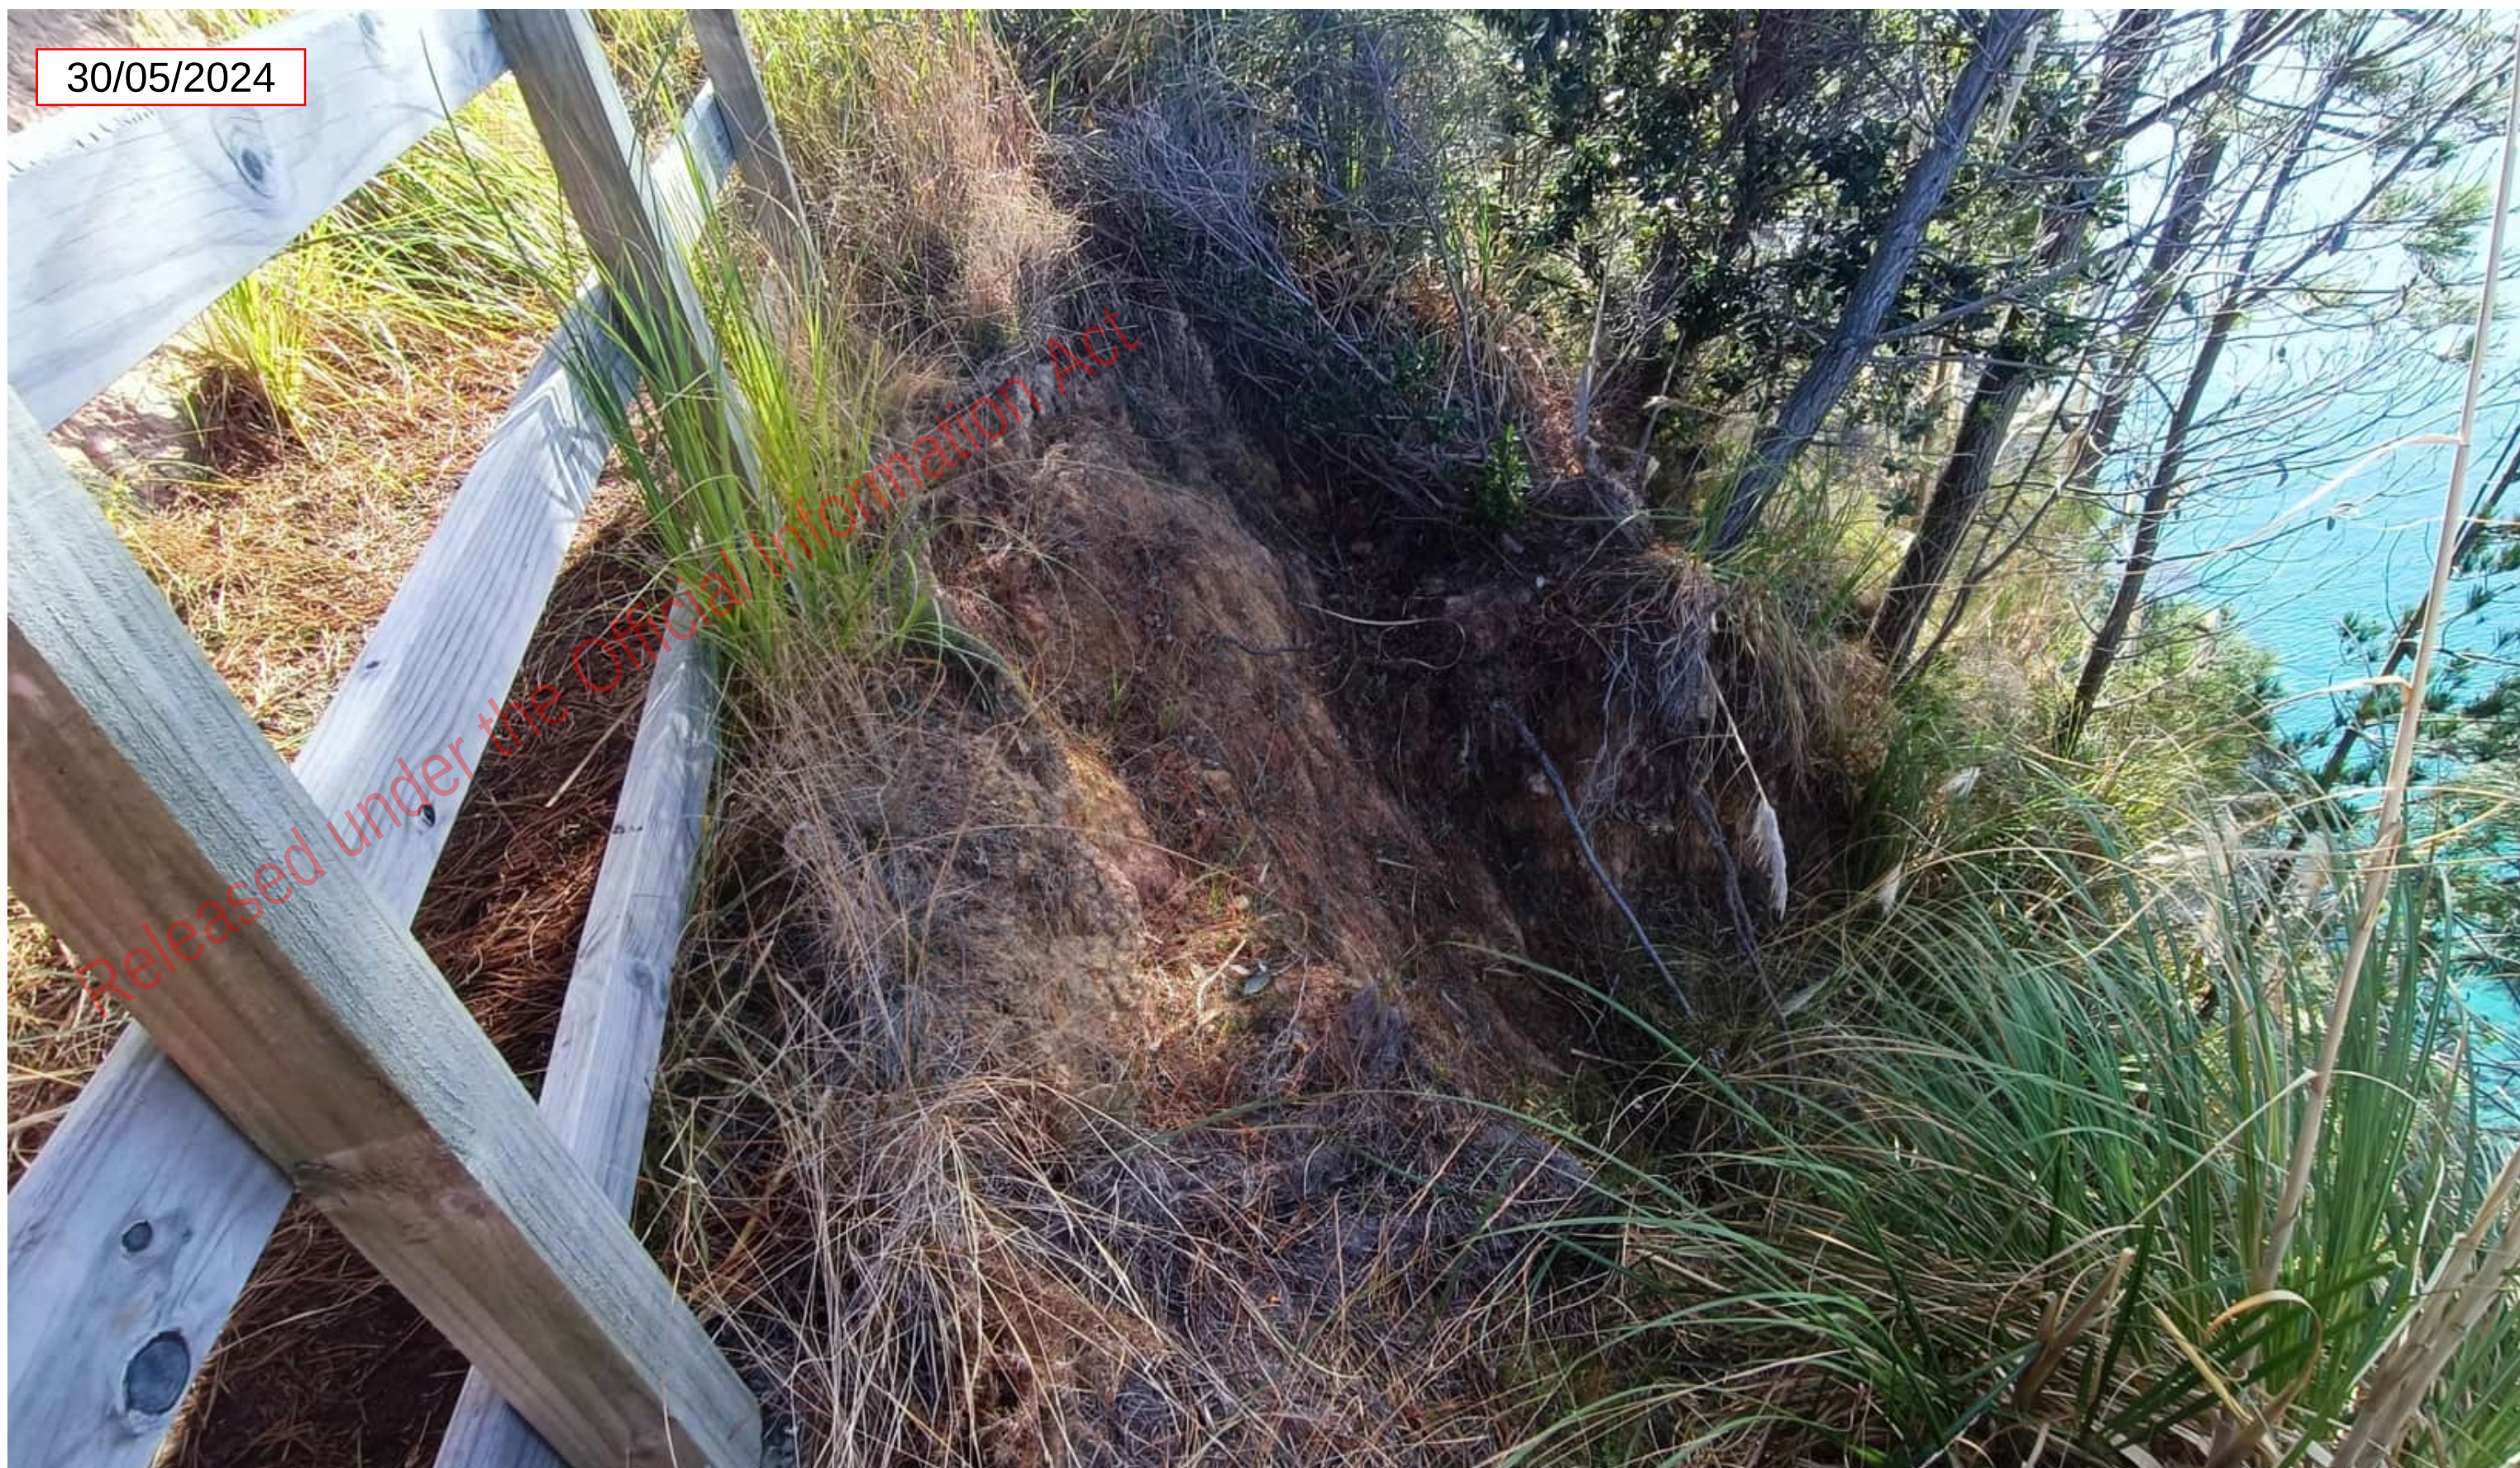
Feature 30 - Translational landslide  
Headscarp is now 150mm away from the  
fence. A new tension crack has formed  
near the Southern end of the fence (193).  
(Observed during Feb 2024 visit).

Feature 30 - Translational landslide  
No new movement observed during May 2024 visit.

| ID | Type_II_Fieldnotes | Type_II | Width_m | Length_overall | Height_overall | Height_of_scarp | Geology | Adopted_volume | Adopted_Age | Method_of_capture | February 2024 monitoring round comments | Feb 2024 Change? | May 2024 monitoring round comments | May 2024 change? |
|---|---|---|---|---|---|---|---|---|---|---|---|---|---|---|
| 30 | Translational | Landslide | 3.5 | 5 | 6 | 0.5 | Residual to extremely weathered rock | 10 | 28/01/2023 | Site observation | New nearby tension crack developed (refer 193). | Y | | |
