**Cathedral Cove Basic Level  
Landslide Risk Assessment**

**Prepared for**  
Department of Conservation  
**Prepared by**  
Tonkin & Taylor Ltd  
**Date**  
July 2023  
**Job Number**  
1007838.3000 v3

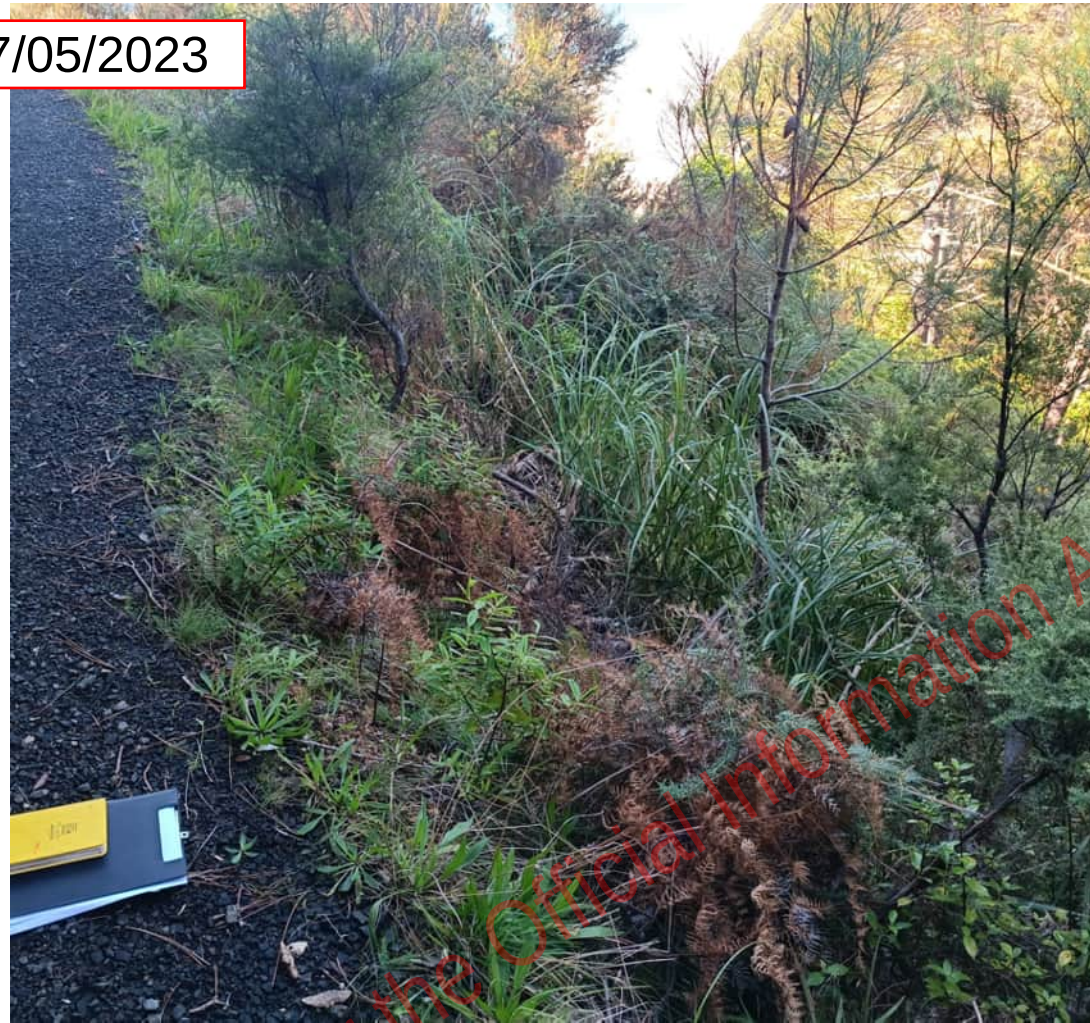
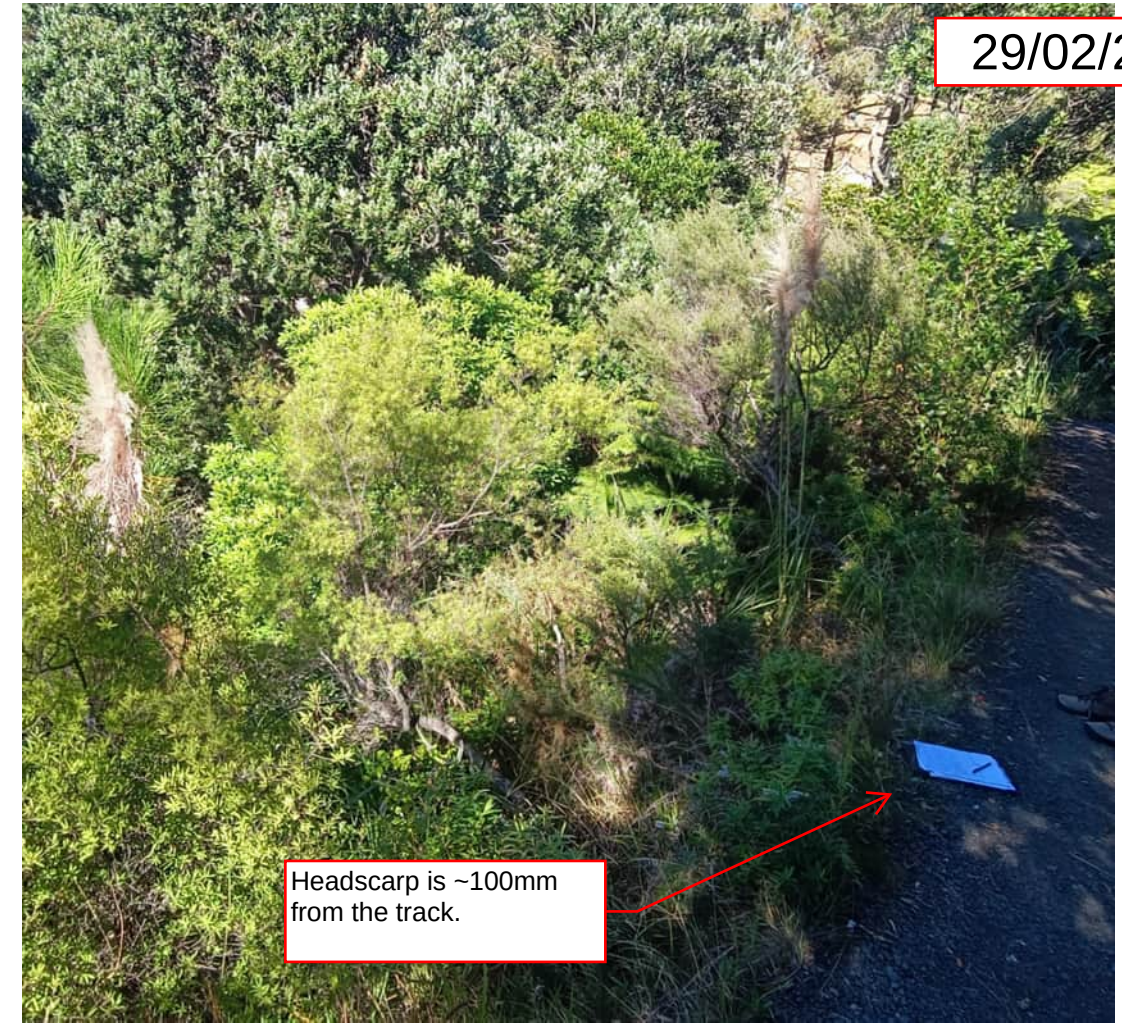
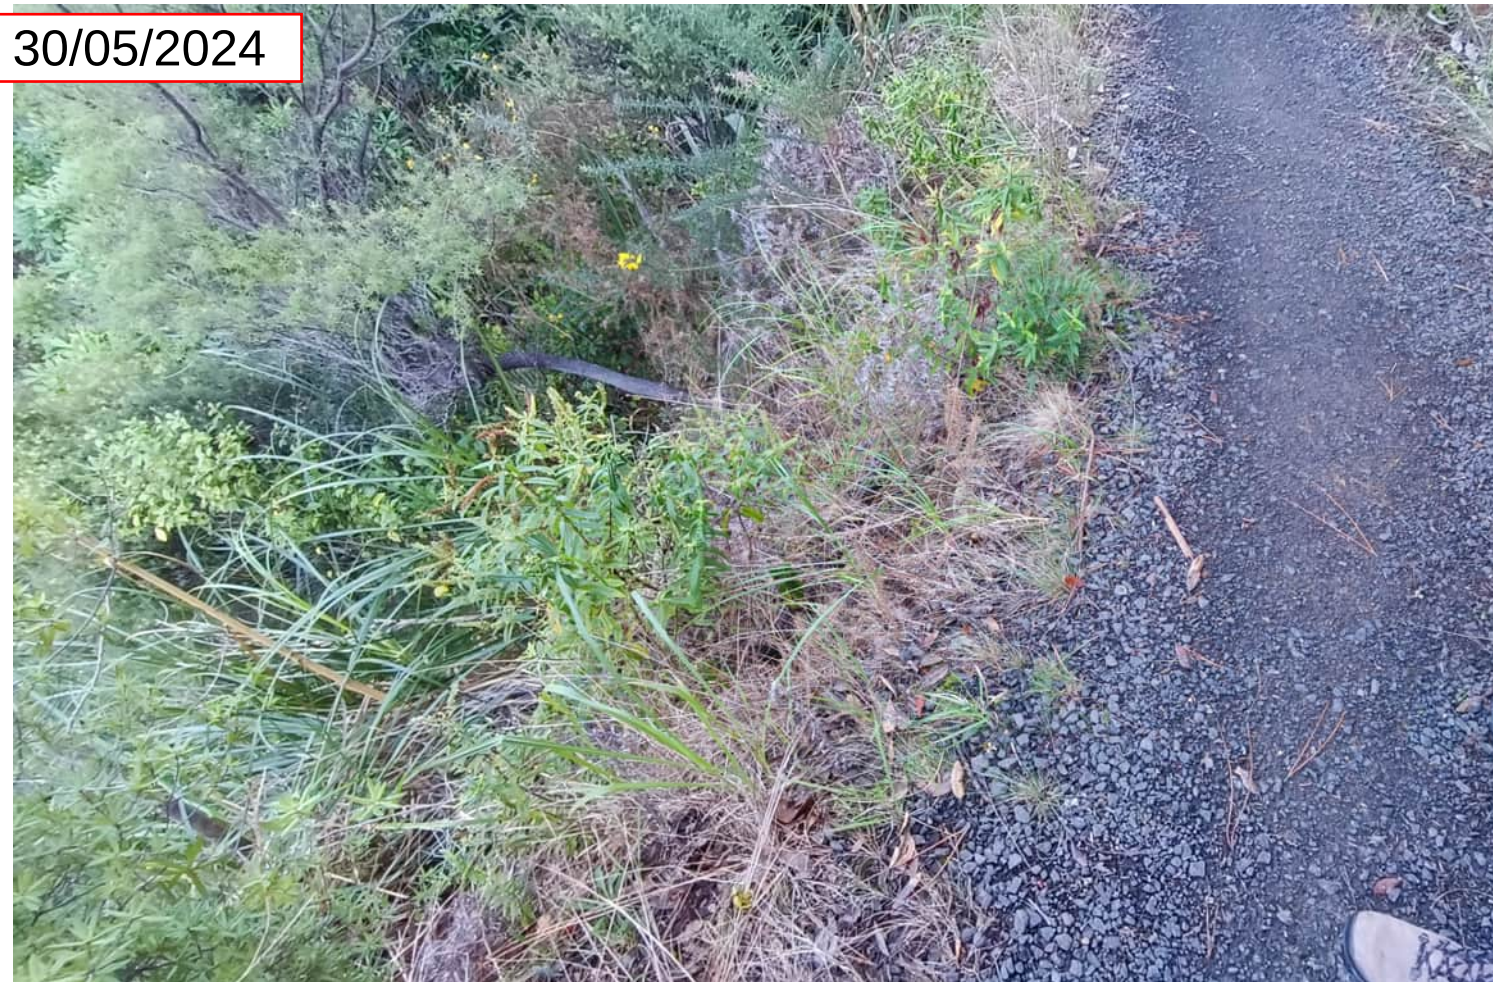
Feature 31 - Historical Translational landslide. No new damage. Well vegetated.

Headscarp is ~100mm from the track.

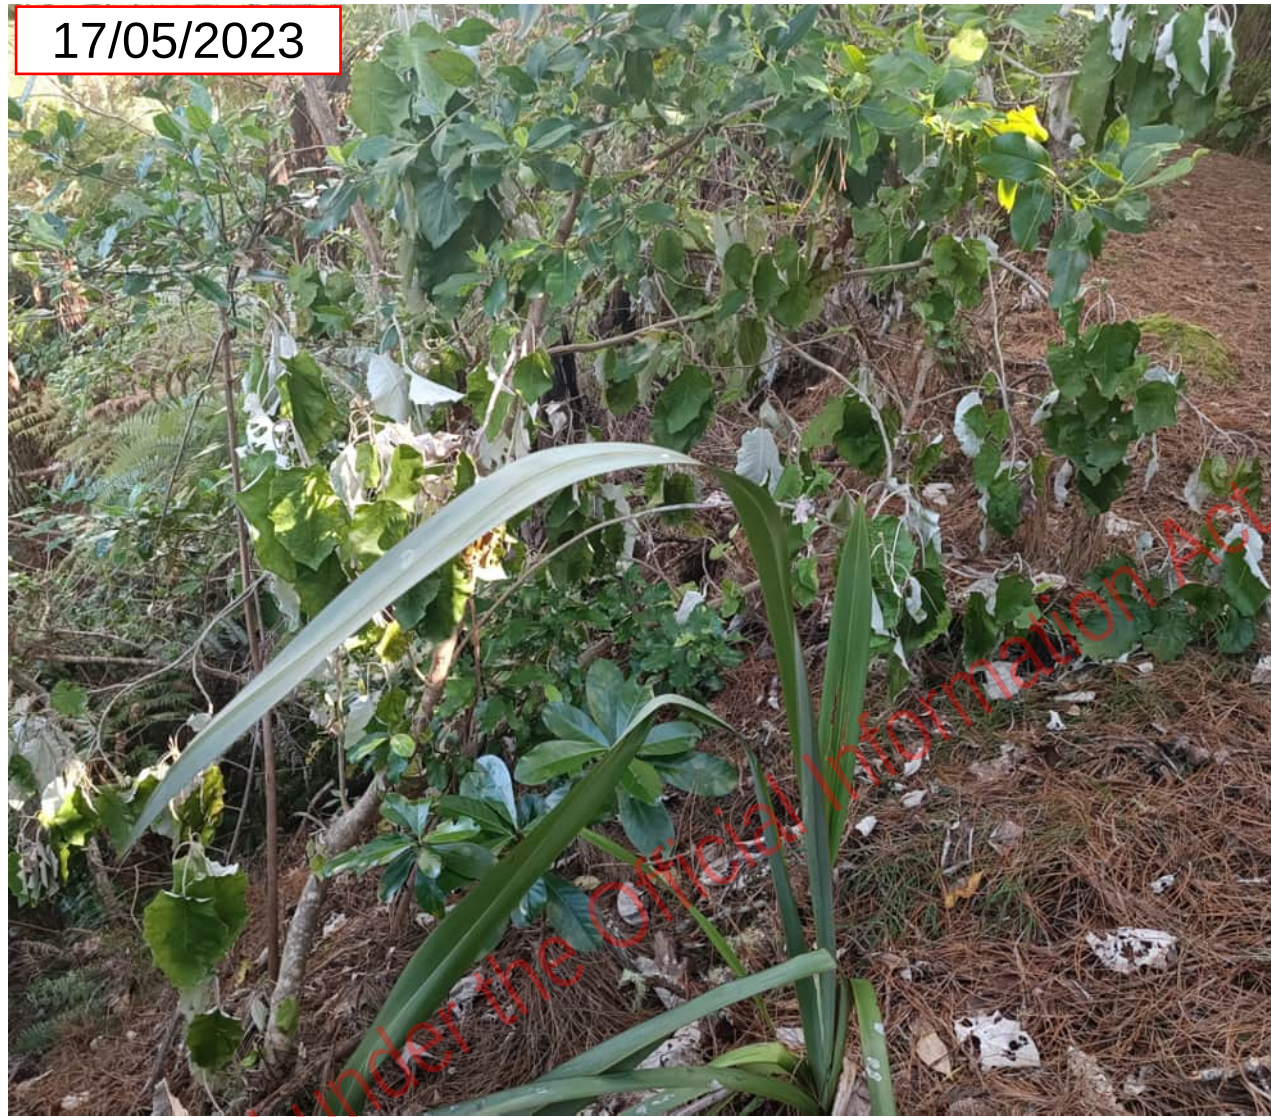
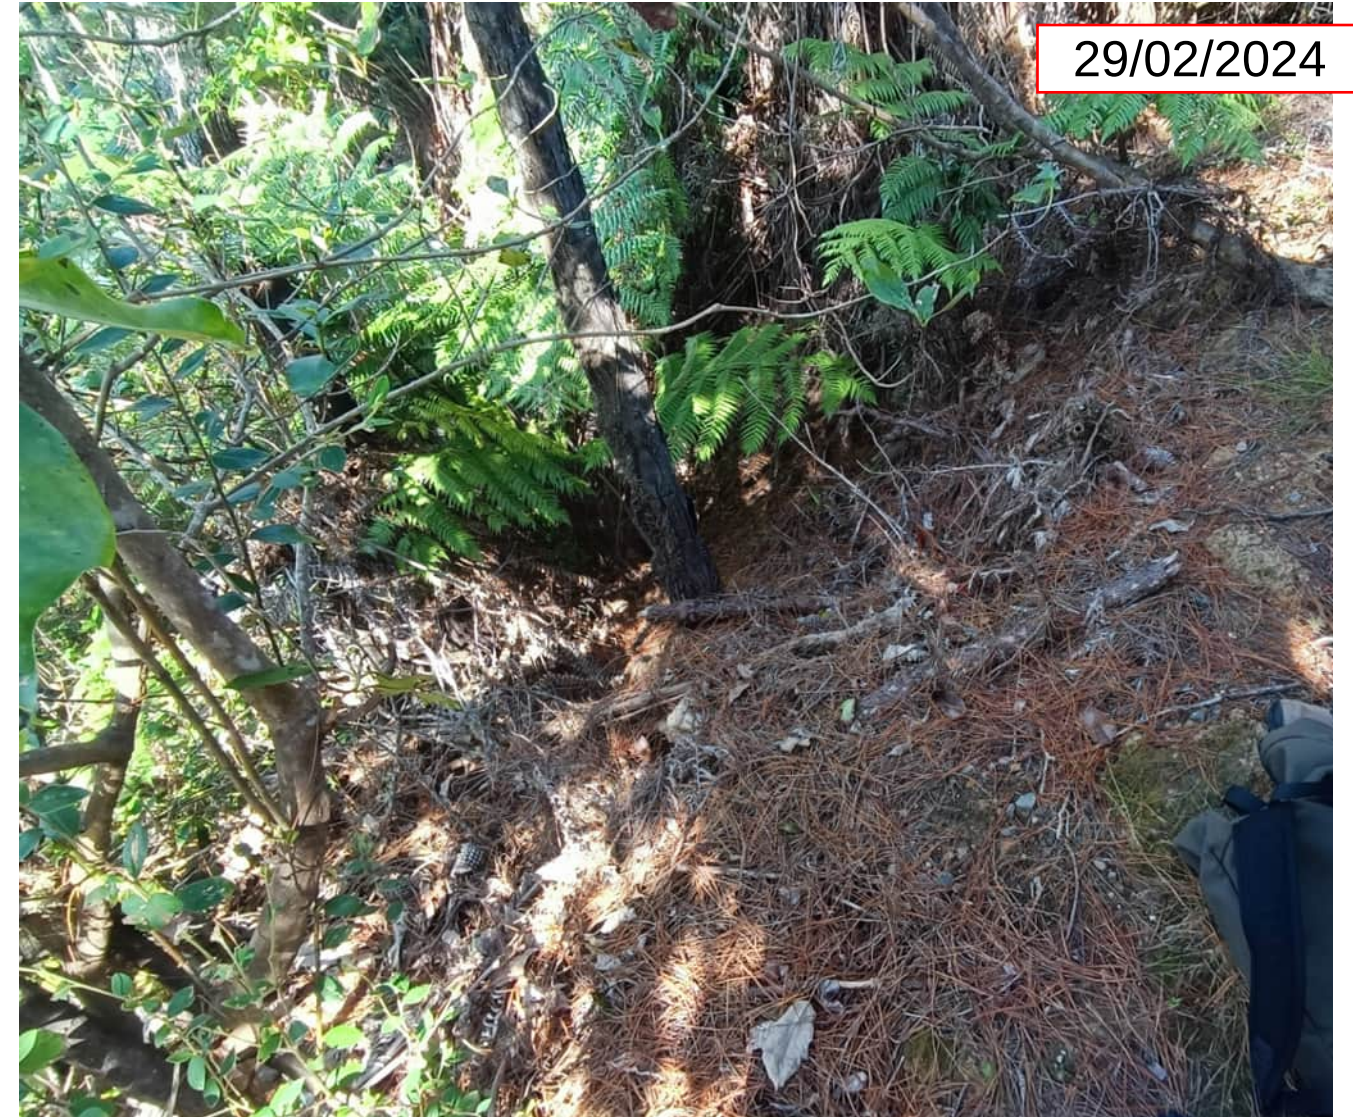
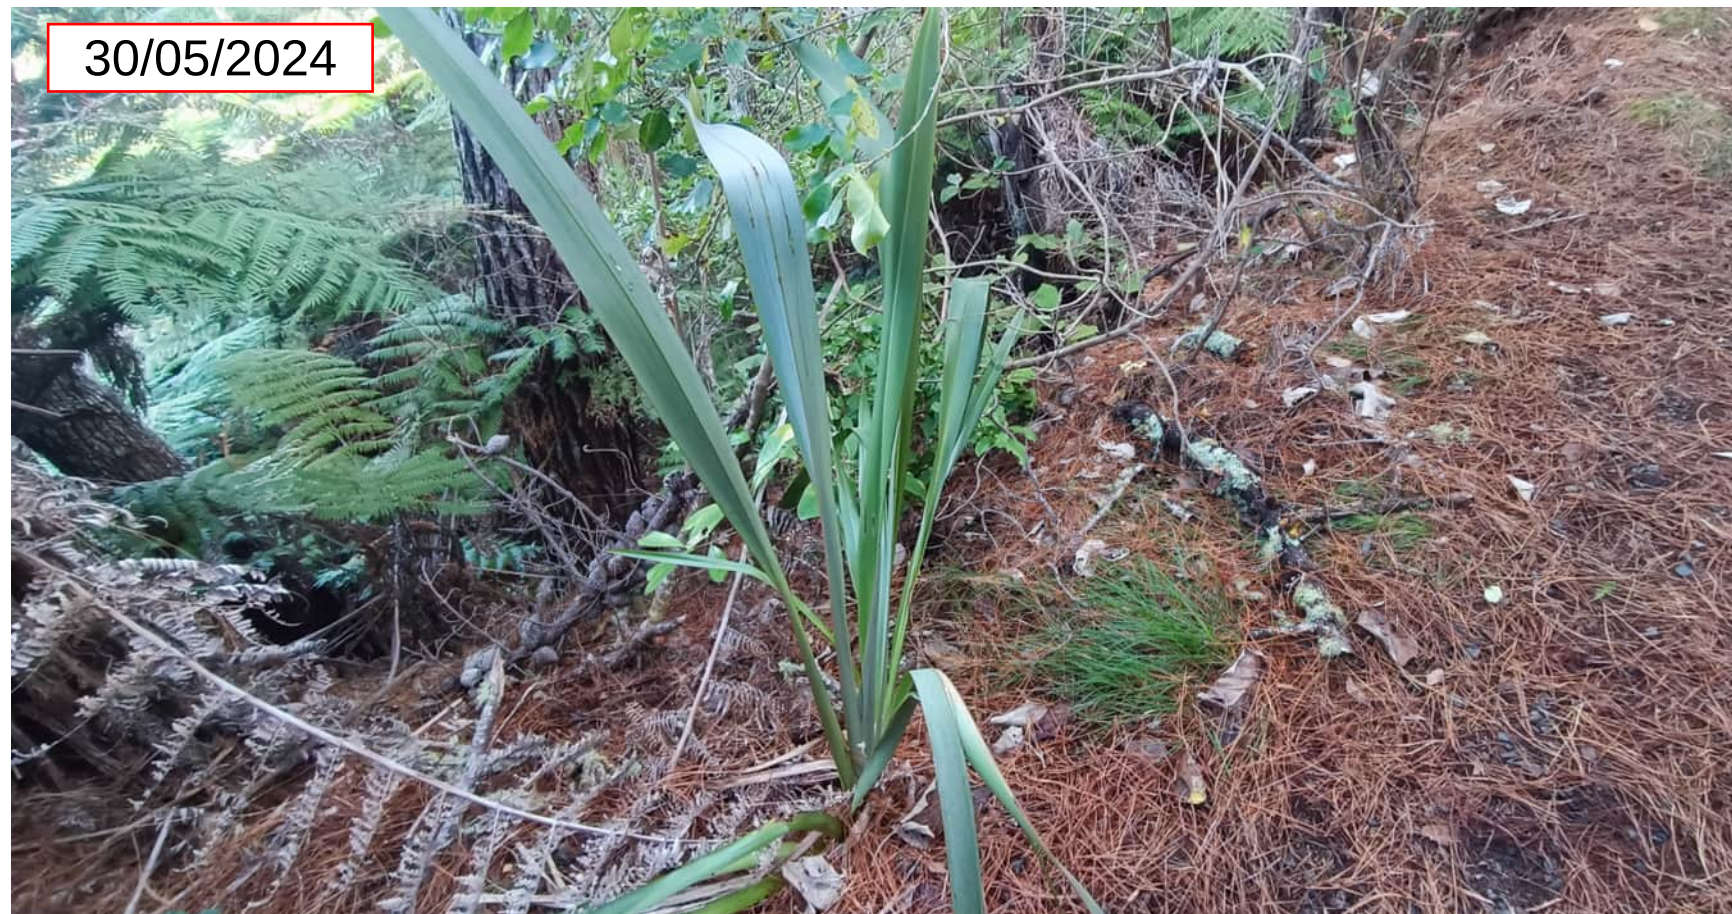
Feature 32 - Historical translational landslide. No new damage, well vegetated.

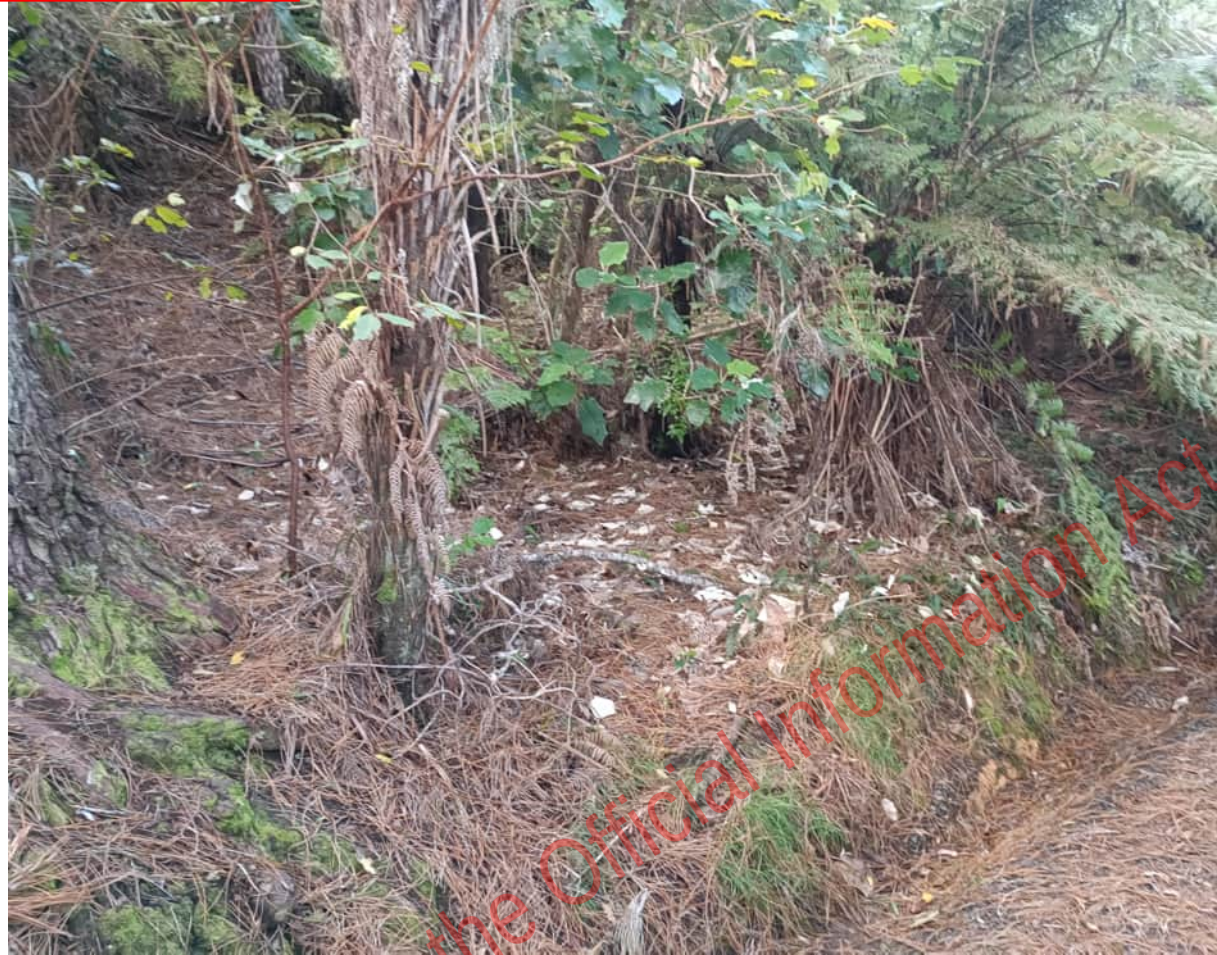
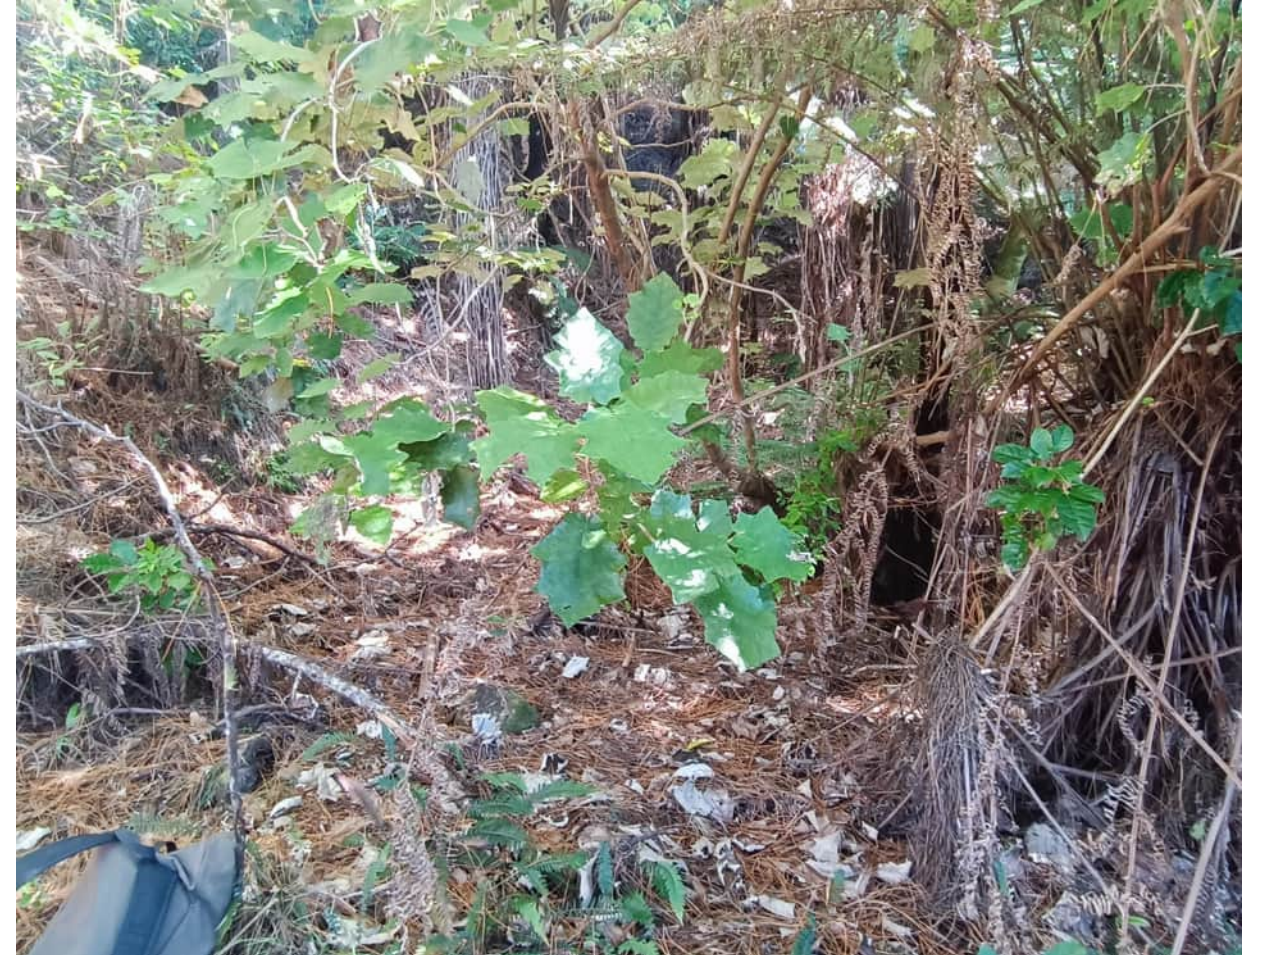
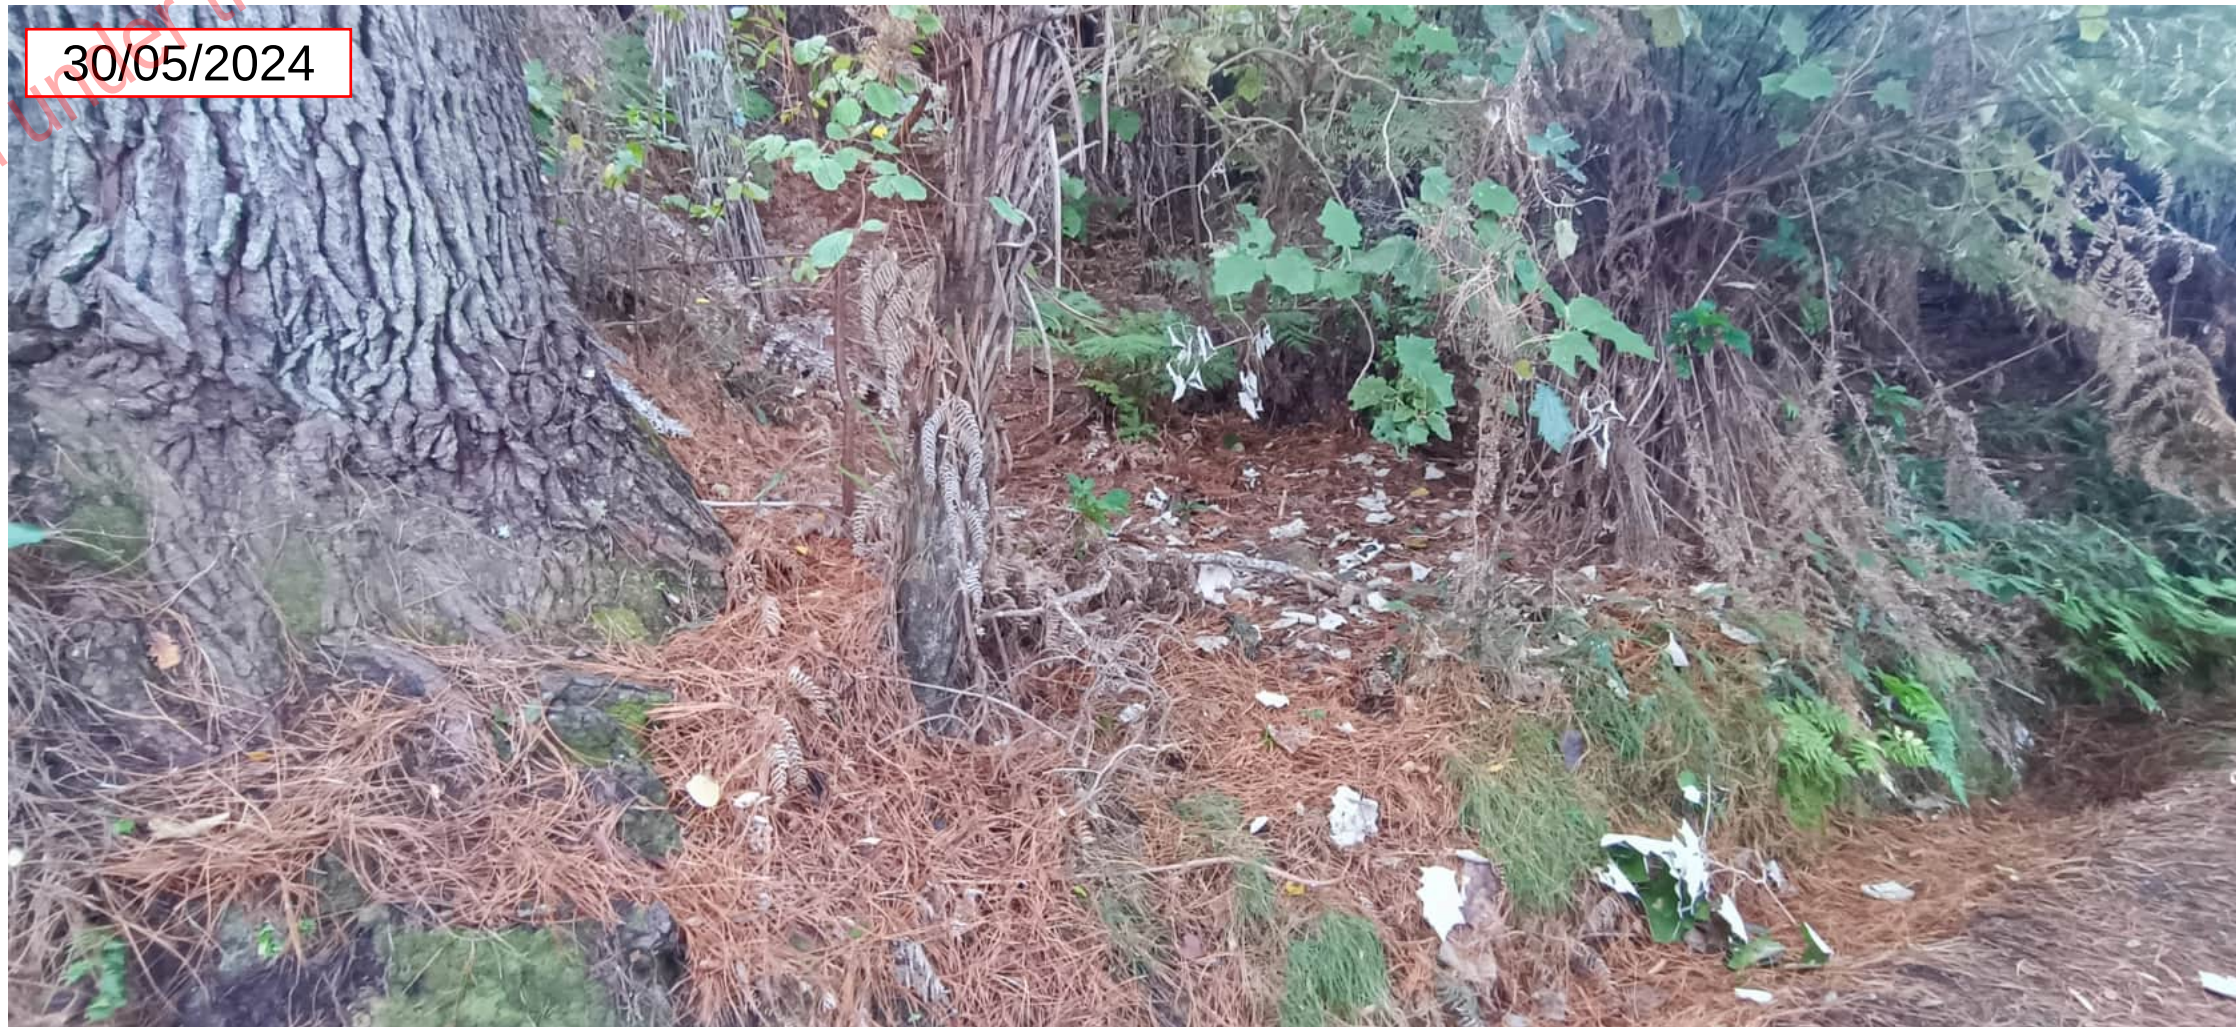
Feature 33 - Historical translational landslide. No new damage, well vegetated.

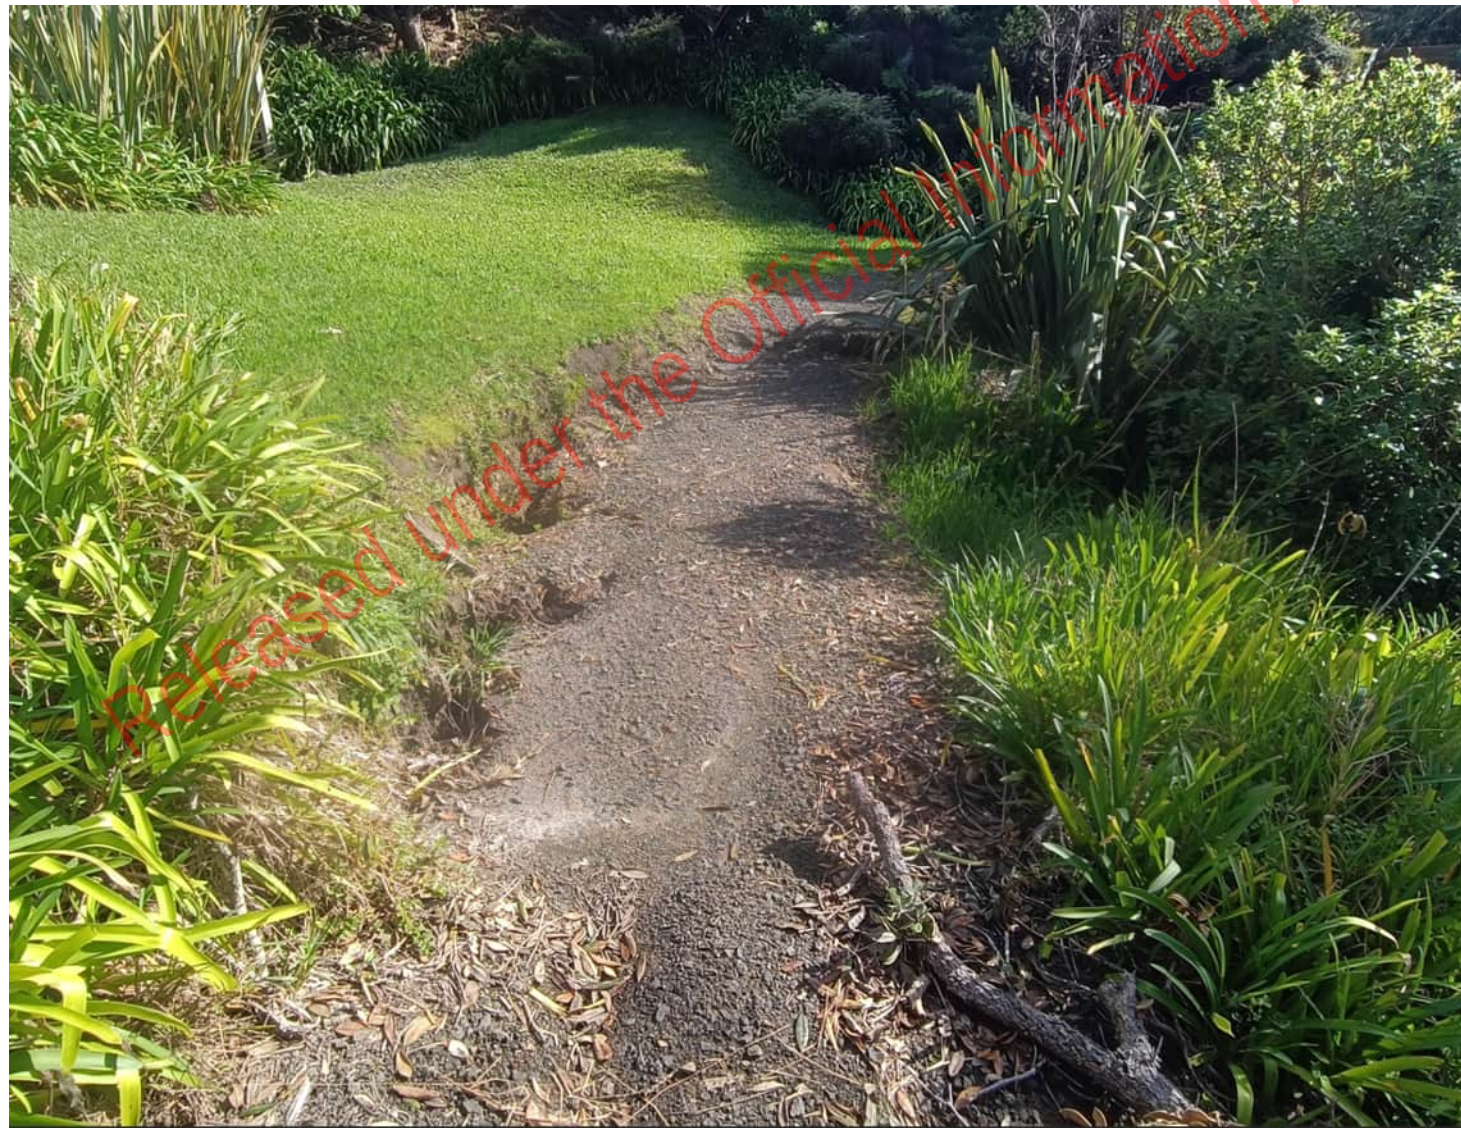
Feature 34 - Rotational slump.  
No new movement observed.

| ID | Type_II_Fieldnotes | Type_II | Width_m | Length_overall | Height_overall | Height_of_scarp | Geology | Adopted_volume | Adopted_Age | Method_of_capture | February 2024 monitoring round comments | Feb 2024 Change? | May 2024 monitoring round comments | May 2024 change? |
|---|---|---|---|---|---|---|---|---|---|---|---|---|---|---|
| 34 | Rotational slump | Landslide | 4 | 3 | 2 | 0.5 | Residual soil | 6 | 28/01/2023 | Site observation | Likely no change. Total existing deflection up to 200 mm. 2 x culverts discharge below track near cracks. | N | | |

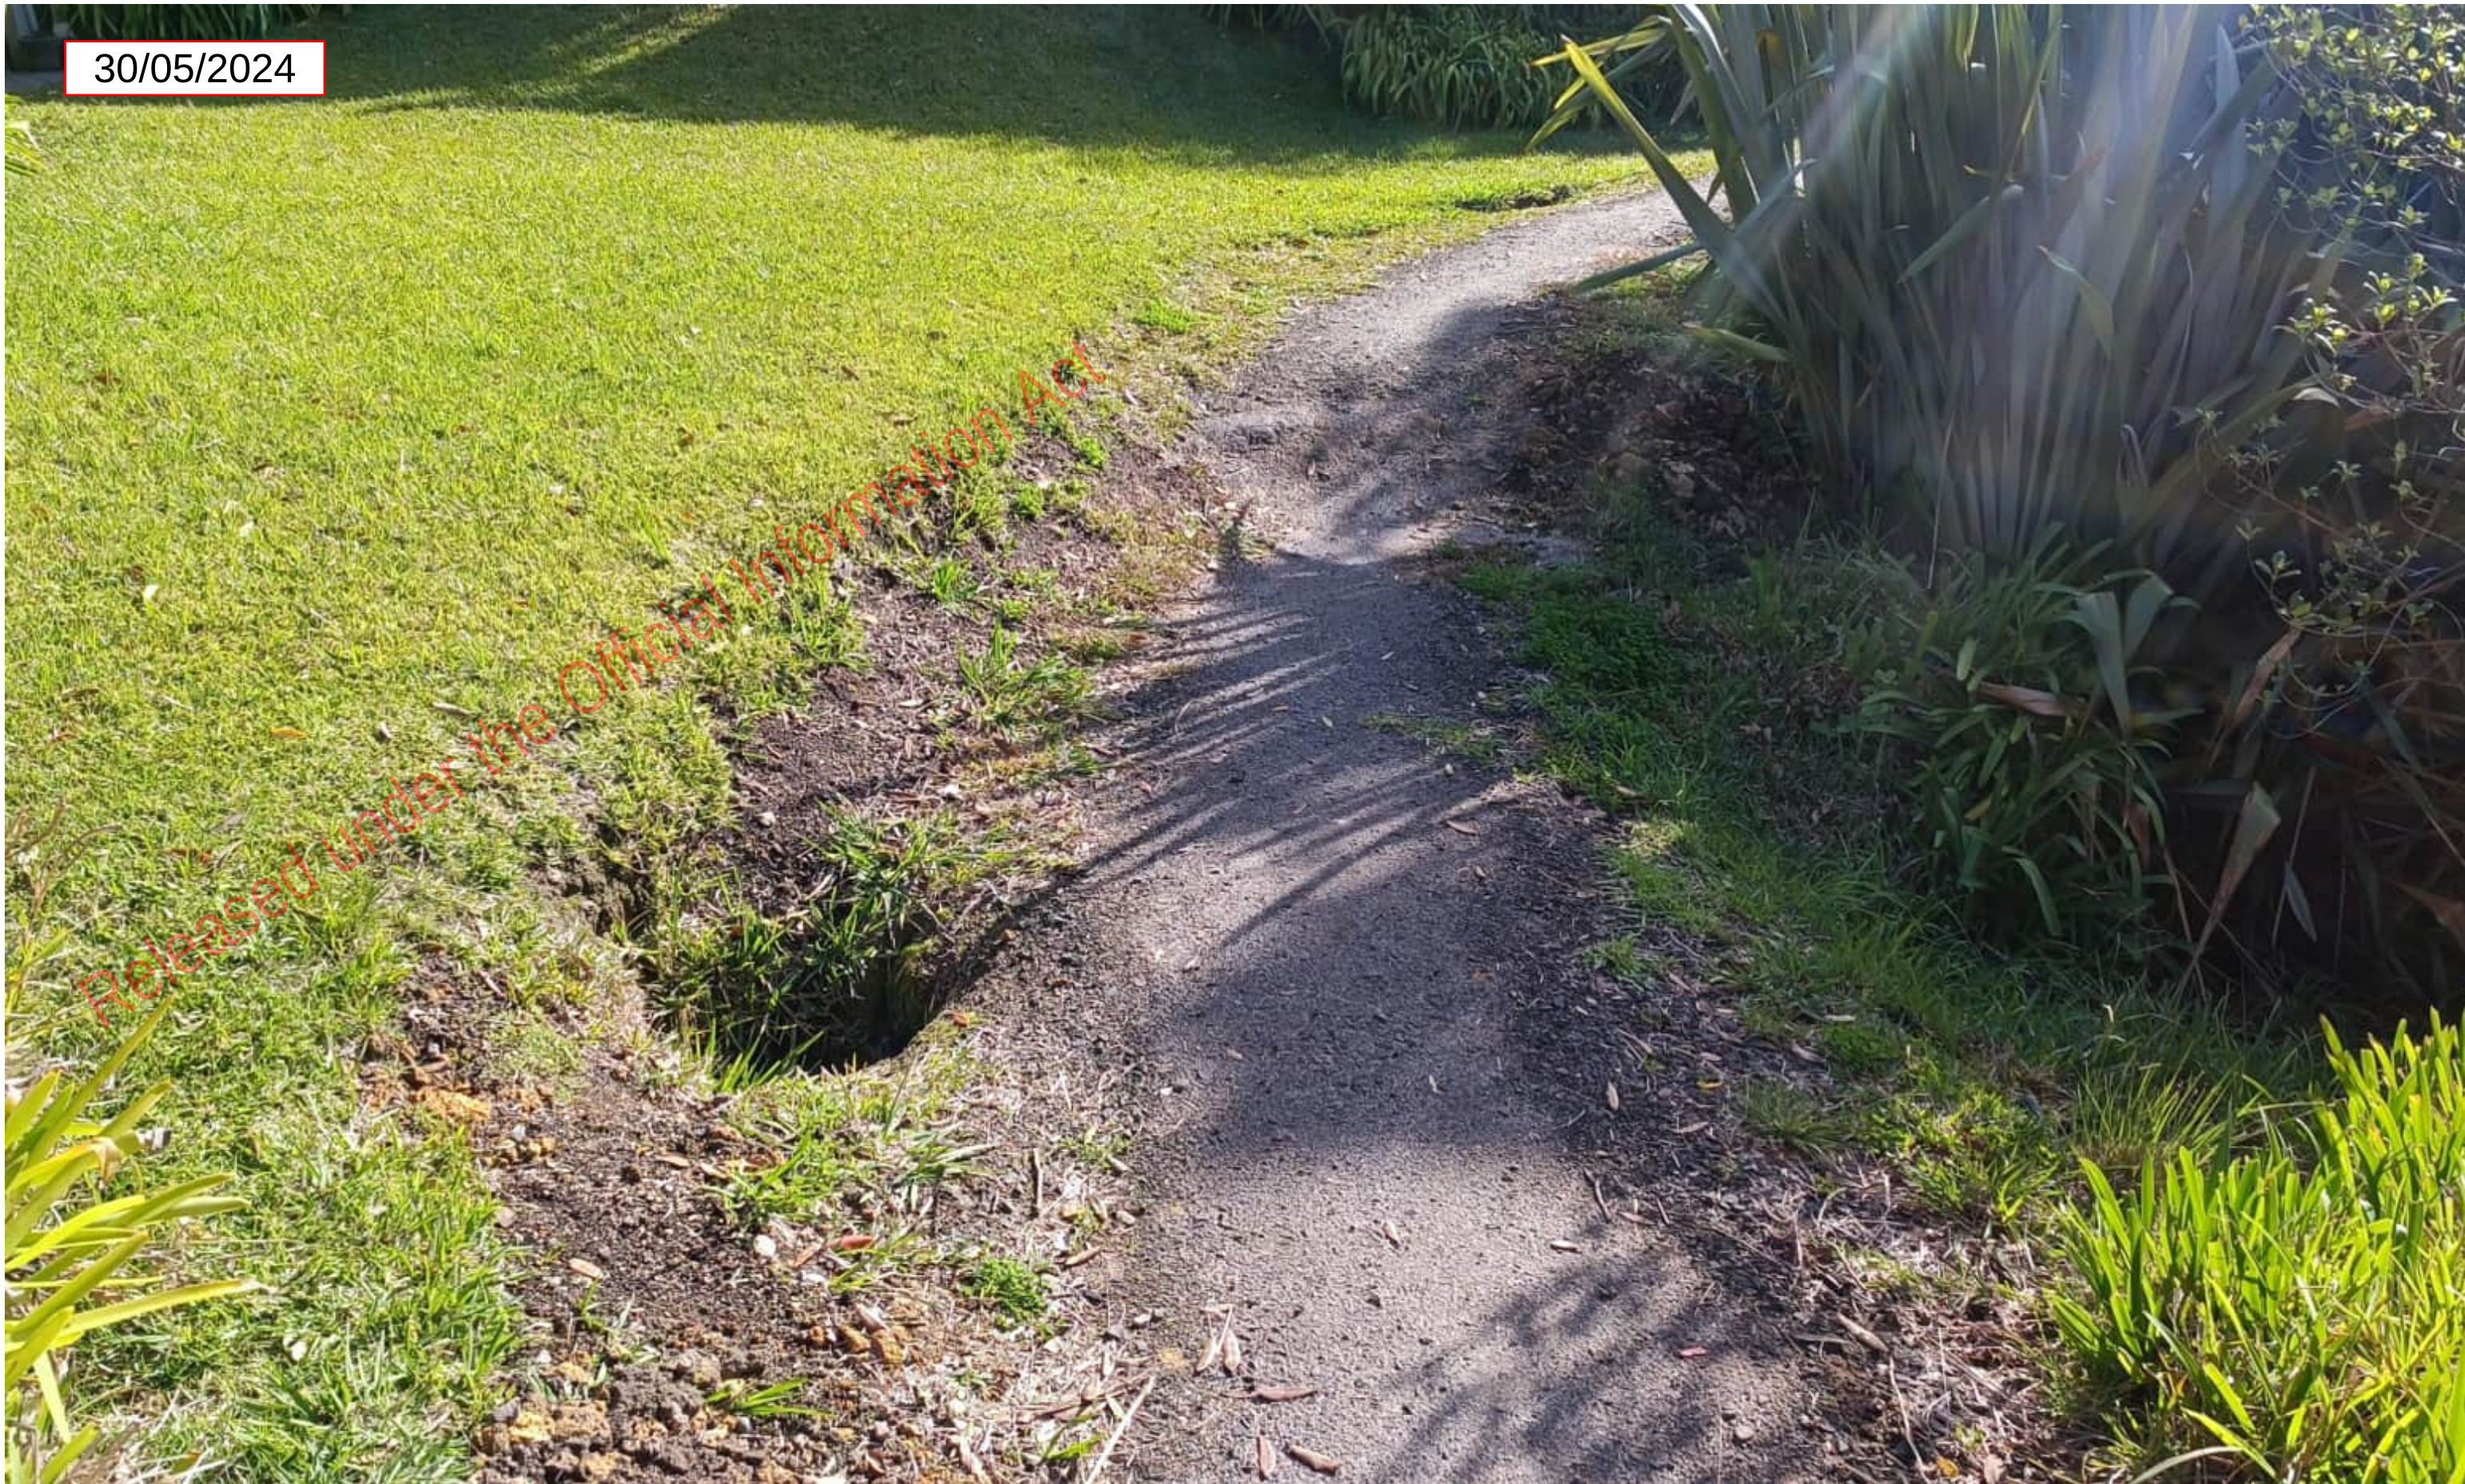
30/05/2024

Feature 35 - Translational landslide where ignimbrite abuts rhyolite.  
No new movement observed.

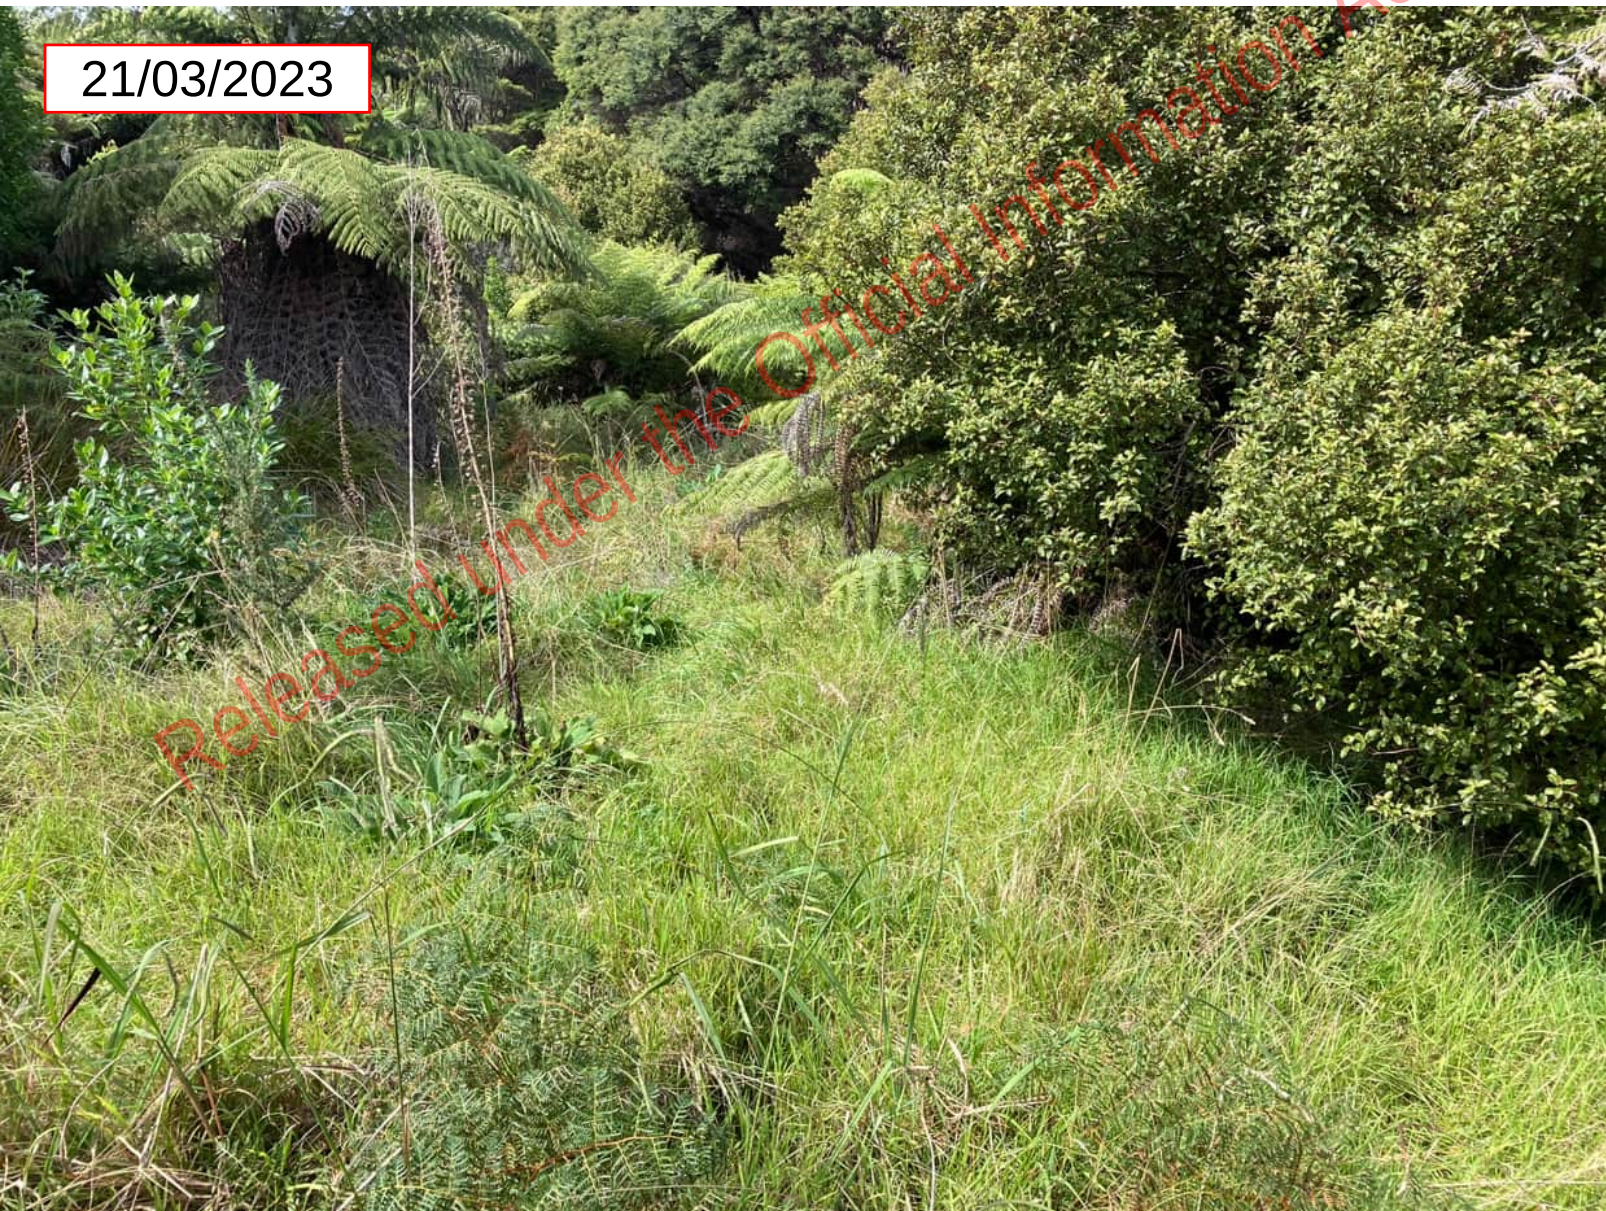
21/03/2023

Feature 39 - Translational landslide  
No new movement, scrubby and vegetated

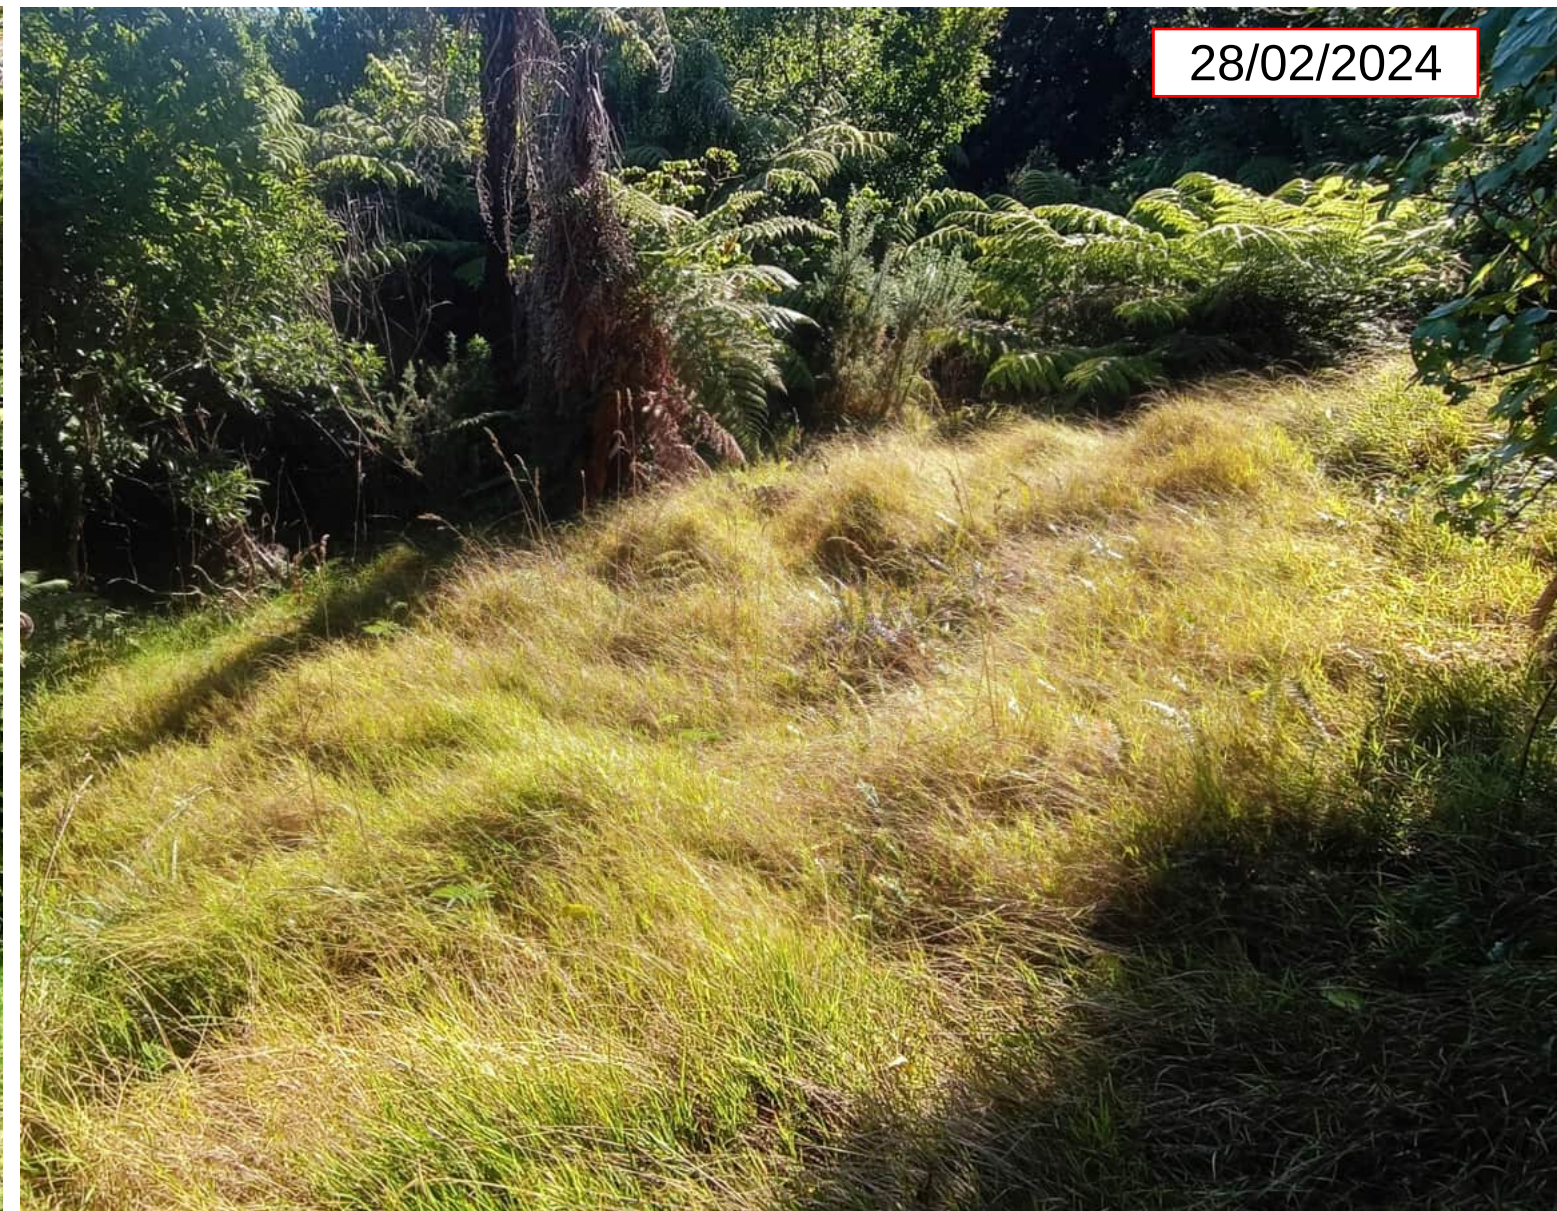
28/02/2024

Feature 53 - Tension crack/creep.  
No new movement of the tension crack  
observed. Current aperture  
approximately 50mm, no deflection.  
(Observed during Feb 2024 visit).

| ID | Type_II_Fieldnotes | Type_II | Width_m | Length_overall | Height_overall | Height_of_scarp | Geology | Adopted_volume | Adopted_Age | Method_of_capture | February 2024 monitoring round comments | Feb 2024 Change? | May 2024 monitoring round comments | May 2024 change? |
|---|---|---|---|---|---|---|---|---|---|---|---|---|---|---|
| 53 | Tension crack | Creep | 0.05 | 10 | 1 | 1 | Residual soil | - | 28/01/2023 | Site observation | 2 x cracks at each end (1 additional) suggest the creep is wider (10m wider than thought and has bowed out toward RTW). These are likely associated with 2023 events. | N | | |
